XE 6006J

| Affiliated to Federation Internationale Des Experts En Automobile | | | |
|---|---|---|---|
| MSIG INSURANCE (SINGAPORE) PTE LTD | | Ref : CS/MSG17003854/R1qb | |

**XE6006J - Submitted by: LKK Auto Consultants Pte Ltd (HQ)**

**VEHICLE DAMAGE INSPECTION REPORT**

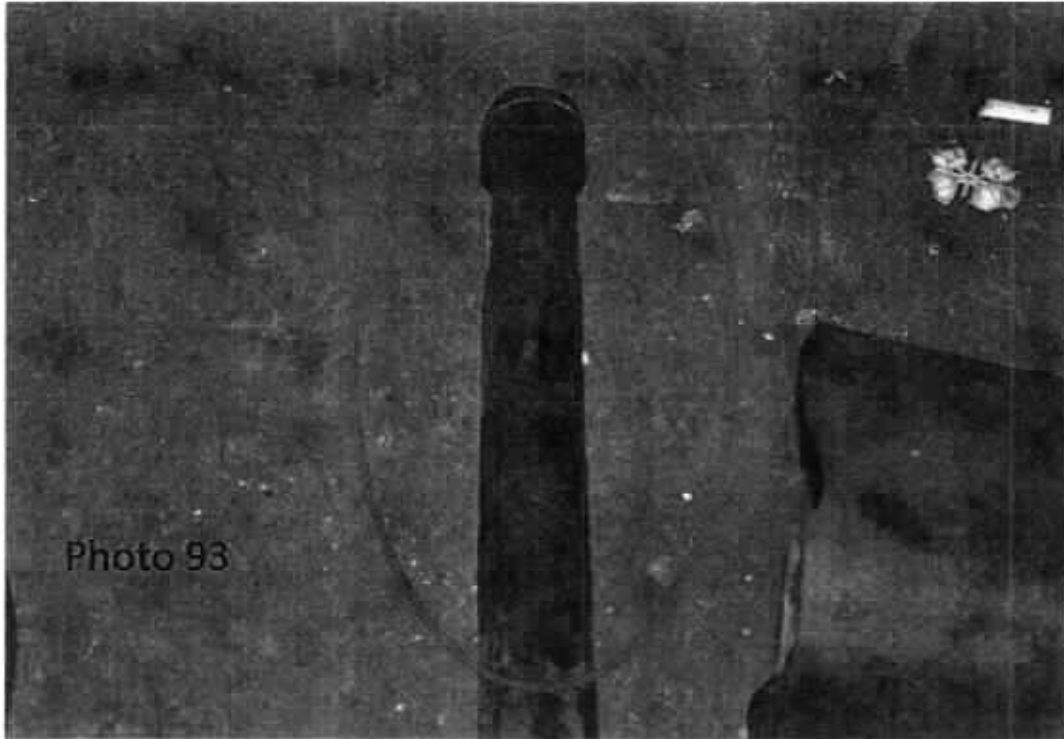
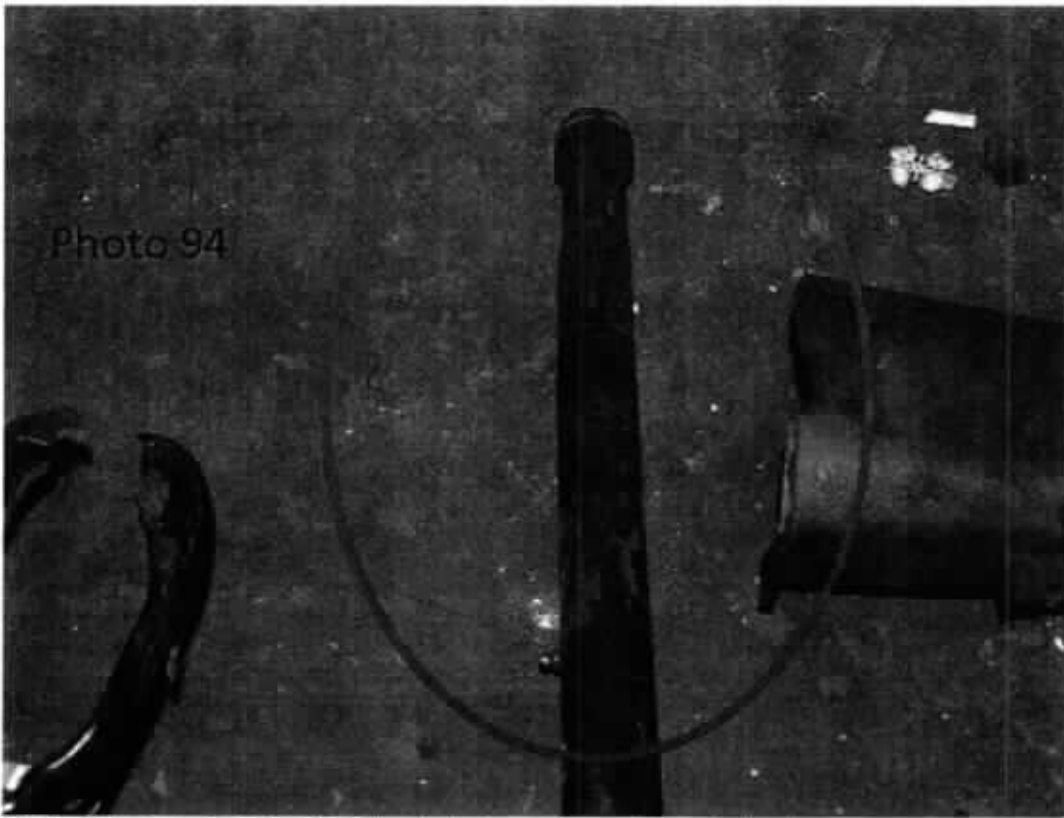
We refered to Mr K. K. Lau  
explanation at your good office this  
afternoon. The damages to the  
steering shaft and related were  
due to the "induced damage"  
as the a results of impact at  
the cabin & floor board panel.

Photo 92 to 94 - Steering Shaft bent, during re-inspection checked.

1) The damage was on the front RH portion. The damages was on the steering linkages side near to the driver side. Due to the impact, possibility the steering shaft will bend.

2) During the physical inspection, I observed the steering wheel by turning it left or right, found irregular movements, ± for the checked & looked at the underneath it was damaged,

Shoot picture  
unable to get a close-up due to  
blockage. (See photos 66)  
However, during the reinspection confirmed  
it was bent & beyond repair.

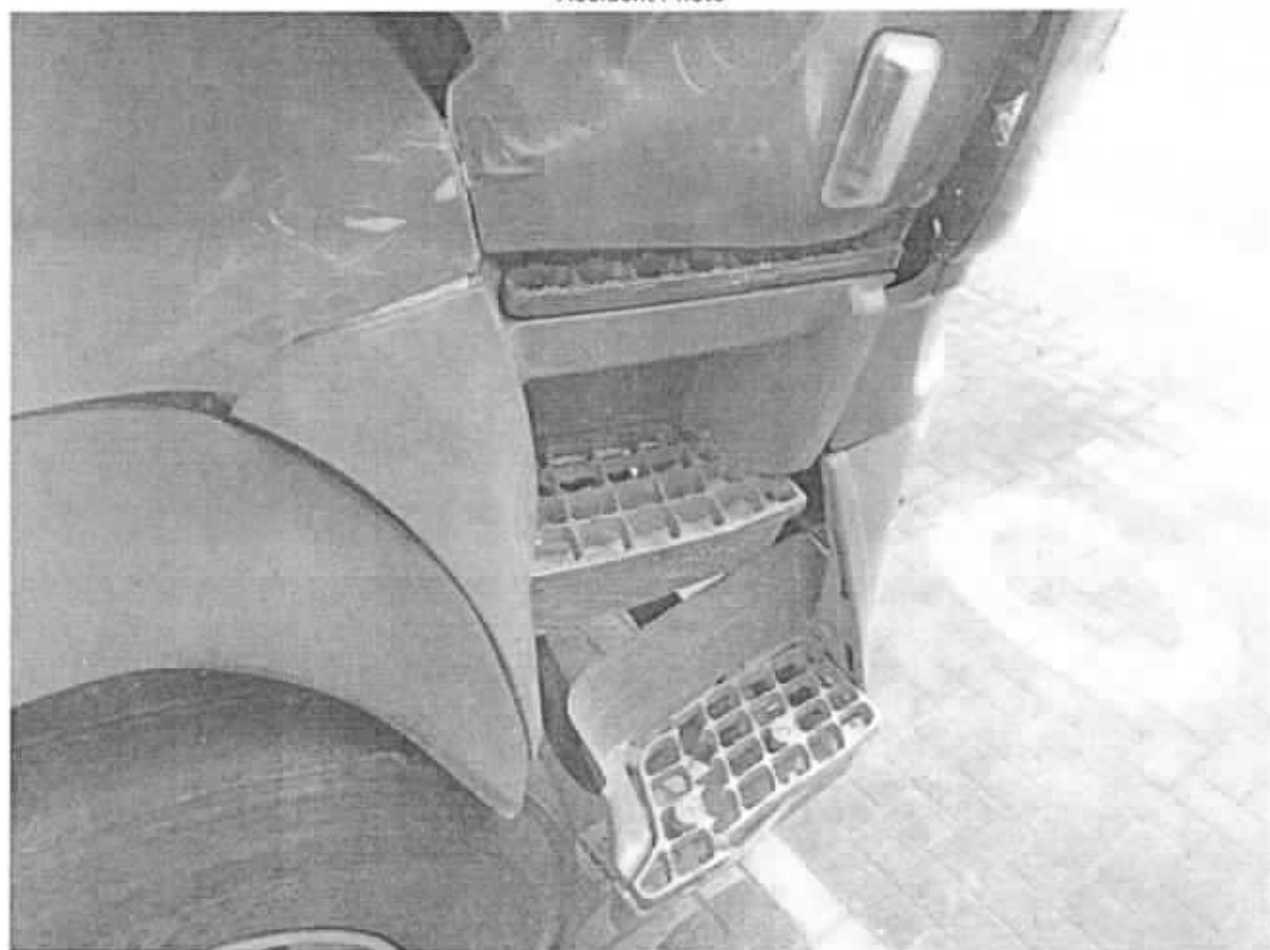
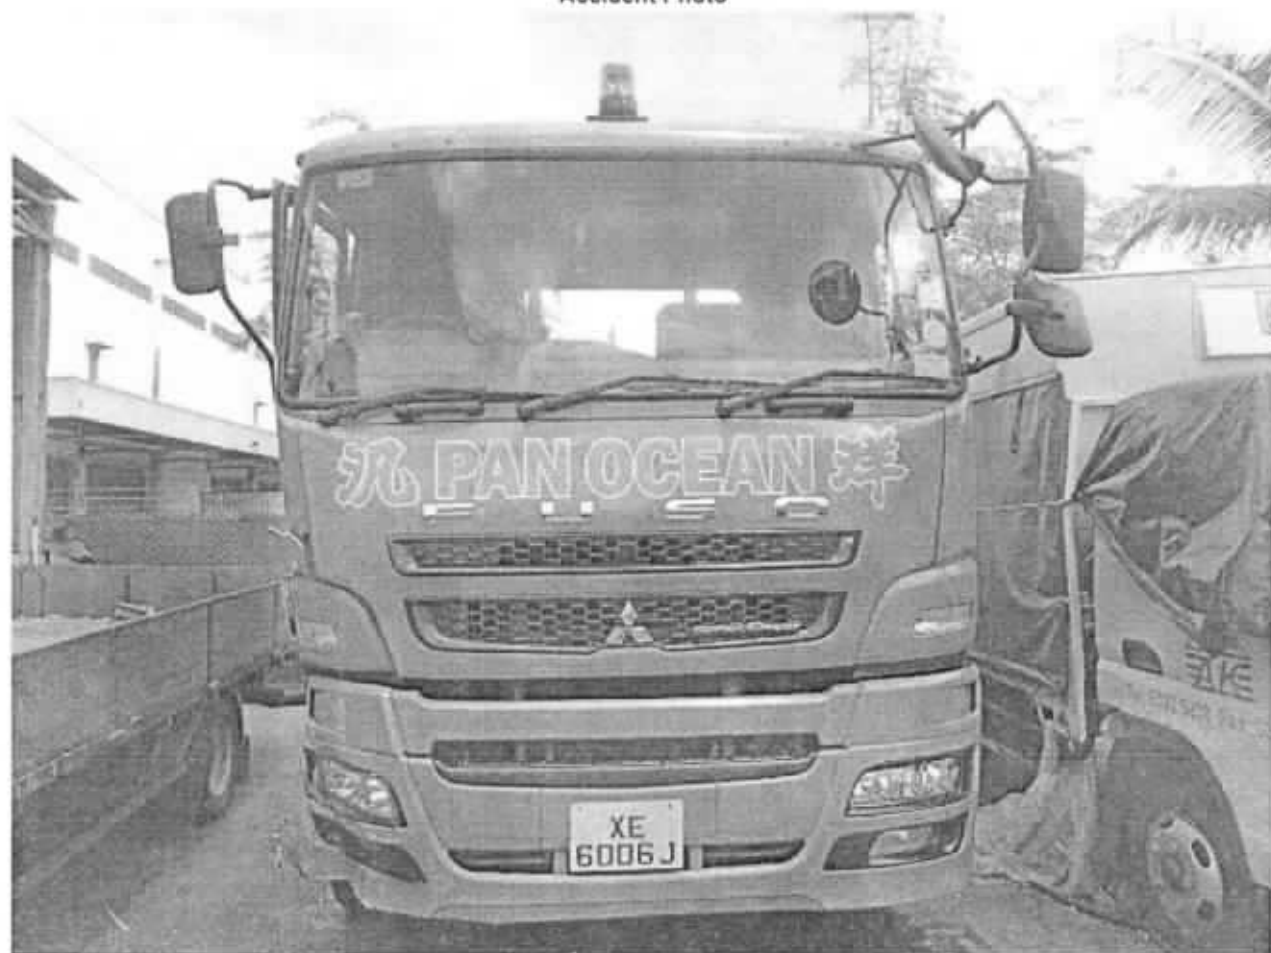
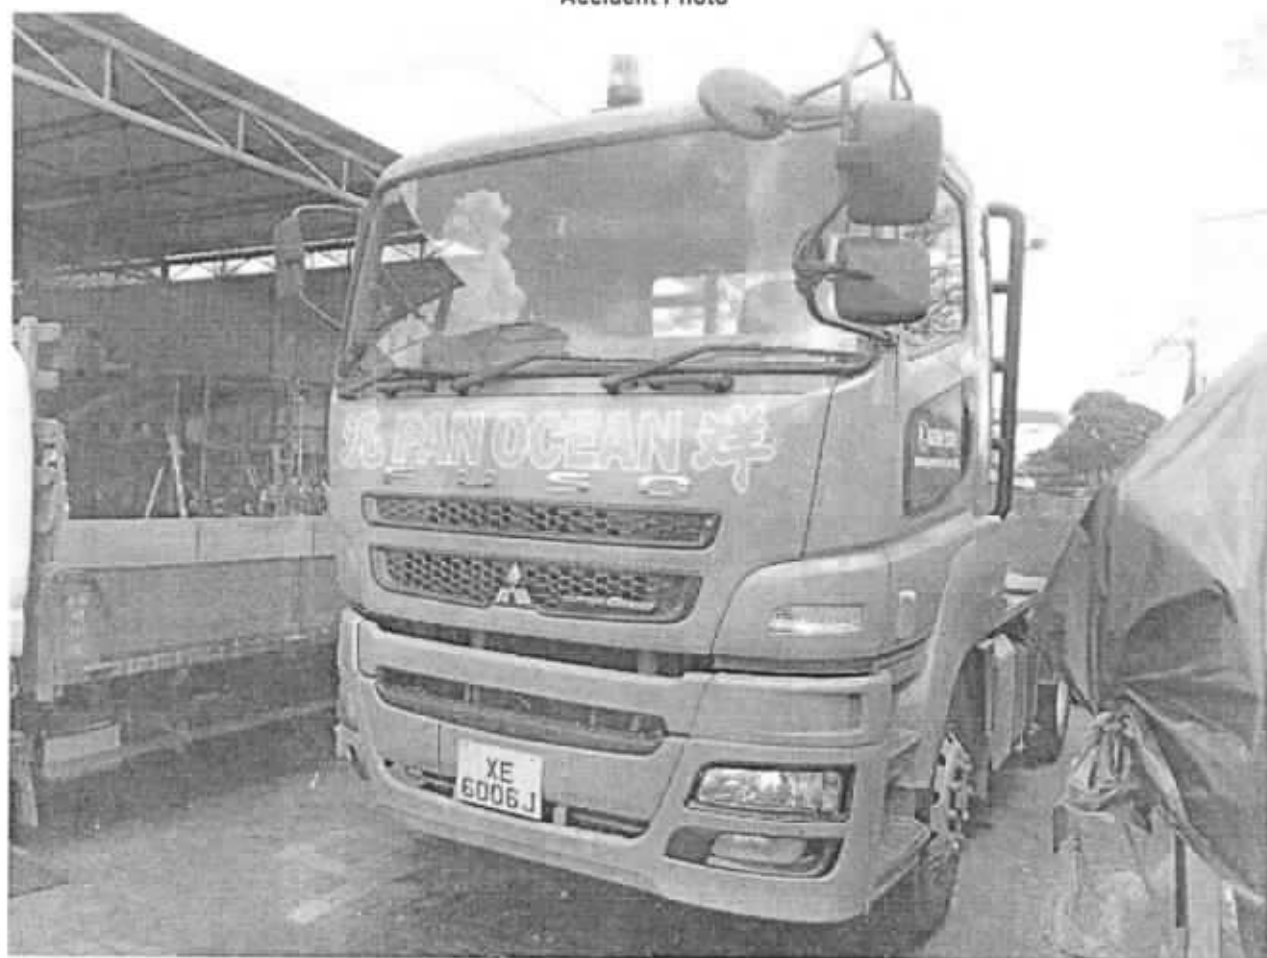
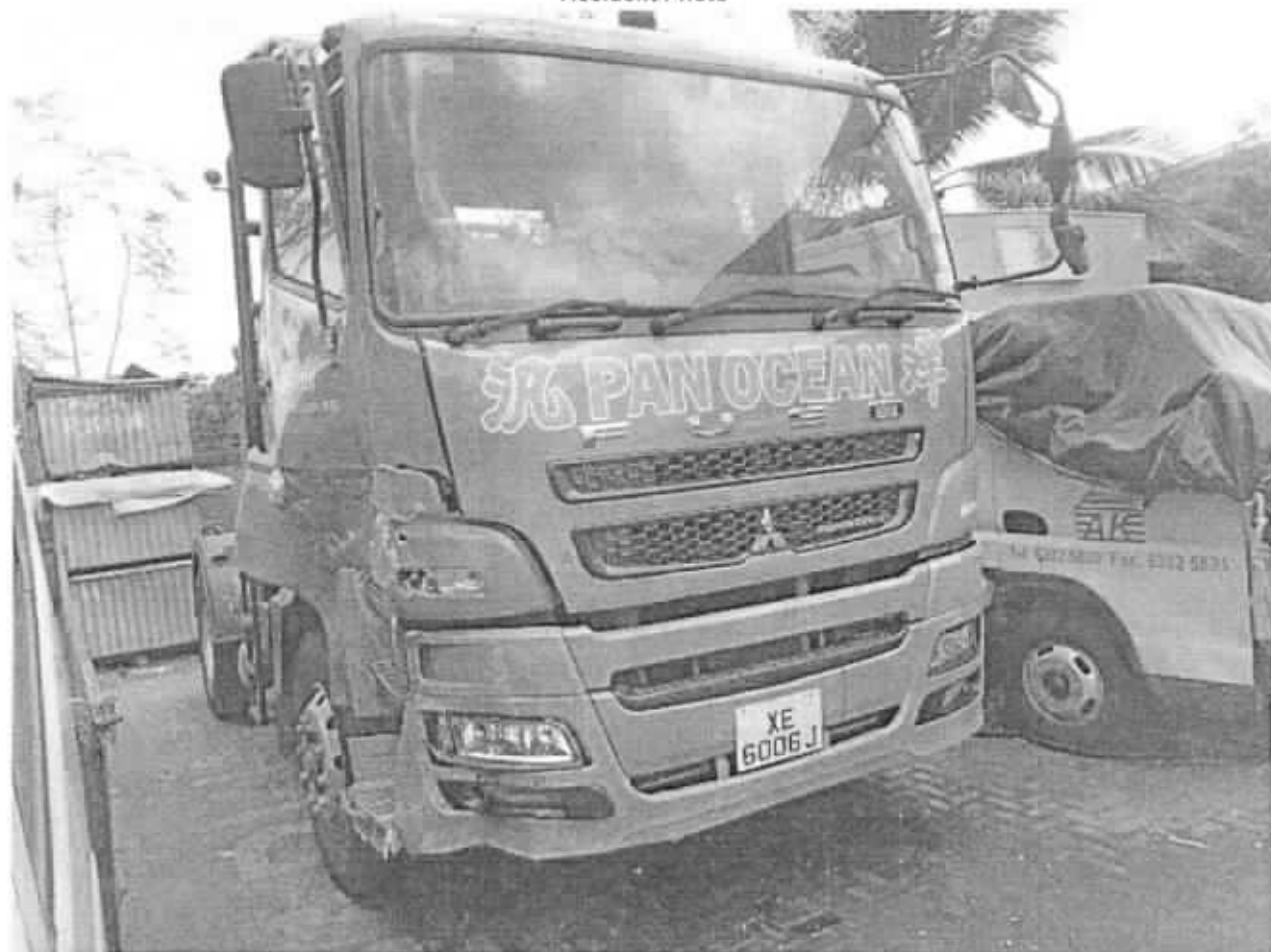
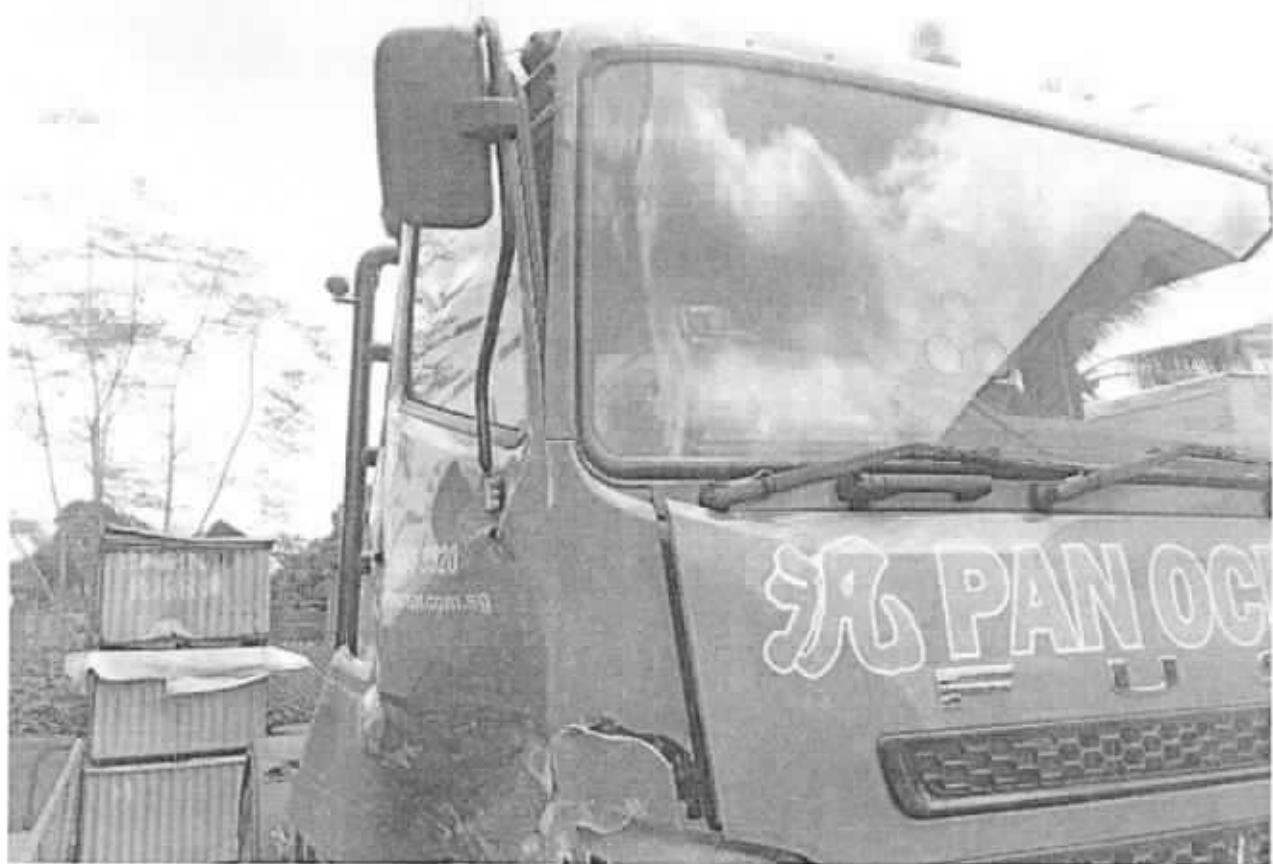
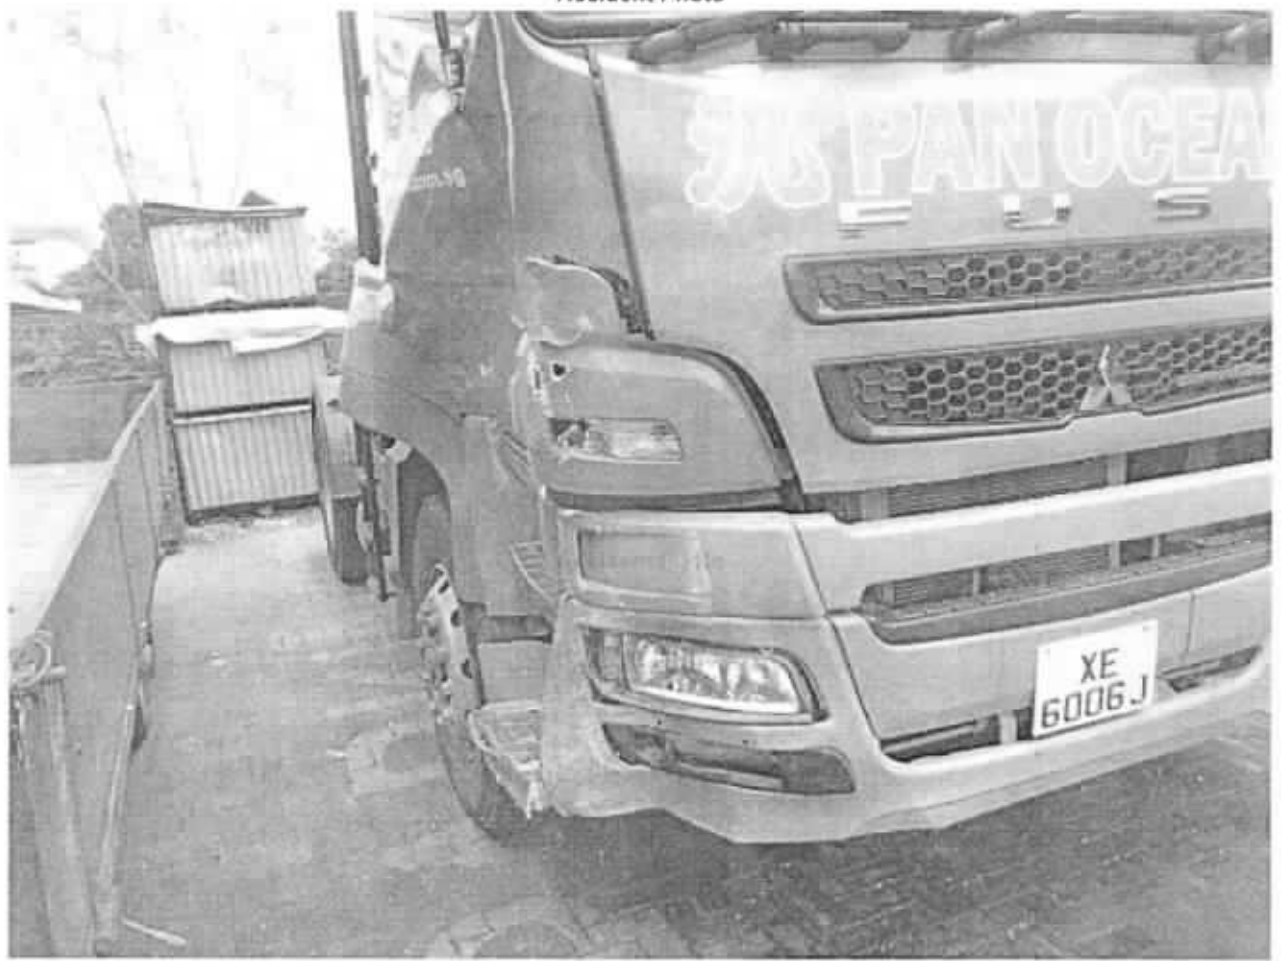
The vehicle sustained impact / damages o/s front portion and parts claimed are consistent to the accident.
