PARTICULARS REQUIRED FOR VEHICLES ACCIDENTS

Vehicle Number : MID32369

JOB DESCRIPTION FOR REPAIR.

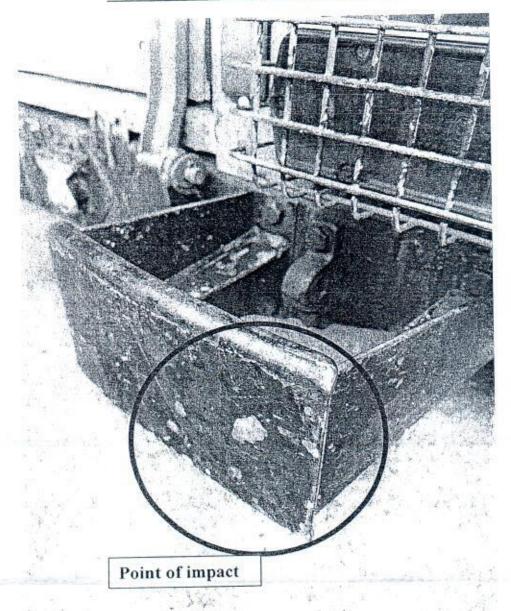
Figure C-5: Close up of RHR of MID32369

SCRATCHES ON RHR STOPPER

REPAIR COST = NIL

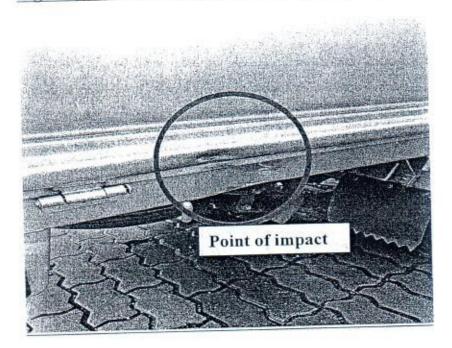
Figure C-10: Damage on GBE7564T's Right side chassis
