VEHICLE ACCIDENT DAMAGE ANALYSIS & ASSESSOR REPORT

Our Ref: S756-1912R-PK SHA3236S

4. Description of Damages				
THE VEHICLE SUSTAINED DAMAGES AT THE FRONT PORTION. DAMAGES SEE DETAILS.				
5. General Information				
Accident Date	17/06/2017	Inspection Date	23/06/2017	
Survey held at	CHUNNI MOTOR WORK PTE LTD BLK 10 ANG MO KIO IND. PARK 2A, #03-19 AMK AUTOPOINT SINGAPORE 568047.			
5a. Remarks				
A)DAMAGES CONSISTENT TO ACCIDENT REPORT. B)THE INSPECTION WAS CONDUCTED ON A"WITHOUT PREJUDICE" BASIS. C)IN ACCORDANCE TO YOUR INSTRUCTIONS, WE HAVE NOT AUTHORISED REPAIRS.				
5b. Estimate Days of Repair				
ESTIMATED NORMAL PERIOD FOR REPAIR:		18 Working Days

ADJUSTMENT ON REPAIR COST FOR VEHICLE NO. SHA 3236S

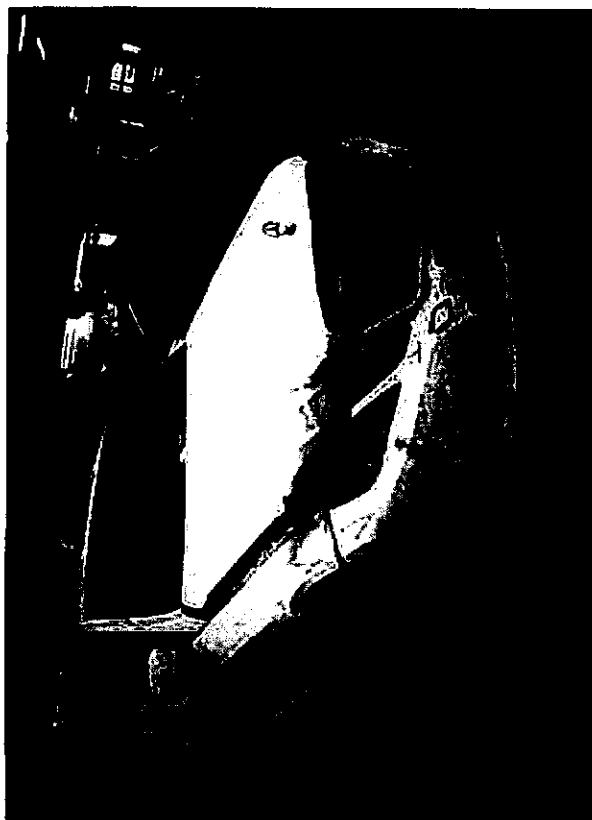
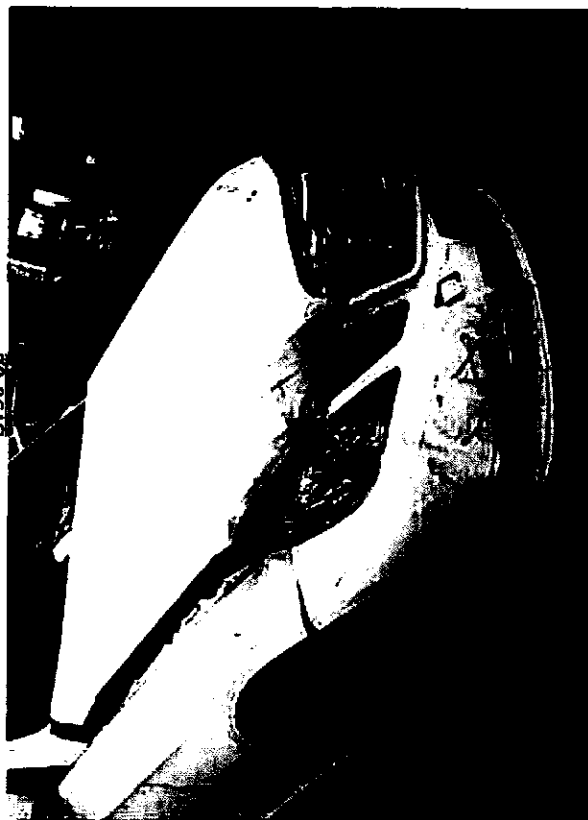
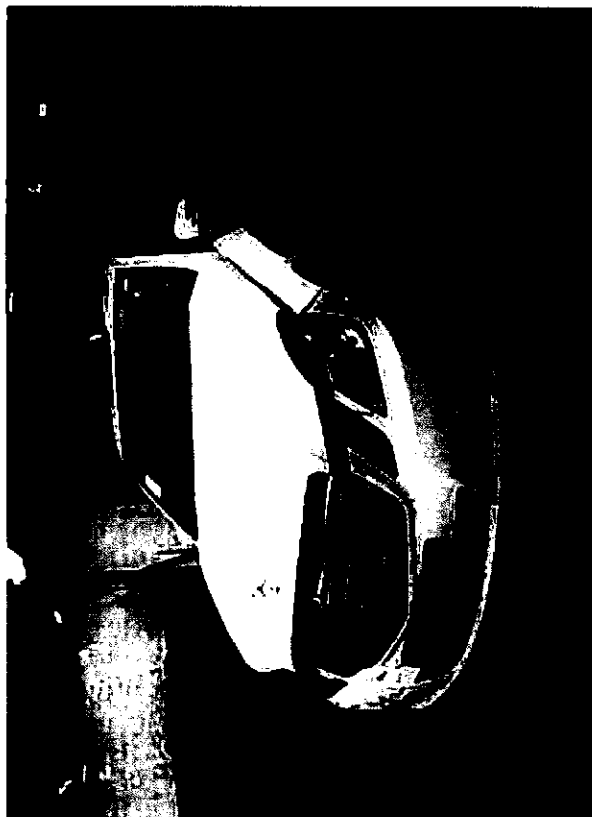
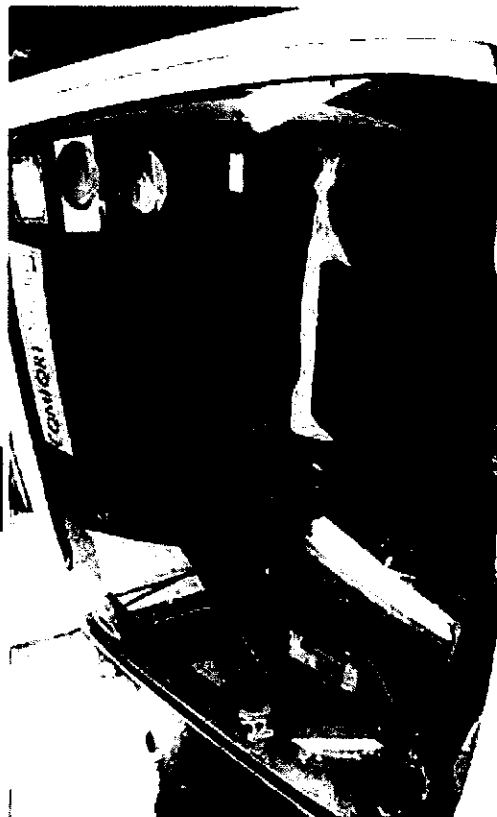
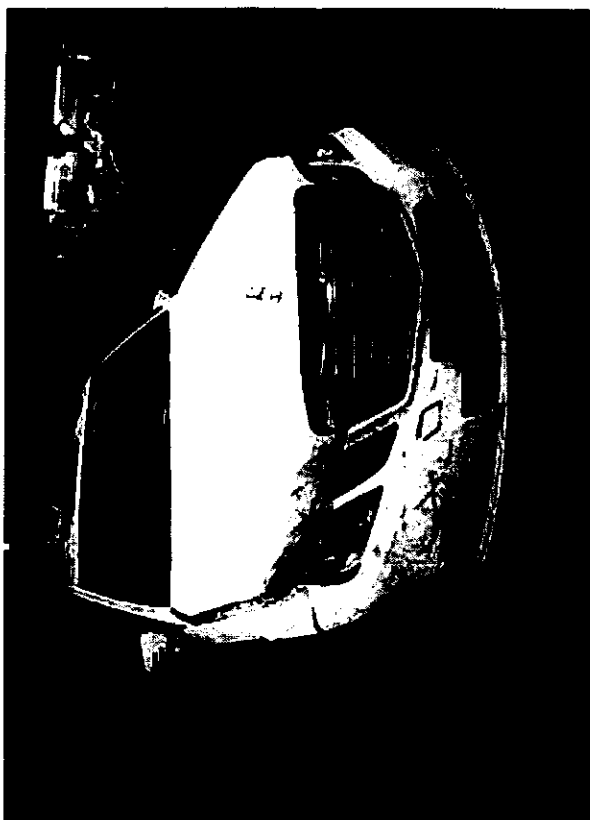
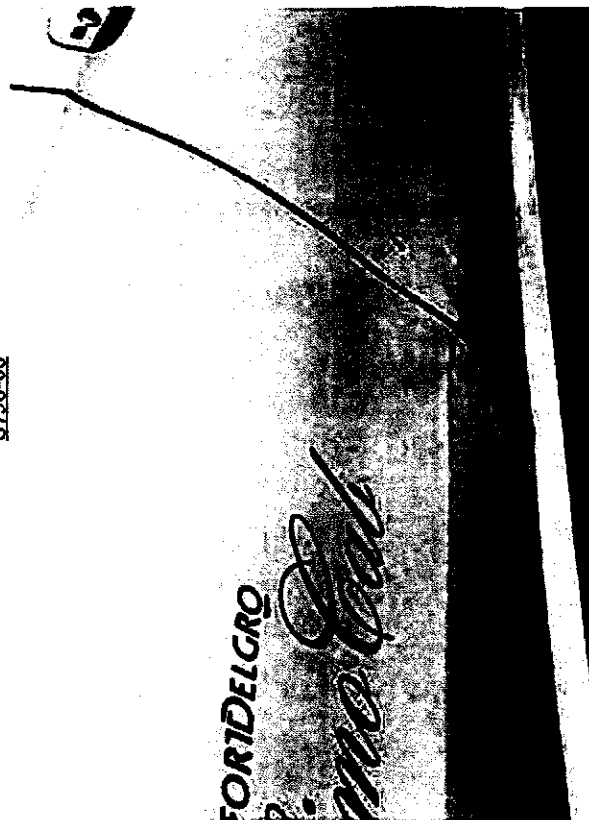
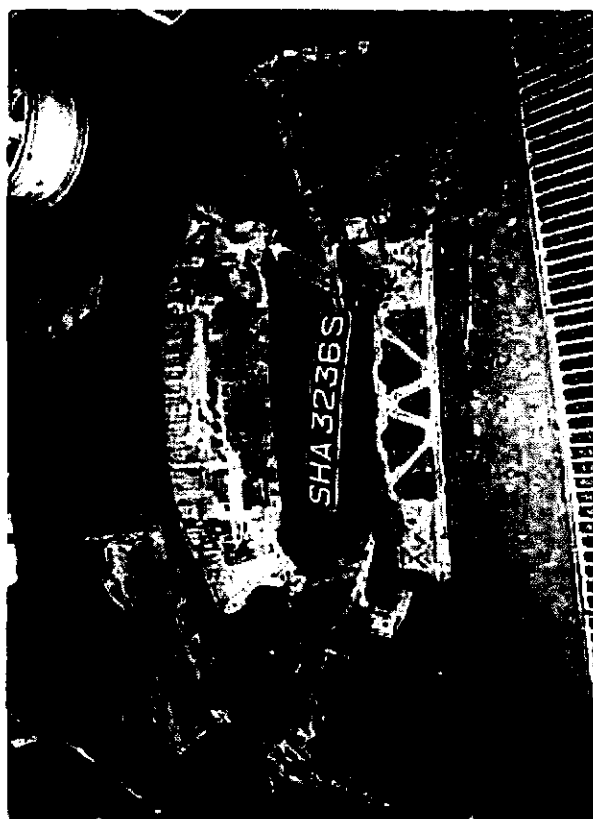
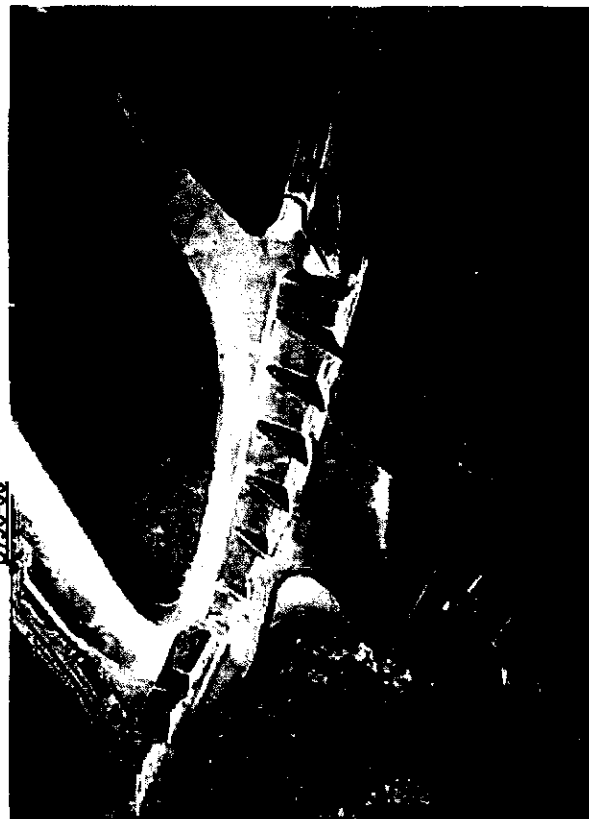
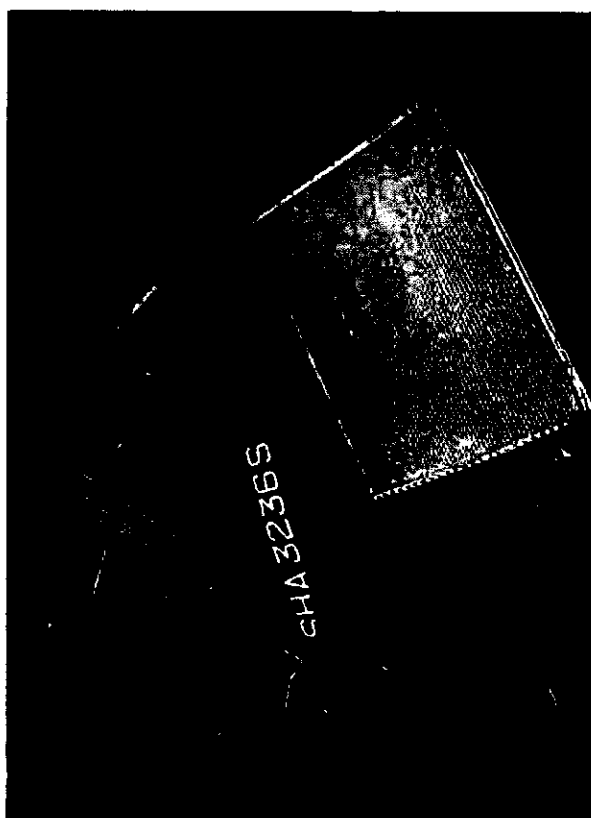
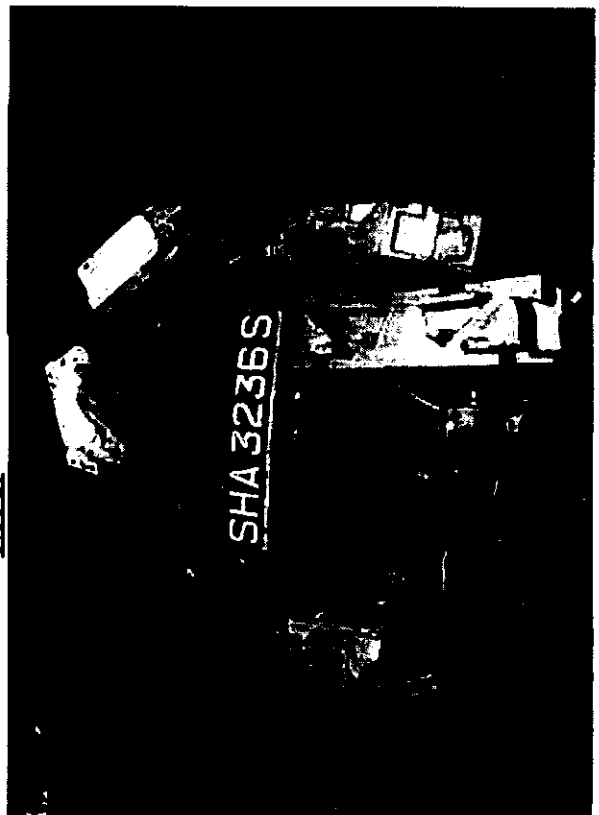
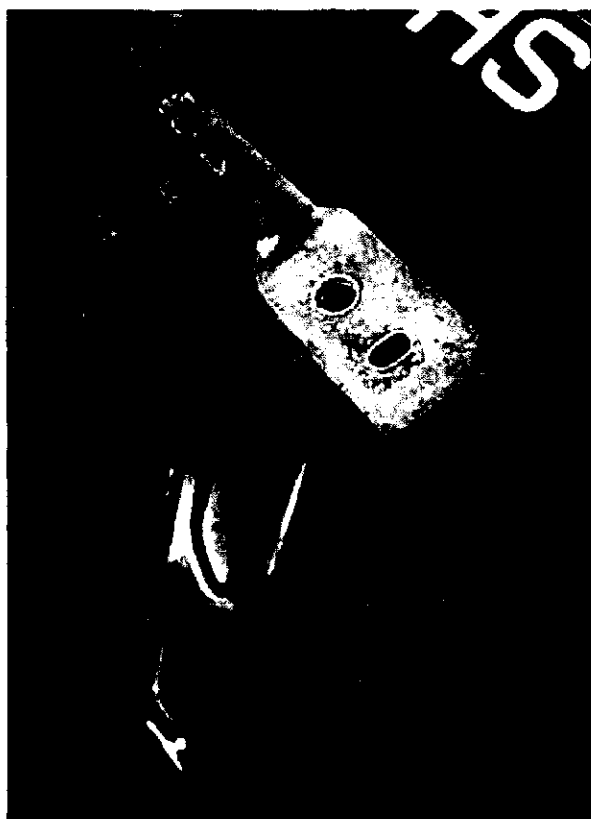
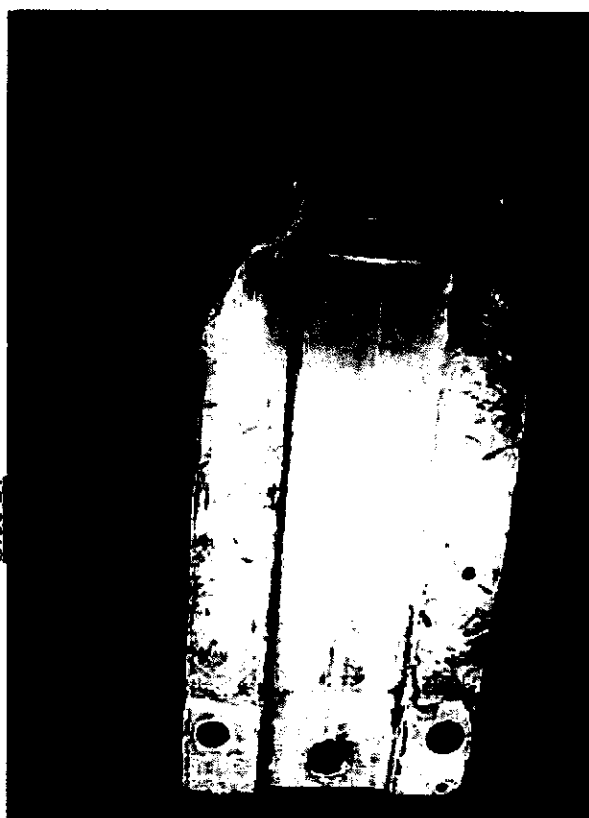
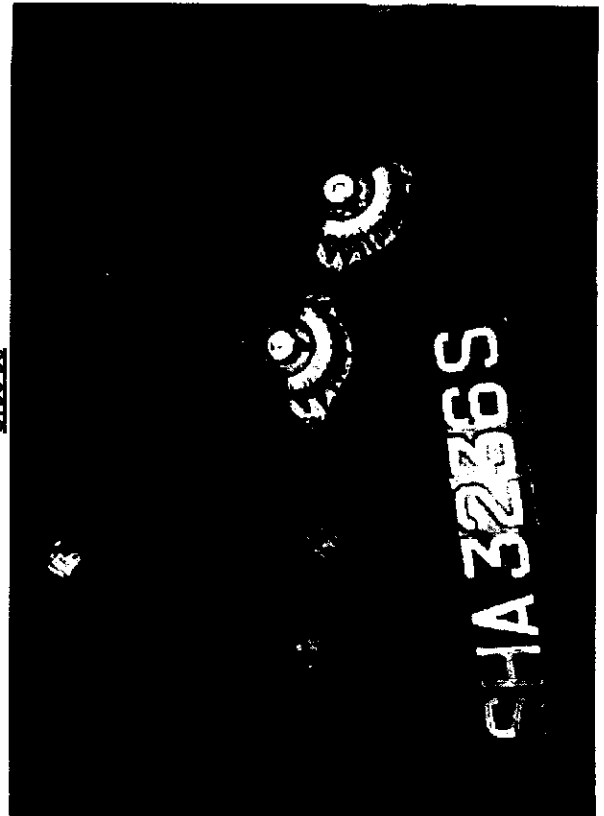
Contact damage to: Front bumper, front RH fender, RH headlamp, bonnet, etc
Front bumper reinforcement, headlamp support panel, air-con condenser, radiator, front

Induced damage to: undercarriage items, etc

b) Damage profile to the taxi appear consistent with the reported accident. Its right front portion sustained impact damage of a moderate-heavy nature. As the front right wheel was subjected to the impact from the collision, it would have been consistent that the front undercarriage would have sustained induced damage

Recommended cost of the repairs \$58,000.00 lump sum

Recommended downtime to repair 25 days
