Your Ref : 5068756335SG- 003
Our Ref : CC6/AIG17013850/N

10 October 2018

**AUTOMOBILE TECHNICAL INVESTIGATION REPORT OF ACCIDENT
INVOLVING SLP 4194X AND SLN 8403C ON 16 JULY 2017**

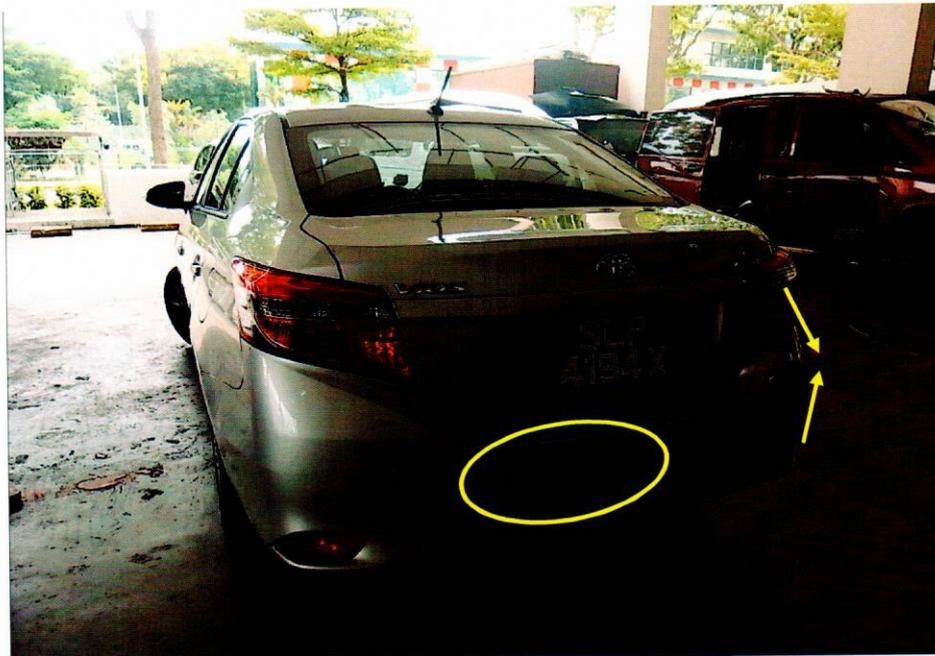
Photo 1 shows a rear view of the Toyota at the time of the Pre- Repair Survey conducted by LKK Auto Consultants Pte. Ltd. which was taken about 2 days after the accident. We observed small 'V' shaped indentations as well as a vertical indentation on the top portion of the Toyota's rear bumper. There were also horizontal whitish marks found on the left reverse sensor of the Toyota (circled). However we also noted that the rear bumper was not misaligned at its corner edges.

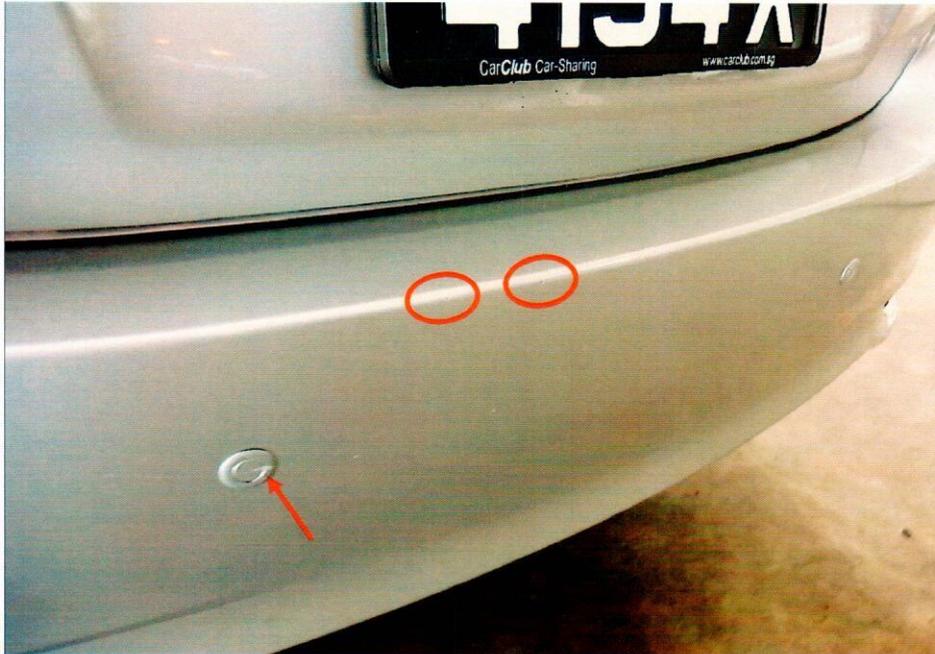
Photo 2 shows a closer view of the top portion of the rear bumper of the Toyota. We observed small 'V' shaped indentations as well as a vertical indentation on the top portion of the Toyota's rear bumper (circled). We also noted horizontal whitish marks found on the left reverse sensor of the Toyota (arrowed).

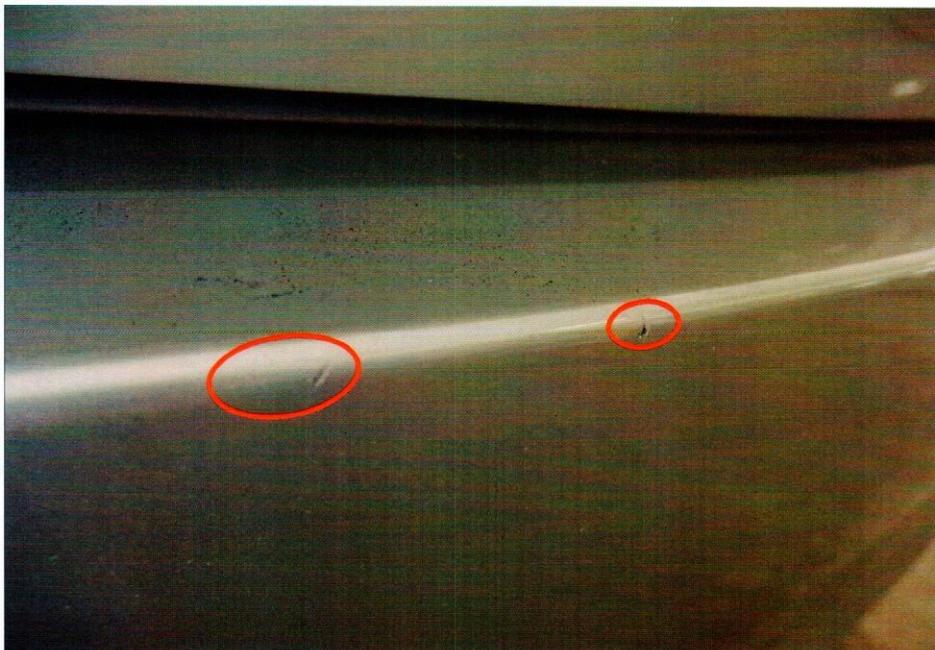
Photo 3 shows a close up view of the small 'V' shaped indentations as well as a vertical indentation on the top portion of the Toyota's rear bumper (circled).

12. The reason for the small 'V' shaped indentations as well as the vertical indentation on the top portion of the Toyota's rear bumper were caused by an object pressing onto the rear portion of the Toyota. If one was to consider the shape of the Mazda's front emblem, it would then appear that the indentations were caused by the front emblem of the Mazda.

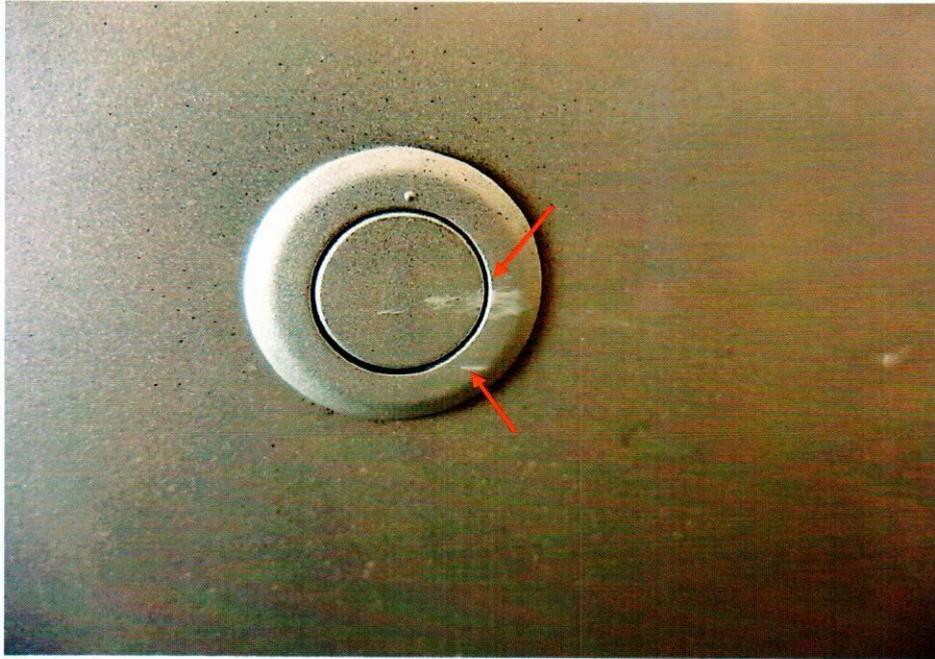
Photo 4 shows a close up view of the horizontal whitish marks found on the left reverse sensor of the Toyota (arrowed).

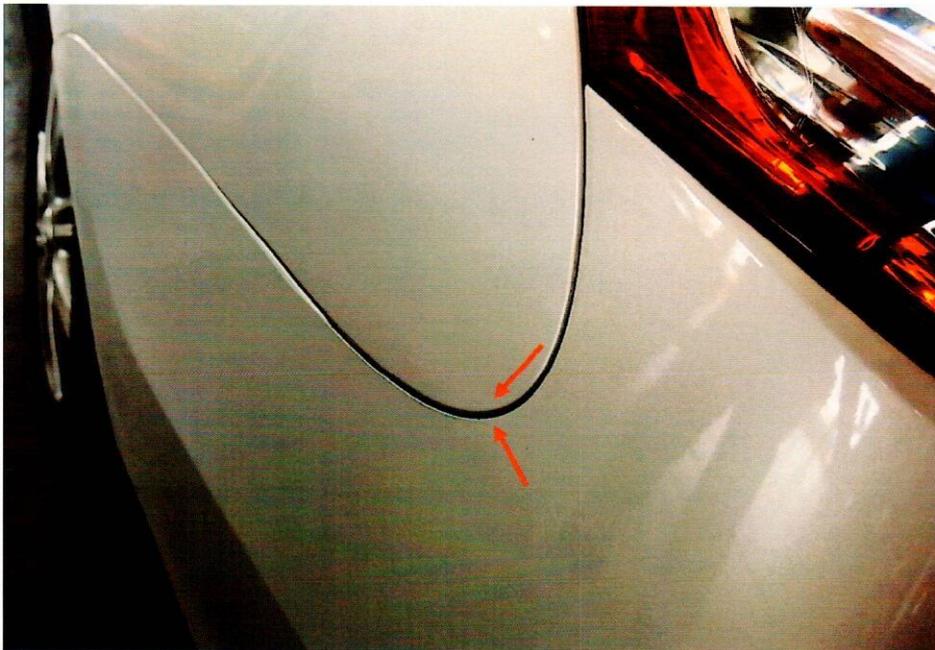
Photo 5 shows a closer view of the left corner edge of the rear bumper of the Toyota. We observed that there was no misalignment at the corner edges (arrowed).

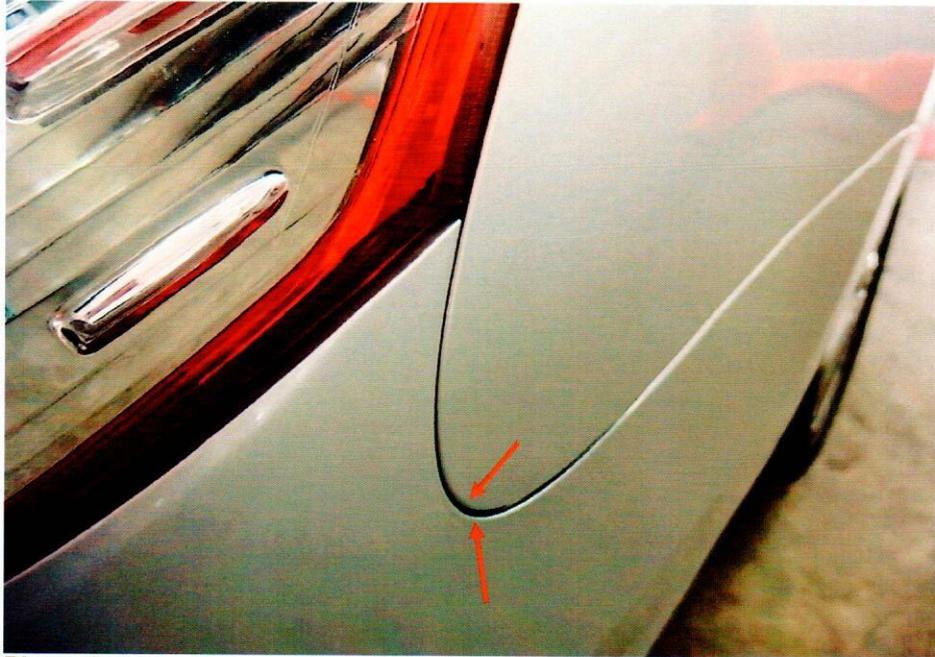
Photo 6 shows a closer view of the right corner edge of the rear bumper of the Toyota. We observed that there was no misalignment at the corner edges (arrowed).

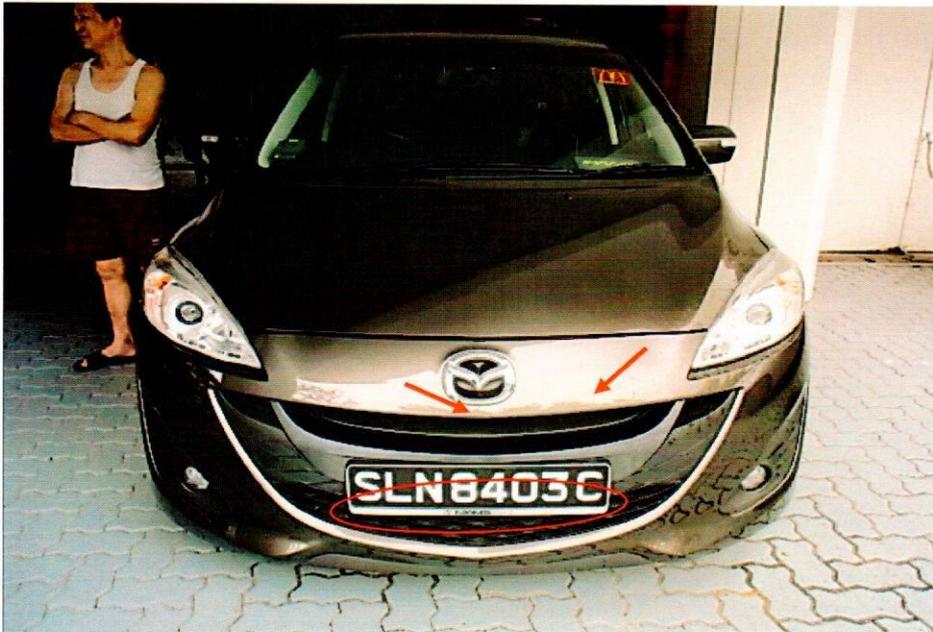
Photo 7 shows the general view of the front portion of the Mazda at the time of our physical inspection. We observed a circular black mark on the top centre portion of the Mazda's front bumper. We also found horizontal whitish marks on the top left portion of the Mazda's front bumper (arrowed). Upon closer examination of the Mazda's front number plate, we observed horizontal blackish marks on some of the bottom alpha- numeric letterings of the front number plate (circled). However we also noted that there was no obvious misalignment of the front bumper at its corner edges.

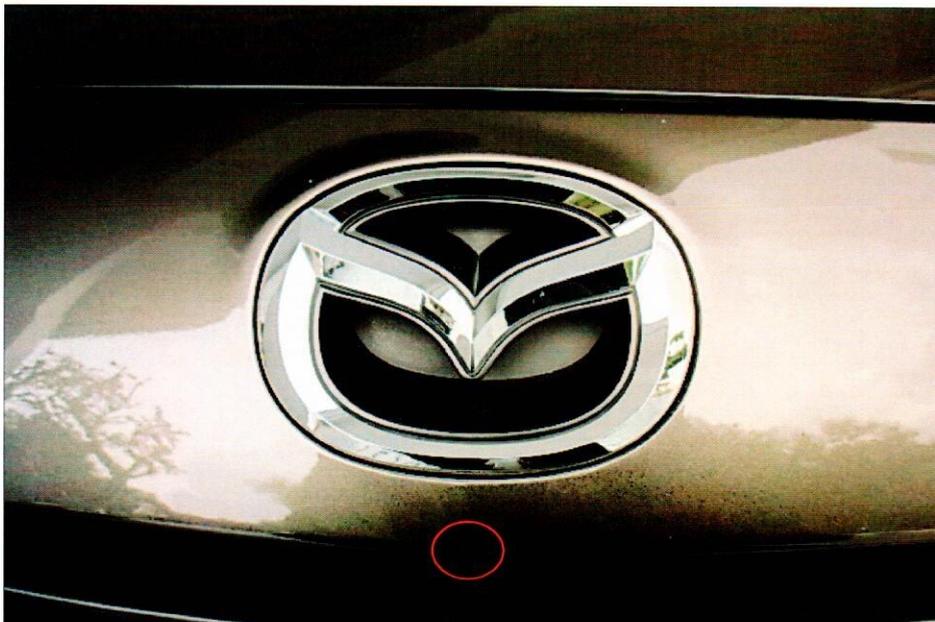
Photo 8 shows a closer view of the circular black mark on the top centre portion of the Mazda's front bumper (circled).

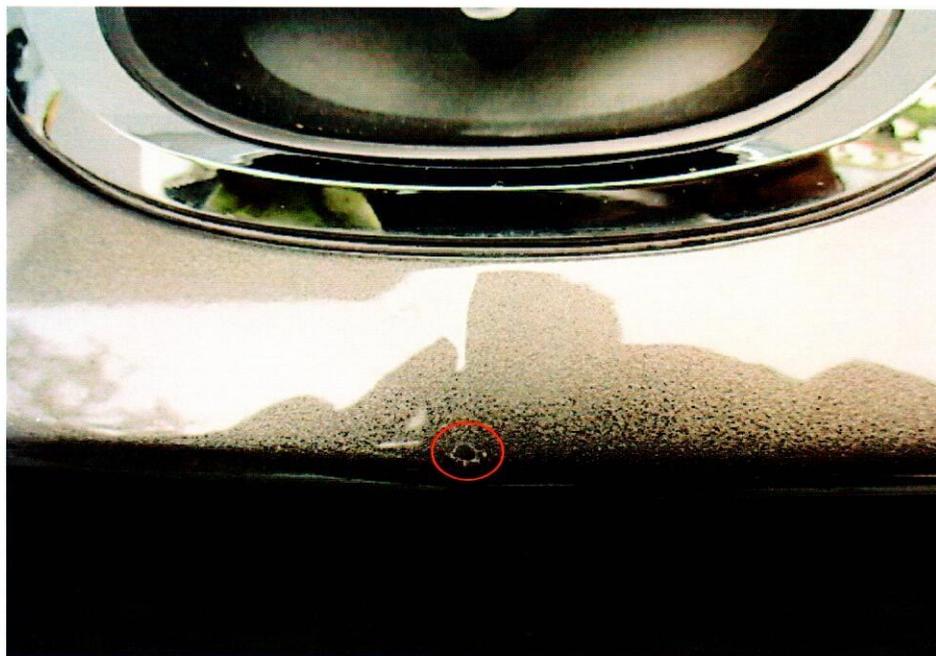
Photo 9 shows a close up view of the circular black mark on the top centre portion of the Mazda's front bumper (circled).

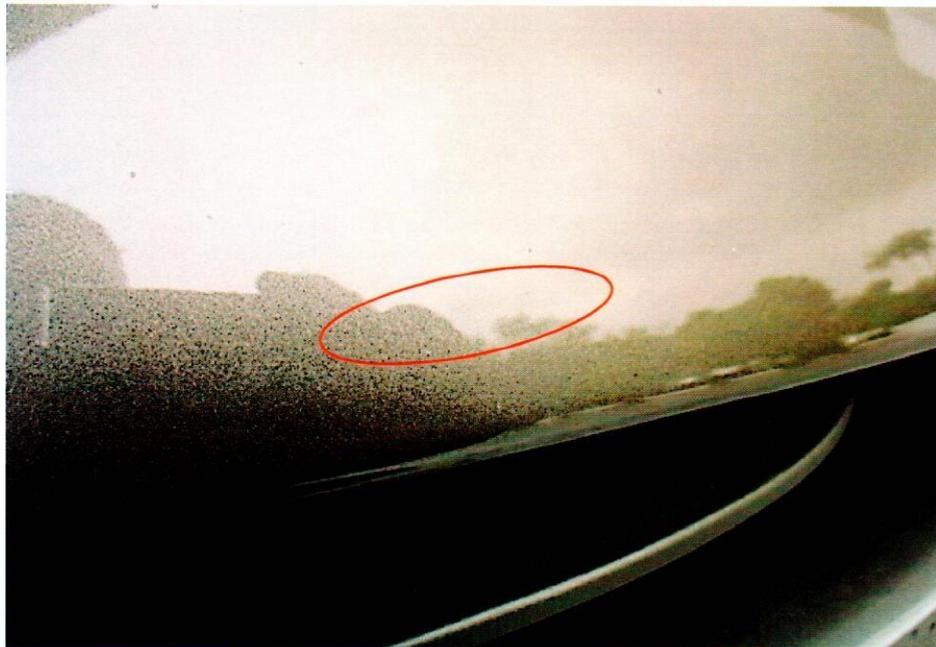
Photo 10 shows a closer view of the horizontal whitish marks on the top left portion of the Mazda's front bumper (circled).

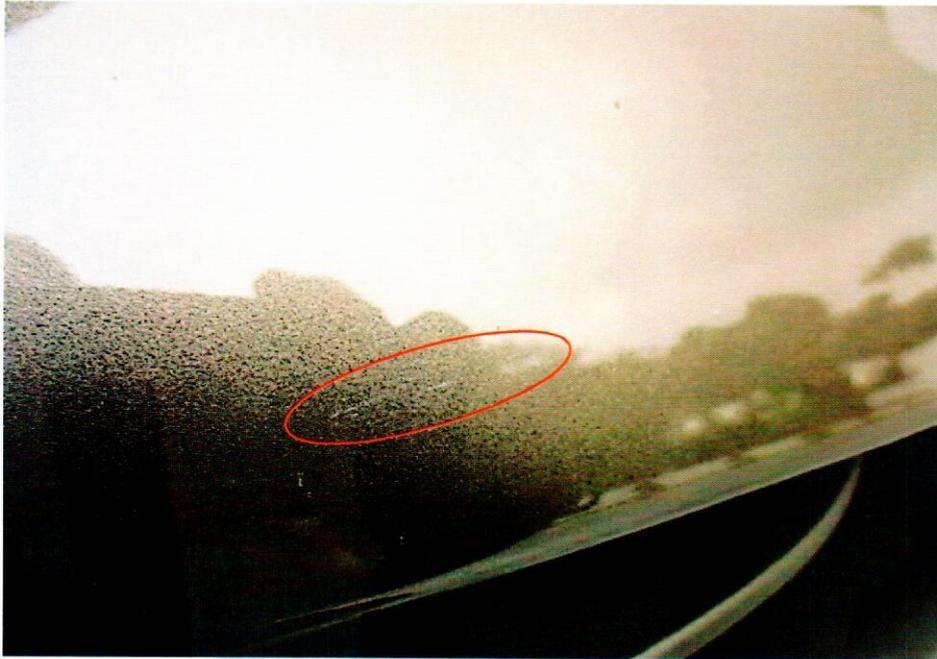
Photo 11 shows a close up view of the horizontal whitish marks on the top left portion of the Mazda's front bumper (circled).

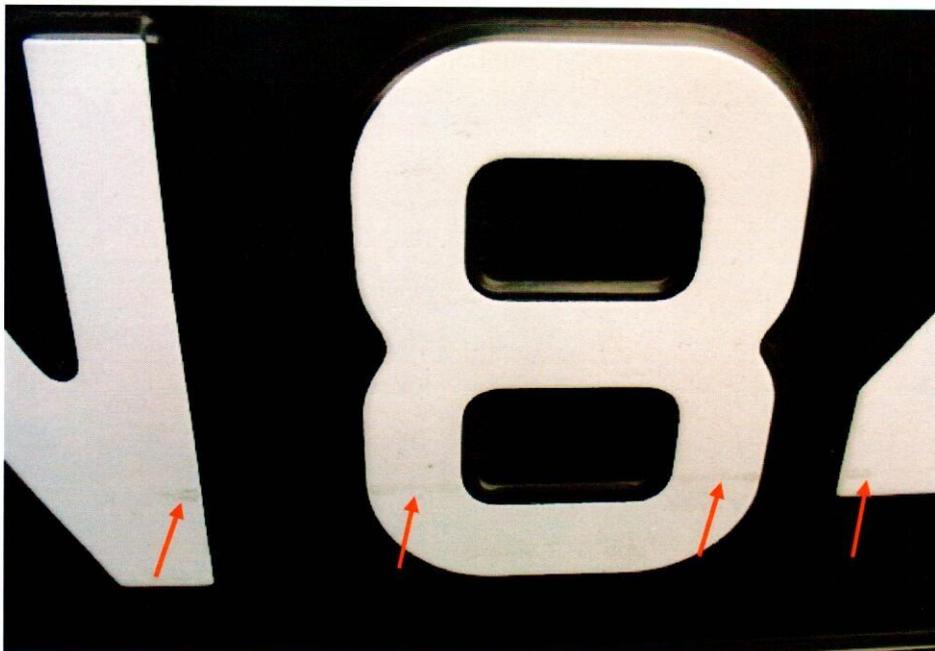
Photo 12 shows a close up view of the horizontal blackish marks on the bottom portion of the alpha-numeric letterings of the Mazda's front number plate (arrowed).

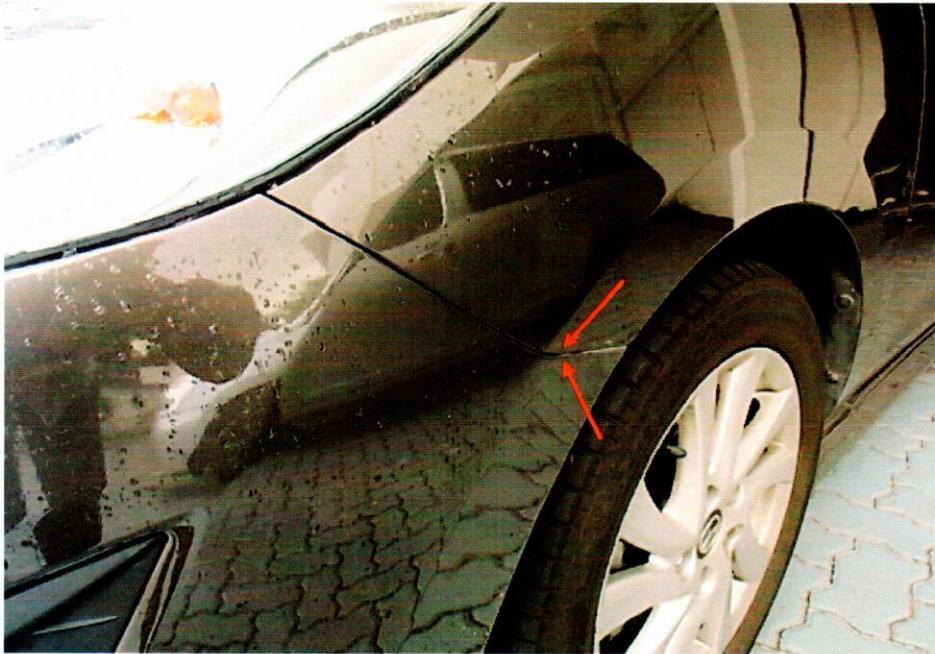
Photo 13 shows a closer view of the left corner edge of the front bumper of the Mazda. We observed that there was no misalignment at the corner edges (arrowed).

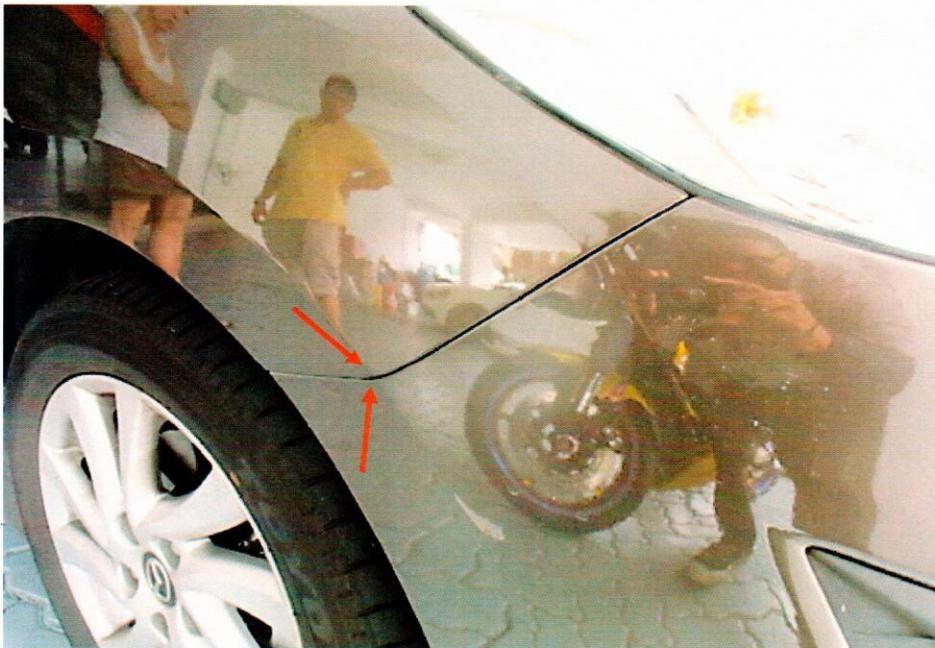
Photo 14 shows a closer view of the right corner edge of the front bumper of the Mazda. We observed that there was no misalignment at the corner edges (arrowed).

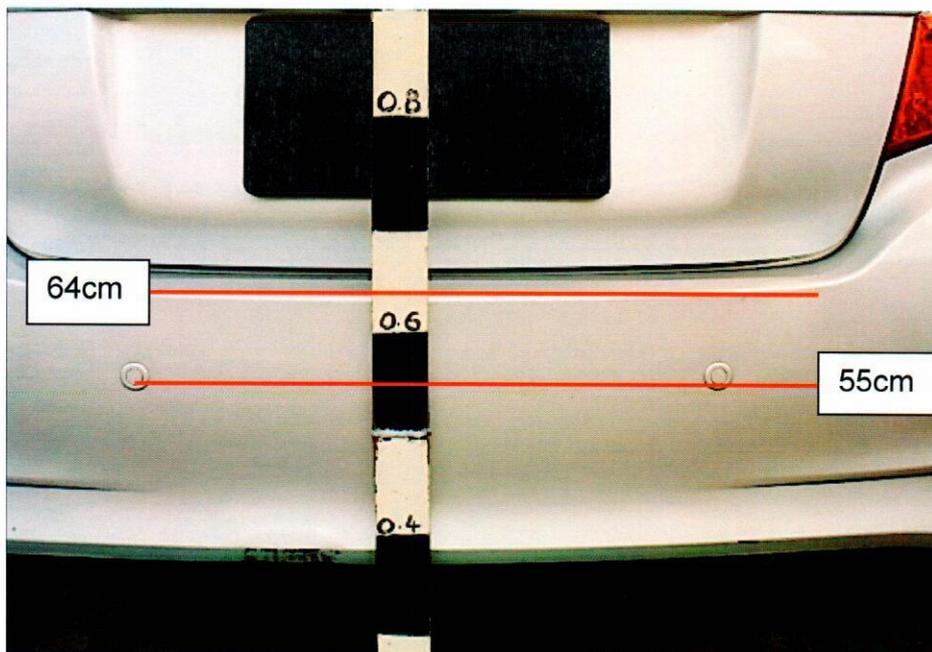
Photo 15 shows the height measurement being conducted on the rear portion of the Toyota (using a similar make and model). The height above ground level of the horizontal whitish marks found on the left reverse sensor of the Toyota was measured to be approximately 55cm. The height above ground level of the vertical indentations found on the top portion of the Toyota's rear bumper was measured to be approximately 64cm.

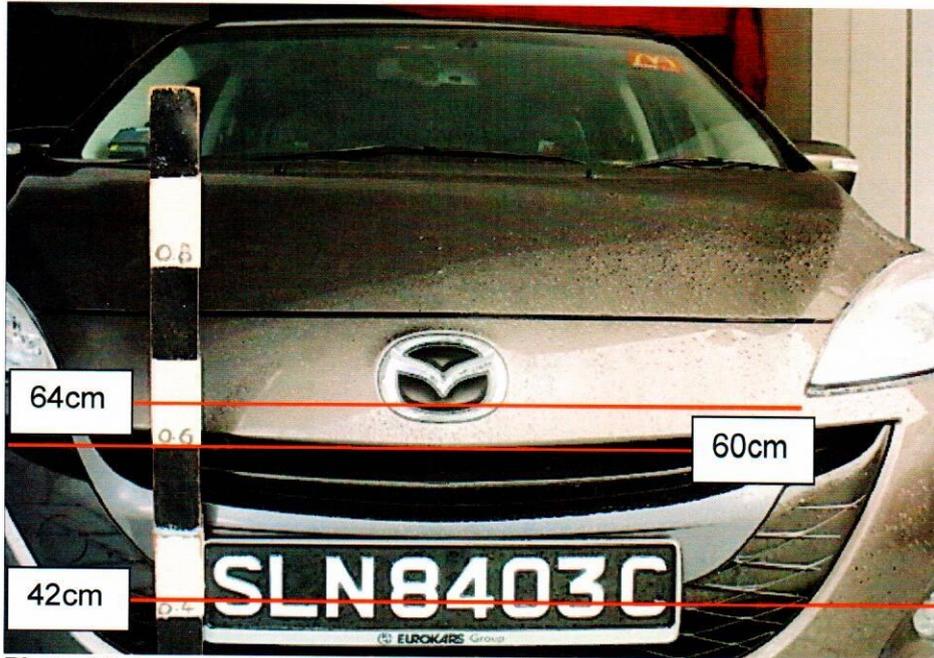
Photo 16 shows the height measurement being conducted on the front portion of the Mazda. The height above ground level of the horizontal blackish marks on the bottom portion of the alpha- numeric letterings of the Mazda's front number plate was measured to be approximately 42cm. The height above ground level of the circular black mark on the top centre portion of the Mazda's front bumper was measured to be approximately 60cm. The bodypart at 64cm above ground level was the Mazda's front emblem.
