Your Ref : 5068756335SG- 003  
Our Ref : CC6/AIG17013850/N

10 October 2018

**AUTOMOBILE TECHNICAL INVESTIGATION REPORT OF ACCIDENT  
INVOLVING SLP 4194X AND SLN 8403C ON 16 JULY 2017**

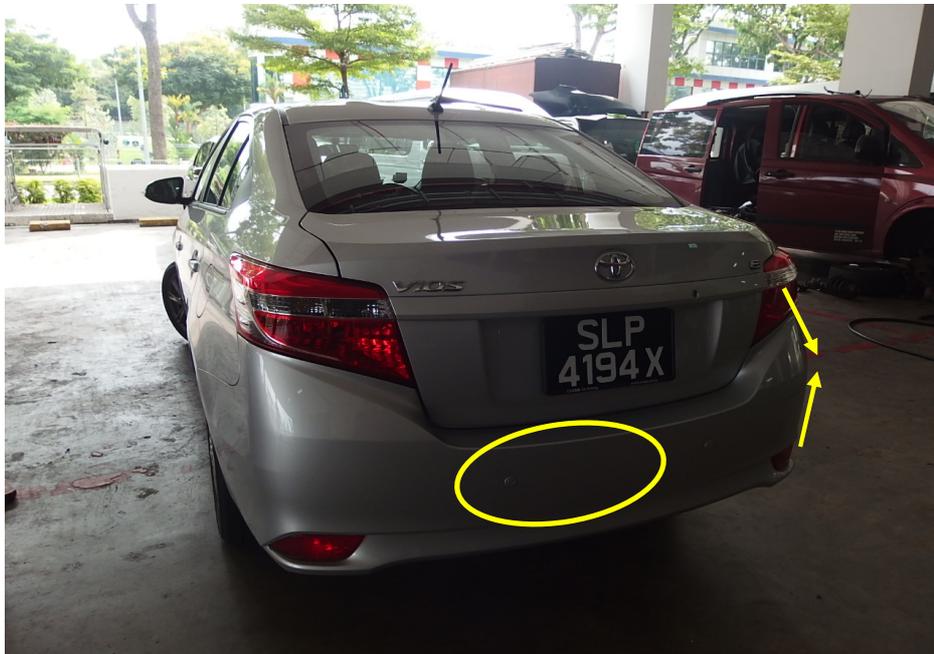
**Photo 1** shows a rear view of the Toyota at the time of the Pre- Repair Survey conducted by LKK Auto Consultants Pte. Ltd. which was taken about 2 days after the accident. We observed small 'V' shaped indentations as well as a vertical indentation on the top portion of the Toyota's rear bumper. There were also horizontal whitish marks found on the left reverse sensor of the Toyota (circled). However we also noted that the rear bumper was not misaligned at its corner edges.

12. The reason for the small 'V' shaped indentations as well as the vertical indentation on the top portion of the Toyota's rear bumper were caused by an object pressing onto the rear portion of the Toyota. If one was to consider the shape of the Mazda's front emblem, it would then appear that the indentations were caused by the front emblem of the Mazda.

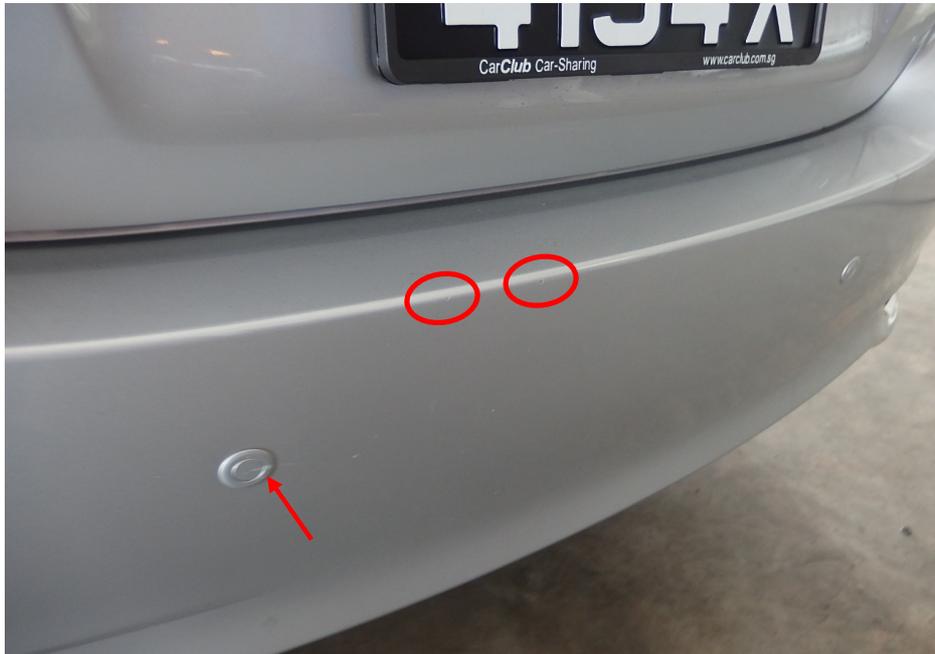
**Photo 2** shows a closer view of the top portion of the rear bumper of the Toyota. We observed small 'V' shaped indentations as well as a vertical indentation on the top portion of the Toyota's rear bumper (circled). We also noted horizontal whitish marks found on the left reverse sensor of the Toyota (arrowed).

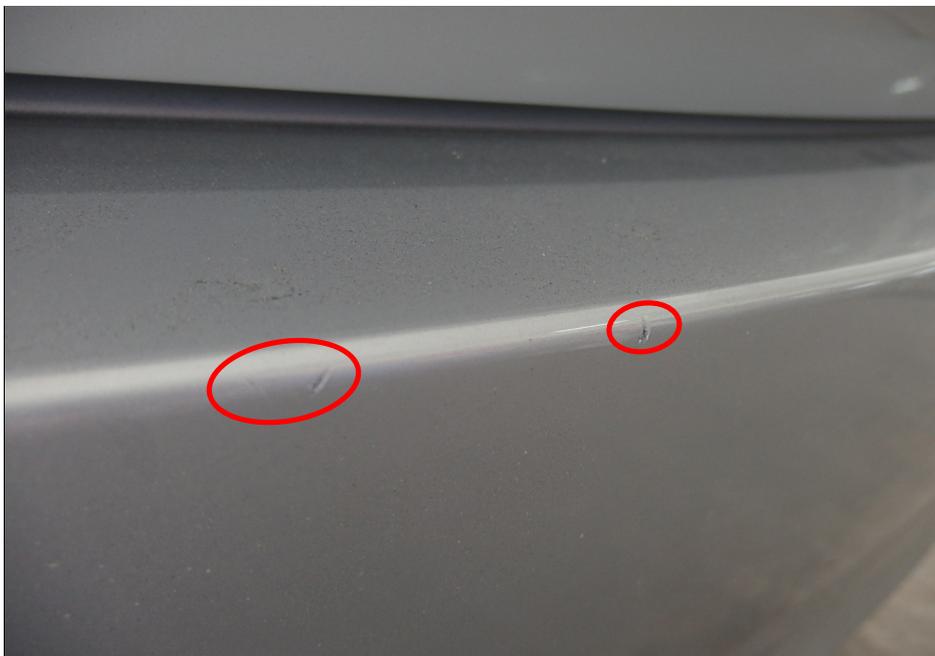
**Photo 3** shows a close up view of the small 'V' shaped indentations as well as a vertical indentation on the top portion of the Toyota's rear bumper (circled).

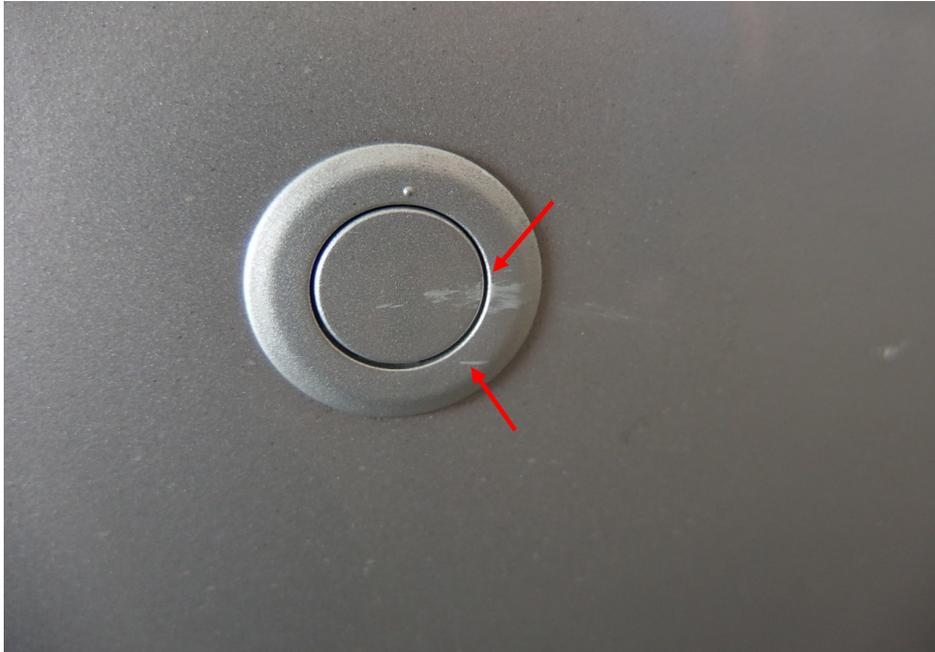
**Photo 4** shows a close up view of the horizontal whitish marks found on the left reverse sensor of the Toyota (arrowed).

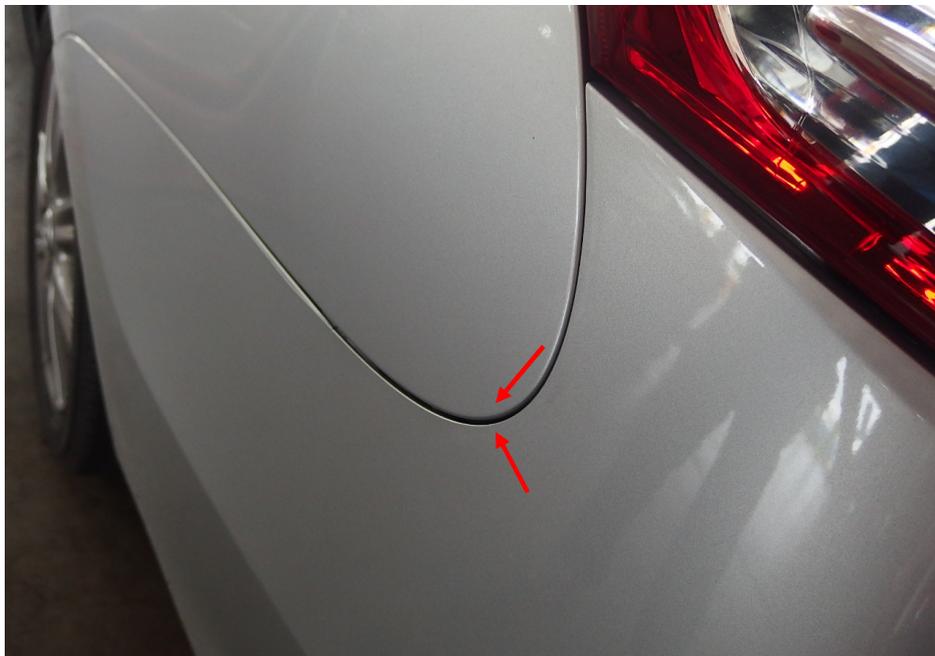
**Photo 5** shows a closer view of the left corner edge of the rear bumper of the Toyota. We observed that there was no misalignment at the corner edges (arrowed).

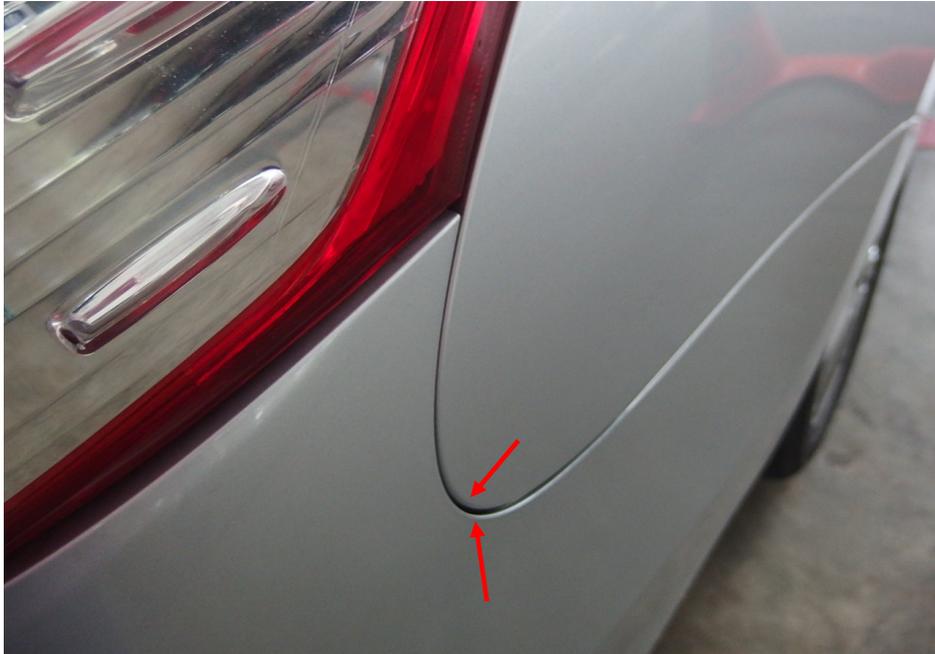
**Photo 6** shows a closer view of the right corner edge of the rear bumper of the Toyota. We observed that there was no misalignment at the corner edges (arrowed).

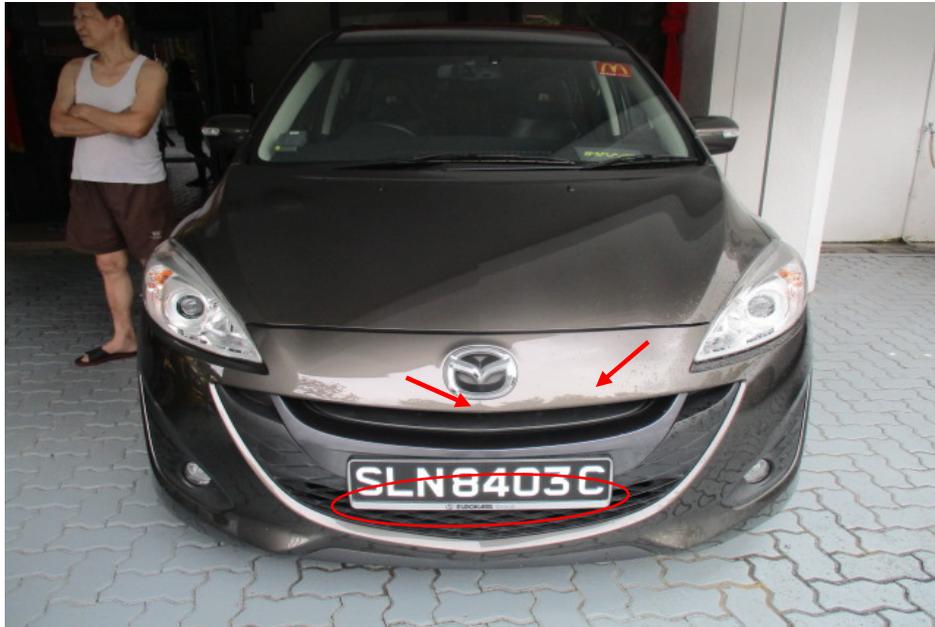
**Photo 7** shows the general view of the front portion of the Mazda at the time of our physical inspection. We observed a circular black mark on the top centre portion of the Mazda's front bumper. We also found horizontal whitish marks on the top left portion of the Mazda's front bumper (arrowed). Upon closer examination of the Mazda's front number plate, we observed horizontal blackish marks on some of the bottom alpha- numeric letterings of the front number plate (circled). However we also noted that there was no obvious misalignment of the front bumper at its corner edges.

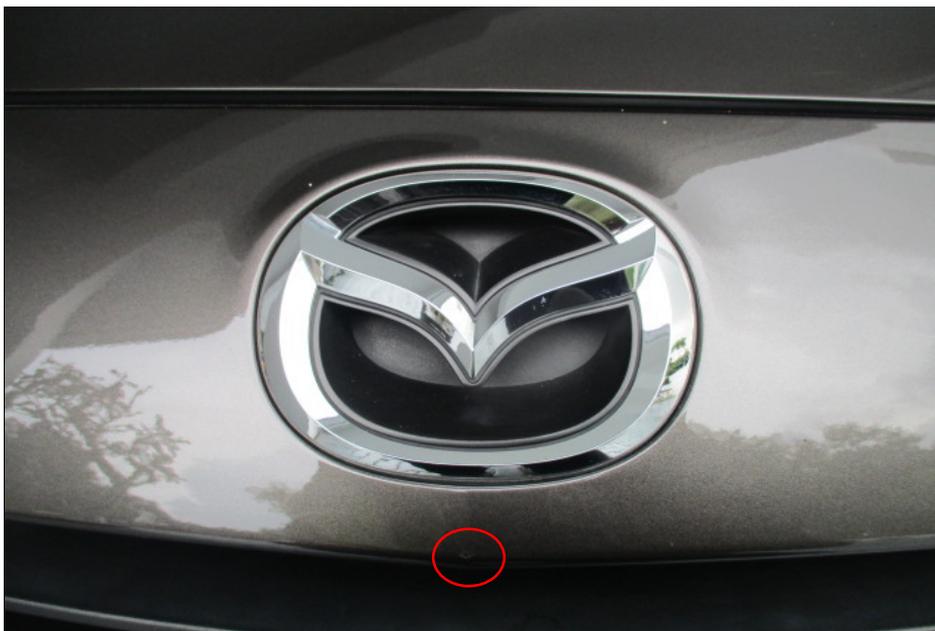
**Photo 8** shows a closer view of the circular black mark on the top centre portion of the Mazda's front bumper (circled).

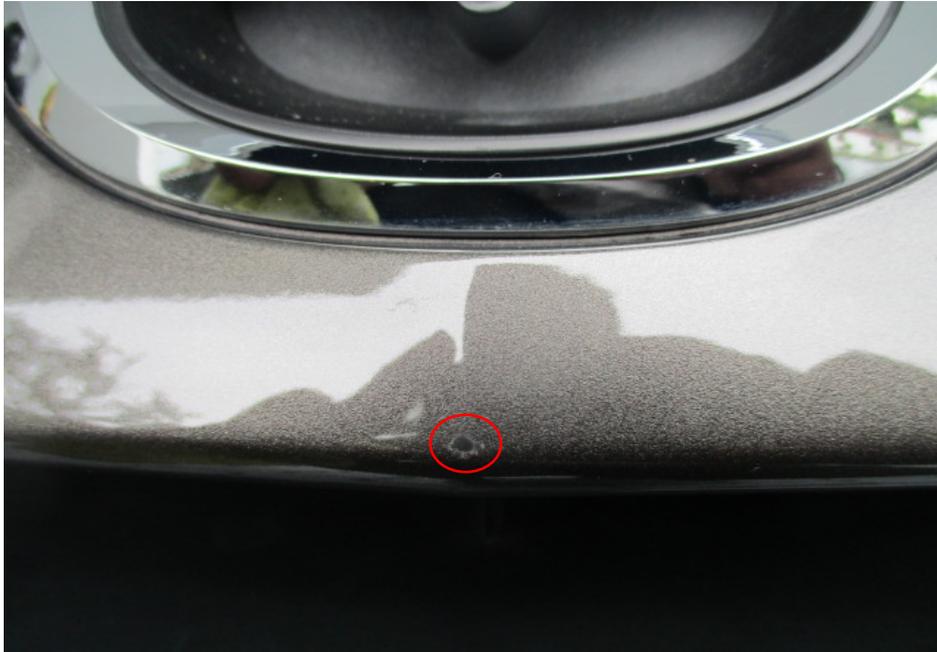
**Photo 9** shows a close up view of the circular black mark on the top centre portion of the Mazda's front bumper (circled).

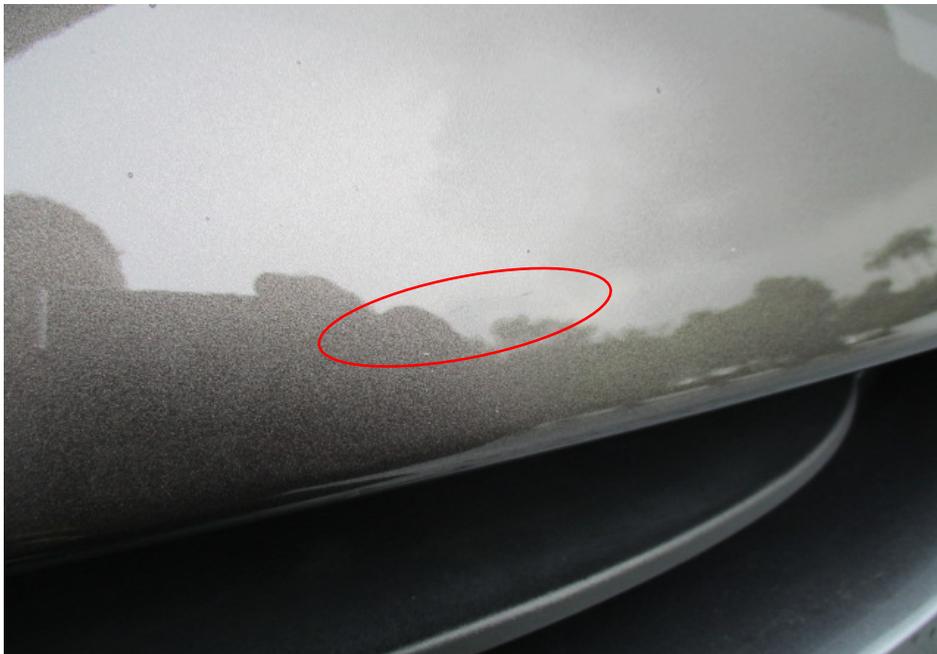
**Photo 10** shows a closer view of the horizontal whitish marks on the top left portion of the Mazda's front bumper (circled).

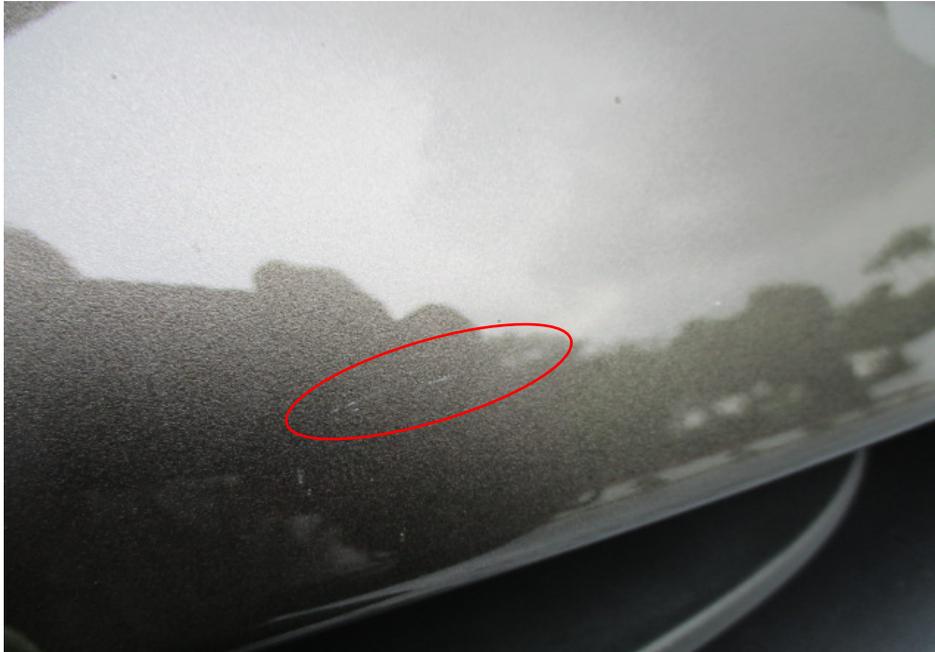
**Photo 11** shows a close up view of the horizontal whitish marks on the top left portion of the Mazda's front bumper (circled).

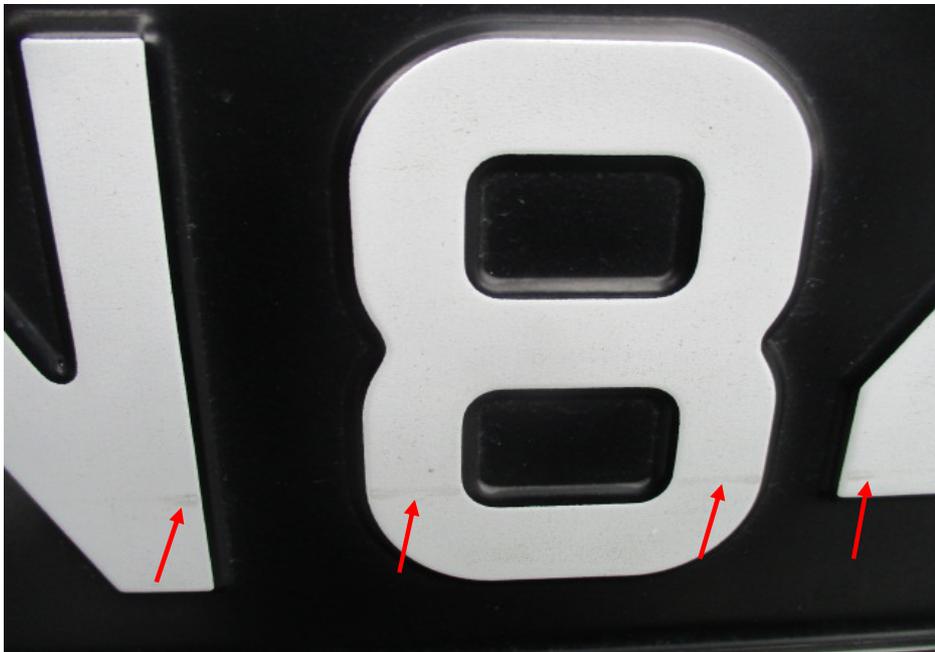
**Photo 12** shows a close up view of the horizontal blackish marks on the bottom portion of the alpha- numeric letterings of the Mazda's front number plate (arrowed).

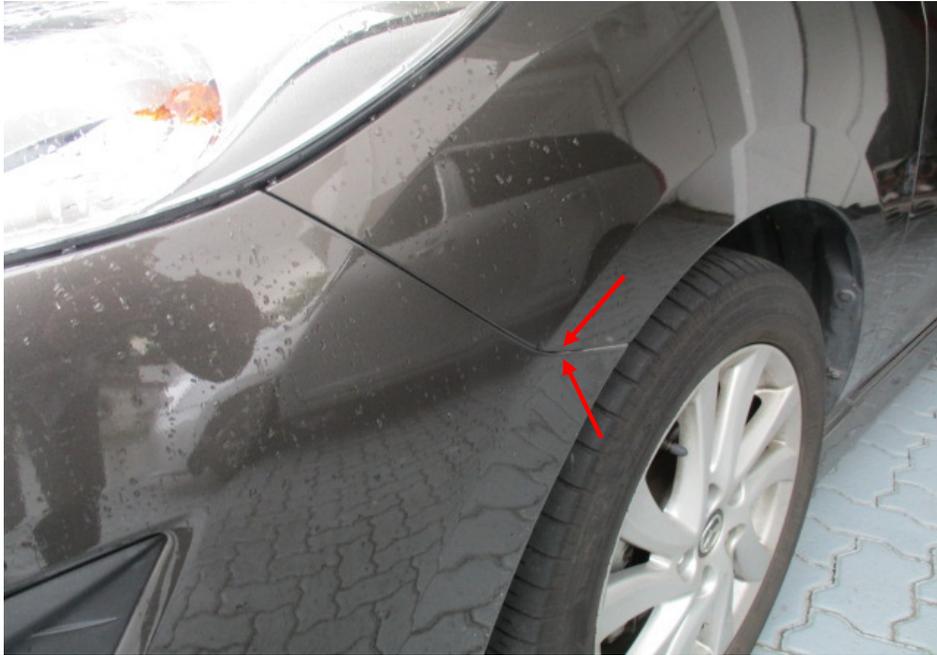
**Photo 13** shows a closer view of the left corner edge of the front bumper of the Mazda. We observed that there was no misalignment at the corner edges (arrowed).

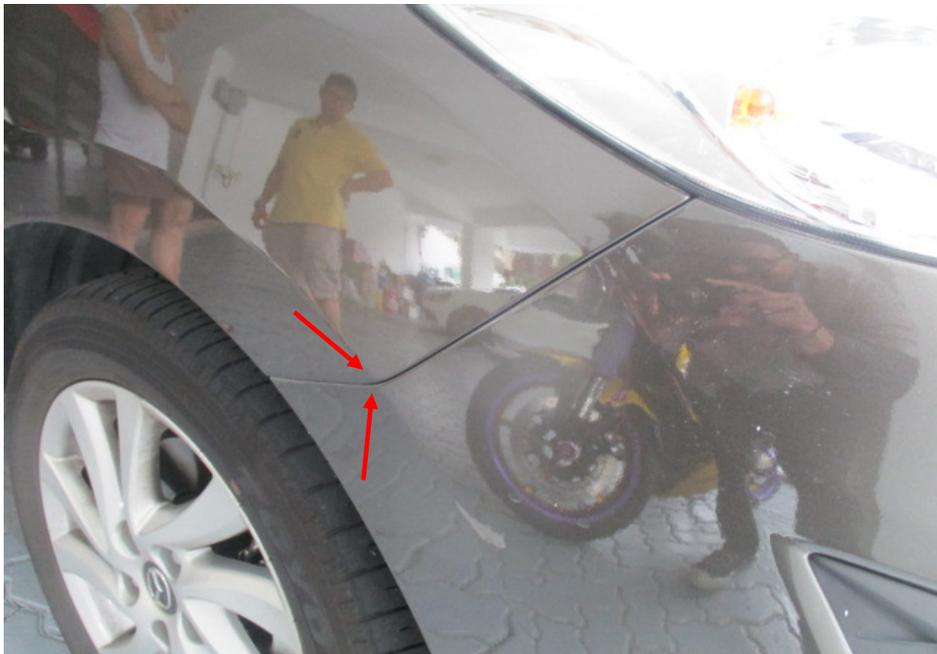
**Photo 14** shows a closer view of the right corner edge of the front bumper of the Mazda. We observed that there was no misalignment at the corner edges (arrowed).

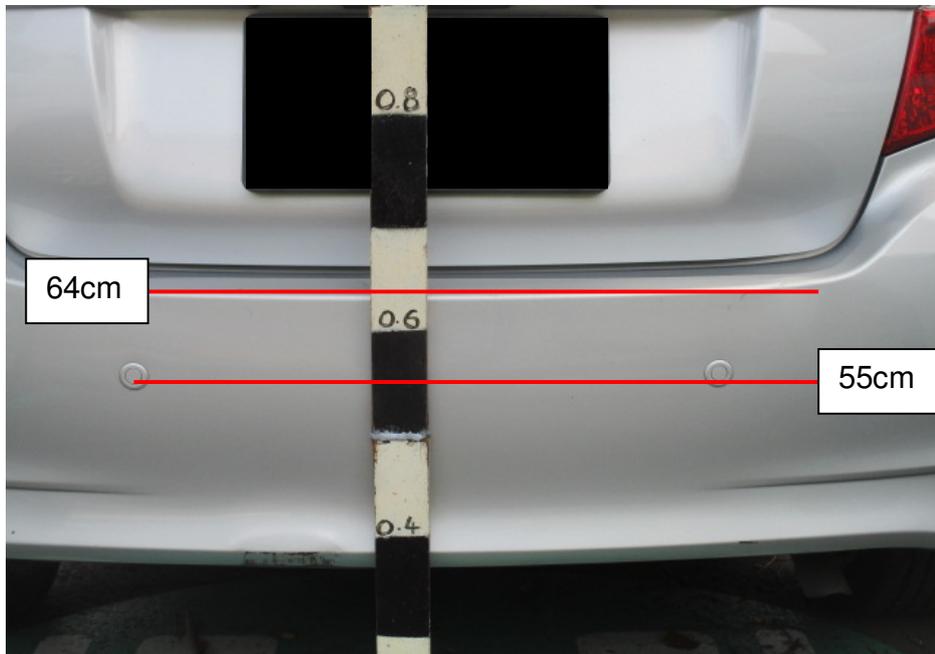
**Photo 15** shows the height measurement being conducted on the rear portion of the Toyota (using a similar make and model). The height above ground level of the horizontal whitish marks found on the left reverse sensor of the Toyota was measured to be approximately 55cm. The height above ground level of the vertical indentations found on the top portion of the Toyota's rear bumper was measured to be approximately 64cm.

- a) the height above ground level of the horizontal whitish marks found on the left reverse sensor of the Toyota was measured to be approximately 55cm;
- b) the height above ground level of the indentations found on the top portion of the Toyota's rear bumper was measured to be approximately 64cm;
- c) the height above ground level of the horizontal blackish marks on the bottom portion of the alpha- numeric letterings of the Mazda's front number plate was measured to be approximately 42cm;

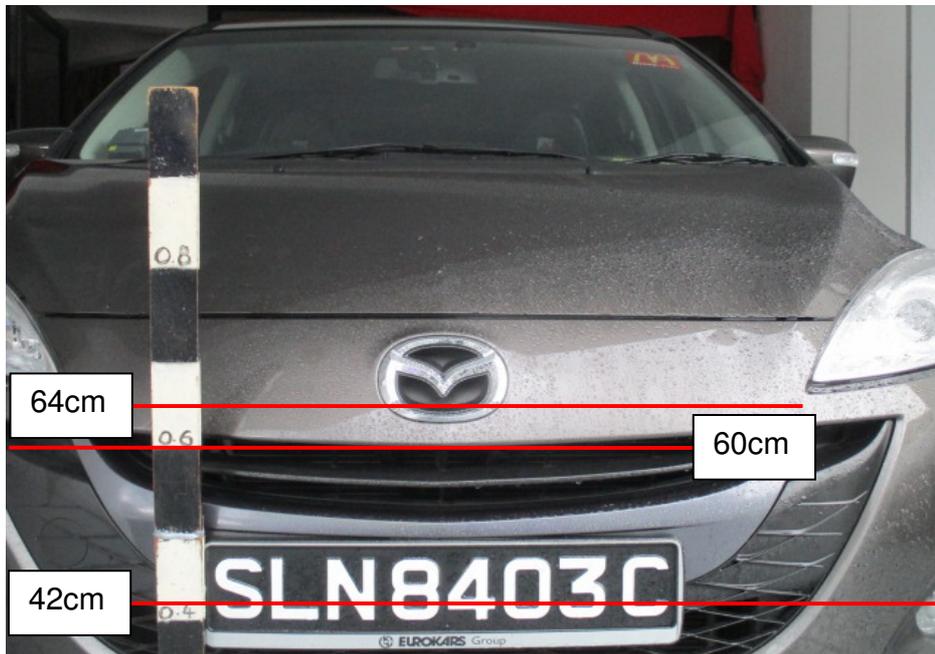
**Photo 16** shows the height measurement being conducted on the front portion of the Mazda. The height above ground level of the horizontal blackish marks on the bottom portion of the alpha- numeric letterings of the Mazda's front number plate was measured to be approximately 42cm. The height above ground level of the circular black mark on the top centre portion of the Mazda's front bumper was measured to be approximately 60cm. The bodypart at 64cm above ground level was the Mazda's front emblem.

- d) the height above ground level of the circular black mark on the top centre portion of the Mazda's front bumper was measured to be approximately 60cm;

- e) the bodypart at 64cm above ground level was the Mazda's front emblem;
  - f) the height measurements appear to support the findings of possible contact between the rear portion of the Toyota and the front portion of the Mazda. The damage observed on the rear bumper of the Toyota was a result of this contact and corresponds to the damage observed on the front bumper of the Mazda. In other words, the damage observed on the front bumper of the Mazda is consistent to the damage observed on the rear bumper of the Toyota.
