Claim Type: Third Party
Vehicle Reg No: SJE9568A
Vehicle Make/Model: Nissan Latio 1.5

VEHICLE DAMAGE INSPECTION REPORT

Our Ref: 307/TP/2017

Date of loss: 28/5/2017
Claimant: Ng Hoe Leong Alvin

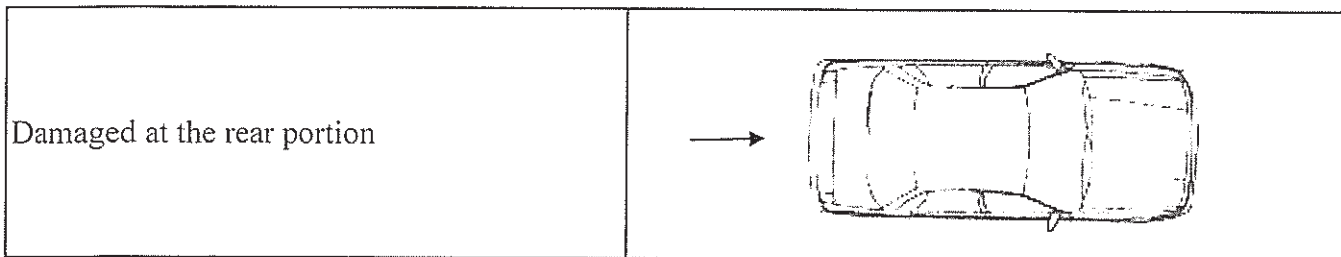
POINT OF IMPACT

Our visual inspection of the vehicle revealed that the damages noted are at the rear portion.

We have inspected the actual damages found on the vehicle and recommend the replacement of parts and repairs accordingly. The estimated repair cost is \$12,470.55. The repairer has agreed to undertake the repairs at our adjusted lump sum amount of \$9,000.
