Your Ref: CMTD1703331  
Our Ref : CI/SMO17019484/D

**Sompo Insurance Singapore Pte Ltd**

**TECHNICAL INVESTIGATION REPORT OF ENGINE DAMAGE TO THE INSURED VEHICLE SKS 7683C**

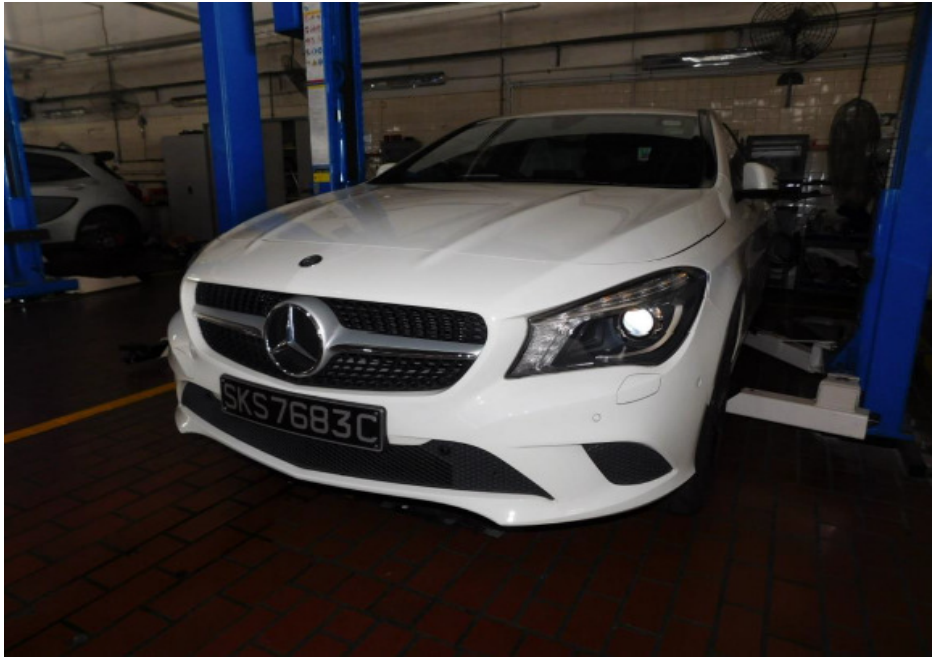
**Photo 1** shows a general view of the Insured Vehicle as seen from the photographs that were provided to me.

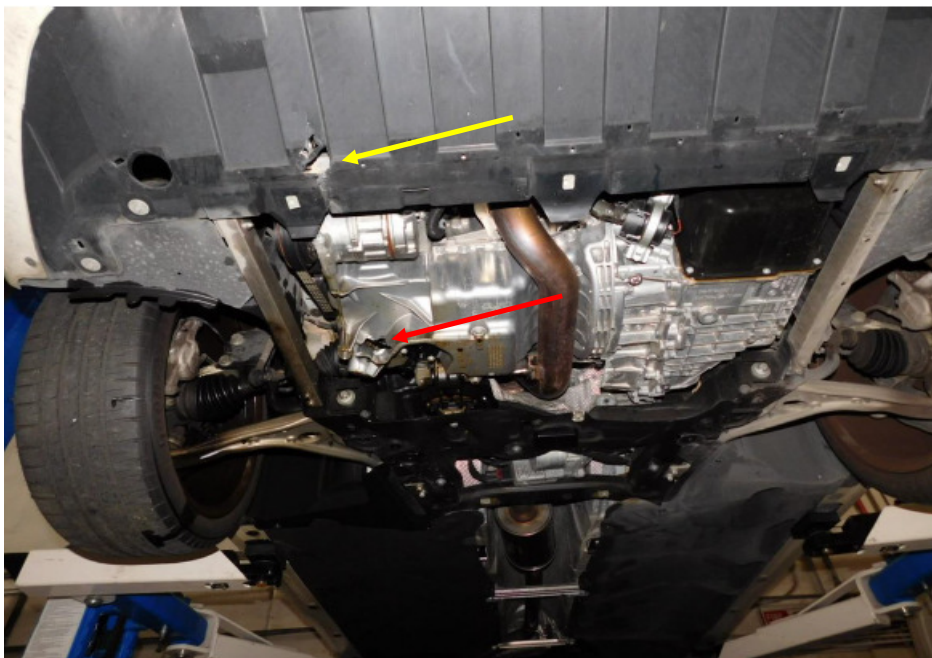
4. It was noted from the photographs provided to me that the engine oil sump, front engine undercover and centre engine undercover of the Insured Vehicle were damaged as a result of the incident.

5. The photographs had depicted both the front engine undercover and centre engine undercover torn, and engine oil sump broken. The damage profile of these 3 parts correspond to the Insured Vehicle going over an object. See photo 1 – 4 below.

**Photo 2** shows the torn front engine undercover (yellow arrow) and broken engine oil sump (red arrow) of the Insured Vehicle.

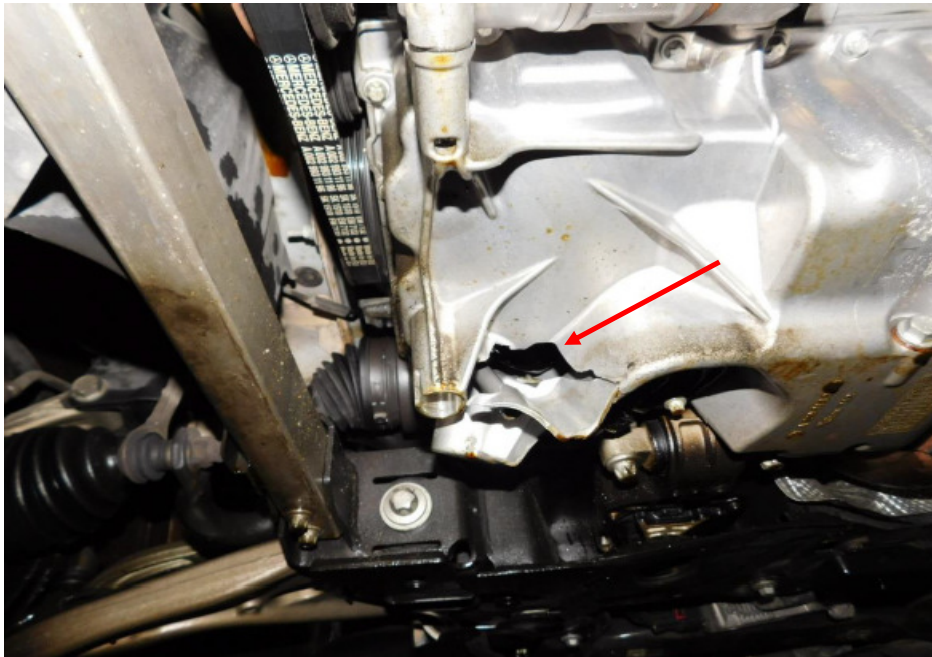
**Photo 3** shows a closer view of the broken engine oil sump (red arrow) of the Insured Vehicle. The damage profile of the engine oil sump corresponds to the Insured Vehicle going over an object.

7. For this case, the damage profile of the Insured Vehicle's underside corresponds to the Insured Vehicle going over an object(s), leading to the engine oil sump puncturing. However In such going over object(s) type of incidents, the engine of the vehicle will not be affected by the vehicle going over the object(s), provided that there was no further operation of the engine and/or continued driving after it had gone over the object(s), and also provided that there was no engine oil leakage.

8. Given that the Insured Vehicle's engine oil sump was found to have been punctured, the amount of engine oil would have decreased from leakage of engine oil, triggering the warning message of "check engine oil level" to appear on the console screen of the Insured Vehicle after it was continued to be driven, as per the circumstance of incident in the Singapore Accident Statement of the driver of the Insured Vehicle. As a result of the leakage, the engine oil became insufficient for lubricating and heat removal purposes during the continued driving of the Insured Vehicle, ultimately affecting the mechanical parts inside the engine, as per the cracking sound described by the driver.

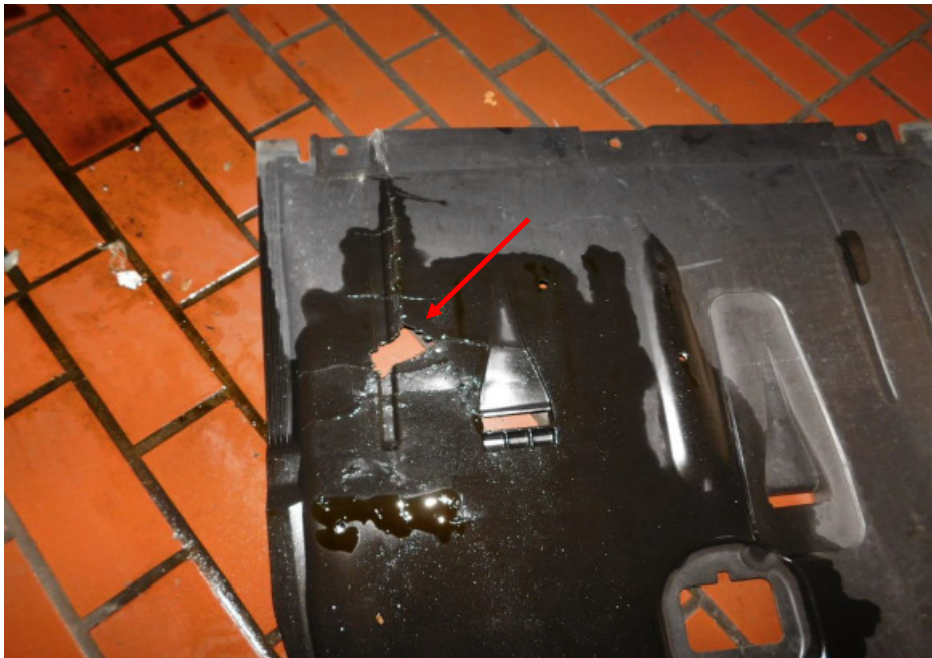
**Photo 4** shows the centre engine undercover of the Insured Vehicle, which was observed to be torn (arrowed) and covered with fresh fluid stain. The damage profile of the centre engine undercover corresponds to the Insured Vehicle going over an object

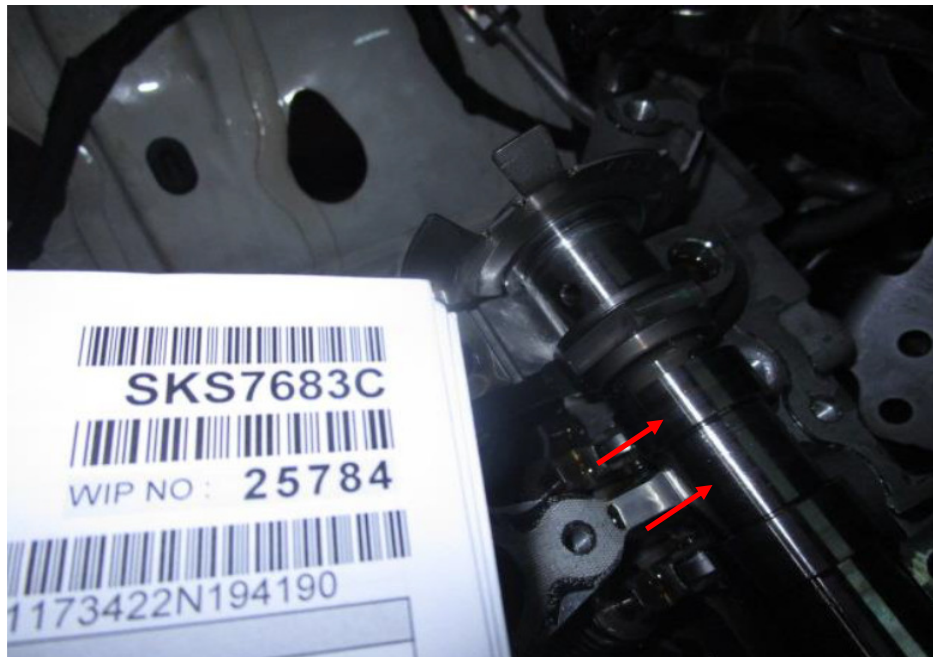
6. The photographs provided had also showed scoring marks on the camshaft lobe and under surface of the engine top cover. Causation of such scoring marks is usually due to direct contact between moving/rotating mechanical parts inside the engine as a result of insufficient lubricant (engine oil), which was unable to form adequate oil film (protection layer) between the mechanical parts. See photo 5 & 6 below.

**Photo 5** shows the scoring marks (arrowed) that were seen on the camshaft lobe of the Insured Vehicle (from the photographs that were provided to me). Such scoring marks are usually due to moving/rotating mechanical parts inside the engine coming into contact with each other as a result of insufficient lubricant (engine oil).

16. Having carried out a review and analysis of the material evidence, I am of the opinion that the damage to the engine of the Insured Vehicle was due to operating of the engine with insufficient engine oil for lubrication and heat removal purposes. Due to the insufficient engine oil, the oil film (protection layer) between the mechanical parts was inadequate, resulting in direct contact between moving/rotating mechanical parts inside the engine.
17. The insufficient engine oil was due to leakage of engine oil from a punctured engine oil sump that was caused by the Insured Vehicle going over the stones. The subsequent driving had led to the engine operating with insufficient engine oil, which affected the mechanical parts inside the engine.

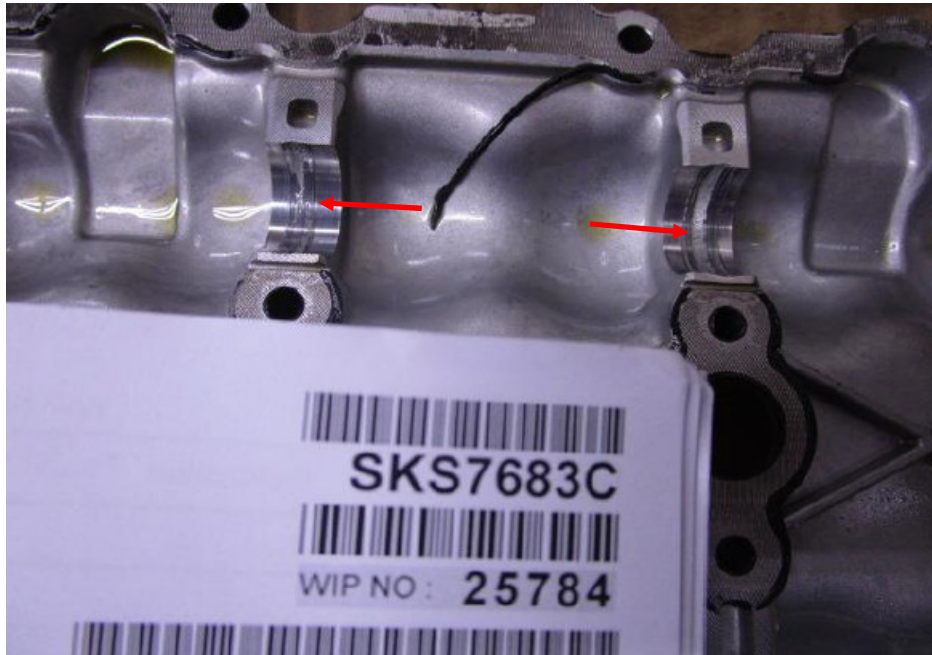
**Photo 6** shows the scoring marks (arrowed) that were seen on the under surface of the engine top cover, at the area where the camshaft lobes sit (from the photographs that were provided to me). Such scoring marks are usually due to moving/rotating mechanical parts inside the engine coming into contact with each other as a result of insufficient lubricant (engine oil).
