Your Ref: CMTD1703331  
Our Ref : CI/SMO17019484/D

**Sompo Insurance Singapore Pte Ltd**  
50 Raffles Place #05-01/06  
Singapore Land Tower  
Singapore 048623  
(Motor Claims Department)

### **TECHNICAL INVESTIGATION REPORT OF ENGINE DAMAGE TO THE INSURED VEHICLE SKS 7683C**

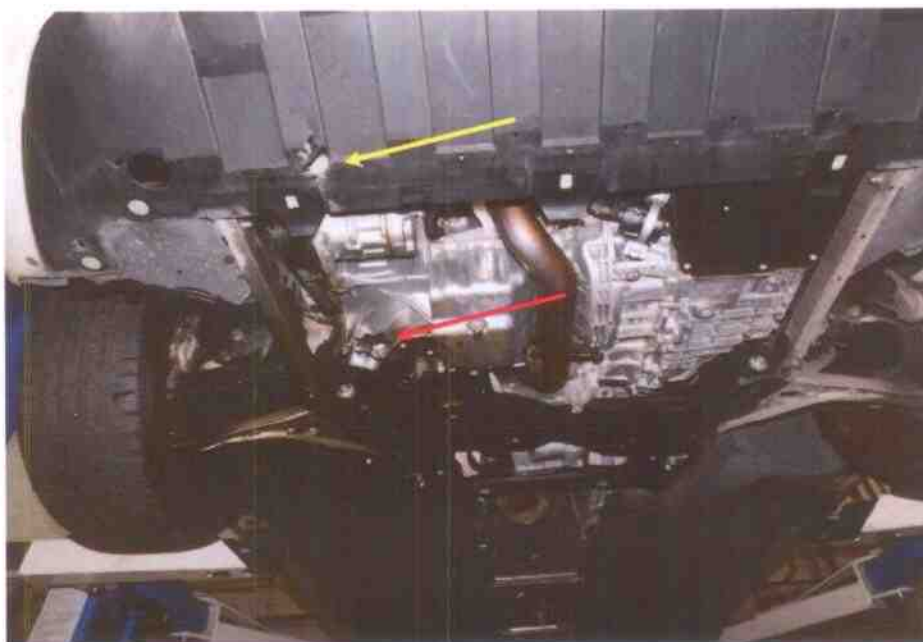
5. The photographs had depicted both the front engine undercover and centre engine undercover torn, and engine oil sump broken. The damage profile of these 3 parts correspond to the Insured Vehicle going over an object. See photo 1 – 4 below.

**Photo 2** shows the torn front engine undercover (yellow arrow) and broken engine oil sump (red arrow) of the Insured Vehicle.

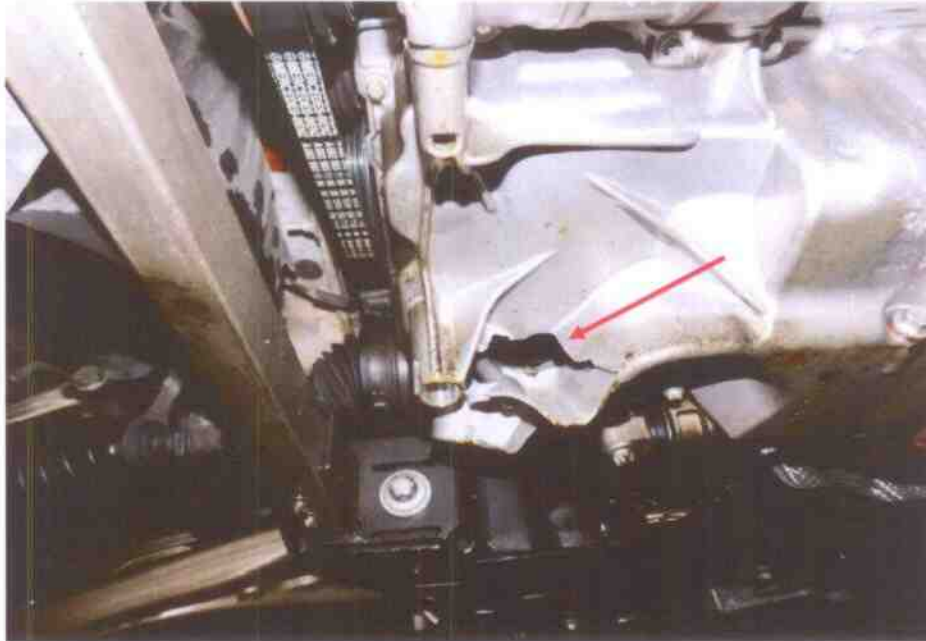
**Photo 3** shows a closer view of the broken engine oil sump (red arrow) of the Insured Vehicle. The damage profile of the engine oil sump corresponds to the Insured Vehicle going over an object.

7. For this case, the damage profile of the Insured Vehicle's underside corresponds to the Insured Vehicle going over an object(s), leading to the engine oil sump puncturing. However In such going over object(s) type of incidents, the engine of the vehicle will not be affected by the vehicle going over the object(s), provided that there was no further operation of the engine and/or continued driving after it had gone over the object(s), and also provided that there was no engine oil leakage.

8. Given that the Insured Vehicle's engine oil sump was found to have been punctured, the amount of engine oil would have decreased from leakage of engine oil, triggering the warning message of "check engine oil level" to appear on the console screen of the Insured Vehicle after it was continued to be driven, as per the circumstance of incident in the Singapore Accident Statement of the driver of the Insured Vehicle. As a result of the leakage, the engine oil became insufficient for lubricating and heat removal purposes during the continued driving of the Insured Vehicle, ultimately affecting the mechanical parts inside the engine, as per the cracking sound described by the driver.

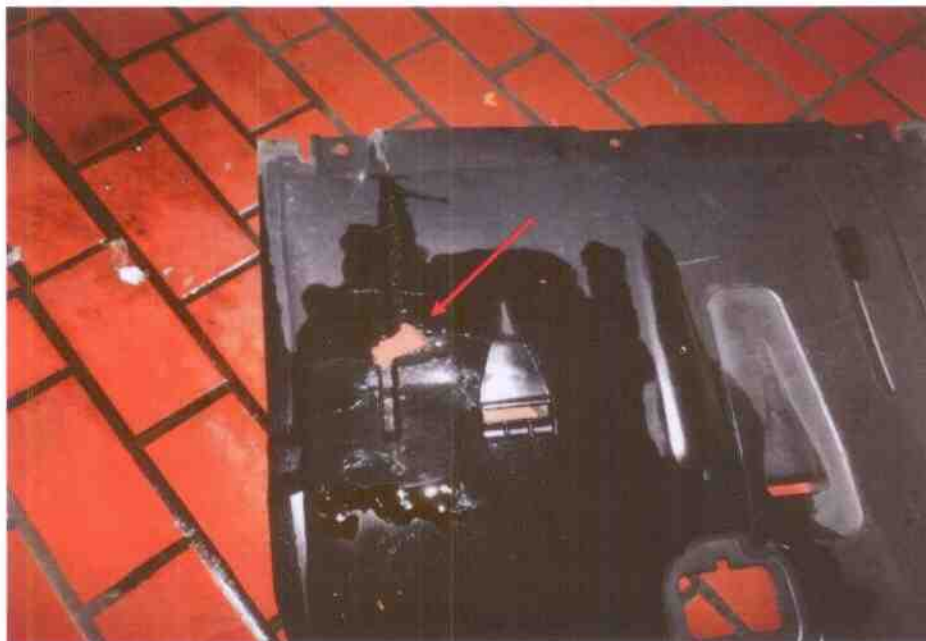
**Photo 4** shows the centre engine undercover of the Insured Vehicle, which was observed to be torn (arrowed) and covered with fresh fluid stain. The damage profile of the centre engine undercover corresponds to the Insured Vehicle going over an object

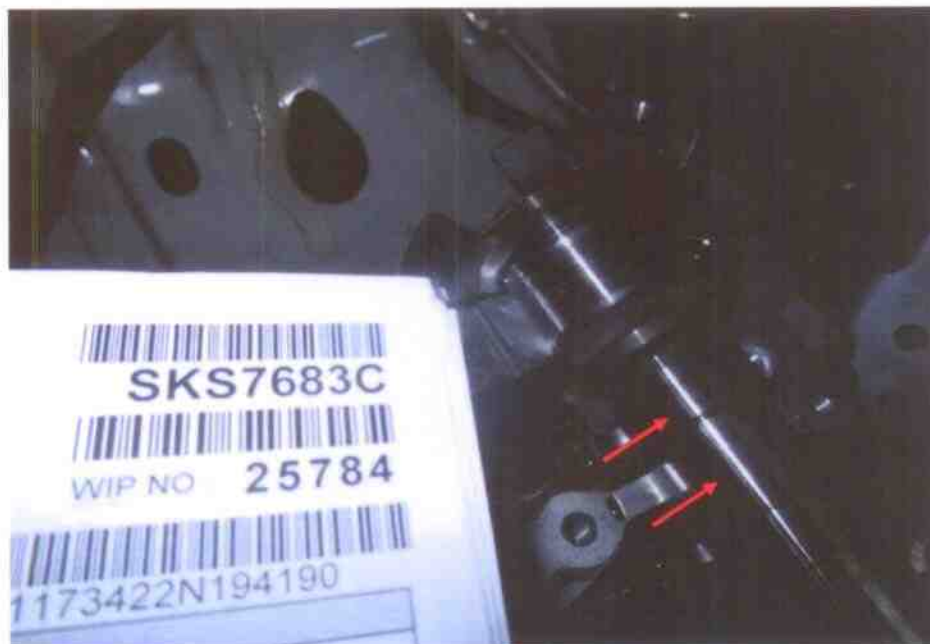
6. The photographs provided had also showed scoring marks on the camshaft lobe and under surface of the engine top cover. Causation of such scoring marks is usually due to direct contact between moving/rotating mechanical parts inside the engine as a result of insufficient lubricant (engine oil), which was unable to form adequate oil film (protection layer) between the mechanical parts. See photo 5 & 6 below.

**Photo 5** shows the scoring marks (arrowed) that were seen on the camshaft lobe of the Insured Vehicle (from the photographs that were provided to me). Such scoring marks are usually due to moving/rotating mechanical parts inside the engine coming into contact with each other as a result of insufficient lubricant (engine oil).

16. Having carried out a review and analysis of the material evidence, I am of the opinion that the damage to the engine of the Insured Vehicle was due to operating of the engine with insufficient engine oil for lubrication and heat removal purposes. Due to the insufficient engine oil, the oil film (protection layer) between the mechanical parts was inadequate, resulting in direct contact between moving/rotating mechanical parts inside the engine.
17. The insufficient engine oil was due to leakage of engine oil from a punctured engine oil sump that was caused by the Insured Vehicle going over the stones. The subsequent driving had led to the engine operating with insufficient engine oil, which affected the mechanical parts inside the engine.

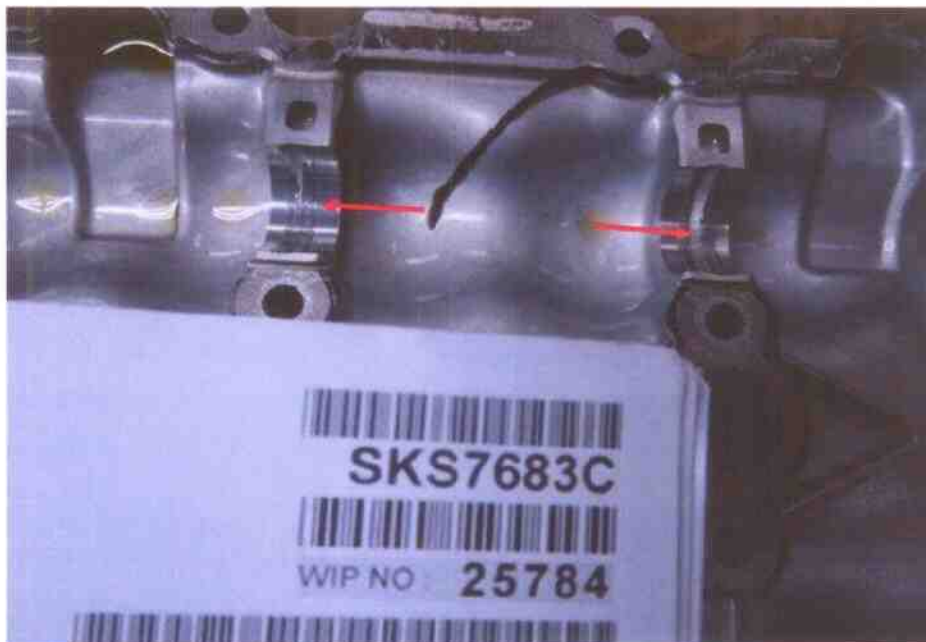
**Photo 6** shows the scoring marks (arrowed) that were seen on the under surface of the engine top cover, at the area where the camshaft lobes sit (from the photographs that were provided to me). Such scoring marks are usually due to moving/rotating mechanical parts inside the engine coming into contact with each other as a result of insufficient lubricant (engine oil).
