Your Ref: C0456701
Our Ref : CS/AXA17020335/N

3 November 2017

**TECHNICAL INVESTIGATION REPORT OF FIRE INCIDENT INVOLVING THE
MOTOR VEHICLE XD 3957P ON 29 JULY 2017**

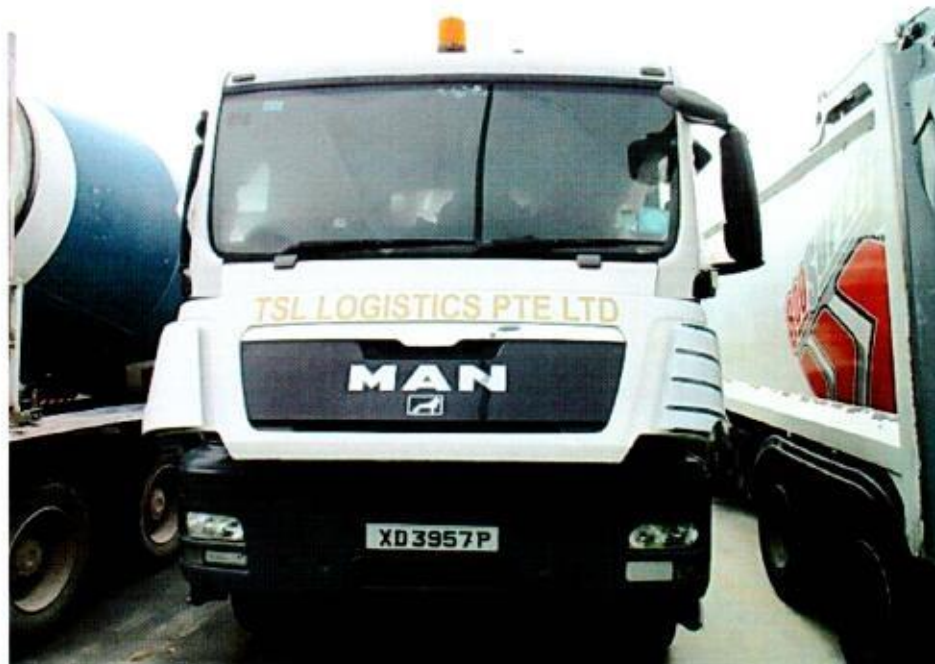
Photo 1 shows the front view of the Insured Vehicle at the time of our inspection. The fire damage to the Insured Vehicle was confined to its interior compartment. Most parts of the front portion were unaffected by the fire except for the front windscreen.

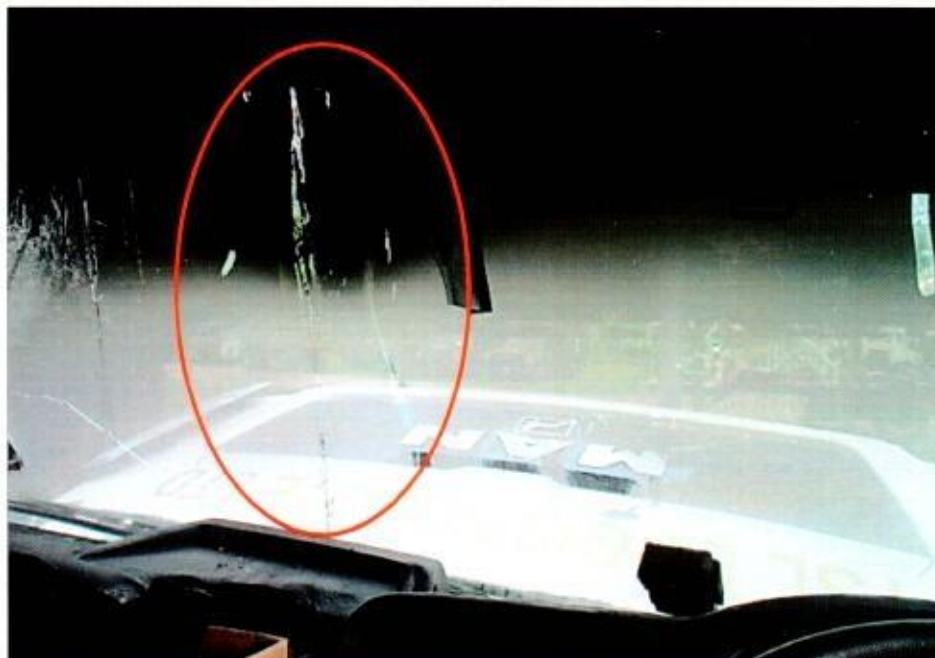
Photo 2 shows the general view of the front windscreen of the Insured Vehicle (as viewed from the interior compartment). The centre portion of the windscreen seemed to have sustained visible fire damage (circled).

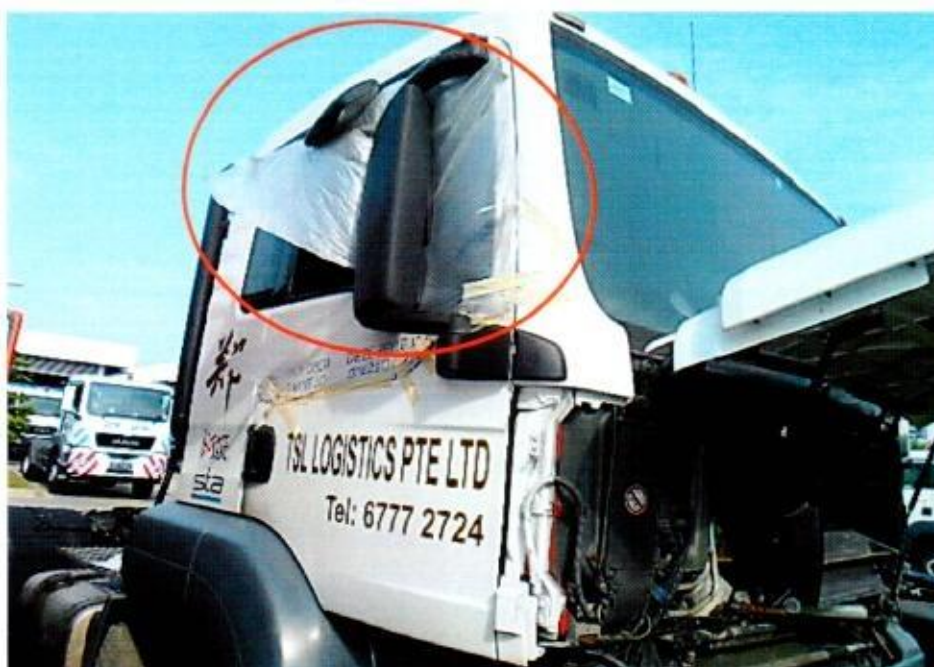
Photo 3 shows the right side view of the Insured Vehicle at the time of our inspection. The fire damage to the Insured Vehicle was confined to its interior compartment. The right side was observed to have been unaffected by the fire except for the driver door window (circled).

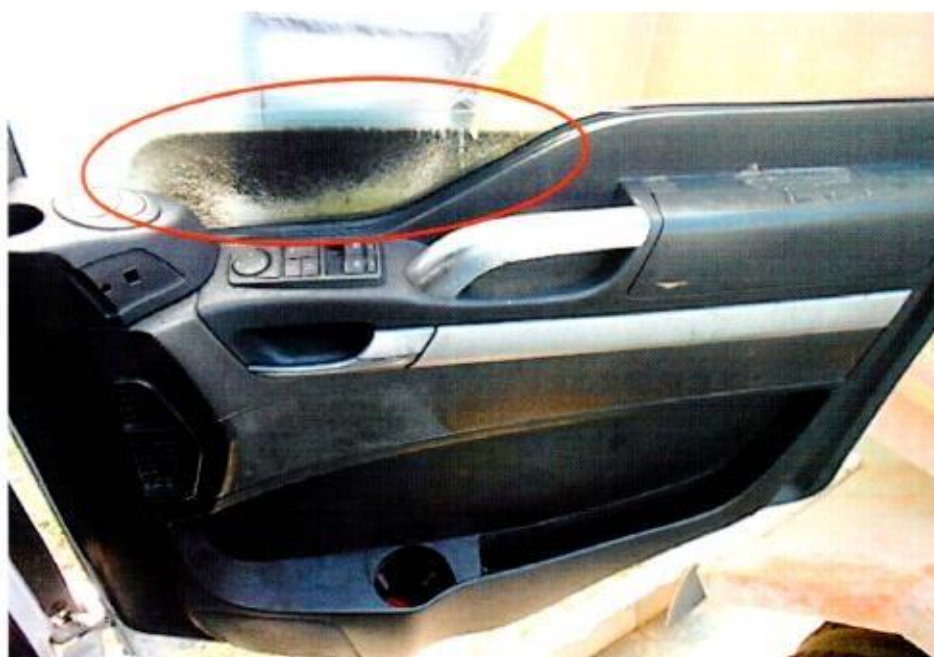
Photo 4 shows a closer view of the driver door window of the Insured Vehicle at the time of our inspection (as viewed from the interior compartment). The window was covered in soot (circled).

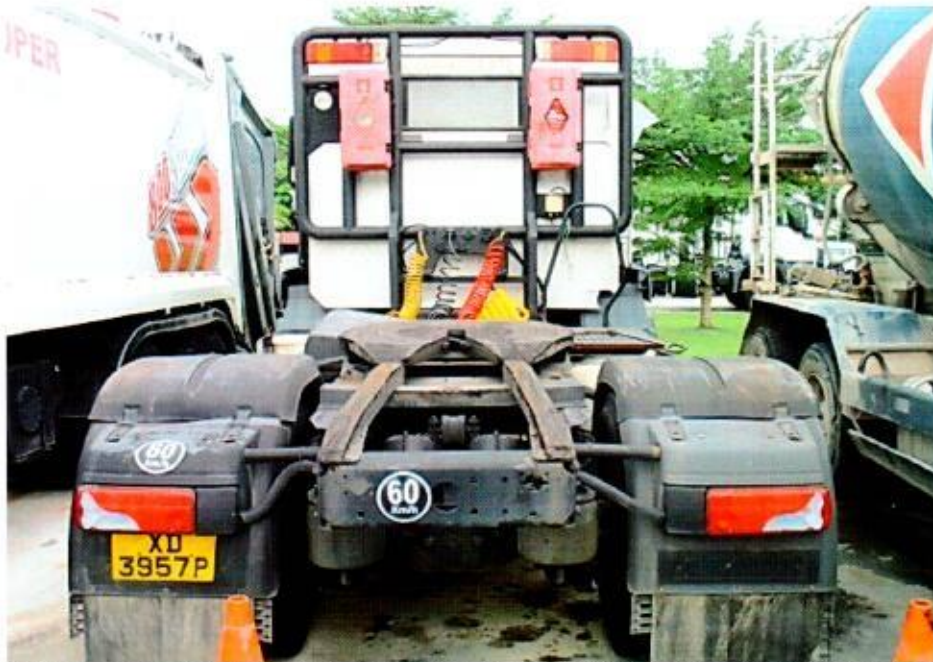
Photo 5 shows the rear view of the Insured Vehicle at the time of our inspection. The fire damage to the Insured Vehicle was confined to its interior compartment. The rear portion was observed to have been unaffected by the fire.

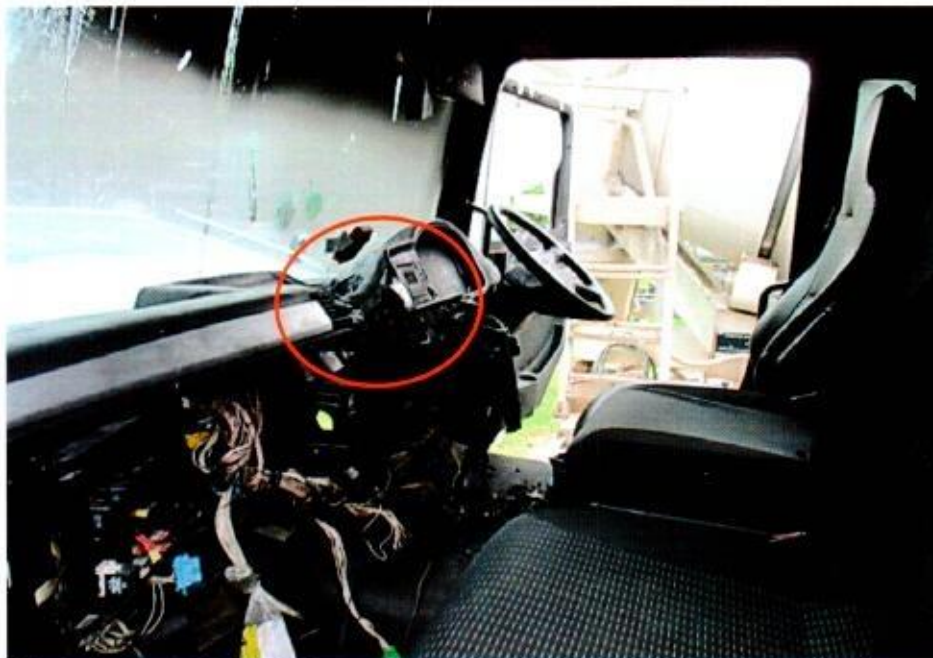
Photo 6 shows the interior compartment of the Insured Vehicle at the time of inspection. Most of the components in the centre of the dashboard (circled) were found to be burnt and/or melted as a result of the fire.

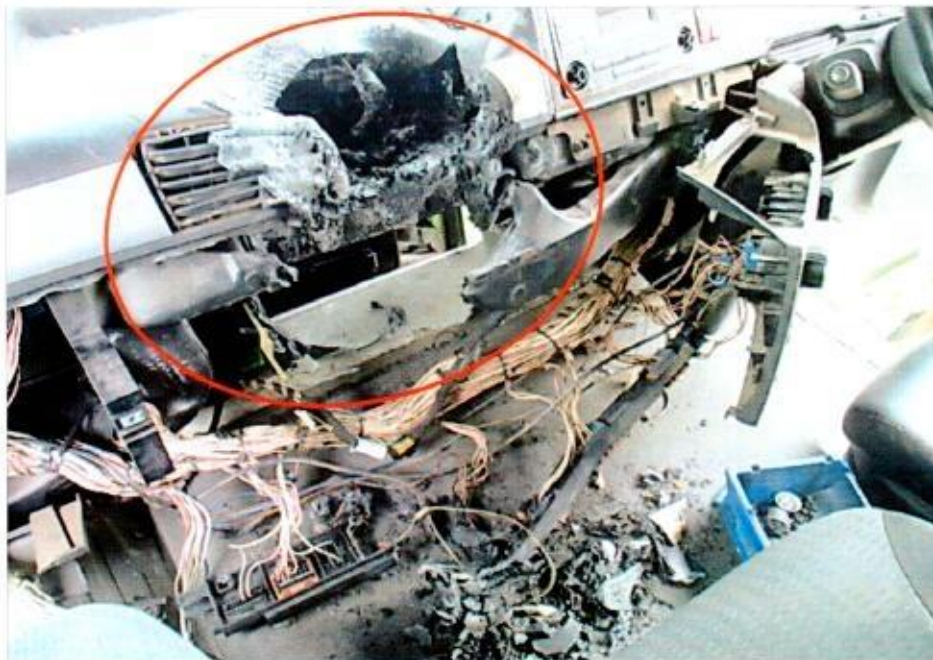
7. For this particular case, the fire appears to have started from the centre of the dashboard. This can be determined basing on the area where the extent of fire damage was most severe which was the centre portion of the instrument panel. Various components of the instrument panel were observed to have been burnt and/or partly melted from prolonged exposure to high heat intensity which included the upper and central parts of the instrument panel assembly, air outlet assembly, beaker holder assembly and carrier assembly, amongst others. See photos 7 - 9 below.

Photo 7 shows the centre of the dashboard of the Insured Vehicle. The fire seemed to have originated from the centre portion of the instrument panel basing on the area where the extent of fire damage was most severe. Various components of the instrument panel were observed to have been burnt and/or partly melted from prolonged exposure to high heat intensity which included the upper and central parts of the instrument panel assembly, air outlet assembly, beaker holder assembly and carrier assembly, amongst others (circled).

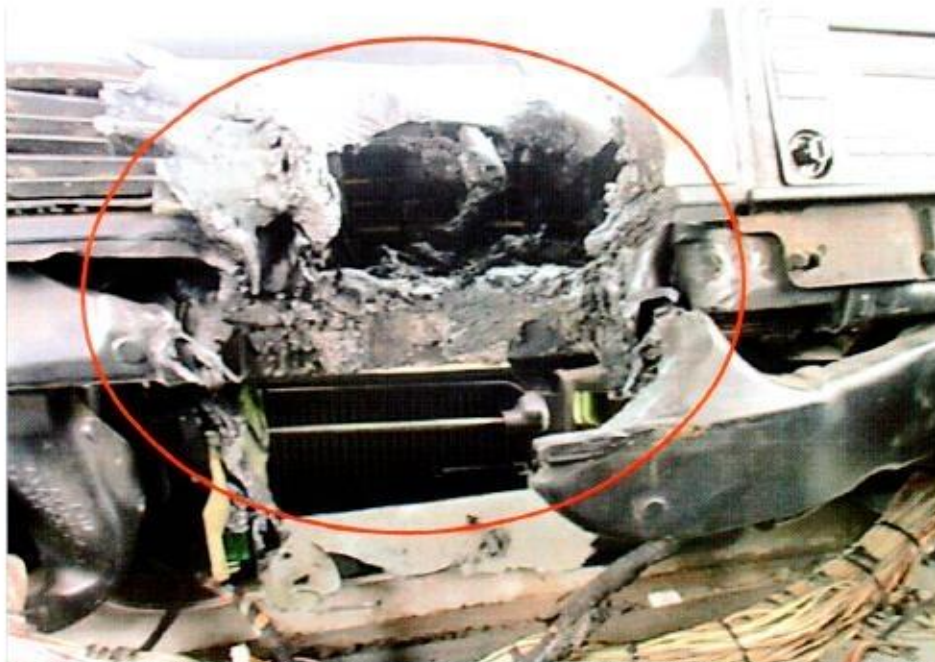
Photo 8 shows a closer view of the centre portion of the instrument panel. Various components of the instrument panel were observed to have been burnt and/or partly melted from prolonged exposure to high heat intensity which included the upper and central parts of the instrument panel assembly, air outlet assembly, beaker holder assembly and carrier assembly, amongst others (circled).

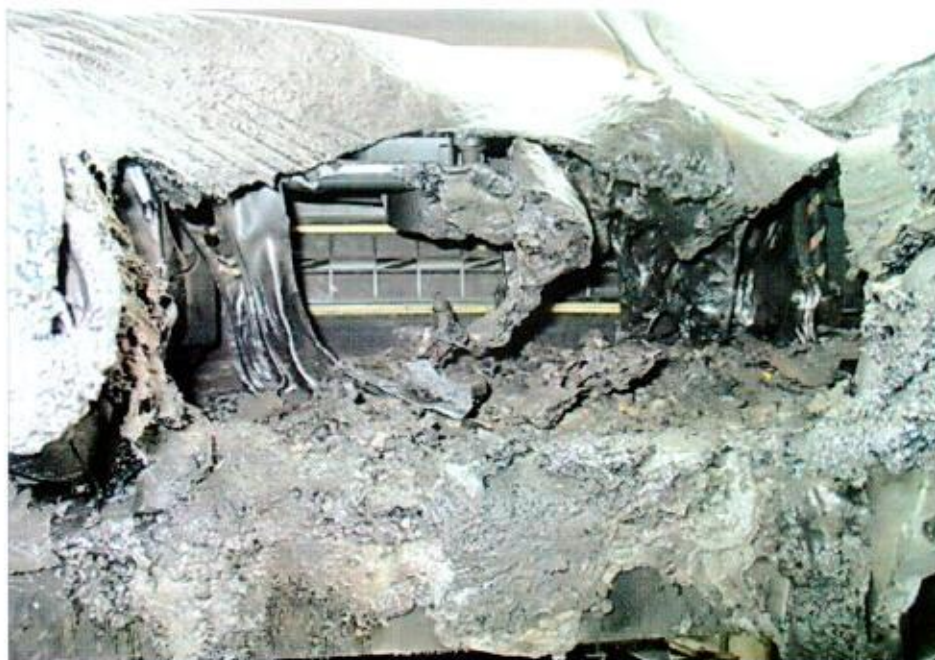
Photo 9 shows a close up view of the centre portion of the instrument panel. Most of the components of the instrument panel were observed to have been burnt and/or partly melted from prolonged exposure to high heat intensity.

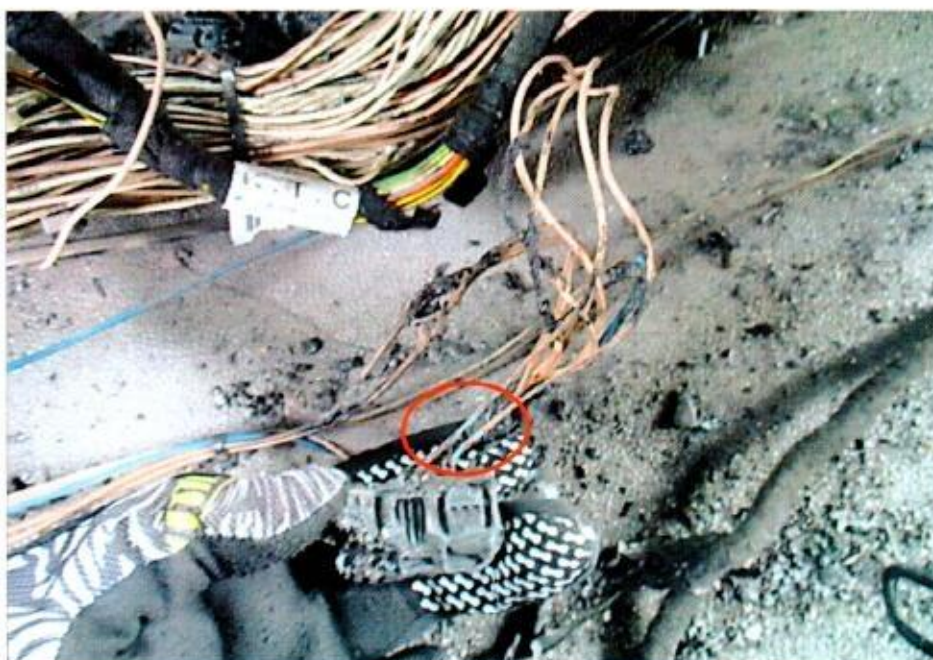
8. Upon closer examination of the various components contained within the centre portion of the instrument panel, which was where the fire to the Insured Vehicle had likely started, we had found greenish residue on some of the wirings leading to a connector. The wirings were original factory fitted wirings. We also found traces of greenish residue on the front portion of the air- conditioning blower connector as well as on the air- conditioning blower motor resistor. The presence of greenish residue indicates internal heating of copper wires, a sign of an electrical short circuit occurring. The greenish residue is normally left behind from oxidation as a result of chemical reaction involving the copper wires. These physical evidences would then appear to suggest that the cause of fire to the Insured Vehicle could have possibly been due to electrical in nature. See photos 10 - 16 below.

Photo 10 shows some original factory fitted wirings leading to a connector with greenish residue (circled). The presence of such greenish residue suggests occurrence of an electrical short circuit.

31. Having investigated and technically analysed the damages of burnt nature to the Insured Vehicle, we are of the view that the cause of fire to the Insured Vehicle was of electrical in nature. For this particular case, the fire had originated from the wirings within the centre portion of the instrument panel of the Insured Vehicle. The wirings were original factory wirings of the Insured Vehicle.

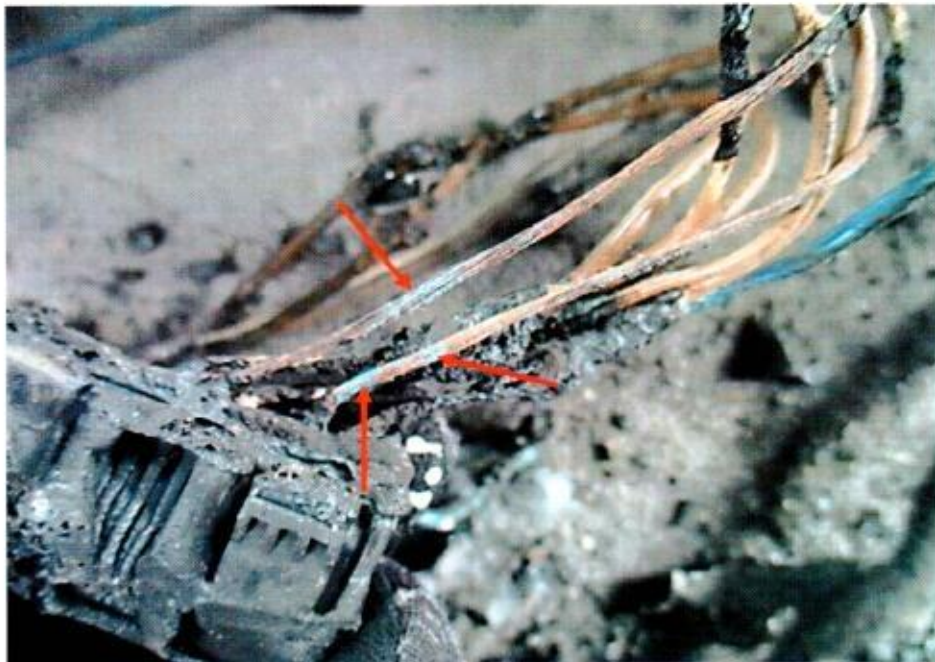
Photo 11 shows a closer view of the original factory fitted wirings leading to a connector with greenish residue (red arrows). The presence of such greenish residue suggests occurrence of an electrical short circuit.

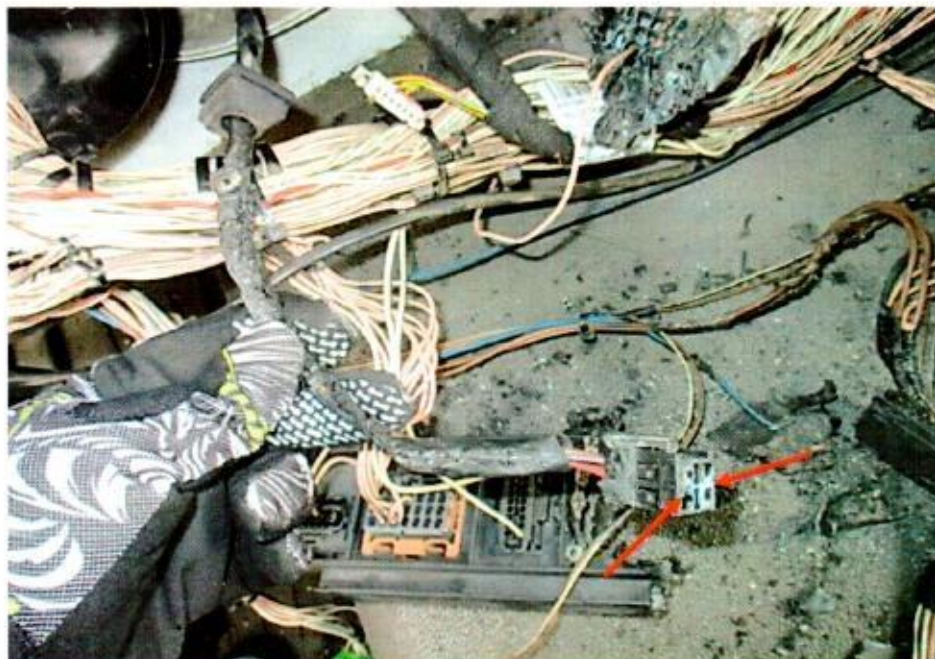
Photo 12 shows traces of greenish residue found on the front portion of the air-conditioning blower connector (red arrows). The presence of such greenish residue suggests occurrence of an electrical short circuit.

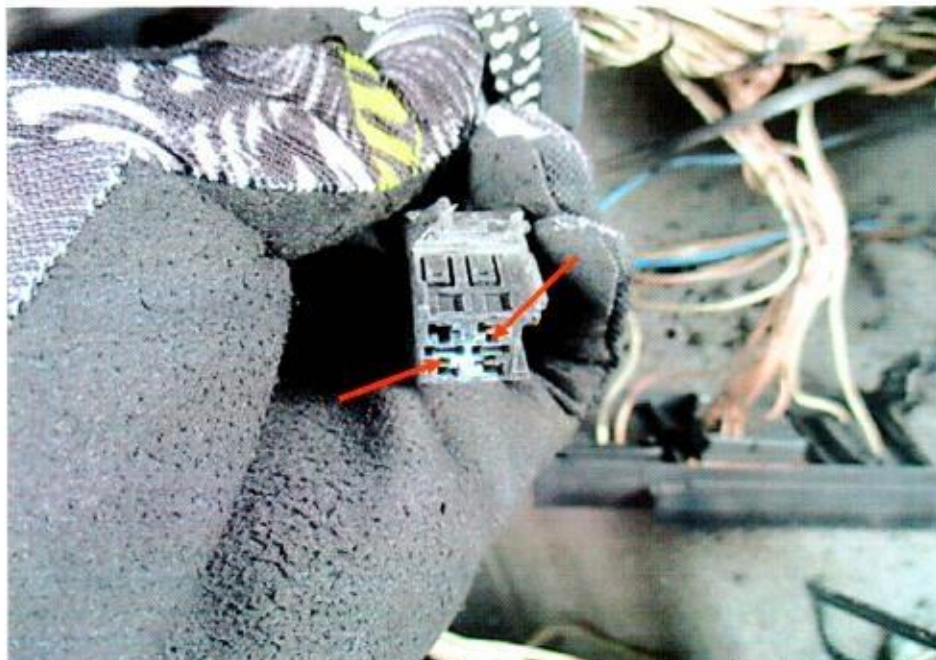
Photo 13 shows a close up view of the greenish residue found on the front portion of the air- conditioning blower connector (red arrows). The presence of such greenish residue suggests occurrence of an electrical short circuit.

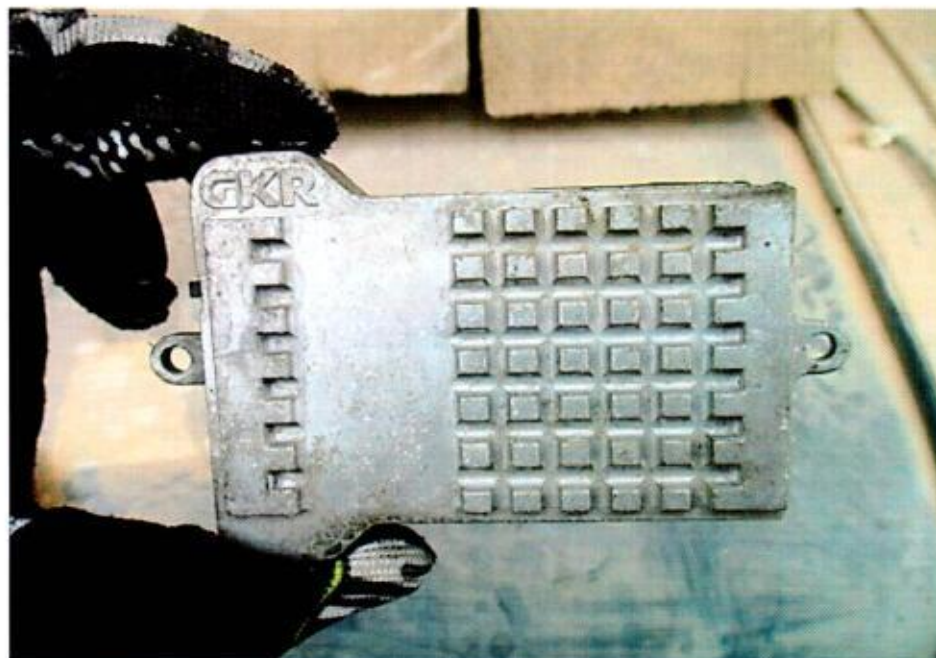
Photo 14 shows the air- conditioning blower motor resistor casing that is part of the instrument panel.

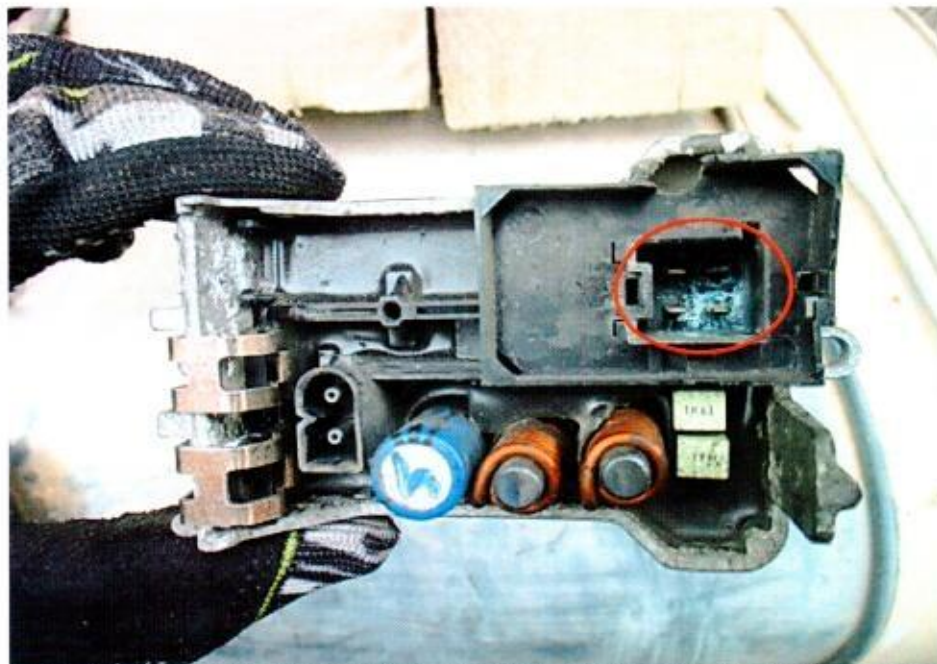
Photo 15 shows the air- conditioning blower motor resistor. We found traces of greenish residue on the air- conditioning blower connector contact point (circled). The presence of such greenish residue suggests occurrence of an electrical short circuit.

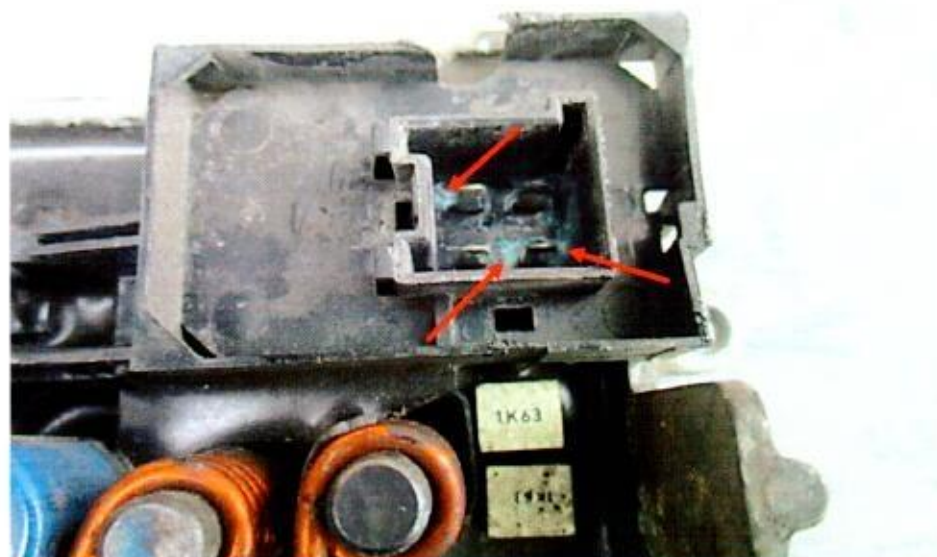
Photo 16 shows a close up view of the greenish residue found on the air- conditioning blower connector contact point (circled). The presence of such greenish residue suggests occurrence of an electrical short circuit.

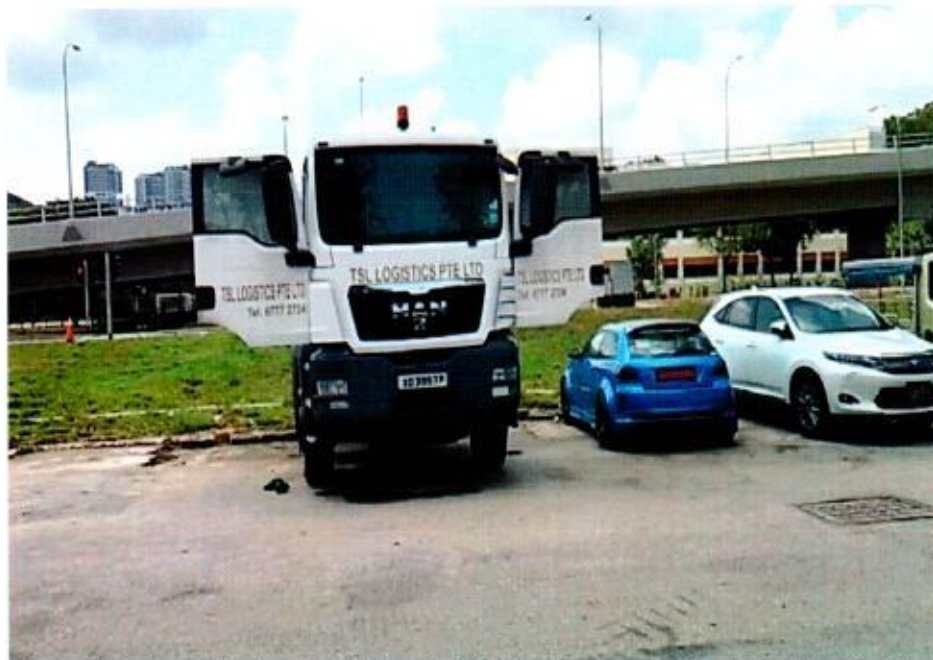
Photo 17 shows the Insured Vehicle after the fire was extinguished by Mr Chai. In general, the information that could be gathered from this photograph had corresponded to the events that were related to us by Mr Chai, which is the fire started from the interior compartment.

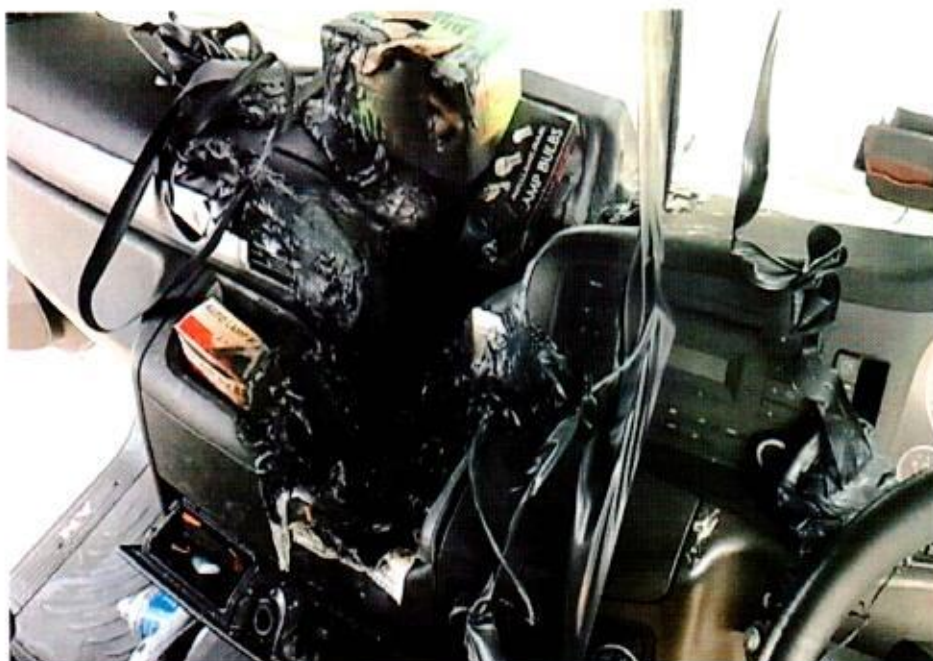
Photo 18 shows the interior compartment of the Insured Vehicle after the fire was extinguished. In general, the extensive damages sustained to the centre portion of the instrument panel had corresponded to the events that were related to us by Mr Chai, which is the fire started from the interior compartment.

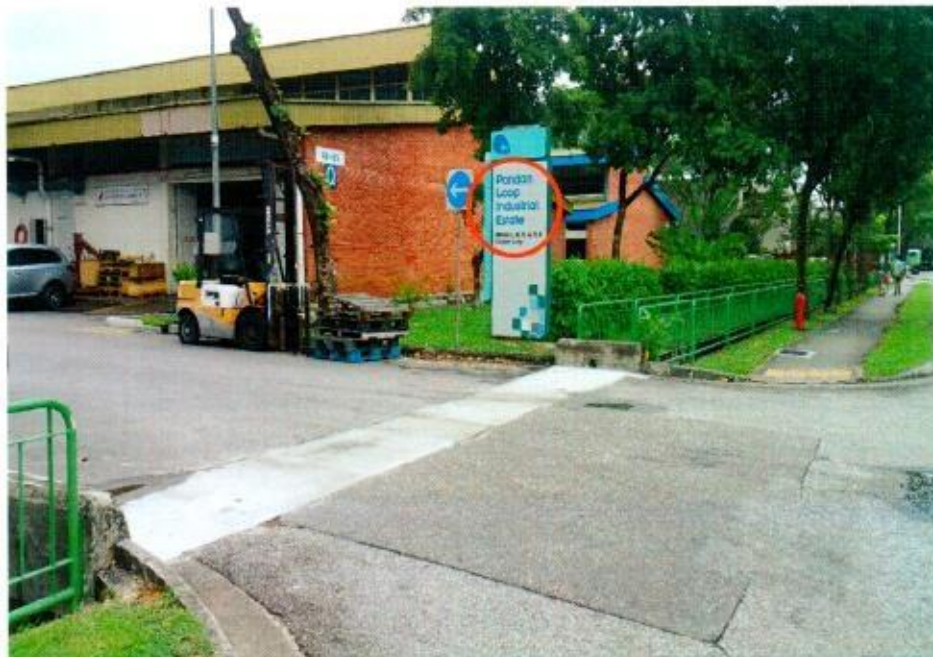
Photo 19 shows the entrance to the open carpark inside the Pandan Industrial Estate (circled) located along Pandan Loop which is across from TSL.

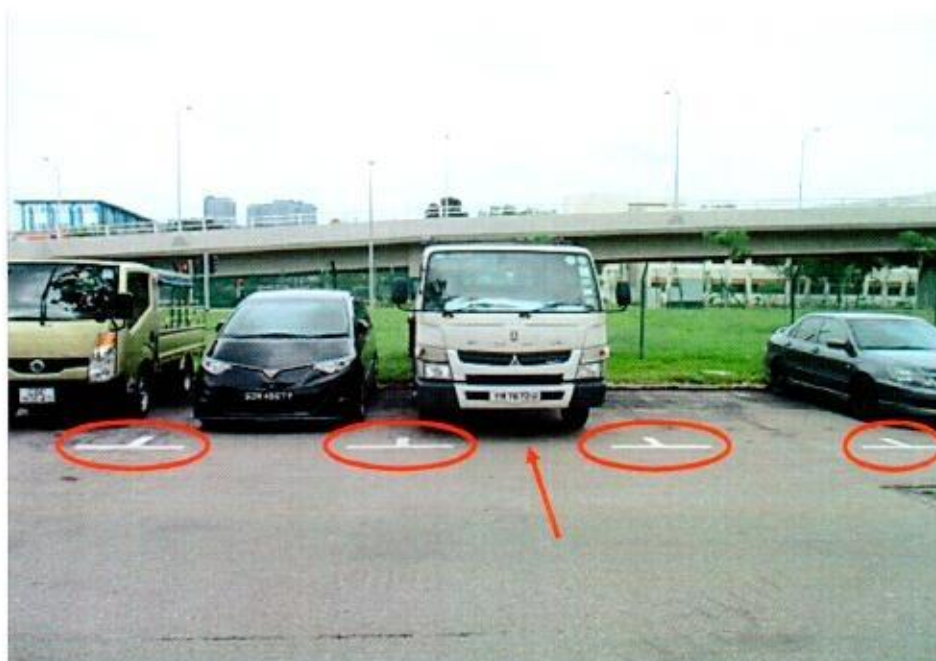
Photo 20 shows the position where the Insured Vehicle was parked on the day of the incident (arrowed). We noticed that parking lots had been constructed in the open space where the Insured Vehicle was parked on the day of the incident (circled).

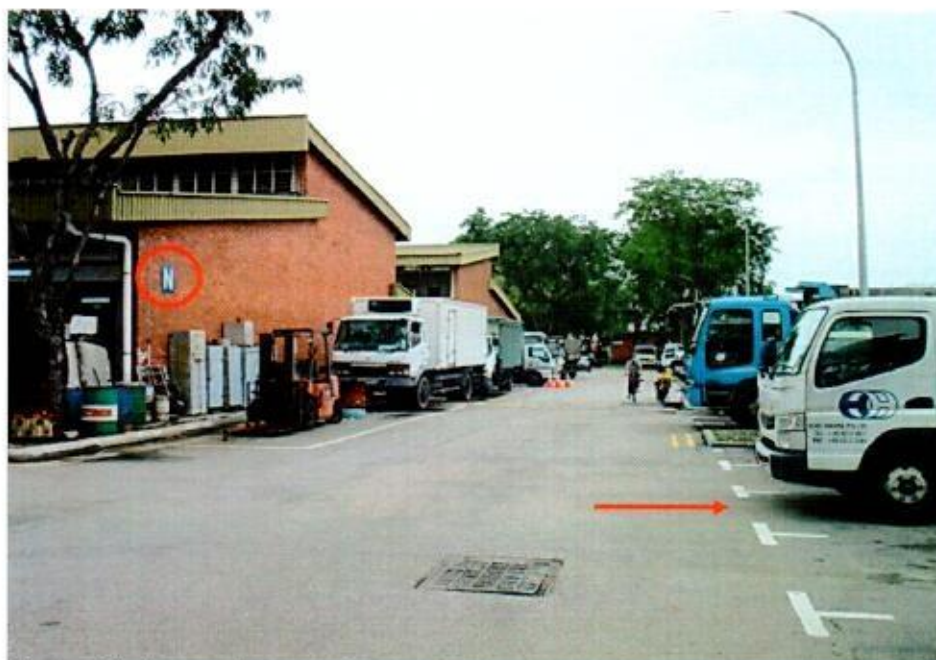
Photo 21 shows the open carpark inside the Pandan Industrial Estate. The Insured Vehicle was parked (arrowed) in between blocks N (circled) and Q on the day of the incident.

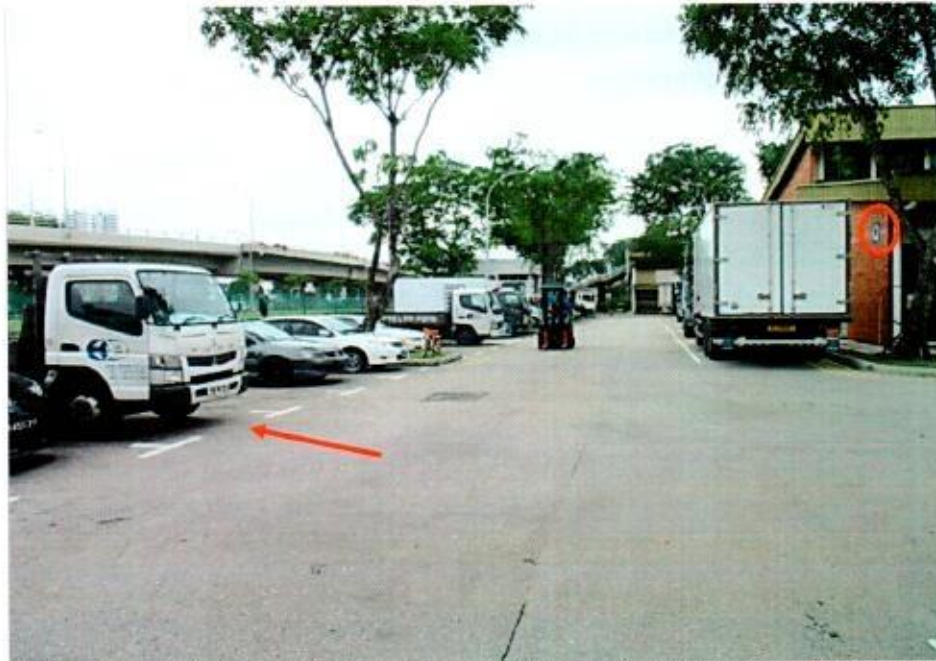
Photo 22 shows the open carpark inside the Pandan Industrial Estate. The Insured Vehicle was parked (arrowed) in between blocks N and Q (circled) on the day of the incident.

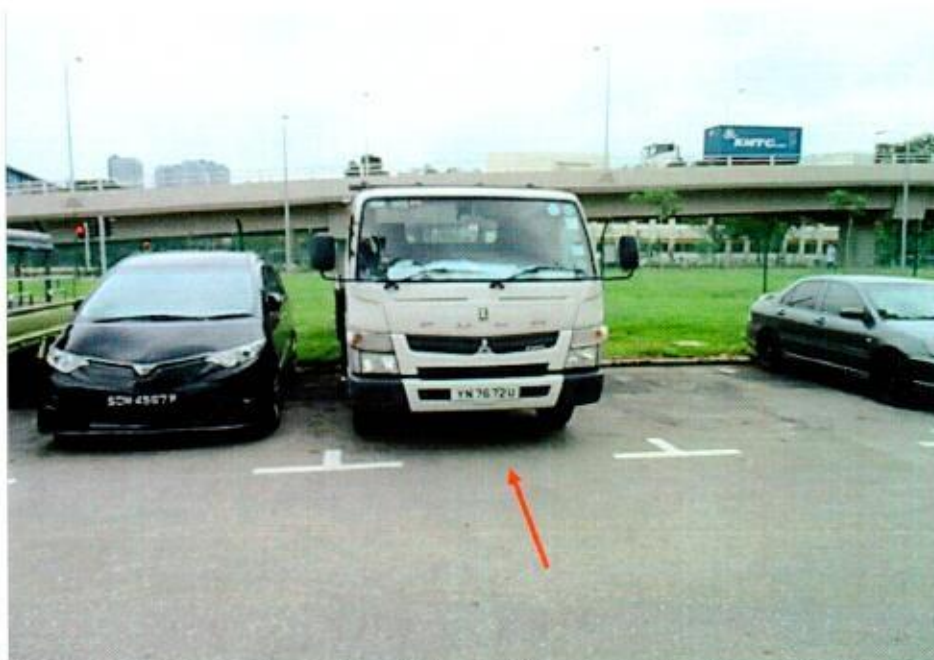
Photo 23 shows a closer view of the position where the Insured Vehicle was parked on the day of the incident. We did not find any burnt residual remains on the ground where the Insured was positioned as it was a minor fire. Moreover, the incident occurred approximately 3 months before the insurance claim was made. Moreover, parking lots had been constructed in the open space where the Insured Vehicle was parked on the day of the incident.
