Your Ref: C0456701
Our Ref : CS/AXA17020335/N

3 November 2017

TECHNICAL INVESTIGATION REPORT OF FIRE INCIDENT INVOLVING THE MOTOR VEHICLE XD 3957P ON 29 JULY 2017

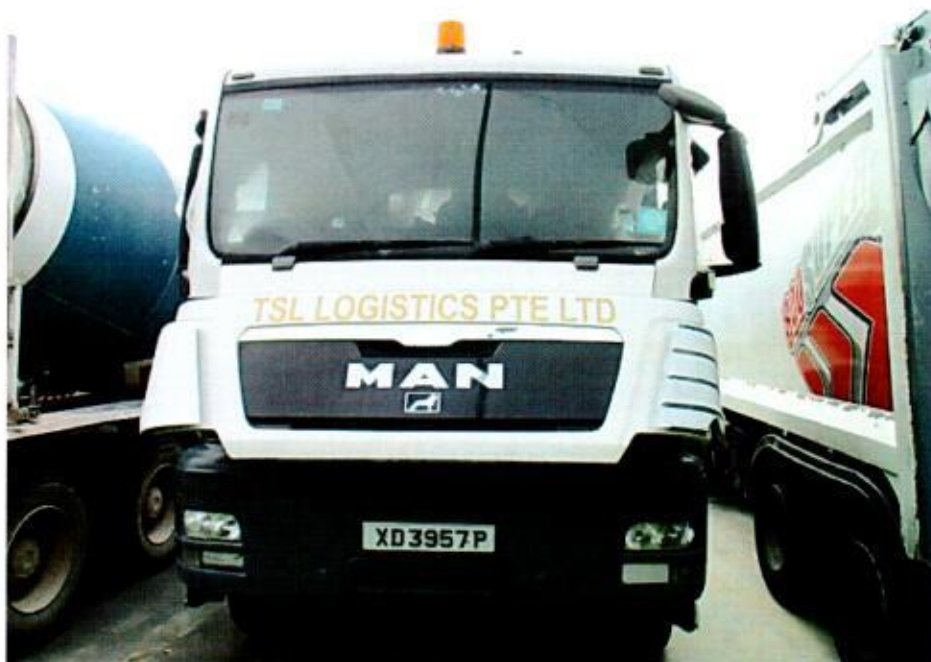
Photo 1 shows the front view of the Insured Vehicle at the time of our inspection. The fire damage to the Insured Vehicle was confined to its interior compartment. Most parts of the front portion were unaffected by the fire except for the front windscreen.

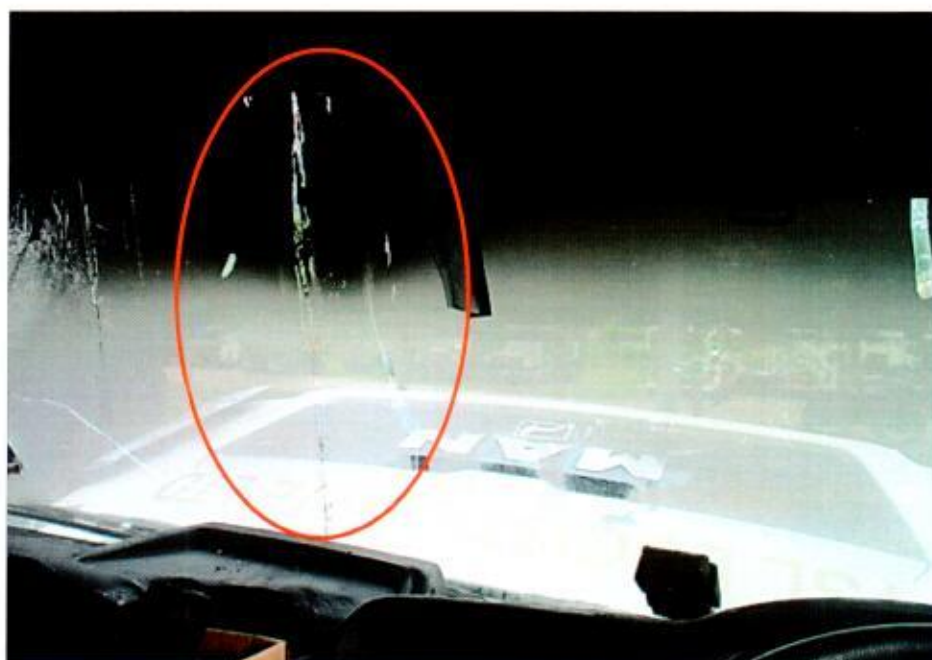
Photo 2 shows the general view of the front windscreen of the Insured Vehicle (as viewed from the interior compartment). The centre portion of the windscreen seemed to have sustained visible fire damage (circled).

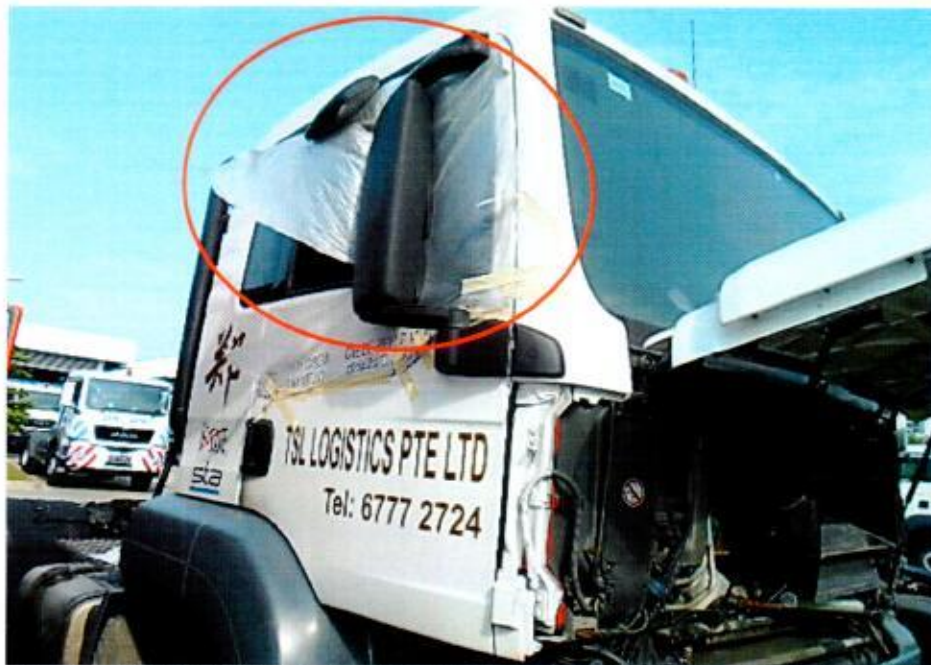
Photo 3 shows the right side view of the Insured Vehicle at the time of our inspection. The fire damage to the Insured Vehicle was confined to its interior compartment. The right side was observed to have been unaffected by the fire except for the driver door window (circled).

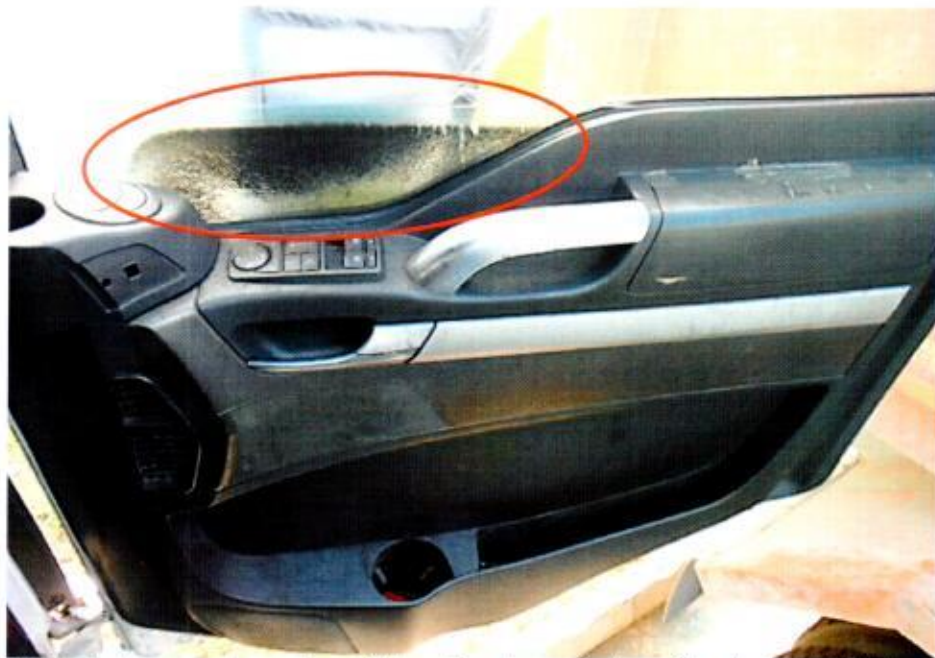
Photo 4 shows a closer view of the driver door window of the Insured Vehicle at the time of our inspection (as viewed from the interior compartment). The window was covered in soot (circled).

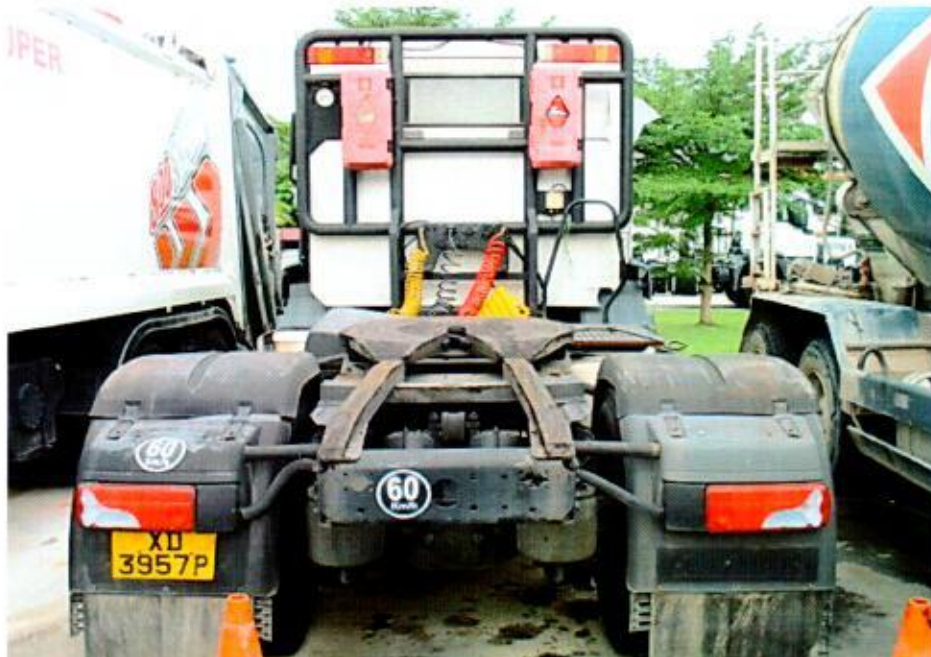
Photo 5 shows the rear view of the Insured Vehicle at the time of our inspection. The fire damage to the Insured Vehicle was confined to its interior compartment. The rear portion was observed to have been unaffected by the fire.

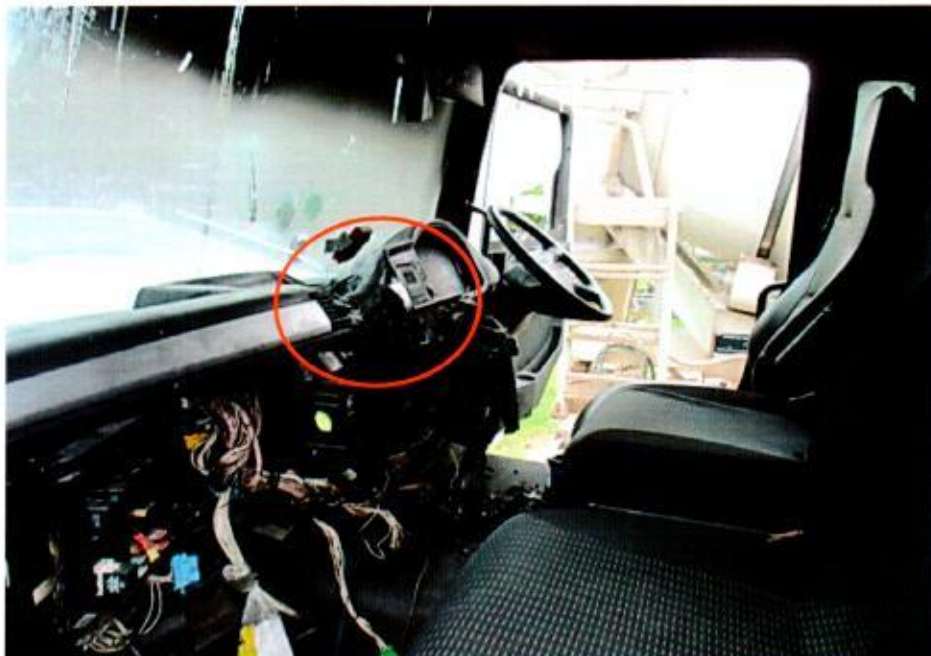
Photo 6 shows the interior compartment of the Insured Vehicle at the time of inspection. Most of the components in the centre of the dashboard (circled) were found to be burnt and/or melted as a result of the fire.

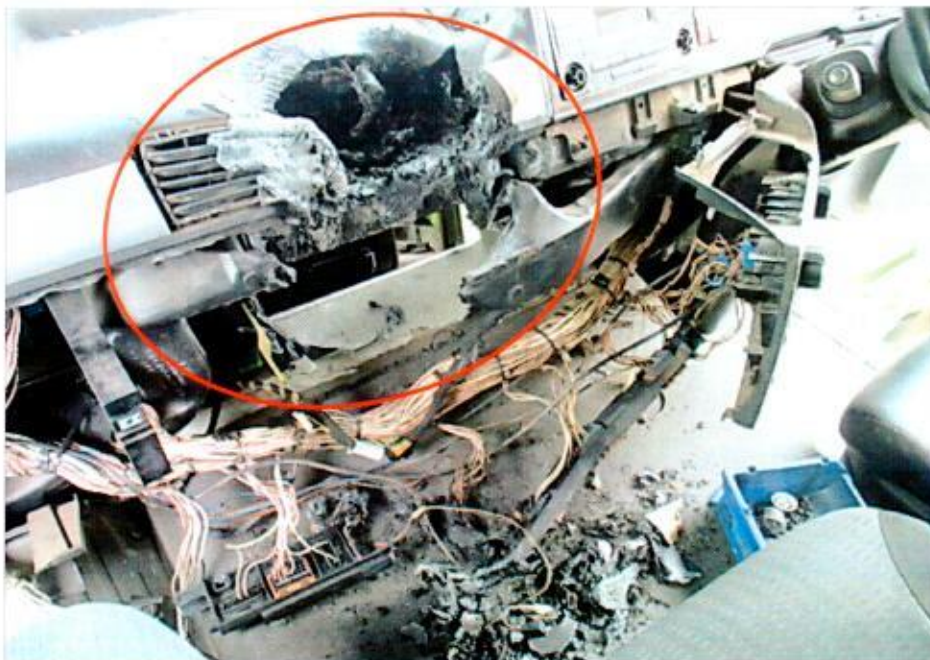
7. For this particular case, the fire appears to have started from the centre of the dashboard. This can be determined basing on the area where the extent of fire damage was most severe which was the centre portion of the instrument panel. Various components of the instrument panel were observed to have been burnt and/or partly melted from prolonged exposure to high heat intensity which included the upper and central parts of the instrument panel assembly, air outlet assembly, beaker holder assembly and carrier assembly, amongst others. See photos 7 - 9 below.

Photo 7 shows the centre of the dashboard of the Insured Vehicle. The fire seemed to have originated from the centre portion of the instrument panel basing on the area where the extent of fire damage was most severe. Various components of the instrument panel were observed to have been burnt and/or partly melted from prolonged exposure to high heat intensity which included the upper and central parts of the instrument panel assembly, air outlet assembly, beaker holder assembly and carrier assembly, amongst others (circled).

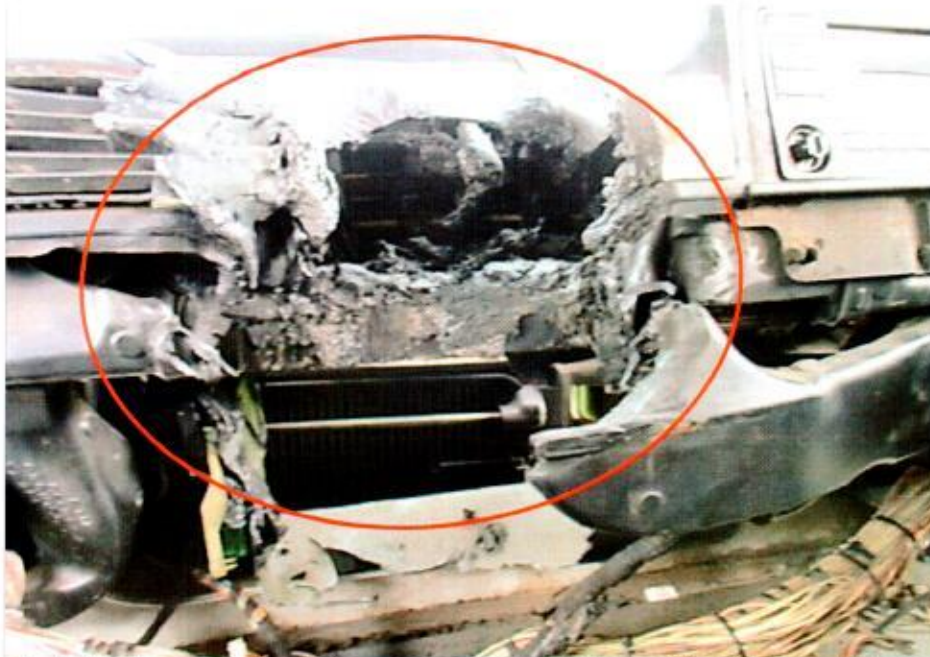
Photo 8 shows a closer view of the centre portion of the instrument panel. Various components of the instrument panel were observed to have been burnt and/or partly melted from prolonged exposure to high heat intensity which included the upper and central parts of the instrument panel assembly, air outlet assembly, beaker holder assembly and carrier assembly, amongst others (circled).

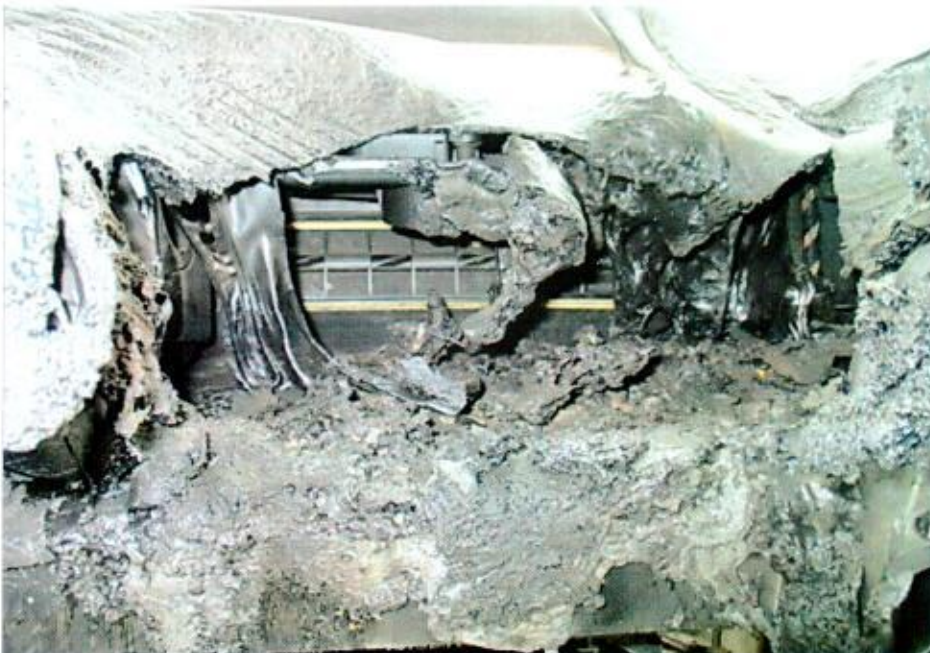
Photo 9 shows a close up view of the centre portion of the instrument panel. Most of the components of the instrument panel were observed to have been burnt and/or partly melted from prolonged exposure to high heat intensity.

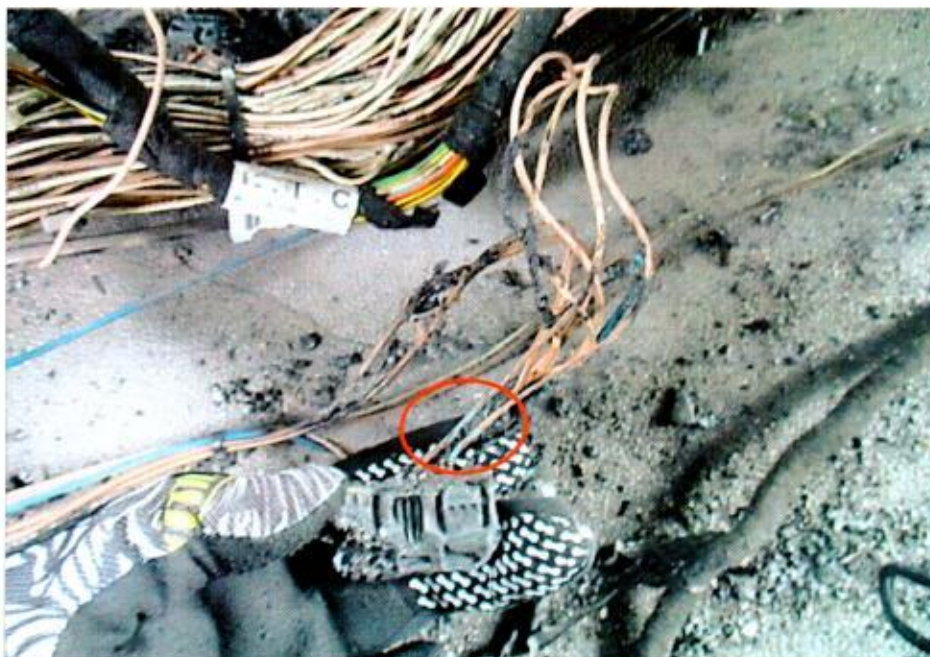
8. Upon closer examination of the various components contained within the centre portion of the instrument panel, which was where the fire to the Insured Vehicle had likely started, we had found greenish residue on some of the wirings leading to a connector. The wirings were original factory fitted wirings. We also found traces of greenish residue on the front portion of the air- conditioning blower connector as well as on the air- conditioning blower motor resistor. The presence of greenish residue indicates internal heating of copper wires, a sign of an electrical short circuit occurring. The greenish residue is normally left behind from oxidation as a result of chemical reaction involving the copper wires. These physical evidences would then appear to suggest that the cause of fire to the Insured Vehicle could have possibly been due to electrical in nature. See photos 10 - 16 below.

Photo 10 shows some original factory fitted wirings leading to a connector with greenish residue (circled). The presence of such greenish residue suggests occurrence of an electrical short circuit.

31. Having investigated and technically analysed the damages of burnt nature to the Insured Vehicle, we are of the view that the cause of fire to the Insured Vehicle was of electrical in nature. For this particular case, the fire had originated from the wirings within the centre portion of the instrument panel of the Insured Vehicle. The wirings were original factory wirings of the Insured Vehicle.

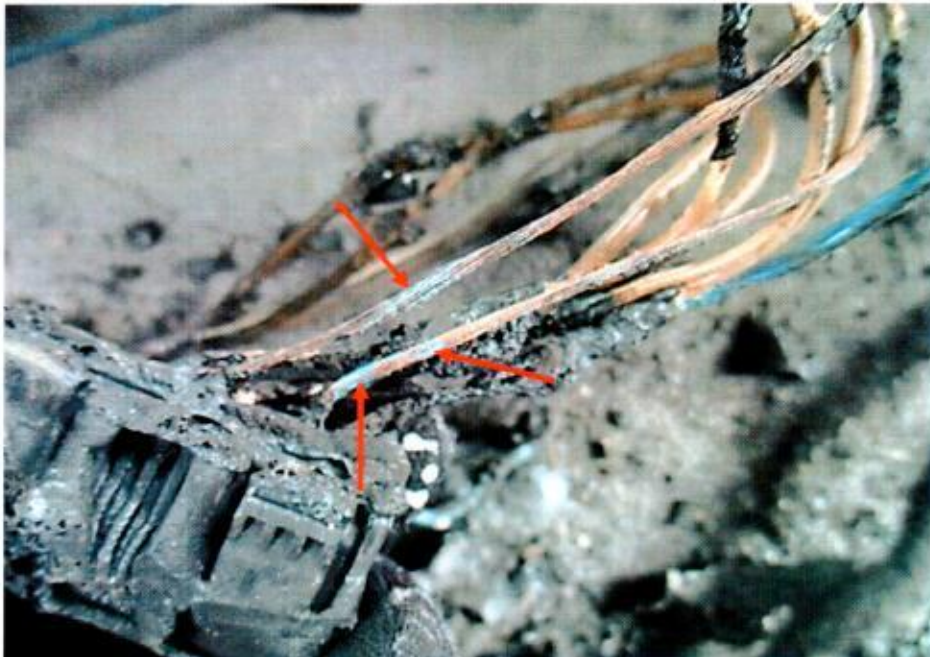
Photo 11 shows a closer view of the original factory fitted wirings leading to a connector with greenish residue (red arrows). The presence of such greenish residue suggests occurrence of an electrical short circuit.

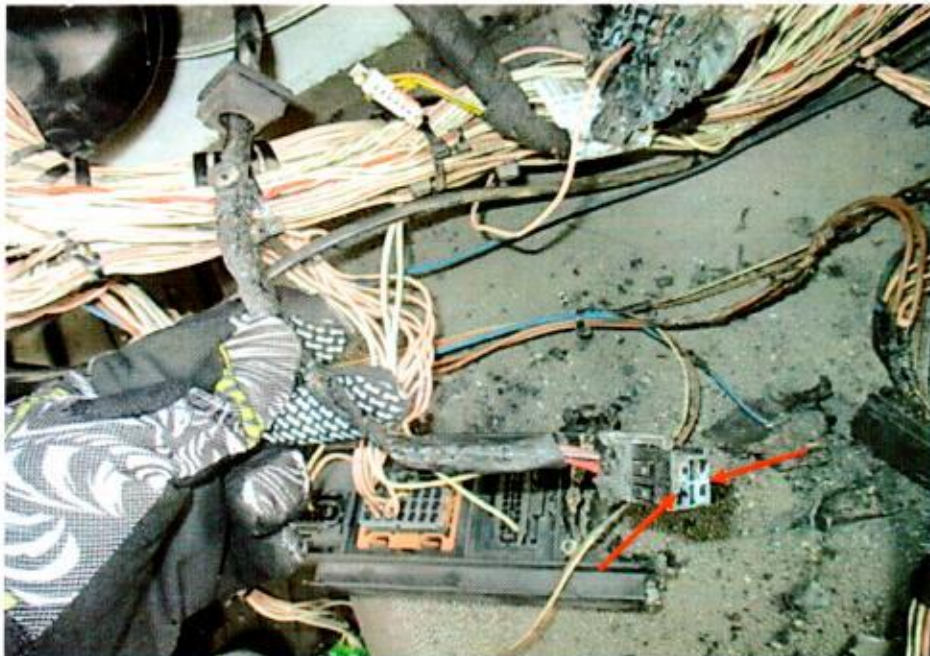
Photo 12 shows traces of greenish residue found on the front portion of the air-conditioning blower connector (red arrows). The presence of such greenish residue suggests occurrence of an electrical short circuit.

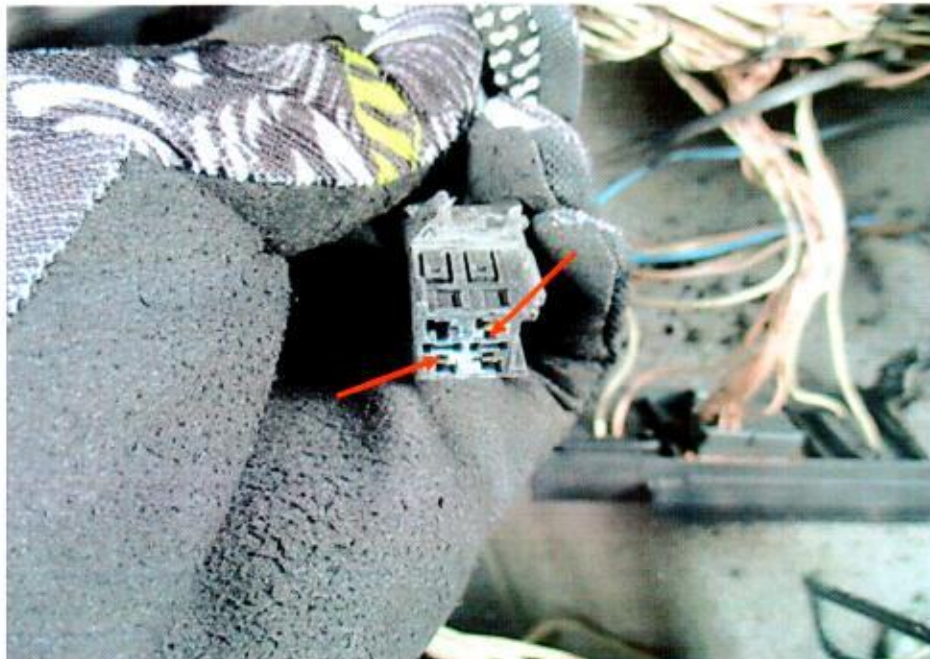
Photo 13 shows a close up view of the greenish residue found on the front portion of the air- conditioning blower connector (red arrows). The presence of such greenish residue suggests occurrence of an electrical short circuit.

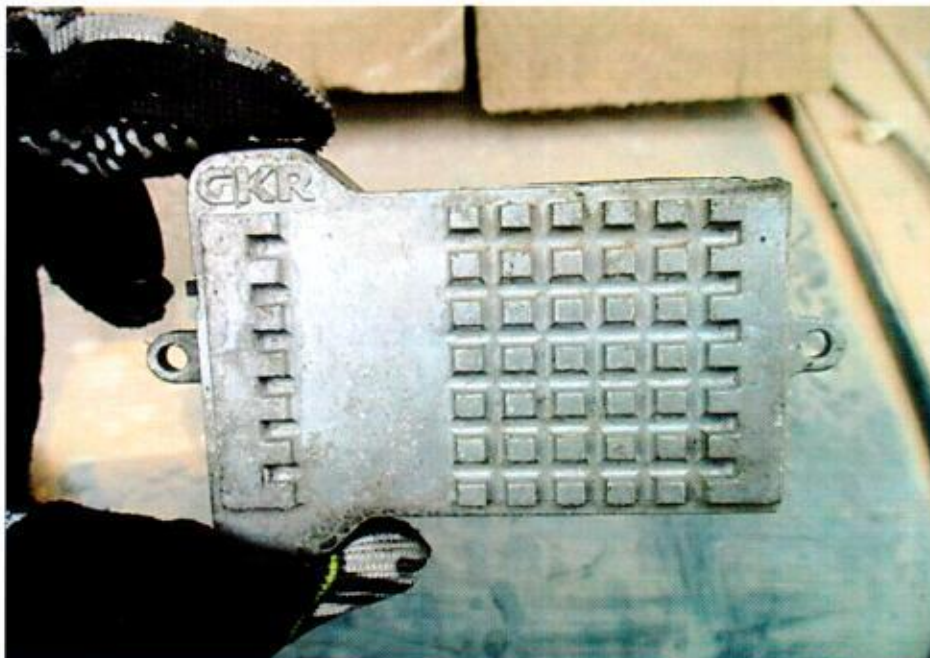
Photo 14 shows the air- conditioning blower motor resistor casing that is part of the instrument panel.

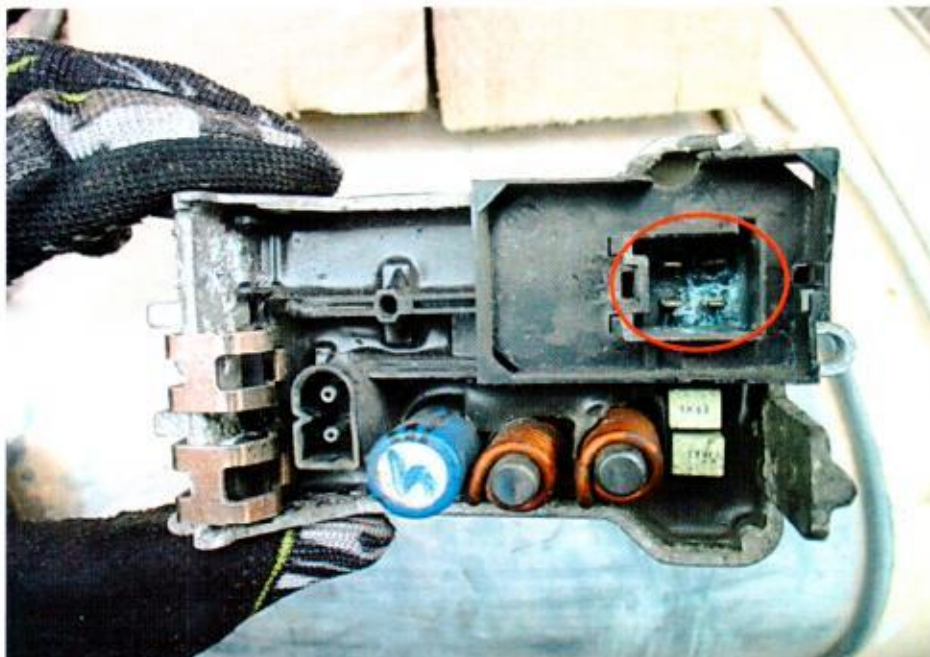
Photo 15 shows the air- conditioning blower motor resistor. We found traces of greenish residue on the air- conditioning blower connector contact point (circled). The presence of such greenish residue suggests occurrence of an electrical short circuit.

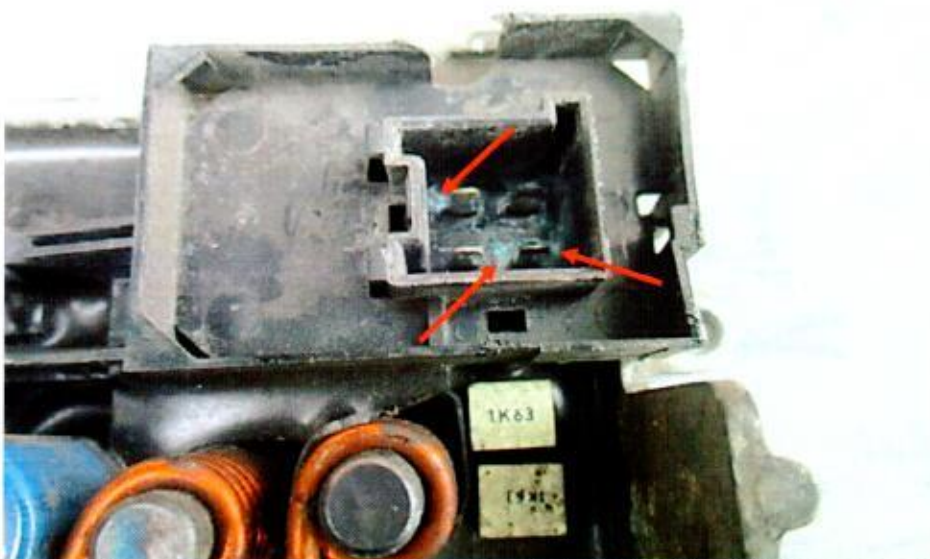
Photo 16 shows a close up view of the greenish residue found on the air- conditioning blower connector contact point (circled). The presence of such greenish residue suggests occurrence of an electrical short circuit.

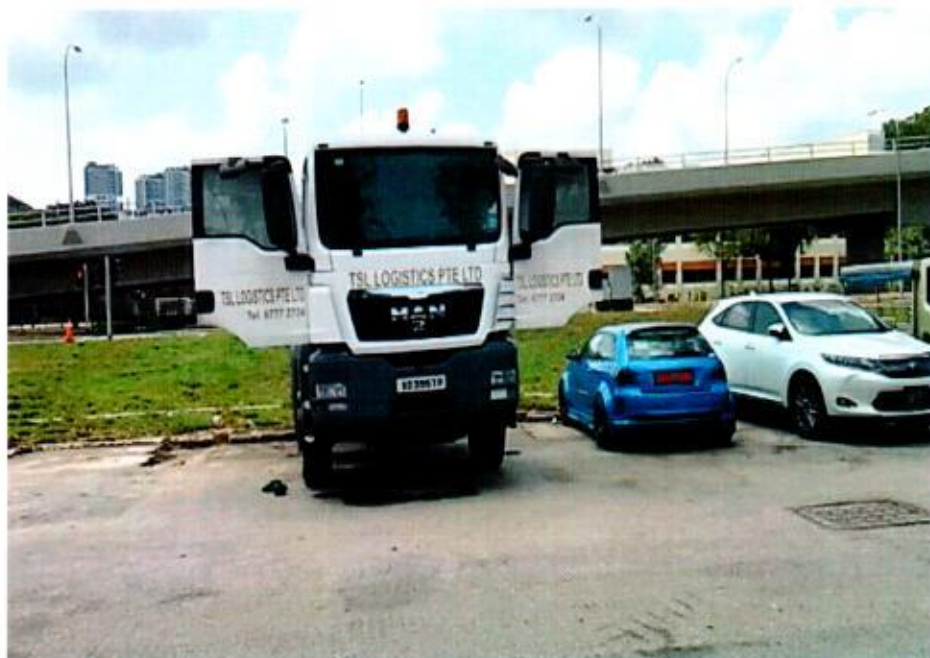
Photo 17 shows the Insured Vehicle after the fire was extinguished by Mr Chai. In general, the information that could be gathered from this photograph had corresponded to the events that were related to us by Mr Chai, which is the fire started from the interior compartment.

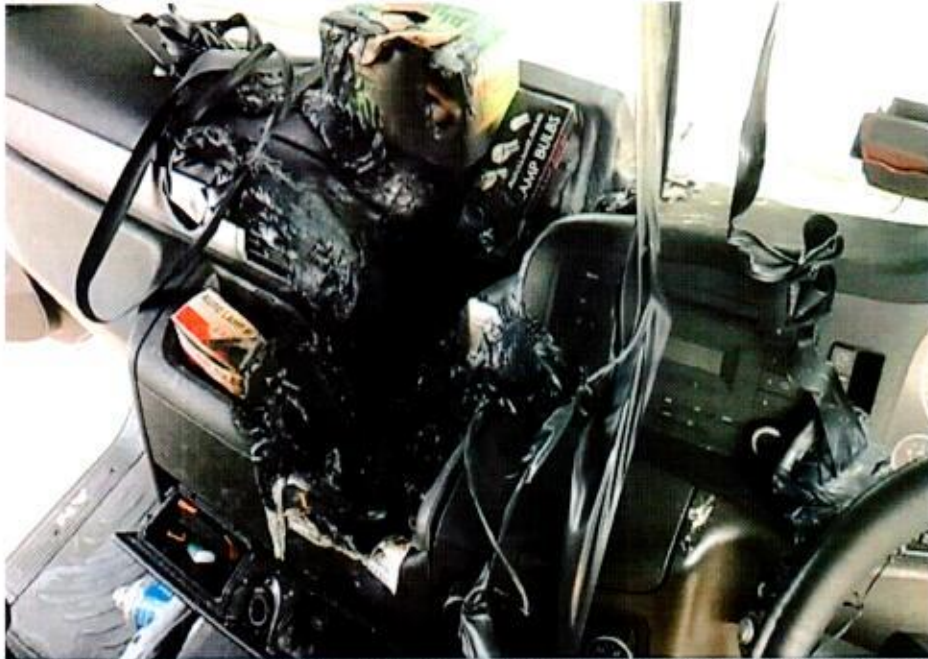
Photo 18 shows the interior compartment of the Insured Vehicle after the fire was extinguished. In general, the extensive damages sustained to the centre portion of the instrument panel had corresponded to the events that were related to us by Mr Chai, which is the fire started from the interior compartment.

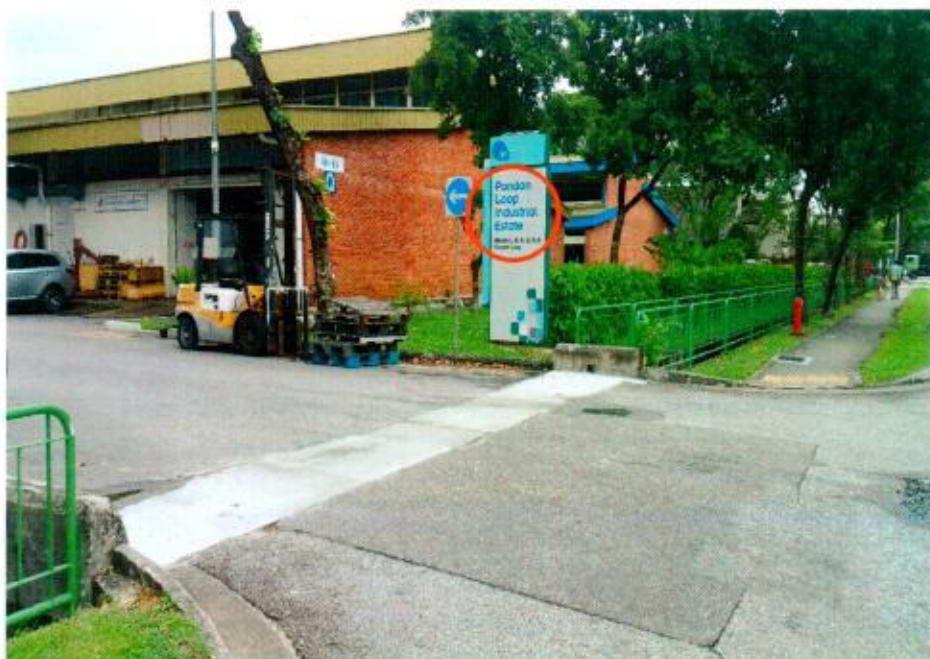
Photo 19 shows the entrance to the open carpark inside the Pandan Industrial Estate (circled) located along Pandan Loop which is across from TSL.

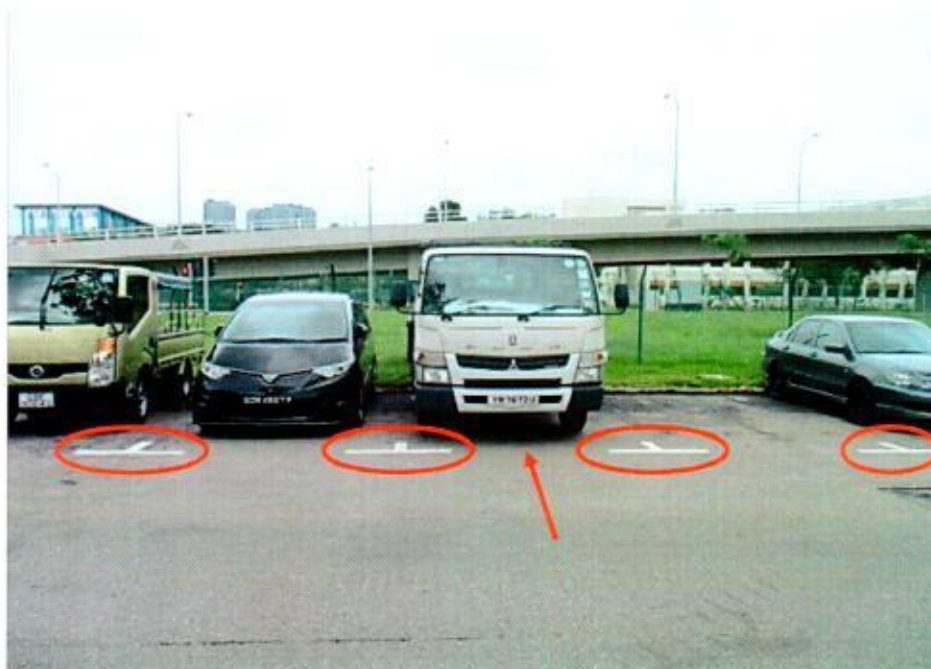
Photo 20 shows the position where the Insured Vehicle was parked on the day of the incident (arrowed). We noticed that parking lots had been constructed in the open space where the Insured Vehicle was parked on the day of the incident (circled).

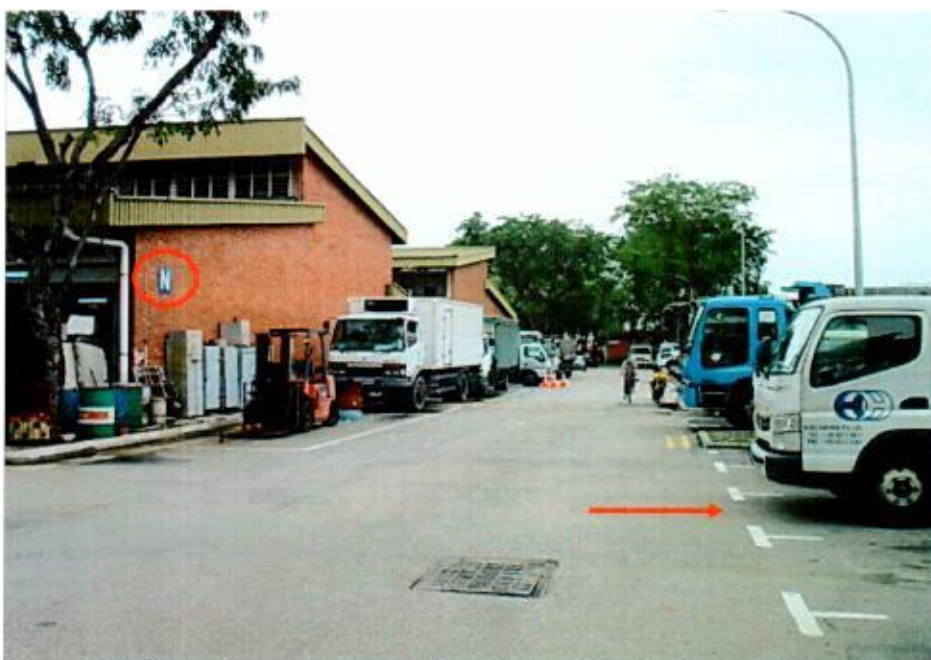
Photo 21 shows the open carpark inside the Pandan Industrial Estate. The Insured Vehicle was parked (arrowed) in between blocks N (circled) and Q on the day of the incident.

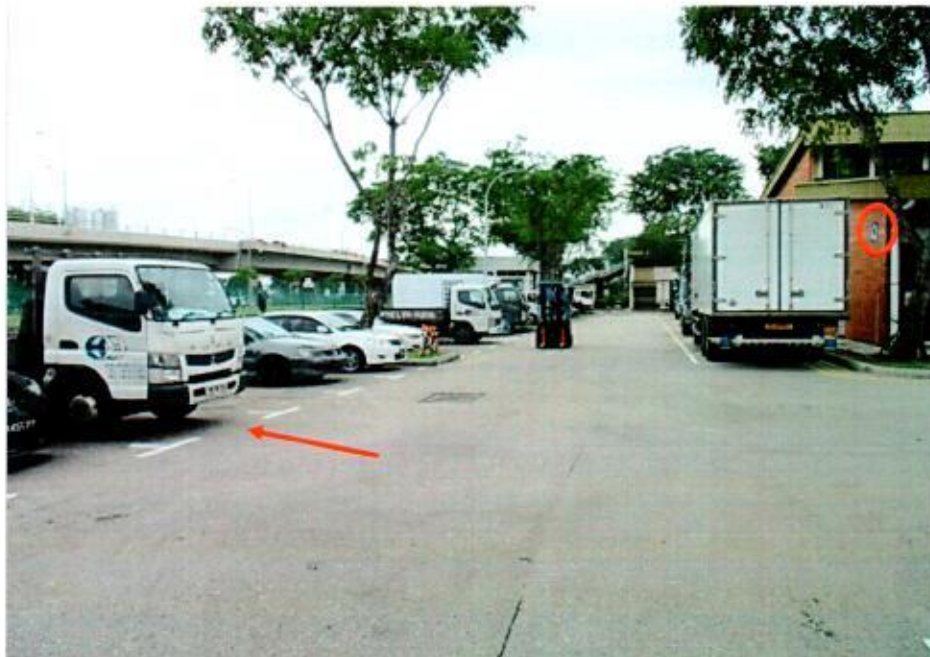
Photo 22 shows the open carpark inside the Pandan Industrial Estate. The Insured Vehicle was parked (arrowed) in between blocks N and Q (circled) on the day of the incident.

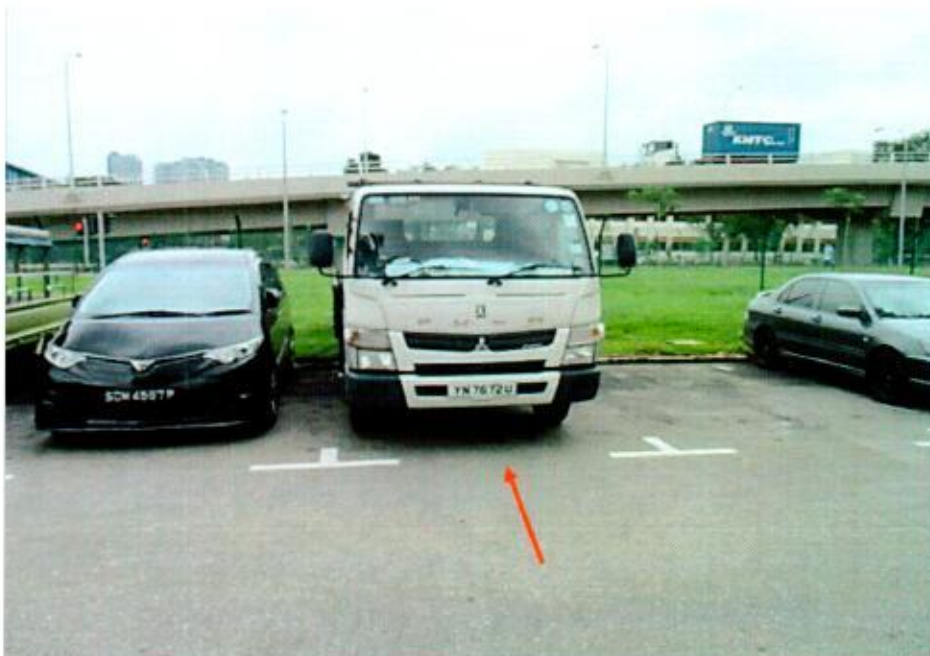
Photo 23 shows a closer view of the position where the Insured Vehicle was parked on the day of the incident. We did not find any burnt residual remains on the ground where the Insured was positioned as it was a minor fire. Moreover, the incident occurred approximately 3 months before the insurance claim was made. Moreover, parking lots had been constructed in the open space where the Insured Vehicle was parked on the day of the incident.
