MID 40937

GP Car

SJE6823H

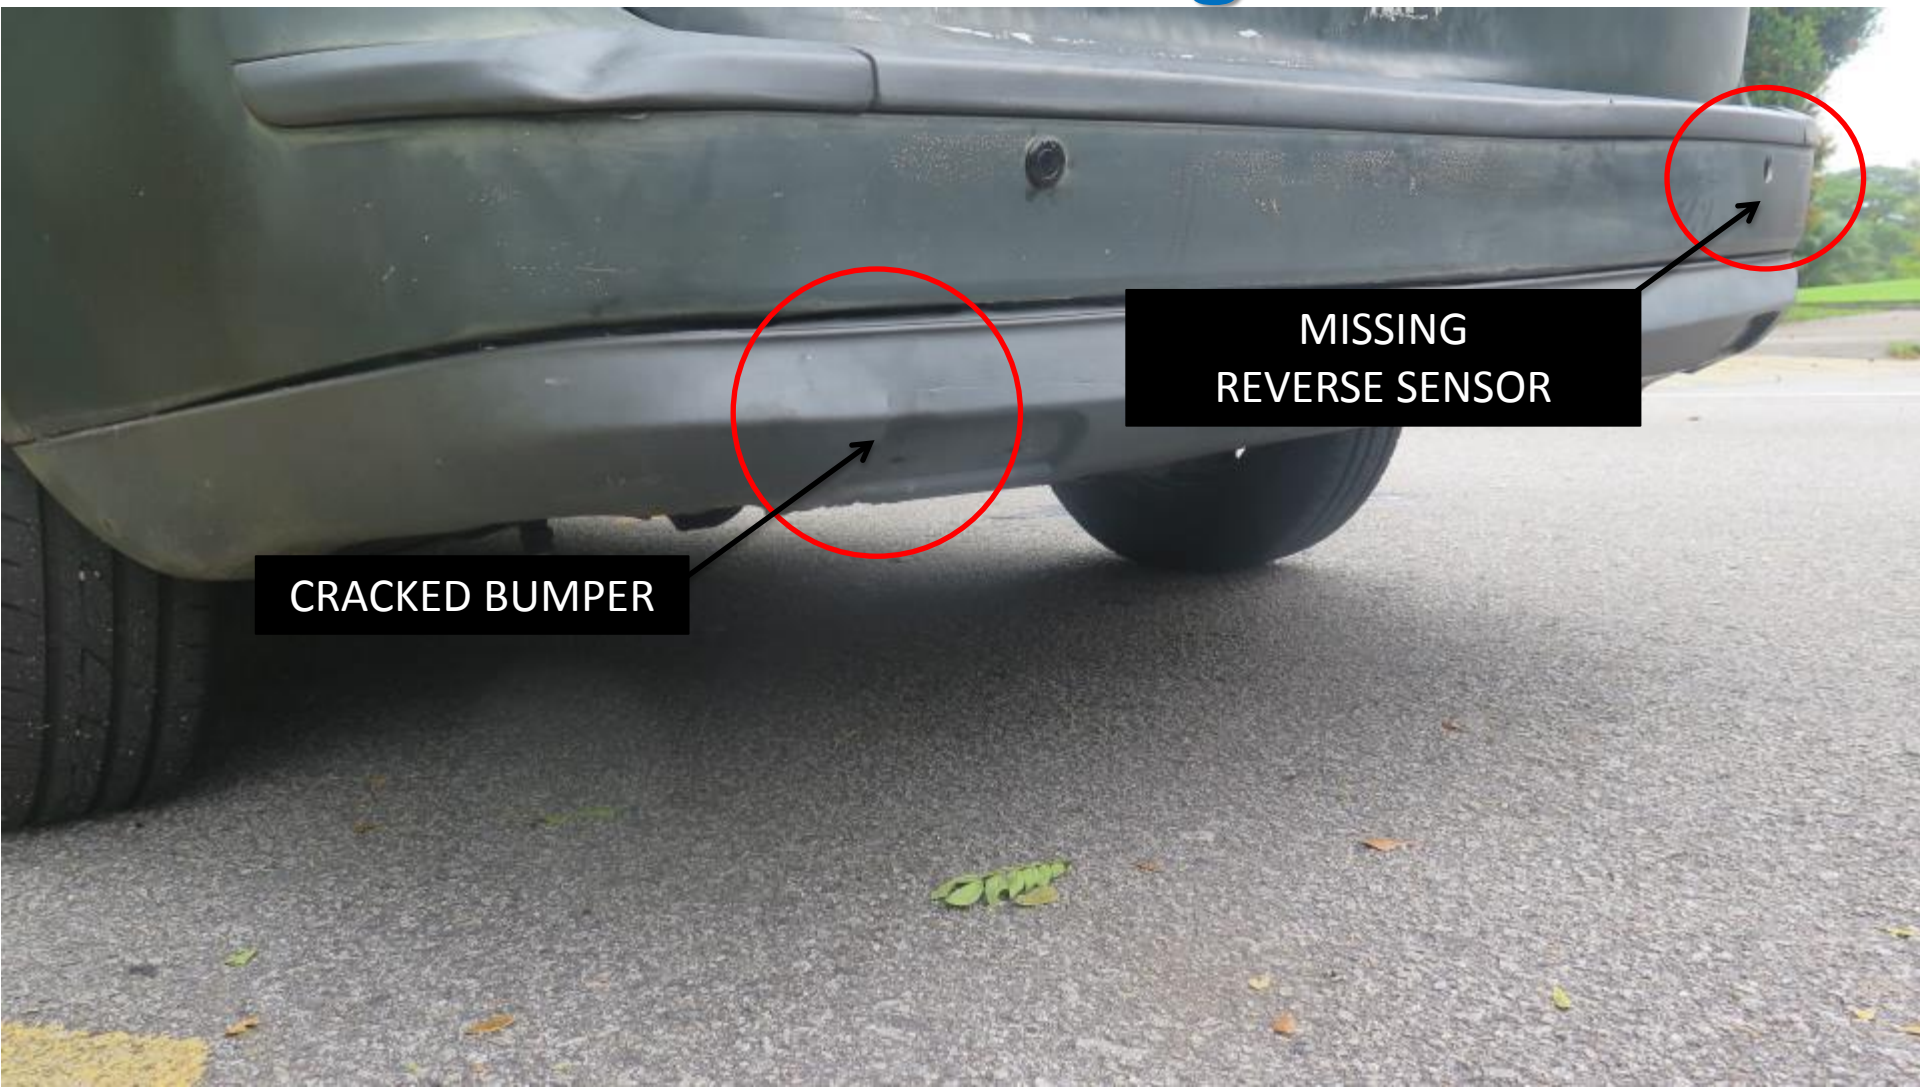
Picture of the damaged GP Car

CRACKED BUMPER

MISSING
REVERSE SENSOR

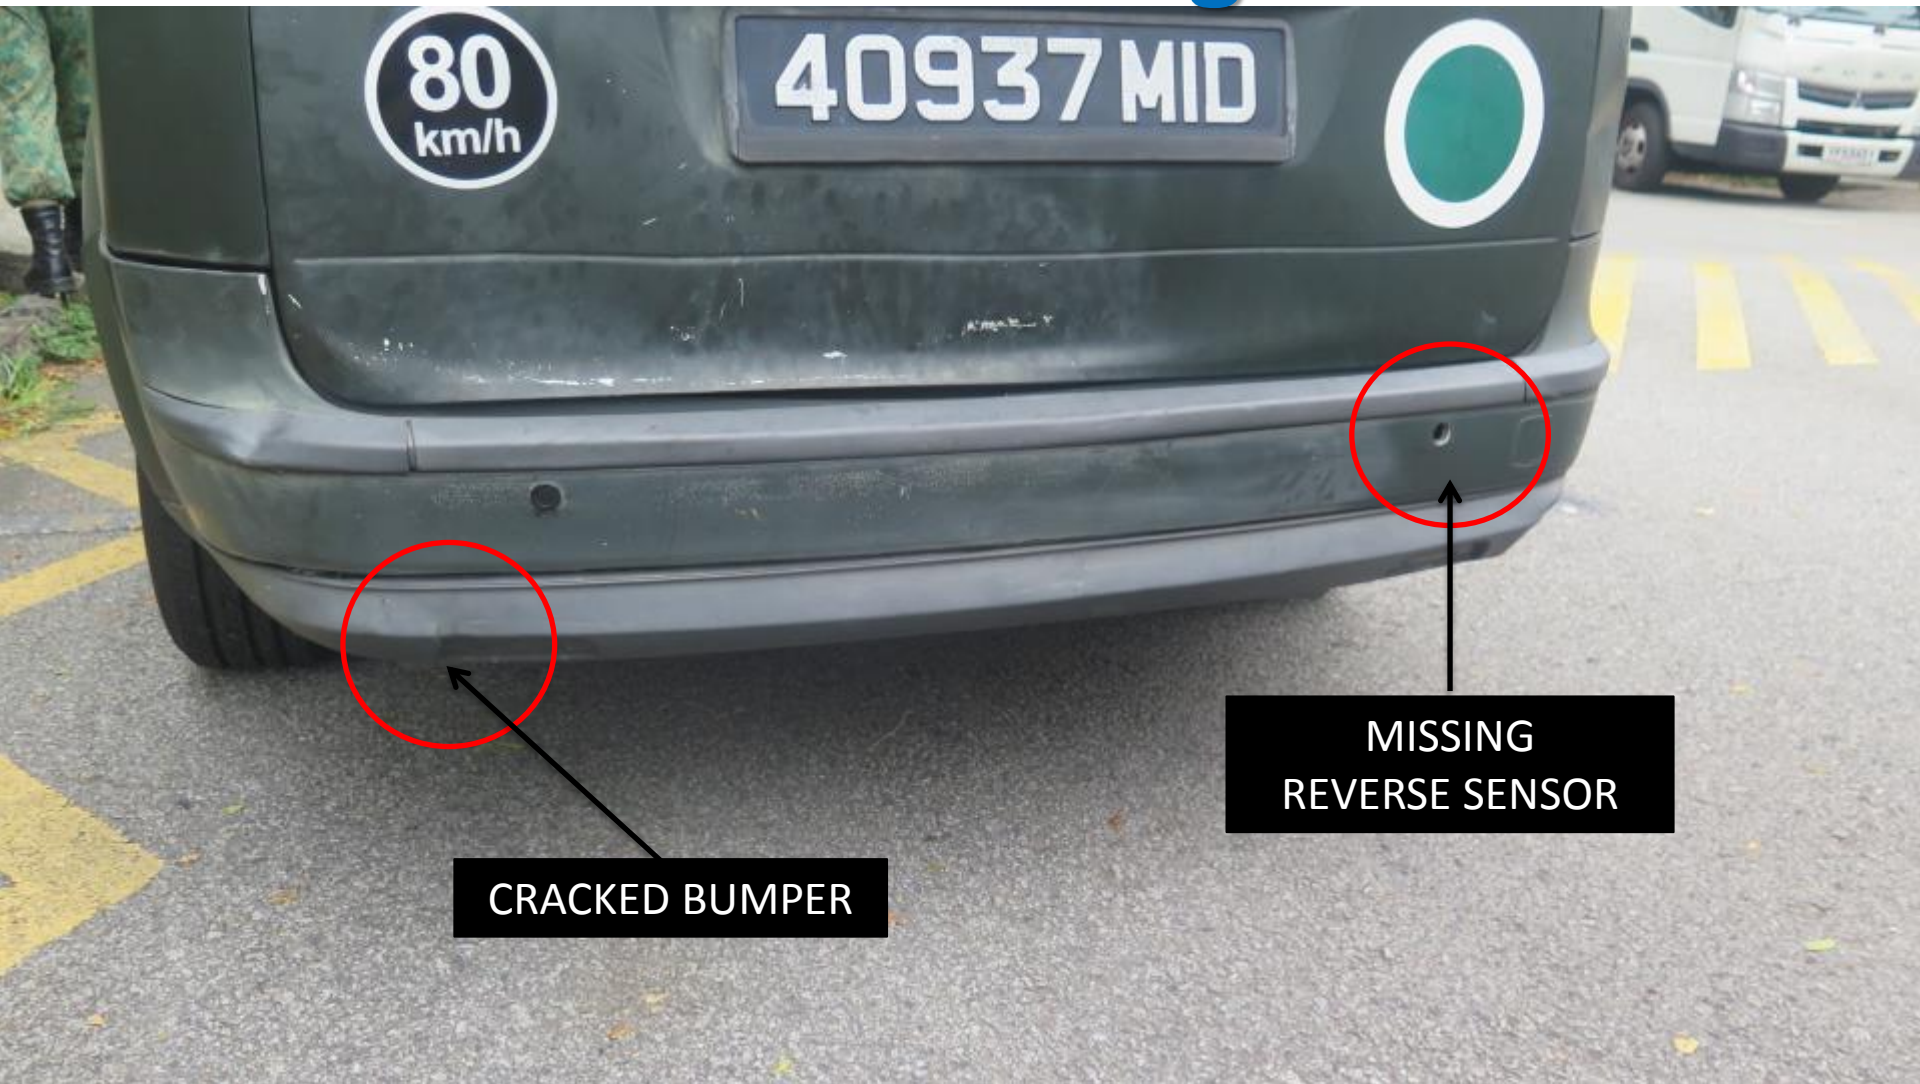
Picture of the damaged GP Car

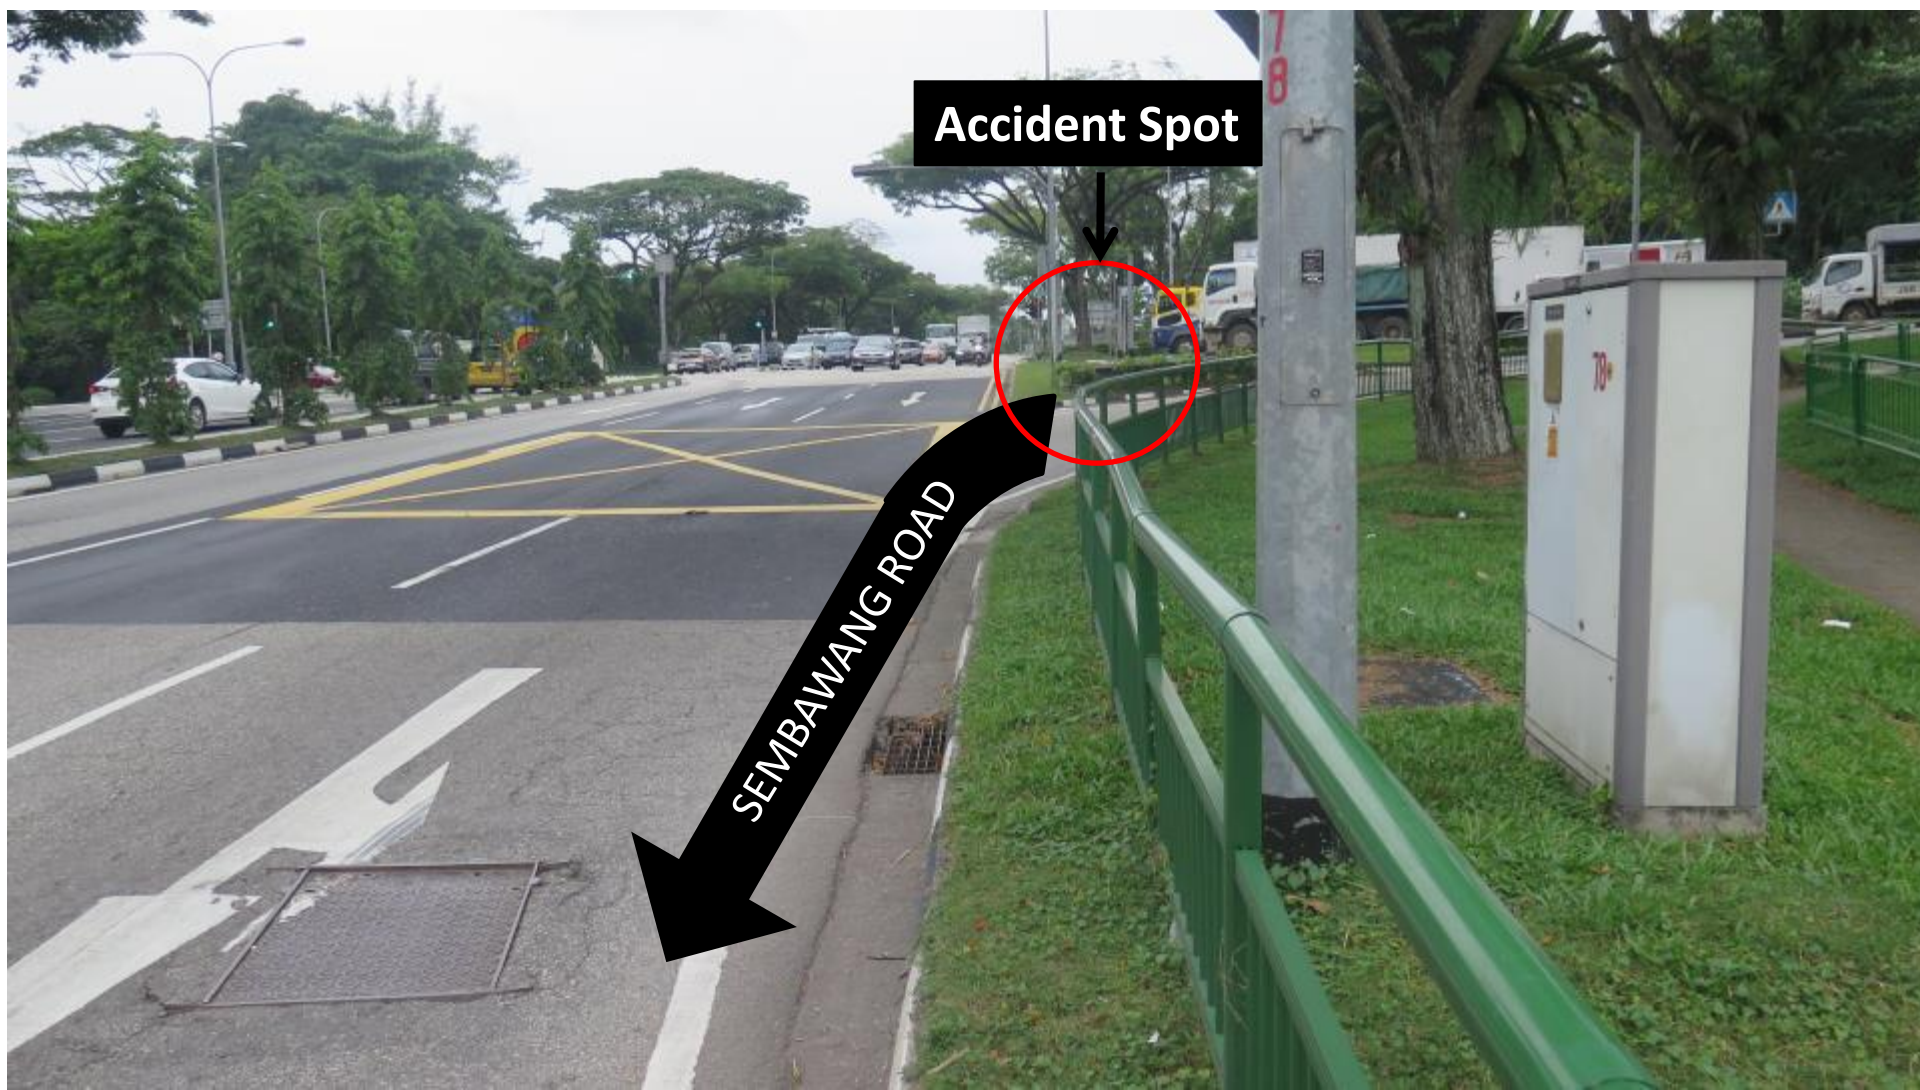
Picture of the accident site

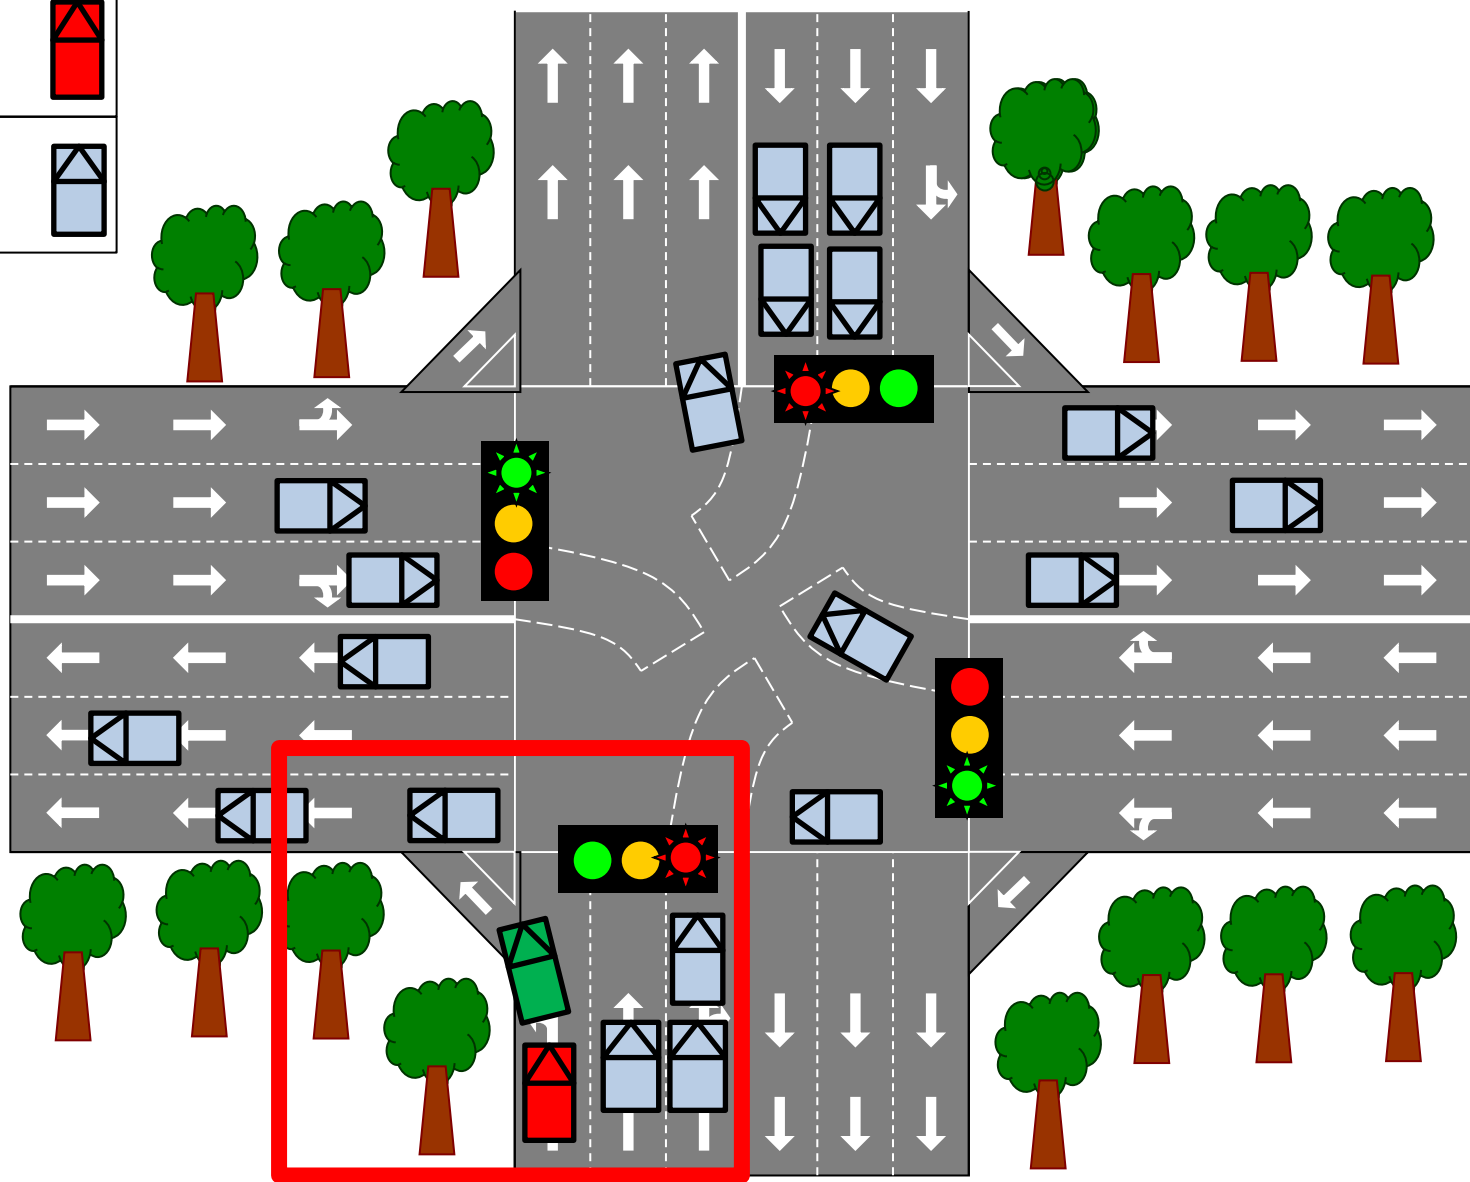
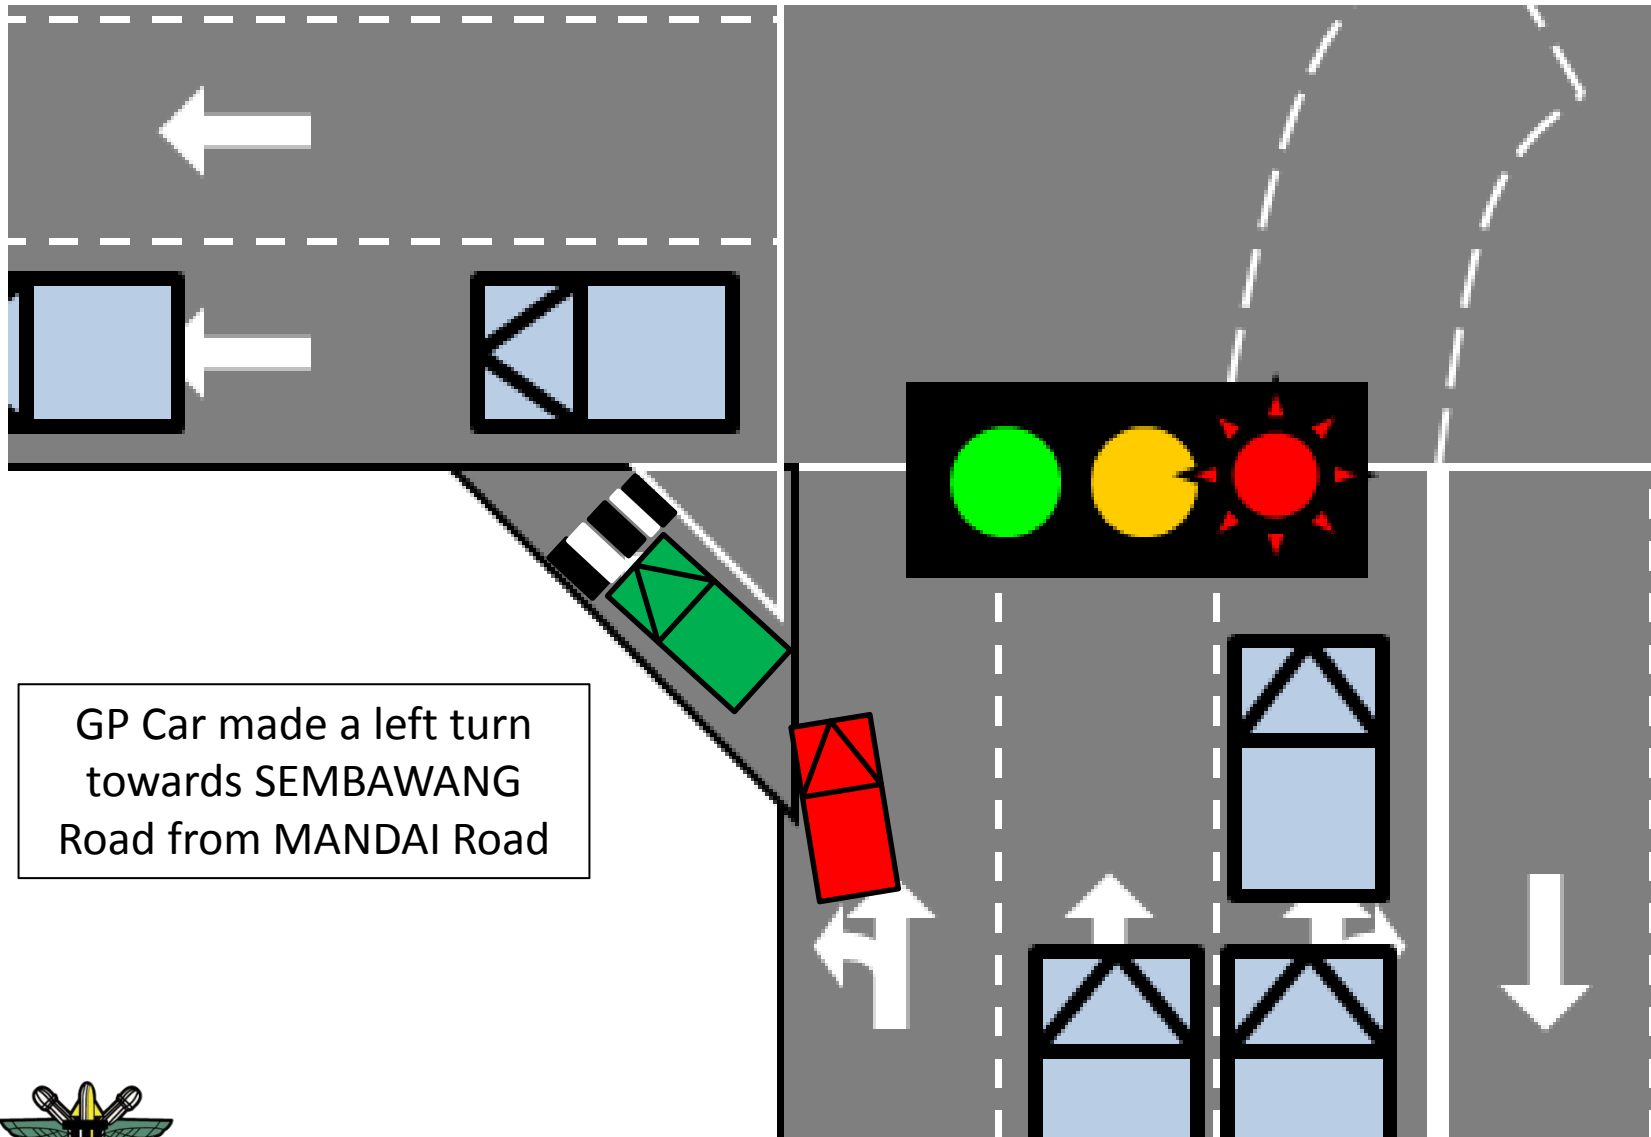
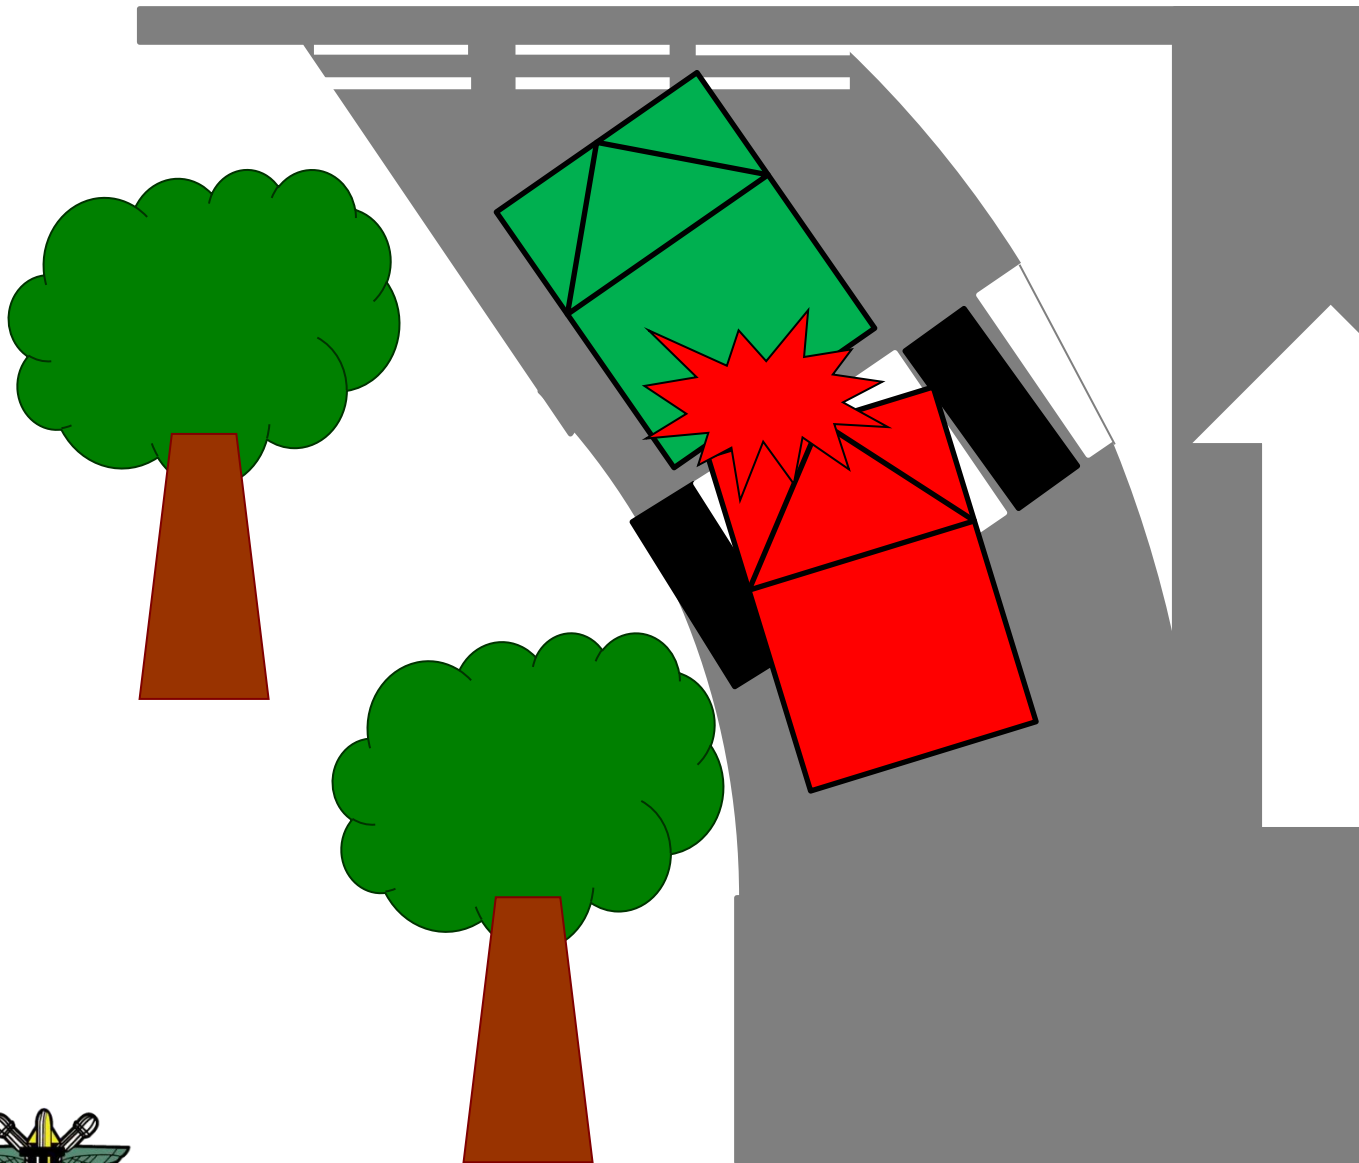
Illustration of accident

When at the slip road, the Transport Operator made a complete stop so as to give way to the main traffic. At this point, the POV rear ended the GP car as the POV did not stop in time.
