SINGAPORE ACCIDENT STATEMENT

Automobile Inspection Report

RE-INSPECTION OF VEHICLE NO . SKQ 796S

EVALUATION REPORT (PAPER SURVEY) OF ACCIDENT VEHICLE NO:

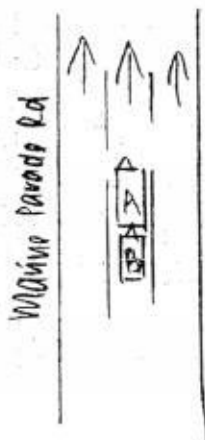
Sketch Plan

A: GV 7493R
(Alone)
B: SKQ 7965
