Your Ref: 73306  
Our Ref :CS/DAI17021032/D

03 November 2017

**TECHNICAL INVESTIGATION REPORT OF FIRE INCIDENT INVOLVING THE INSURED VEHICLE SJJ 5064L ON 27 OCTOBER 2017**

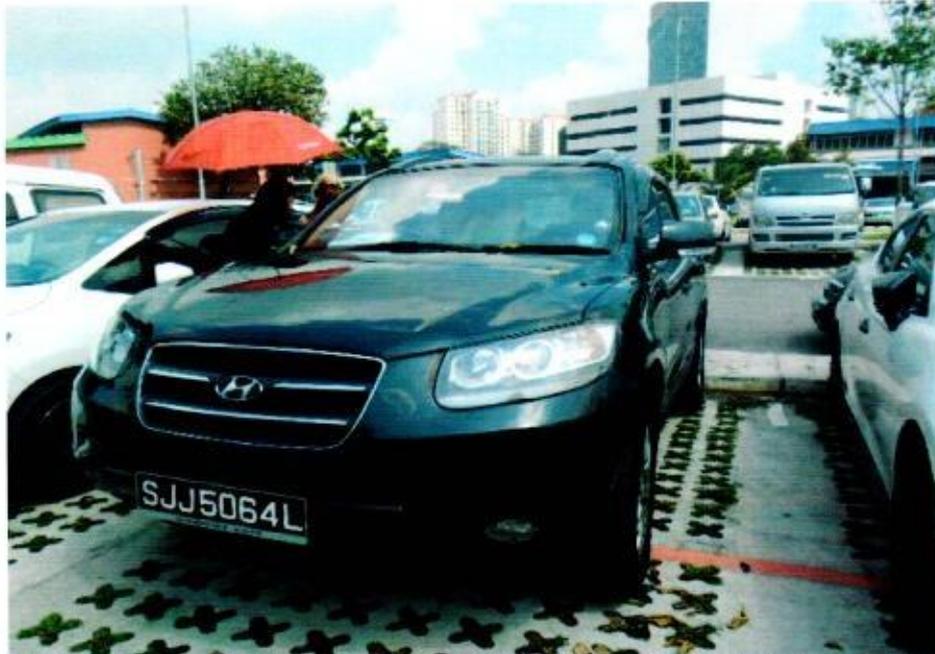
**Photo 1** shows a general view of the front left body of the Insured Vehicle at the time of my inspection. There was no visible fire damage found on the exterior body of the Insured Vehicle. The mileage of the Insured Vehicle recorded at the time of my inspection was 105,806km.

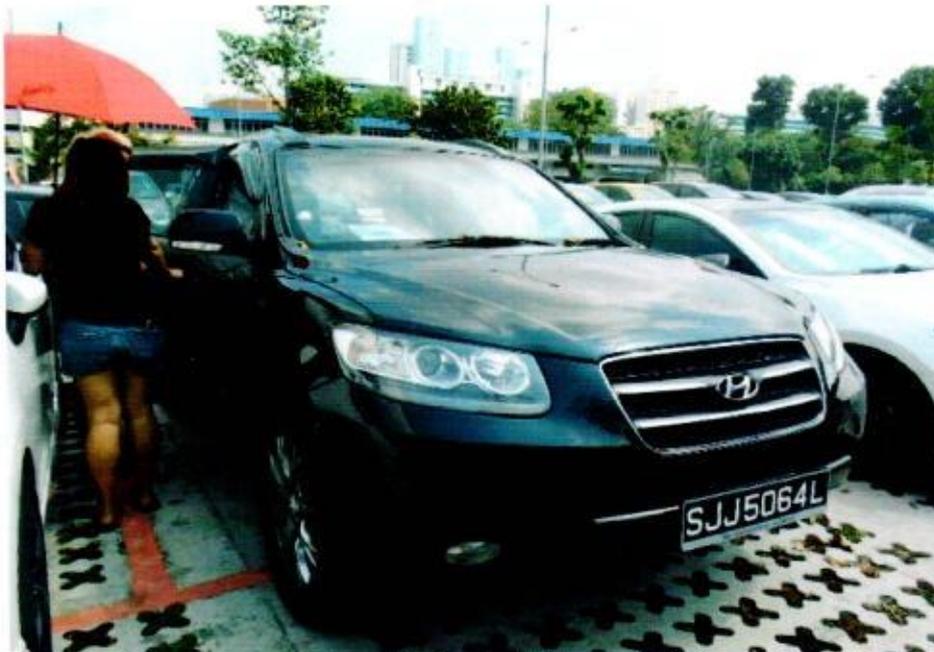
**Photo 2** shows a general view of the front right body of the Insured Vehicle at the time of my inspection. There was no visible fire damage found on its exterior body and interior compartment.

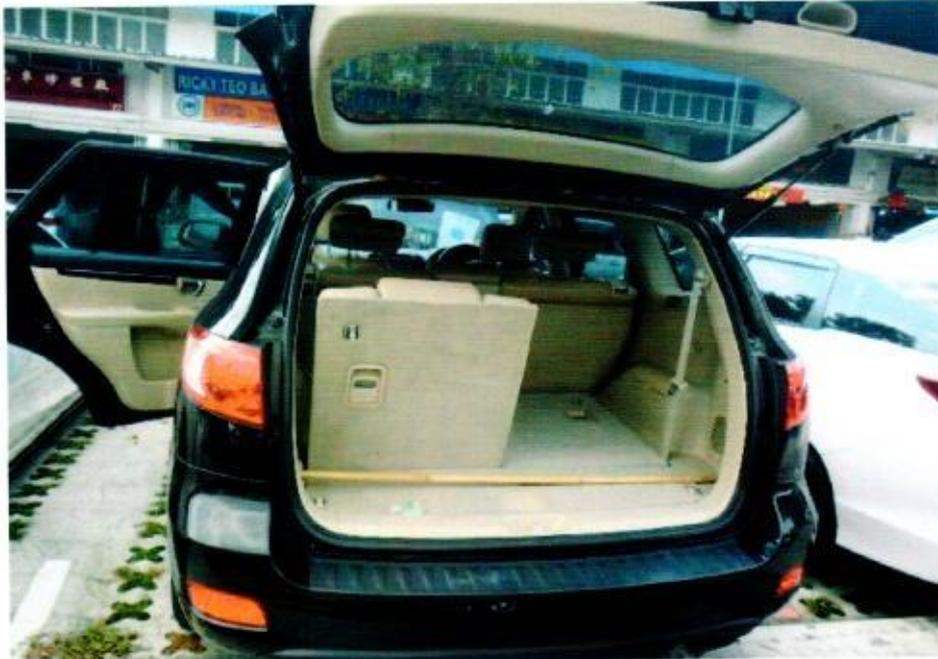
**Photo 3** shows a general view of the rear body of the Insured Vehicle at the time of my inspection. The Insured Vehicle was observed to be in good general condition with no visible fire damage found on its exterior body and interior compartment.

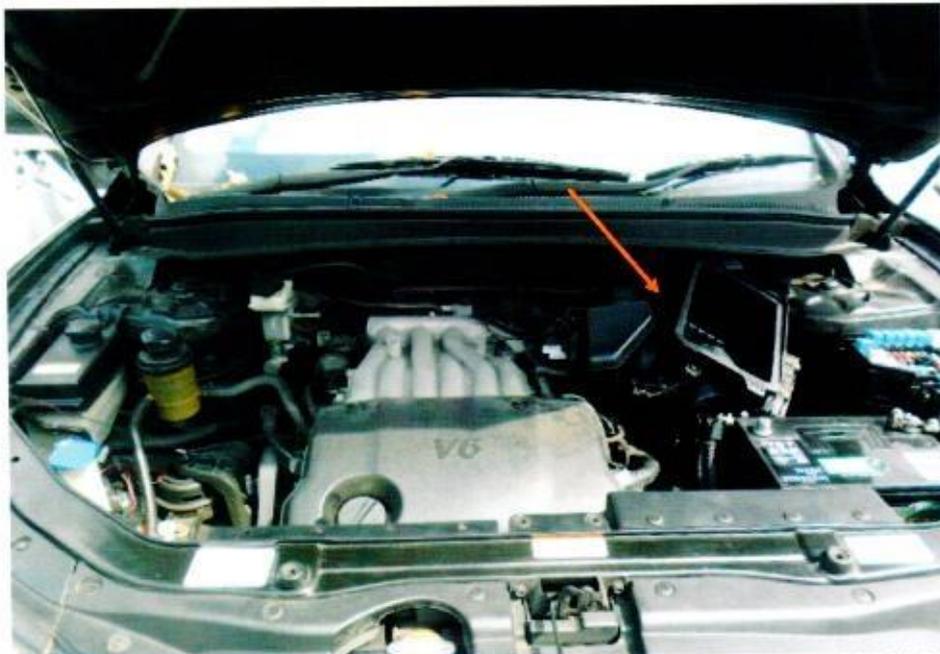
**Photo 4** shows a general view of the engine compartment of the Insured Vehicle. Evidence suggesting an occurrence of a fire/smoke incident was found at the left rear area of the engine compartment. The bonnet insulator and bottom part of the front windscreen, directly above this area, had also sustained slight heat damage.

8. For this particular case, the fire/smoke incident had originated within the engine compartment of the Insured Vehicle, at the left rear area of the engine compartment. This was established given that the damage of fire/smoke nature was confined to that single particular area of the Insured Vehicle.
9. The cause of fire/smoke can also be clearly established to be due to electrical in nature given that the wirings of the ABS control module was found to be partially melted with no other part(s) sustaining fire/heat damage. See photo 7 below.

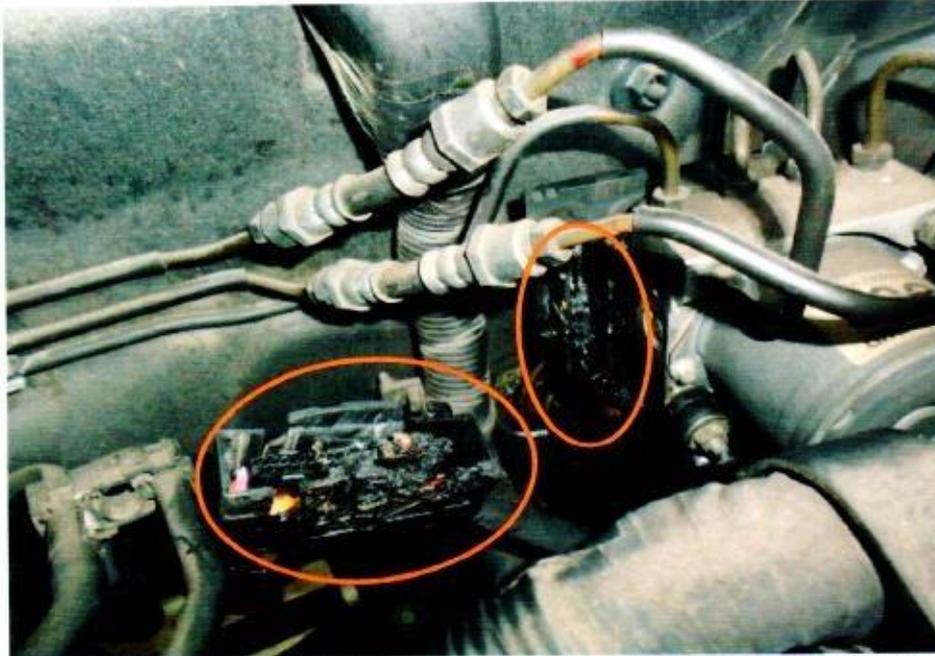
**Photo 5** shows the partially melted wiring connector (circled) for the ABS control module (Anti-Brake Lock), suggesting an occurrence of a fire/smoke incident.

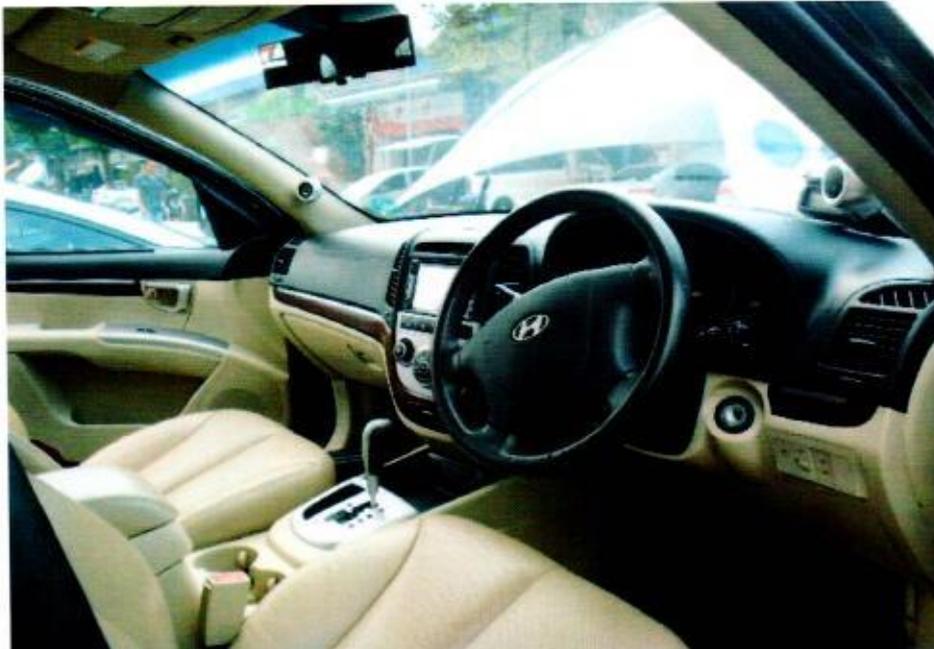
7. A pair of additional speakers was found fitted to the Insured Vehicle. These speakers and its wirings were intact and unaffected by the incident. See photo 6 below.

**Photo 6** shows the interior compartment of the Insured Vehicle, which was unaffected by the incident. A pair of additional speakers (arrowed) was found fitted to the Insured Vehicle. These speakers and its wirings were intact and unaffected by the incident.

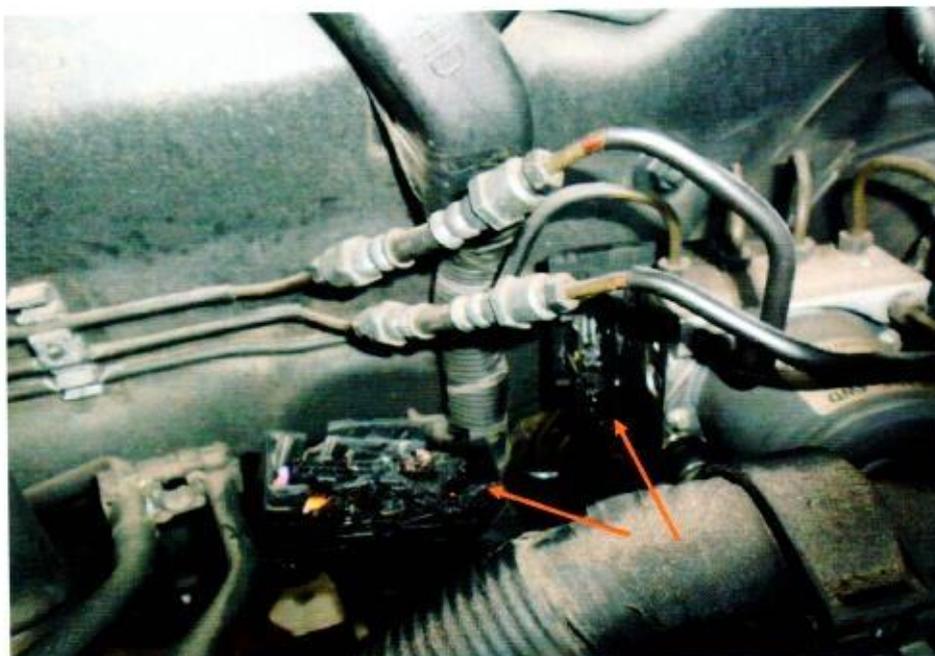
Photo 7 shows the partially melted wirings of the ABS control module (arrowed) at the left rear area of the engine compartment. Since there was no other damage of fire/smoke nature found, it can hence be established that the fire/smoke incident had originated at this area of the Insured Vehicle, with the cause of fire/smoke due to electrical nature.

15. Basing on my inspection of the Insured Vehicle, I am of the view that the fire/smoke incident had originated around the left rear area of the Insured Vehicle's engine compartment. The cause of fire was likely to be of electrical in nature along the wirings for the ABS control module.
16. I did not find any evidence to suggest that the cause of fire was due to poor maintenance and/or recurring electrical problem.
17. There was a pair of additional speakers fitted on the Insured Vehicle at the time of incident however these speakers did not cause and/or contribute to the fire/smoke incident. Other than these speakers, there were no other modification(s) fitted on the Insured Vehicle.

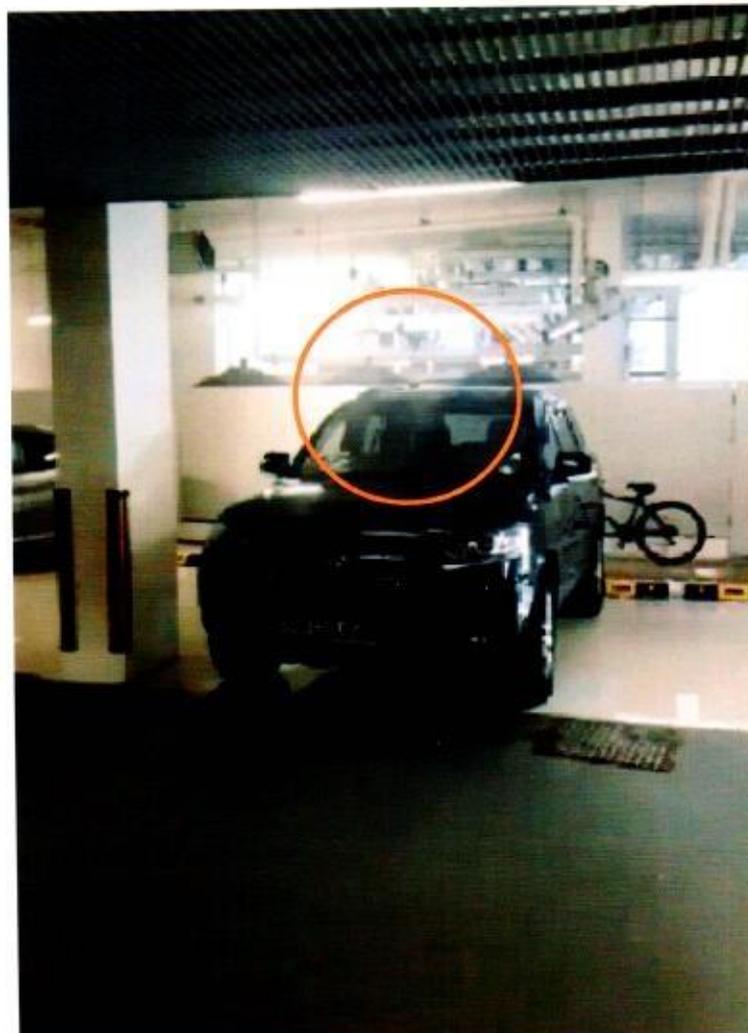
11. The possibility of the fire/smoke incident being due to external factor (foreign material(s) stuck on hot surfaces, arson and sabotage amongst others) would also seem unlikely as the incident had originated from within the engine compartment of the Insured Vehicle, with no damage of fire/smoke nature found on its exterior body. Furthermore, my review of a video recording taken at the time of incident had showed no unusual object(s) and/or material(s) on the ground in the immediate vicinity of where the Insured Vehicle was parked. See screenshot below taken from the video recording that I had manage to obtain in the course of my investigations.

Screenshot from the video recording showing smoke (circled) coming out from the gaps between the front bonnet and front windscreen. There was no unusual object(s) and/or material(s) on the ground in the immediate vicinity of where the Insured Vehicle was parked. This would suggest that the cause of incident was unlikely to be due to external factor like arson or sabotage.
