Your Ref: 73306  
Our Ref :CS/DAI17021032/D

03 November 2017

**TECHNICAL INVESTIGATION REPORT OF FIRE INCIDENT INVOLVING THE INSURED VEHICLE SJJ 5064L ON 27 OCTOBER 2017**

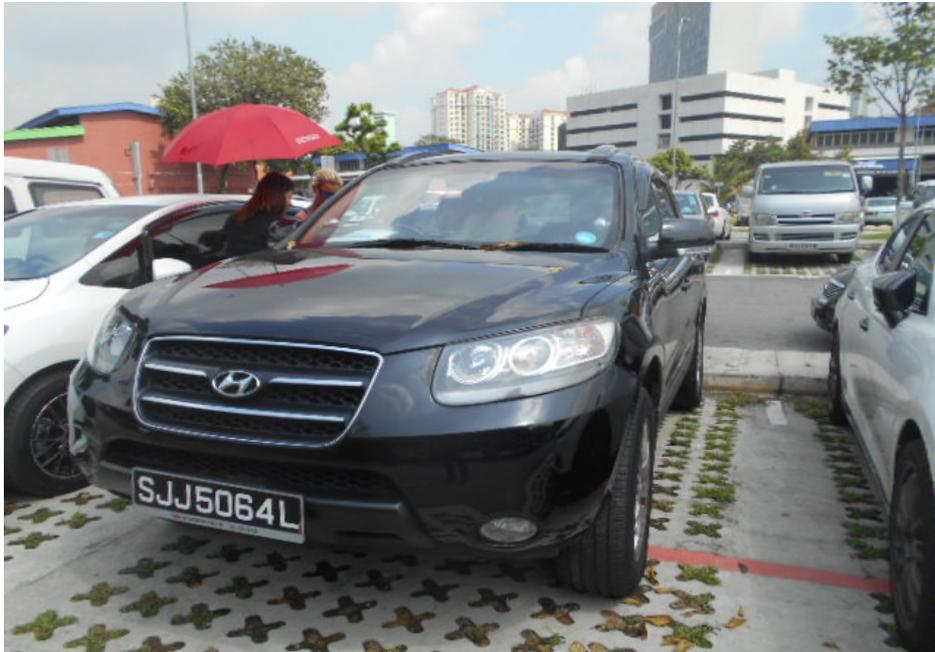
**Photo 1** shows a general view of the front left body of the Insured Vehicle at the time of my inspection. There was no visible fire damage found on the exterior body of the Insured Vehicle. The mileage of the Insured Vehicle recorded at the time of my inspection was 105,806km.

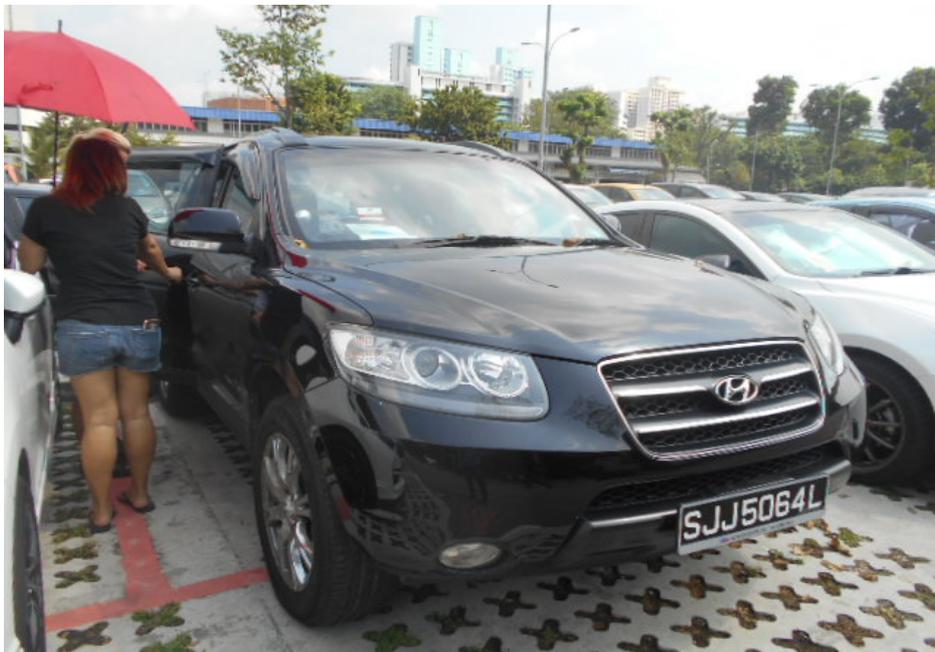
**Photo 2** shows a general view of the front right body of the Insured Vehicle at the time of my inspection. There was no visible fire damage found on its exterior body and interior compartment.

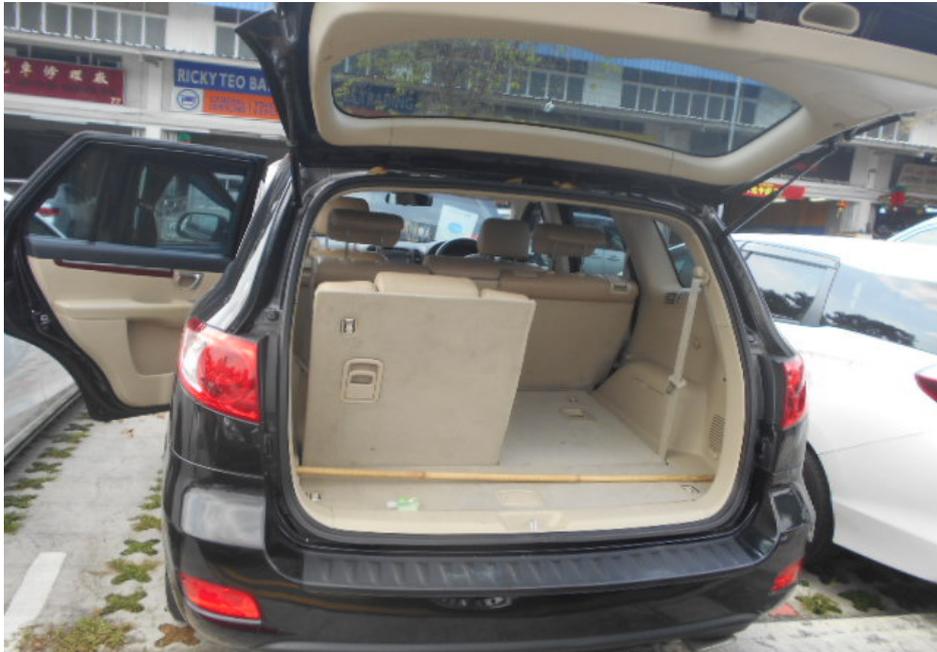
**Photo 3** shows a general view of the rear body of the Insured Vehicle at the time of my inspection. The Insured Vehicle was observed to be in good general condition with no visible fire damage found on its exterior body and interior compartment.

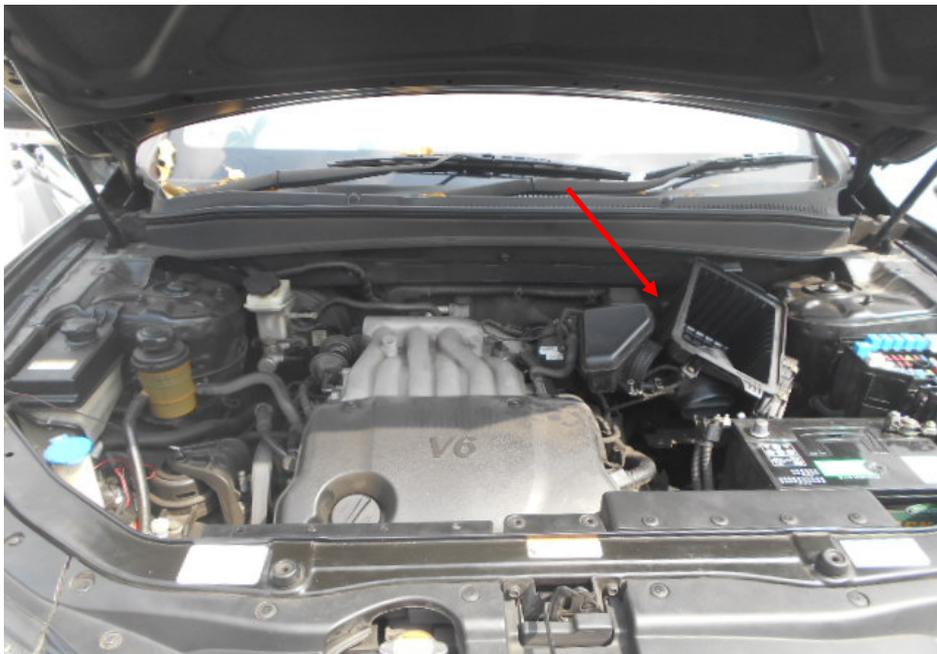
**Photo 4** shows a general view of the engine compartment of the Insured Vehicle. Evidence suggesting an occurrence of a fire/smoke incident was found at the left rear area of the engine compartment. The bonnet insulator and bottom part of the front windscreen, directly above this area, had also sustained slight heat damage.

8. For this particular case, the fire/smoke incident had originated within the engine compartment of the Insured Vehicle, at the left rear area of the engine compartment. This was established given that the damage of fire/smoke nature was confined to that single particular area of the Insured Vehicle.
9. The cause of fire/smoke can also be clearly established to be due to electrical in nature given that the wirings of the ABS control module was found to be partially melted with no other part(s) sustaining fire/heat damage. See photo 7 below.

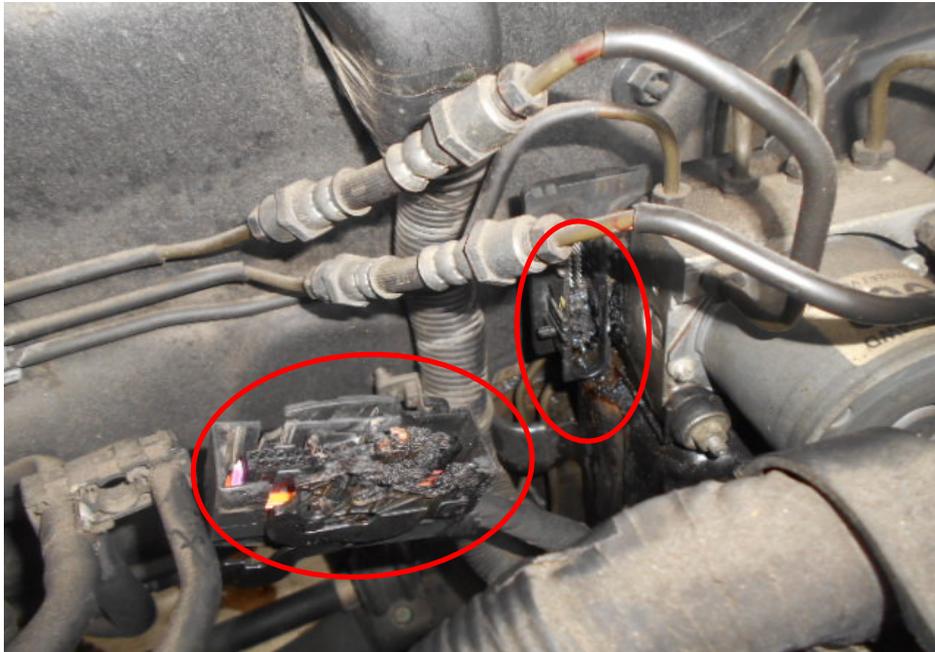
**Photo 5** shows the partially melted wiring connector (circled) for the ABS control module (Anti-Brake Lock), suggesting an occurrence of a fire/smoke incident.

15. Basing on my inspection of the Insured Vehicle, I am of the view that the fire/smoke incident had originated around the left rear area of the Insured Vehicle's engine compartment. The cause of fire was likely to be of electrical in nature along the wirings for the ABS control module.
16. I did not find any evidence to suggest that the cause of fire was due to poor maintenance and/or recurring electrical problem.
17. There was a pair of additional speakers fitted on the Insured Vehicle at the time of incident however these speakers did not cause and/or contribute to the fire/smoke incident. Other than these speakers, there were no other modification(s) fitted on the Insured Vehicle.

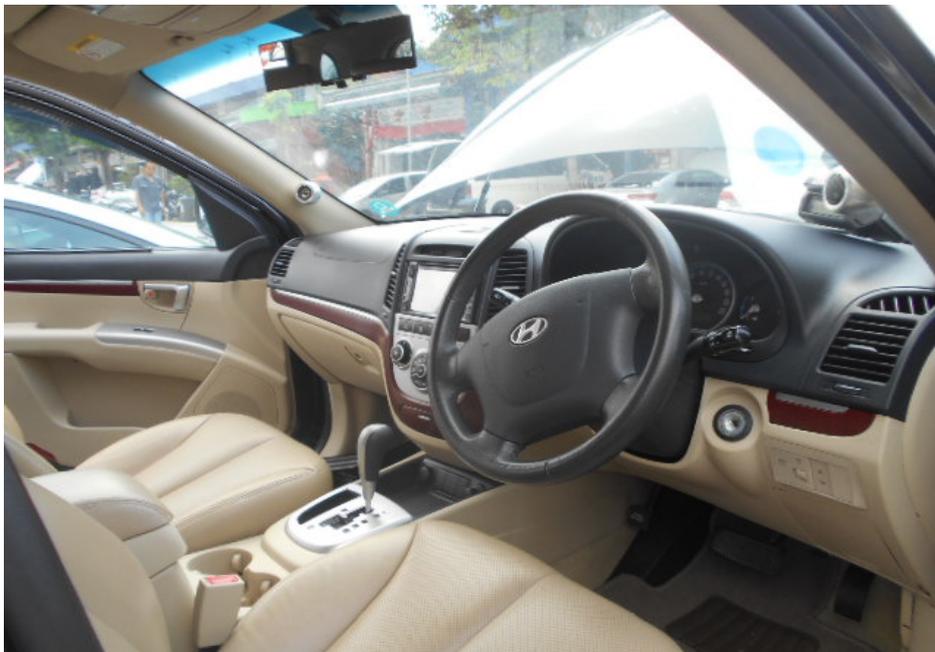
7. A pair of additional speakers was found fitted to the Insured Vehicle. These speakers and its wirings were intact and unaffected by the incident. See photo 6 below.

**Photo 6** shows the interior compartment of the Insured Vehicle, which was unaffected by the incident. A pair of additional speakers (arrowed) was found fitted to the Insured Vehicle. These speakers and its wirings were intact and unaffected by the incident.

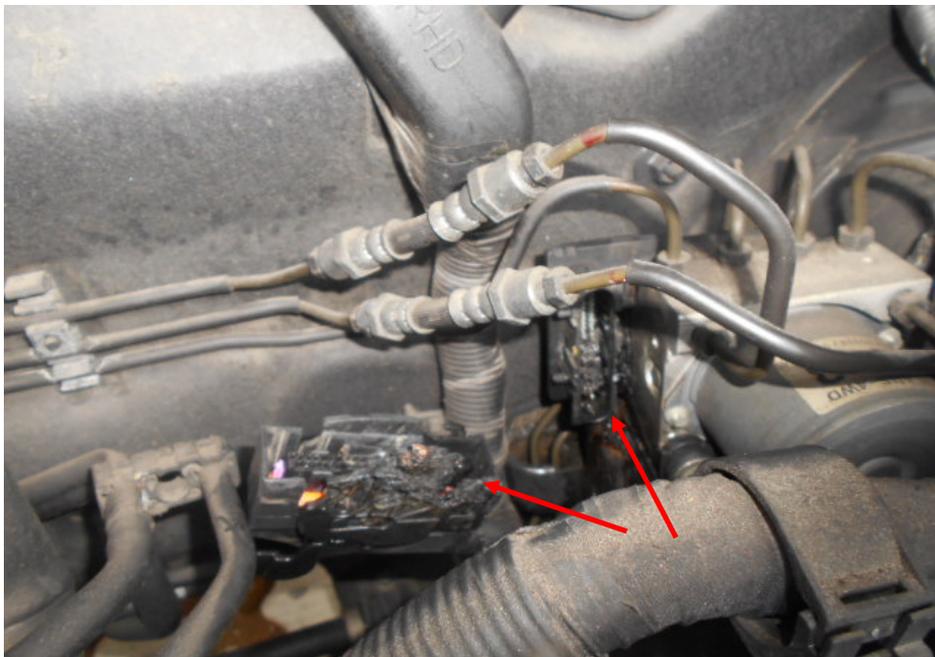
**Photo 7** shows the partially melted wirings of the ABS control module (arrowed) at the left rear area of the engine compartment. Since there was no other damage of fire/smoke nature found, it can hence be established that the fire/smoke incident had originated at this area of the Insured Vehicle, with the cause of fire/smoke due to electrical nature.

10. The cause of fire/smoke incident being due to electrical nature is also supported by the reported circumstances of incident where it was reported that the incident had occurred at a time when the Insured Vehicle was parked. This would indicate that the engine of the Insured Vehicle was not in operation hence the cause of the incident being due to engine overheating would seem unlikely. The cause of incident being due to fluid self-igniting from contact onto hot surfaces would also seem unlikely for similar reasons that the engine of the Insured Vehicle was not in operation. There was no heat (arising from engine operation) within the engine compartment for the fluids to reach temperatures that would be high enough (flashpoint) to cause the fluids to self-ignite.

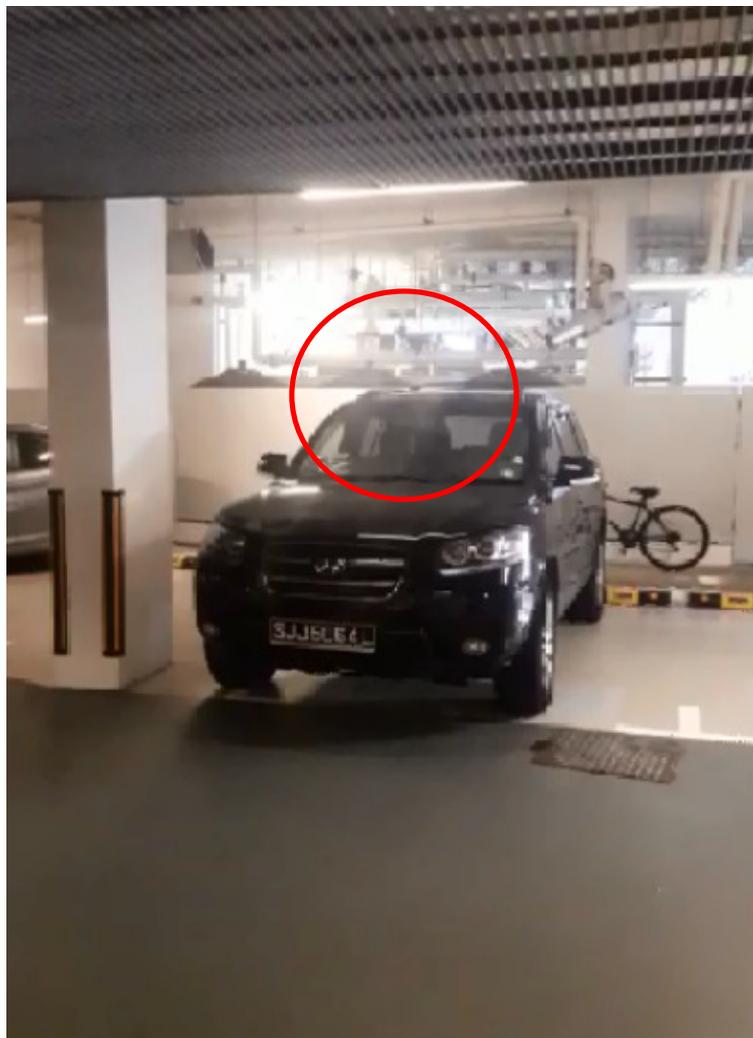
11. The possibility of the fire/smoke incident being due to external factor (foreign material(s) stuck on hot surfaces, arson and sabotage amongst others) would also seem unlikely as the incident had originated from within the engine compartment of the Insured Vehicle, with no damage of fire/smoke nature found on its exterior body. Furthermore, my review of a video recording taken at the time of incident had showed no unusual object(s) and/or material(s) on the ground in the immediate vicinity of where the Insured Vehicle was parked. See screenshot below taken from the video recording that I had manage to obtain in the course of my investigations.

Screenshot from the video recording showing smoke (circled) coming out from the gaps between the front bonnet and front windscreen. There was no unusual object(s) and/or material(s) on the ground in the immediate vicinity of where the Insured Vehicle was parked. This would suggest that the cause of incident was unlikely to be due to external factor like arson or sabotage.

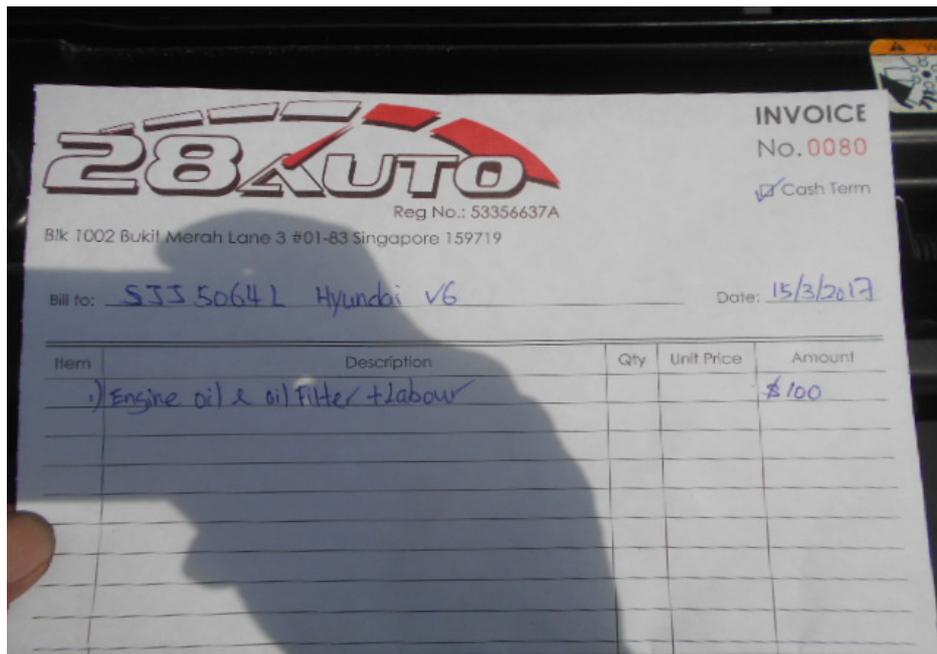
**Photo 8** shows the document relating to the engine oil and oil filter that were replaced on 15 March 2017.

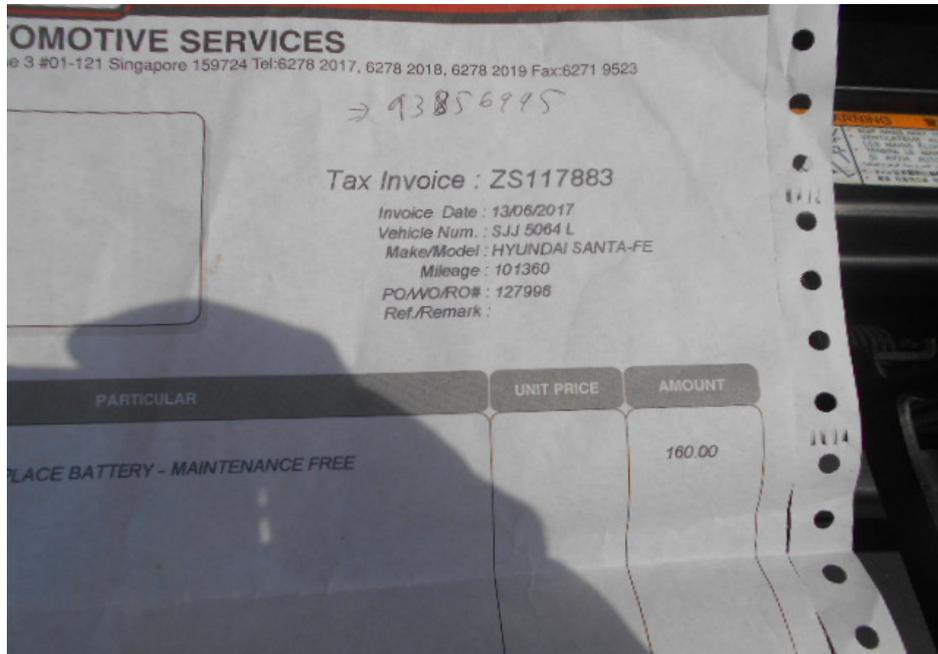
Photo 9 shows document relating to the battery replacement on 13 June 2017.

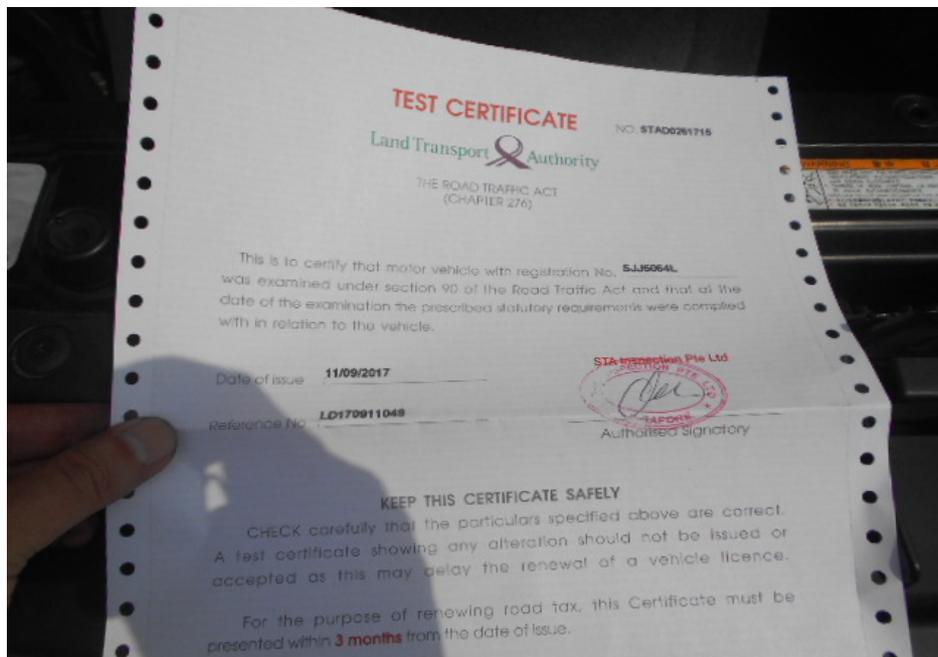
Photo 10 shows document certifying that the Insured Vehicle had passed the mandatory vehicle inspection on 11 September 2017.
