Your Ref : 522431/IT
Our Ref : CC3/MSG17013261/Dvb-1

**AUTOMOBILE TECHNICAL INVESTIGATION REPORT OF INCIDENT
INVOLVING SJV 8022A AND SHB 1209D ON 06 JULY 2017**

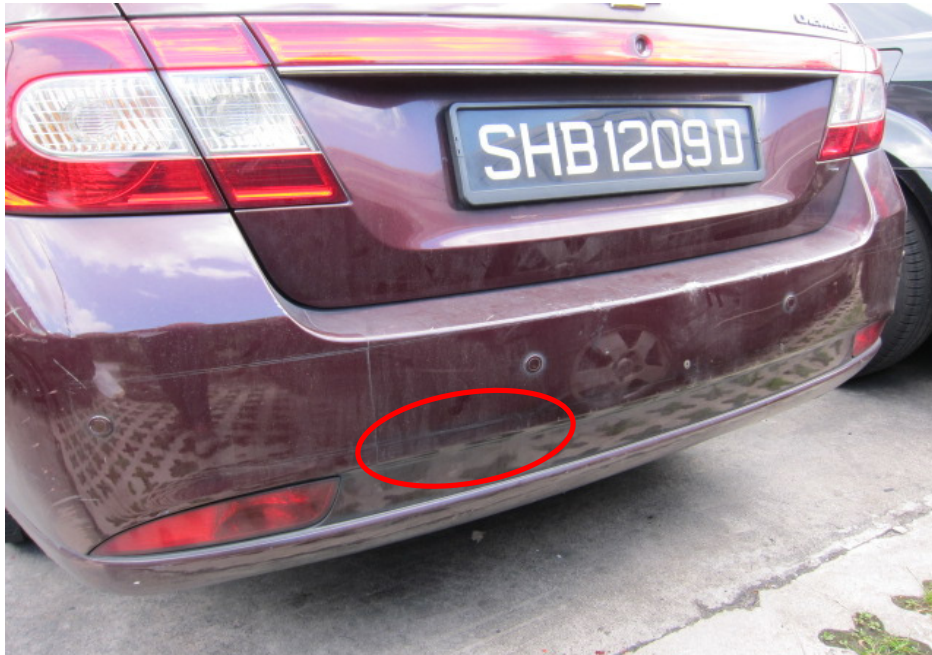
Photo 1 shows a general view of the rear portion of the Motor Taxi at the time of inspection on 07 July 2017. The Motor Taxi was observed to be generally in good condition. What appears to be an inverted L shape imprint mark was however observed towards the left of the Motor Taxi's rear bumper (circled).

25. Earlier in paragraph 12, I had commented that the incident scene photographs had showed the centre of the Insured Vehicle was aligned slightly towards the left of the Motor Taxi. At this position as seen in the incident scene photographs, the front number plate frame of the Insured Vehicle would have come into contact with the rear bumper of the Motor Taxi, at the area slightly towards the left of the rear bumper. This contact area on the Motor Taxi had corresponded to the area where the damage to the Motor Taxi was found ie towards the left side of the Motor Taxi's rear bumper (refer to photograph 1 above).

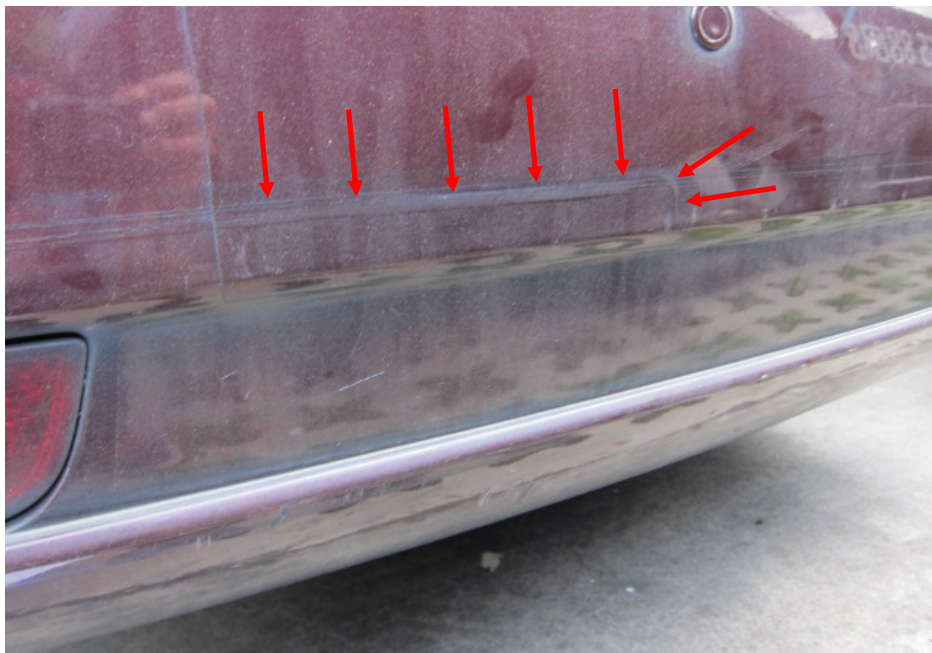
Photo 2 shows a closer view of the area where the inverted L shape imprint mark was found (arrowed). This was towards the left of the Motor Taxi's rear bumper. The imprint mark was a result of a load/force from a similarly shaped object (inverted L) pressing onto the rear bumper, inwards.

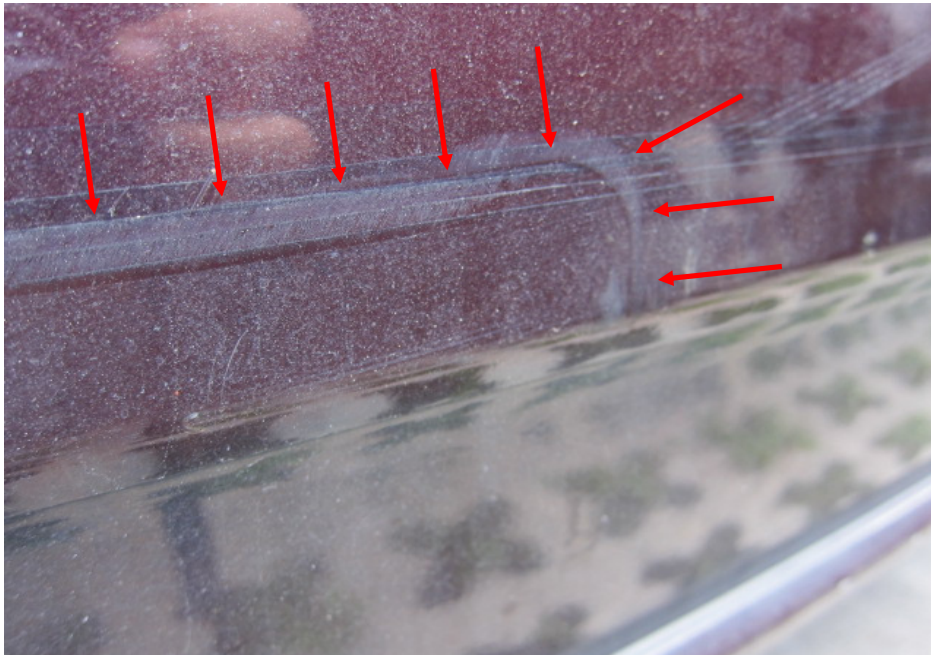
Photo 3 shows a close up view of the inverted L shape imprint mark which was caused by a load/force from a similarly shaped object (inverted L) pressing onto the rear bumper, inwards.

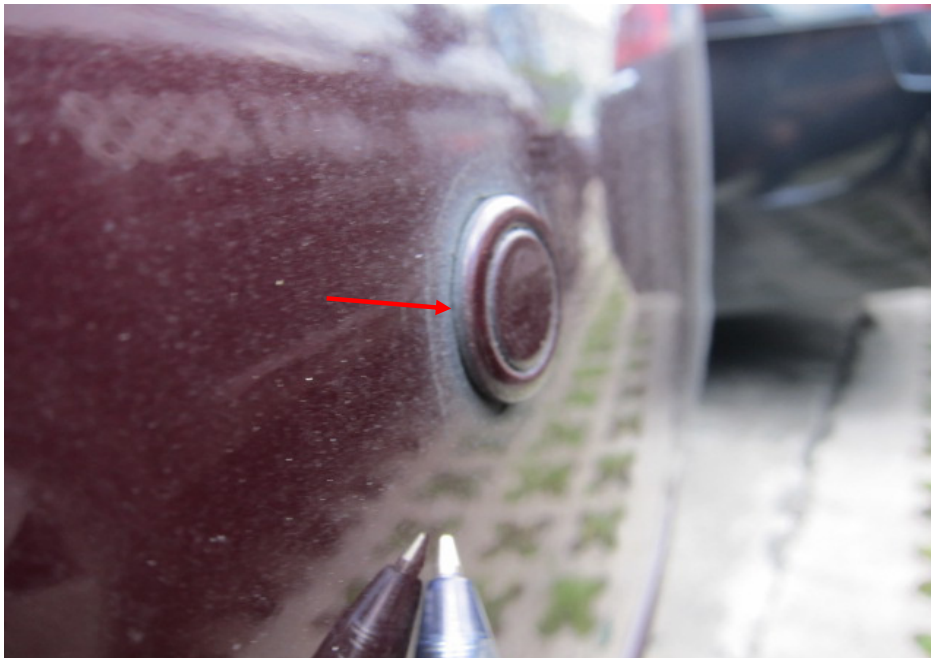
Photo 4 shows a close up view of the left reverse sensor of the Motor Taxi. The reverse sensor was observed to have been slightly pushed inwards, at the left side of the reverse sensor (arrowed).

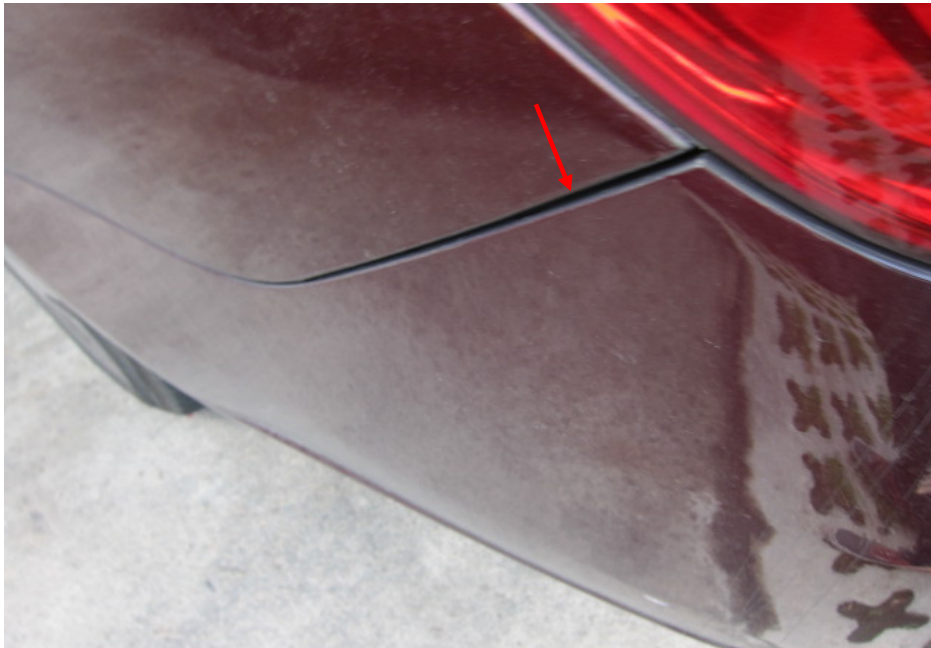
Photo 5 shows the slight misalignment (arrowed) at the left corner edges of the rear bumper, adjacent to the rear left fender of the Motor taxi. Such misalignment indicates that the Motor Taxi had sustained an impact directly onto its rear portion. This impact was however relatively light given that the misalignment was observed to be slight.

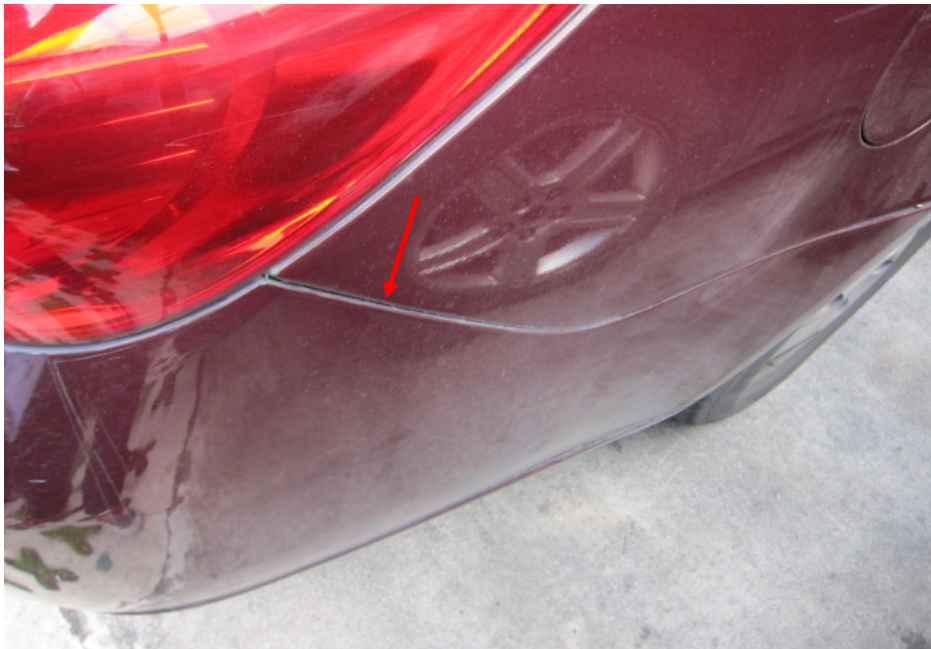
Photo 6 shows the right corner edges of the rear bumper, adjacent to the rear right fender of the Motor Taxi. There was no obvious misalignment at the right corner edges of the rear bumper (arrowed) as compared to the left corner edges. This would indicate that the impact onto the rear portion of the Motor Taxi was relatively light and was more towards the left of the rear bumper given that there was slight misalignment to the left corner edges.

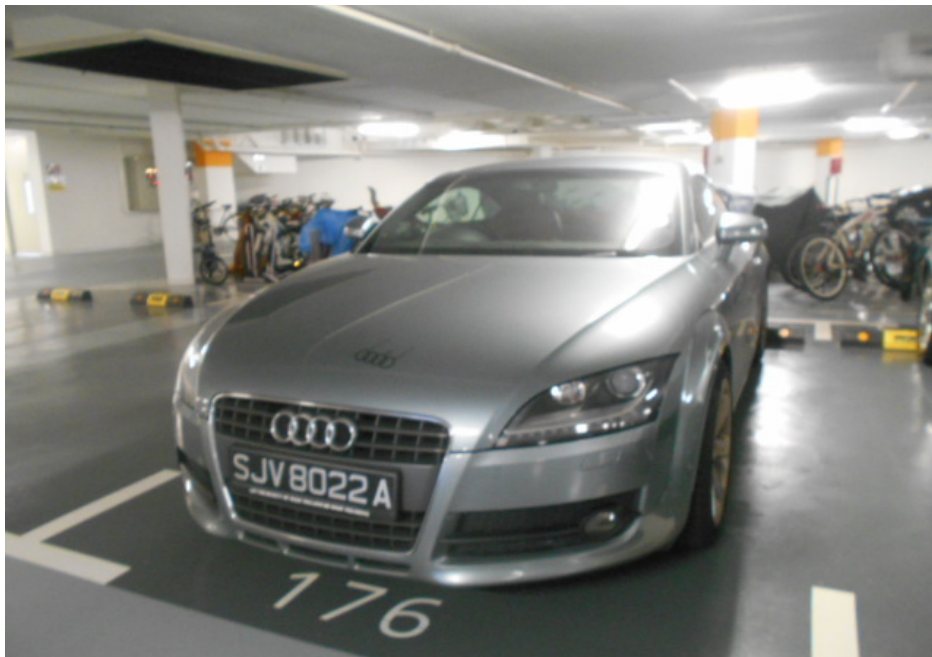
Photo 7 shows a general view of the front left portion of the Insured Vehicle at the time of my inspection. The mileage of the Insured Vehicle at the time of my inspection was recorded to be 69,739km.

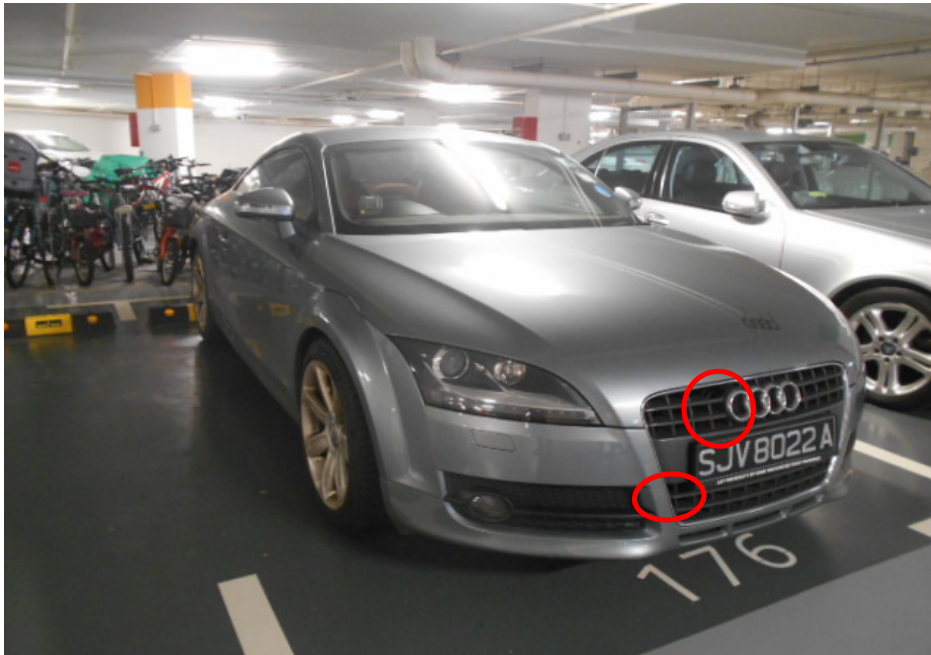
Photo 8 shows a general view of the front right portion of the Insured Vehicle at the time of my inspection. The inspection carried out had primarily focused on the frontal portion of the Insured Vehicle, as the incident was reported to be of a head to rear nature where the Insured Vehicle was behind the Motor Taxi at the material time. Its front bumper was observed to be distorted at the area slightly towards the right of the front number plate. Its front grille was observed to be cracked (circled).

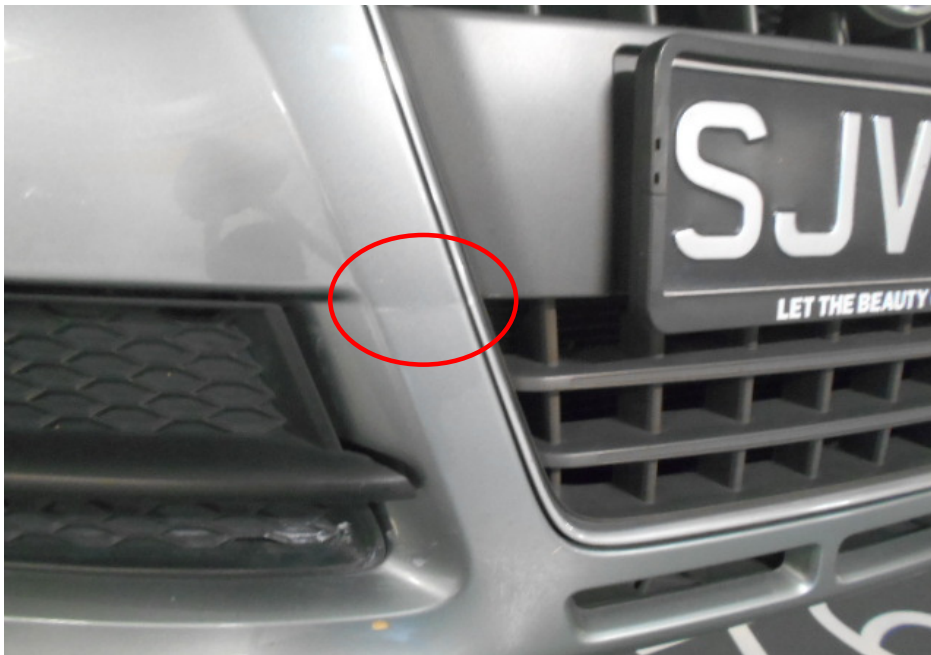
Photo 9 shows a close up view of the distortion (circled) to the front bumper of the Insured Vehicle, at the area slightly towards the right of the front number plate.

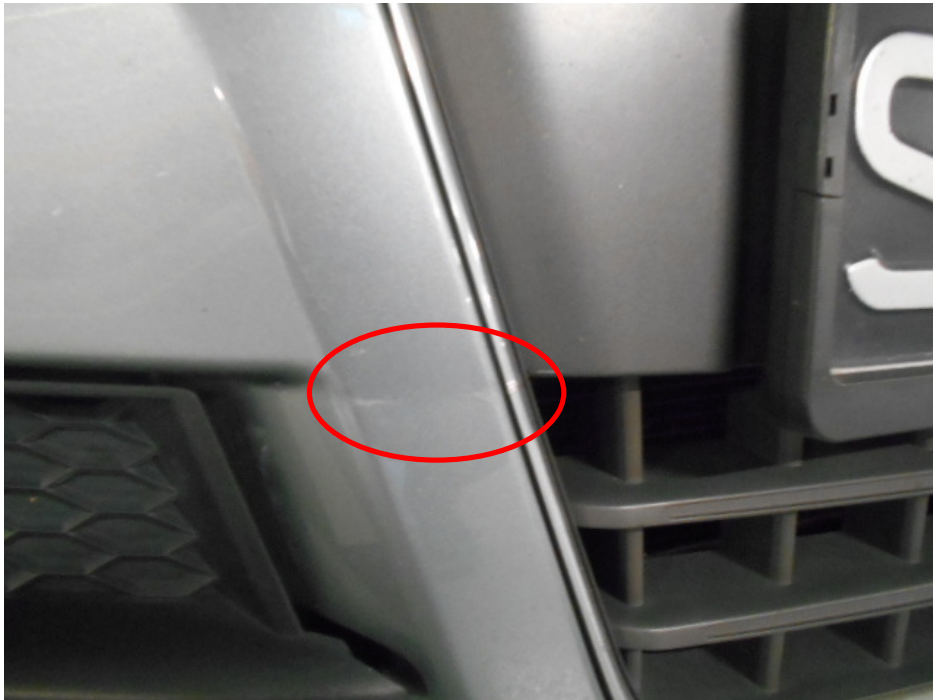
Photo 10 shows a close up view of the distortion (circled) to the front bumper of the Insured Vehicle, at the area slightly towards the right of the front number plate.

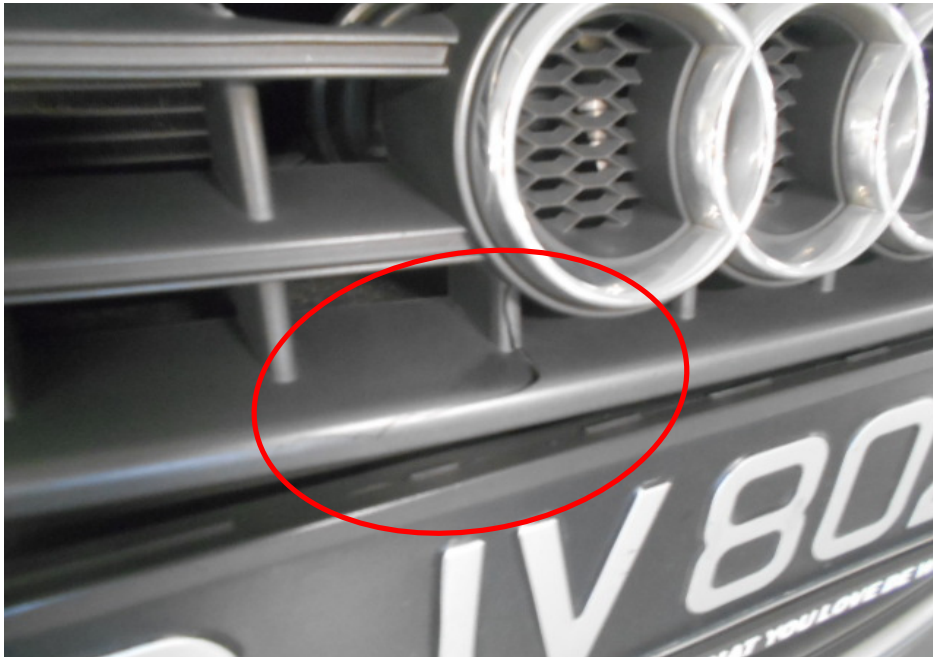
Photo 11 shows a close up view of the crack (circled) to the front grille of the Insured Vehicle, at the area directly above the front number plate.

26. From this relative position, the shape of the inverted L was caused by the right top corner edge of the Insured Vehicle's front number plate frame. The front grille of the Insured Vehicle, at the area directly above the right top side of the front number plate frame was also found to be cracked at the time of my inspection (refer to photograph 11 above), indicating that this area of the Insured Vehicle was exposed to a force/load.

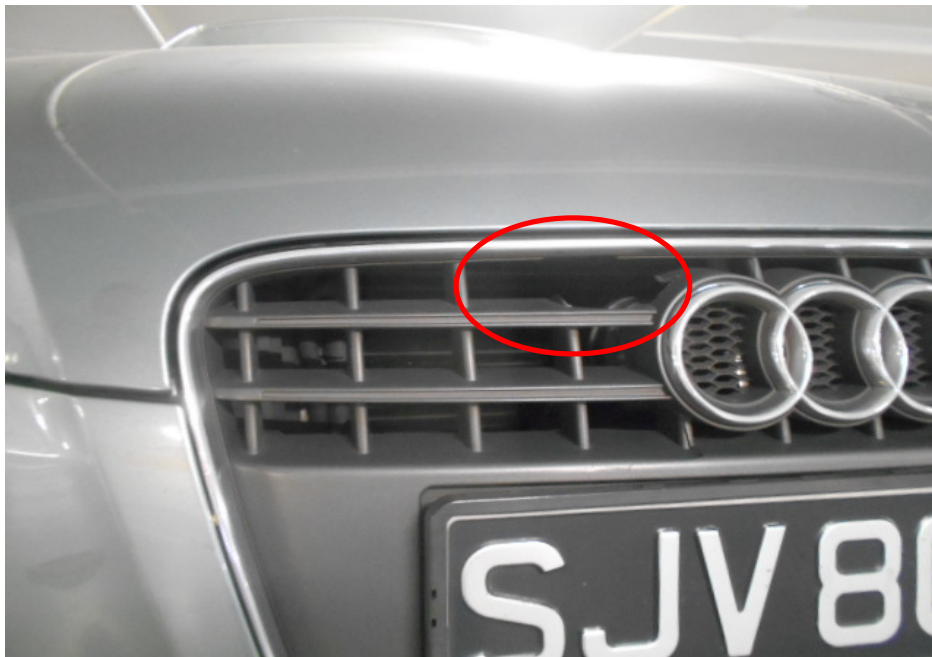
Photo 12 shows a general view of the crack (circled) to the front grille of the Insured Vehicle, at the top centre area of the front grille.

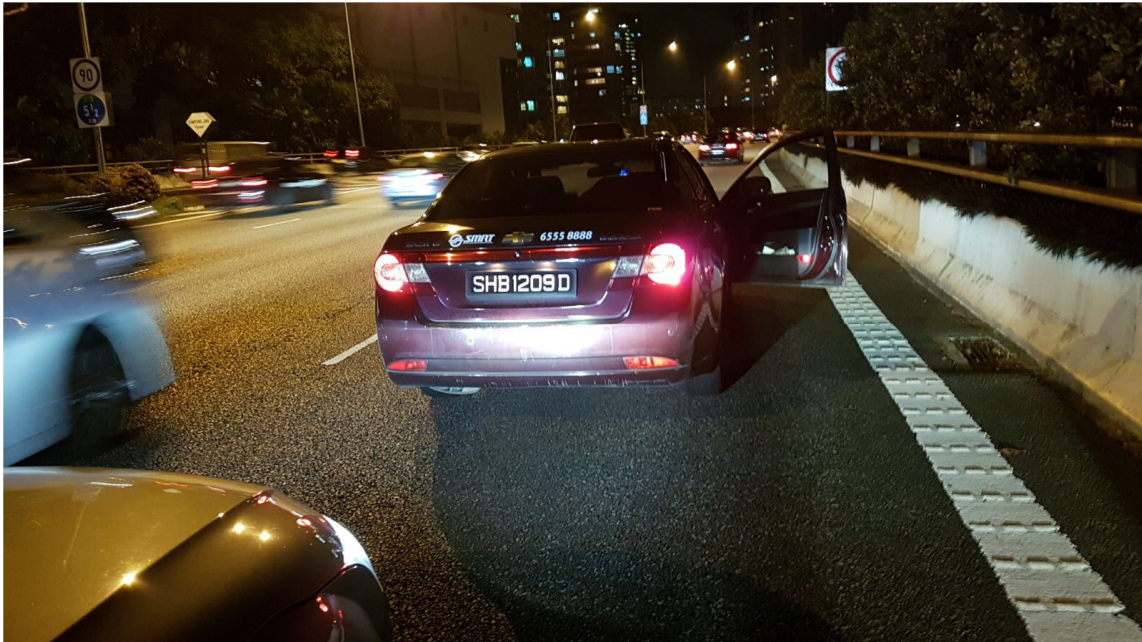
Photo 13 shows the Insured Vehicle behind the Motor Taxi. The centre of the Insured Vehicle was observed to be slightly aligned towards the left of the Motor Taxi. There was also a gap between the front portion of the Insured Vehicle and the rear portion of the Motor Taxi.

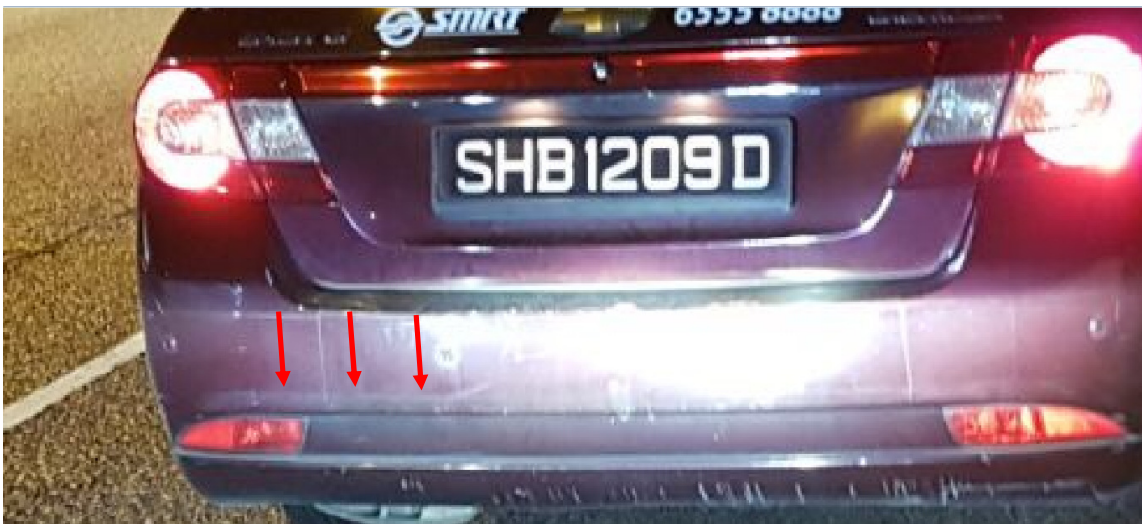
Photo 14 shows an enlarged view of the Motor Taxi's rear bumper, using photograph 13 above. I had observed what appears to be the same inverted L shape imprint mark on the rear bumper of the Motor Taxi, similar to what was observed from the photographs of the Motor Taxi that were taken at the time of inspection by LKK Auto Consultants Pte Ltd (refer to photograph 2 above for comparison).

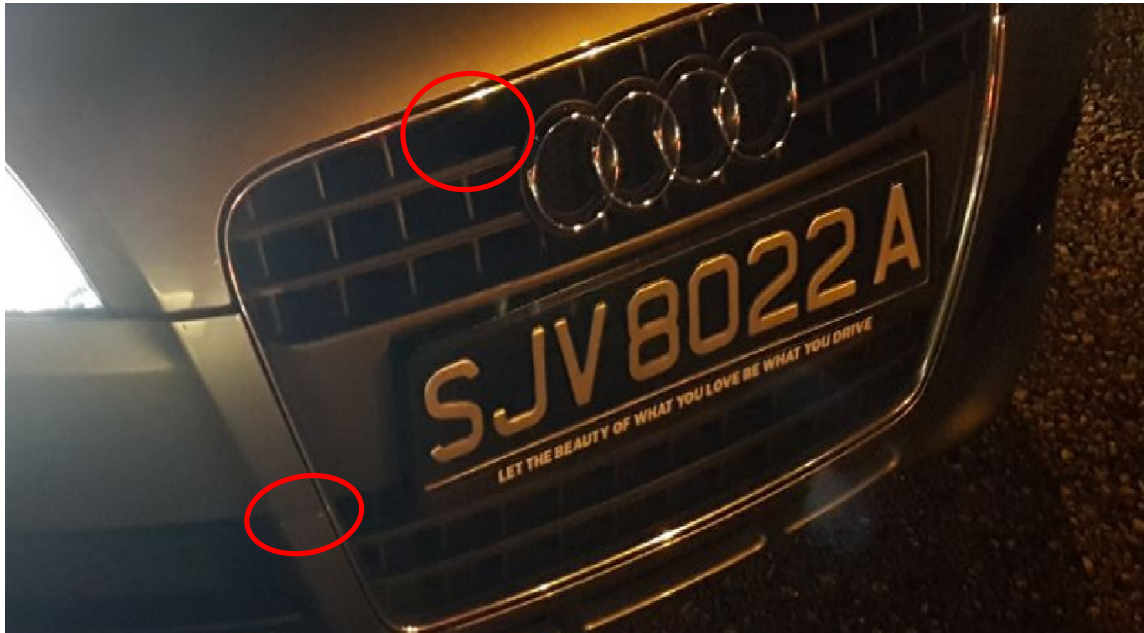
Photo 15 shows an enlarged view of the frontal portion of the Insured Vehicle (from photographs taken at the incident scene). The distortion to the front bumper and crack to the front grille that I had noted on the frontal portion of the Insured Vehicle at the time of my inspection was similarly observed on its frontal portion at the incident scene (circled).

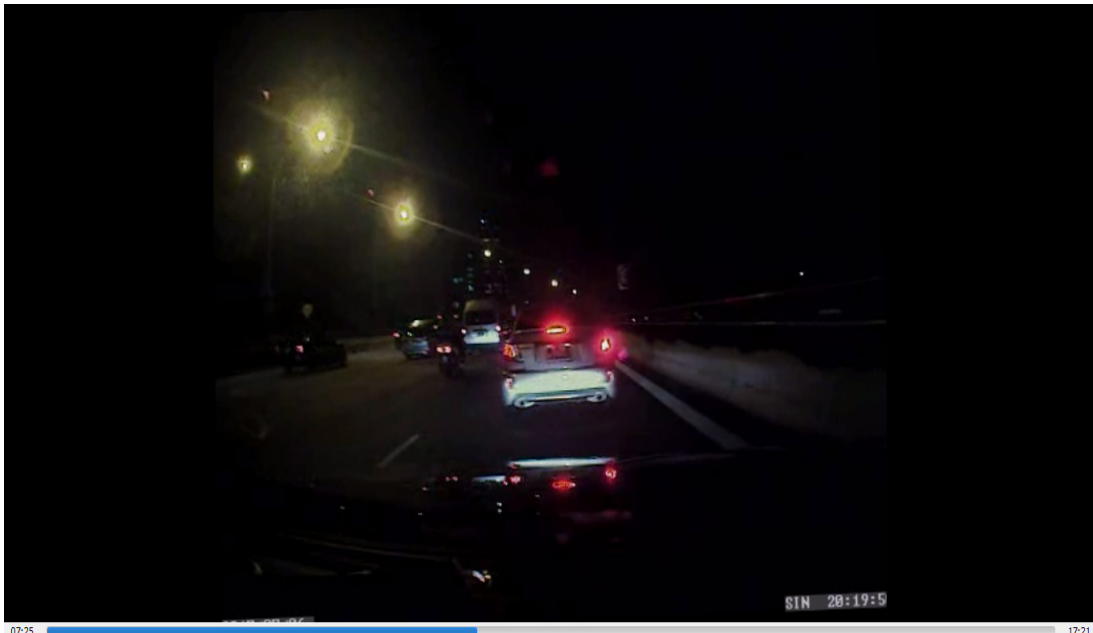
Screenshot shows the 7 minute 25 second mark of the video clip that was recorded from a recording device mounted on the front windscreen of the Motor Taxi. The Motor Taxi was seen coming to a complete stop as the vehicle that was travelling in front had also stopped. Thereafter there was shaking of the image captured by the recording device. The capturing of shaky image by the recording device, while the Motor Taxi was stationary, indicates that there was a jerk like movement of the Motor Taxi, causing the recording device to shake and ultimately capturing the shaky image.

17. The capturing of a shaky image whilst stationary is a sign that there was jerk movement to the Motor Taxi causing the recording device to shake and therefore capturing the shaky image. For this particular case, the jerk movement experienced by the Motor Taxi could possibly arise from a force/load acting on the Motor Taxi (in the context of this case, represent a contact from the Insured Vehicle), and/or the releasing of the brake pedal and instantly stepping on the brake pedal again by the Motor Taxi driver.

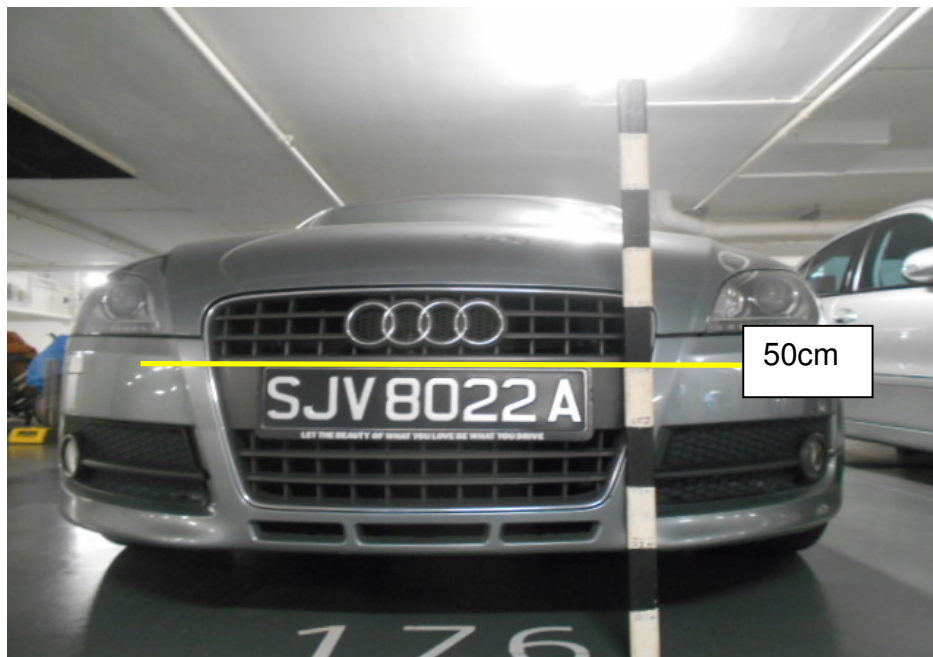
Photo 16 shows the height measurement that was conducted on the front portion of the Insured Vehicle. The top horizontal end of the Insured Vehicle's front number plate frame was measured to be approximately 50cm above ground level.

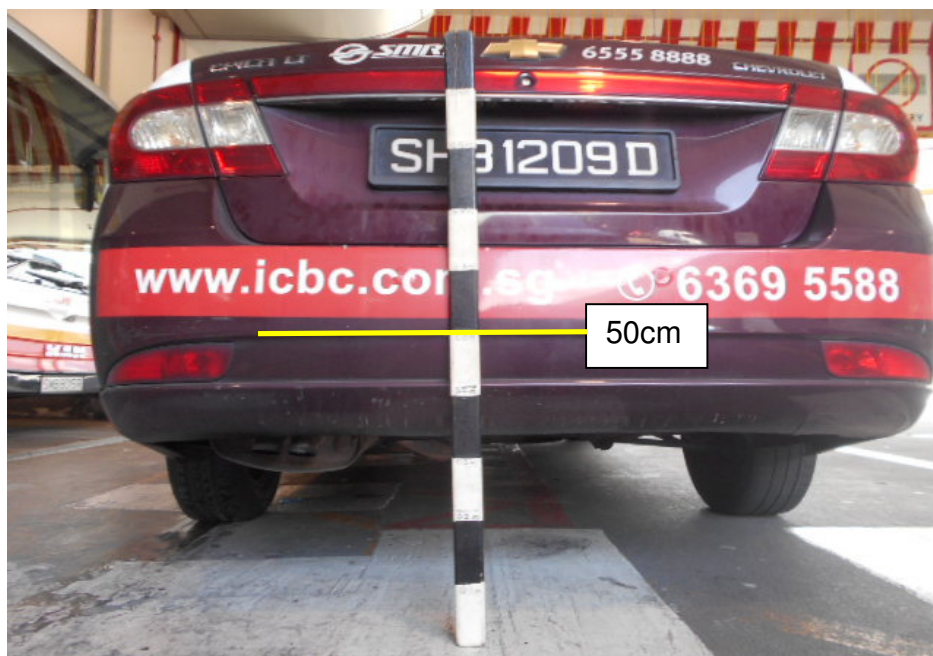
Photo 17 shows the height measurement that was conducted on the rear portion of the Motor Taxi. The height of the top horizontal end of the Insured Vehicle's front number plate frame was at similar height above ground level on the Motor Taxi where the inverted L shape imprint mark on its rear bumper was found (refer to photograph 2 and 3 above).
