Your Ref: TP/IP/51353/2017
Our Ref : CI/TPD17021563/Z

20th November 2017

Fatal Accident Investigation Team

MECHANICAL INSPECTION REPORT OF MOTOR LORRY GBF 1281T

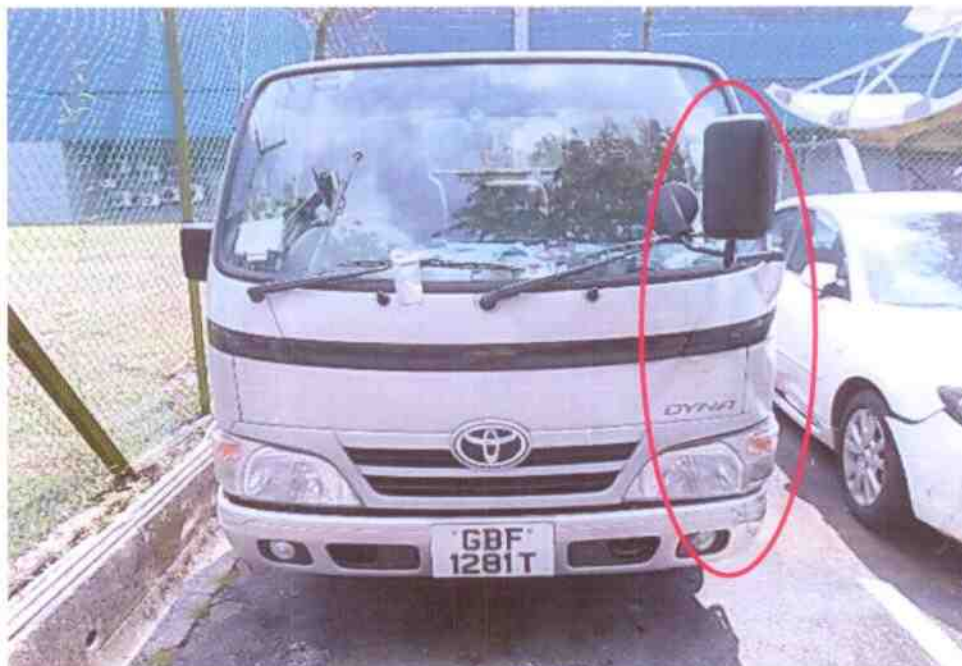
4. The mileage of the Motor Lorry at the time of our inspection was 94,097km.
5. The Motor Lorry was observed to have sustained damages at its front left panel, front left wiper panel, front left bumper, front left side mirror, headlamp and left passenger door were amongst the body parts that were damaged as a result of the accident.

Photo 1 shows a general view of the front left body of the Motor Lorry at the time of our inspection. The Motor Lorry was observed to have sustained damages at its front left panel, front left wiper panel, front left bumper, front left side mirror, headlamp and left passenger door were amongst the body parts that were damaged as a result of the accident. (circled).

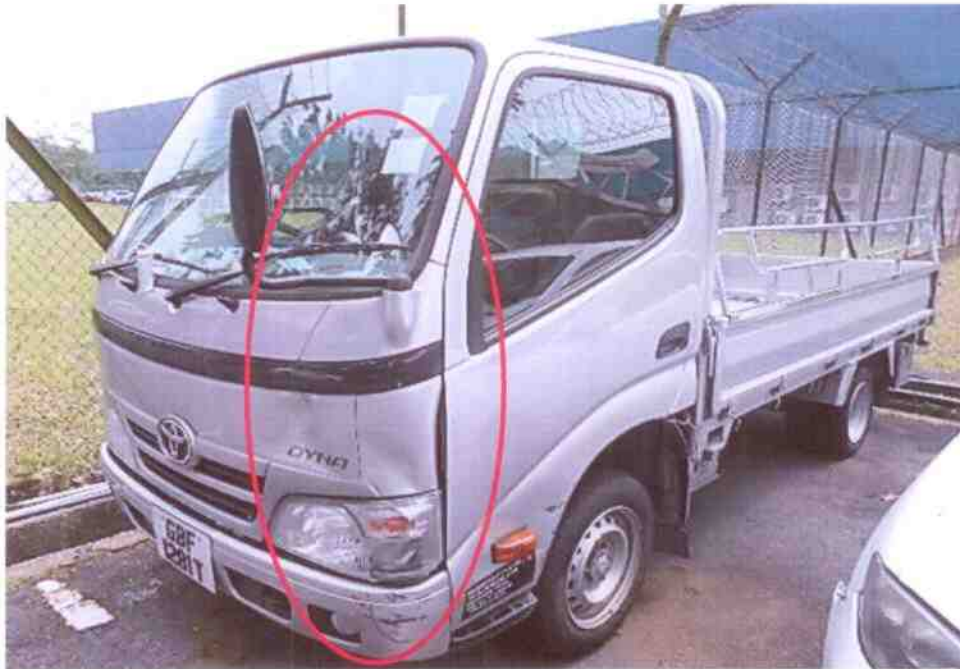
Photo 2 shows a general view of the front left body of the Motor Lorry at the time of my inspection. The Motor Lorry was observed to have sustained damages at its front left panel, front left wiper panel, front left bumper, front left side mirror, headlamp and left passenger door were amongst the body parts that were damaged as a result of the accident. (circled).

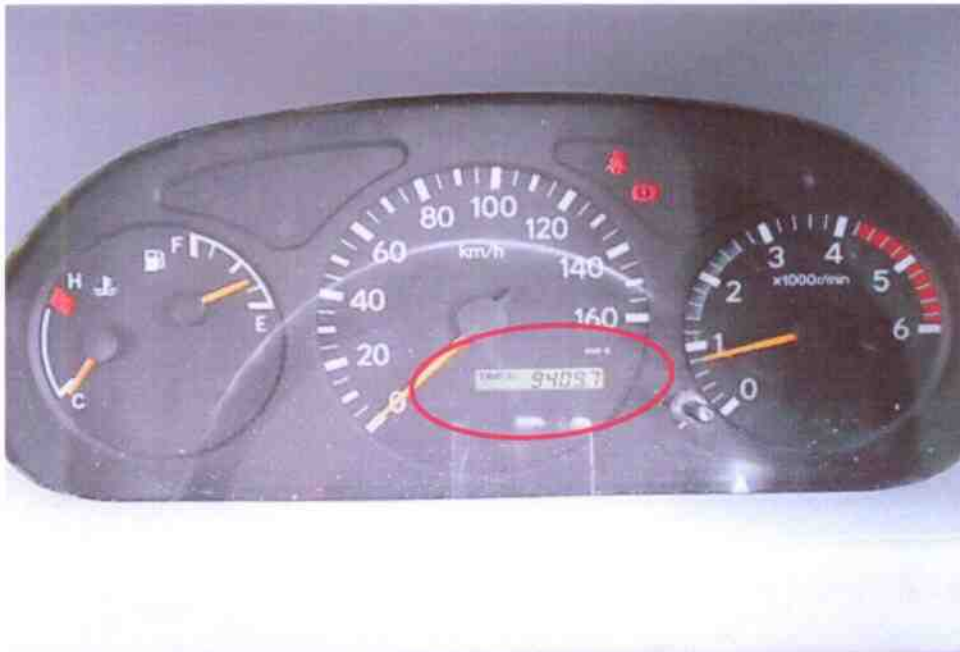
Photo 3 shows the mileage of the Motor Lorry at the time of our inspection was 94,097km.

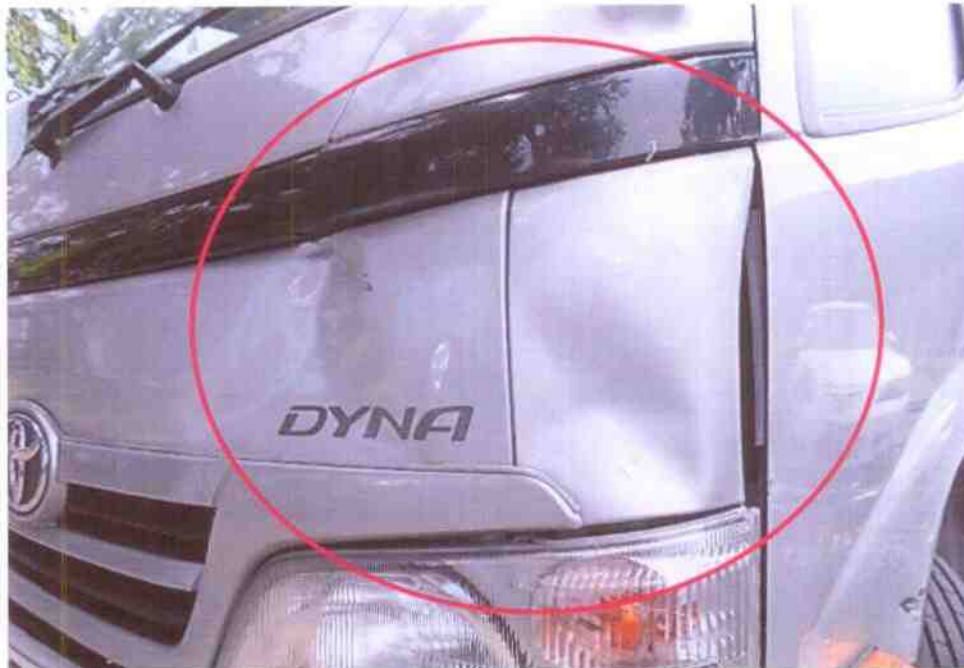
Photo 4 shows the damage sustained on the front left panels as a result of the accident.

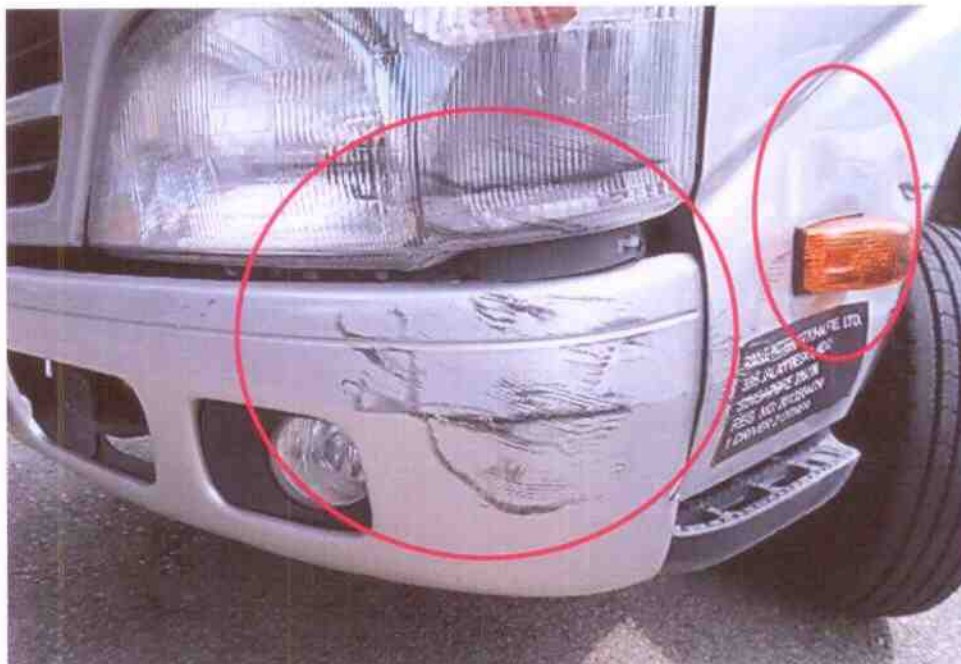
Photo 5 shows the damage sustained on the front left lower bumper & left passenger door as a result of the accident.

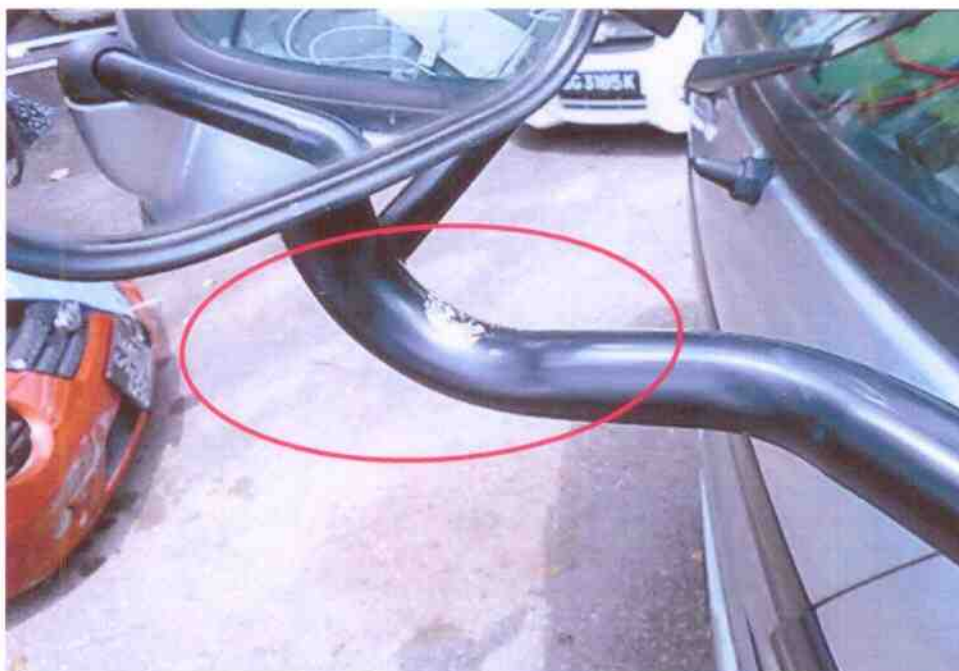
Photo 6 shows the damage sustained on the front left side mirror as a result of the accident.

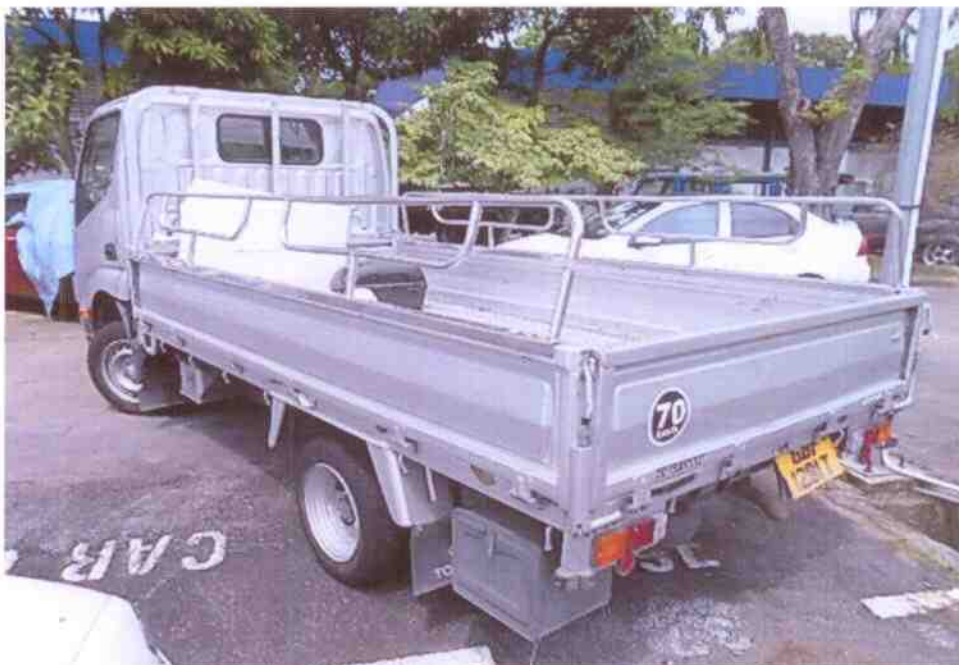
Photo 7 shows a general view of the Motor Lorry's rear left body at the time of our inspection. There was no damage found to the rear portion of the Motor Lorry.

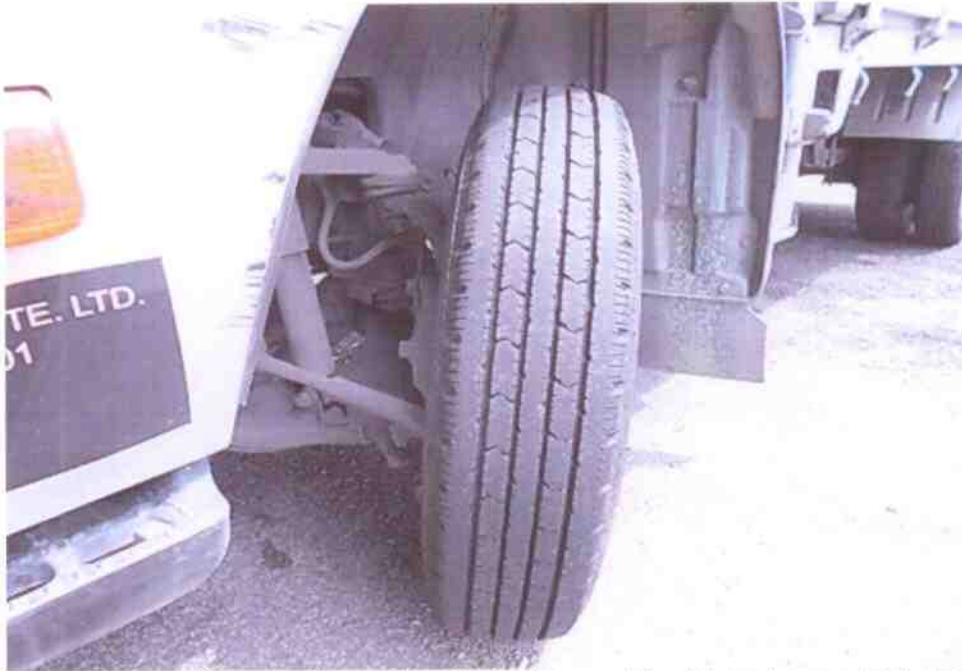
Photo 8 shows the condition of the front left tyre of the Motor Lorry, which was observed to be in serviceable condition with remaining tread depth of approximately 6mm. The tyre, which was wrapped around standard alloy wheel rim, was also observed to be sufficiently inflated for vehicular operation. There was no tear, cut or burst mark(s) on the outer and the inner sidewalls.

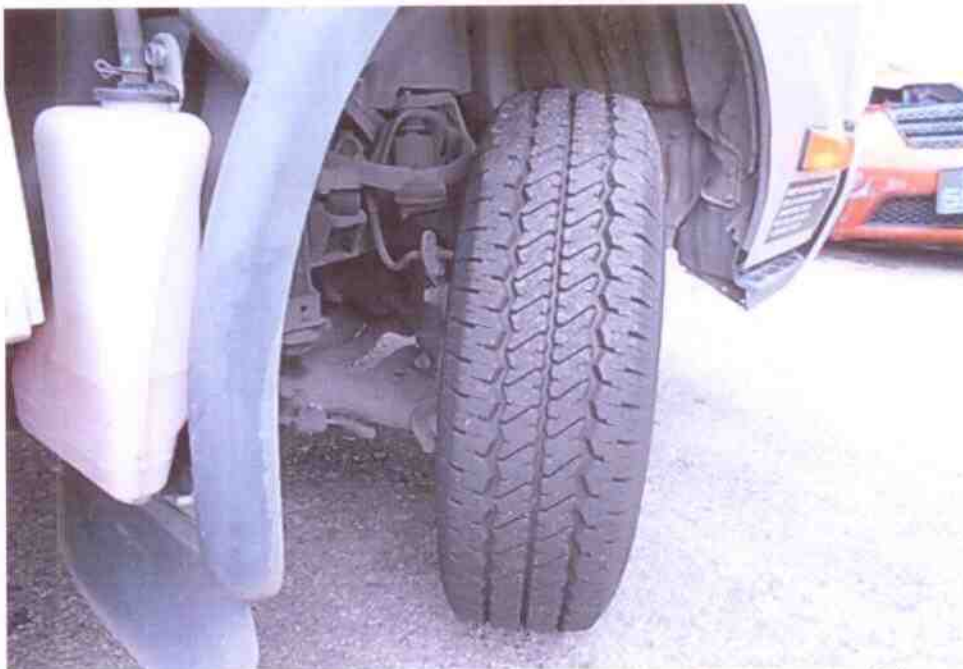
Photo 9 shows the condition of the front right tyre of the Motor Lorry, which was observed to be in serviceable condition with remaining tread depth of approximately 9mm. The tyre, which was wrapped around standard alloy wheel rim, was also observed to be sufficiently inflated for vehicular operation.

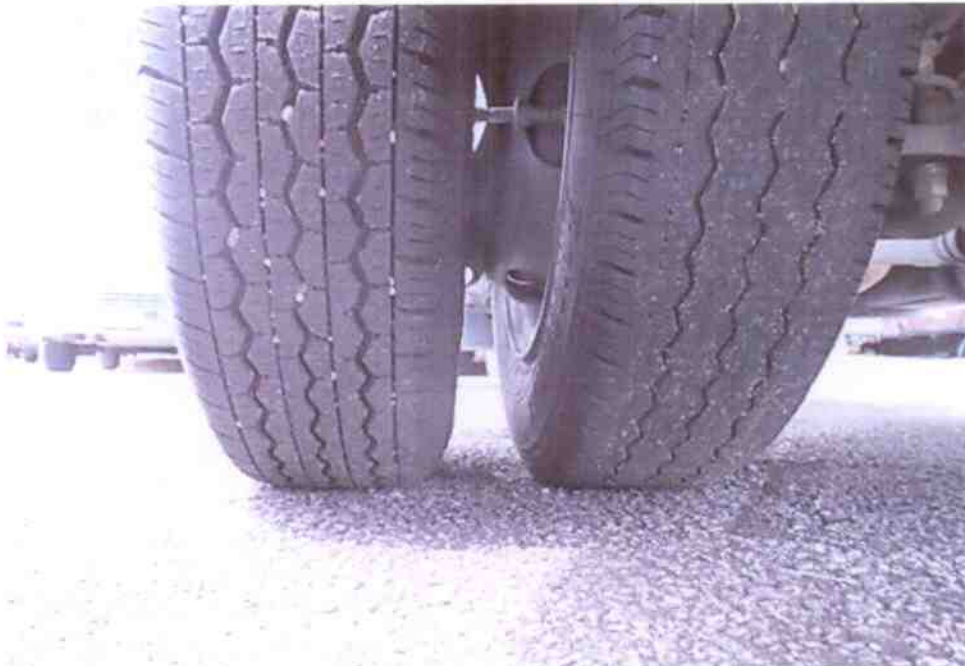
Photo 10 shows the condition of the rear left tyres of the Motor Lorry, which was observed to be in serviceable condition with remaining tread depth of approximately 5mm. The tyres, which were wrapped around standard alloy wheel rim, were also observed to be sufficiently inflated for vehicular operation.

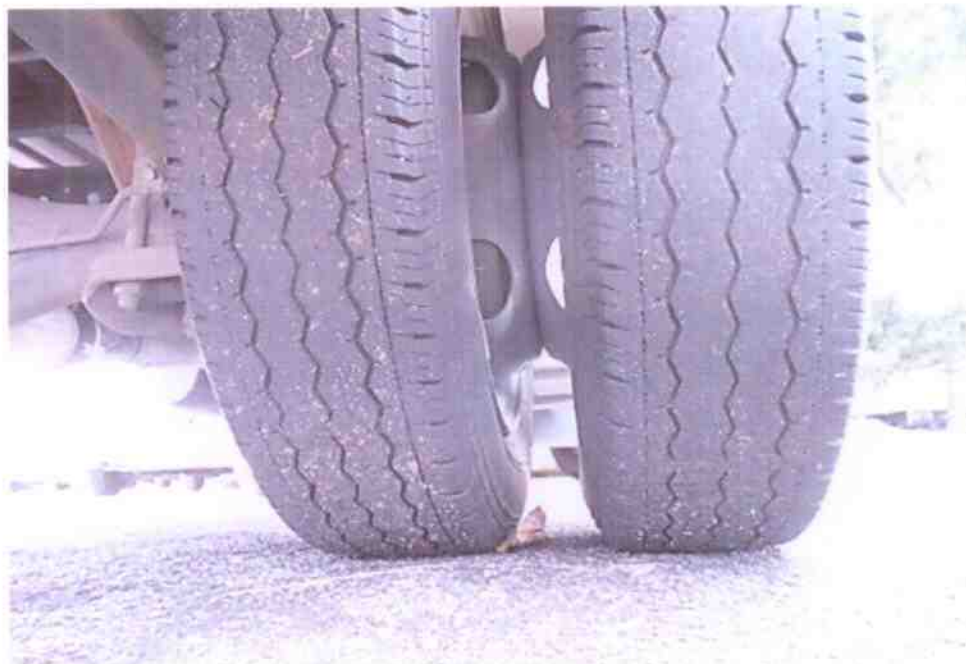
Photo 11 shows the condition of the rear right tyres of the Motor Lorry, which were observed to be in serviceable condition with remaining tread depth of approximately 2mm. There was also no tear, cut or burst mark(s) on the outer and the inner sidewalls.

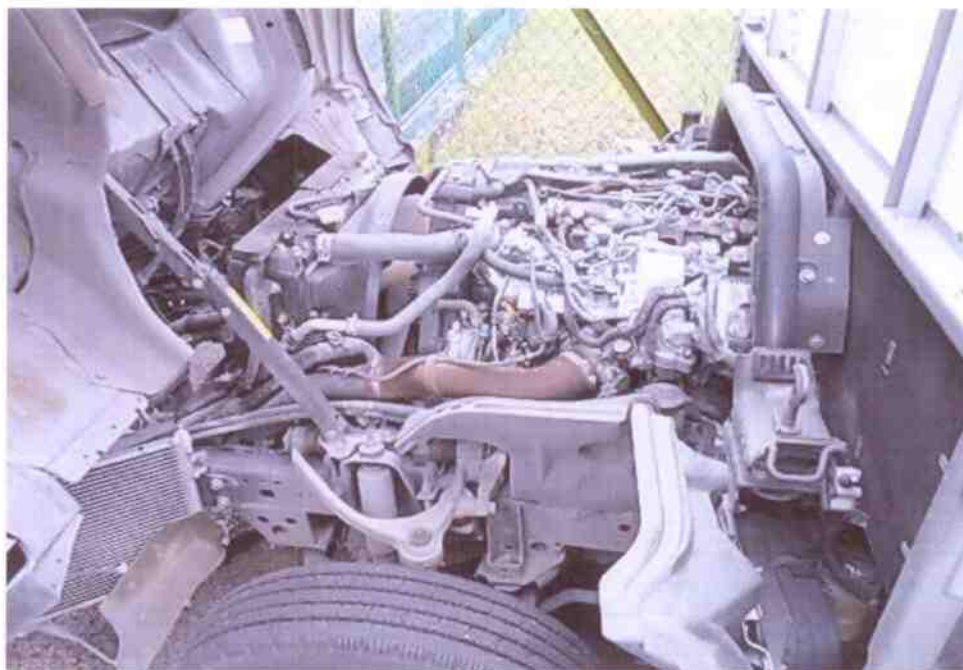
Photo 12 shows a general view of the Motor Lorry's engine compartment, which was accessed by lifting the front cabin of the Motor Lorry. The various parts and components inside the engine compartment were unaffected by the accident. There was also no sign(s) or indication(s) of fresh fluid leakage and/or fluid stain within the engine compartment (photograph shows the engine compartment as viewed from the left front side of the Motor Lorry).

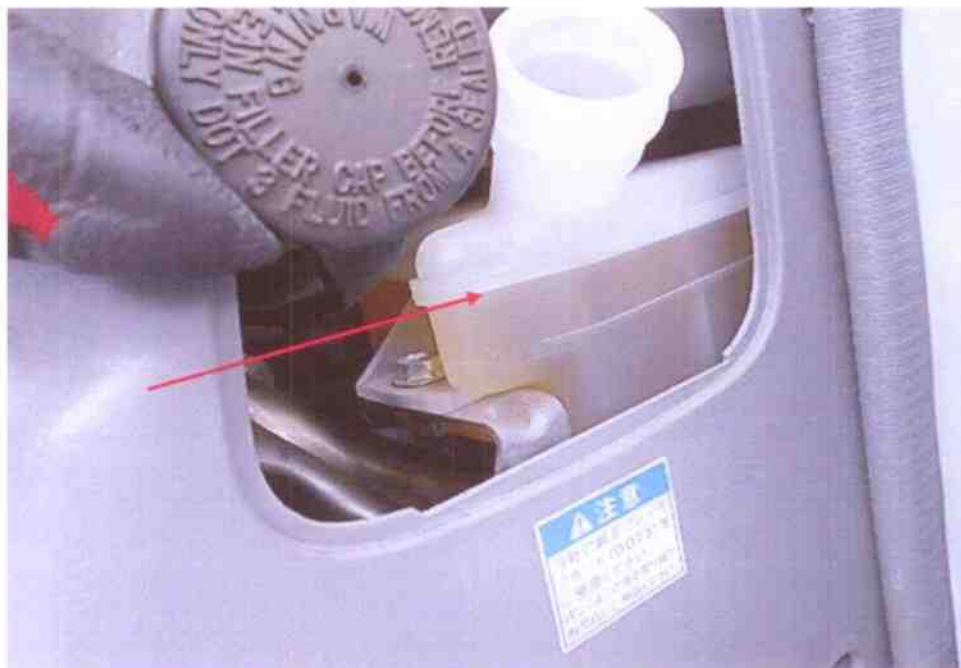
Photo 13 shows the brake fluid reservoir of the Motor Lorry at the time of our inspection. The brake fluid was observed to be of sufficient level and without any visible contamination.

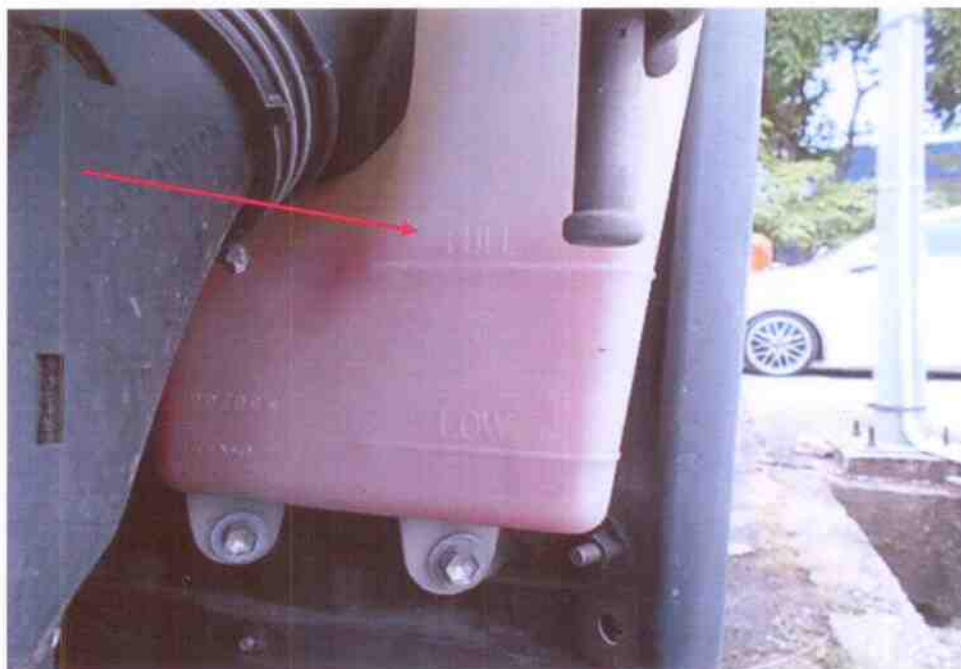
Photo 14 shows the engine coolant reservoir of the Motor Lorry at the time of our inspection. The engine coolant was observed to be of sufficient level and without any visible contamination.

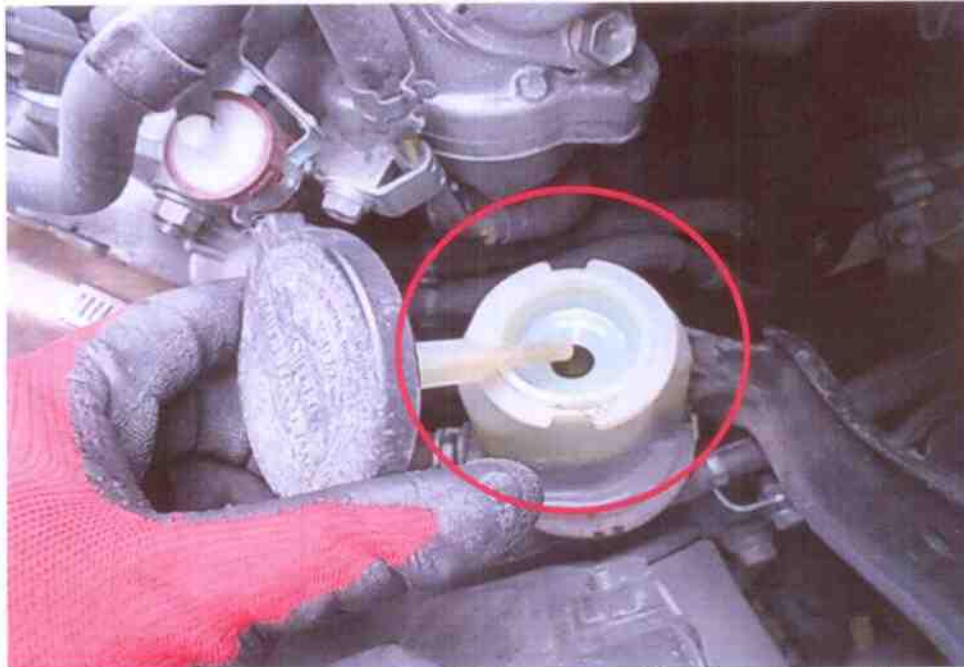
Photo 15 shows the power steering fluid reservoir of the Motor Lorry at the time of our inspection. The power steering fluid (circled) was observed to be of sufficient level and without any visible contamination.

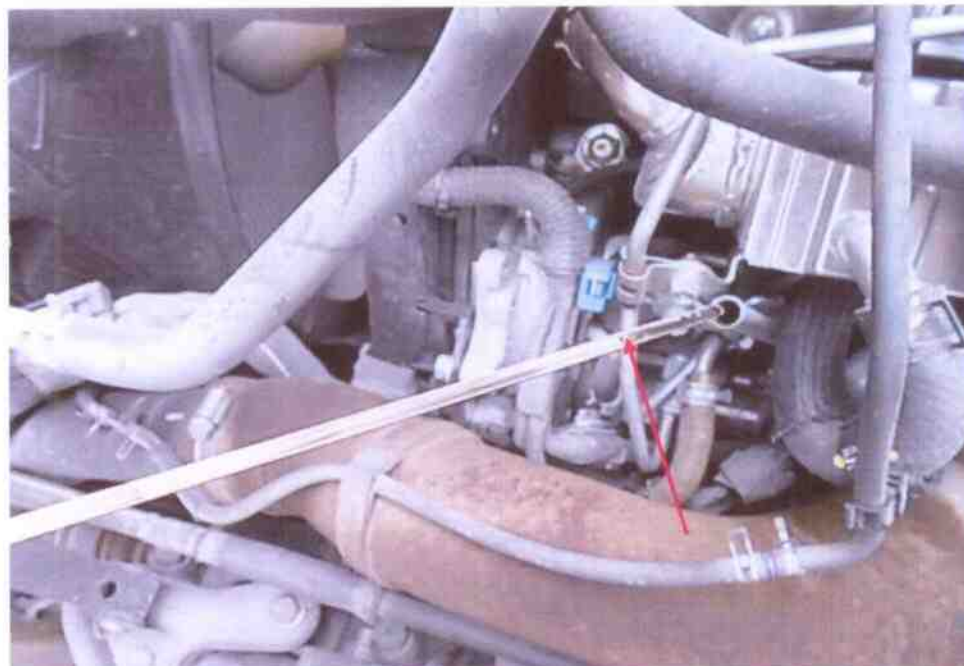
Photo 16 shows the engine dip stick of the Motor Lorry at the time of our inspection. The engine oil was observed to be of sufficient level and without any visible contamination (arrowed).

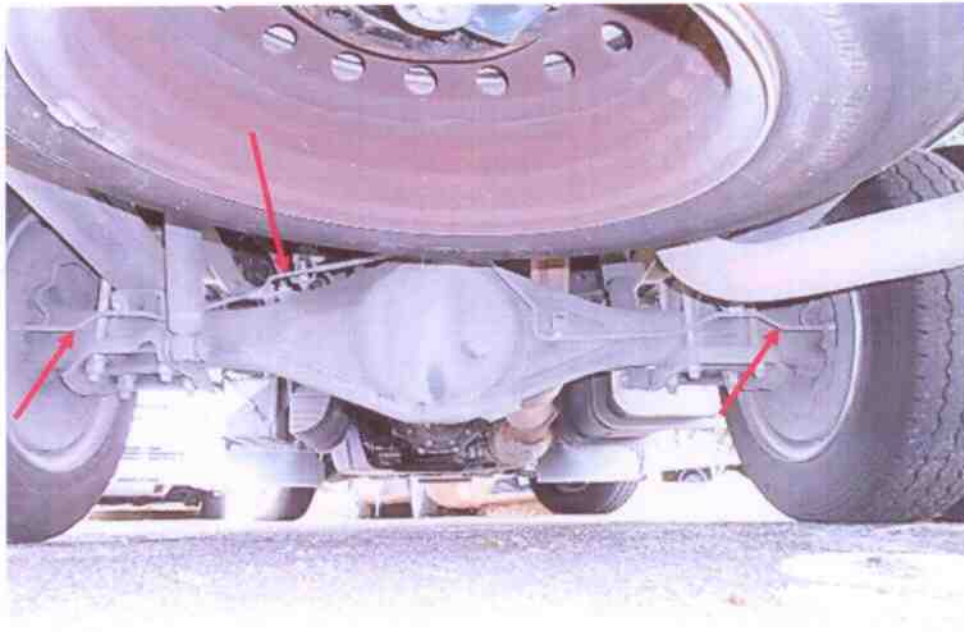
11. Static brake tests conducted on the Motor Lorry revealed no abnormality. The brake booster had responded well to the various tests conducted. There was also no abnormal movement of the brake pedal when it was depressed. In general, the static brake tests had suggested that there was no internal leakage of pressure/vacuum in the braking system of the Motor Lorry. The braking system of the Motor Lorry was likely to be in serviceable condition at the material time. This was also taking into consideration that the brake fluid was of sufficient level, and also that there was no sign(s) of brake fluid leakage along the brake hoses and brake pipes.

Photo 17 shows the brake pipe (arrowed) at the rear right wheel of the Motor Lorry. We did not observe any leakage of brake fluid at the time of our inspection of the Motor Lorry. Our static tests of the Motor Lorry's braking system, along with our visual examination of the various mechanical components in the braking system, had indicated that there was no internal leakage of pressure/vacuum. Hence the braking system of the Motor Lorry was likely to be in serviceable condition at the material time of accident.

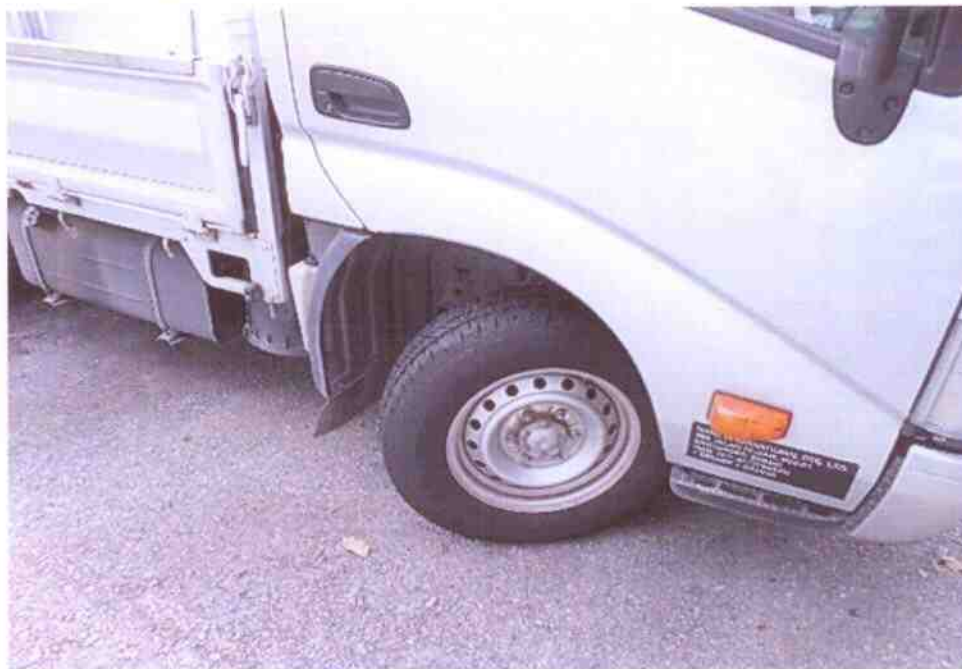
12. Static test on the steering system of the Motor Lorry also revealed no abnormality to the steering system. We did not experience any abnormal free play and/or other resistance when turning the steering wheel left and right to full lock positions. Our visual examination of the various steering components which had included the rack and pinion, tie rods, tie rod ends and ball joints had revealed that these components were all generally in good condition. See photo 17 - 20 below.

Photo 18 shows the front right wheel of the Motor Lorry turned to its full left. During our steering system test, we did not experience any abnormal free play and/or resistance when we had turned the steering wheel towards full left and full right. This would suggest that the steering system of the Motor Lorry was likely to be in serviceable condition at the material time of accident.

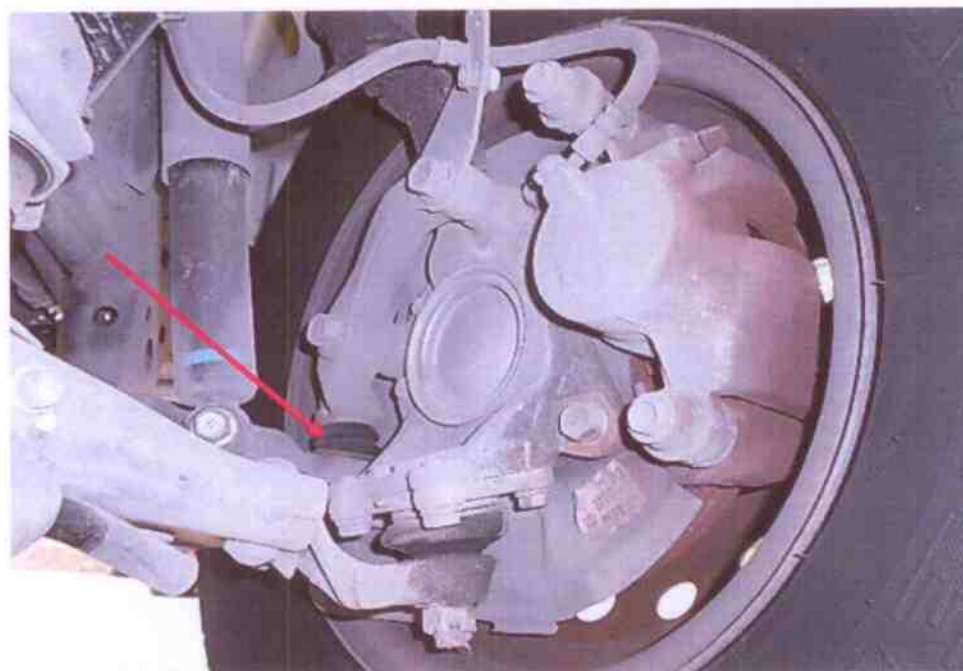
Photo 19 shows the various undercarriage components at the front right wheel of the Motor Lorry, in particular the steering tie rod end (arrowed). The various steering components were all found to be intact, suggesting that the steering system of the Motor Lorry was likely to be in serviceable condition at the material time of accident. There was also no sign of fluid stain(s) observed on the various undercarriage components.

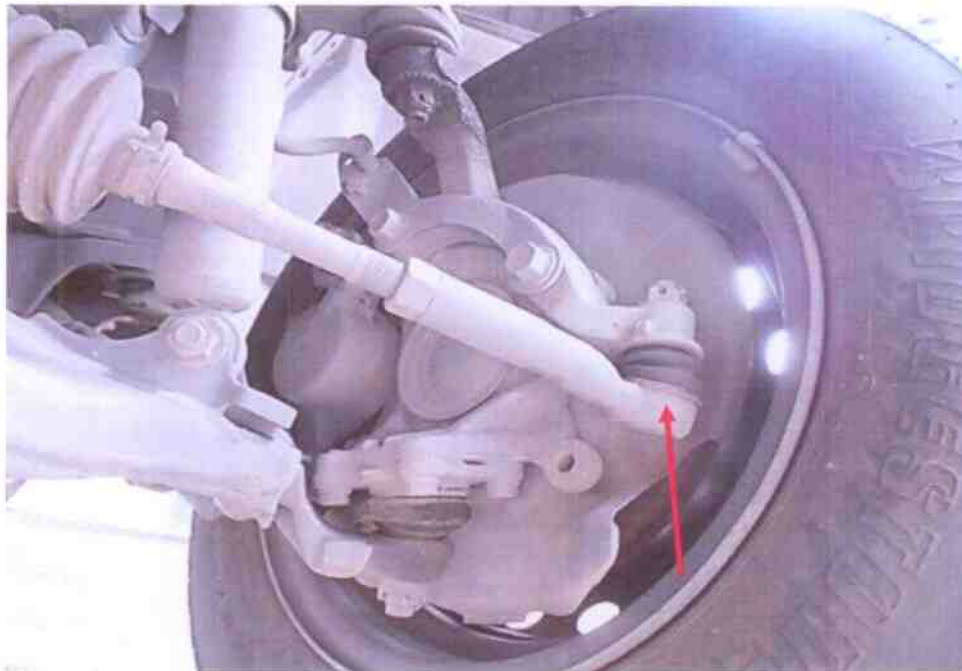
Photo 20 shows the various undercarriage components at the front left wheel of the Motor Lorry, in particular the steering tie rod end (arrowed). The various undercarriage components of the Motor Lorry were all found to be intact without any visible damage. There was also no sign of fluid stain(s) observed on the various undercarriage components.
