Your Ref: TP/IP/45529/2017  
Our Ref : CI/TPD17021579/Zn

**Fatal Accident Investigation Team**

**MECHANICAL INSPECTION REPORT OF MOTOR TAXI SHD 1875U**

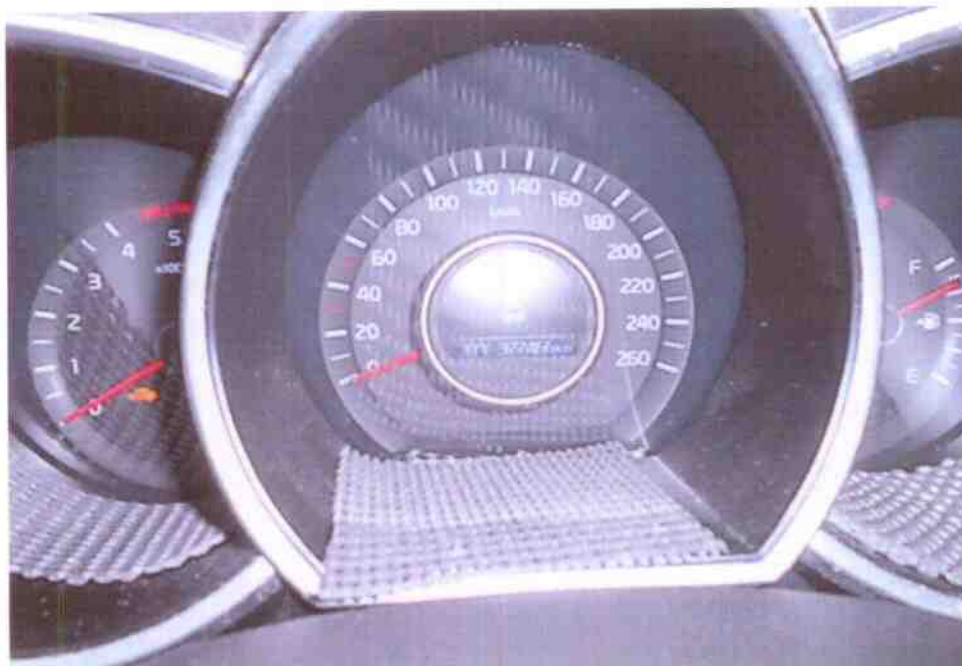
**Photo 1** shows the mileage of the Motor Taxi was 977466 km.

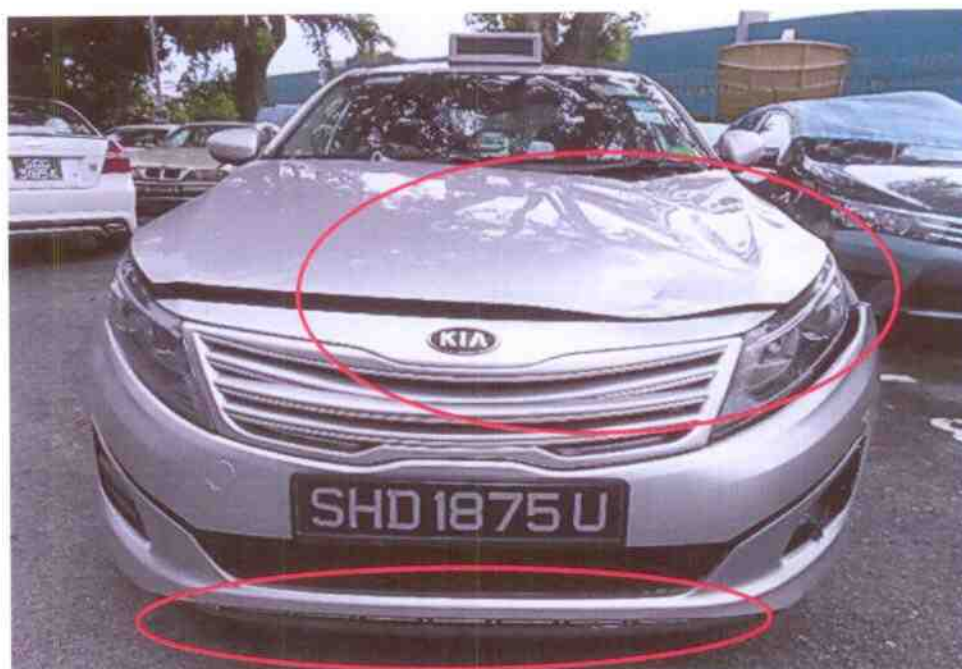
4. The mileage of the Motor Taxi at the time of our inspection was 977,466km.
5. The Motor Taxi had sustained a relatively minor impact damages that was confined to its frontal portion. Its front left bonnet was observed to have minor dent & its lower bumper was observed to have minor cracked & scratches.

**Photo 2** shows a general view of the front body of the Motor Taxi at the time of our inspection. The Motor Taxi was observed to have sustained minor damages at the frontal portion.

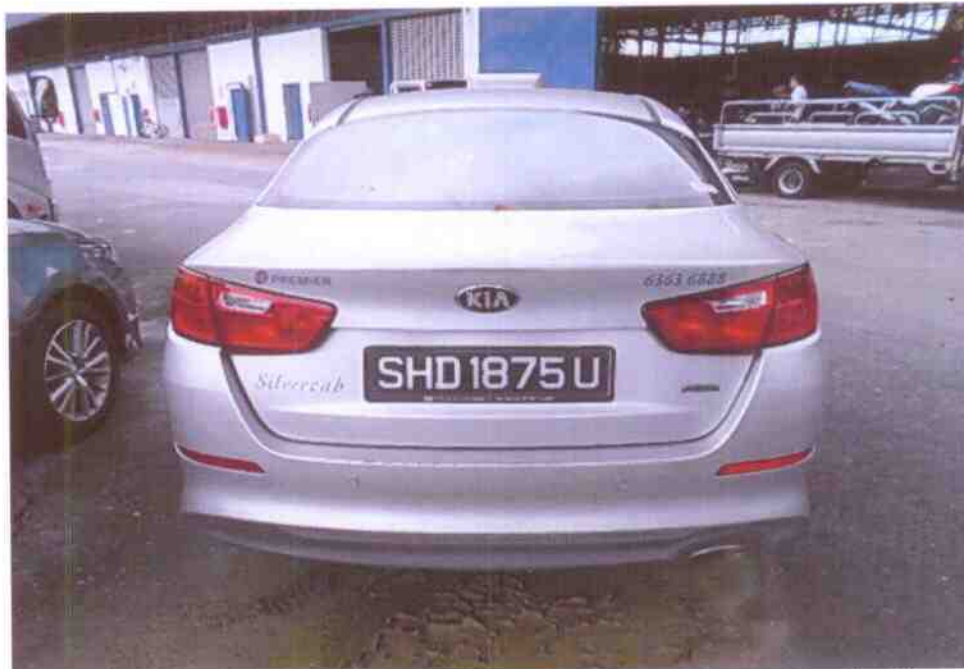
**Photo 3** shows a general view of the rear body of the Motor Taxi at the time of our inspection. The Motor Taxi was observed to be in good general condition.

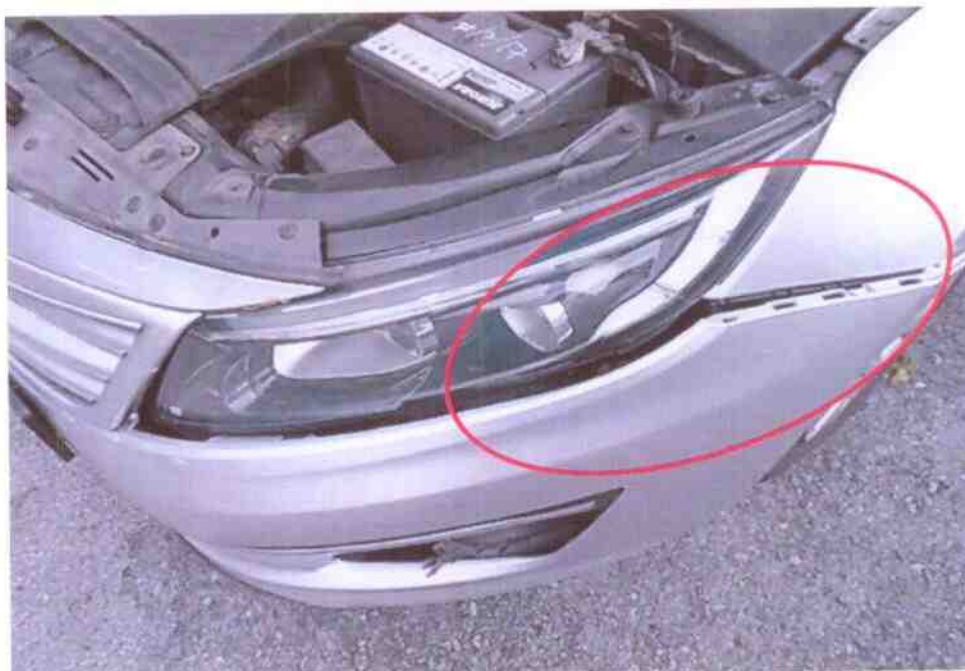
**Photo 4** shows a close up view of the front bonnet of the Motor Taxi at the time of our inspection. The Motor Taxi had sustained relatively minor misalignment at the front bonnet of the Motor Taxi.

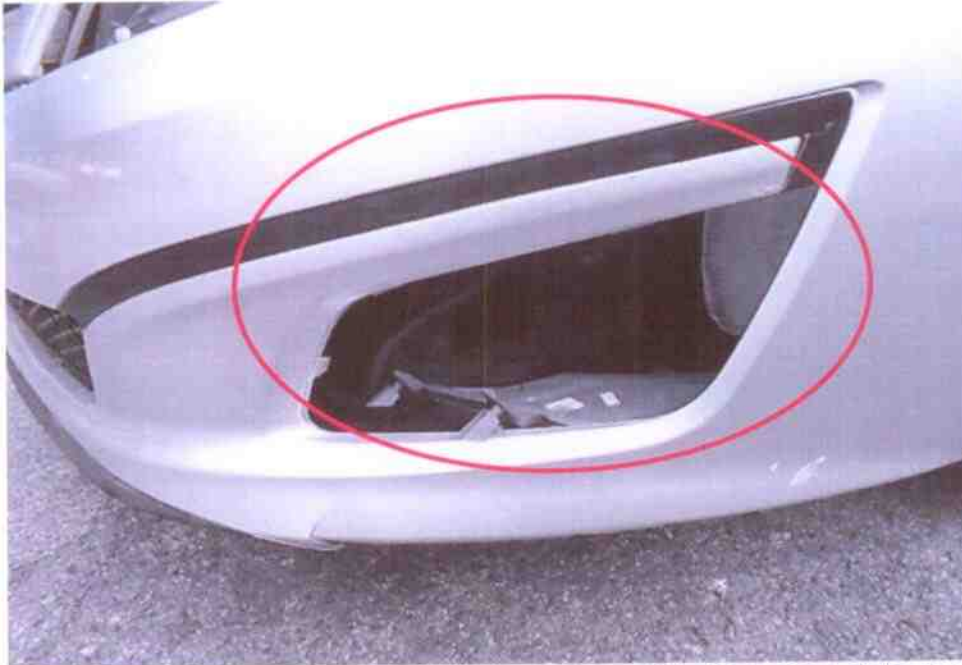
**Photo 5** shows a close up view of the lower bumper of the Motor Taxi at the time of our inspection. The Motor Taxi had sustained relatively minor cracked at the lower bumper of the Motor Taxi.

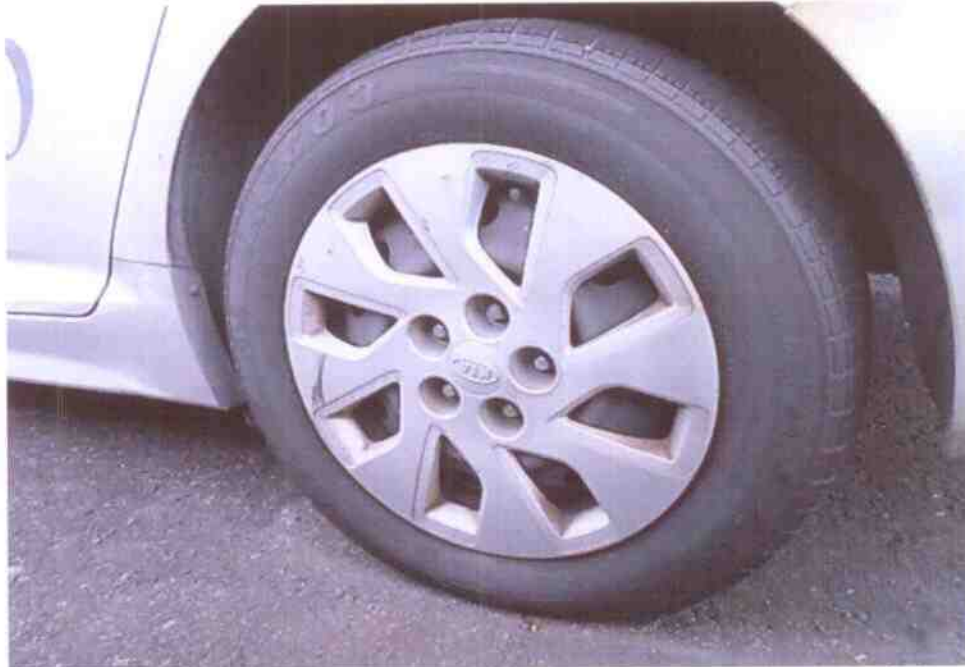
7. The 4 tyres were observed to be wrapped around standard wheel rims with wheel caps fitted on its outer side. Multiple grazed marks that are commonly associated to grazing against a road kerb, were found on all the wheel caps of the Motor Taxi. See photo 6 – 10 below.

**Photo 6** shows the 4 tyres were observed to be wrapped around standard wheel rims with wheel caps fitted on its outer side. Multiple grazed marks that are commonly associated to grazing against a road kerb were found on all the wheel caps of the Motor Taxi.

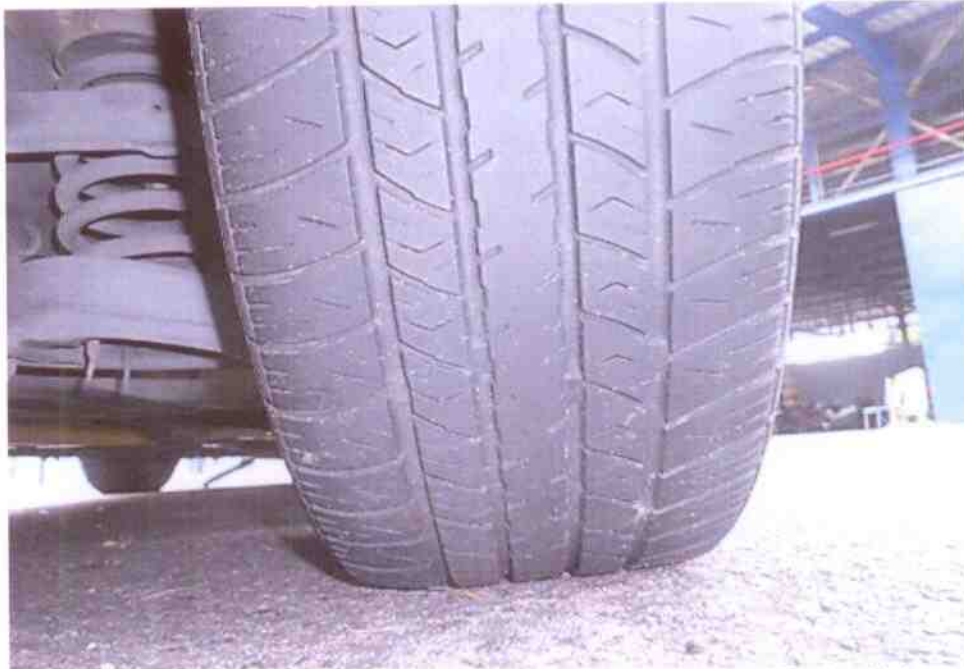
**Photo 7** shows the condition of the rear right tyre of the Motor Taxi, which was observed to be in serviceable condition with remaining tread depth of approximately 4mm.

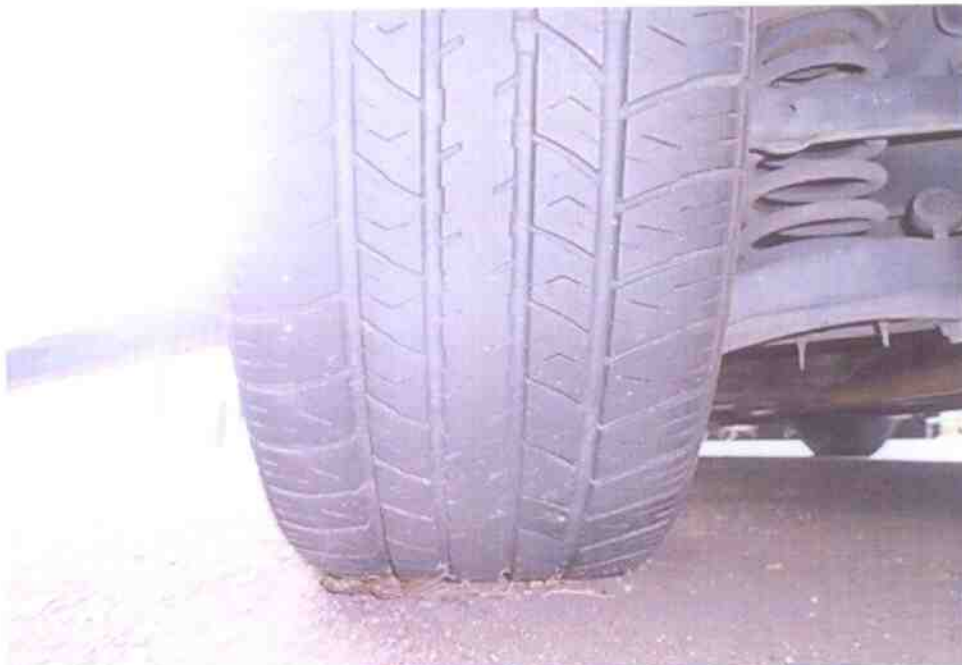
**Photo 8** shows the condition of the rear left tyre of the Motor Taxi, which was observed to be in serviceable condition with tread depth of approximately 4mm.

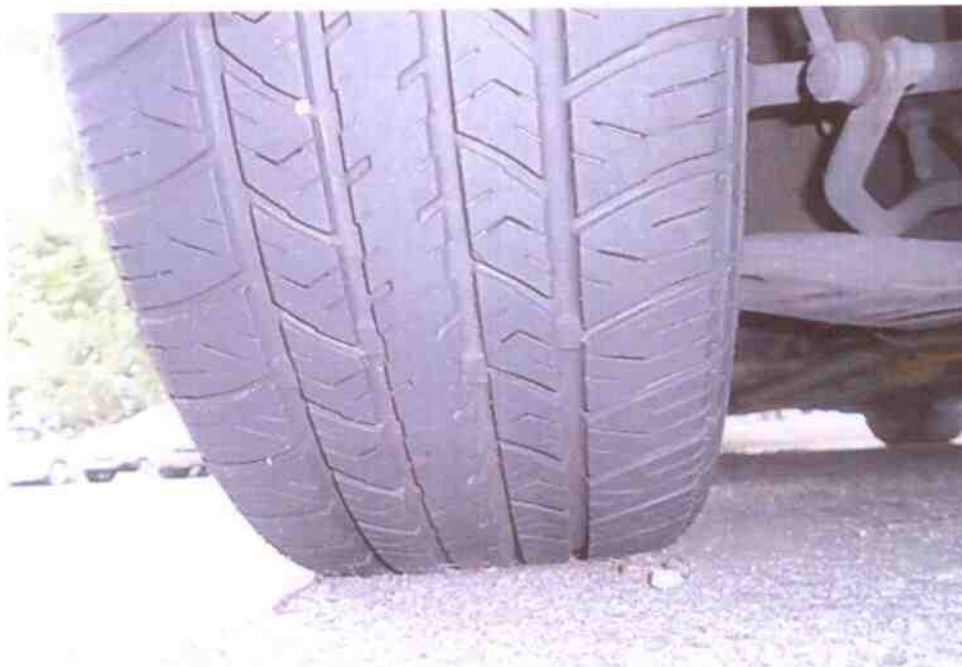
**Photo 9** shows the condition of the front right tyre of the Motor Taxi, which was observed to be in serviceable condition with remaining tread depth of approximately 5mm.

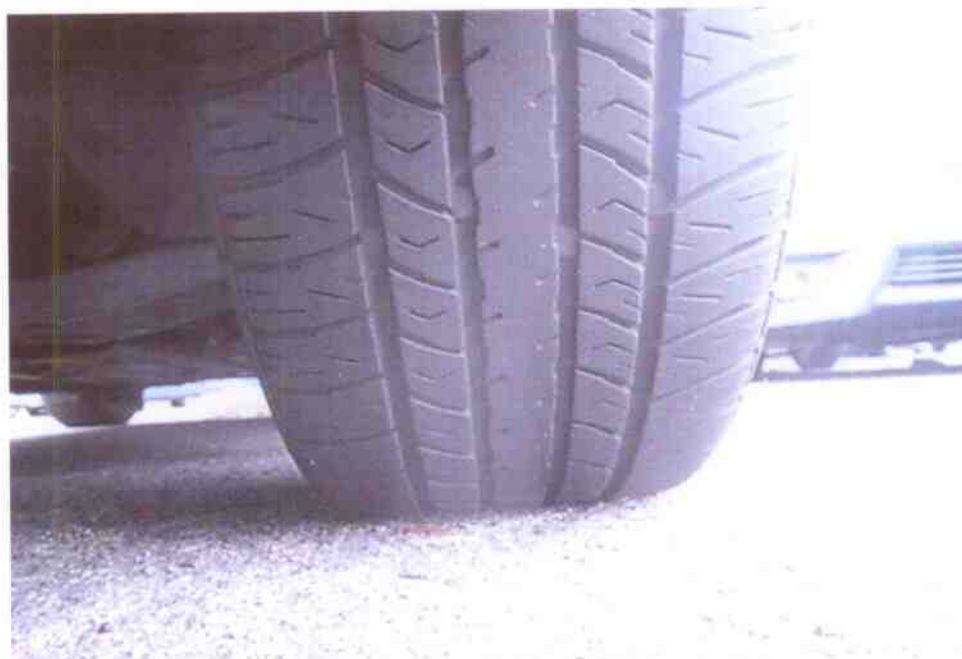
**Photo 10** shows the condition of the front left tyre of the Motor Taxi, which was observed to be in serviceable condition with remaining tread depth of approximately 4mm.

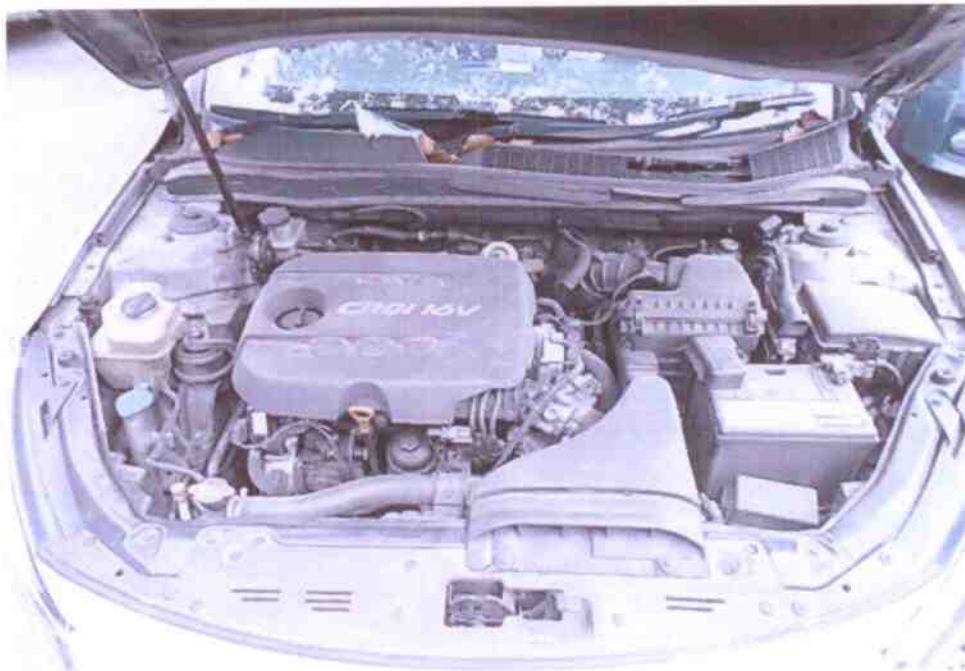
**Photo 11** shows a general view of the Motor Taxi's engine compartment. The various parts and components inside the engine compartment were unaffected by the accident. There was also no sign(s) or indication(s) of fluid leakage and/or fluid stain within the engine compartment.

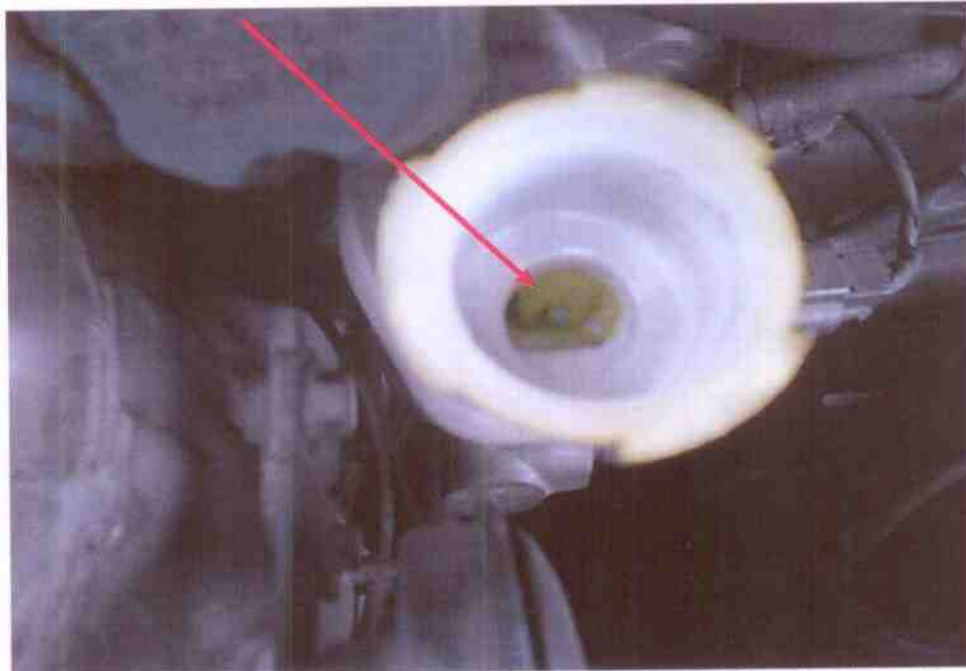
**Photo 12** shows the brake fluid reservoir of the Motor Taxi at the time of our inspection. The brake fluid was observed to be of sufficient level (arrowed) and without any visible contamination.

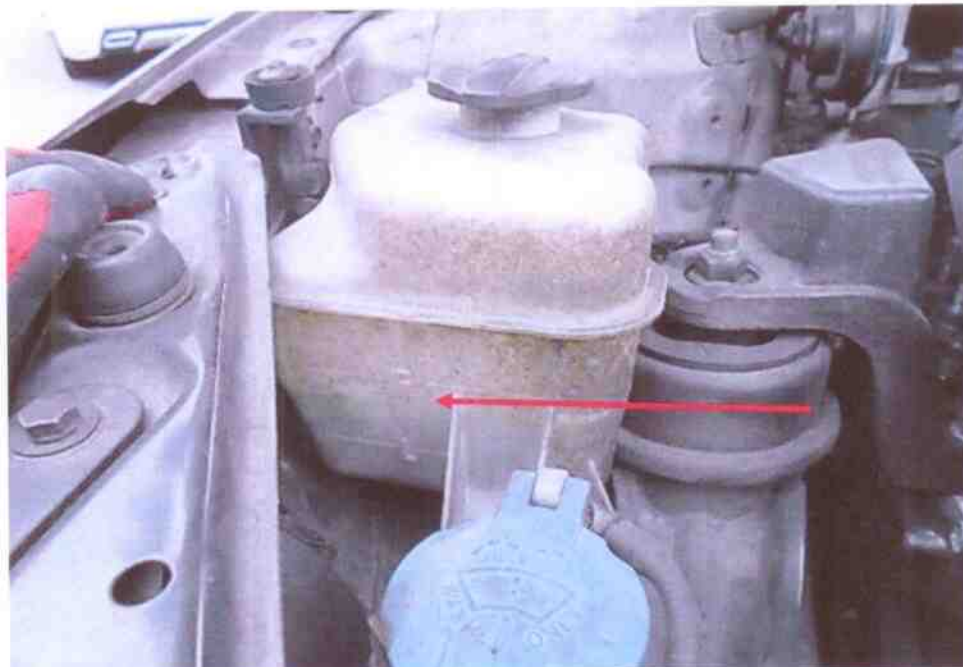
**Photo 13** shows the coolant fluid reservoir of the Motor Taxi at the time of our inspection. The coolant fluid was observed to be of sufficient level and without any visible contamination.

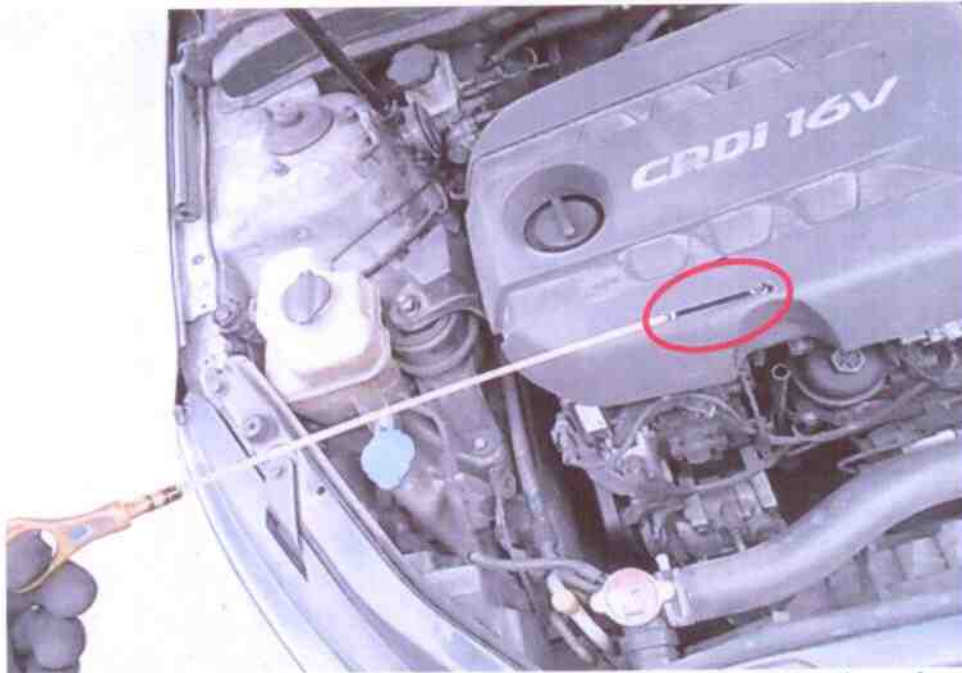
**Photo 14** shows the engine oil dip stick of the Motor Taxi at the time of our inspection. The engine oil was observed to be of sufficient level and without any visible contamination.

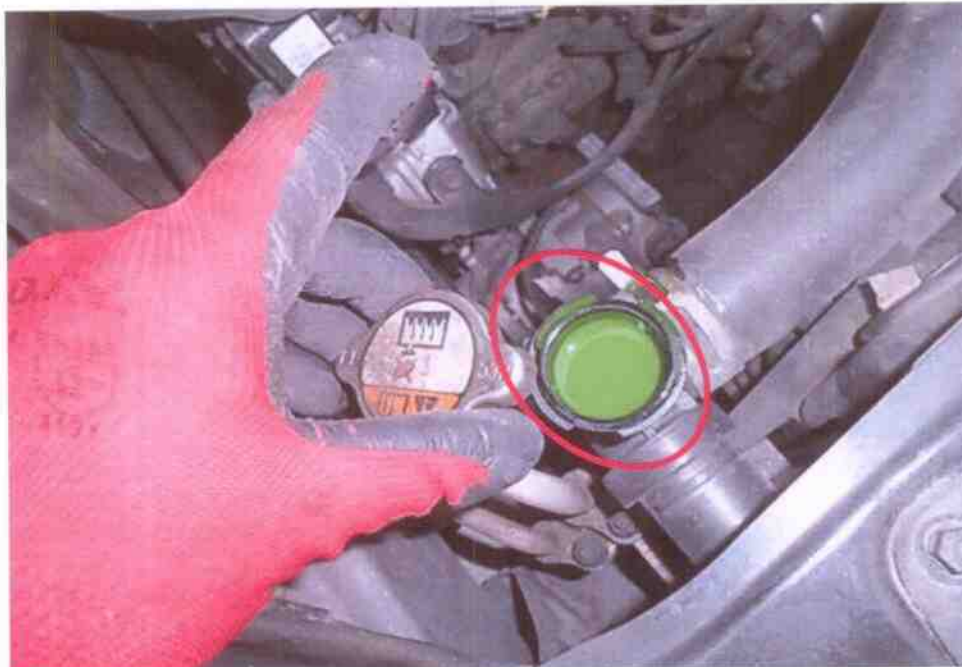
**Photo 15** shows the coolant fluid at radiator tank of the Motor Taxi at the time of our inspection. The coolant fluid was observed to be of sufficient level and without any visible contamination.

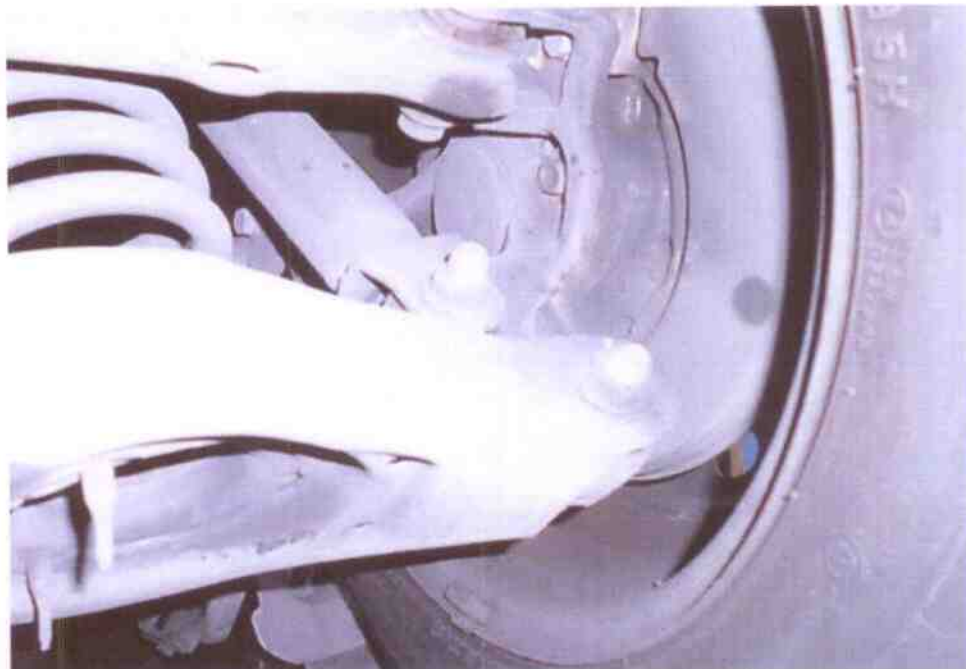
**Photo 16** shows the rear left wheel of the Motor Taxi. We did not observe any leakage of brake fluid at the time of our inspection of the Motor Taxi.

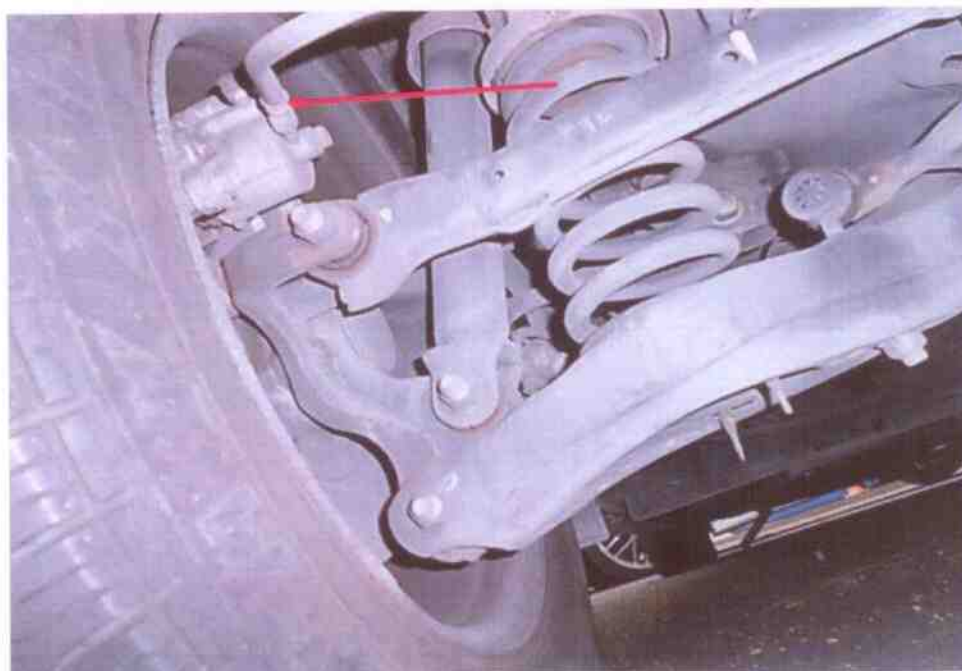
**Photo 17** shows the brake hose (arrowed) at the rear right wheel of the Motor Taxi. We did not observe any leakage of brake fluid at the time of our inspection of the Motor Taxi. Our visual inspection of the various mechanical components of the Motor Taxi's braking system, including its brake calliper, revealed all to be intact and without visible damage, indicating that the braking system was likely to be in serviceable condition at the material time of accident.

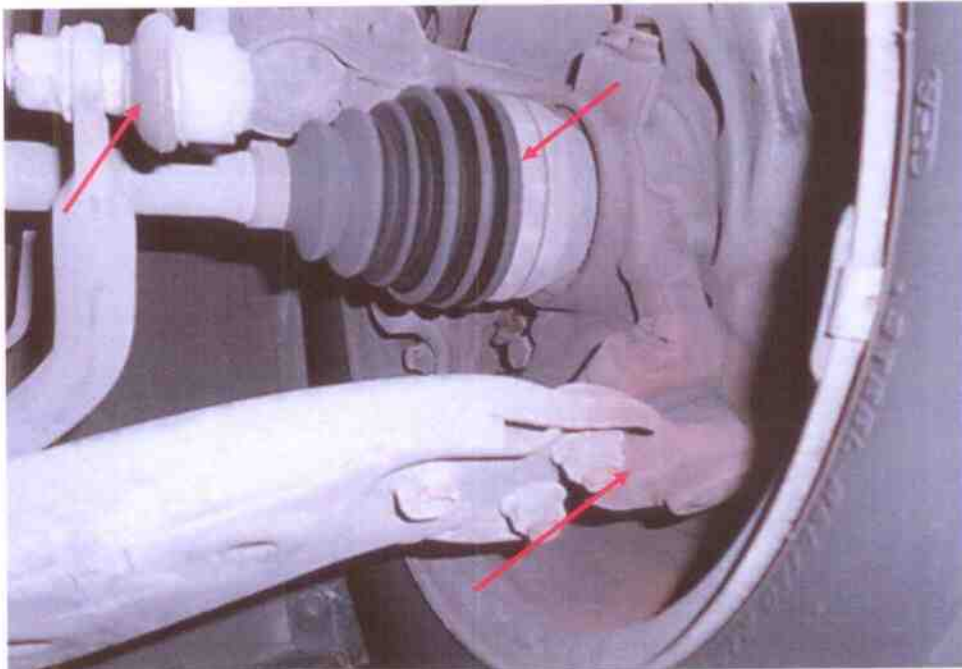
**Photo 18** shows the various undercarriage components at the front left wheel of the Motor Taxi, in particular the steering tie rod. The various steering components were all found to be intact, suggesting that the steering system of the Motor Taxi was likely to be in serviceable condition. (arrowed)

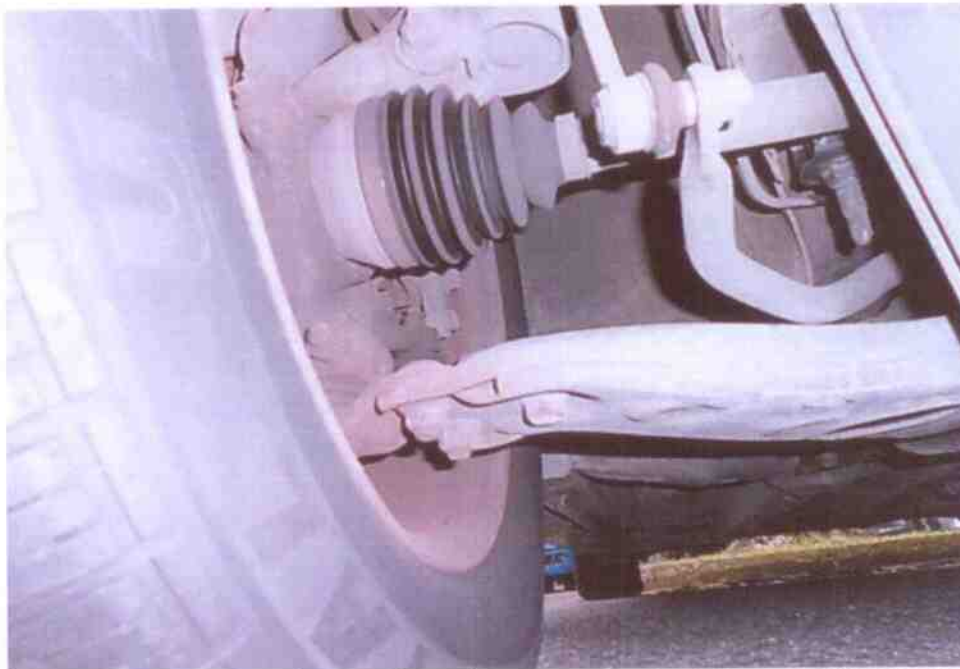
**Photo 19** shows the various undercarriage components at the rear right wheel of the Motor Taxi. We did not observe any leakage of brake fluid at the time of our inspection of the Motor Taxi. Our visual inspection of the various mechanical components of the Motor Taxi's braking system revealed all to be intact and without visible damage, indicating that the braking system was likely to be in serviceable condition at the material time of accident.

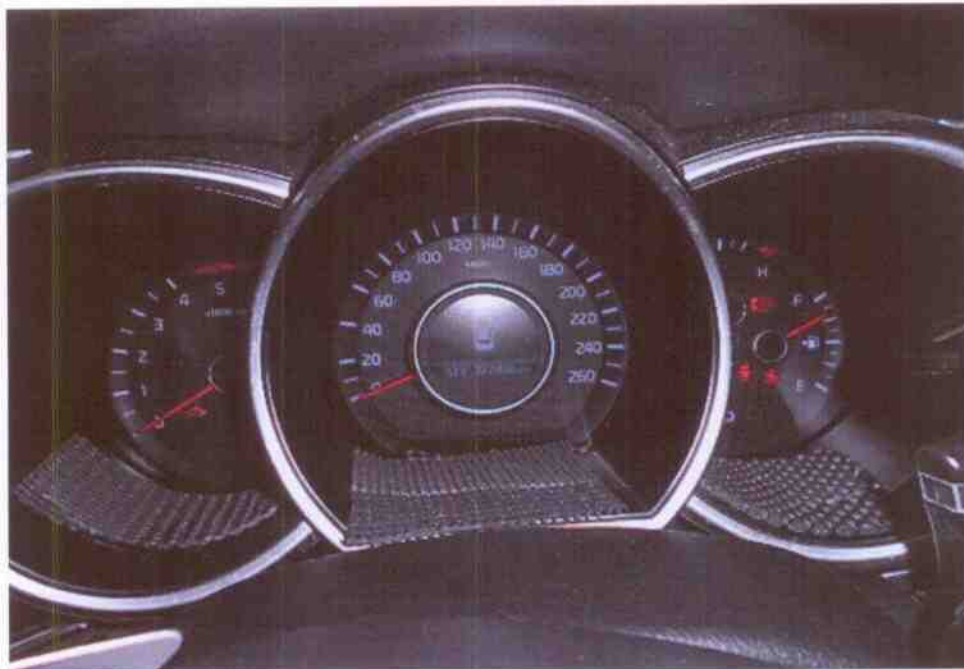
14. The Motor Taxi's automatic self-test of the functionality of its various operating systems like the Anti-Brake Lock System (ABS) and Supplemental Restraint System (SRS) during cranking of the engine was not able to be initiated as the engine of the Motor Taxi could not be started due to a flat battery. See photo 20 below.

Photo 20 shows the warning lights for the various electronic operating systems of the Motor Taxi appearing on its instrument panel during the ignition start, in particular the ABS light and SRS light. Despite the engine was unable to be started at time of inspection.
