Your Ref: TP/IP/51283/2017
Our Ref : CI/TPD17021582/Z

Fatal Accident Investigation Team

MECHANICAL INSPECTION REPORT OF MOTOR CAR SGY 7268J

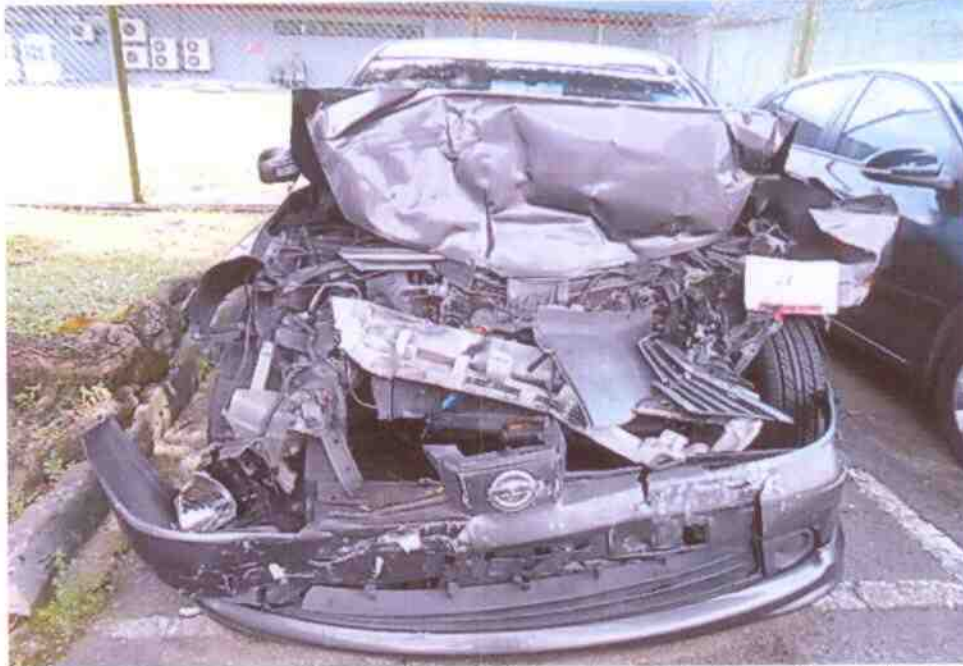
Photo 1 shows a general view of the frontal portion of the Motor Car at the time of our inspection. The Motor Car was observed to have sustained extensive impact damage at its frontal portion. The impact force was significant, causing the various parts and components inside the engine compartment to be damaged.

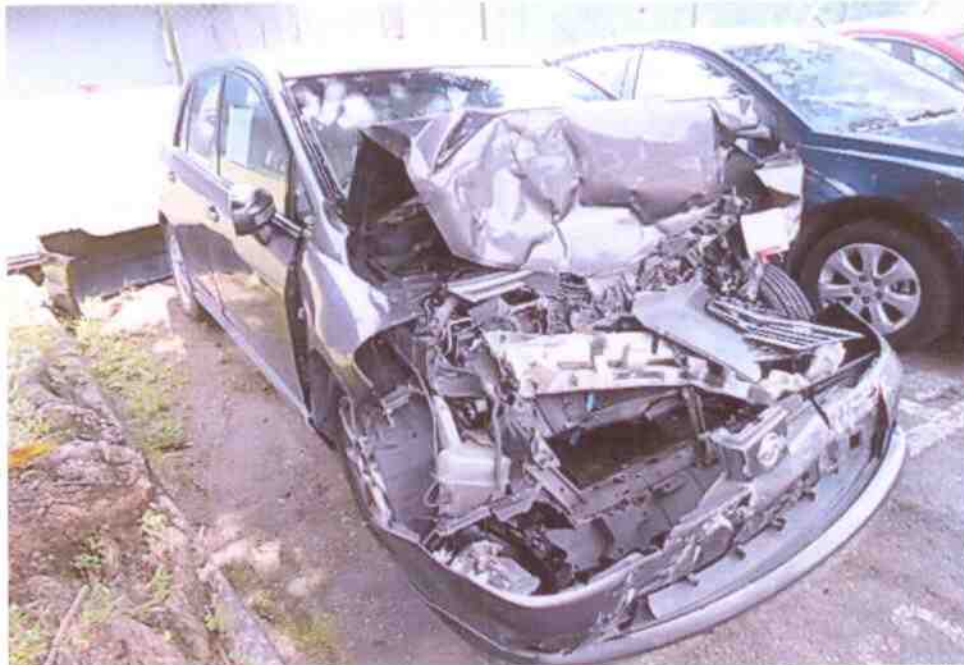
Photo 2 shows a general view of the front right portion of the Motor Car at the time of our inspection. The Motor Car was observed to have sustained extensive impact damage at its frontal portion.

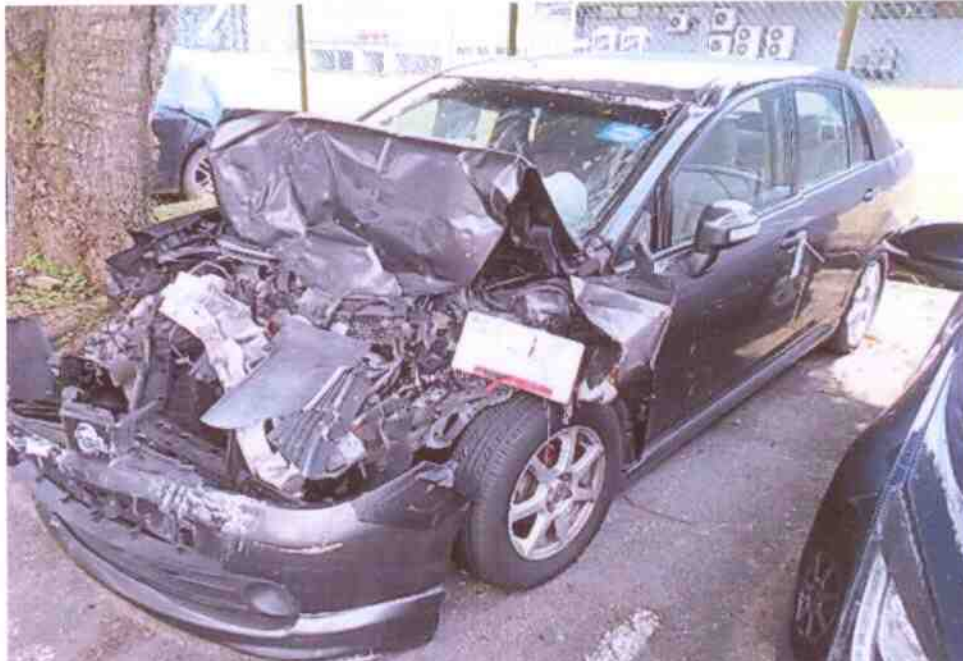
Photo 3 shows a general view of the front left portion of the Motor Car at the time of our inspection. The Motor Car was observed to have sustained with extensive impact damage at its frontal portion.

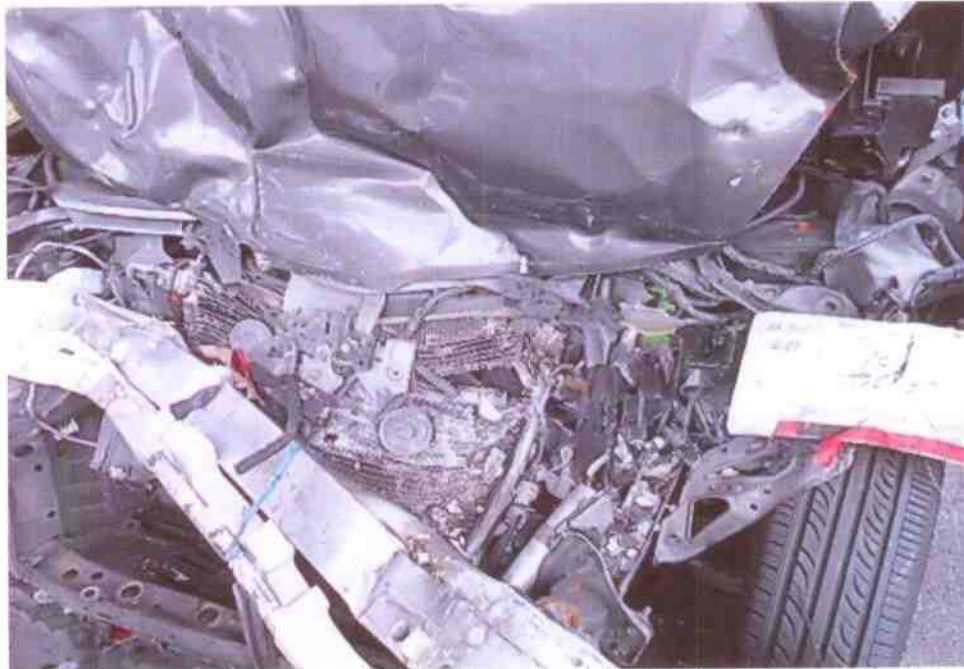
Photo 4 shows a closer view of the damage at the frontal portion of the Motor Car's engine. The impact force was significant, causing the various parts and components inside the engine compartment to be pushed inwards, towards the rear of the Motor Car.

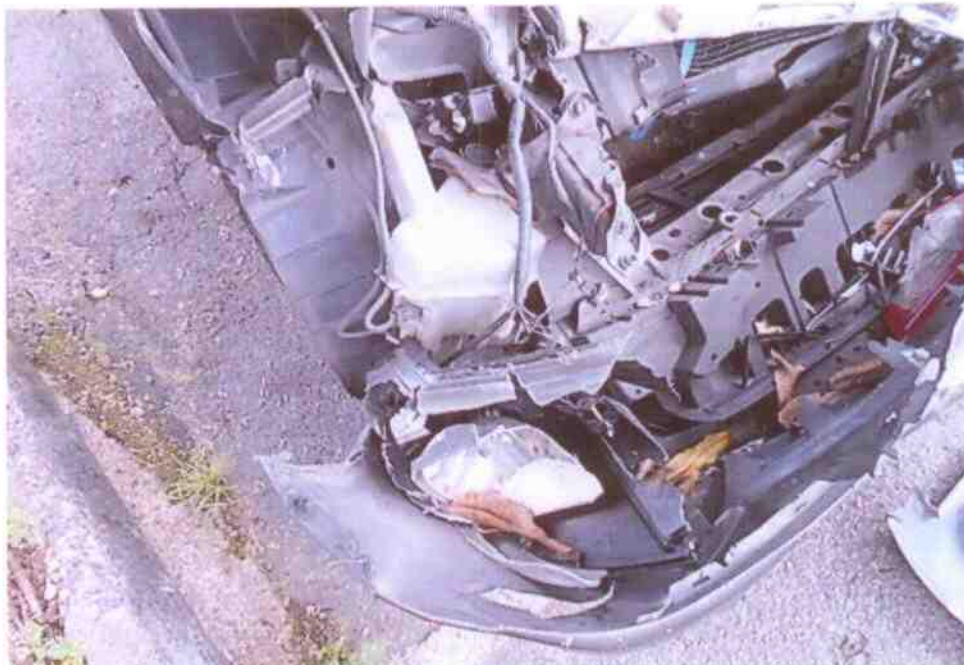
Photo 5 shows a closer view of the damage at the frontal right portion of the Motor Car. The impact force was significant, causing the various parts and components inside the engine compartment to be pushed inwards, towards the rear of the Motor Car.

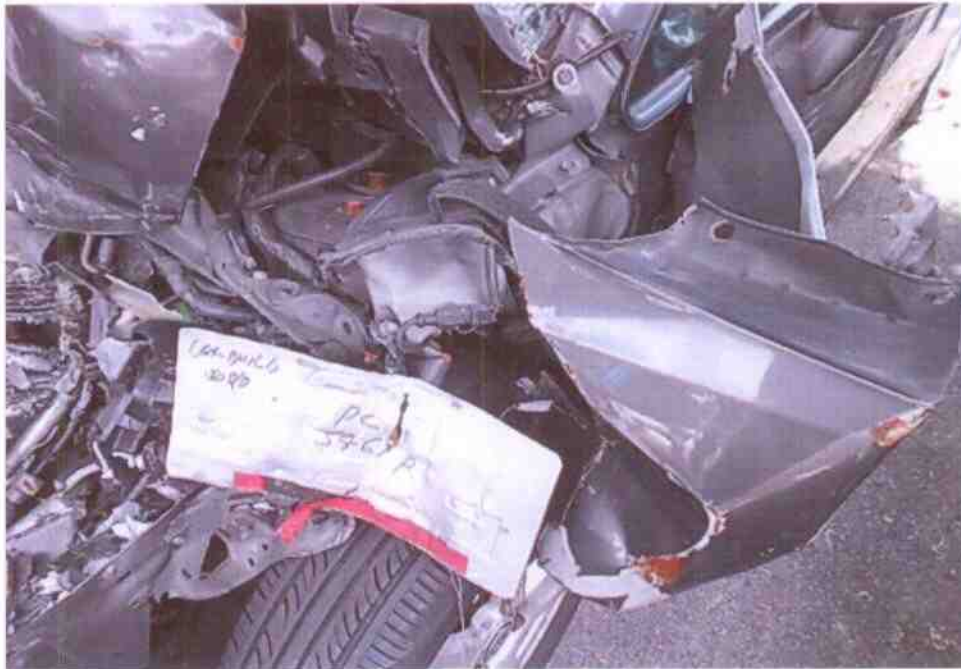
Photo 6 shows a closer view of the damage at the frontal left portion of the Motor Car. The impact force was significant, causing the various parts and components inside the engine compartment to be pushed inwards, towards the rear of the Motor Car.

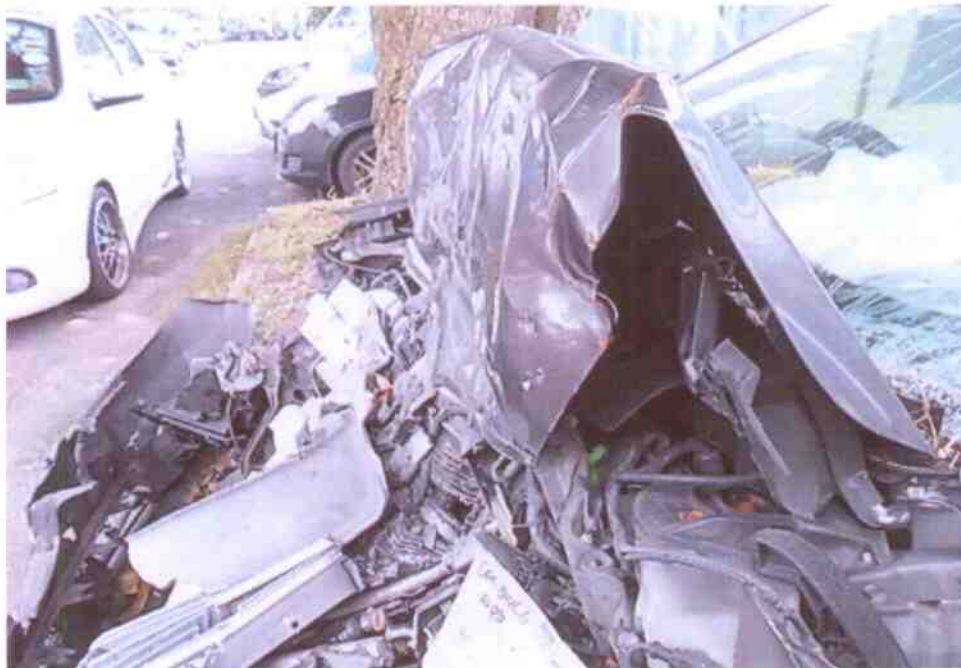
Photo 7 shows a closer view of the damage at the frontal portion of the Motor Car. The impact force was significant, causing the various parts and components inside the engine compartment to be pushed inwards, towards the rear of the Motor Car.

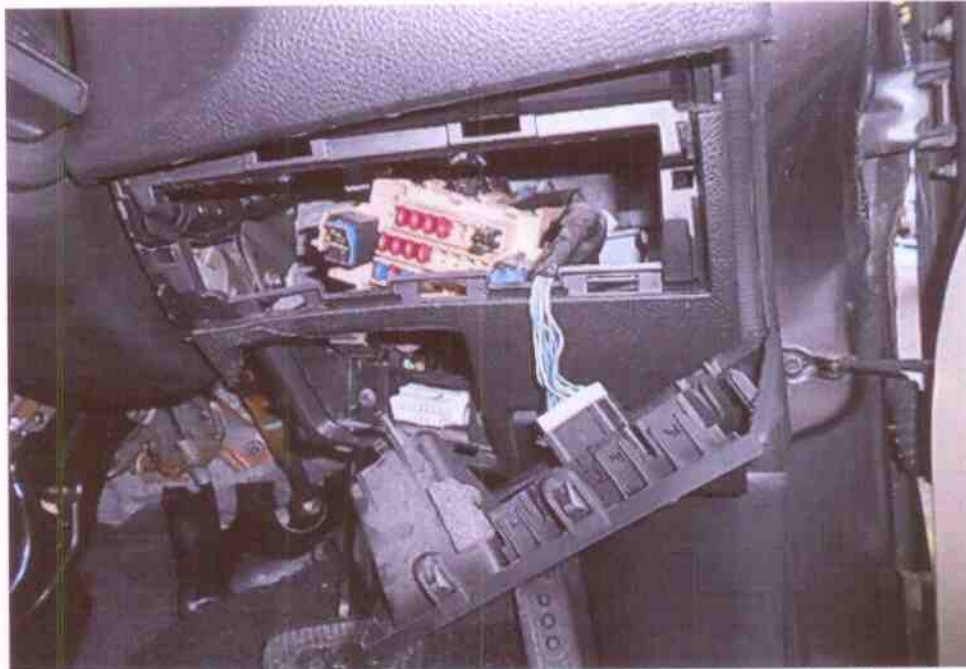
Photo 8 shows a closer view of the damage at the driver's seat of the Motor Car. The impact force was significant, causing the various parts and components inside the interior compartment to be pushed inwards, including its ignition system.

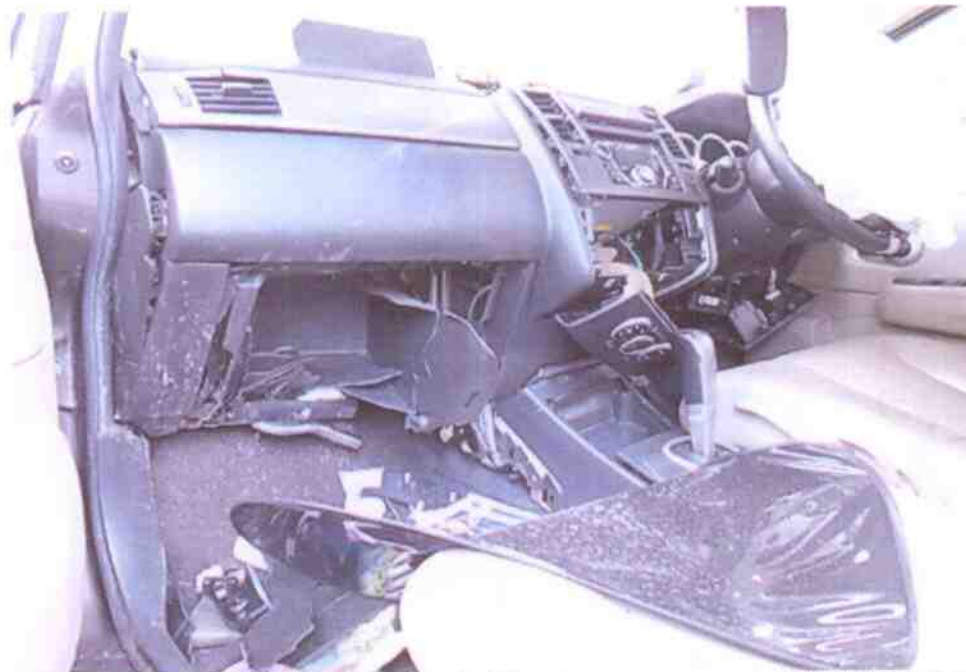
Photo 9 shows a closer view of the left front passenger seat of the Motor Car. The impact force was significant, causing the various parts and components inside the engine compartment to be pushed inwards, towards the rear of the Motor Car.

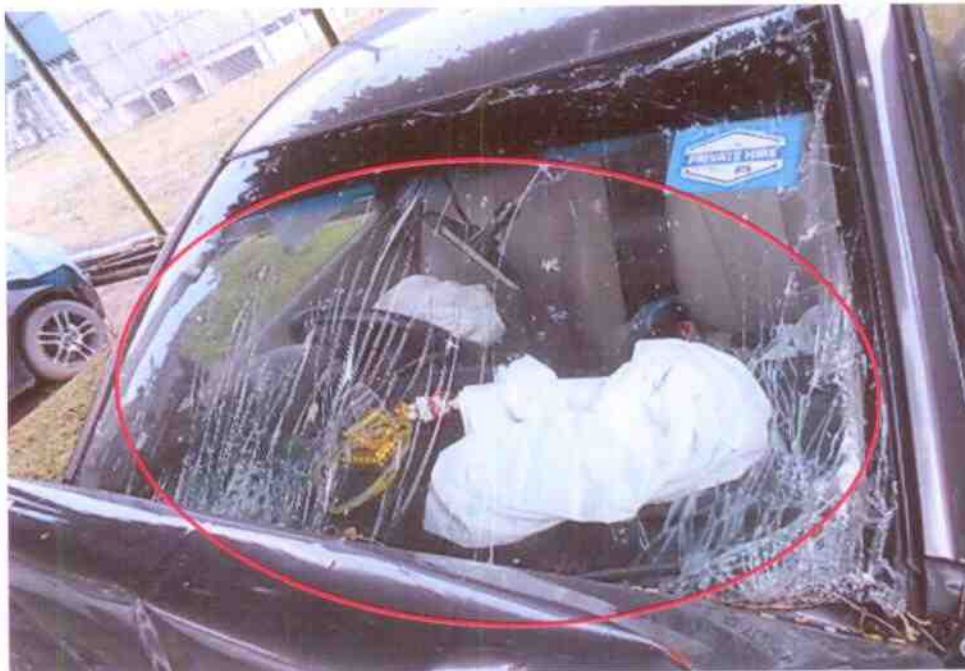
Photo 10 shows a closer view of the damage at the windscreen area of the Motor Car. The impact force was significant, causing the windscreen to sustain a shattering cracked.

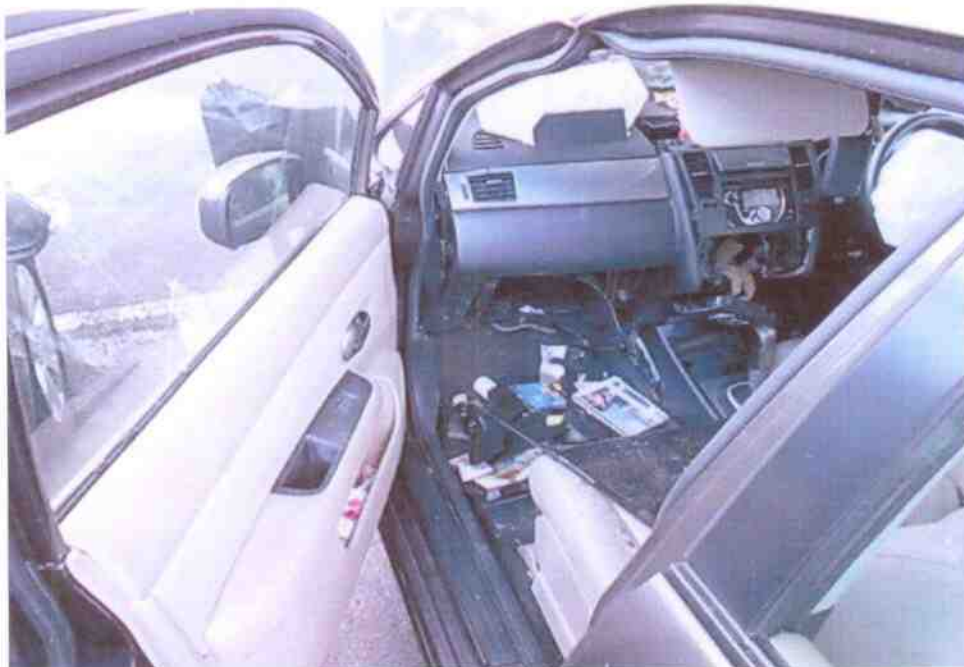
Photo 11 shows a closer view of the damage at the interior portion of the Motor Car. The driver & front passenger's airbag was noted to be activated due to the extensive impact collision at time of the accident.

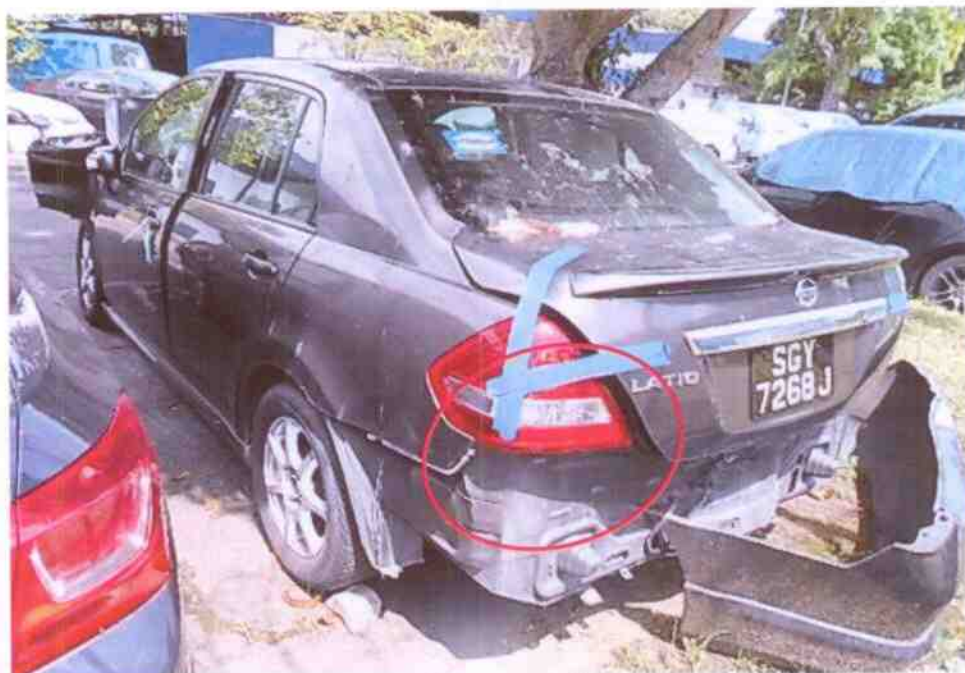
Photo 12 shows a general view of the rear left portion of the Motor Car at the time of our inspection. The rear portion was observed to be relatively sustained with minor impact by the accident that caused the rear bumper to be dislodged.

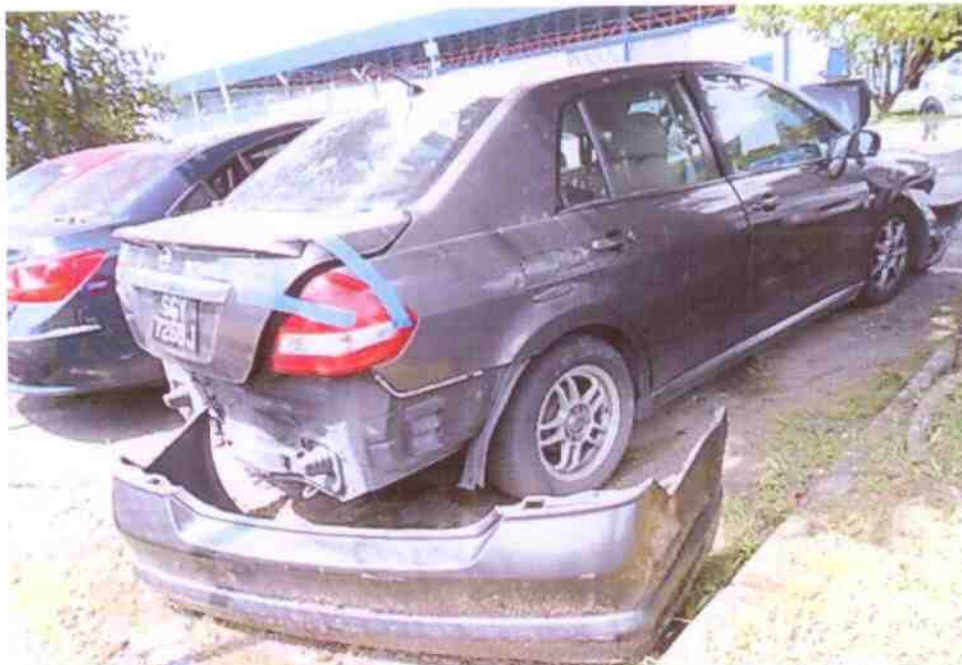
Photo 13 shows a general view of the rear right portion of the Motor Car at the time of our inspection. The rear portion was observed to be relatively sustained with minor damages.

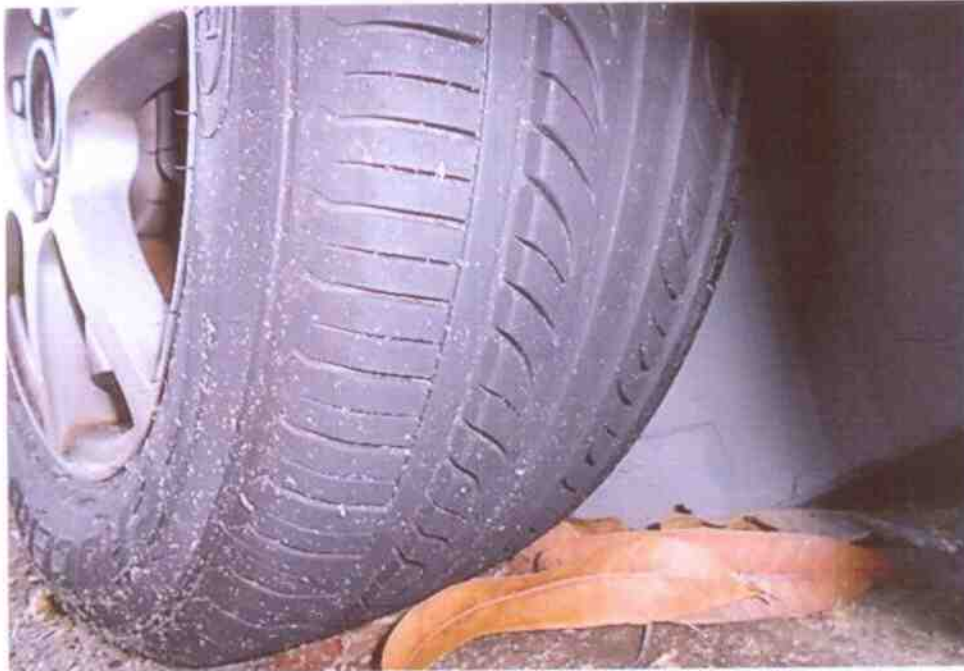
8. The 4 tyres were observed to be wrapped around alloy wheel rims that were found to be without any significant damage except for some marks of grazing nature on the outer spokes of the wheel rims, which are commonly associated to grazing against a road kerb. See photo 14 – 17 below.

Photo 14 shows the condition of the front right tyre of the Motor Car, which was observed to be in serviceable condition. The 4 tyres were also observed to be sufficiently inflated for vehicular operation.

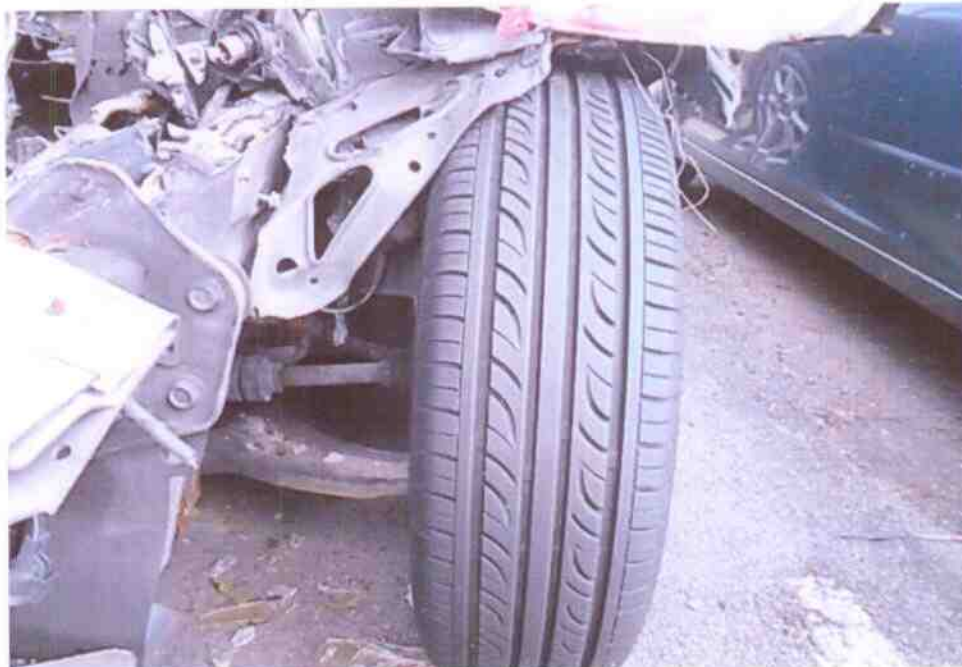
Photo 15 shows the condition of the front left tyre of the Motor Car, which was observed to be in serviceable condition. The 4 tyres were also observed to be sufficiently inflated for vehicular operation.

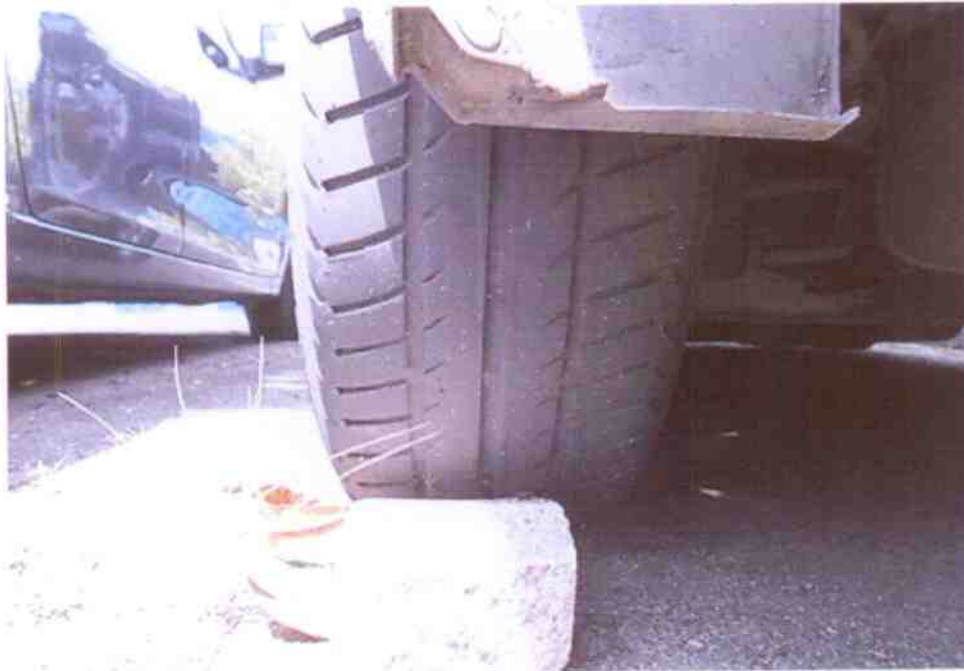
Photo 16 shows the condition of the rear left tyre of the Motor Car, which was observed to be in serviceable condition. The 4 tyres were also observed to be sufficiently inflated for vehicular operation.

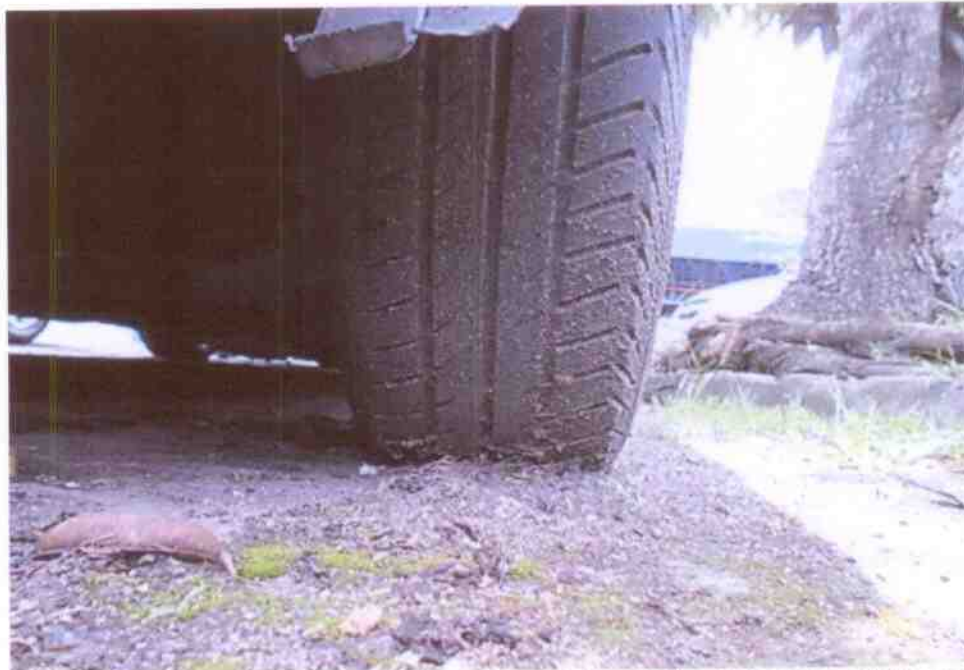
Photo 17 shows the condition of the rear right tyre of the Motor Car, which was observed to be in serviceable condition. The 4 tyres were also observed to be sufficiently inflated for vehicular operation.

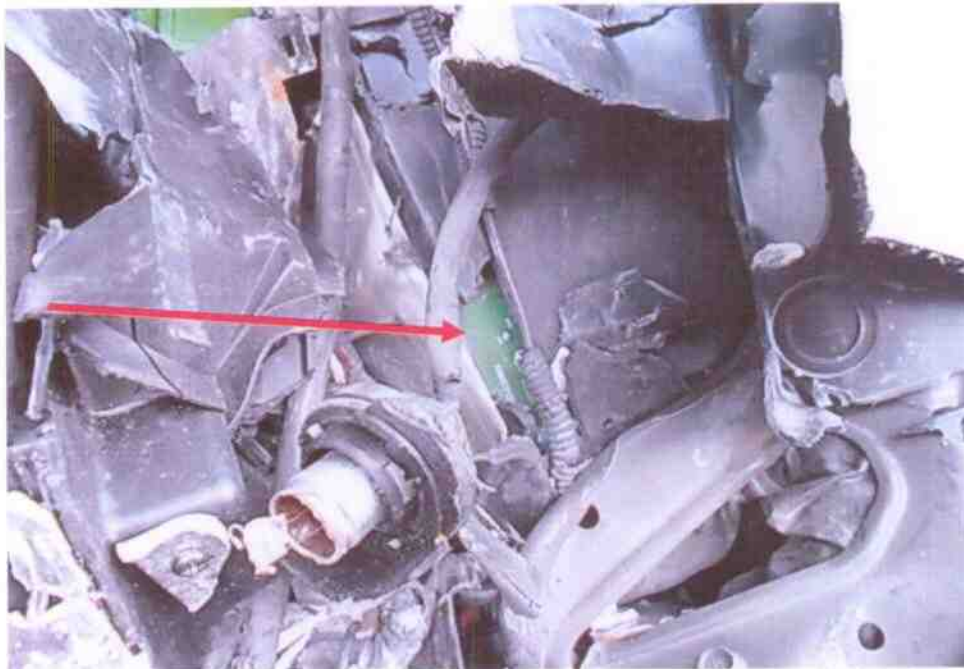
9. The engine compartment of the Motor Car was severely affected by the collision. Almost all the parts and components inside the engine compartment were badly damaged. Parts like the radiator, air intake system, fuel rails, exhaust manifold, fuse box and control modules amongst others were found to be damaged.

Photo 18 shows the close up view of the damaged electronics modules due to the accident impact.

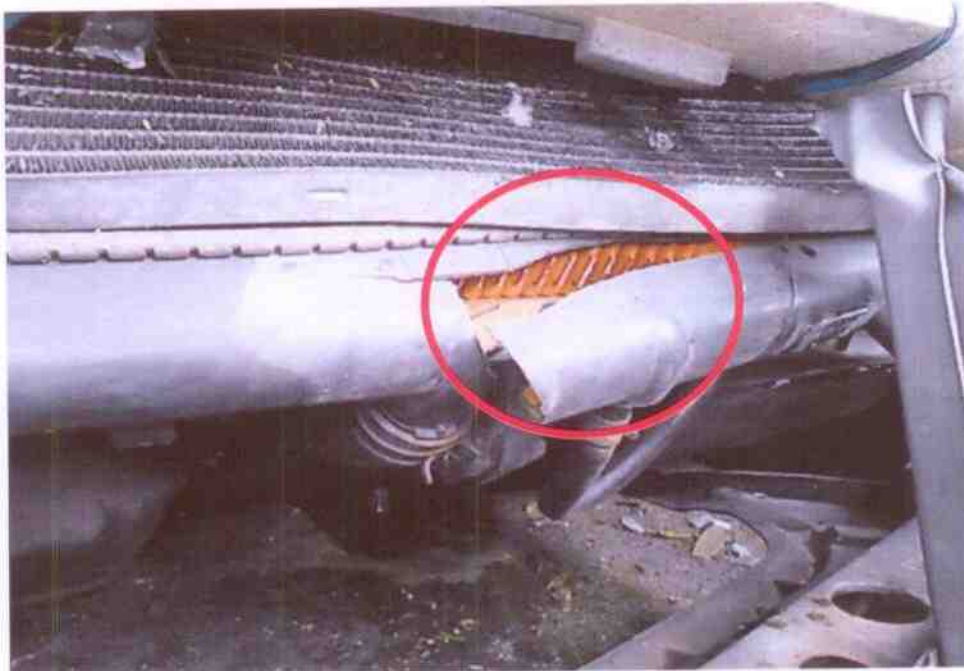
Photo 19 shows the close up view of the radiator's tank that was observed to be damaged likely due to the accident impact.

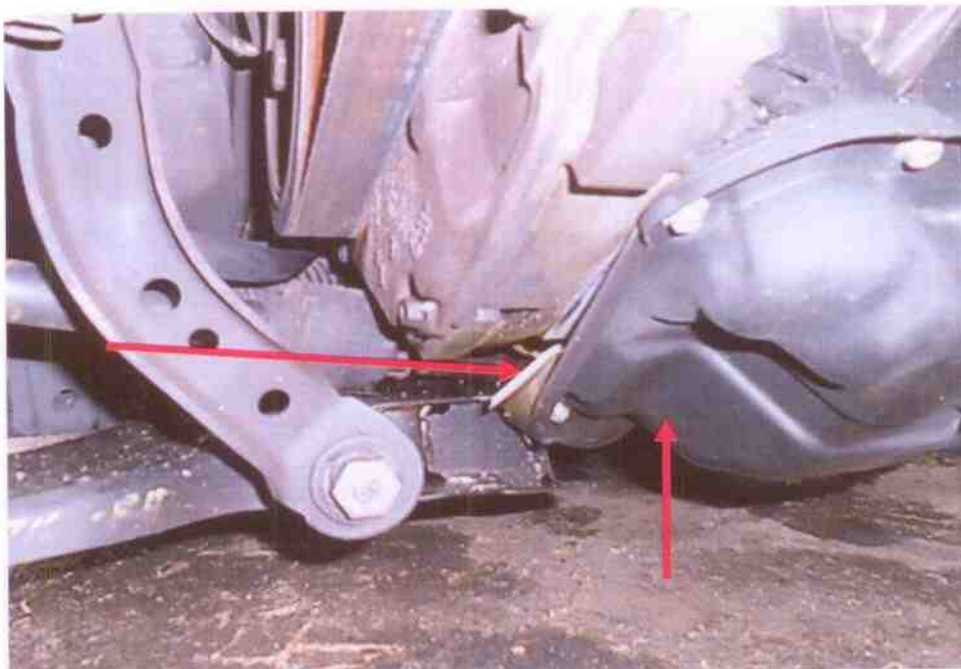
10. Leakage of the various operating fluids like the engine oil, engine coolant, power steering fluid and brake fluid was also noted. Given the extent of damages to the engine compartment, the leakages were likely due to the accident. The engine undercarriage was however observed to be covered with fluid, suggesting leakage of fluid. There was no accumulation of dust and/or dirt particles on the engine housing where the fluid stains had formed. This would indicate that the fluid leakage was a fresh leak and likely to be a result of the accident. We were therefore unable to comment whether these operating fluids were of sufficient level and without contamination for vehicular operation prior to the accident.

Photo 20 shows the close up view of the fluid leakage at the undercarriage area likely due to the accident impact.

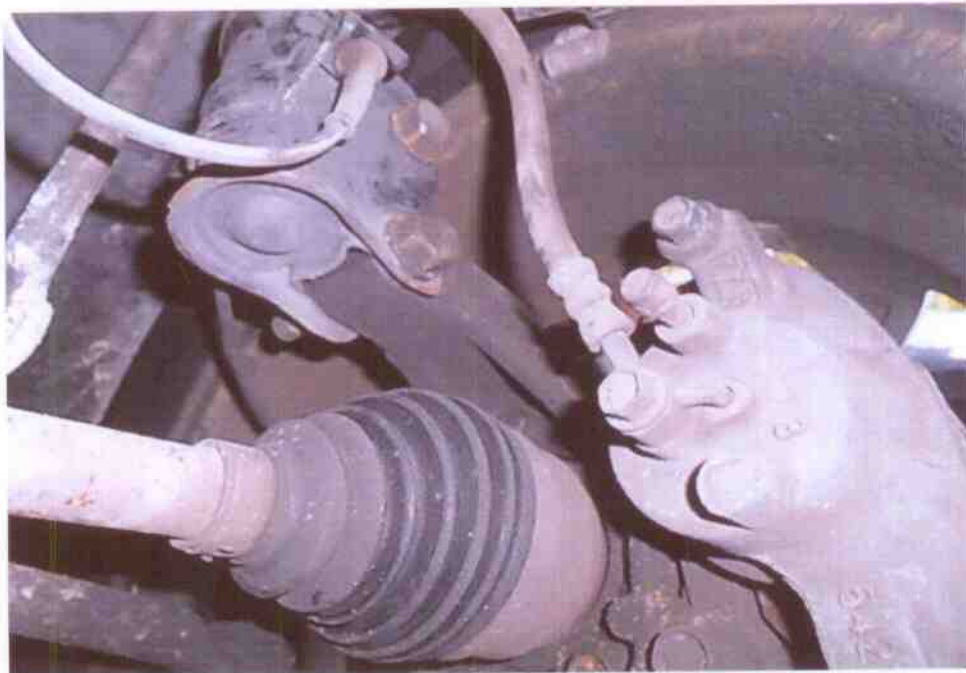
11. We were not able to conduct any tests on the steering system and braking system of the Motor Car. This was due to leakage of power steering fluid and brake fluid, both of which were a result of the accident, as well as damage to several mechanical components of the steering system and braking system. See photo 21 - 26 below.

Photo 21 shows a close up view on the front right drive shaft of the Motor Car. We were not able to conduct any tests on the steering system of the Motor Car due to the damage to this components, as well as leakage of power steering fluid.

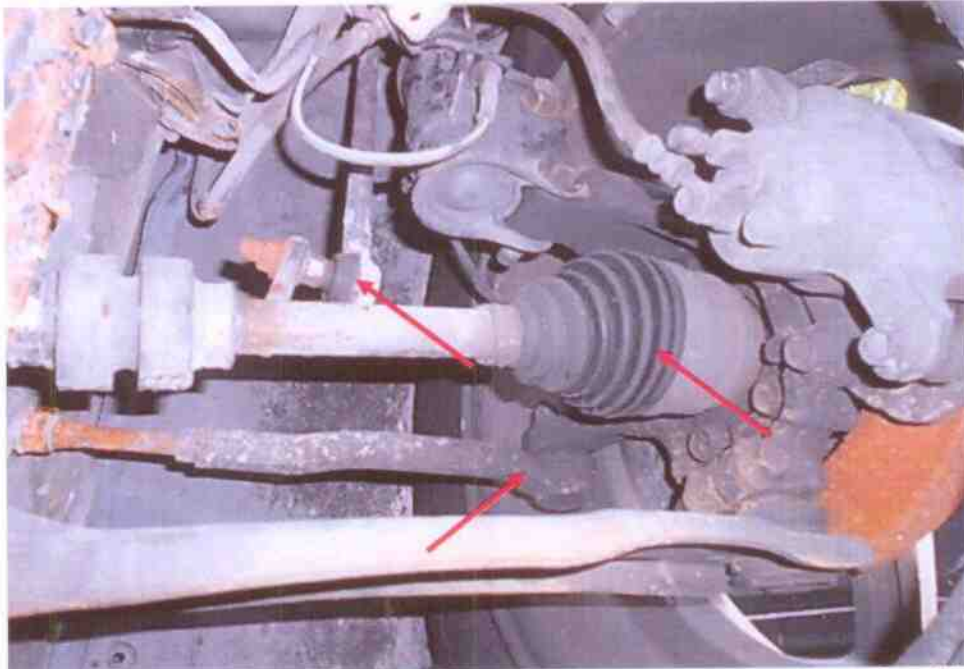
Photo 22 shows the damaged on the front left drive shaft of the Motor Car. We were not able to conduct any tests on the steering system of the Motor Car due to the damage to this components, as well as leakage of fluids.

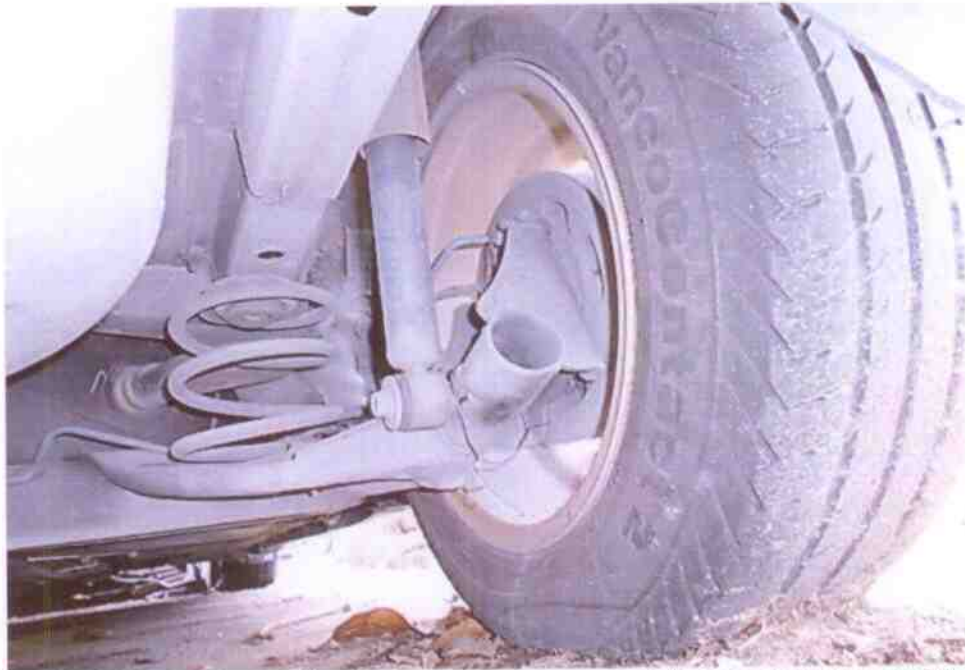
Photo 23 shows the braking & steering components at the rear right wheel of the Motor Car. We did not observe any leakage of brake fluid at the time of our inspection of the Motor Car.

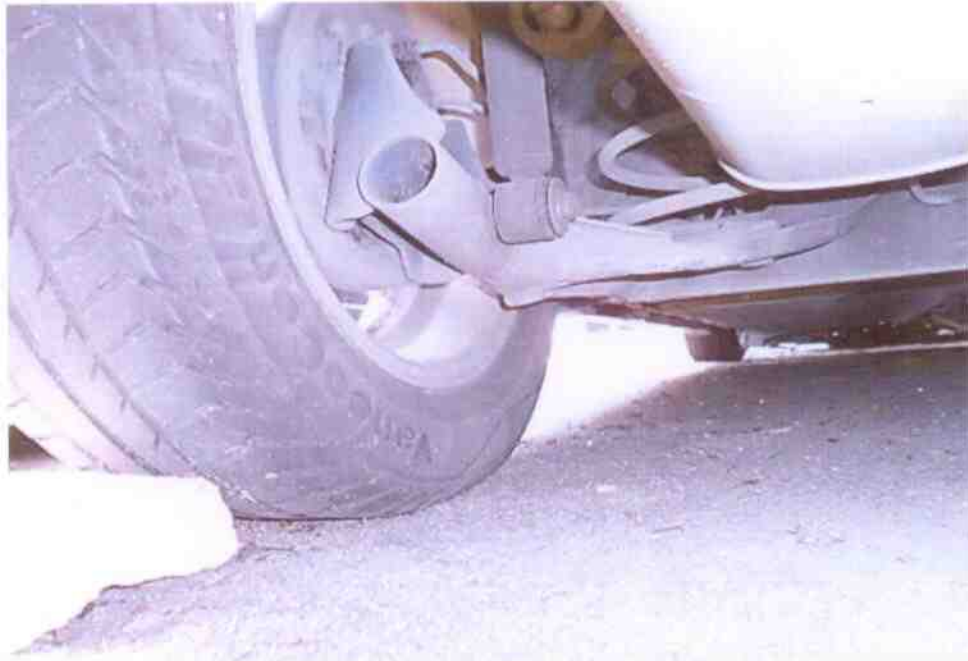
Photo 24 shows the braking & steering components at the left front wheel of the Motor Car. We did not observe any leakage of brake fluid at the time of our inspection of the Motor Car.

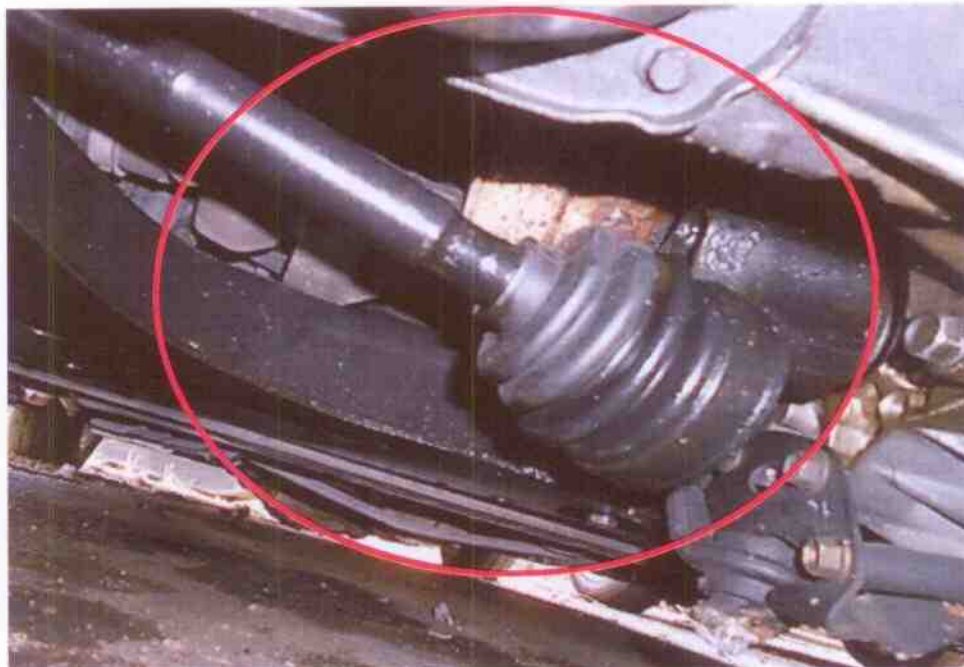
Photo 25 shows the undercarriage components of the Motor Car. We observe signs of fluid leakage at the time of our inspection of the Motor Car.

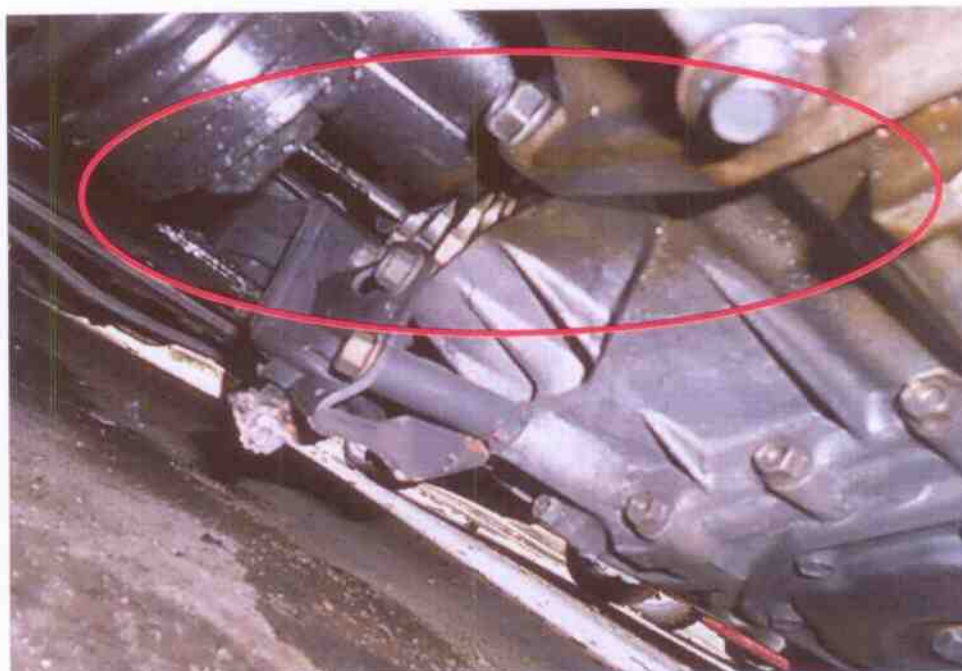
Photo 26 shows close up view of the undercarriage components of the Motor Car. We observe signs of fluid leakage at the time of our inspection of the Motor Car.

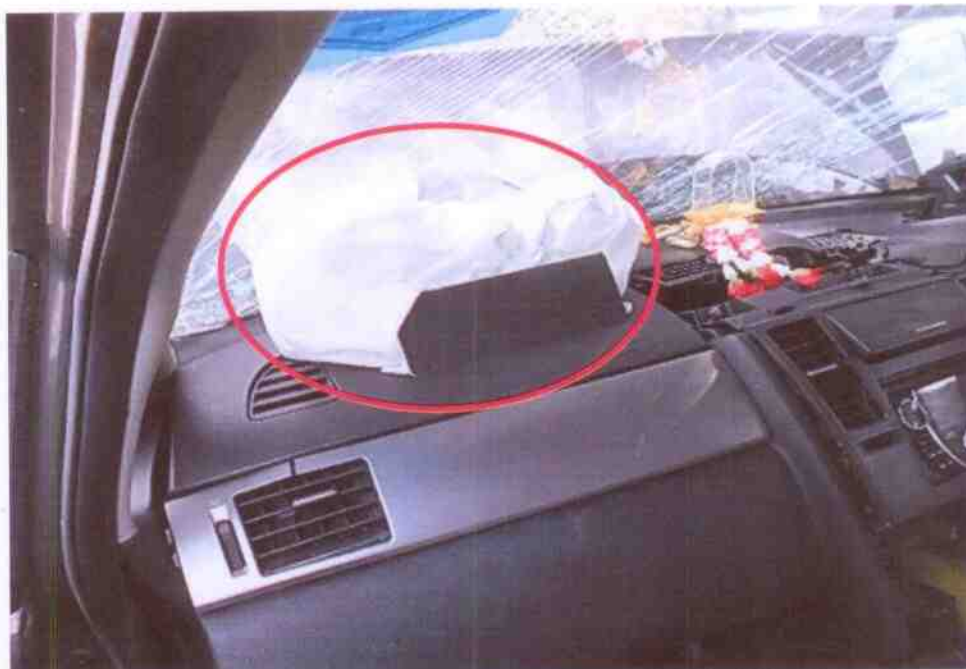
Photo 27 shows the Supplemental Restraint System (SRS) of the Motor Car was however likely to be in normal operating condition at the material time of the accident. The evidence of the deployed front passenger's airbag indicates that the impact sensors and control module of the Motor Car's SRS were all in serviceable condition at the material time of accident.

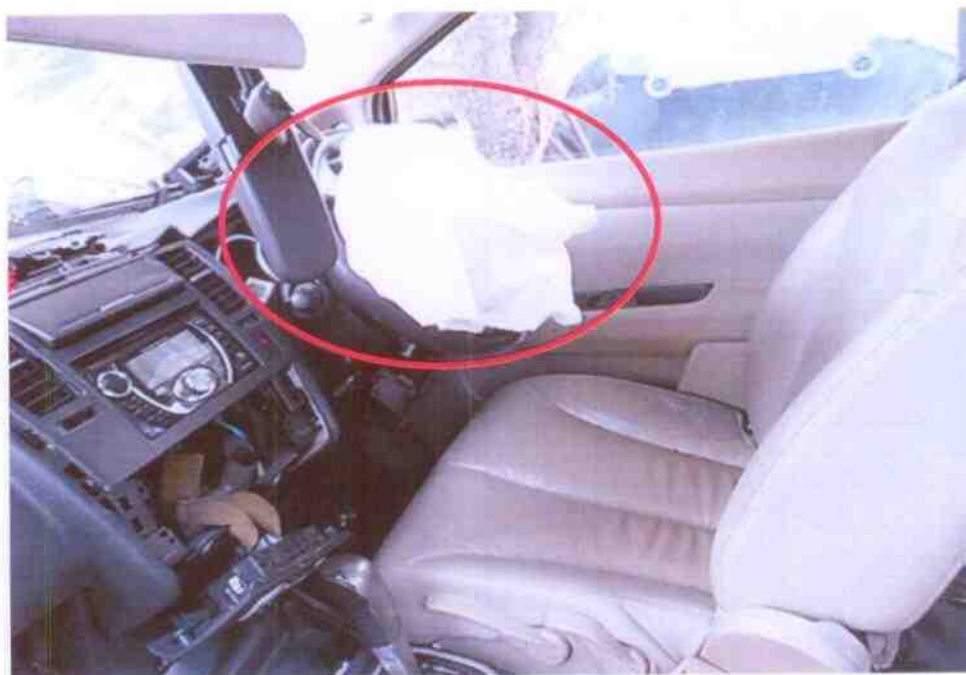
Photo 28 shows the Supplemental Restraint System (SRS) of the Motor Car was however likely to be in normal operating condition at the material time of the accident. The evidence of the deployed driver's airbag indicates that the impact sensors and control module of the Motor Car's SRS were all in serviceable condition at the material time of accident.
