Report no: 286M0817.HC

Vehicle no: SFW512Y

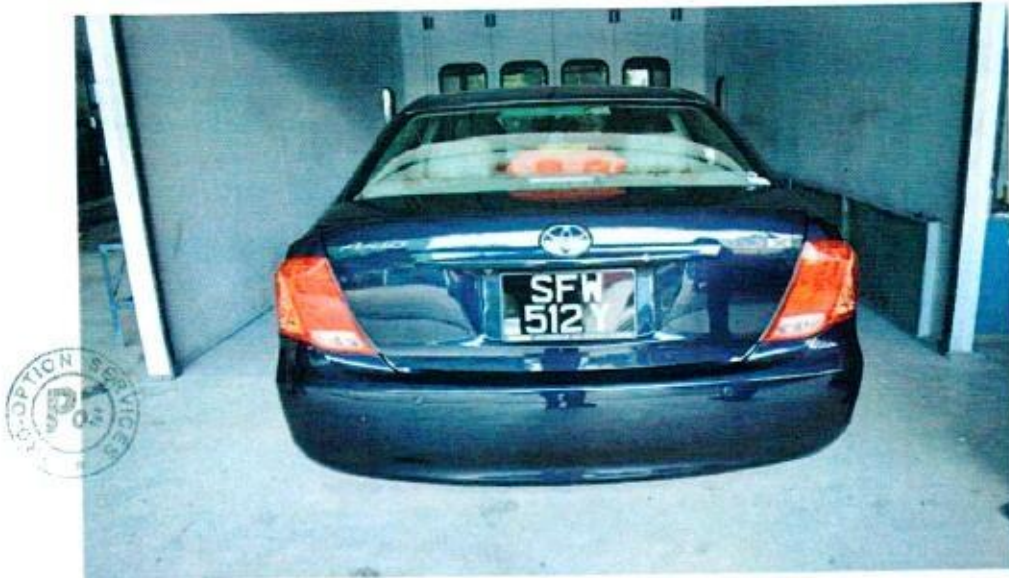
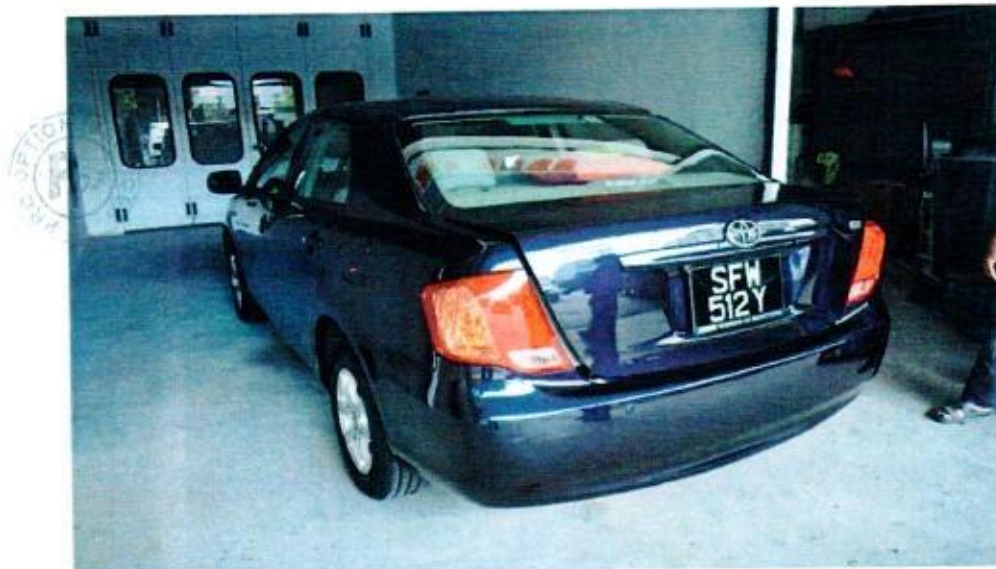
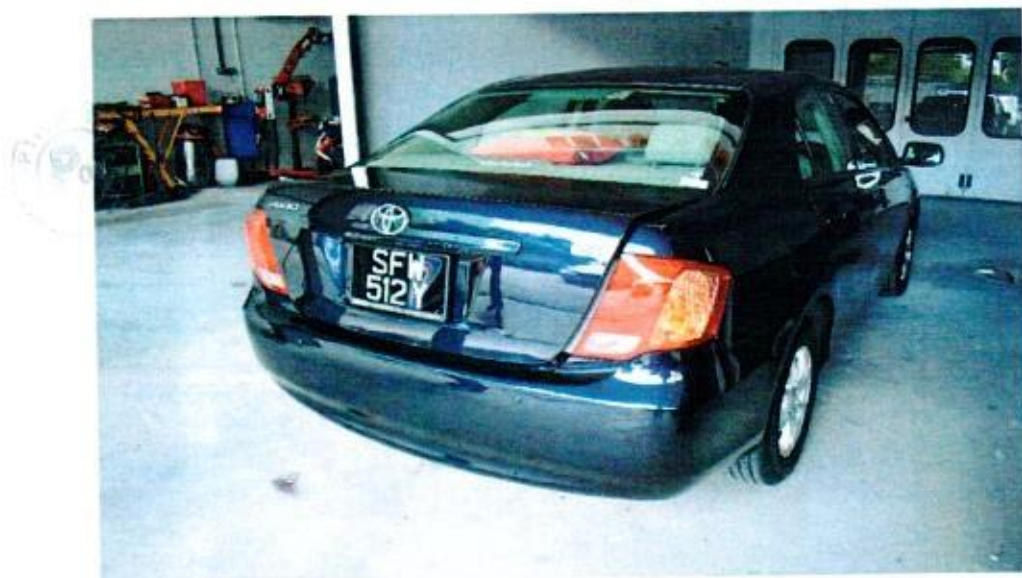
After Repair

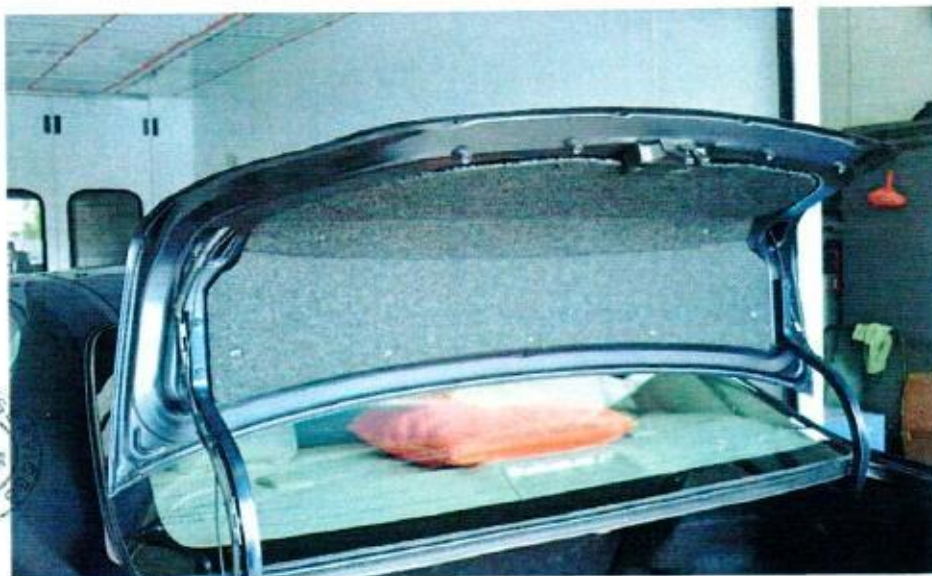
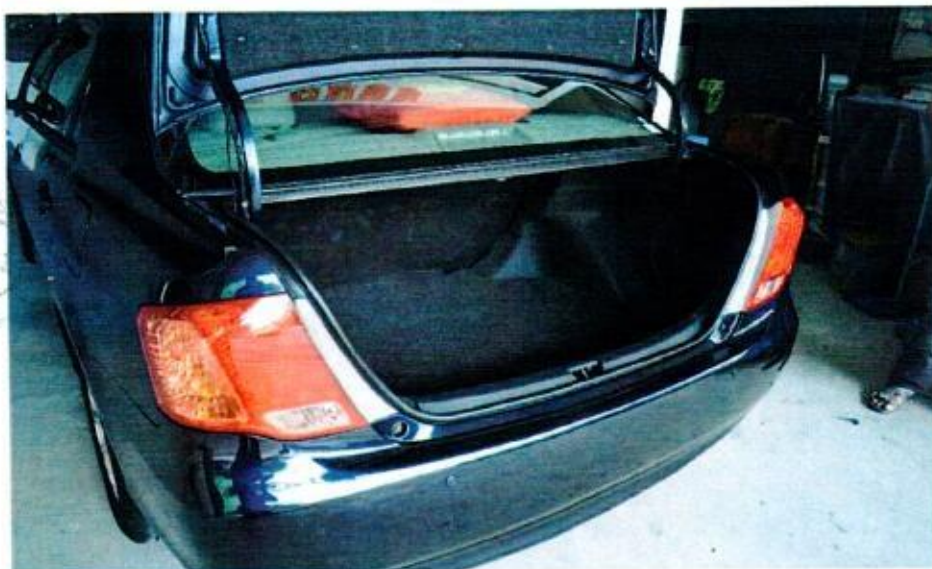
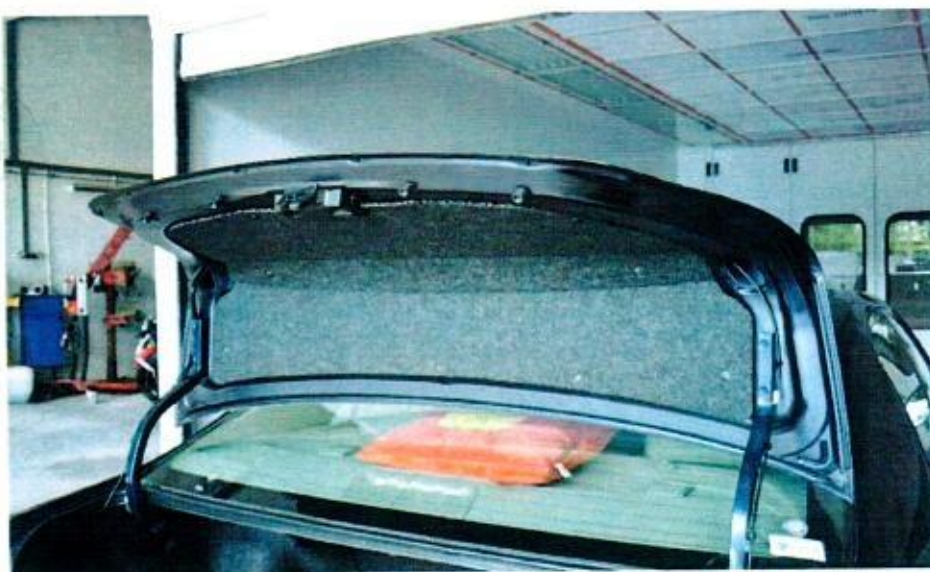
After Repair

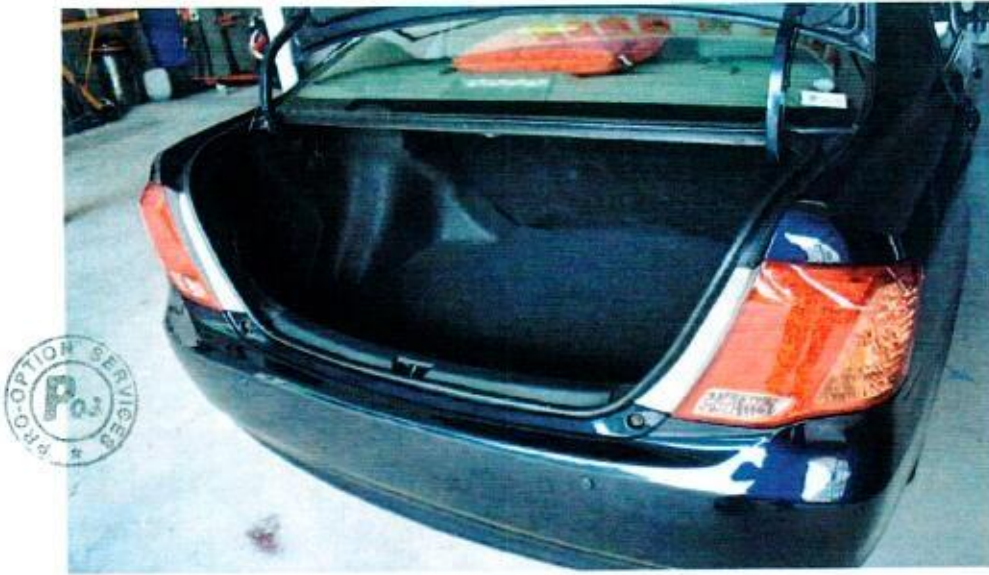
After Repair
