Your Ref: TP/IP/42119/2017
Our Ref : CI/TPD17021836/D

15 November 2017

MECHANICAL INSPECTION REPORT OF MOTOR CAR SLA 8948R

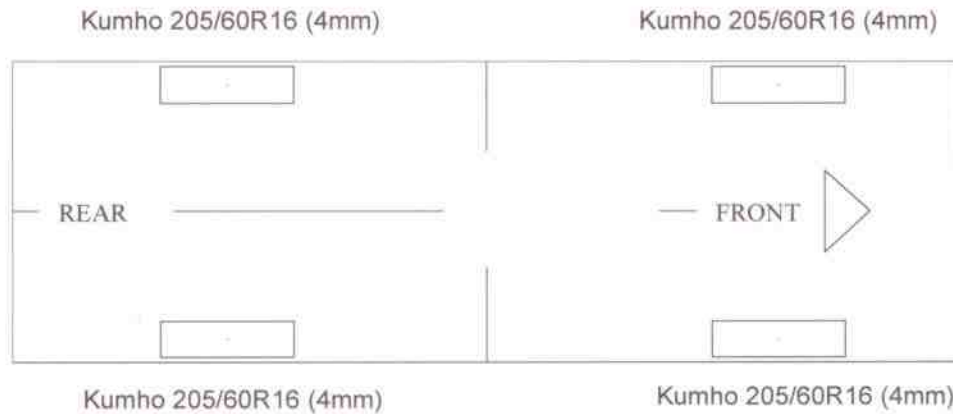
6. The condition of the Motor Car's 4 tyres was observed to be in serviceable condition. I did not find any tear, cut or burst mark(s) on the outer and the inner sidewalls as well as across the tread of the 4 tyres. The 4 tyres were also observed to be sufficiently inflated for vehicular operation. The tyre brand, tyre size and remaining tread depth of the 4 tyres were recorded as follows:-

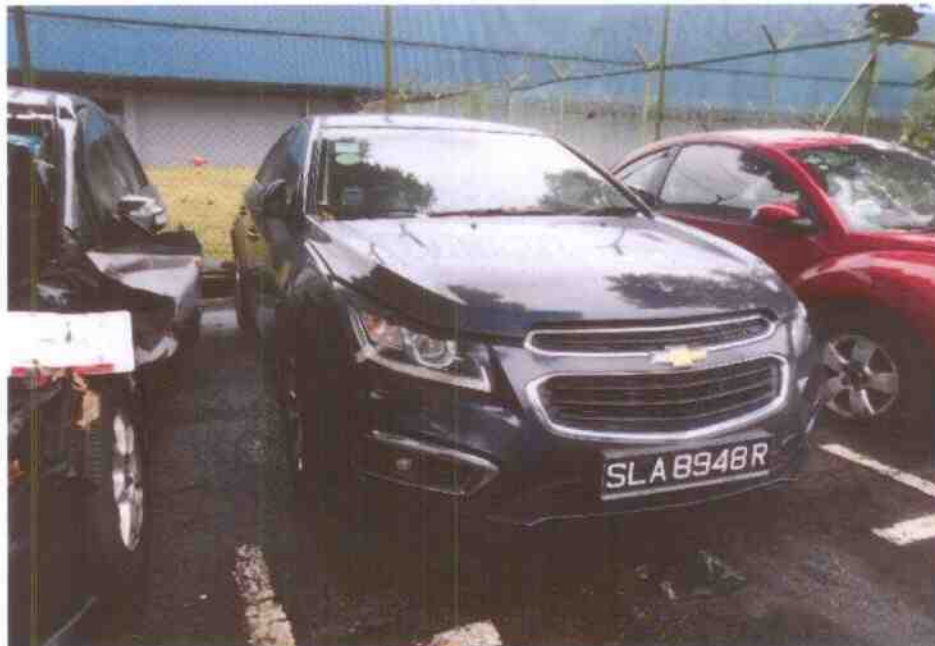
Photo 1 shows a general view of the front right body of the Motor Car at the time of my inspection. The Motor Car's exterior body was observed to be in good general condition except for a slight dent at the leading edge of its front bonnet. The mileage of the Motor Car at the time of my inspection was recorded to be 27,032km.

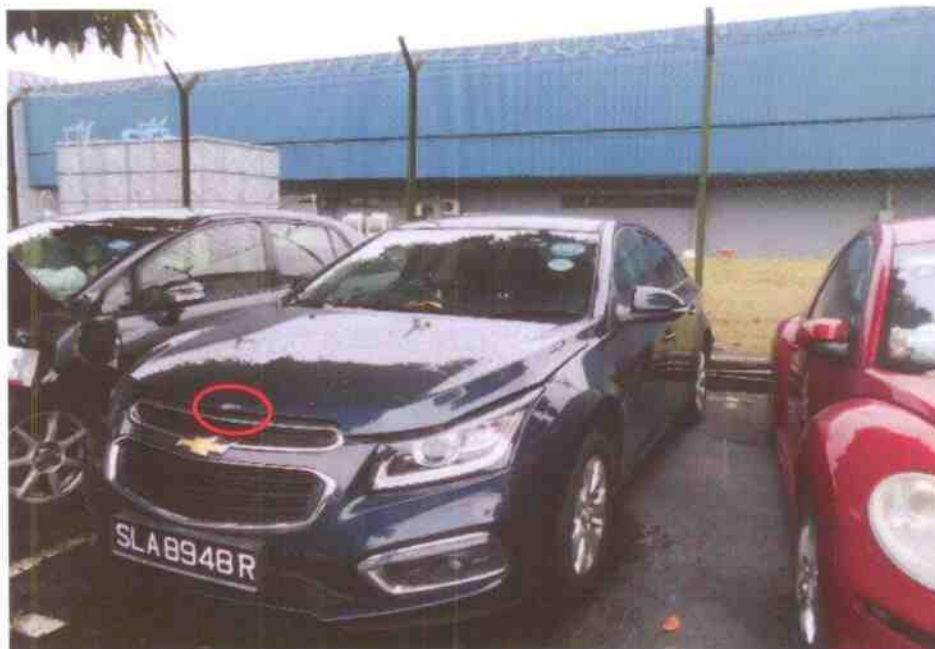
Photo 2 shows a general view of the front left body of the Motor Car at the time of my inspection. The Motor Car's exterior body was observed to be in good general condition. However I had observed a slight dent (circled) at the leading edge of its front bonnet.

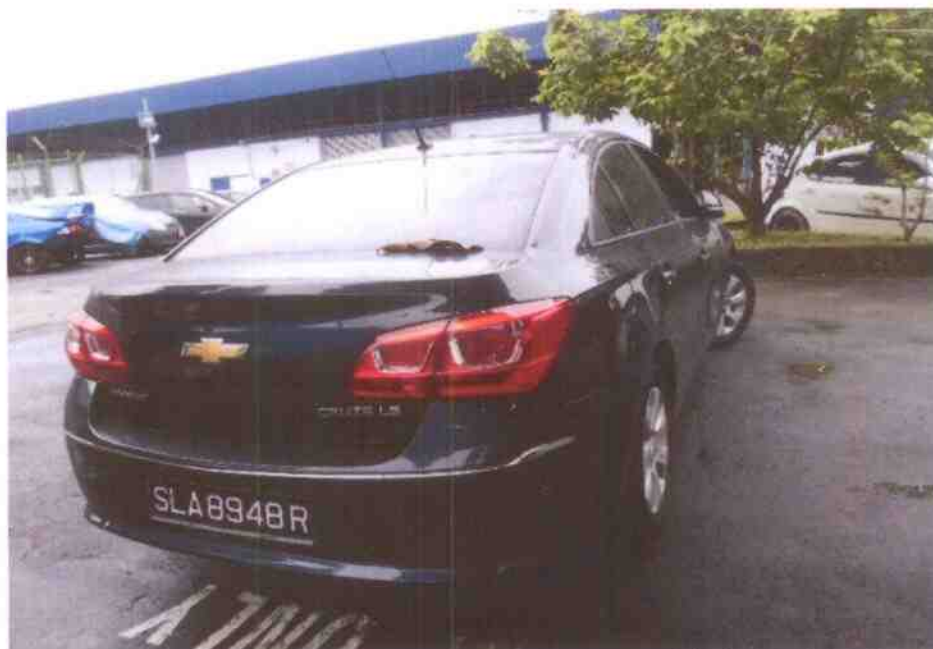
Photo 3 shows a general view of the Motor Car's rear right body at the time of my inspection. There was no damage found to the rear portion of the Motor Car.

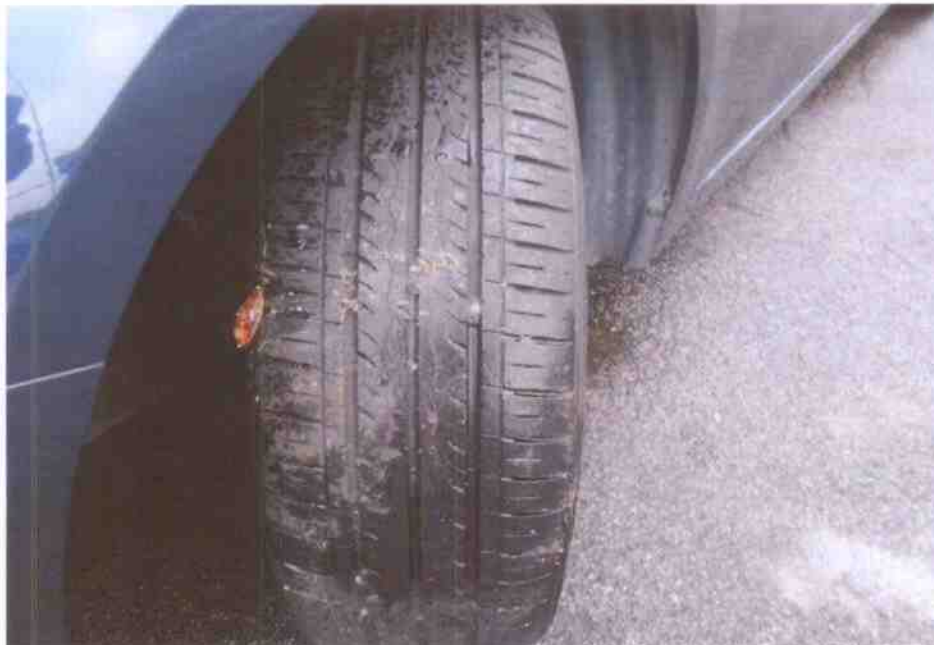
Photo 4 shows the condition of the front left tyre of the Motor Car, which was observed to be in serviceable condition with remaining tread depth of approximately 4mm. The tyre, which was wrapped around alloy wheel rim, was also observed to be sufficiently inflated for vehicular operation. There was no tear, cut or burst mark(s) on the outer and the inner sidewalls as well as across the tread of the 4 tyres.

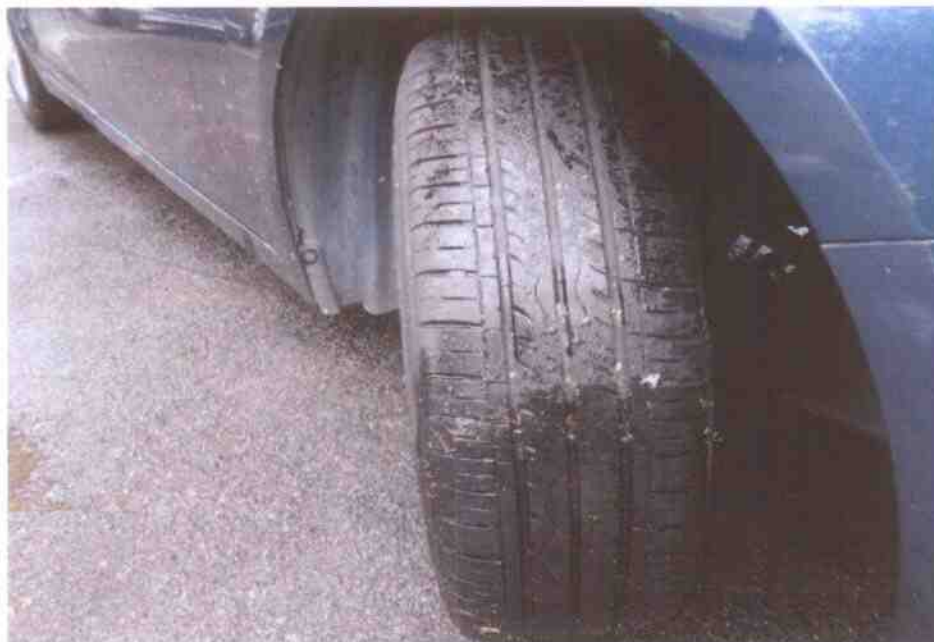
Photo 5 shows the condition of the front right tyre of the Motor Car, which was observed to be in serviceable condition with remaining tread depth of approximately 4mm. The tyre, which was wrapped around alloy wheel rim, was also observed to be sufficiently inflated for vehicular operation.

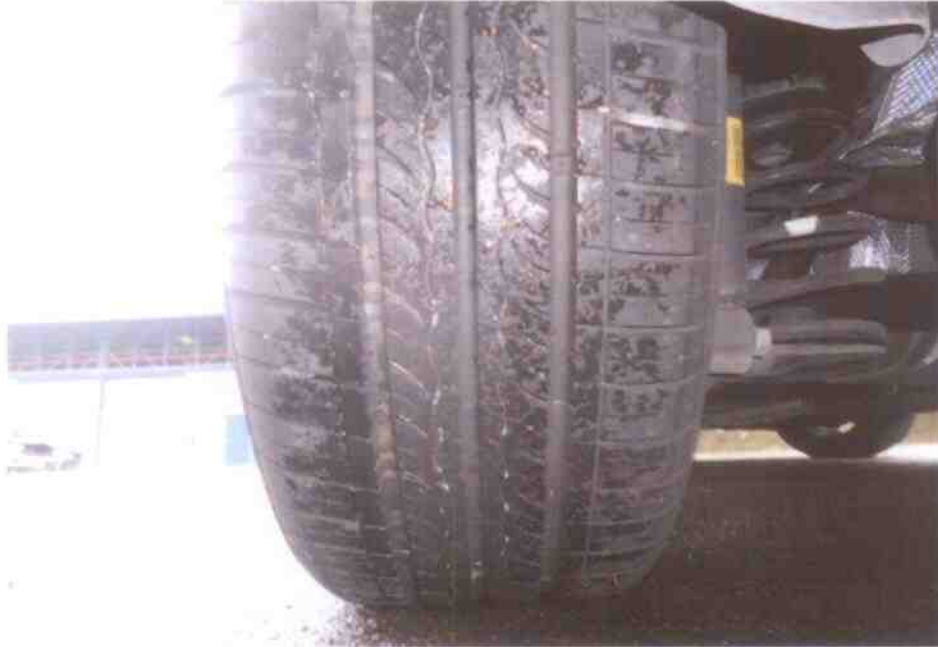
Photo 6 shows the condition of the rear left tyre of the Motor Car, which was observed to be in serviceable condition with remaining tread depth of approximately 4mm. The tyre, which was wrapped around alloy wheel rim, was also observed to be sufficiently inflated for vehicular operation. There was also no damage found on the 4 wheel rims of the Motor Car.

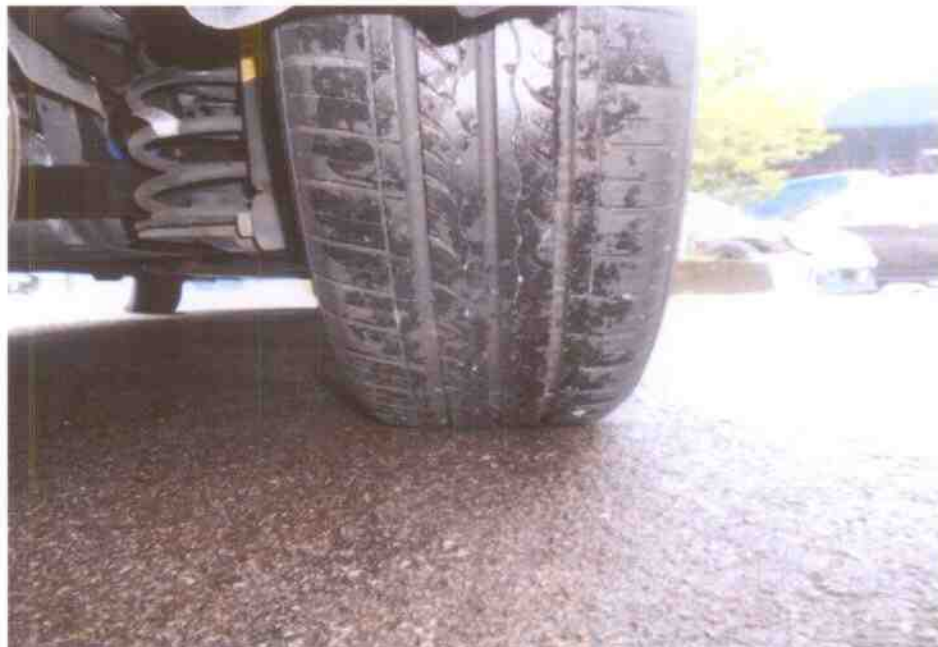
Photo 7 shows the condition of the rear right tyre of the Motor Car, which was observed to be in serviceable condition with remaining tread depth of approximately 4mm. There was also no tear, cut or burst mark(s) on the outer and the inner sidewalls as well as across the tread of the 4 tyres.

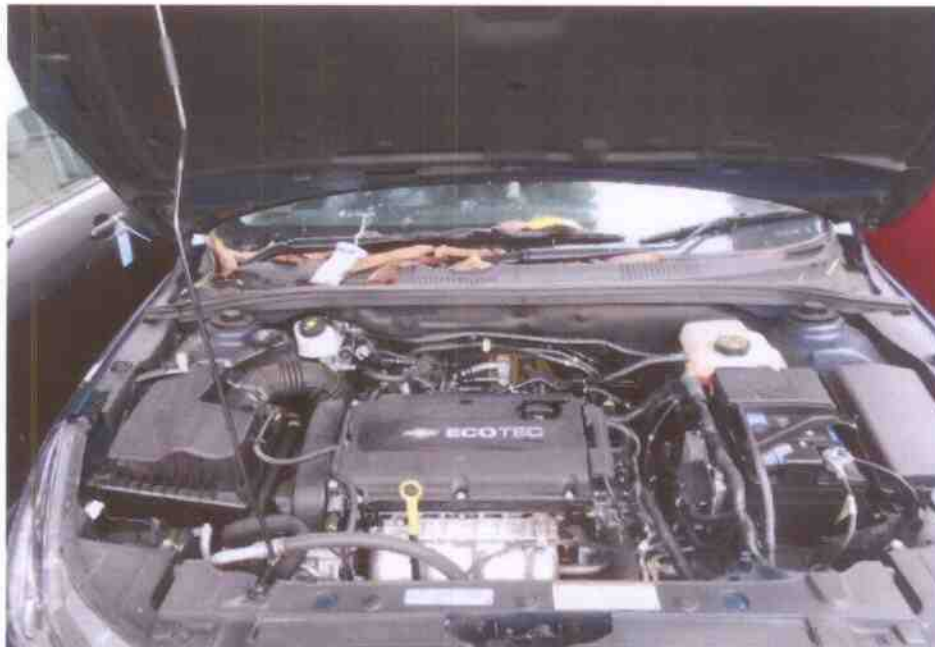
Photo 8 shows a general view of the Motor Car's engine compartment. The various parts and components inside the engine compartment were unaffected by the accident. There was also no sign(s) or indication(s) of fluid leakage and/or fluid stain within the engine compartment.

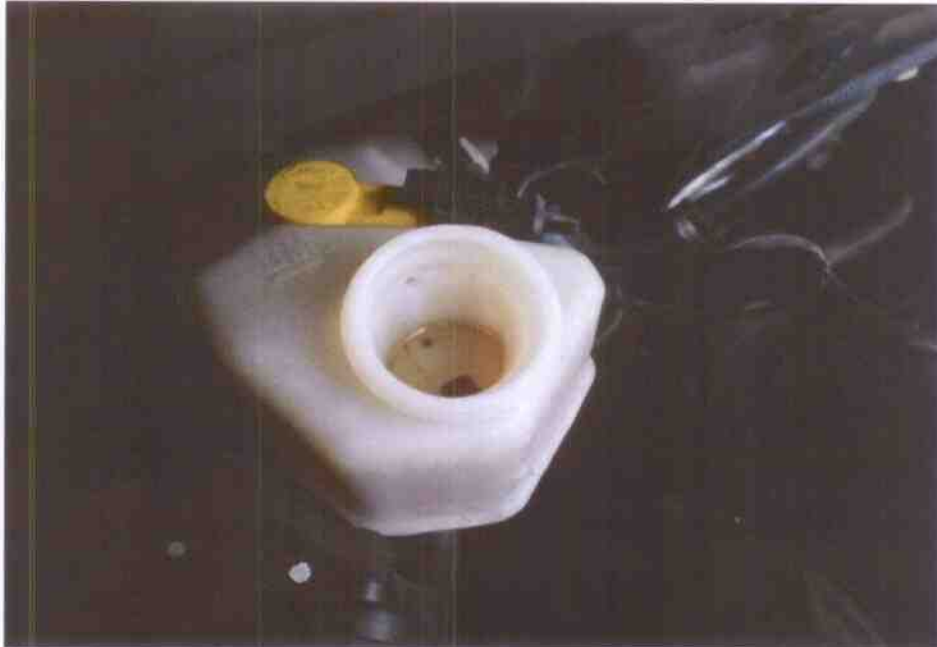
Photo 9 shows the brake fluid reservoir of the Motor Car at the time of my inspection. The brake fluid was observed to be of sufficient level and without any visible contamination.

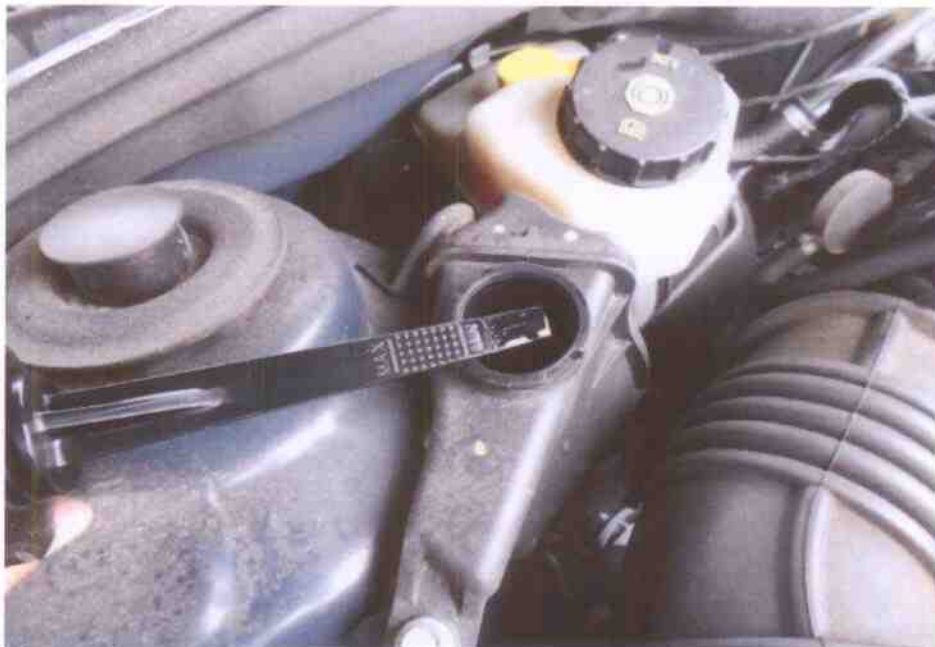
Photo 10 shows the power steering fluid reservoir of the Motor Car at the time of my inspection. The power steering fluid was observed to be of sufficient level and without any visible contamination.

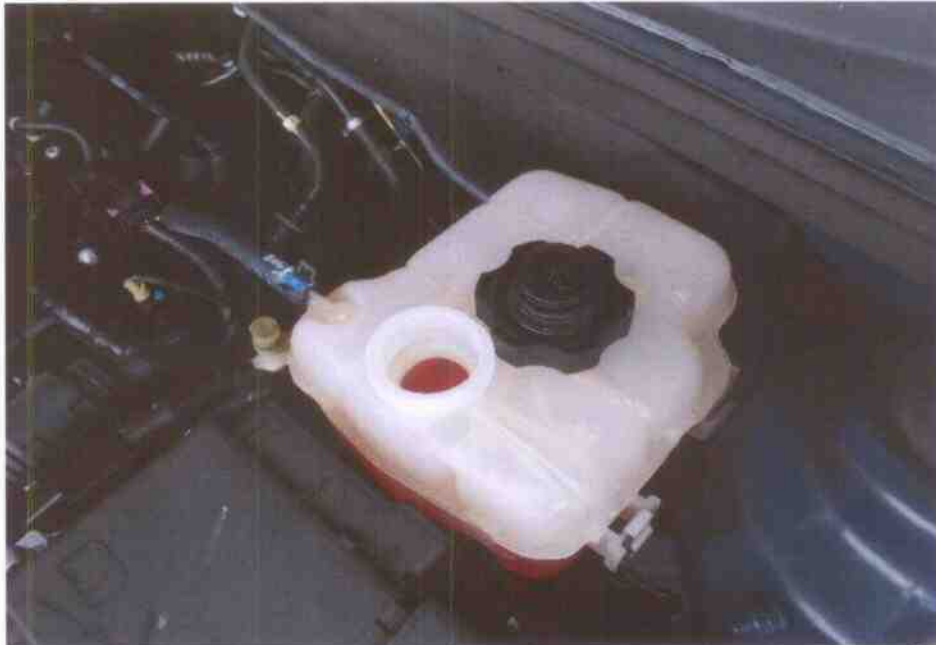
Photo 11 shows checks being carried out to the engine coolant of the Motor Car at the time of my inspection. The engine coolant was observed to be of sufficient level and without any visible contamination.

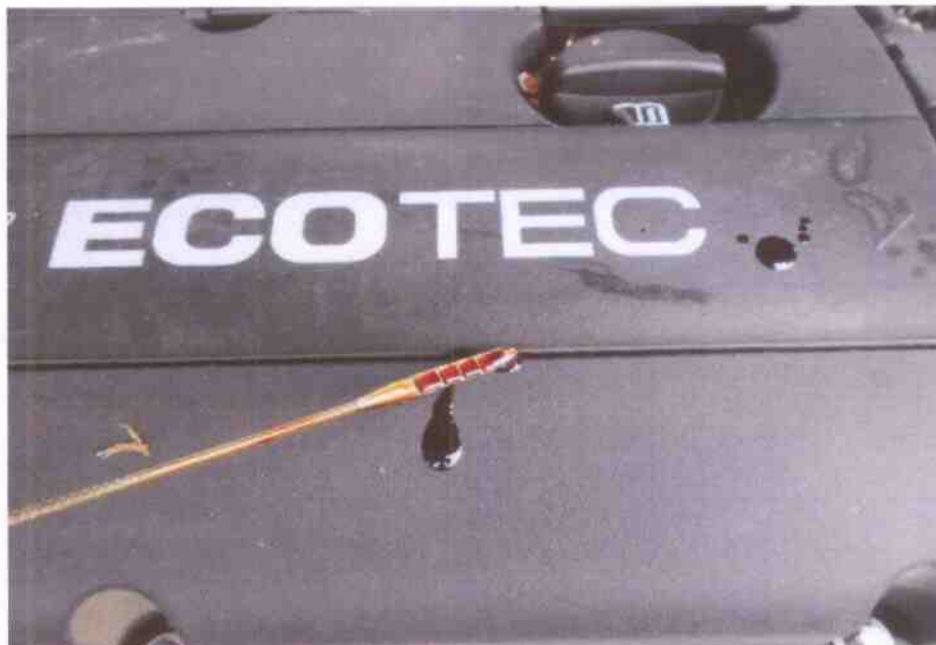
Photo 12 shows the engine oil dip stick of the Motor Car at the time of my inspection. The engine oil was observed to be of sufficient level and without any visible contamination.

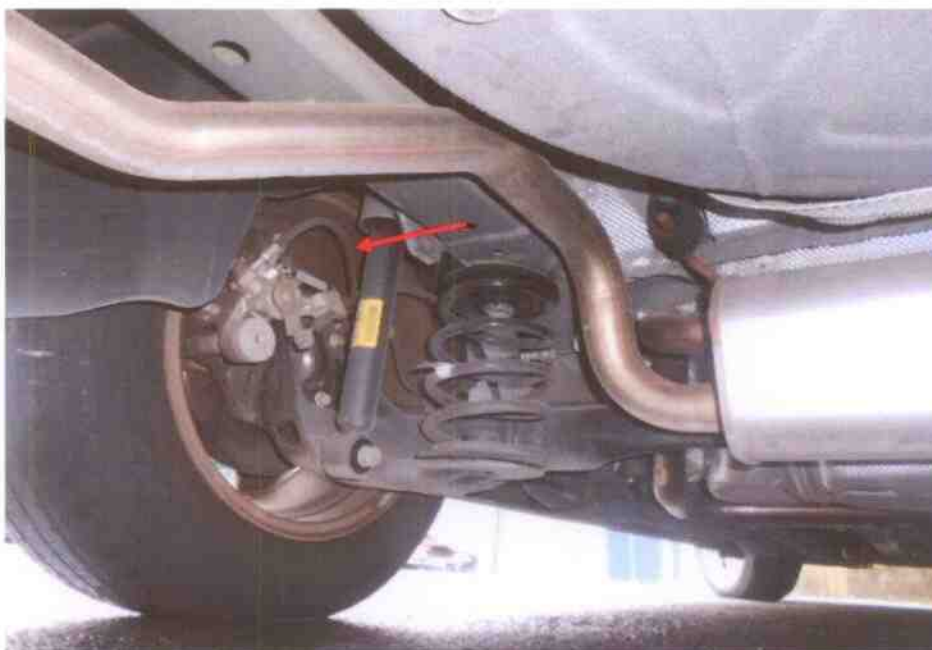
Photo 13 shows the brake hose/pipe (arrowed) at the rear left wheel of the Motor Car. I did not observe any leakage of brake fluid at the time of my inspection of the Motor Car. Static tests of the Motor Car's braking system had indicated that there was no internal leakage of pressure/vacuum. Hence the braking system was likely to be in serviceable condition at the material time of accident. The undercarriage components of the Motor Car were also all found to be intact and without any visible damage.

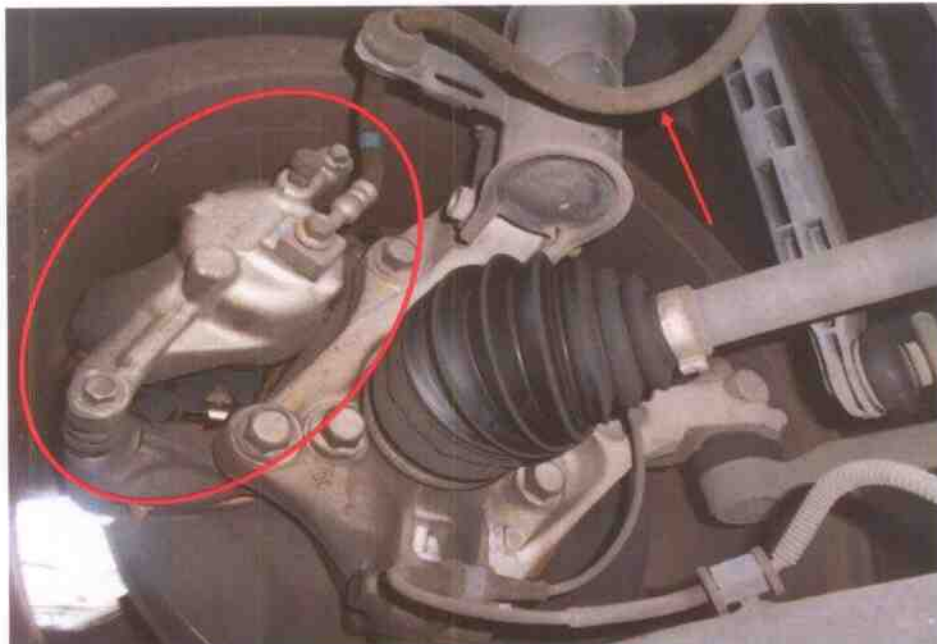
Photo 14 shows the brake hose/pipe (arrowed) at the front right wheel of the Motor Car. No leakage of brake fluid was observed. Visual examination of the various components of the braking system like the brake caliper (circled), brake booster, brake pedal etc had revealed all to be intact and without visible damage.

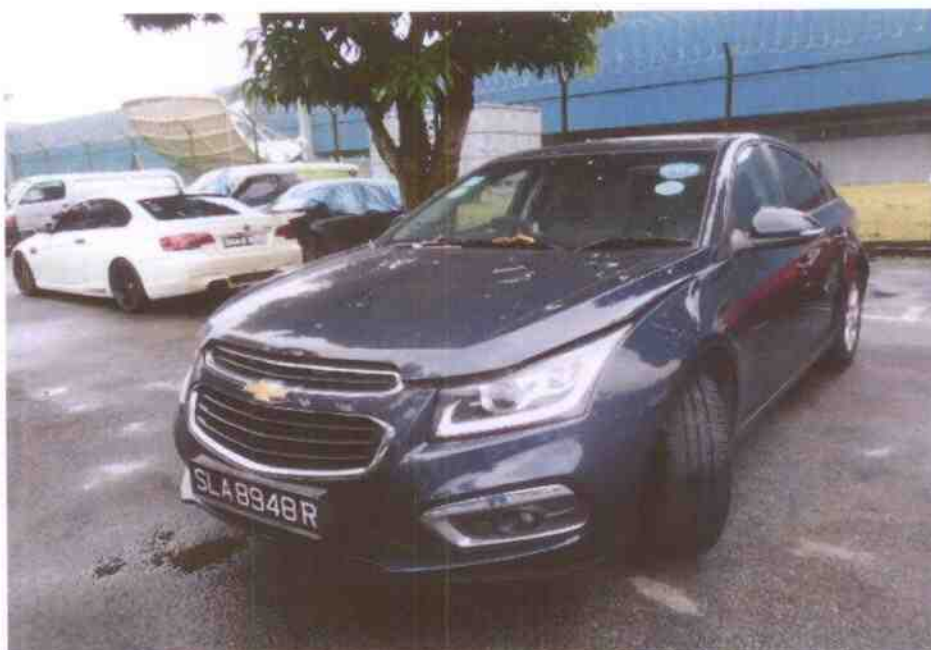
Photo 15 shows the front left wheel of the Motor Car turned to its full left. During my steering system test, I did not experience any abnormal free play and/or resistance when I had turned the steering wheel towards the left and right. This would suggest that the steering system of the Motor Car was likely to be in serviceable condition at the material time of accident.

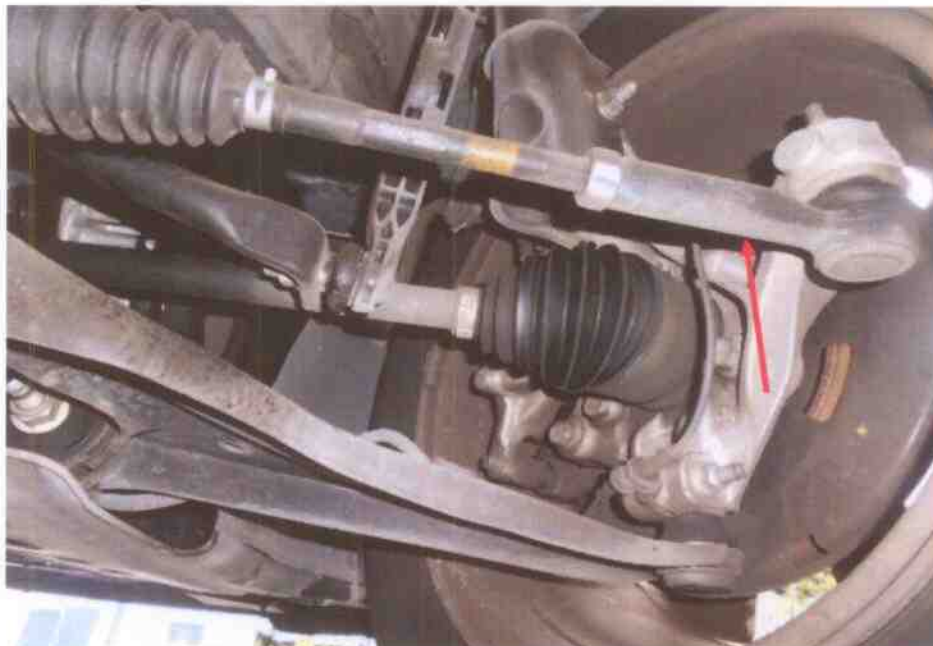
Photo 16 shows the various undercarriage components at the front right wheel of the Motor Car, in particular the steering tie rod (arrowed). The various steering components were all found to be intact, suggesting that the steering system of the Motor Car was likely to be in serviceable condition at the material time of accident. There was also no sign of fluid stain observed on the various undercarriage components at the front right wheel of the Motor Car.

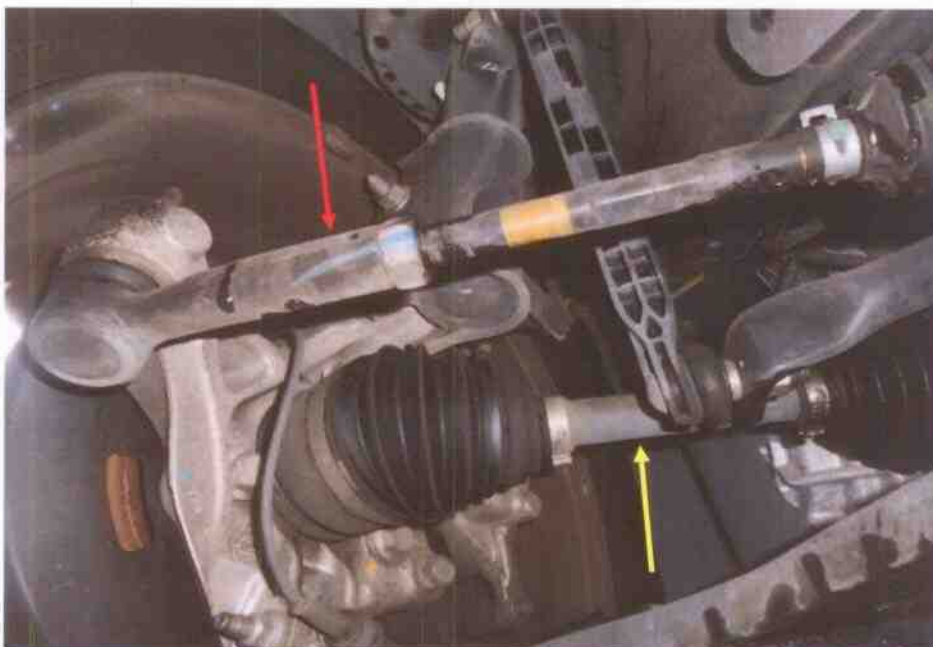
Photo 17 shows the various undercarriage components at the front left wheel of the Motor Car, which had included the steering tie rod (red arrow) and left drive shaft (yellow arrow). The various undercarriage components of the Motor Car were all found to be intact without any visible damage.

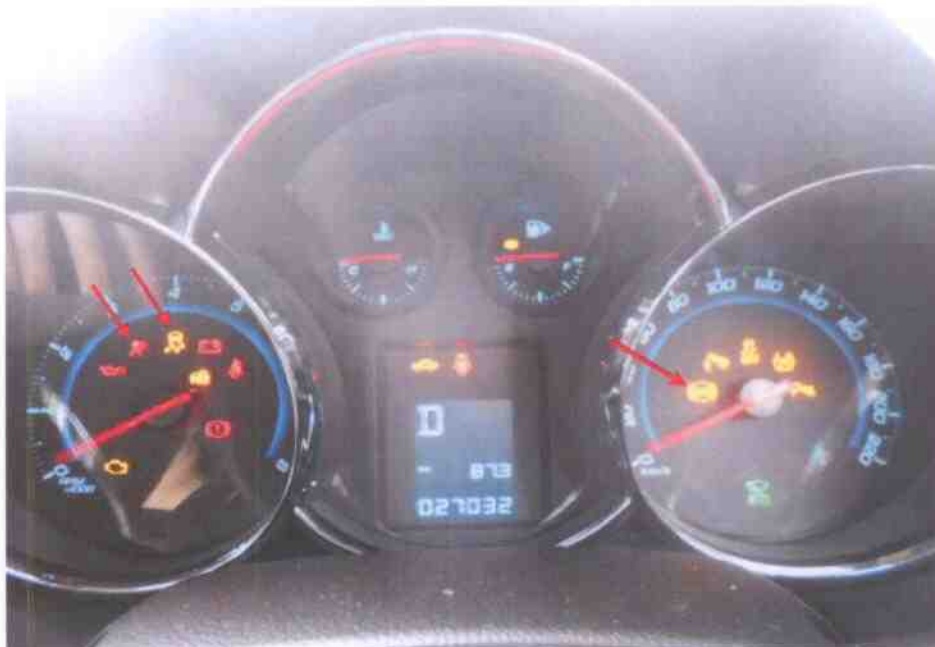
Photo 18 shows the warning lights for the various electronic operating systems of the Motor Car appearing on its instrument panel during the self-test when the engine is cranked, in particular the ABS light, TCS light and SRS light (arrowed).

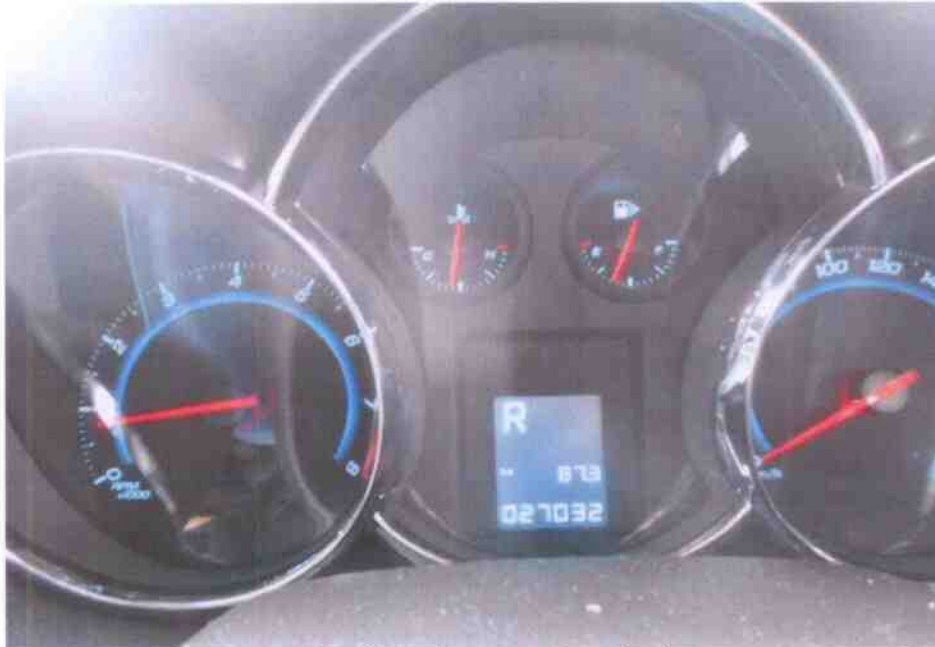
Photo 19 shows no warning lights illuminated on the instrument panel of the Motor Car after the engine was cranked. This would suggest that there was no abnormality to the various electronic operating systems of the Motor Car, like the ABS, TCS and SRS etc.
