Your Ref: TP/IP/38869/2017
Our Ref : CI/TPD17021939/D

MECHANICAL INSPECTION REPORT OF MOTOR BUS PC 3728J

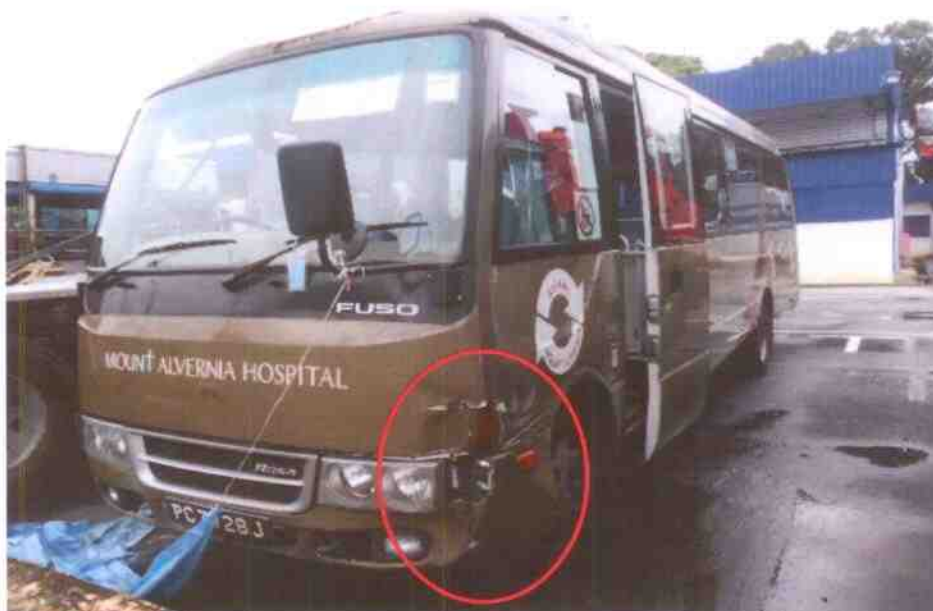
Photo 1 shows a general view of the front left body of the Motor Bus at the time of my inspection. The Motor Bus was observed to have sustained damage at its front left body. Its front bumper, front left signal lamp and front panel were amongst the body parts at the front left of the Motor Bus that had sustained damages as a result of the accident.

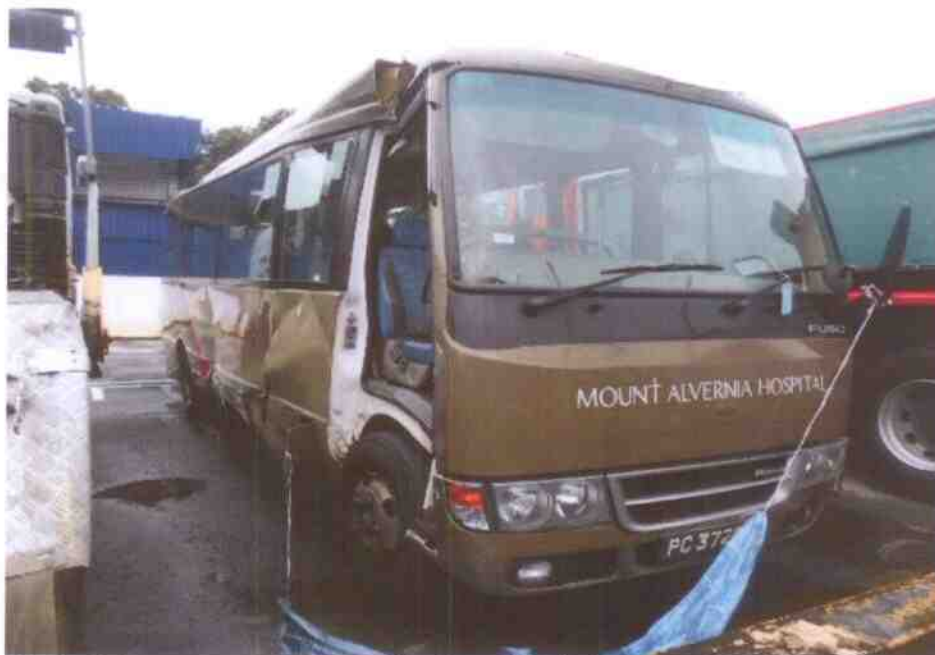
Photo 2 shows a general view of the front right body of the Motor Bus at the time of my inspection. The right front body of the Motor Bus was observed to have been damaged. Its roof panel was also observed to be affected while its driver's door was observed to have been removed for rescue purposes.

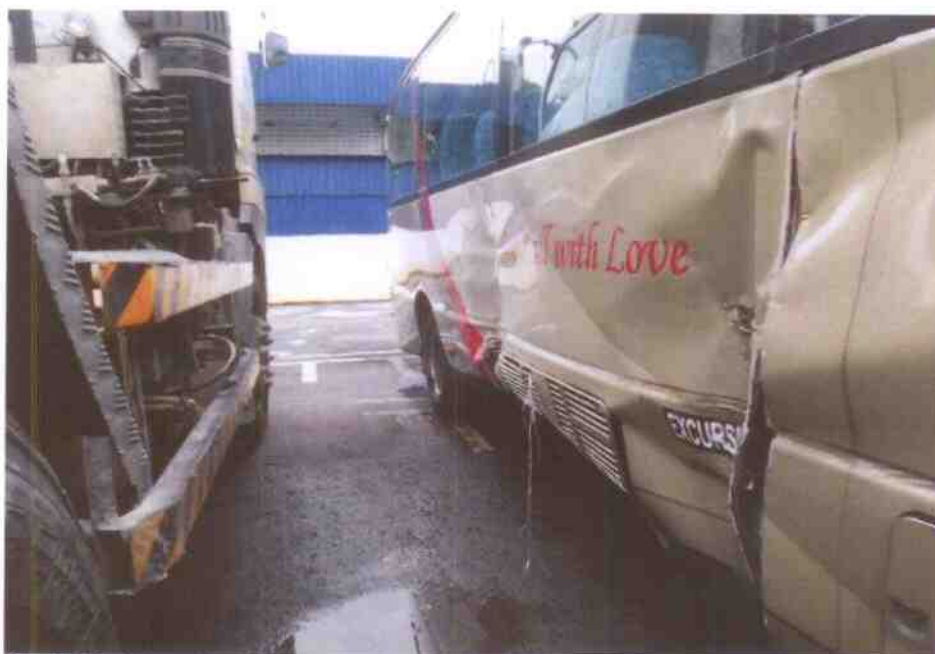
Photo 3 shows the right centre body of the Motor Bus. The body panels along the right side of the Motor Bus were observed to be have been dented/buckled.

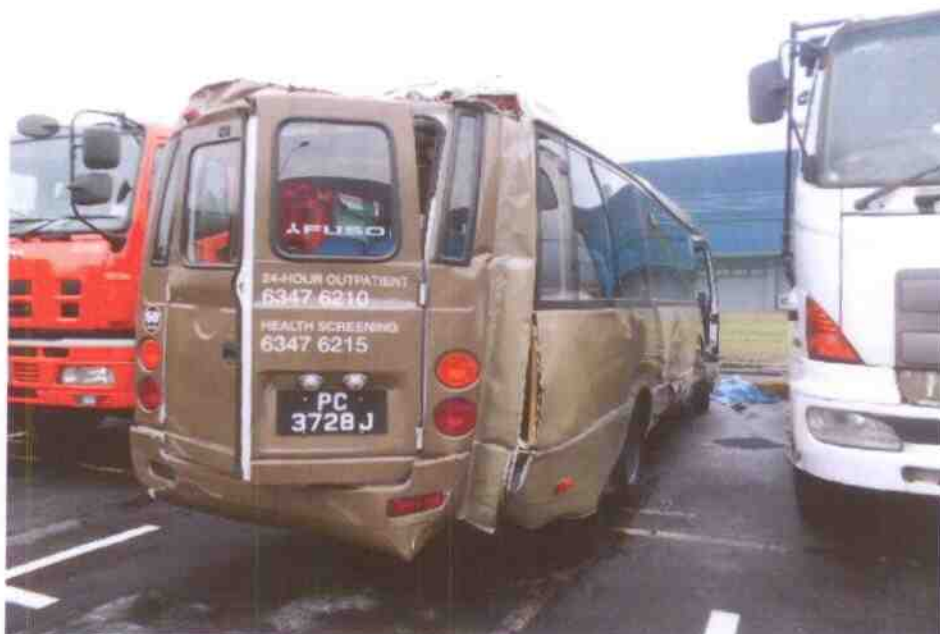
Photo 4 shows a general view of the Motor Bus's rear right body at the time of my inspection. The rear doors, rear bumper and rear right panel were amongst the body parts at the rear right of the Motor Bus that had sustained damages. Its roof panel was also observed to have been buckled as a result of the accident.

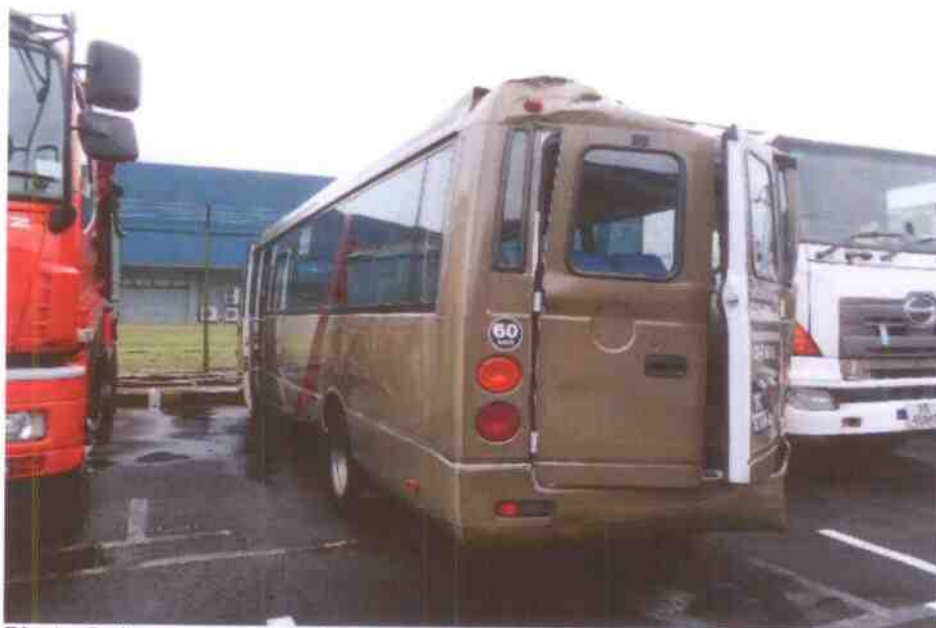
Photo 5 shows a general view of the Motor Bus's rear left body at the time of my inspection. The rear doors, rear bumper and rear right panel were amongst the body parts at the rear right of the Motor Bus that had sustained damages. Its roof panel was also observed to have been buckled as a result of the accident. The left side of the Motor Bus was relatively unaffected by the collision.

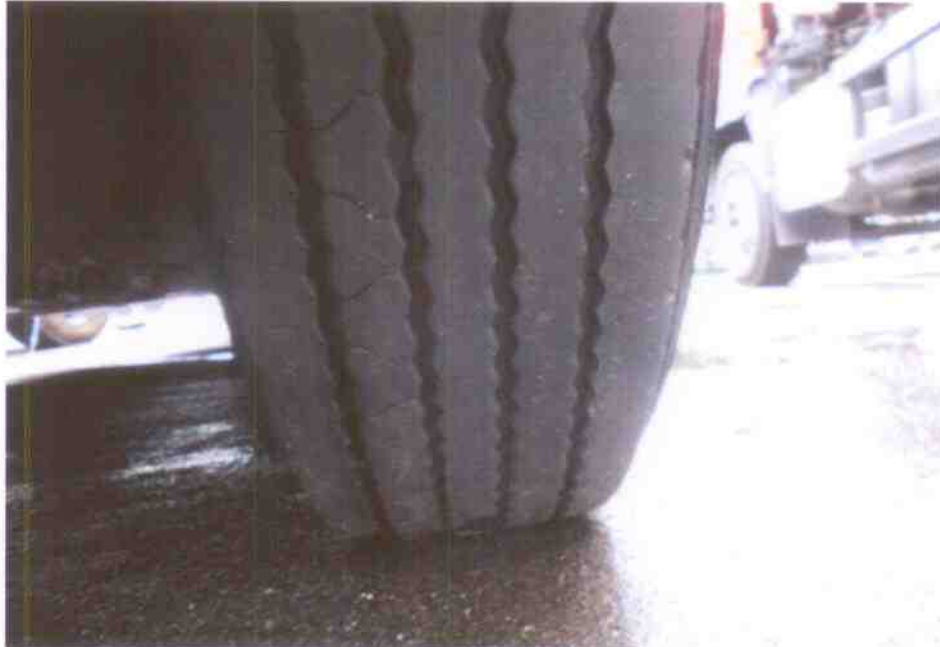
Photo 6 shows the condition of the front left tyre of the Motor Bus, which was observed to be in serviceable condition with remaining tread depth of approximately 5mm. The tyre, which was wrapped around standard alloy wheel rim, was also observed to be sufficiently inflated for vehicular operation. There was no tear, cut or burst mark(s) on the outer and the inner sidewalls as well as across the tread of the 6 tyres that were fitted on the Motor Bus.

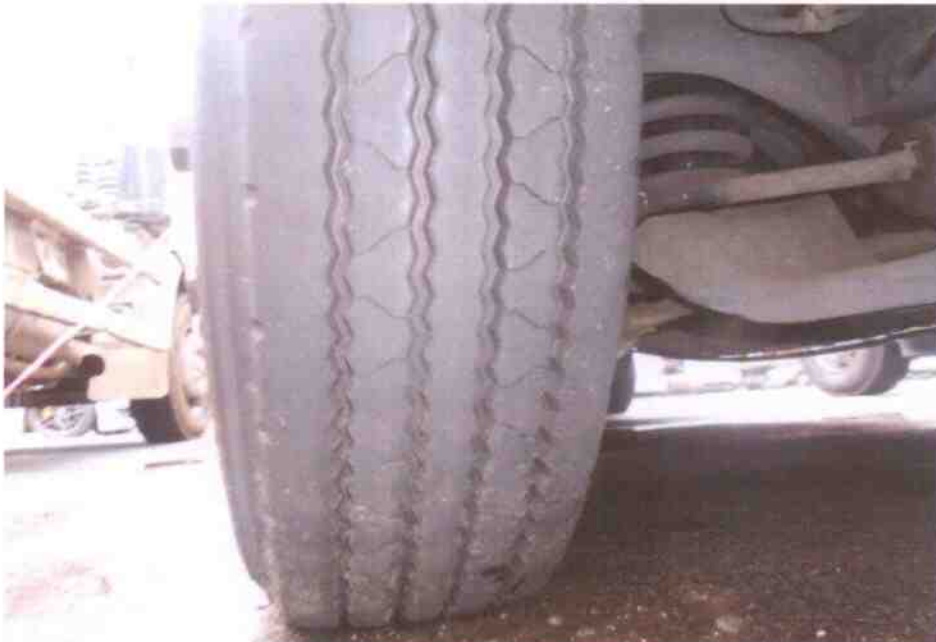
Photo 7 shows the condition of the front right tyre of the Motor Bus, which was observed to be in serviceable condition with remaining tread depth of approximately 6mm. The tyre, which was wrapped around standard alloy wheel rim, was also observed to be sufficiently inflated for vehicular operation.

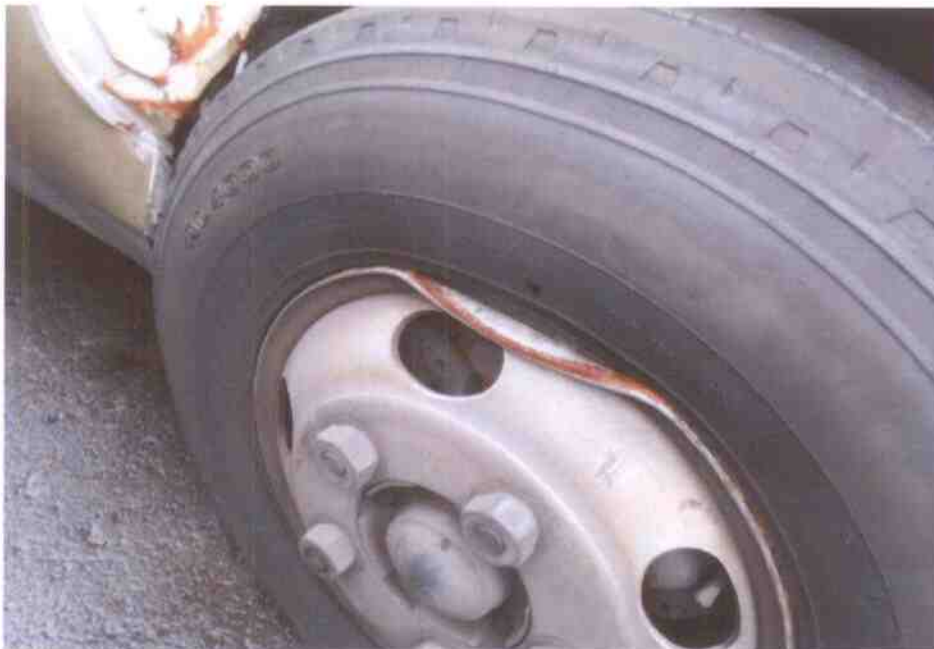
Photo 8 shows the front right tyre of the Motor Bus wrapped around standard alloy wheel rim. The front left wheel rim was observed to be dented due to the accident.

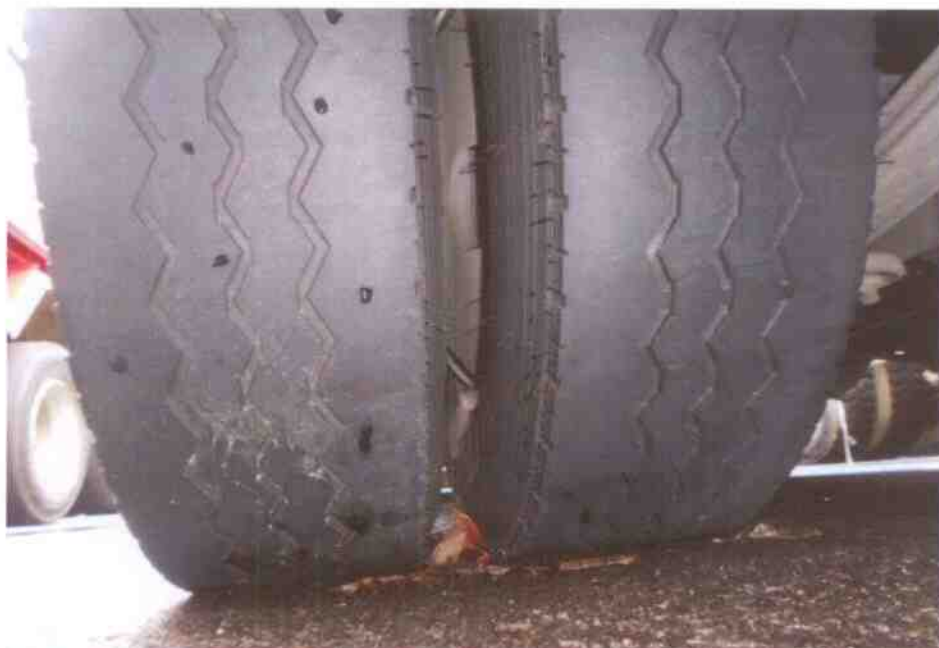
Photo 9 shows the condition of the rear left tyres of the Motor Bus, which was observed to be in serviceable condition with remaining tread depth of approximately 3mm. The tyres, which were wrapped around standard alloy wheel rim, were also observed to be sufficiently inflated for vehicular operation. There was also no damage found on all 6 standard alloy wheel rims of the Motor Bus except for the front right wheel rim and rear right outer wheel rim, which were both dented due to the accident.

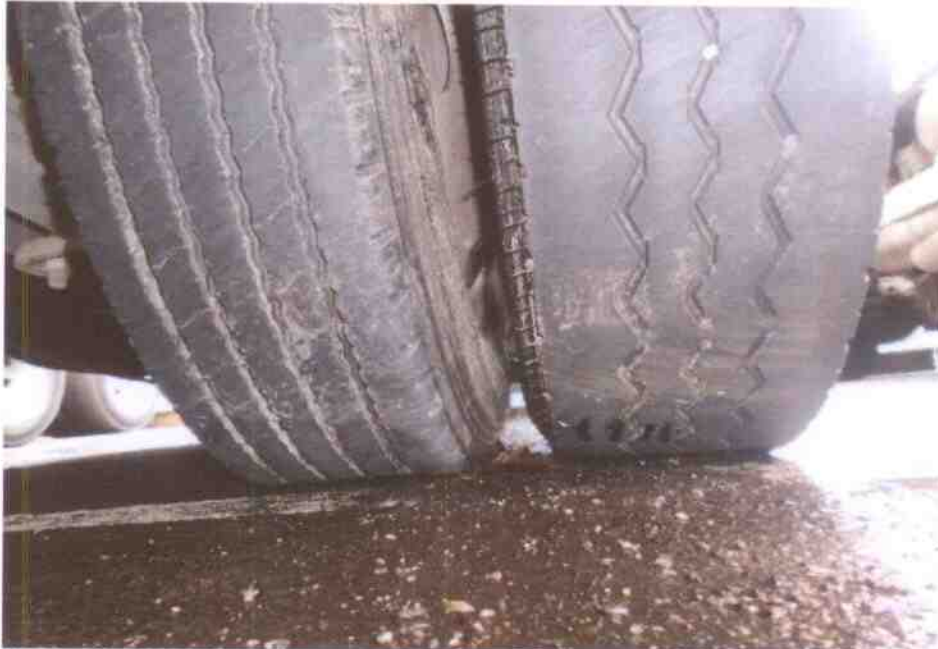
Photo 10 shows the condition of the rear right tyres of the Motor Bus, which were observed to be in serviceable condition with remaining tread depth of approximately 4mm. There was also no tear, cut or burst mark(s) on the outer and the inner sidewalls as well as across the tread of the 6 tyres that were fitted on the Motor Bus.

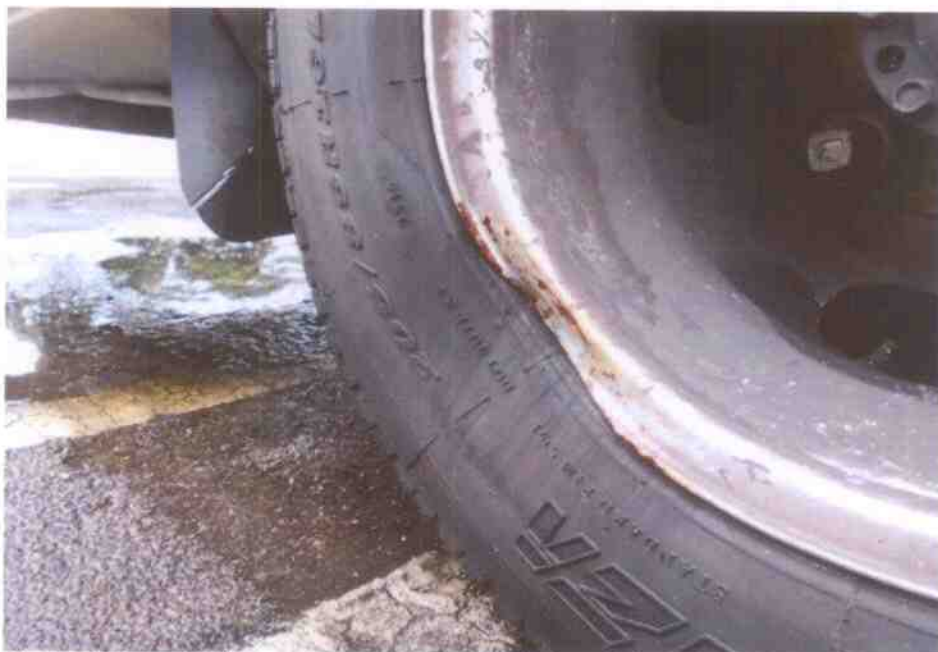
Photo 11 shows the rear right outer wheel rim of the Motor Bus which was observed to be dented due to the accident.

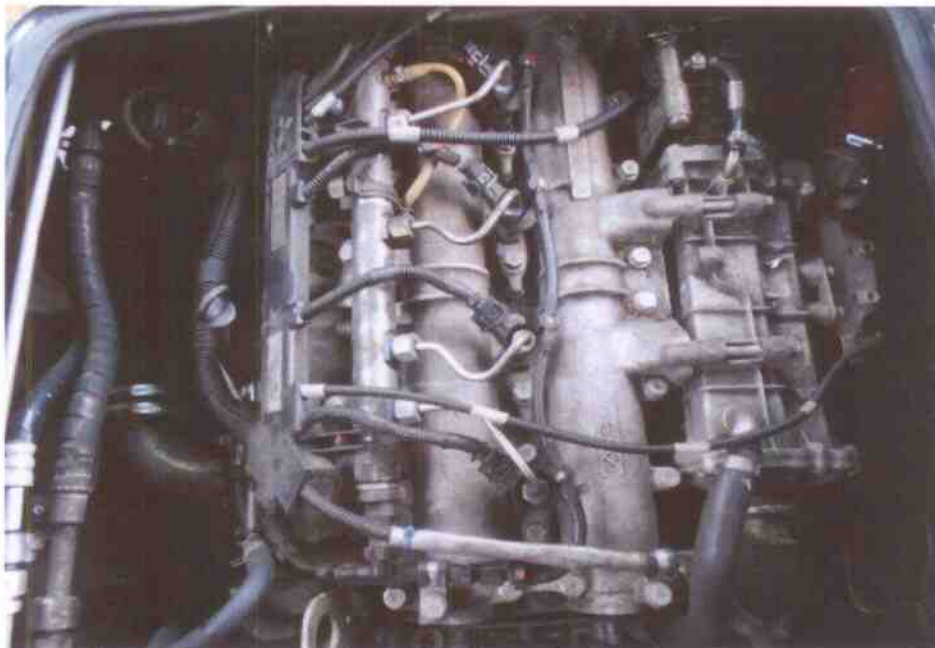
Photo 12 shows a general view of the Motor Bus's engine compartment, which was accessed from the interior of the Motor Bus by lifting the cover adjacent to the left side of the driver's seat. The various parts and components inside the engine compartment were unaffected by the accident. There was also no sign(s) or indication(s) of fluid leakage and/or fluid stain within the engine compartment.

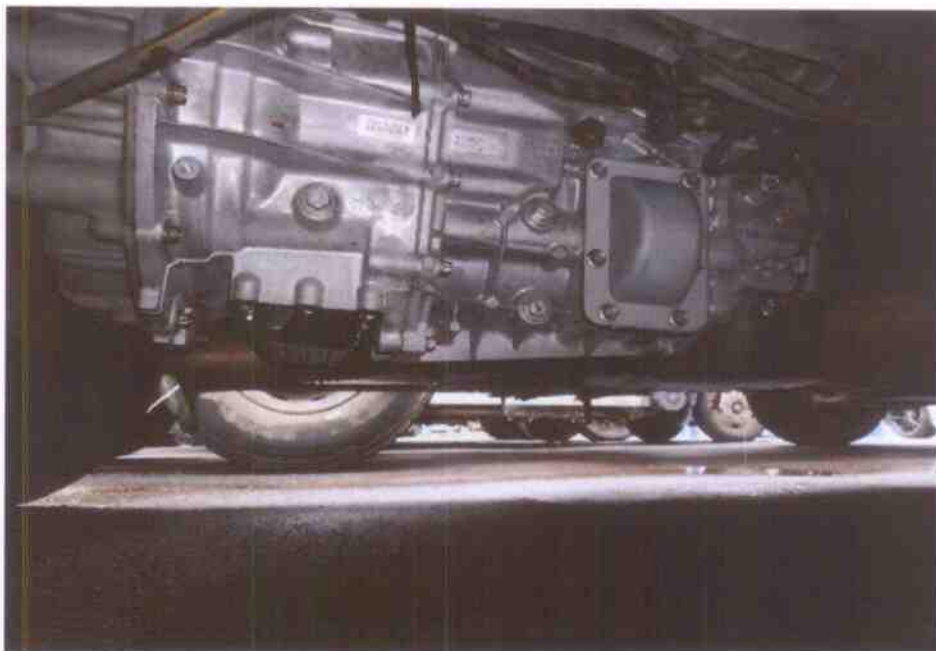
Photo 13 shows a general view of the Motor Bus's transmission housing, as viewed from the bottom of the Motor Bus. The engine and transmission, along with all its related parts, were found to be intact and unaffected by the accident. There was also no sign(s) or indication(s) of fluid leak/stain observed on the underside of the Motor Bus.

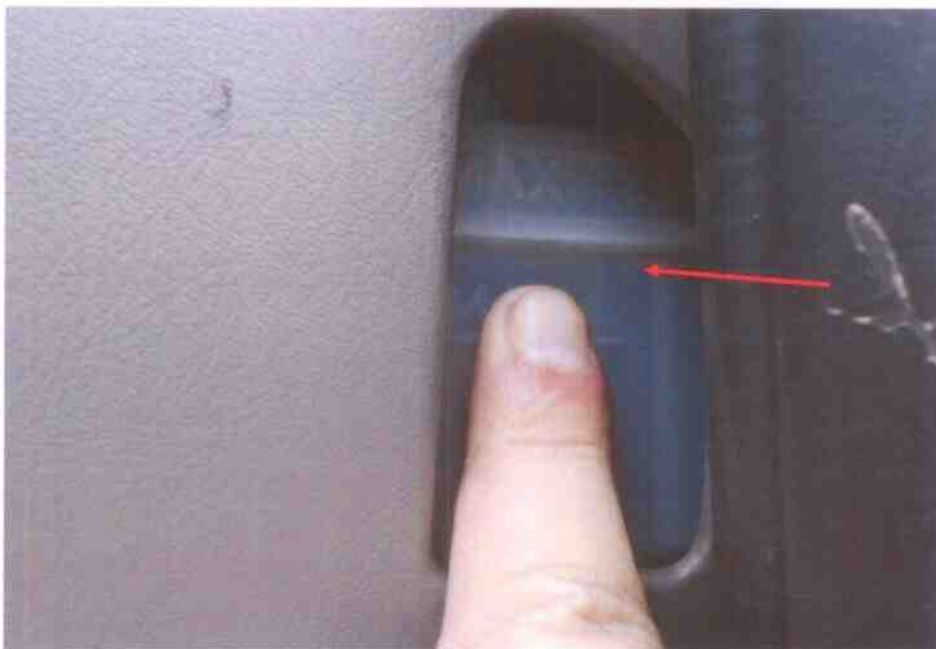
Photo 14 shows the brake fluid reservoir of the Motor Bus at the time of my inspection. The brake fluid was observed to be of sufficient level (arrowed) and without any visible contamination.

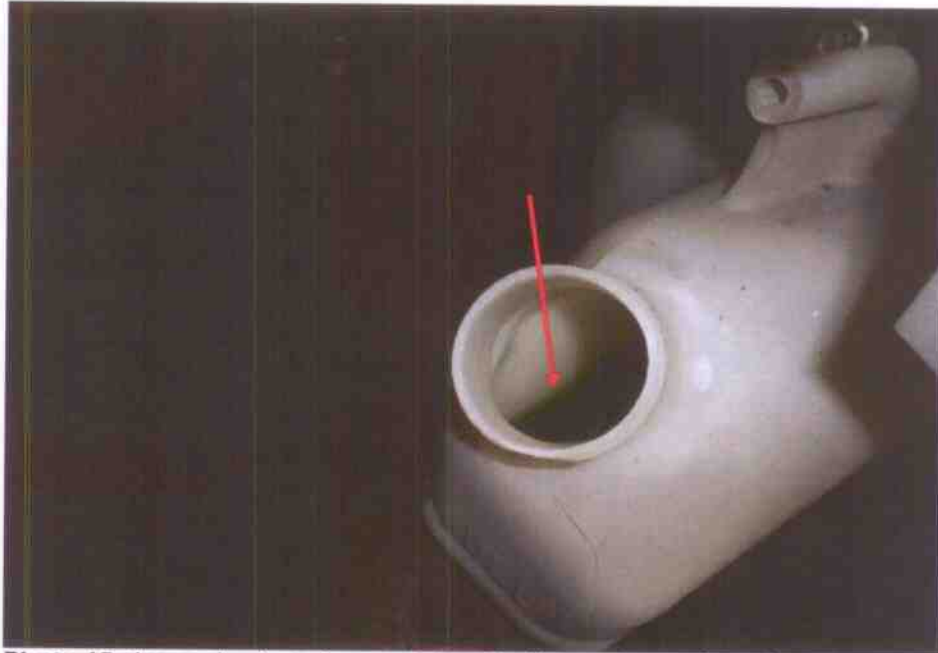
Photo 15 shows checks being carried out to the engine coolant of the Motor Bus at the time of my inspection. The engine coolant was observed to be of sufficient level (arrowed) and without any visible contamination.

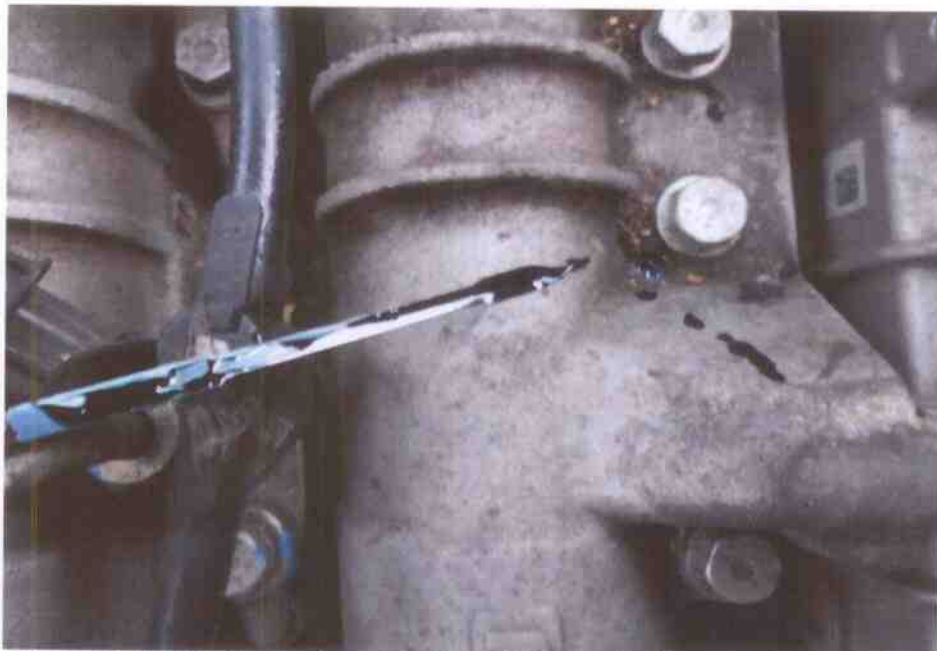
Photo 16 shows the engine dip stick of the Motor Bus at the time of my inspection. The engine oil was observed to be of sufficient level and without any visible contamination.

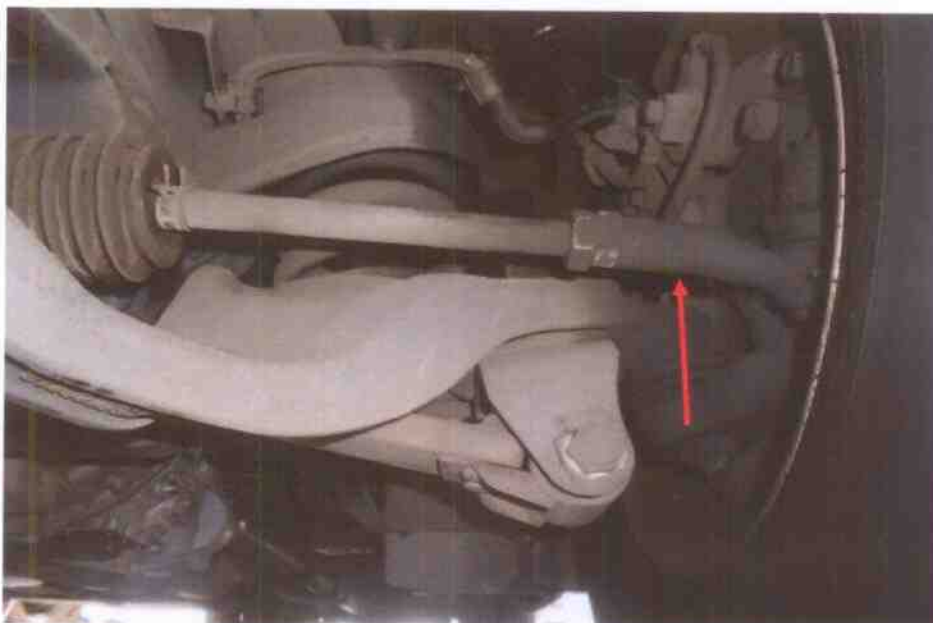
Photo 17 shows the various undercarriage components at the front right wheel of the Motor Bus, in particular the steering tie rod end (arrowed). The various steering mechanical components were all found to be intact, suggesting that the steering system of the Motor Bus was likely to be in serviceable condition.

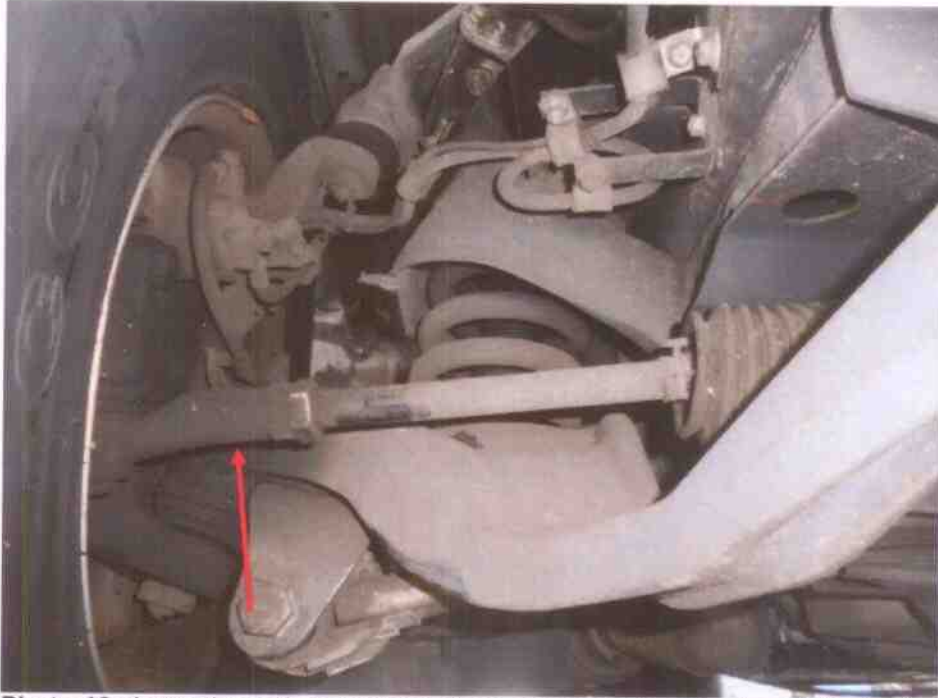
Photo 18 shows the various undercarriage components at the front left wheel of the Motor Bus, in particular the steering tie rod end (arrowed). The various steering mechanical components of the Motor Bus were all found to be intact without any visible damage. There was also no sign of fluid stain(s) observed on the various undercarriage components.

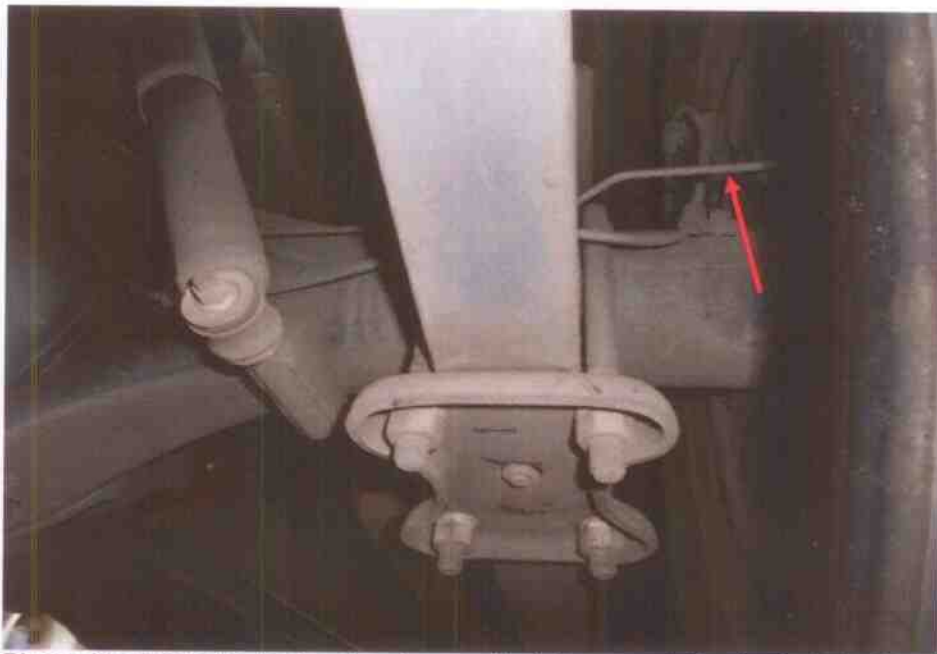
Photo 19 shows the brake pipe (arrowed) at the rear right wheel of the Motor Bus. I did not observe any leakage of brake fluid at the time of my inspection of the Motor Bus.

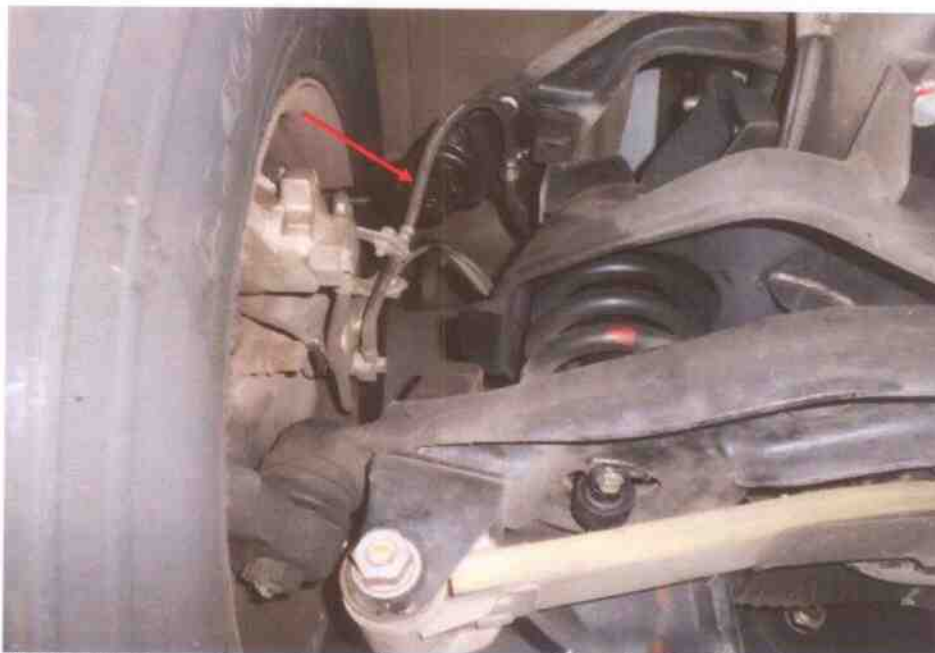
Photo 20 shows the undercarriage components at the front right wheel of the Motor Bus, in particular the brake hose (arrowed). The Motor Bus's braking system was likely to be in serviceable condition at the material time of accident as my visual examination of the various mechanical parts in the braking system did not produce any observations that had suggested otherwise. This was also taking into consideration that the brake fluid was of sufficient level and without any visible contamination.
