LKK Auto Consultants Pte Ltd

VEHICLE DAMAGE INSPECTION REPORT

ACCIDENT DAMAGED VEHICLE INSPECTION REPORT

ADJUSTMENT ON REPAIR COST FOR VEHICLE NO. SLJ 9040E

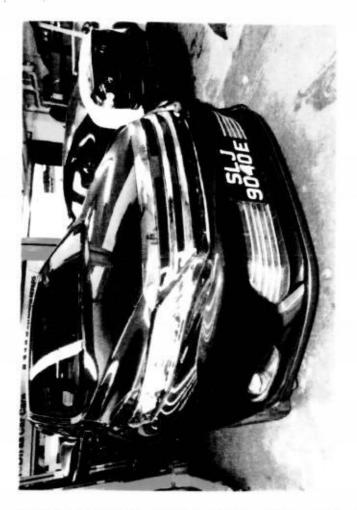
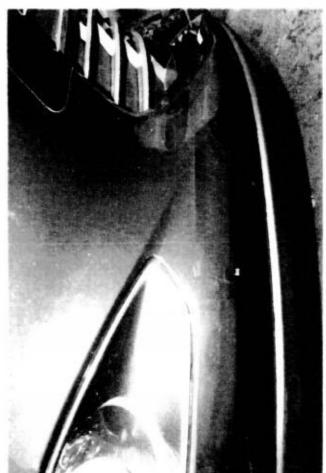
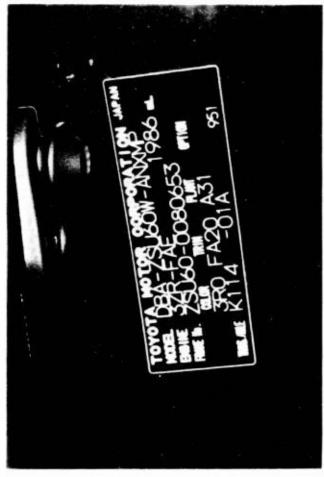
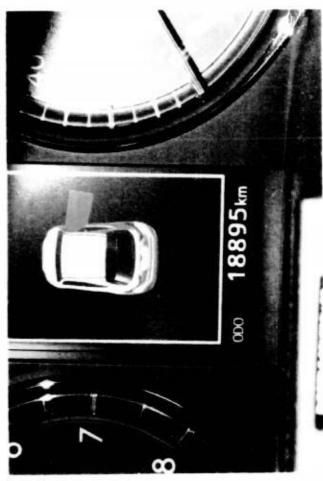
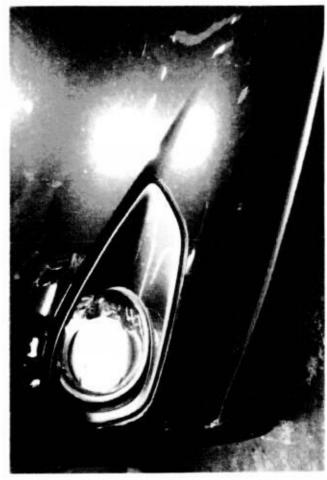
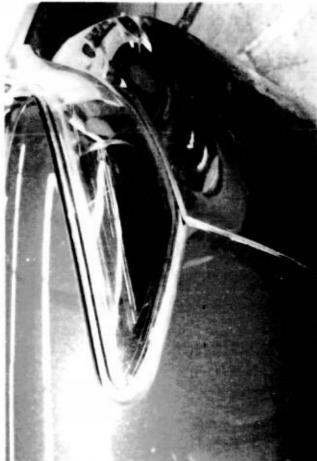
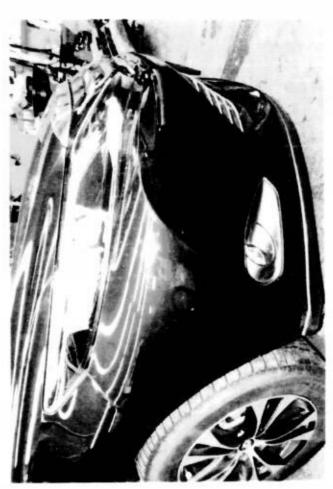
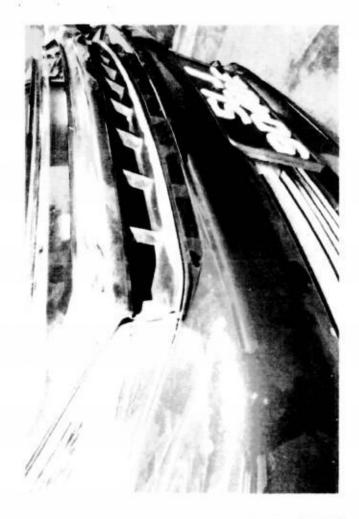
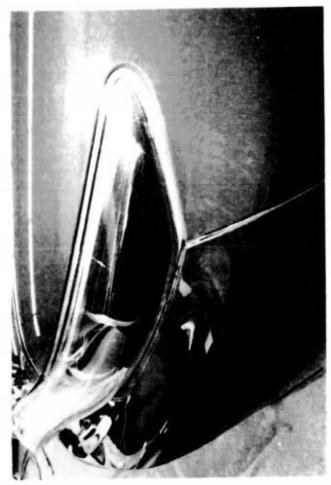
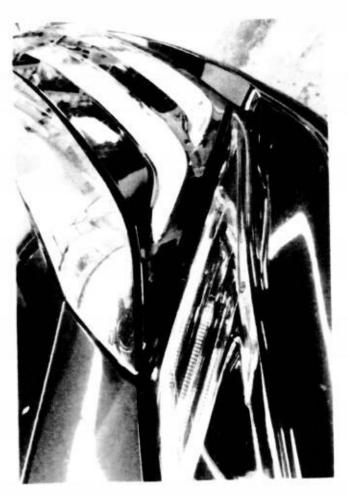
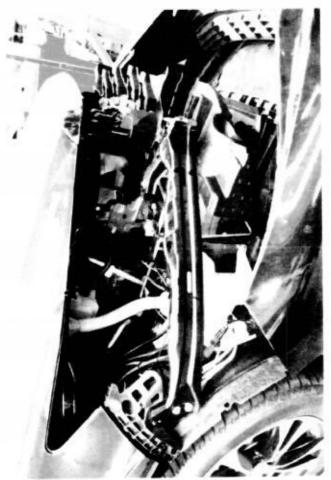
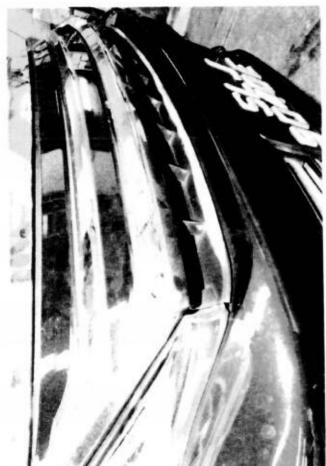
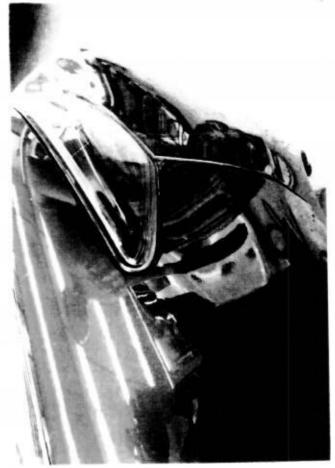
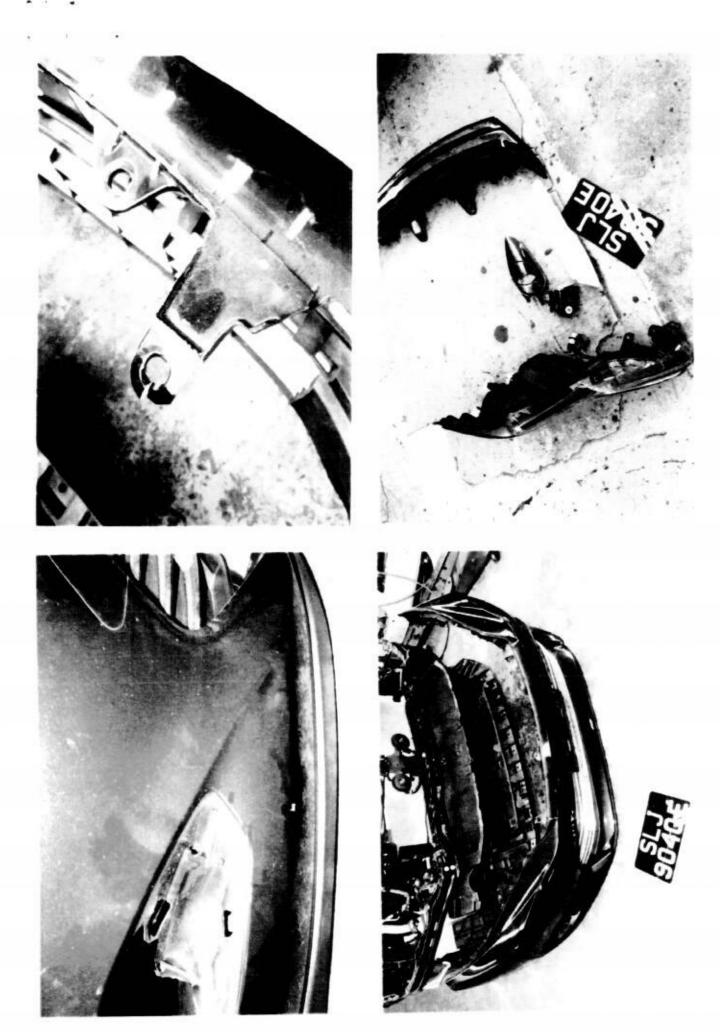
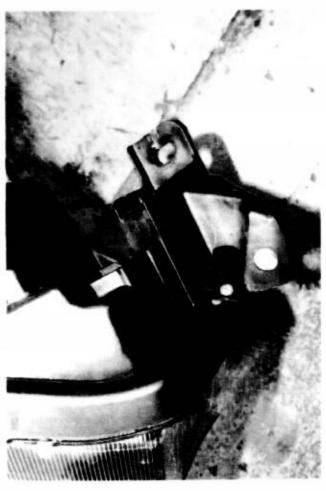
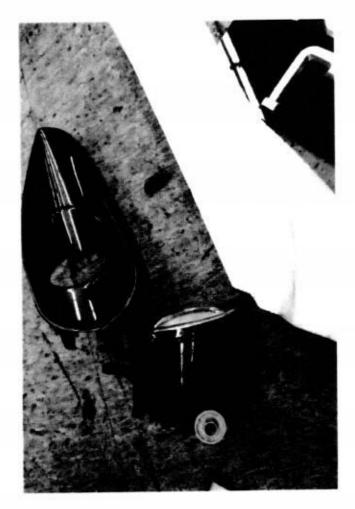
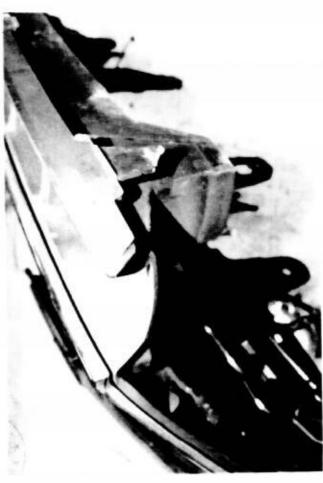
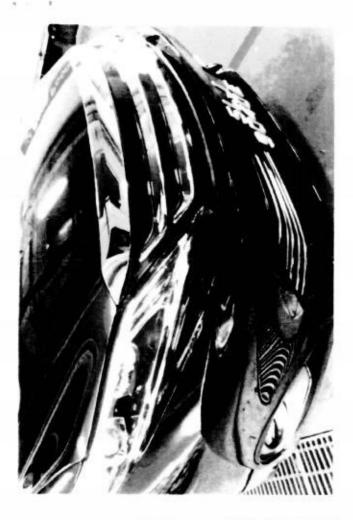
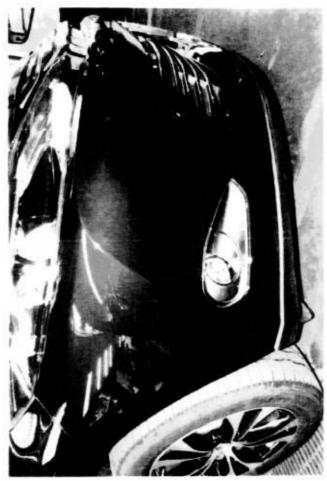
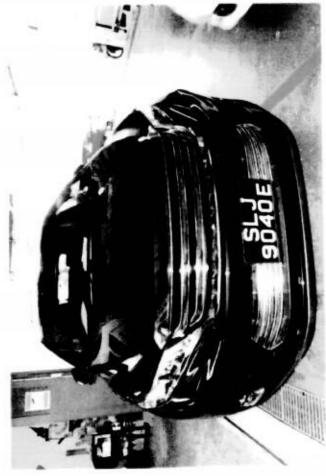
The vehicle sustained damage at the front off side portion. For details, refer to assessment for repairs and photographs

Enclosed Twenty-Eight (28) photographs depicting damage to the vehicle and after repair.

The damages appeared to be consistent as per the accident report statement.

Our assessment of the repair costs to pre-accident condition was \$5,100.00 nett at lump sum basis. (Subject to GST if applicable)

Under normal circumstances, estimated period required for repairs: Four (4) working days.
