Your Ref: TP/IP/35431/2017
Our Ref : CI/TPD17021951/D

Fatal Accident Investigation Team

MECHANICAL INSPECTION REPORT OF MOTOR CAR SJG 2498D

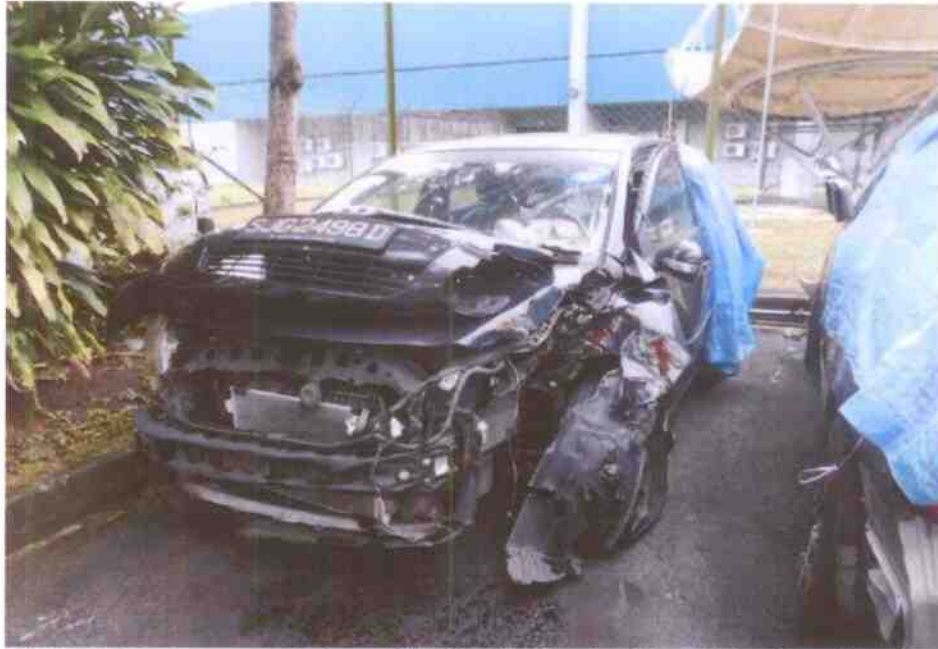
Photo 1 shows a general view of the front left body of the Motor Car at the time of my inspection. The Motor Car was observed to have sustained extensive impact damage at its left front body. The impact force was relatively significant causing severe damage to its front bumper, front left headlamp, front left fender, front left wheel house, front bonnet and front left door amongst others.

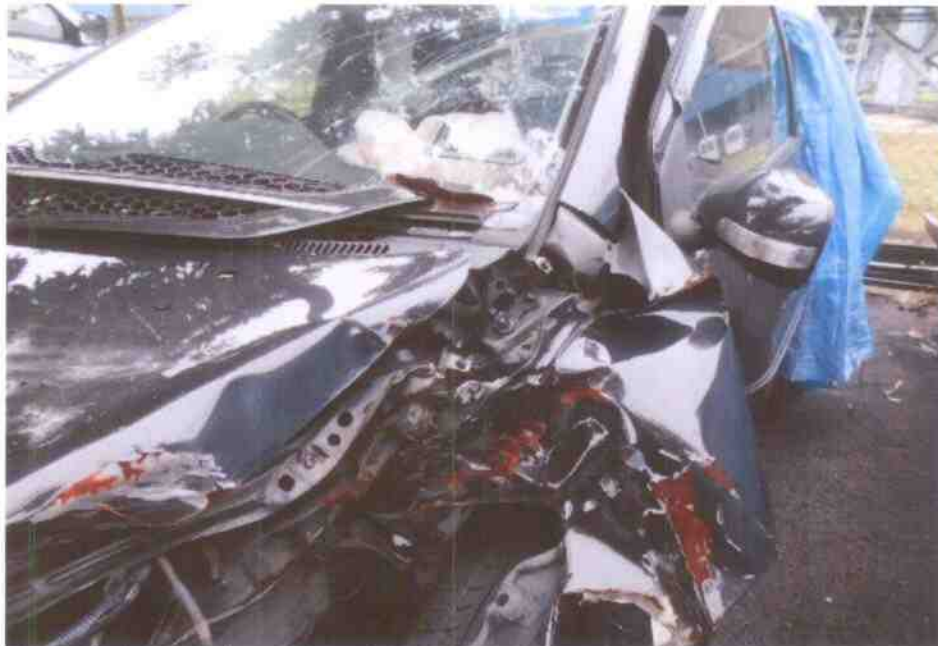
Photo 2 shows a closer view of the extent of damage at the left front body of the Motor Car. Its front bonnet, front left fender, front left wheel house and front left door were amongst the body parts that were severely damaged as a result of the impact force.

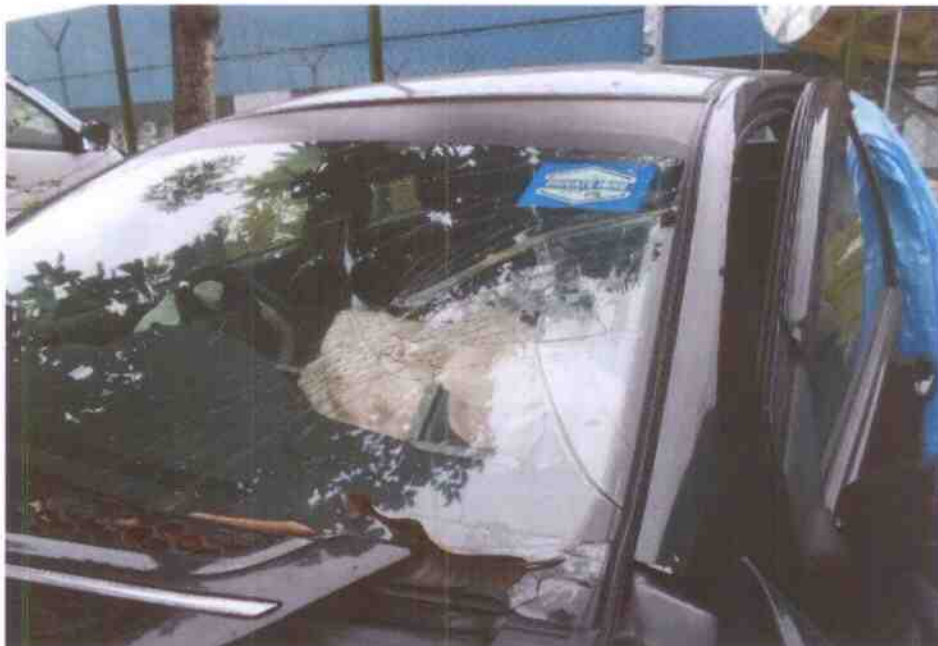
Photo 3 shows the front windscreen of the Motor Car cracked at the left side. Its front airbags were also activated as a result of the accident.

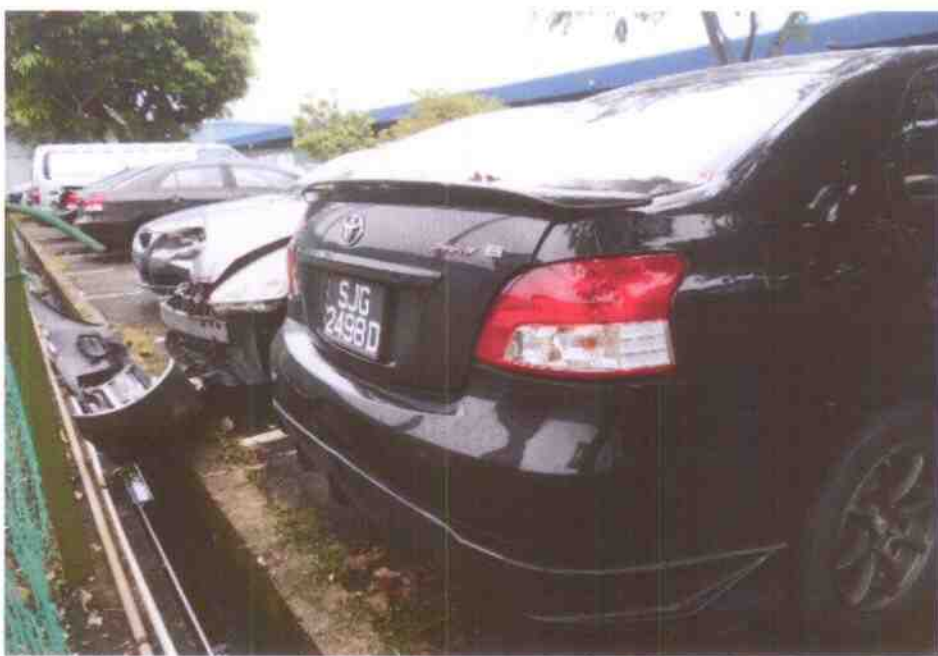
Photo 4 shows a general view of the rear body of the Motor Car. The rear body and right side body of the Motor Car were observed to be unaffected from the accident.

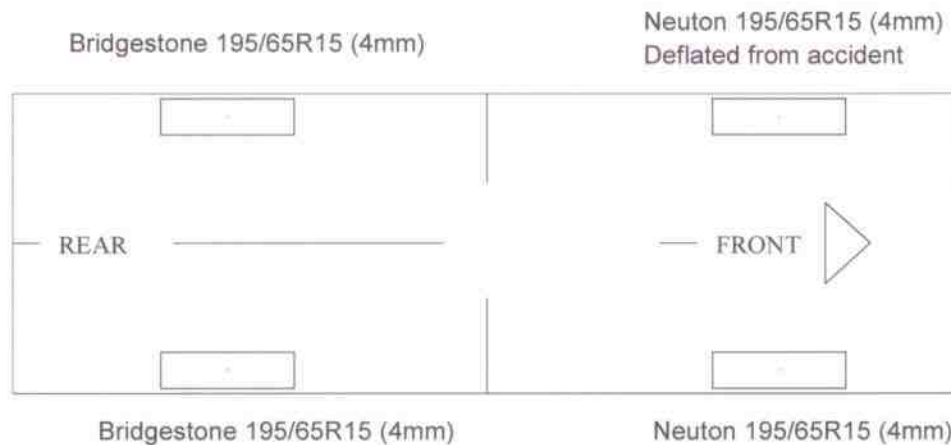
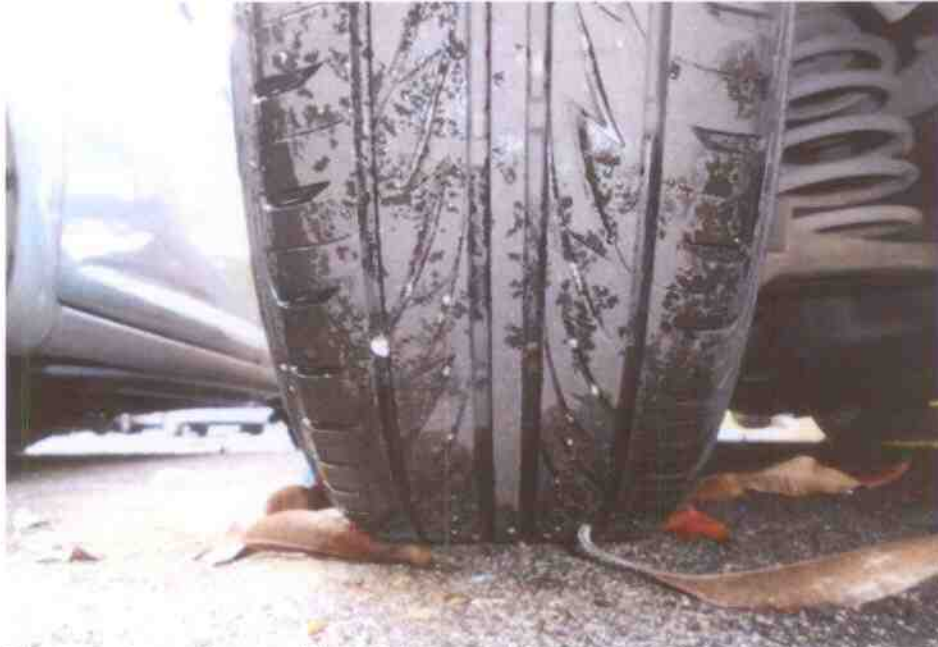
Photo 5 shows the condition of the rear left tyre of the Motor Car, which was observed to be in serviceable condition with remaining tread depth of approximately 4mm. There was no tear, cut or burst mark(s) on the outer and the inner sidewalls as well as across the tread of this tyre. The tyre, which was wrapped around alloy wheel rim, was also observed to be sufficiently inflated for vehicular operation.

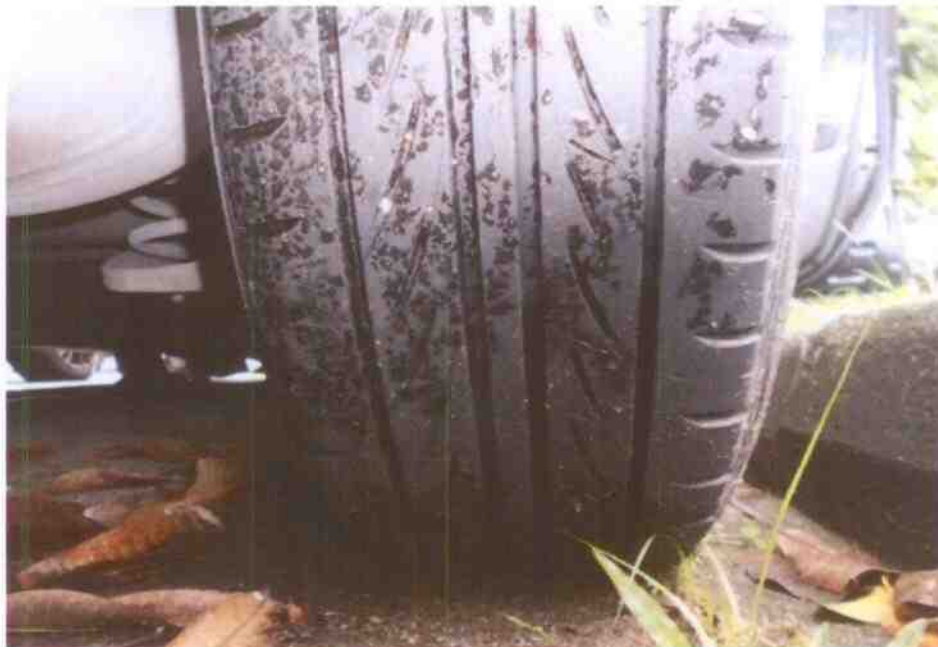
Photo 6 shows the condition of the rear right tyre of the Motor Car, which was observed to be in serviceable condition with remaining tread depth of approximately 4mm. There was no tear, cut or burst mark(s) on the outer and the inner sidewalls as well as across the tread of this tyre, which was sufficiently inflated for vehicular operation.

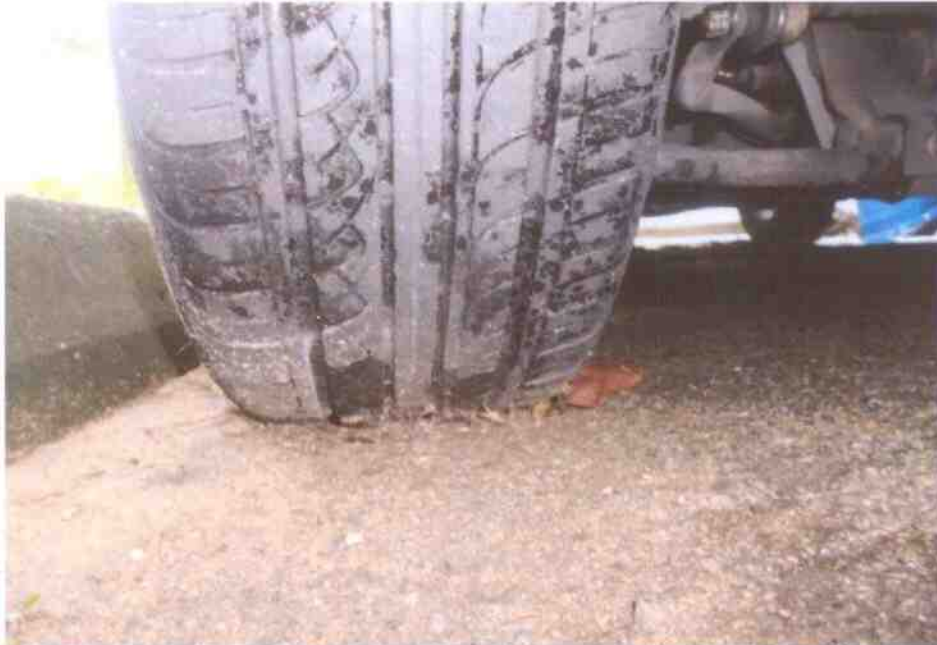
Photo 7 shows the condition of the front right tyre of the Motor Car, which was observed to be in serviceable condition with remaining tread depth of approximately 4mm. There was also no tear, cut or burst mark(s) on the outer and the inner sidewalls as well as across the tread of this tyre. The tyre, which was wrapped around a wheel rim, was also observed to be sufficiently inflated for vehicular operation.

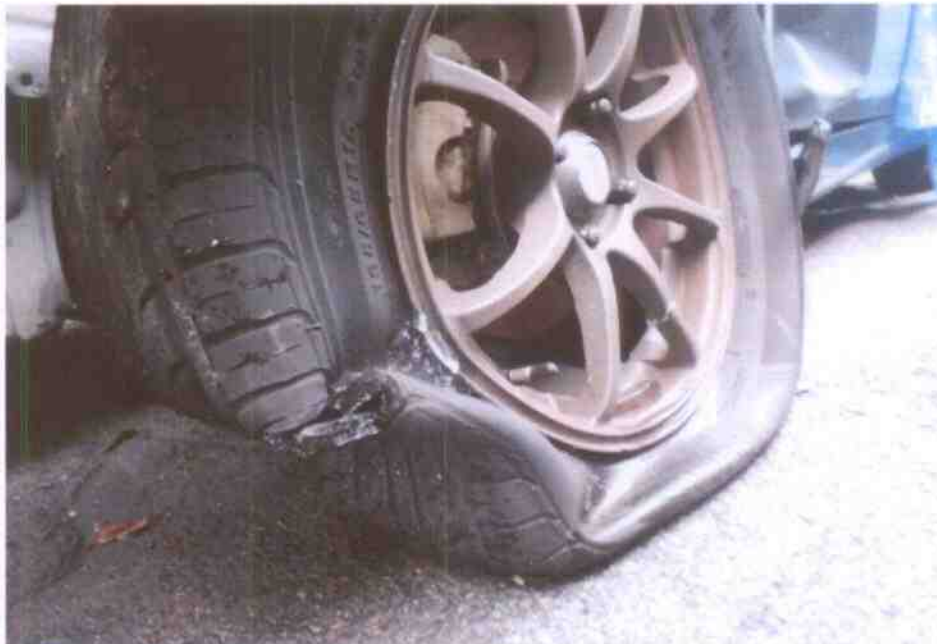
Photo 8 shows the condition of the front left tyre of the Motor Car, which was observed to be in serviceable condition with remaining tread depth of approximately 4mm. The tyre, which was wrapped around alloy wheel rim, was observed to be cut and deflated as a result of the accident.

19. The 4 tyres of the Motor Car were found to be in serviceable condition with remaining tread depth of approximately 4mm each. This had included the front left tyre, which was cut and deflated as a result of the accident.

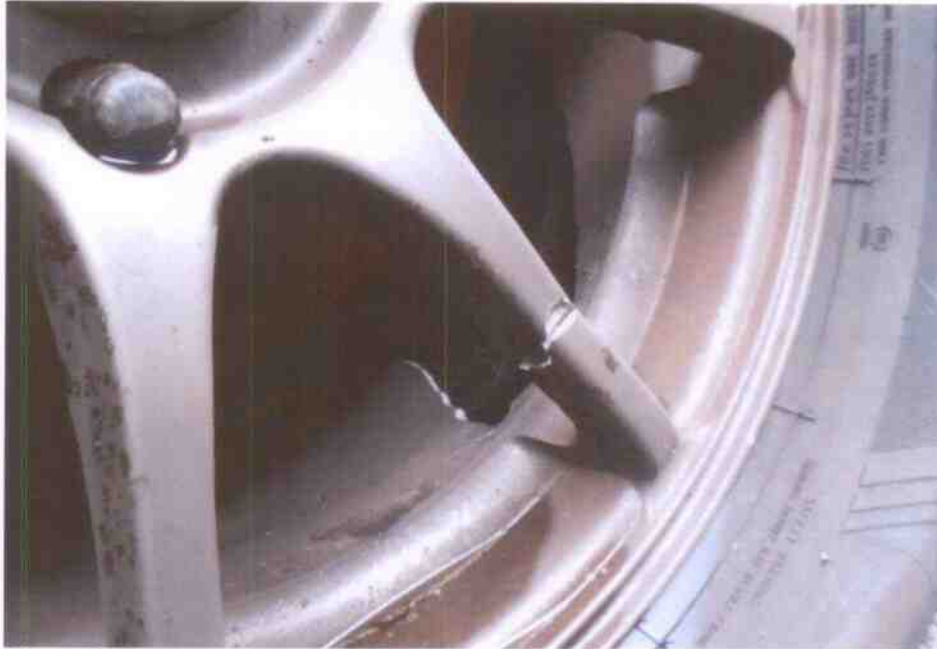
Photo 9 shows the front left wheel rim of the Motor Car was also cracked and broken as a result of the accident. The remaining 3 wheel rims were found to be without any significant damage.

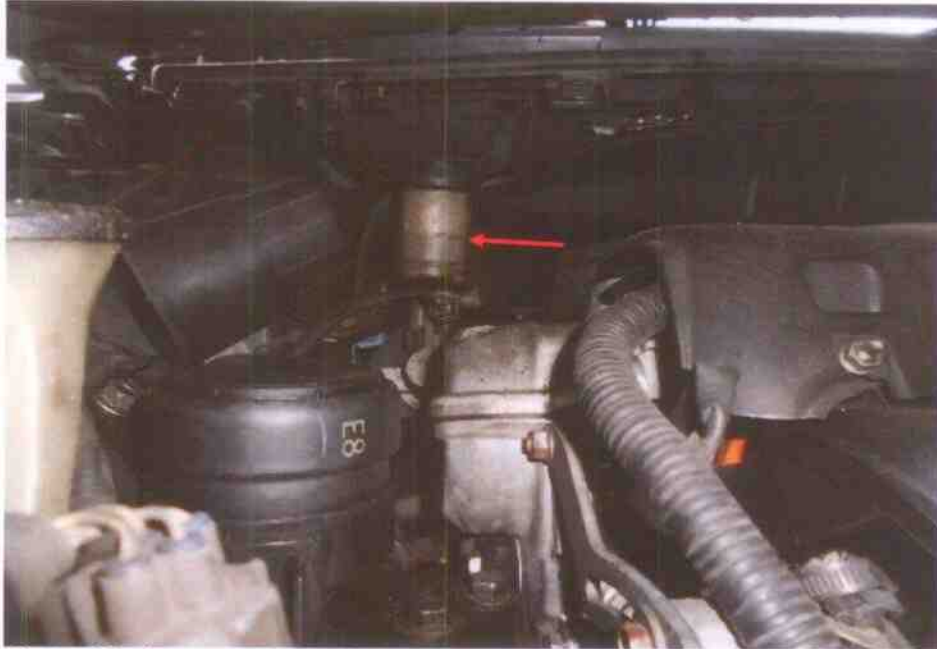
Photo 10 shows the brake fluid reservoir of the Motor Car at the time of my inspection. The brake fluid was observed to be of sufficient level for operating purposes. This was observed from gaps around the front bonnet given that the front bonnet could not be lifted for me to check the Motor Car's engine compartment.

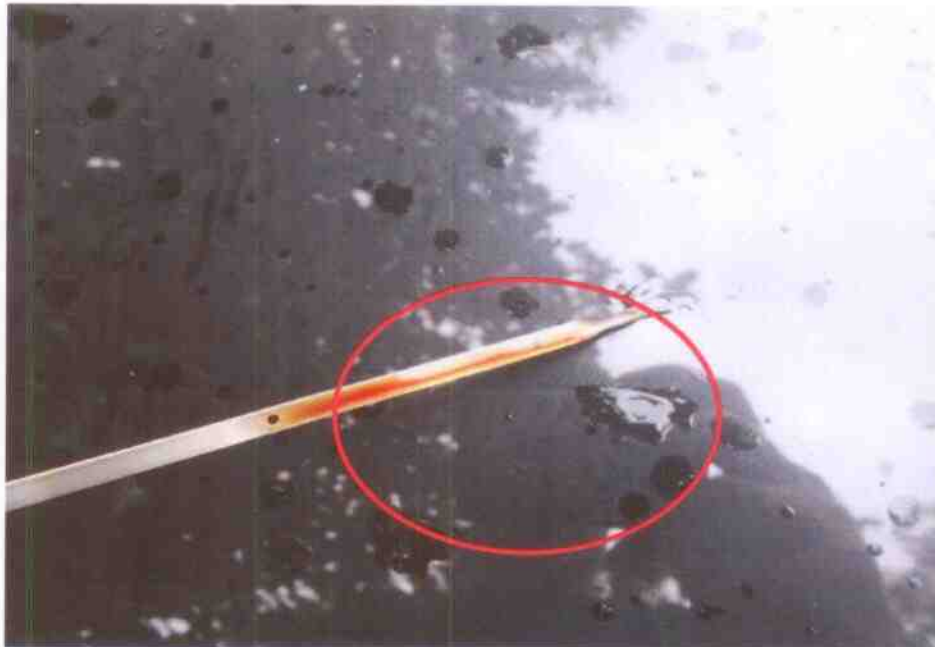
Photo 11 shows the engine oil dip stick of the Motor Car. I was able to pull the engine oil dip stick from the gaps around the front bonnet. The engine oil of the Motor Car was found to be sufficient level and without contamination for operating purposes.

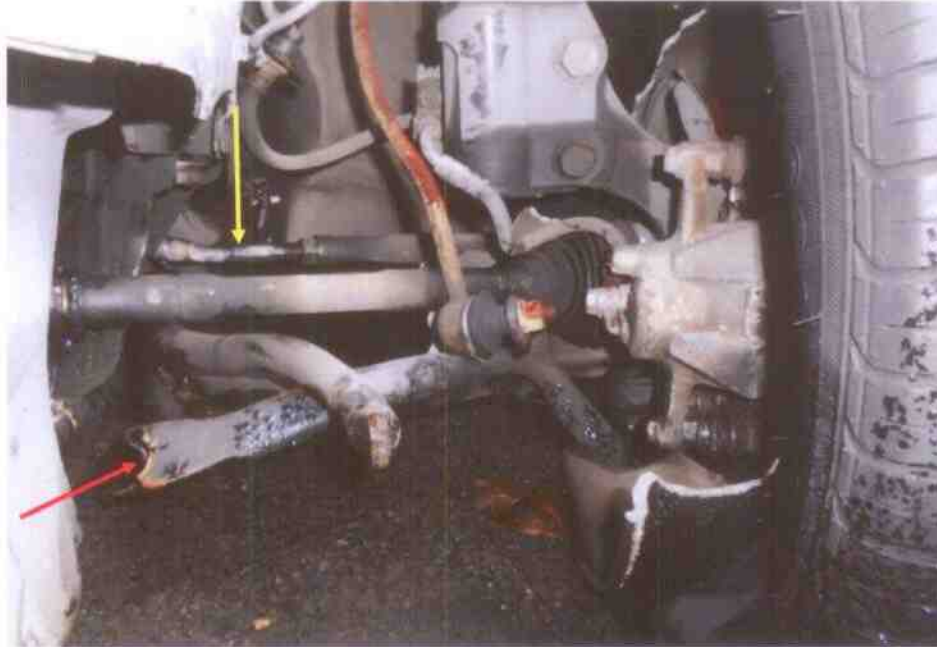
11. My subsequent checks on the underside of the Motor Car revealed damage to the undercarriage components at the front left wheel of the Motor Car. Components like the front left suspension, front left lower arm, front left drive shaft, front left steering tie rod and front stabilizer bar were all damaged. See photo 10 – 15 below.

Photo 12 shows the undercarriage components at the front left wheel of the Motor Car. My checks on the underside of the Motor Car revealed damage to the undercarriage components at the front left wheel of the Motor Car. Components like the front left suspension, front left lower arm (red arrow), front left drive shaft, front stabilizer bar and front left steering tie rod (yellow arrow) were all found to be have been damaged.

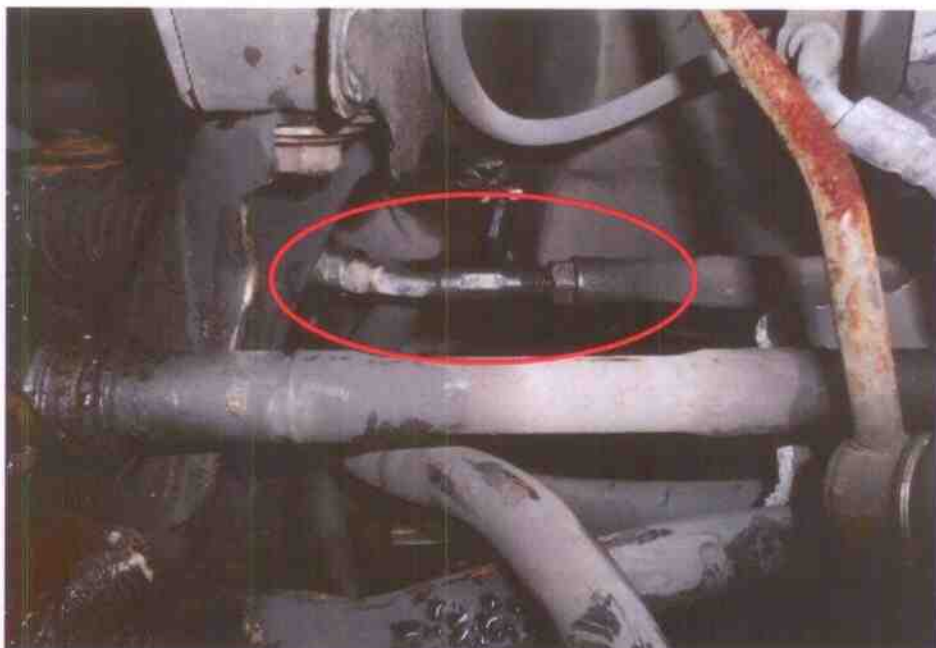
Photo 13 shows the bent steering tie rod (circled) at the front left wheel of the Motor Car. I was not able to conduct any tests on the steering system of the Motor Car due to the damage to the steering tie rod and other undercarriage components at the front left wheel of the Motor Car.

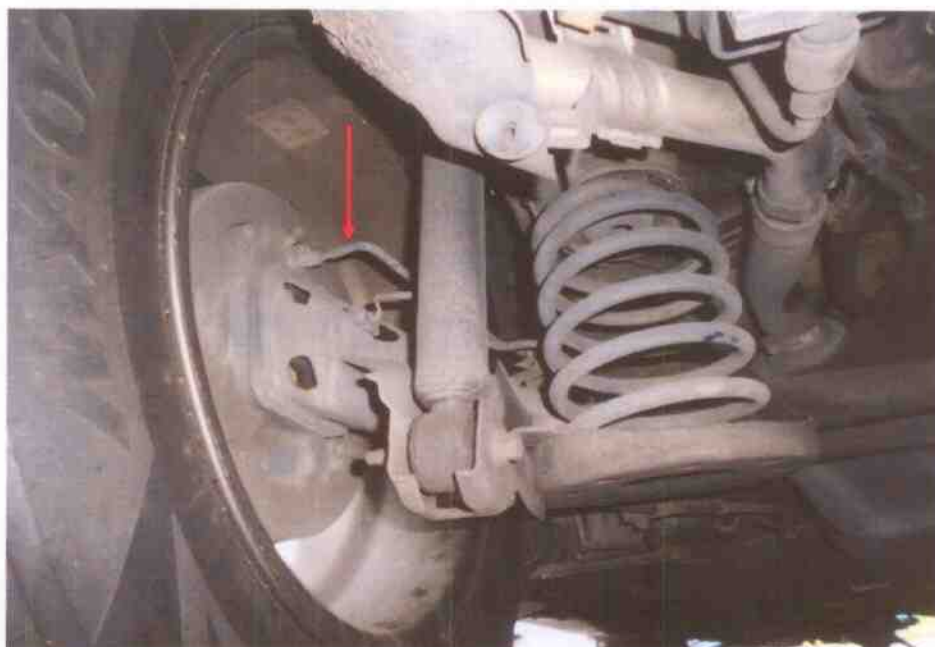
Photo 14 shows the brake pipe (arrowed) at the rear left wheel of the Motor Car. I did not observe any leakage of brake fluid at the time of my inspection of the Motor Car. My visual examination of the mechanical parts of the braking system like the brake booster, brake pipes/hoses and brake pedal revealed all the parts to be intact and undamaged. The braking system of the Motor Car was therefore likely to be in serviceable condition at the material time.

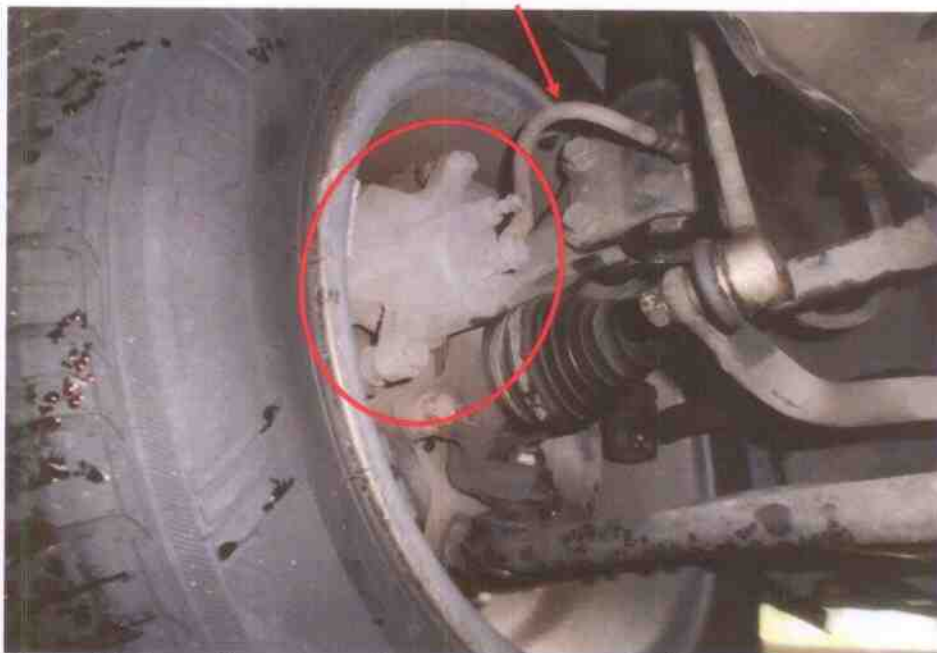
Photo 15 shows the undercarriage components at the front right wheel of the Motor Car, in particular the brake hose (arrowed) and brake caliper (circled). The Motor Car's braking system was likely to be in serviceable condition at the material time of accident as my visual examination of the various mechanical parts in the braking system did not produce any observations that had suggested otherwise. This was also taking into consideration that the brake fluid was of sufficient level for operating purposes.

18. The braking system of the Motor Car was however likely to be in serviceable condition given that my visual examination of the various mechanical parts in the braking system revealed all the parts to be intact and undamaged. This was also taking into consideration that the brake fluid was of sufficient level for operating purposes.
