### INVESTIGATION REPORT:

Our Ref : CS3/AIG17021962/N  
Policy No : 2100489527  
Insured : SJL 332K  
Date of Accident : 16 November 2017  
Location : Open carpark of Block 123 Teck Whye Lane

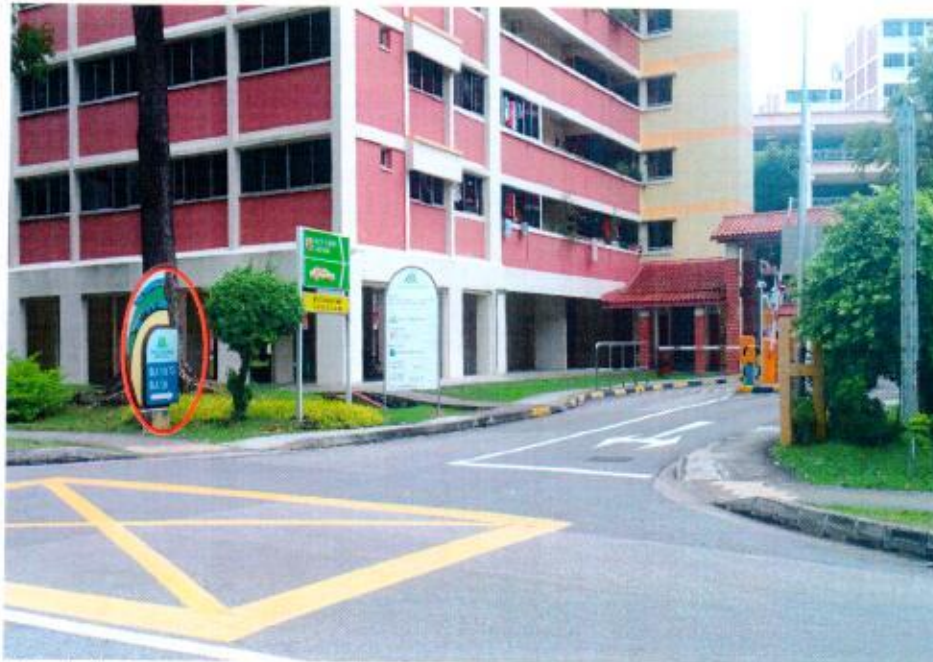
**Photo 1** shows the entrance to the open carpark which bears carpark number CKCK3, serving blocks 118 to 124 of Teck Whye Lane (circled).

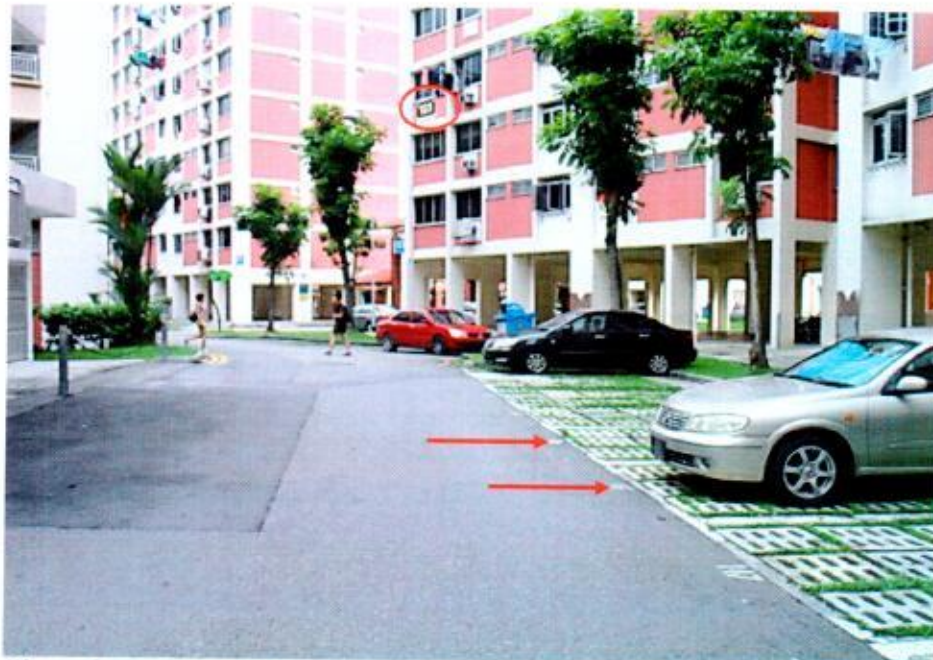
**Photo 2** shows lots 145 & 146 (red arrows) located in front of Block 123 where the Van and Citroen were parked at the day and time of the accident

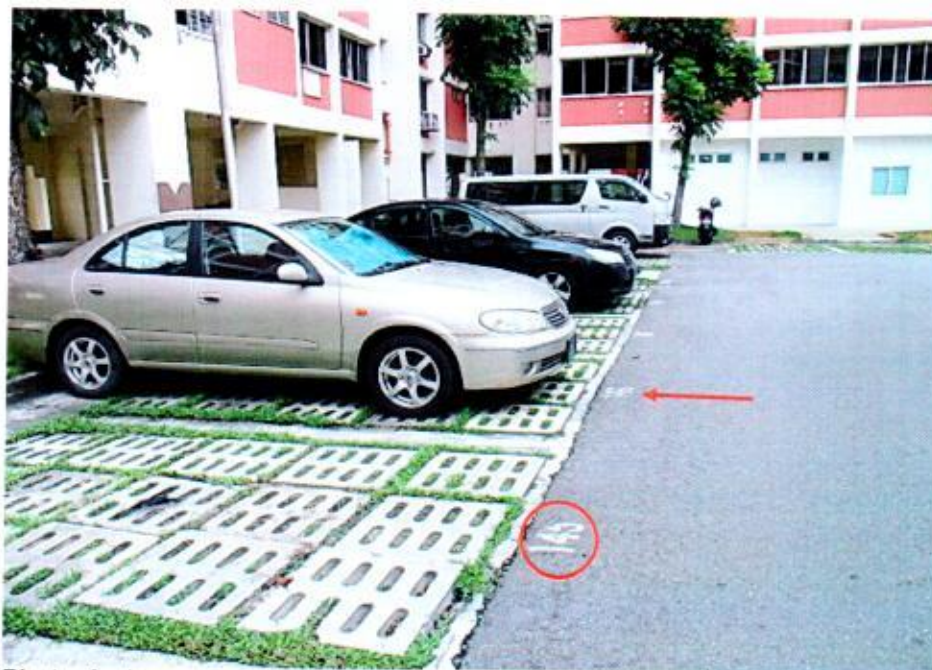
**Photo 3** shows upon closer inspection of lot 145 (circled) and the immediate surrounding area where the Van was parked on the morning of the accident, we could not find any broken plastic parts and/or vehicular debris on the ground. We were unable to conduct a closer inspection of lot 146 where the Citroen was parked at the respective date and time of the accident as there was a parked vehicle at the aforementioned lot (arrowed). We also did not observe any damage or newly replaced government property at the time of our visit to the incident location.

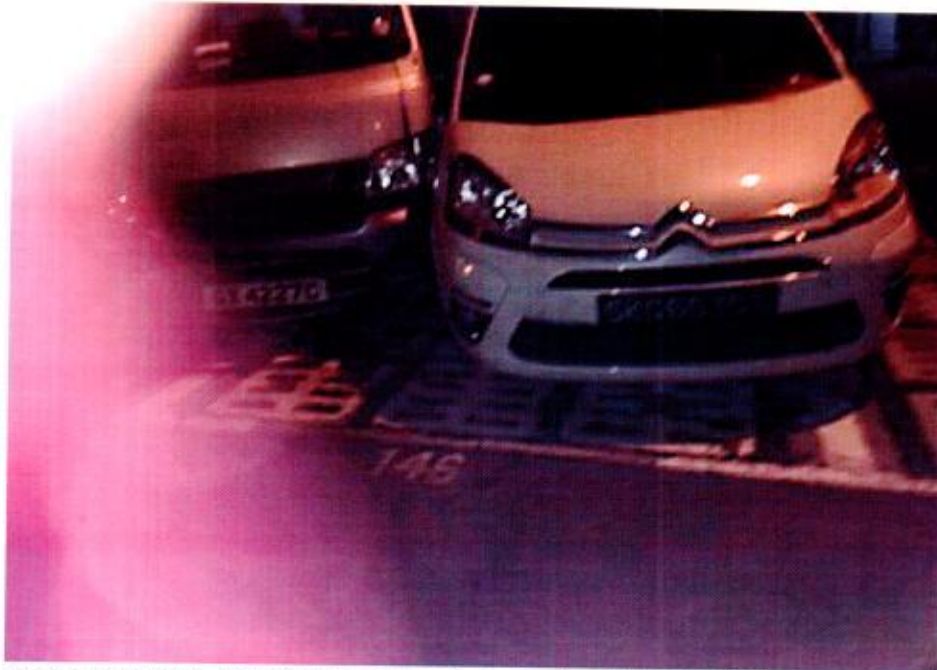
20. Our review of the post- accident photographs taken by Mr Ang seem to correlate with his account of the accident. The impact of the collision to the right front portion of the Van caused the Van to hit the right front portion of the Citroen. Upon closer examination of these photographs, we observed that the Van had sustained damages to its front bumper which was slightly dislodged while the Citroen sustained dents and paint graze marks on its right front panel as well as some relatively minor marks of grazing nature on the edges of the front right wheel rim. See photos 4 - 6 below.

**Photo 4** shows the final position of the parked Van and Citroen after the accident. The impact of the collision to the right front portion of the Van caused the Van to hit the right front portion of the Citroen.

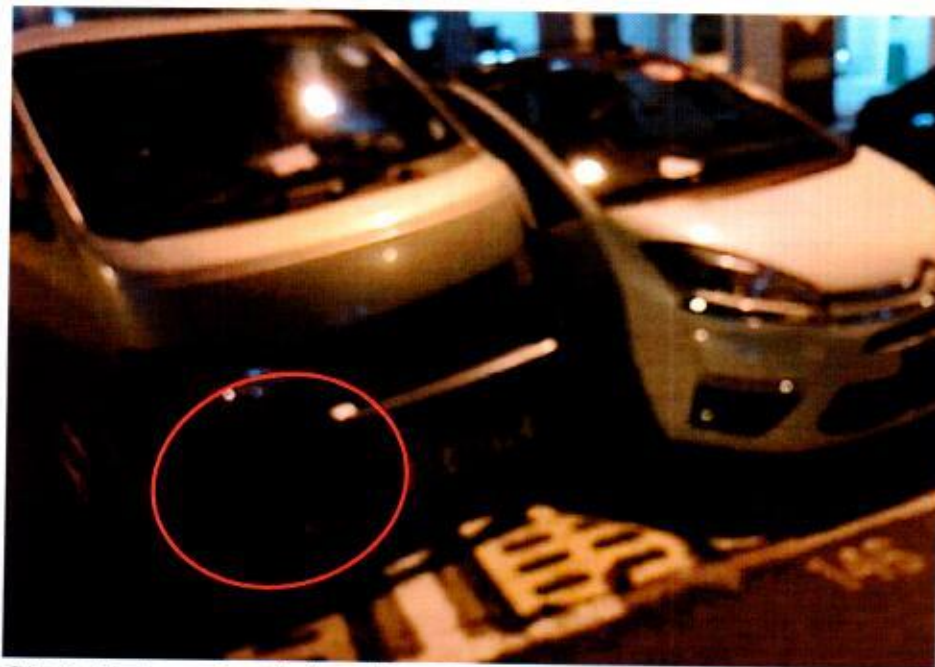
**Photo 5** shows the final position of the parked Van and Citroen after the accident. We observed that the Van had sustained damages to its front bumper which was slightly dislodged (circled) as a result of the impact.

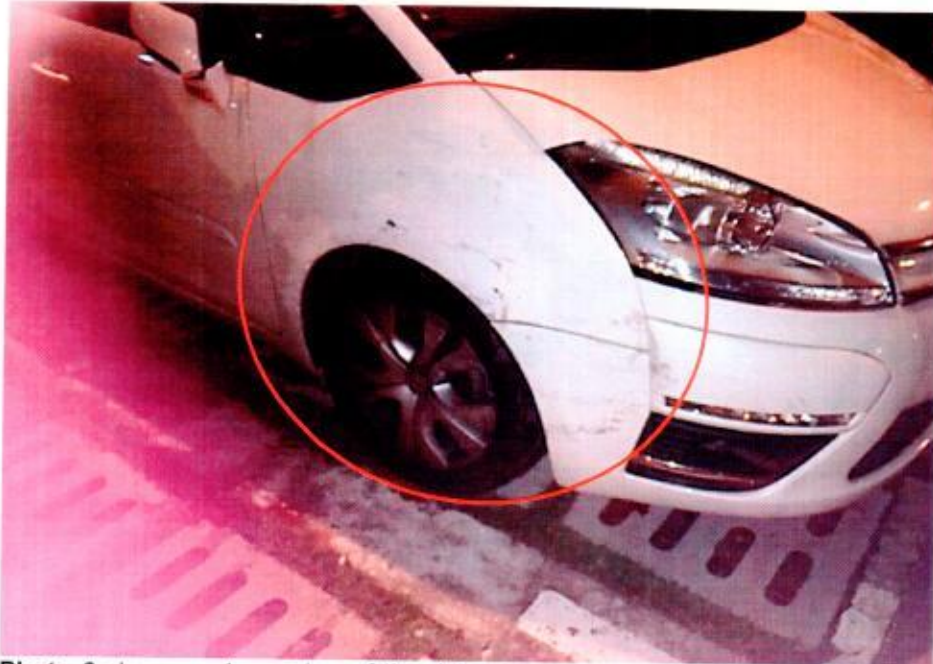
**Photo 6** shows a closer view of the right side of the Citroen post- accident. We observed that the Citroen sustained dents and paint graze marks on its right front panel as well as some relatively minor marks of grazing nature on the edges of the front right wheel rim (circled).

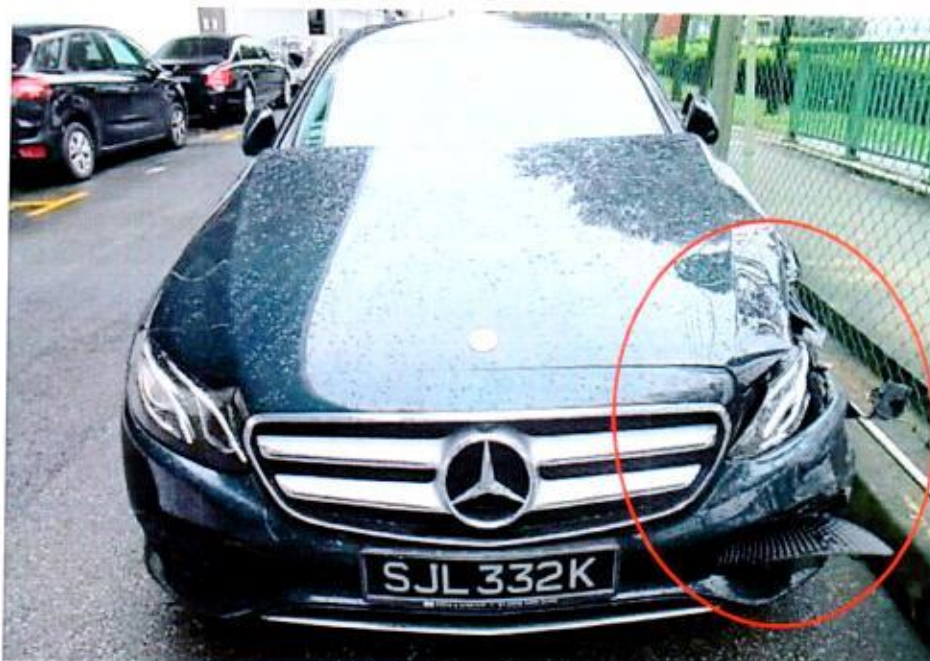
21. Since Mr Ang did not take any photographs of the damages to the Insured Vehicle post- accident, we reviewed the photographs showing the Insured Vehicle at the time of accident reporting at C&C Pandan Loop which were taken on the next day after the accident. Our close examination of these photographs revealed that the Insured Vehicle had sustained significant damages to its front left portion, particularly to its left headlight, front bumper, left front panel and front left wheel rim. The left headlight had cracked and paint graze marks were found on the front left portion of the front bumper which had buckled as a result of the accident. Some relatively minor marks of grazing nature were also observed on the edges of the front left wheel rim. These damages seem to corroborate with Mr Angs' statement in which the front left portion of the Insured Vehicle had collided with the right front portion of the parked Van. See photos 7 - 10 below.

**Photo 7** shows the general front view of the Insured Vehicle at the time of accident reporting at C&C Pandan Loop, taken on the next day after the accident. The Insured Vehicle had sustained damages to its front left portion (circled).

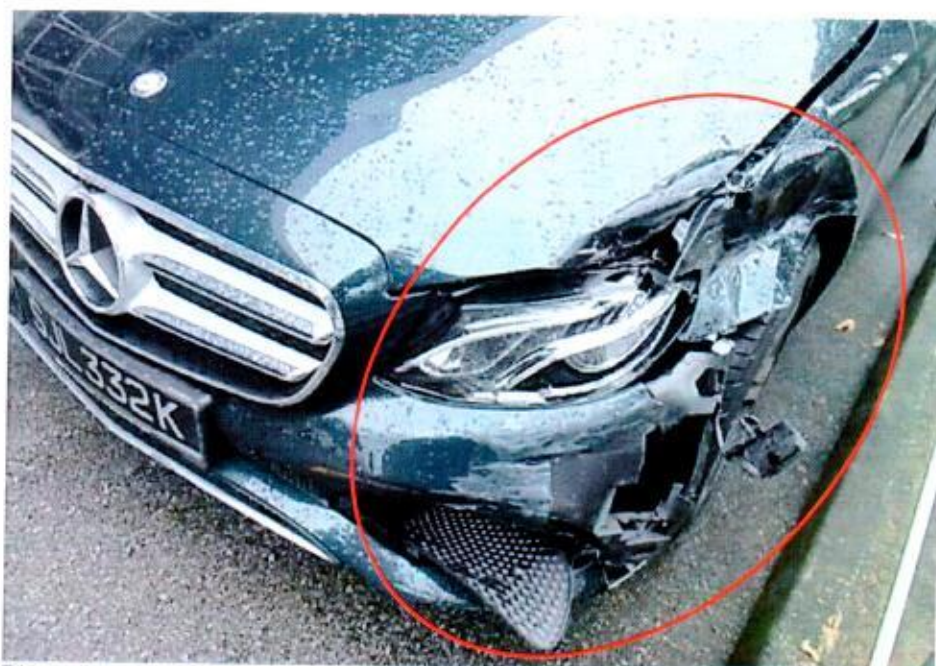
**Photo 8** shows a closer view of the damaged front left portion of the Insured Vehicle. The Insured Vehicle had sustained significant damages to its left headlight, front bumper and left front panel (circled).

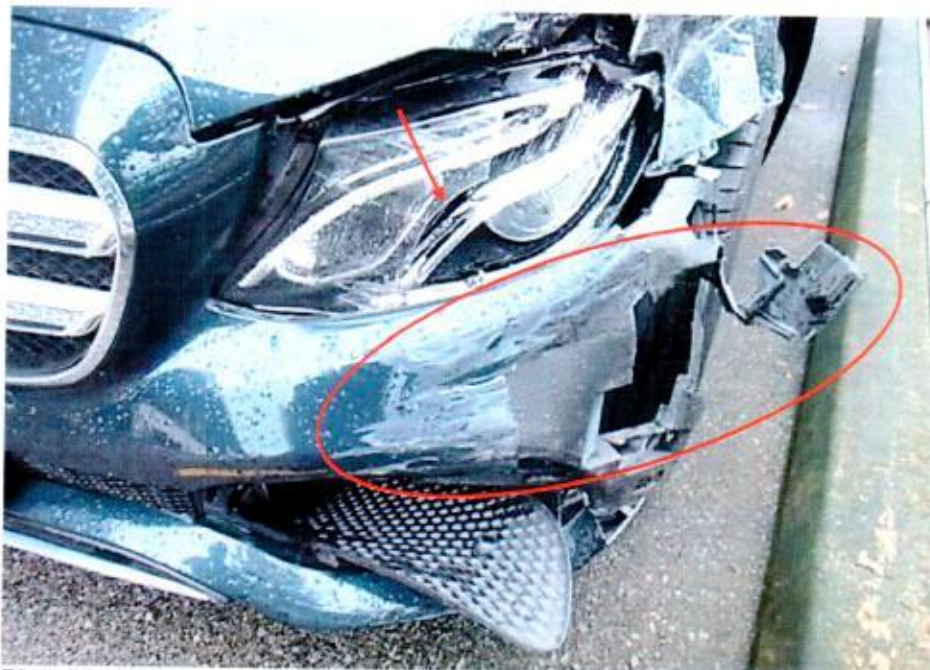
**Photo 9** shows a close up view of the cracked left headlight (arrowed) and paint graze marks found on the front left portion of the front bumper which had buckled as a result of the accident (circled).

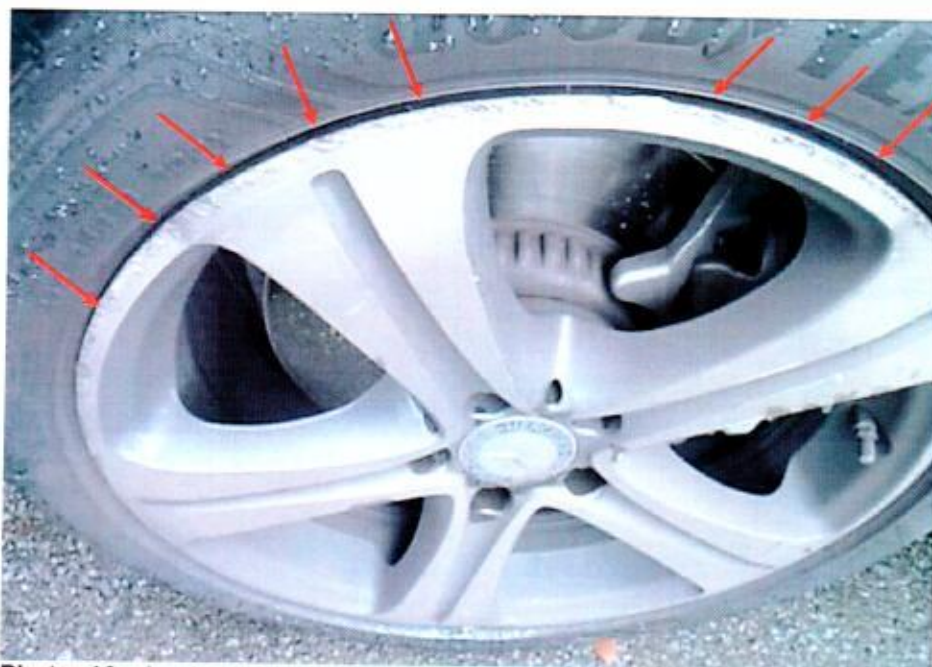
**Photo 10** shows a close up view of the relatively minor marks of grazing observed on the edges of the front left wheel rim (red arrows).
