Your Ref : 531386
Our Ref : CS3/MSG17018815/N

6 February 2108

**AUTOMOBILE TECHNICAL INVESTIGATION REPORT OF ACCIDENT
INVOLVING A MOTOR VAN GZ 2179K AND A MOTOR LORRY YN 1975K ON
28 SEPTEMBER 2017**

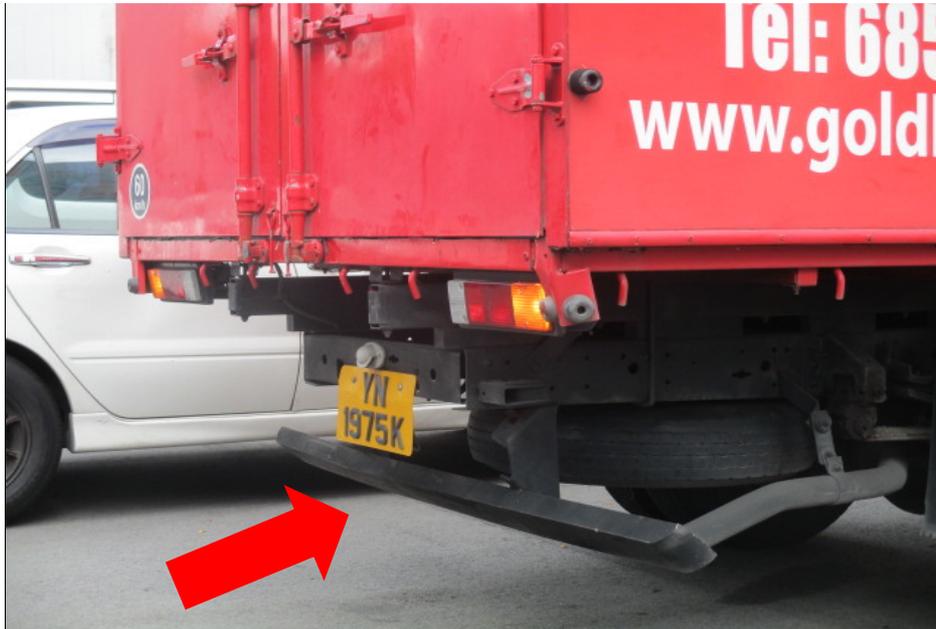
7. Since the front bumper of the Van is positioned at a height which is lower than the rear doors of the Lorry, it would have unlikely come into direct contact with the rear doors and the rear door lock mechanism of the Lorry. Additionally, it would have unlikely come into direct contact with the rear lower step panel of the Lorry. This is also supported by the height measurement test that we had carried out. See photos 1 - 4 below.

Photo 1 shows the rear portion of the Lorry at the time of our inspection. During the collision, the front bumper of the Van would have unlikely come into direct contact with the rear door lock mechanism or the rear lower step panel of the Lorry as the rear lower step panel is positioned slightly inwards from the rear doors of the Lorry (as indicated by the red arrow).

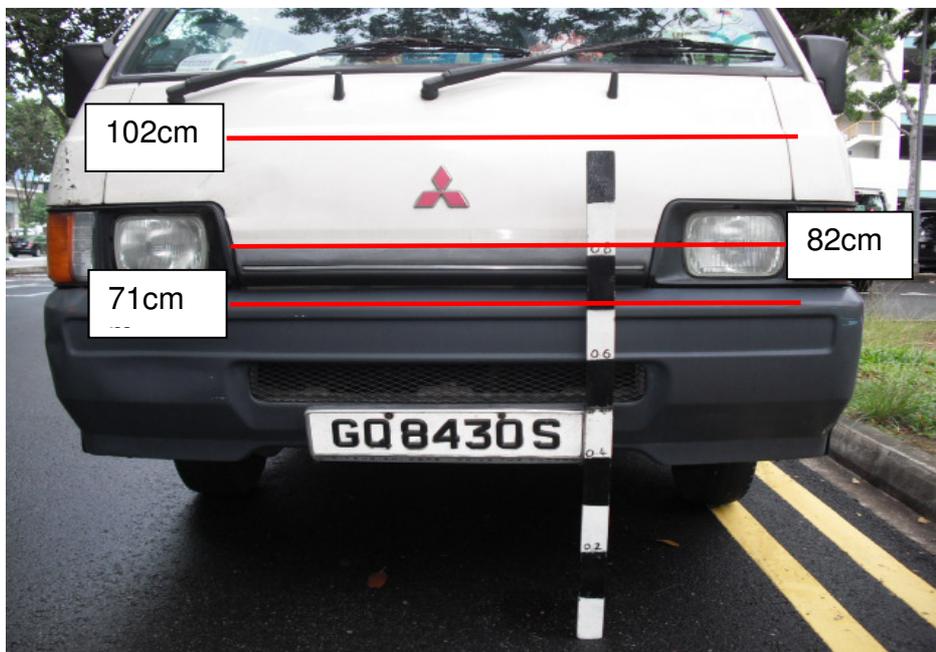
Photo 2 shows the height measurement being conducted on the front portion of the Van (using a similar make and model). The height range of the damages sustained to the centre portion of the front bonnet of the Van was between 82cm to 102 cm above ground level. The most protruded part of the front bumper of the Van was measured at 71cm above ground level.

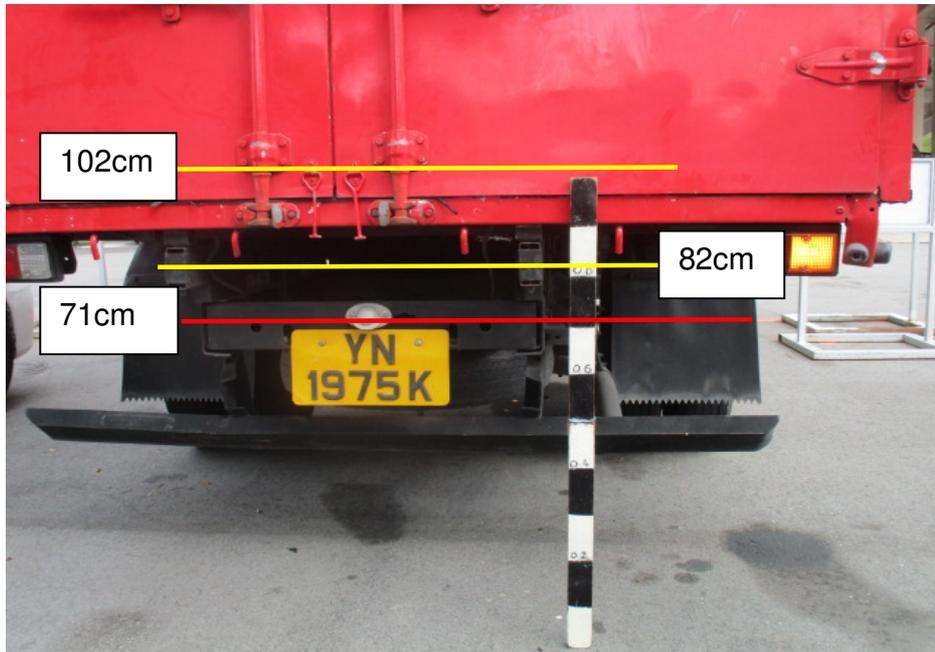
Photo 3 shows the height measurement being conducted on the rear portion of the Lorry. The height above ground level of the damaged centre portion of the front bonnet of the Van appear to correspond to the height above ground level of the rear doors and rear door locking mechanism of the Lorry (within the 82cm to 102cm range). The height of the most protruded part of the front bumper of the Van (71cm) is lower than the height above ground level of the rear doors and rear door locking mechanism of the Lorry.

8. Basing on our height measurement and the profile of the Lorry and the Van as discussed in paragraph 6, the damages to the front centre portion of the front bonnet of the Van was caused by the rear doors and rear door locking mechanism of the Lorry due to the collision from the Lorry. The rear lower step panel of the Lorry would have unlikely been able to come into direct contact with the front bumper of the Van.
9. The damages to the front bumper of the Van could not have been caused by the rear lower step panel of the Lorry as for this to occur, the rear lower step panel of the Lorry would have to be positioned directly below the rear doors of the Lorry. However photographs taken during the physical inspection and height measurements of the Lorry showed that the rear lower step panel of the Lorry was positioned slightly inwards from the rear doors of the Lorry.

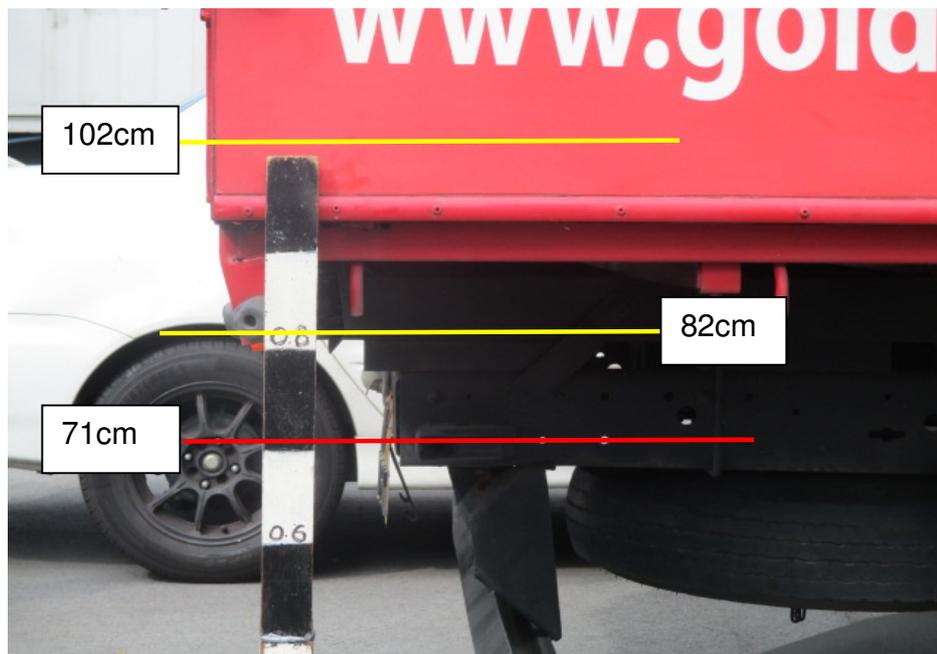
Photo 4 shows the height measurement being conducted on the right rear portion of the Lorry. The height above ground level of the damaged centre portion of the front bonnet of the Van appear to correspond to the height above ground level of the rear doors and rear door locking mechanism of the Lorry (within the 82cm to 102cm range). The height of the most protruded part of the front bumper of the Van (71cm) is lower than the height above ground level of the rear doors and rear door locking mechanism of the Lorry. It can also be seen that the rear lower step panel of the Lorry is positioned slightly inwards from the rear doors of the Lorry.
