**From:** Irene Tan <irene\_tan@sg.msg-asia.com>  
**Sent:** Friday, 15 December, 2017 4:06 PM  
**To:** KKLau; Bryan Ang (LKKAuto)  
**Cc:** Jason Sim; Veron Chen (LKKAuto); Shiao Chan (LKKAuto); Admin-D (LKKAuto)  
**Subject:** Mr Wilson Teo's survey on GZ2179K; Our claim no.: 531386/IT

We refer to your survey report dated 11.12.17 on the subject vehicle.

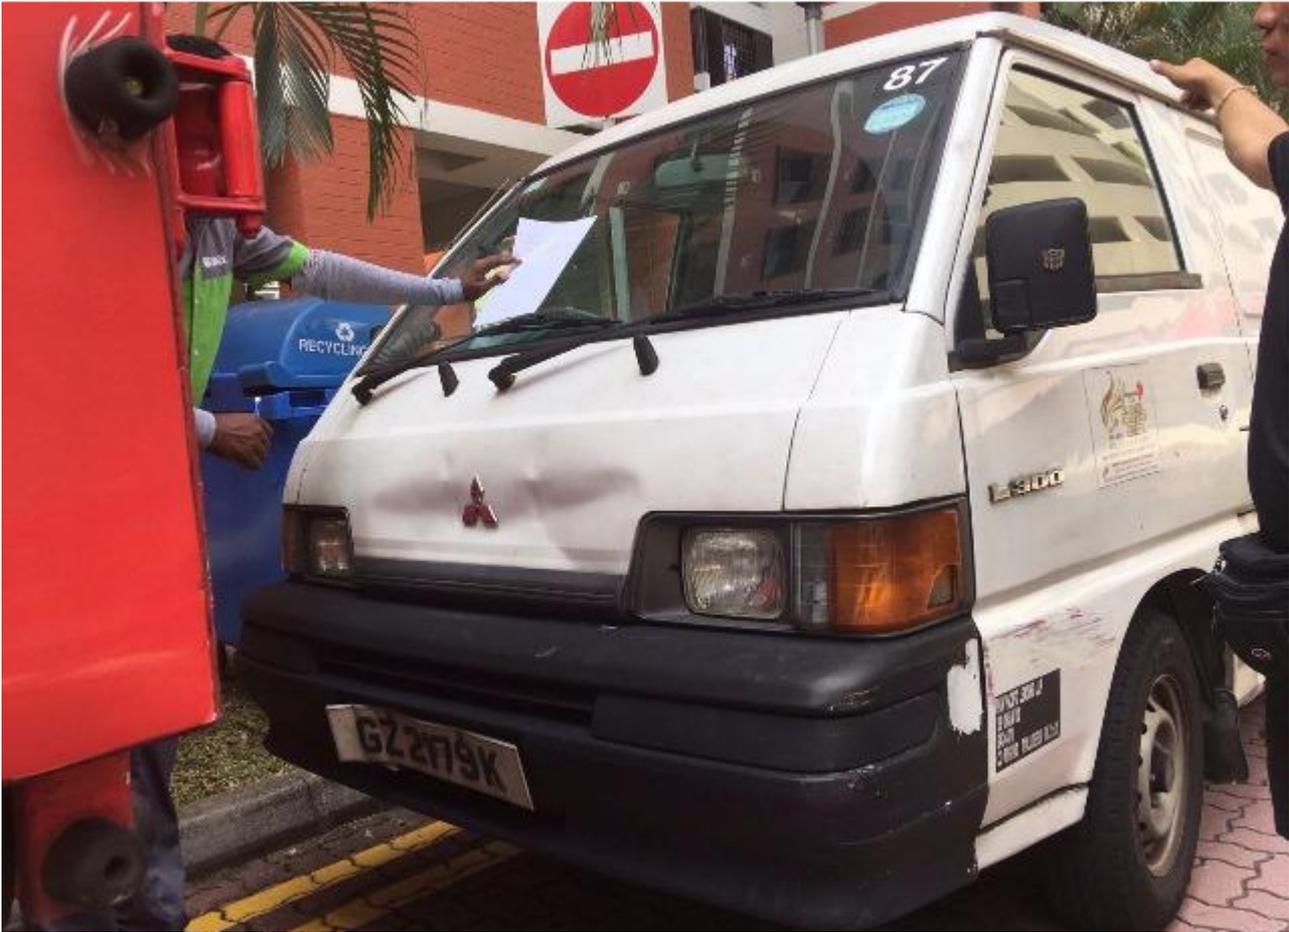
Accident Photo

Our insured driver reported that the front car plate no. and the front bumper/front bumper reinforcement were originally damaged as confirmed by the 3<sup>rd</sup> party's driver. Please see insured driver's statement below under caption no. 1. Therefore, both were not damaged by our insured and not consistent with the subject accident on 28.9.17.

We have also attached some accident scene pictures on both vehicles under caption no. 3. You can see more pictures attaching with the GIA reports of both parties.
