Your Ref : M537502
Our Ref : CS3/MSG17022255/N

25 March 2019

**AUTOMOBILE TECHNICAL INVESTIGATION REPORT OF ACCIDENT
INVOLVING A MOTOR CAR EZ 3663X AND A MOTOR LORRY YP 3664J ON 18
NOVEMBER 2017**

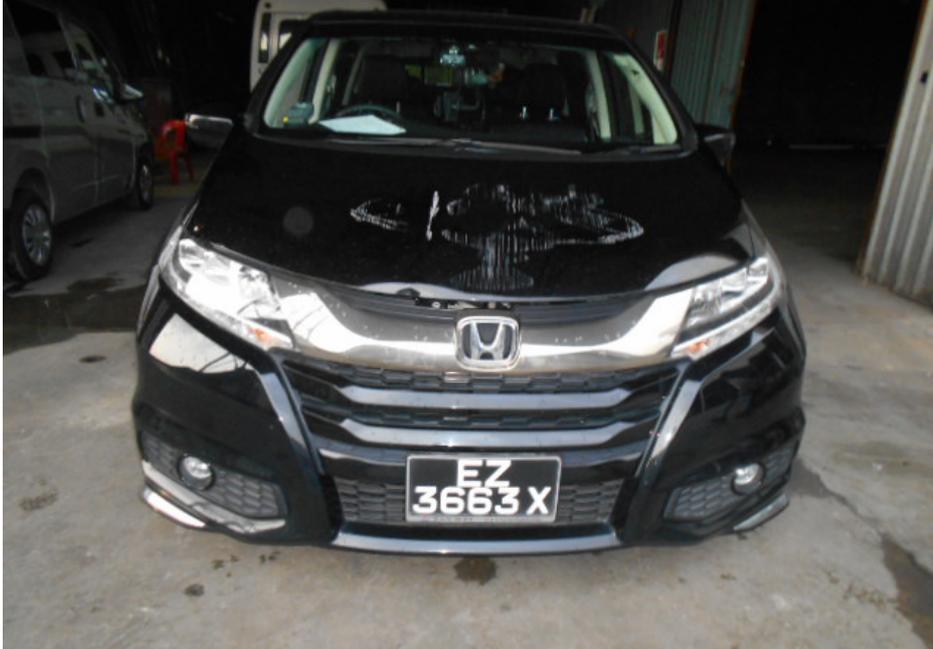
7. From the photographs taken during the Pre- Repair Survey conducted by LKK Auto Consultants Pte. Ltd. 4 days after the accident, we note that the Honda had sustained damages to its front portion, significantly to its front bumper and bonnet. We observed cracks on the front bumper grille and graze marks on the front bumper chrome moulding. We noticed there was a dent on the front right portion of the front bonnet. There were also graze marks on the centre portion of the front bonnet. However we also noted that there was no misalignment of the front bumper at its corner edges. See photos 1 - 7 below.

Photo 1 shows the general view of the front of the Honda at the time of the Pre-
Repair Survey conducted by LKK Auto Consultants Pte. Ltd. which was taken 4
days after the accident. We note that the Honda had sustained damages to its
front portion, significantly to its front bumper and front bonnet.

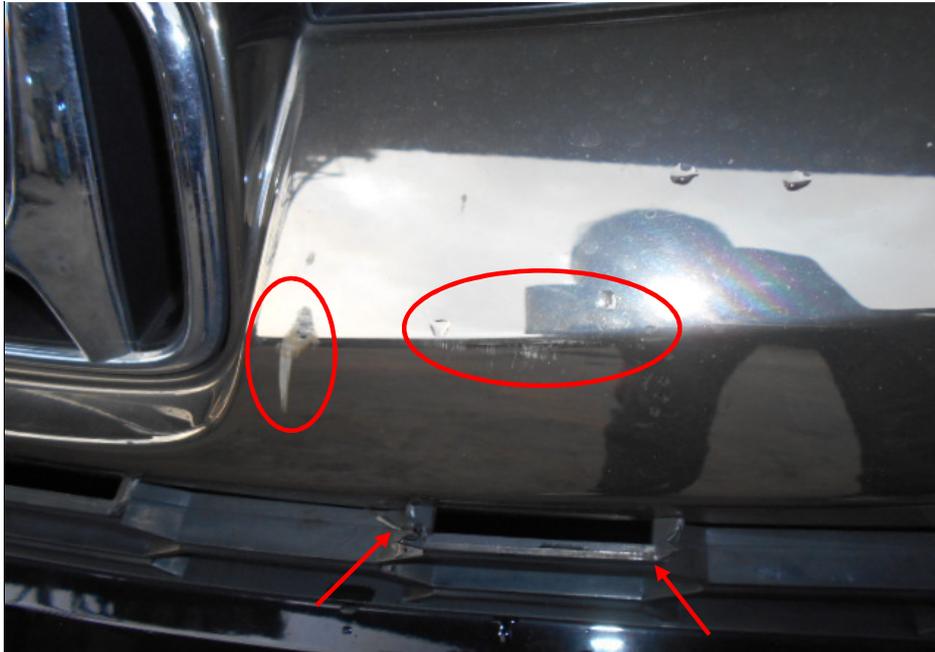
Photo 2 shows a closer view of the cracks on the front bumper grille (arrowed) and the graze marks on the top left portion of the front bumper chrome moulding (circled).

- f) the bodypart at 75cm above ground was the upper portion of the Lorry's rear wooden strip;
- g) the bodypart at 84cm above ground was the bottom portion of the Lorry's rear tailgate hinge;
- h) Basing on our height measurement as well as the profile of the Honda and the Lorry as discussed in paragraph 9, the damages to the front bonnet of the Honda were likely to be caused by the collision with the tailgate of the Lorry.

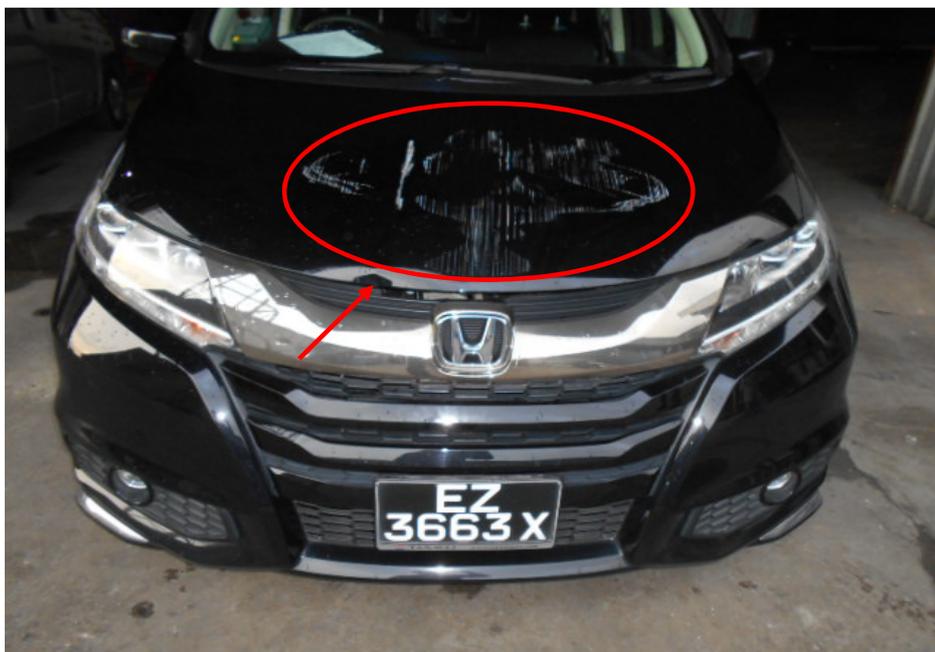
Photo 3 shows the dent on the front right portion of the front bonnet (arrowed). There were also graze marks on the centre portion of the front bonnet (circled).

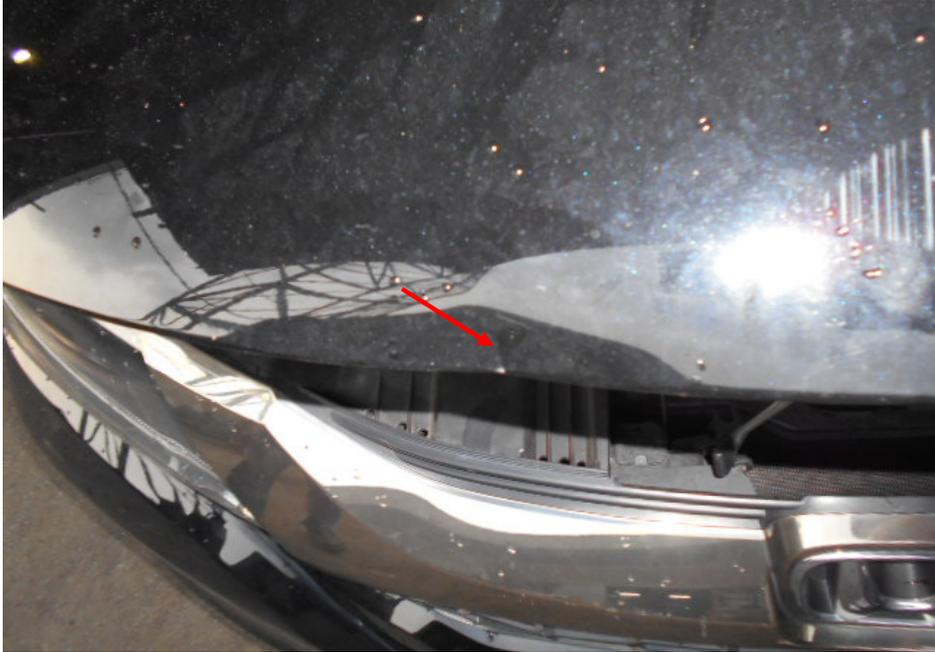
Photo 4 shows a close up view of the dent on the front right portion of the Honda's front bonnet (arrowed).

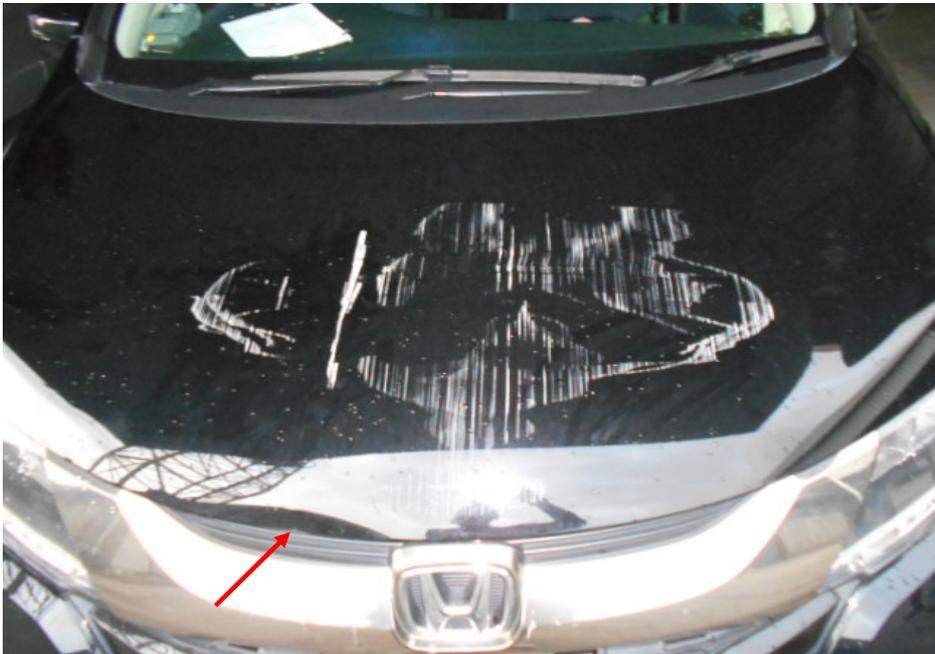
Photo 5 shows a close up view of the graze marks on the centre portion of the Honda's front bonnet (circled).

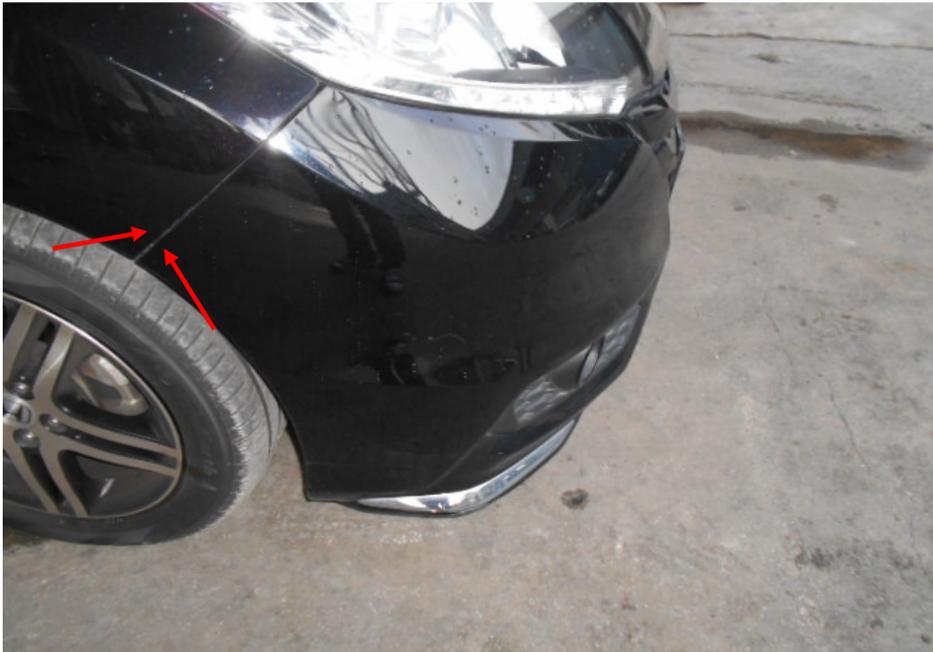
Photo 6 shows a close up view of the right corner edge of the front bumper of the Honda. We observed that there was no misalignment at the corner edges (red arrows).

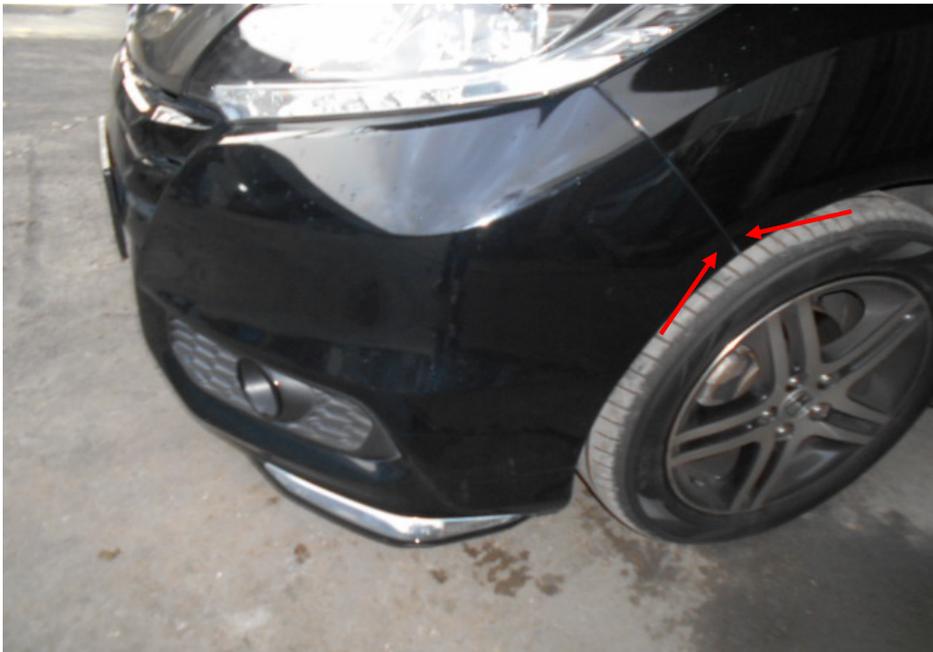
Photo 7 shows a close up view of the left corner edge of the front bumper of the Honda. We observed that there was a slight misalignment at the corner edges (red arrows).

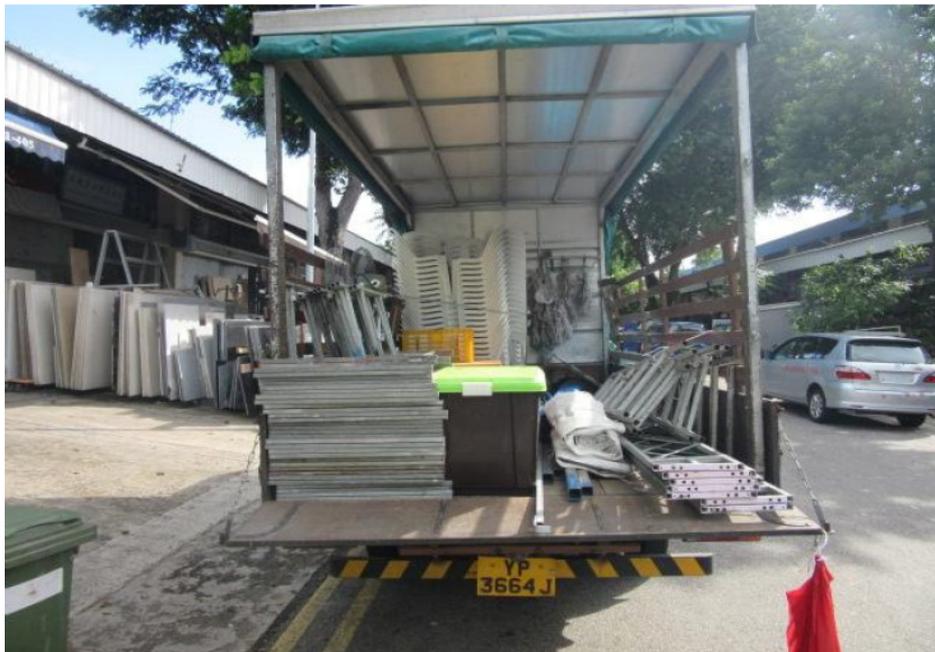
Photo 8 shows a general view of the rear portion of the Lorry at the time of reporting, which was taken a week after the accident. Based on the circumstances of the case contained in the Singapore Accident Statement, the driver of the Lorry stated that there was no collision between the Involved Motor Vehicles

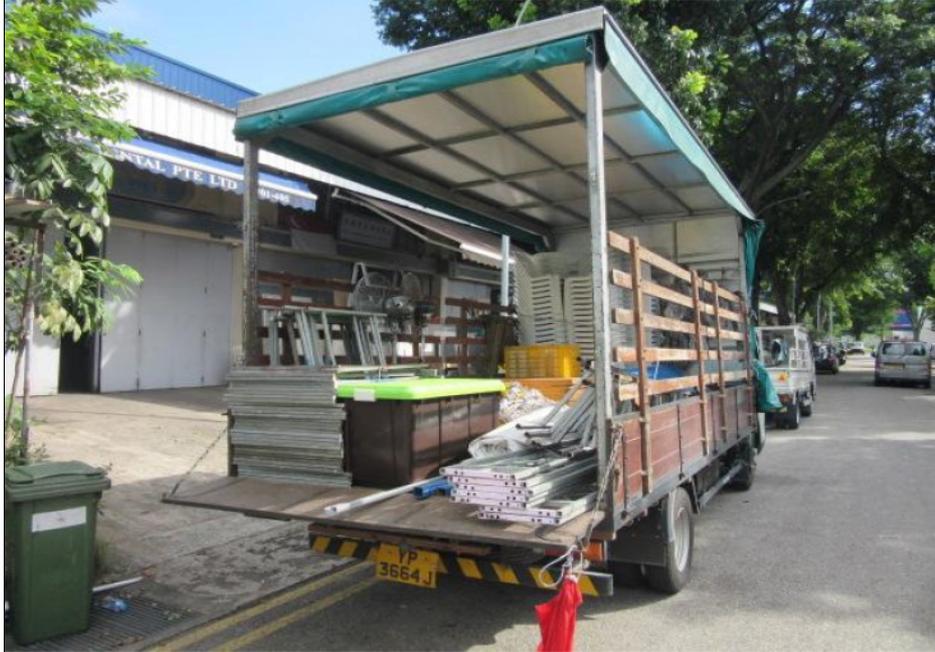
Photo 9 shows a general right view of the rear portion of the Lorry at the time of reporting, which was taken a week after the accident. Our review of the photographs showing the Lorry at the time of reporting did not produce any significant information as the photographs were all taken from afar, without any close up photographs of the body parts at the rear portion of the Lorry.

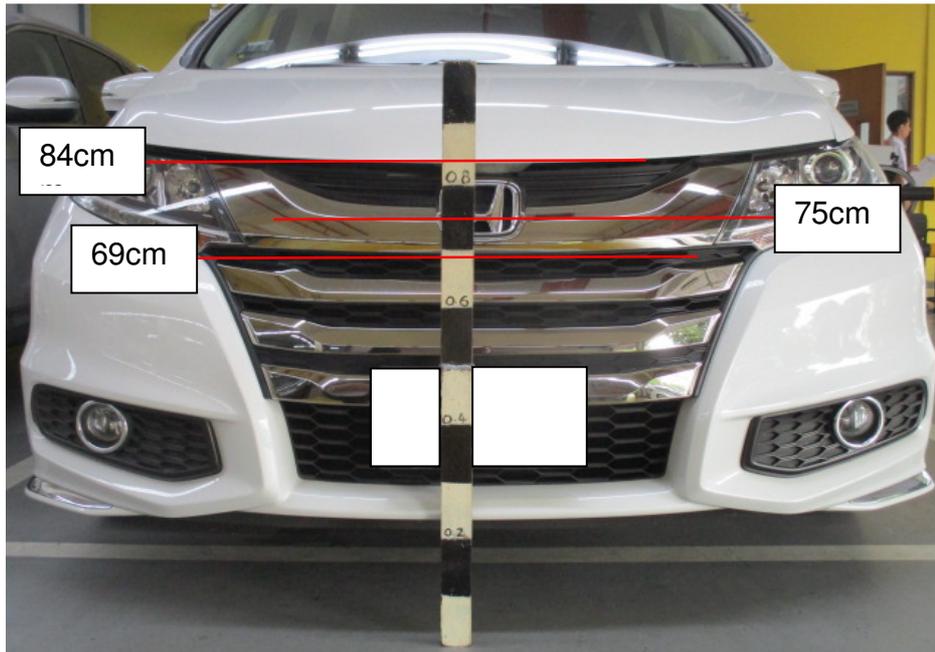
Photo 10 shows the height measurement being conducted on the frontal portion of the Honda (using a similar make and model). The height above ground level of the cracked front bumper grille was measured to be approximately 69cm. The height above ground level of the top left portion of the front bumper chrome moulding where the graze marks were found was measured to be approximately 75cm. The height above ground level of the front bonnet where the dent was found was measured to be approximately 84cm. The graze marks found on the centre portion of the front bonnet were measured to be above 84cm above ground level.

- a) the height above ground level of the cracked front bumper grille of the Honda was measured to be approximately 69cm;
- b) the height above ground level of the top left portion of the Honda's front bumper chrome moulding where the graze marks were found was measured to be approximately 75cm;
- c) the height above ground level of the Honda's front bonnet where the dent was found was measured to be approximately 84cm;
- d) the graze marks found on the centre portion of the Honda's front bonnet were measured to be above 84cm above ground level;
- e) the bodypart at 69cm above ground was the lower portion of the Lorry's rear wooden strip;

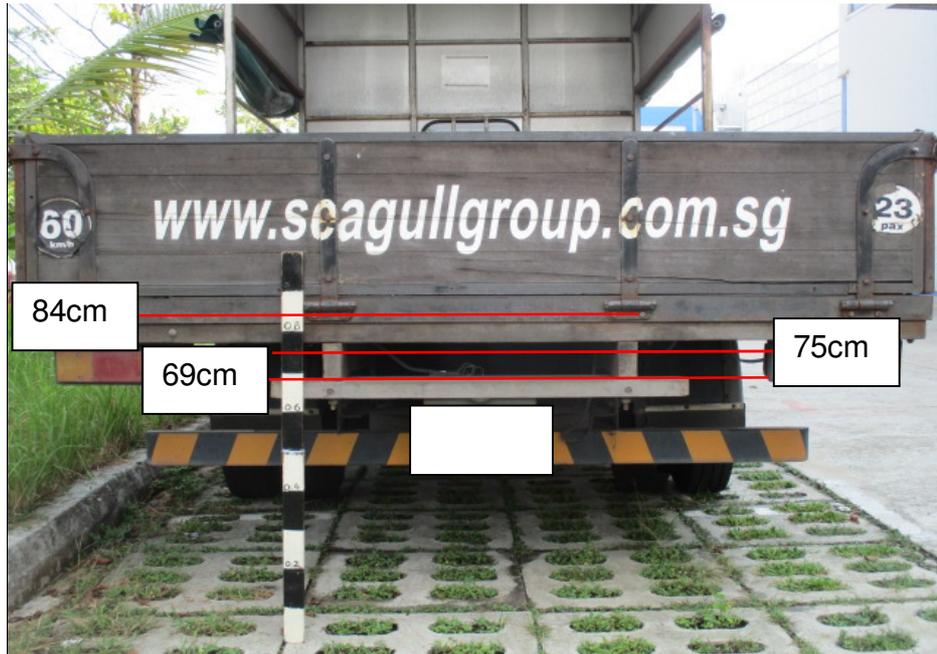
9. The rear profile of the Lorry was of a flat type profile (due to its rear tailgate). However this flat profile had commenced at a certain height above ground level. In the event of a collision, the Honda would have went below the Lorry given the flat rear profile of the Lorry. This is due to the lower height and non-flat front profile of the Honda.
10. Since the rear of the Lorry would have underrun the front of the Honda, it would have come into direct contact with the rear wooden strip which is directly below the tailgate. This is also supported by the height measurement test that we had carried out. See photos 10 & 11 below.

Photo 11 shows the height measurement being conducted on the rear portion of the Lorry (using a similar make and model). The bodypart at 69cm above ground was the lower portion of the rear wooden strip. The bodypart at 75cm above ground was the upper portion of the rear wooden strip. The bodypart at 84cm above ground was the bottom portion of the rear tailgate hinge.
