Your Ref : M537502
Our Ref : CS3/MSG16019773/N

**AUTOMOBILE TECHNICAL INVESTIGATION REPORT OF ACCIDENT
INVOLVING A MOTOR CAR EZ 3663X AND A MOTOR LORRY YP 3664J ON 18
NOVEMBER 2017**

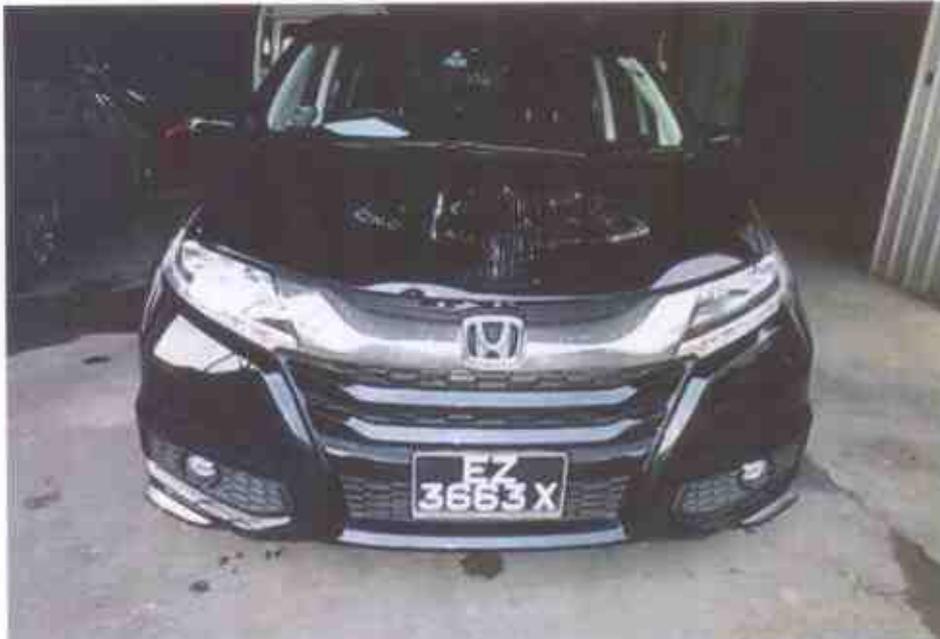
7. From the photographs taken during the Pre- Repair Survey conducted by LKK Auto Consultants Pte. Ltd. 4 days after the accident, we note that the Honda had sustained damages to its front portion, significantly to its front bumper and bonnet. We observed cracks on the front bumper grille and graze marks on the front bumper chrome moulding. We noticed there was a dent on the front right portion of the front bonnet. There were also graze marks on the centre portion of the front bonnet. However we also noted that there was no misalignment of the front bumper at its corner edges. See photos 1 - 7 below.

Photo 1 shows the general view of the front of the Honda at the time of the Pre-
Repair Survey conducted by LKK Auto Consultants Pte. Ltd. which was taken 4
days after the accident. We note that the Honda had sustained damages to its
front portion, significantly to its front bumper and front bonnet.

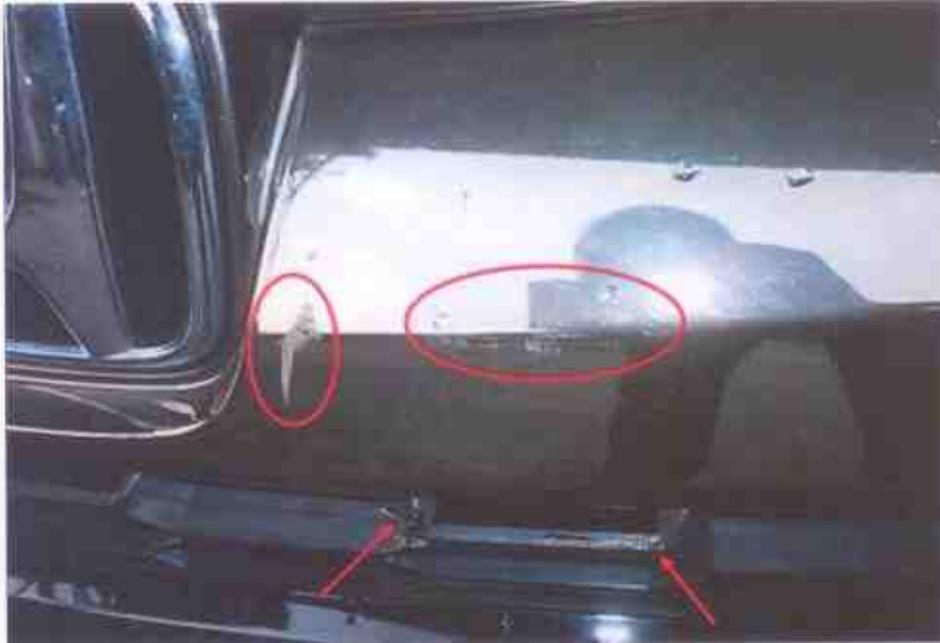
Photo 2 shows a closer view of the cracks on the front bumper grille (arrowed) and the graze marks on the top left portion of the front bumper chrome moulding (circled).

- f) the bodypart at 75cm above ground was the upper portion of the Lorry's rear wooden strip;
- g) the bodypart at 84cm above ground was the bottom portion of the Lorry's rear tailgate hinge;
- h) Basing on our height measurement as well as the profile of the Honda and the Lorry as discussed in paragraph 9, the damages to the front bonnet of the Honda were likely to be caused by the collision with the tailgate of the Lorry.

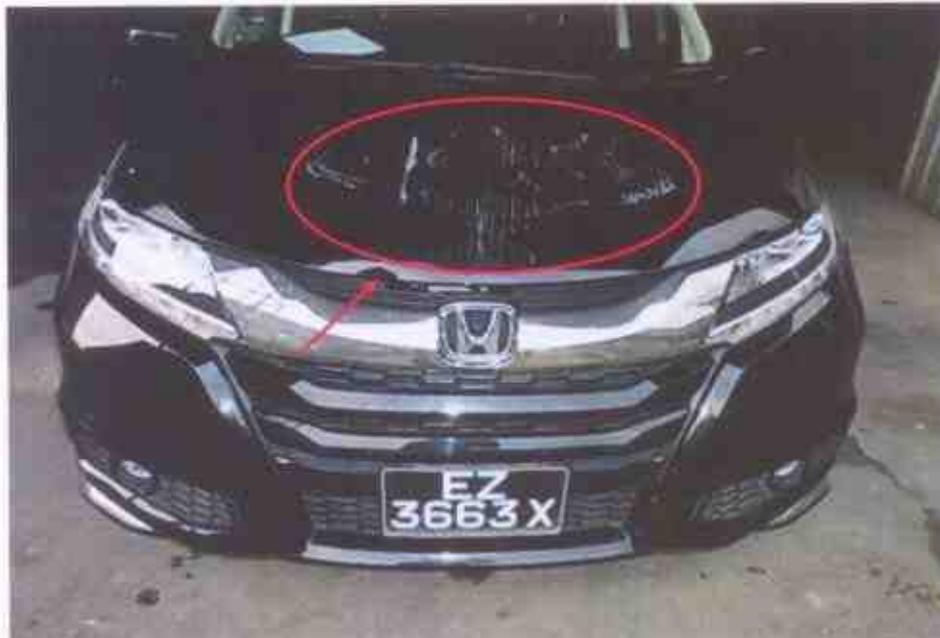
Photo 3 shows the dent on the front right portion of the front bonnet (arrowed). There were also graze marks on the centre portion of the front bonnet (circled).

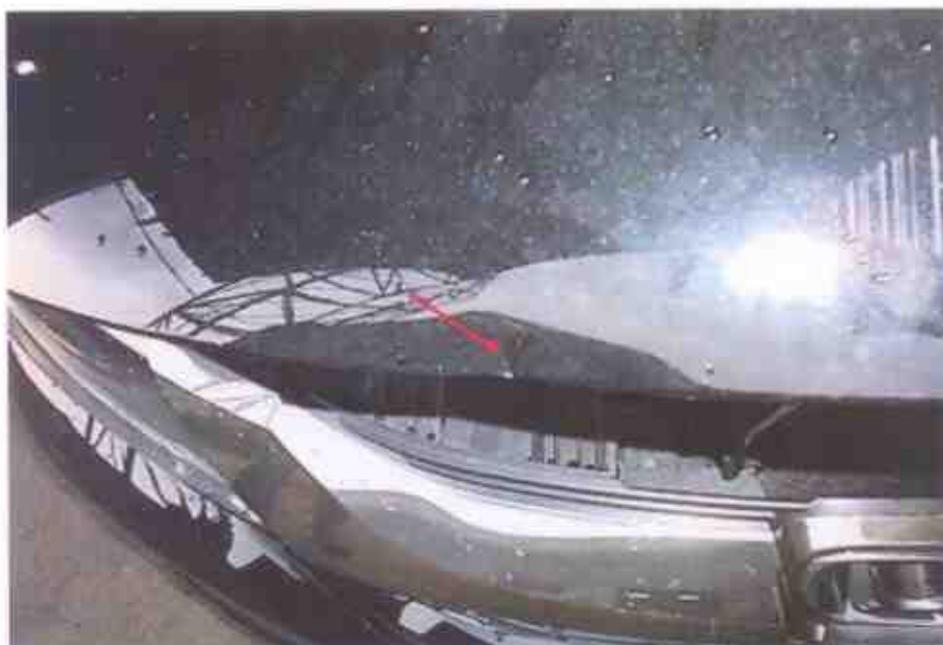
Photo 4 shows a close up view of the dent on the front right portion of the Honda's front bonnet (arrowed).

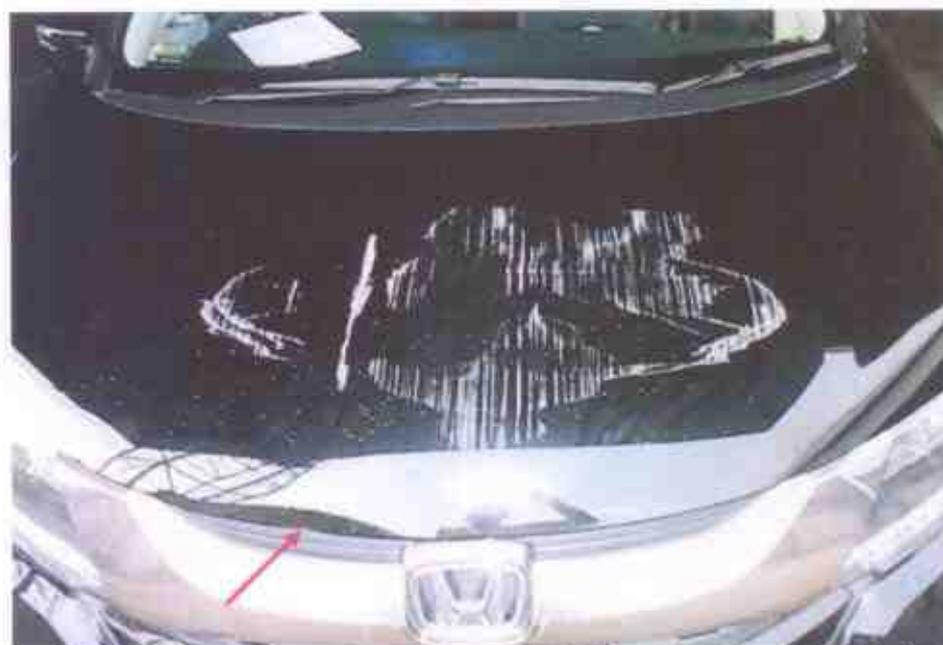
Photo 5 shows a close up view of the graze marks on the centre portion of the Honda's front bonnet (circled).

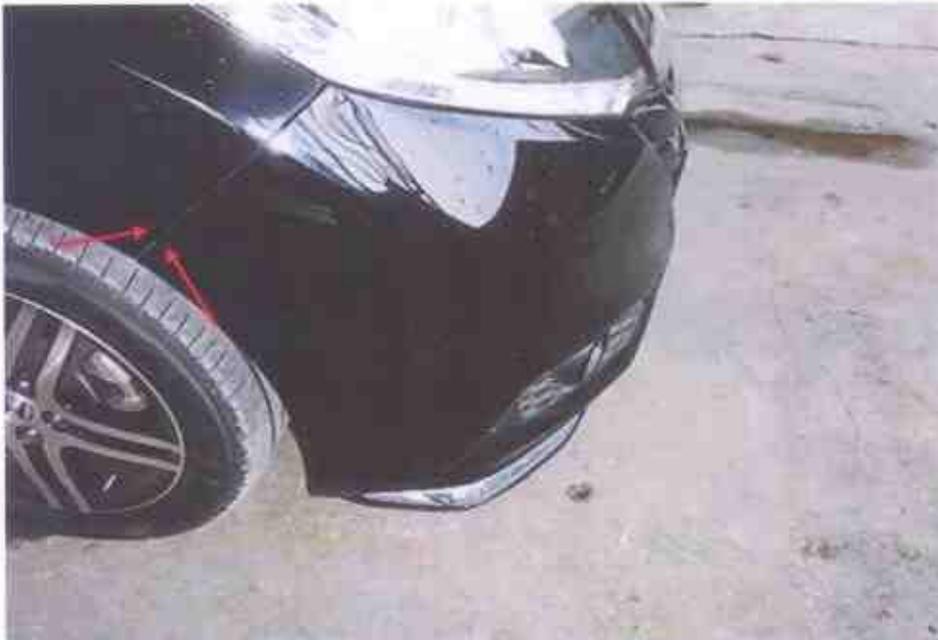
Photo 6 shows a close up view of the right corner edge of the front bumper of the Honda. We observed that there was no misalignment at the corner edges (red arrows).

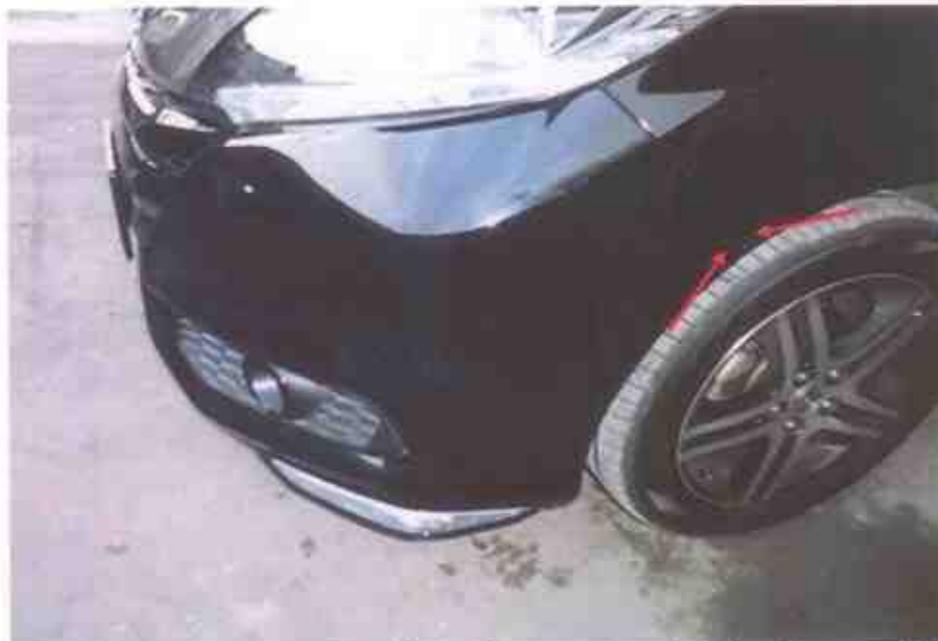
Photo 7 shows a close up view of the left corner edge of the front bumper of the Honda. We observed that there was a slight misalignment at the corner edges (red arrows).

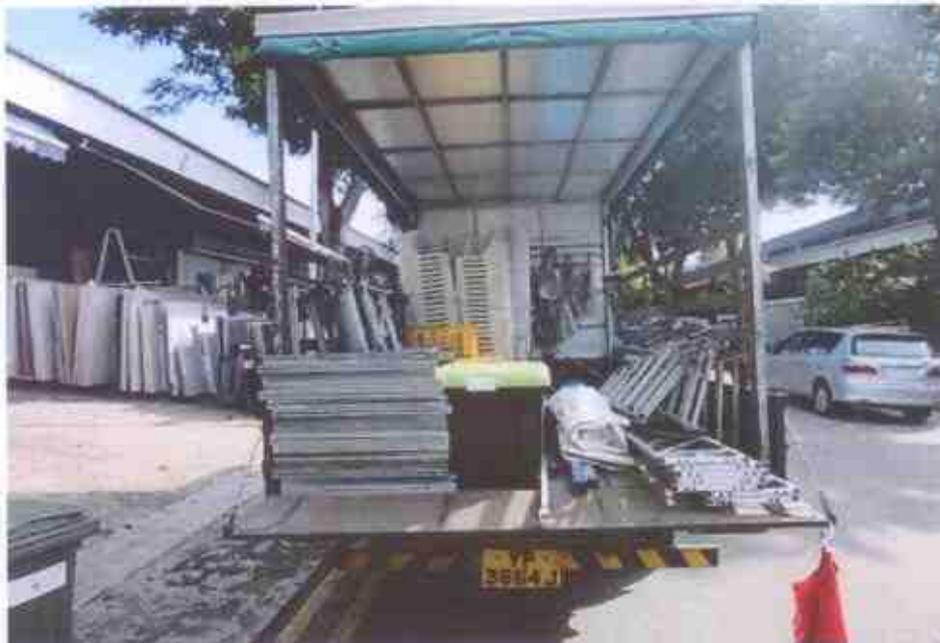
8. Based on the circumstances of the case contained in the Singapore Accident Statement, the driver of the Lorry stated that there was no collision between the Involved Motor Vehicles. Our review of the photographs showing the Lorry at the time of reporting did not produce any significant information as the photographs were all taken from afar, without any close up photographs of the rear portion of the Lorry. See photos 8 & 9 below.

Photo 8 shows a general view of the rear portion of the Lorry at the time of reporting, which was taken a week after the accident. Based on the circumstances of the case contained in the Singapore Accident Statement, the driver of the Lorry stated that there was no collision between the Involved Motor Vehicles

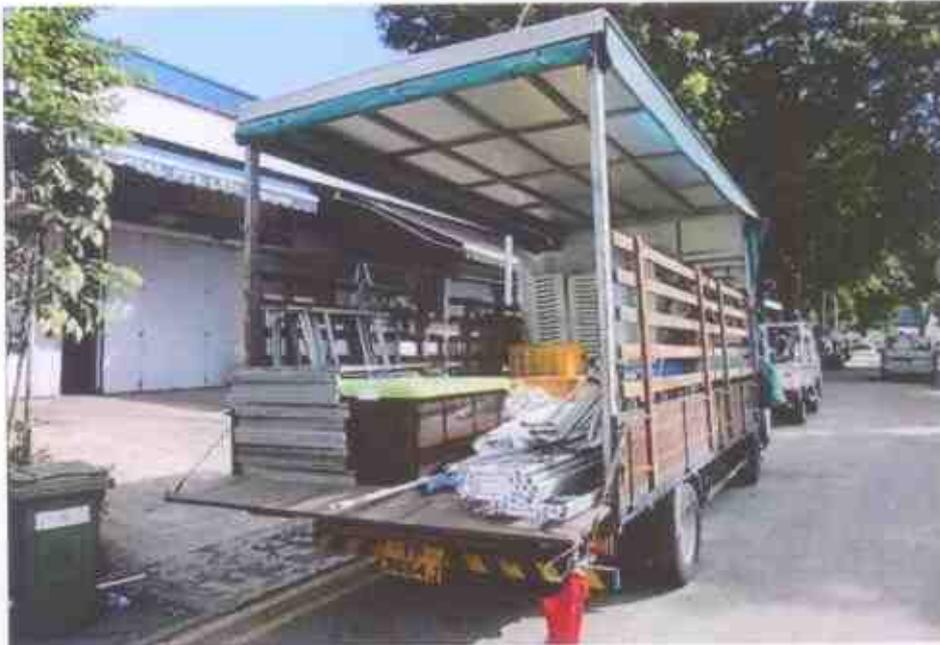
Photo 9 shows a general right view of the rear portion of the Lorry at the time of reporting, which was taken a week after the accident. Our review of the photographs showing the Lorry at the time of reporting did not produce any significant information as the photographs were all taken from afar, without any close up photographs of the body parts at the rear portion of the Lorry.

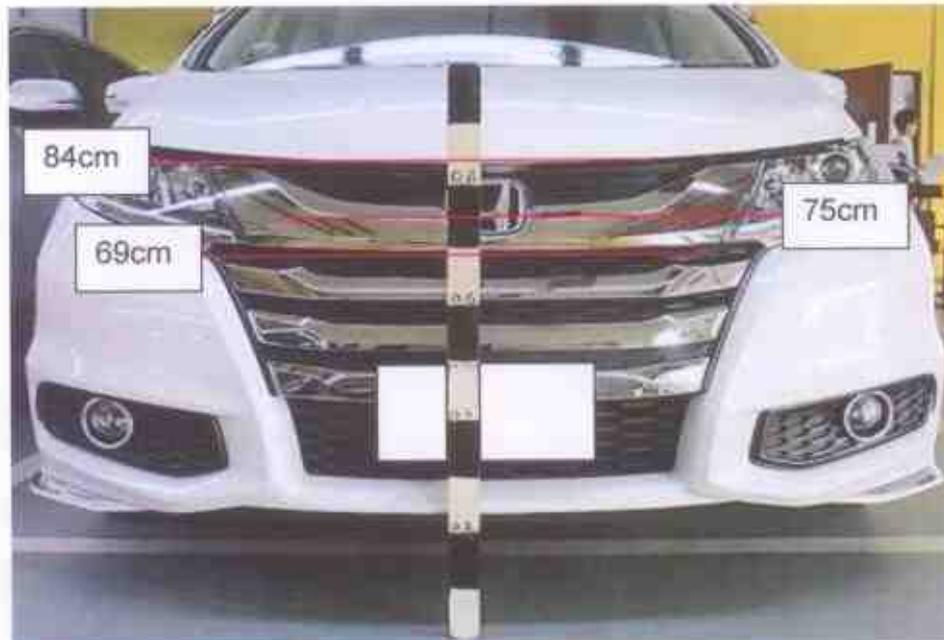
9. The rear profile of the Lorry was of a flat type profile (due to its rear tailgate). However this flat profile had commenced at a certain height above ground level. In the event of a collision, the Honda would have went below the Lorry given the flat rear profile of the Lorry. This is due to the lower height and non-flat front profile of the Honda.
10. Since the rear of the Lorry would have underrun the front of the Honda, it would have come into direct contact with the rear wooden strip which is directly below the tailgate. This is also supported by the height measurement test that we had carried out. See photos 10 & 11 below.

Photo 10 shows the height measurement being conducted on the frontal portion of the Honda (using a similar make and model). The height above ground level of the cracked front bumper grille was measured to be approximately 69cm. The height above ground level of the top left portion of the front bumper chrome moulding where the graze marks were found was measured to be approximately 75cm. The height above ground level of the front bonnet where the dent was found was measured to be approximately 84cm. The graze marks found on the centre portion of the front bonnet were measured to be above 84cm above ground level.

- a) the height above ground level of the cracked front bumper grille of the Honda was measured to be approximately 69cm;
- b) the height above ground level of the top left portion of the Honda's front bumper chrome moulding where the graze marks were found was measured to be approximately 75cm;
- c) the height above ground level of the Honda's front bonnet where the dent was found was measured to be approximately 84cm;
- d) the graze marks found on the centre portion of the Honda's front bonnet were measured to be above 84cm above ground level;
- e) the bodypart at 69cm above ground was the lower portion of the Lorry's rear wooden strip;

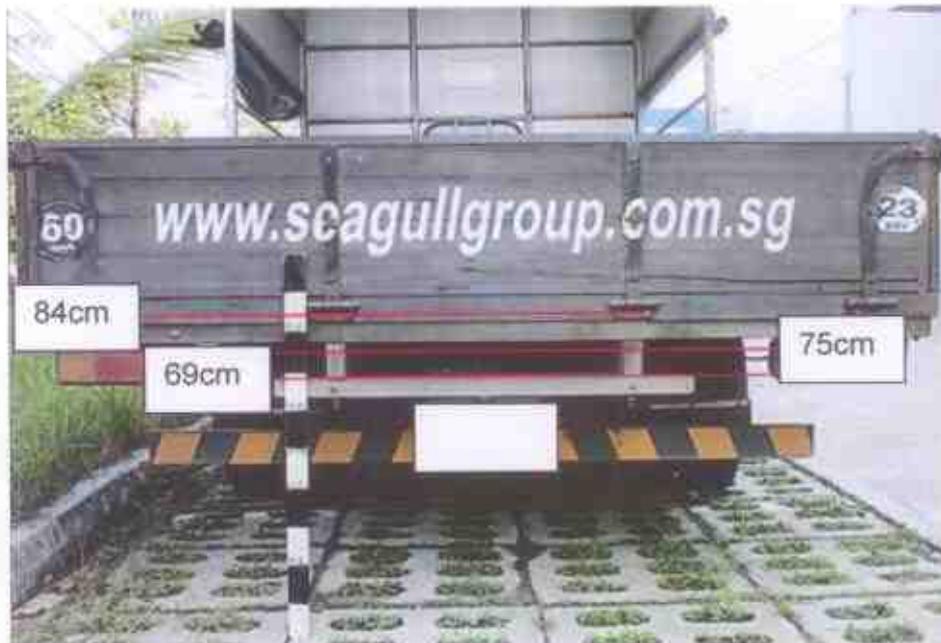
Photo 11 shows the height measurement being conducted on the rear portion of the Lorry (using a similar make and model). The bodypart at 69cm above ground was the lower portion of the rear wooden strip. The bodypart at 75cm above ground was the upper portion of the rear wooden strip. The bodypart at 84cm above ground was the bottom portion of the rear tailgate hinge.
