Your Ref: S7M004KU  
Our Ref : CS/AXA17022355/N

**AXA Insurance Singapore Pte Ltd**  
8 Shenton Way #24-01  
AXA Tower  
Singapore 068811  
(Motor Claims Department)

**TECHNICAL INVESTIGATION REPORT OF FIRE INCIDENT INVOLVING THE  
INSURED VEHICLE EW 8382P ON 1 NOVEMBER 2017**

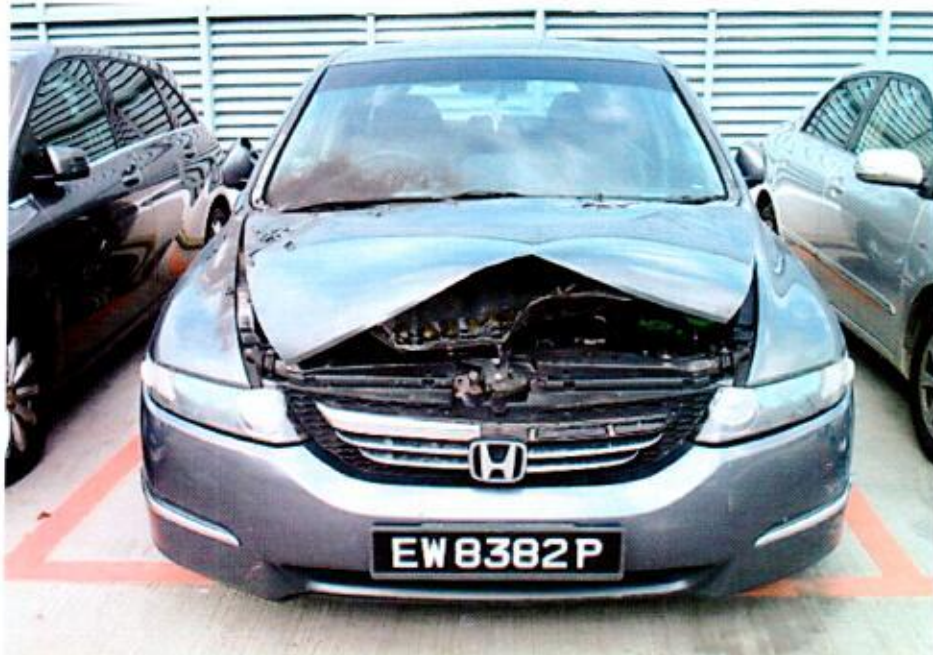
**Photo 1** shows the general view of the front portion of the Insured Vehicle at the time of our inspection. The fire damage to the Insured Vehicle was confined to its front portion. Its front bonnet, front grille, front windscreen and front windscreen wipers were amongst the body parts that were found to have been affected as a result of the fire. The front bonnet of the Insured Vehicle was slightly buckled, likely due to rescue damage.

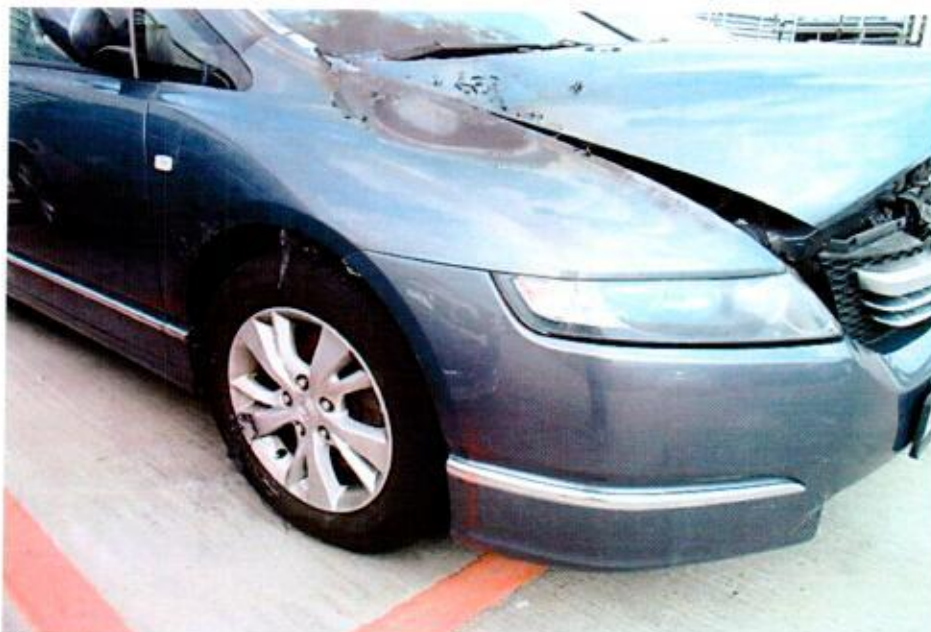
**Photo 2** shows the general view of the front right portion of the Insured Vehicle at the time of our inspection. The fire damage to the Insured Vehicle was confined to its front portion. Its front bonnet and right side panel were amongst the body parts that were found to have been affected as a result of the fire.

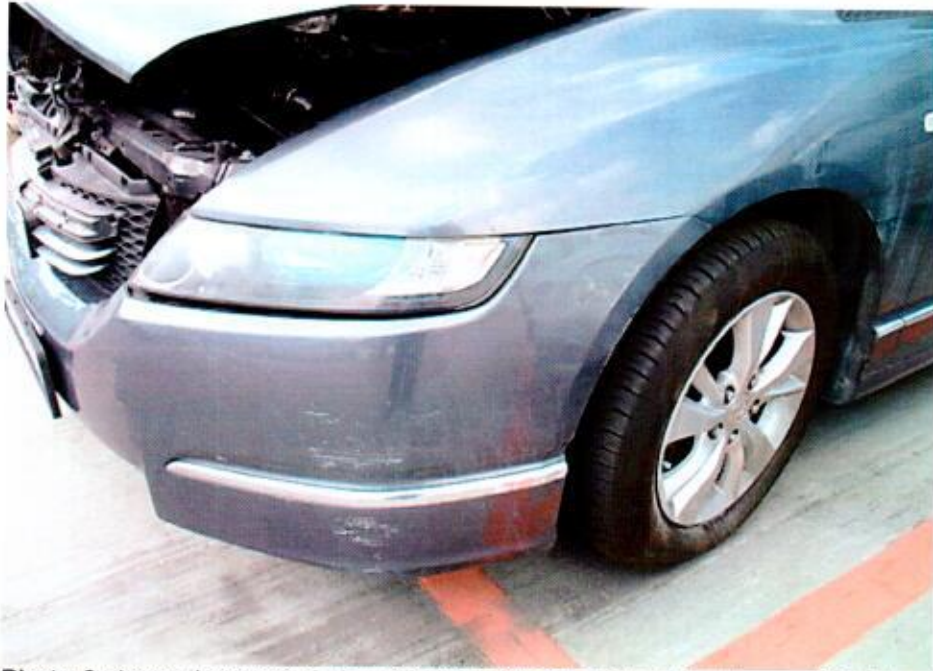
**Photo 3** shows the general view of the front left portion of the Insured Vehicle at the time of our inspection. The front left portion of the Insured Vehicle was relatively unaffected by the fire.

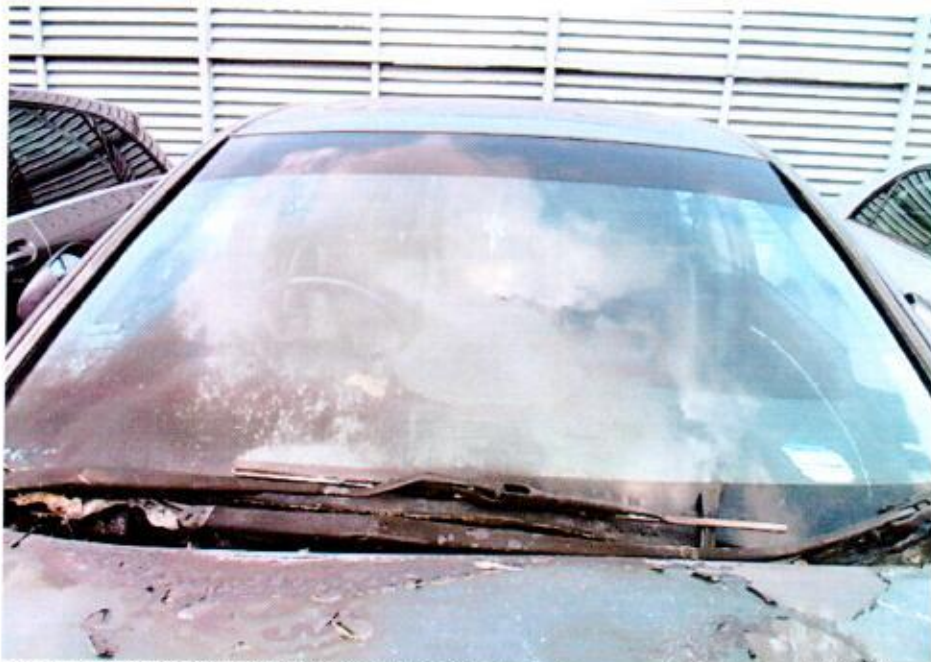
**Photo 4** shows the general view of the front windscreen of the Insured Vehicle at the time of our inspection. The fire damage to the Insured Vehicle was confined to its front portion. Its windscreen, front windscreen wipers, front wiper panel garnish and front windscreen water nozzles were amongst the body parts that were found to have been affected as a result of the fire.

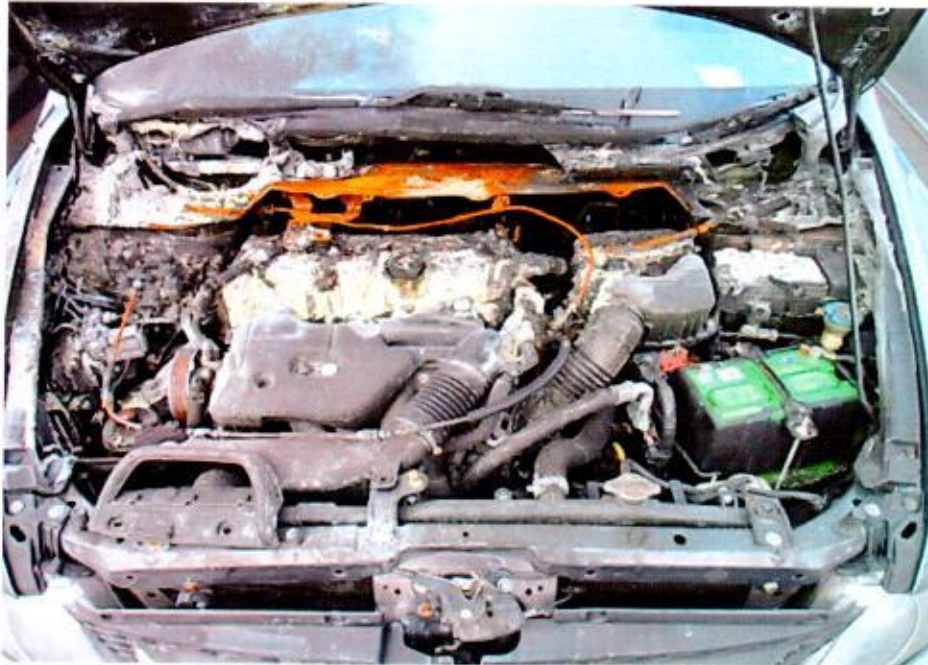
**Photo 5** shows the engine compartment of the Insured Vehicle at the time of our inspection. The entire engine compartment of the Insured Vehicle was observed to be severely burnt. Most of the parts inside the engine compartment were found to be burnt and/or melted as a result of the fire.

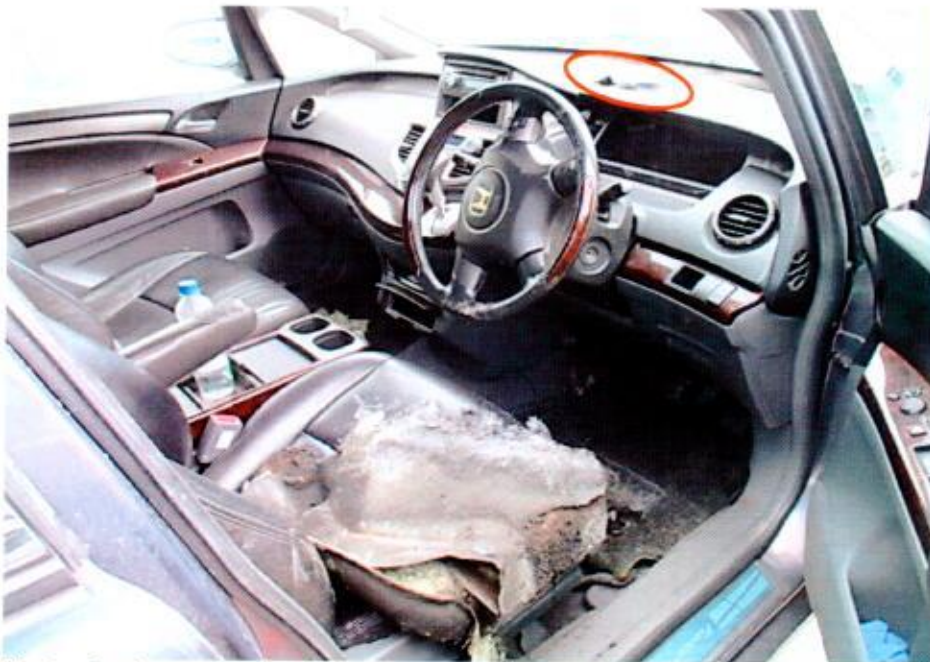
**Photo 6** shows the interior compartment of the Insured Vehicle, which was observed to be partially burnt and/or melted. The dashboard (circled) and front windscreen were amongst the parts that were found to have been partially burnt and/or melted as a result of the fire.

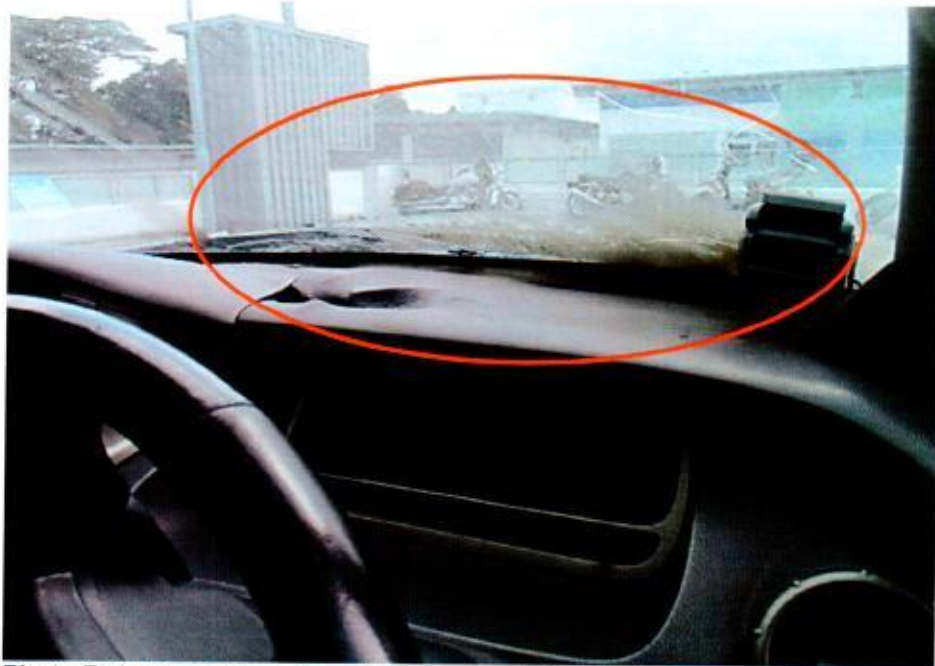
**Photo 7** shows a closer view of the damaged front windscreen and dashboard of the Insured Vehicle (as viewed from the interior compartment).

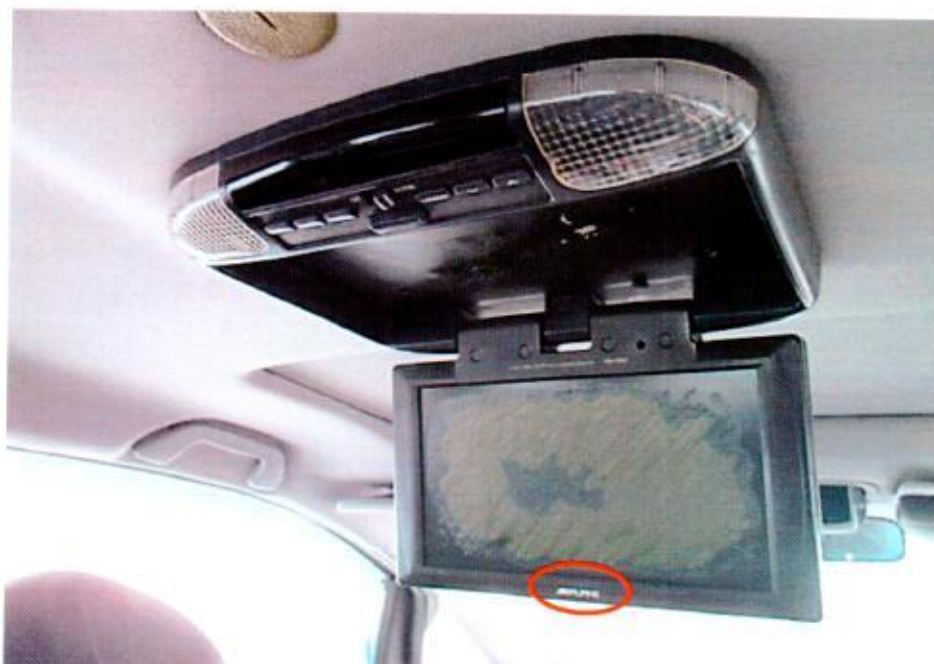
7. At the time of physical inspection of the Insured Vehicle, we had found an additionally fitted electronic and/or electrical component(s) on the Insured Vehicle. It was an in-car flip-down monitor (which had sustained minor fire damage). This fitted component was not the standard type for the Insured Vehicle. See photo 8 below.

**Photo 8** shows the in-car flip-down monitor which had sustained minor fire damage. The brand of the in-car flip-down monitor was 'ALPINE' (circled).

34. Although the in-car flip-down monitor fitted on the Insured Vehicle was not the standard type for the Insured Vehicle, we are of the view that this part did not cause and/or contribute to the fire incident.

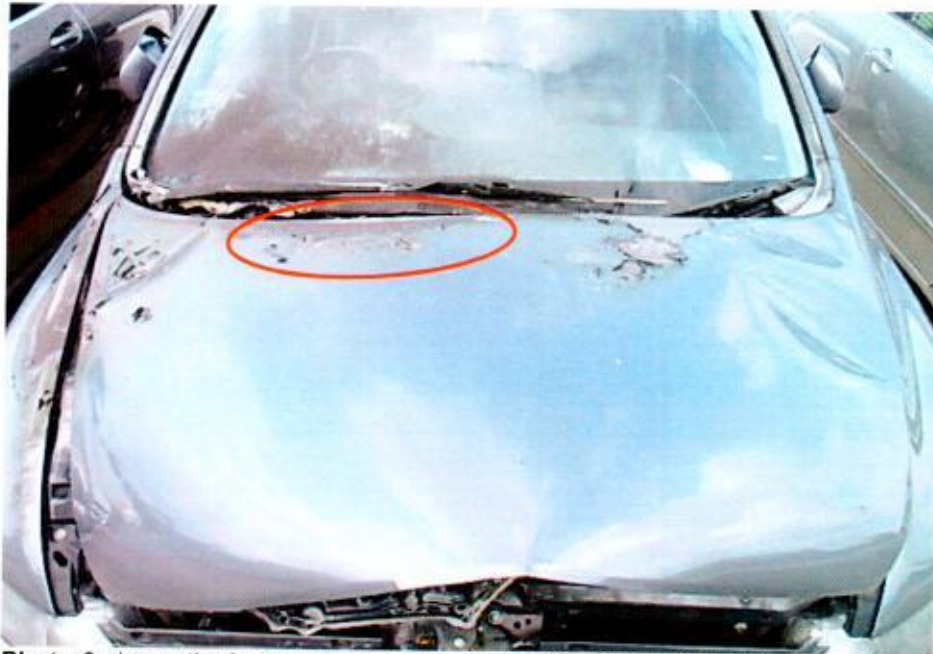
8. For this particular case, the fire appears to have originated within the engine compartment of the Insured Vehicle, somewhere around the rear centre portion of the engine compartment. This can be determined from the burn pattern and the high heat intensity burn marks (whitish burn marks) found on the rear centre side of the front bonnet of the Insured Vehicle and also the rust that had developed on the underside of the front bonnet, at the rear centre area.

9. The whitish burn marks are a result of exposure to prolonged heat intensity. Rust would normally start to develop around these areas soon after a fire as prolonged exposure to high heat intensity usually causes steel/metal material body parts to be exposed to natural environmental condition. The rust that had developed on the underside of the front bonnet, around the rear centre area, is an indication that the rear centre portion of the engine compartment had sustained exposure to prolonged high heat intensity.

**Photo 9** shows the burn pattern and whitish burn marks (circled) that were found on the rear centre side of the front bonnet of the Insured Vehicle. Such whitish burn marks are a result of exposure to prolonged heat intensity, which may indicate where the fire had started. Rust would also begin to develop on these areas soon after the fire.

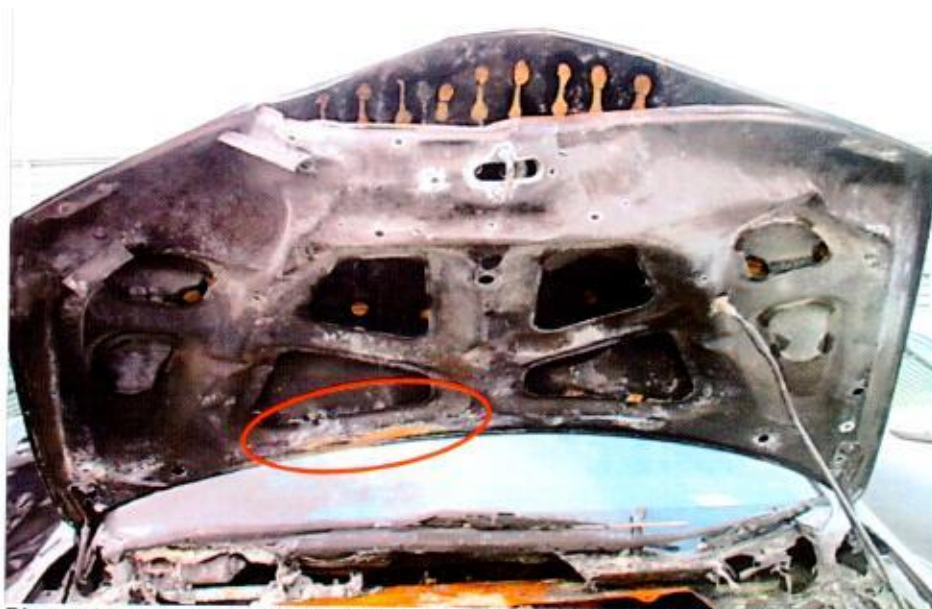
**Photo 10** shows the rust (circled) that had developed on the underside of the front bonnet, around the rear centre area. The development of rust is an indication that the area was exposed to prolonged exposure to high heat intensity, which had caused the steel/metal material of the front bonnet to be exposed to natural environmental condition. Hence the fire to the Insured Vehicle can be determined to have originated towards the rear centre portion of the engine compartment.

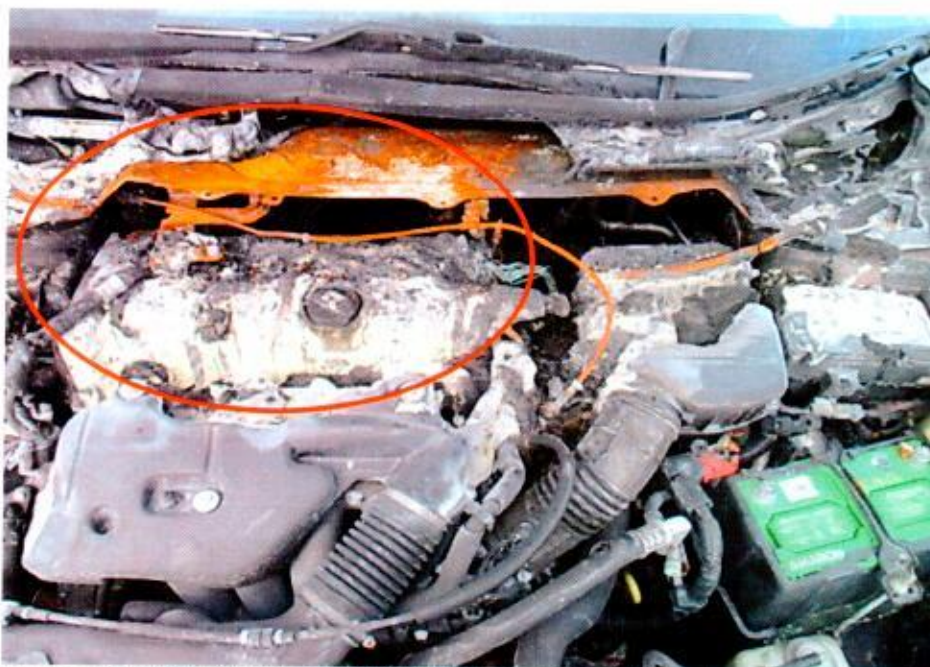
10. Furthermore, we found fire extinguisher residue around these areas. In general the location of the fires' origin was determined given that the damage of fire nature was confined to these particular areas on the Insured Vehicle. See photos 9 - 11 below.

**Photo 11** shows the fire extinguisher residue (circled) found on the rear centre portion of the engine compartment of the Insured Vehicle. The nature of fire damage is an indication as to where the fire started.

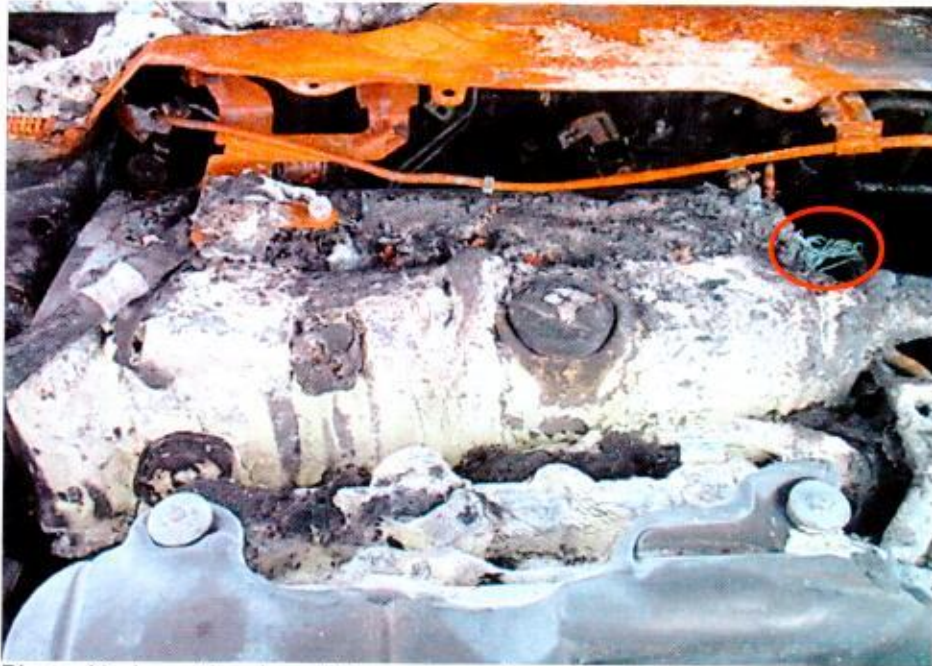
11. Upon closer examination of the rear centre portion of the engine compartment, which was where the fire to the Insured Vehicle had likely started, we had found traces of greenish residue on several stretches of burnt wirings. The presence of greenish residue indicates internal heating of copper wires, a sign of an electrical short circuit occurring. The greenish residue is normally left behind from oxidation as a result of chemical reaction involving the copper wires. This physical evidence would then appear to suggest that the cause of fire to the Insured Vehicle could have possibly been due to electrical in nature. See photos 12 - 14 below.

**Photo 12** shows the view of the centre portion of the engine compartment which is where the fire to the Insured Vehicle had likely started. We observed greenish residue on the wirings (circled) at the rear centre portion of the engine compartment.

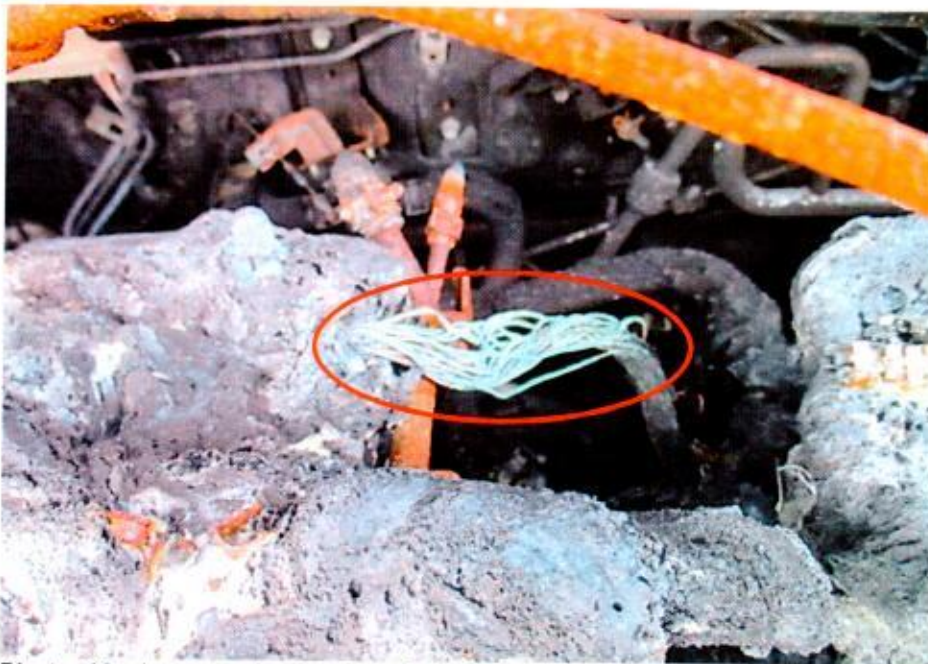
**Photo 13** shows a closer view of the greenish residue found on the wirings (circled) at the rear centre portion of the engine compartment. The presence of such greenish residue suggests occurrence of an electrical short circuit.

28. The possibility of the fire being due to electrical in nature would then seem more likely given that engine overheating and external factors would both seem unlikely. The fire being due to electrical nature is also supported by the condition of the wirings that were found in the engine compartment of the Insured Vehicle, which was earlier discussed in paragraph 11 above.

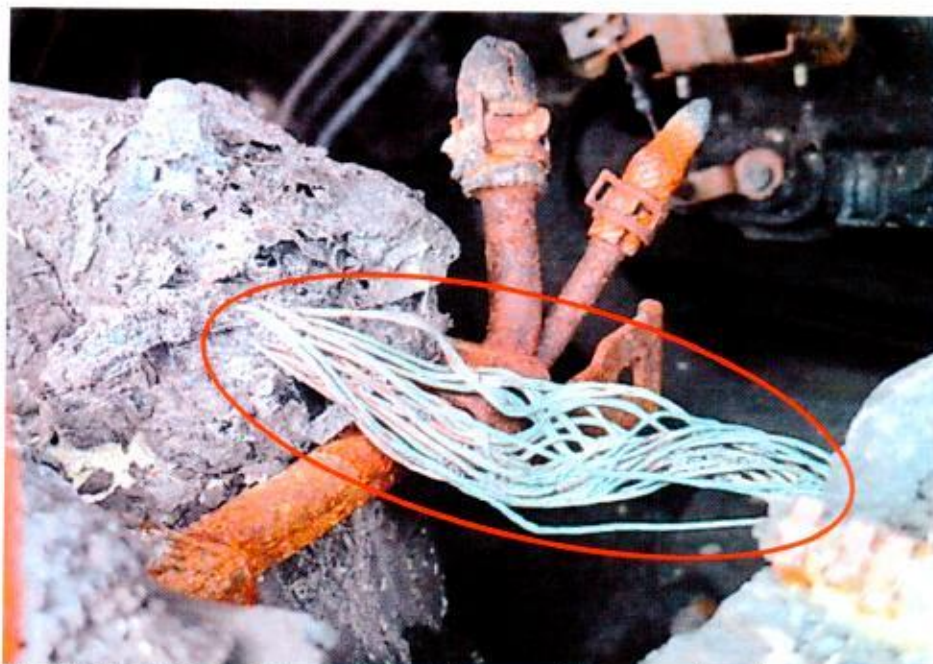
**Photo 14** shows a close up view of the greenish residue found on the wirings (circled) at the rear centre portion of the engine compartment. The presence of such greenish residue suggests occurrence of an electrical short circuit.

31. Having investigated and technically analysed the damages to the Insured Vehicle, we are of the view that the cause of fire to the Insured Vehicle was of electrical in nature. For this particular case, the fire had originated along the wirings inside the engine compartment, somewhere around the rear centre portion. The wirings were original factory wirings of the Insured Vehicle.

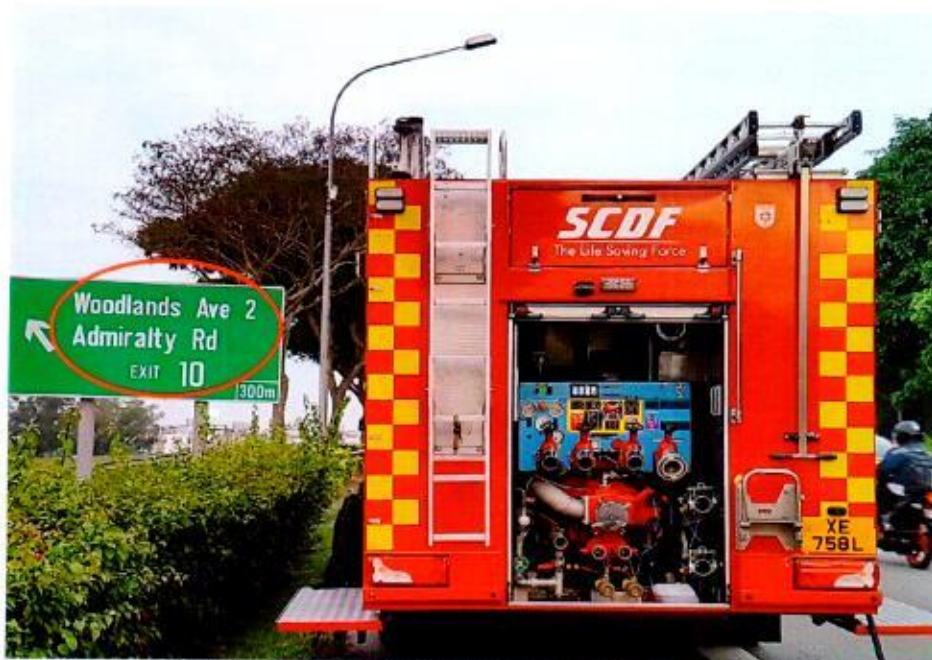
**Photo 15** shows the arrival of the SCDF to the incident location. In general, the information that could be gathered from this photograph had corresponded to the events that were related to us by Mr Jamal, which is he had pulled over the Insured Vehicle along the road shoulder of the BKE (SLE) before the Woodlands Avenue 2 exit (circled).

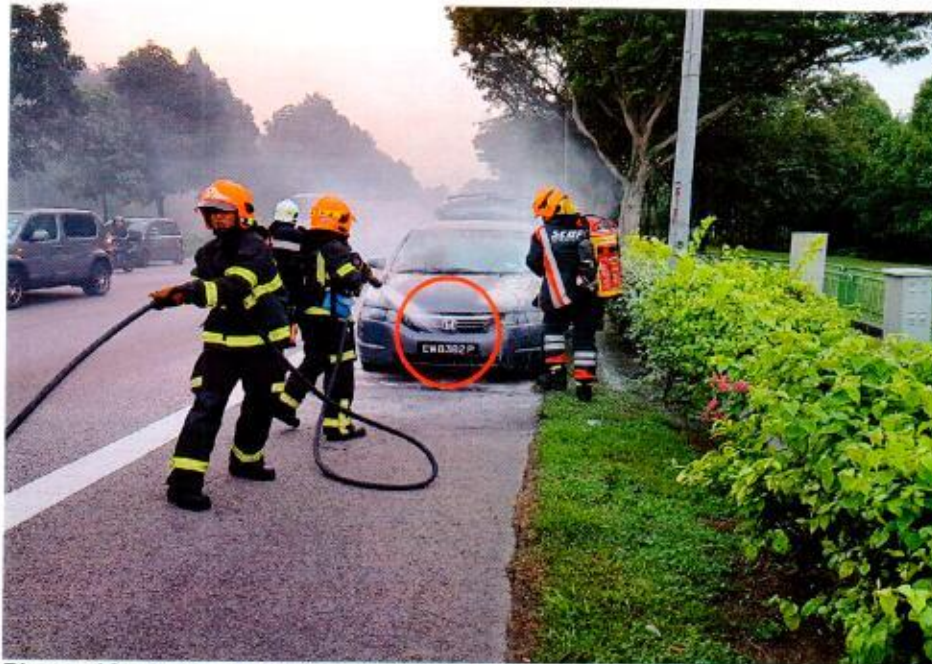
**Photo 16** shows firefighters beginning to put out the fire. In general, the information that could be gathered from this photograph had corresponded to the events that were related to us by Mr Jamal, which is the front bonnet was jammed and could not be opened (circled).

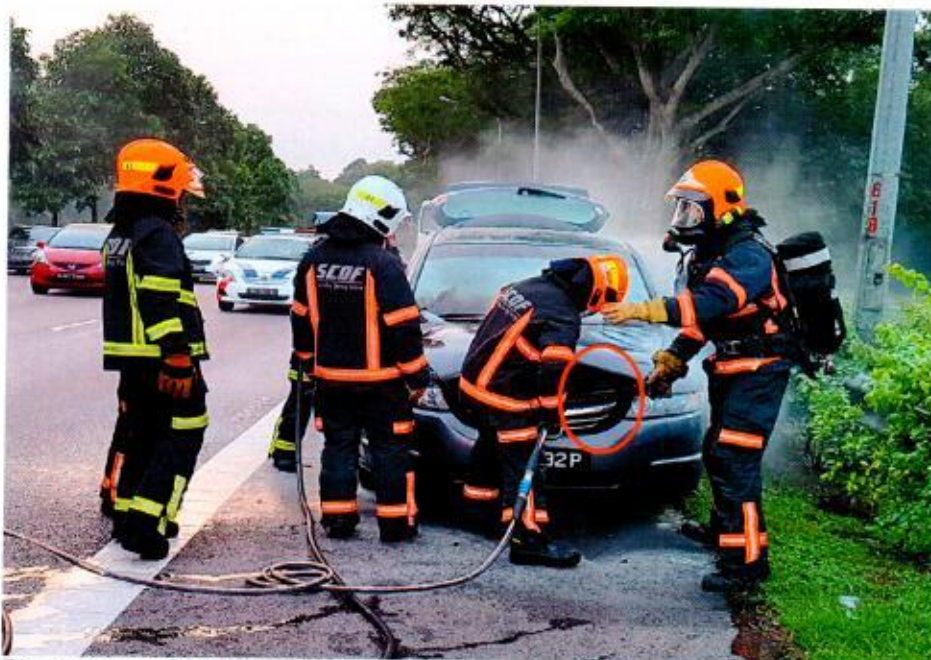
**Photo 17** shows firefighters spraying the engine bay. In general, the information that could be gathered from this photograph had corresponded to the events that were related to us by Mr Jamal, which is the front bonnet was pried open to gain access to the engine bay (circled).

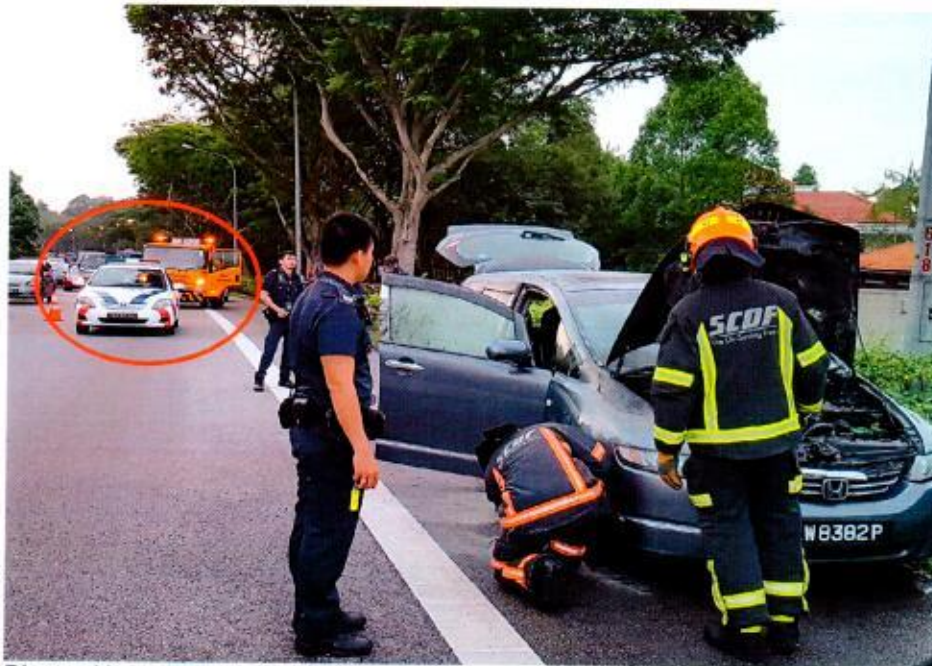
**Photo 18** shows the firefighters making sure that the fire had been completely extinguished. In general, the information that could be gathered from this photograph had corresponded to the events that were related to us by Mr Jamal, which is the police and EMAS Recovery personnel (circled) were present at the incident location together with the SCDF.

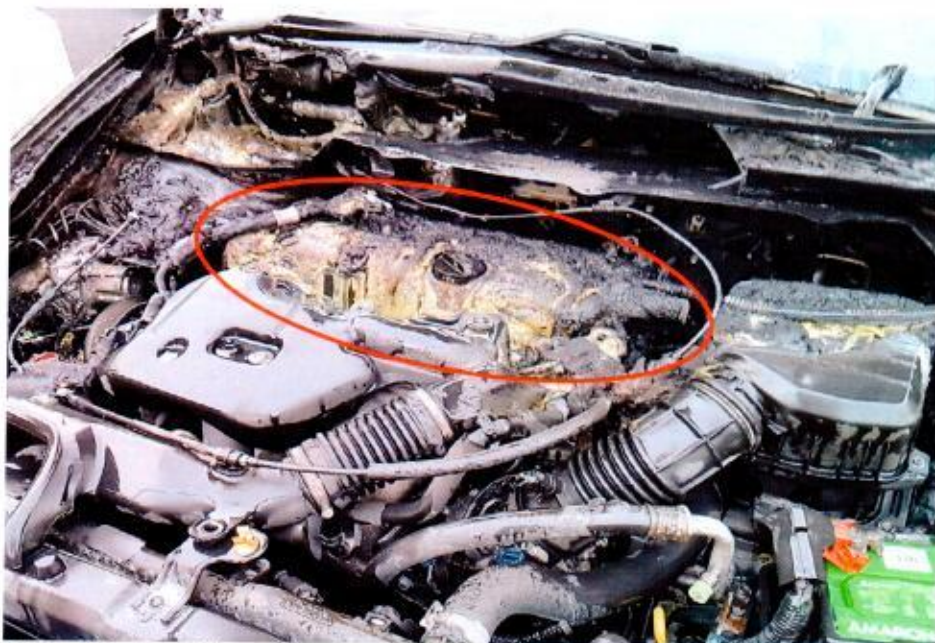
**Photo 19** shows the engine compartment of the Insured Vehicle after the fire was extinguished. In general, the extensive damages sustained and the fire extinguisher residue found on the rear centre portion (circled) had corresponded to the events that were related to us by Mr Jamal, which is the fire started from the engine compartment
