Your Ref: TP/IP/60459/2017
Our Ref : CI/TPD17022391/D

24 November 2017

MECHANICAL INSPECTION REPORT OF MOTOR CAR SJM 3263B

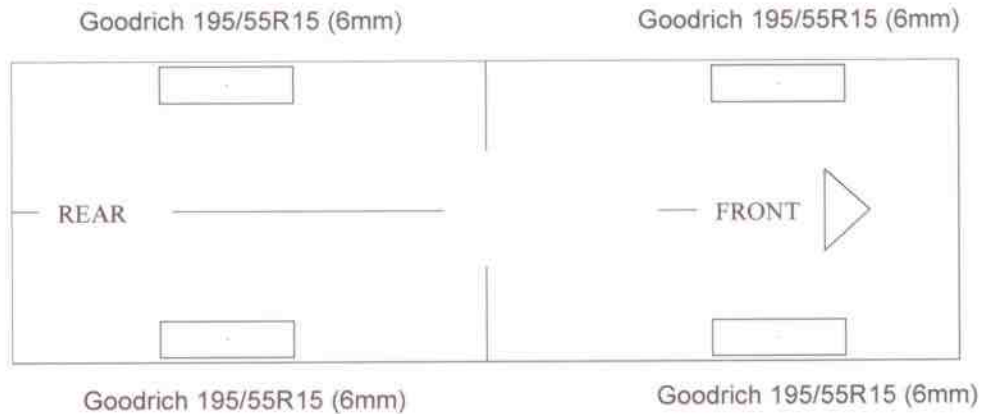
6. The condition of the Motor Car's 4 tyres was observed to be in serviceable condition. I did not find any tear, cut or burst mark(s) on the outer and the inner sidewalls as well as across the tread of the 4 tyres. The 4 tyres were also observed to be sufficiently inflated for vehicular operation. The tyre brand, tyre size and remaining tread depth of the 4 tyres were recorded as follows:-

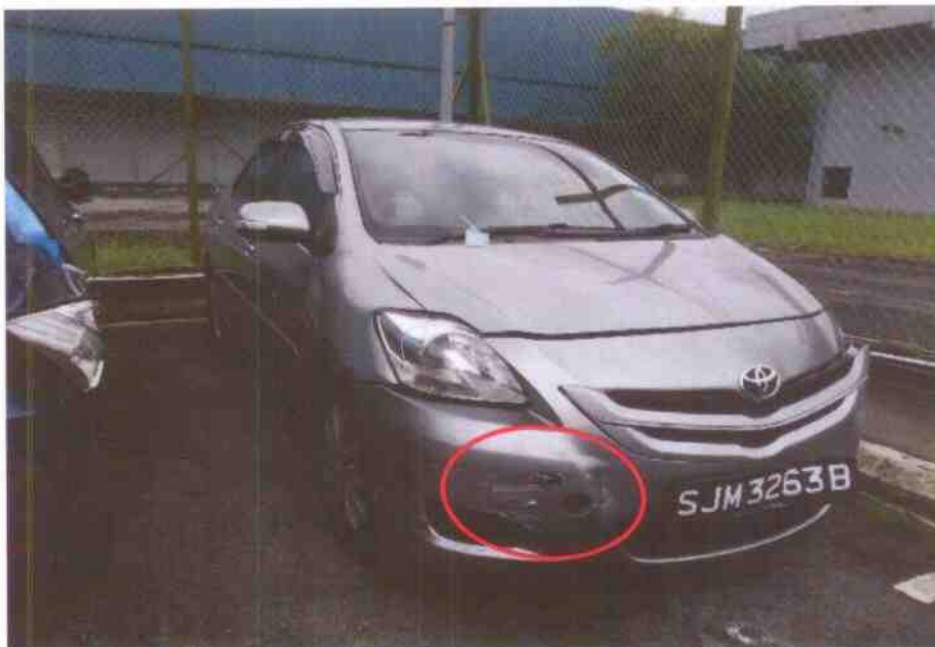
Photo 1 shows a general view of the front right body of the Motor Car at the time of my inspection. The Motor Car was observed to have sustained damage at its front right body. Its front number plate, front bumper (circled), front right headlamp and front right fender were amongst the body parts that were damaged as a result of the accident. The mileage of the Motor Car at the time of my inspection was recorded to be 163,227km.

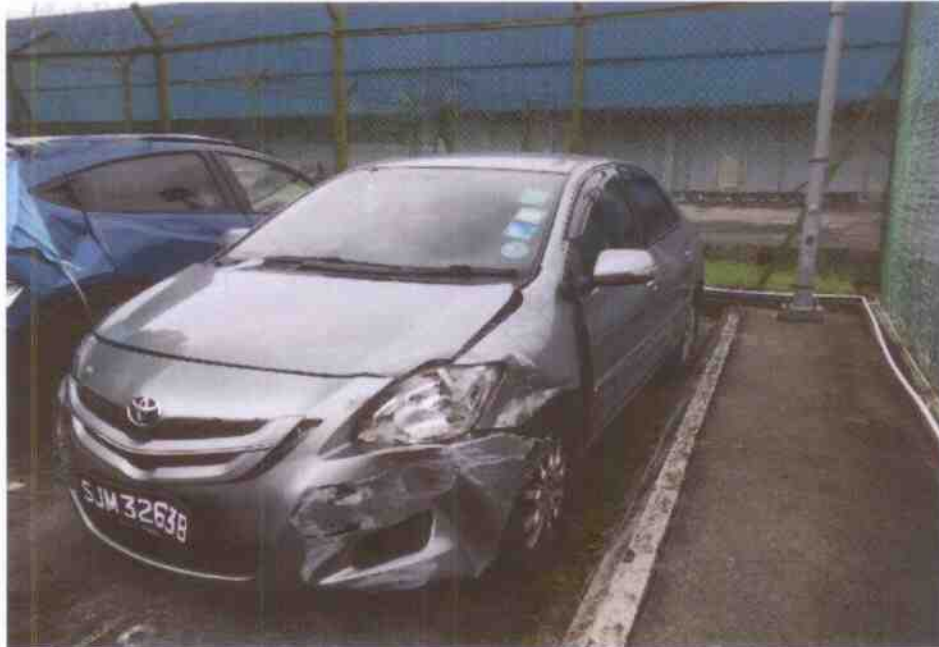
Photo 2 shows a general view of the front left body of the Motor Car at the time of my inspection. The front left body and left front body of the Motor Car were also damaged as a result of the accident. Body parts like the front bonnet, front left fender and front left headlamp were damaged.

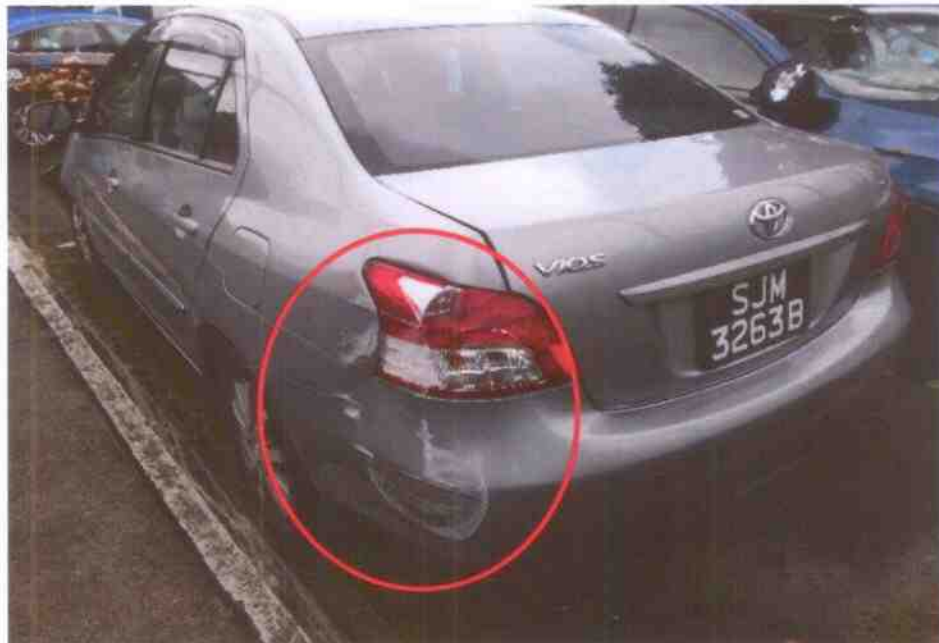
Photo 3 shows a general view of the Motor Car's rear left body at the time of my inspection. The rear bumper, left rear fender and rear left tail lamp of the Motor Car had sustained damage arising from the accident.

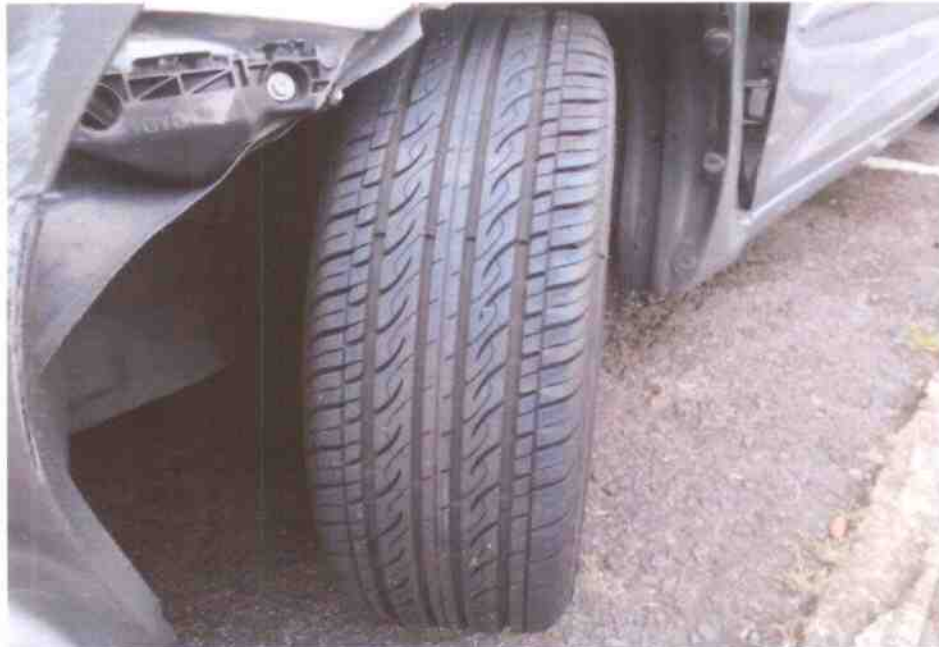
Photo 4 shows the condition of the front left tyre of the Motor Car, which was observed to be in serviceable condition with remaining tread depth of approximately 6mm. The tyre was wrapped around alloy wheel rim that was found to be with grazed marks on the outer spokes. The tyre was also observed to be sufficiently inflated for vehicular operation with no tear, cut or burst mark(s) on the outer and the inner sidewalls as well as across the tread.

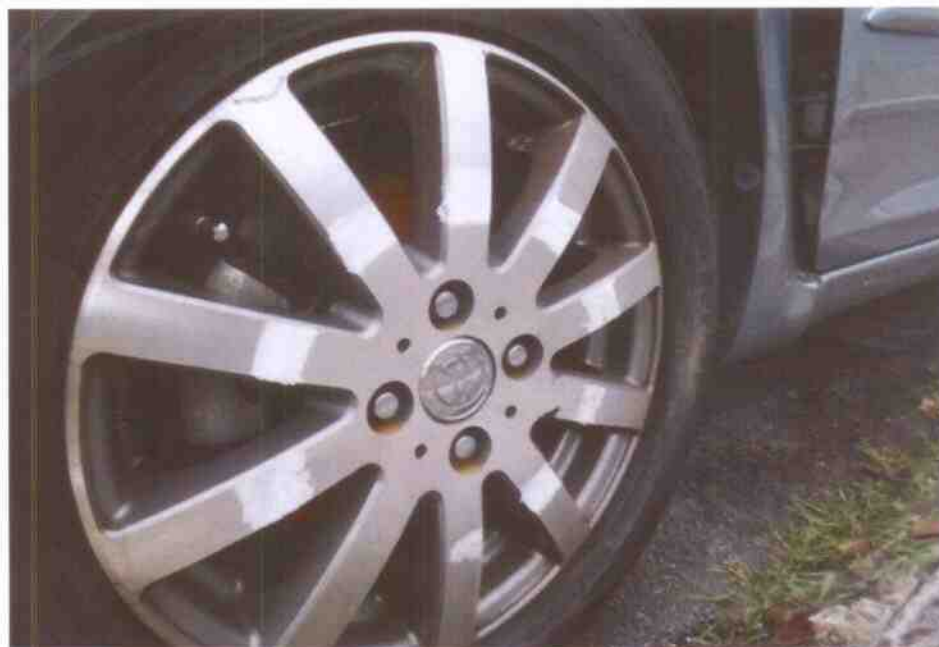
7. The 4 tyres were observed to be wrapped around alloy wheel rims that were found to be without any damage except for the front left wheel rim. Fresh marks of grazing nature were observed on the outer spokes of the front left wheel rim, indicating that the damage was a result of the accident. See photo 1 – 8 below.

Photo 5 shows the front left wheel rim of the Motor Car. Fresh marks of grazing nature were observed on the outer spokes of the front left wheel rim.

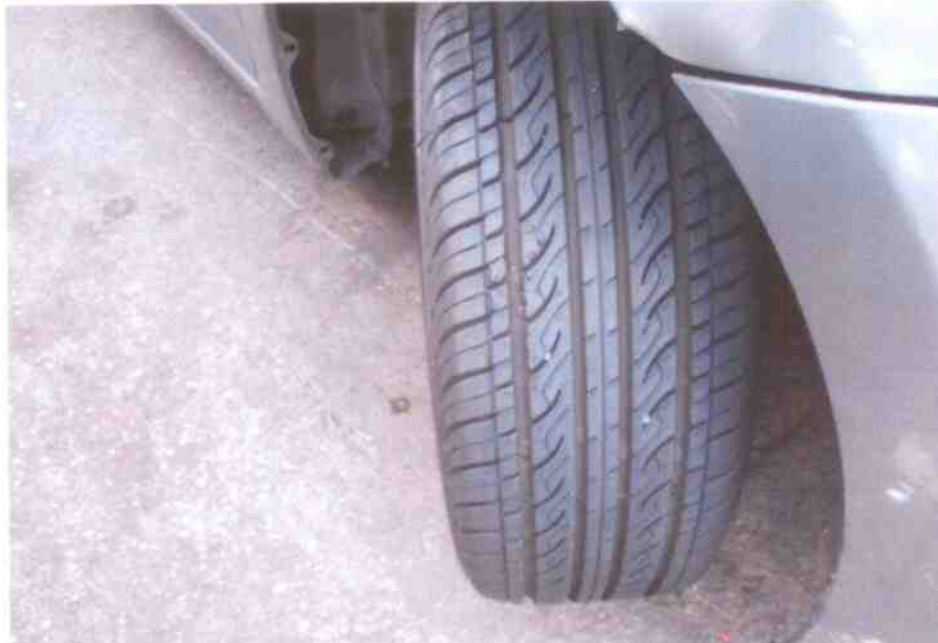
Photo 6 shows the condition of the front right tyre of the Motor Car, which was observed to be in serviceable condition with remaining tread depth of approximately 6mm. The tyre, which was wrapped around alloy wheel rim, was also observed to be sufficiently inflated for vehicular operation.

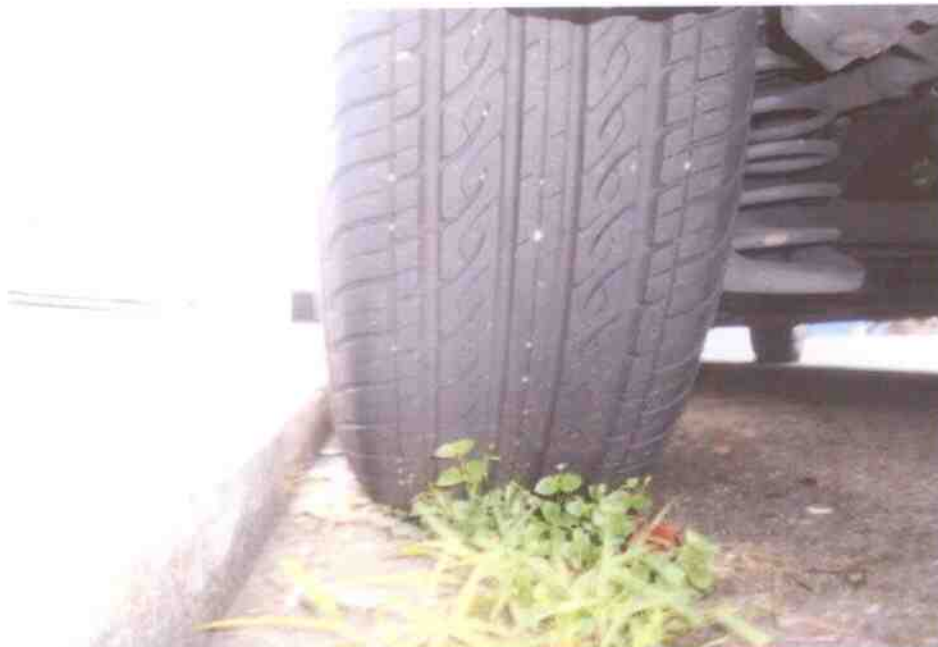
Photo 7 shows the condition of the rear left tyre of the Motor Car, which was observed to be in serviceable condition with remaining tread depth of approximately 6mm. The tyre, which was wrapped around alloy wheel rim, was also observed to be sufficiently inflated for vehicular operation. There was also no damage found on the 4 wheel rims of the Motor Car except for the front left wheel rim, which was damaged as a result of the accident.

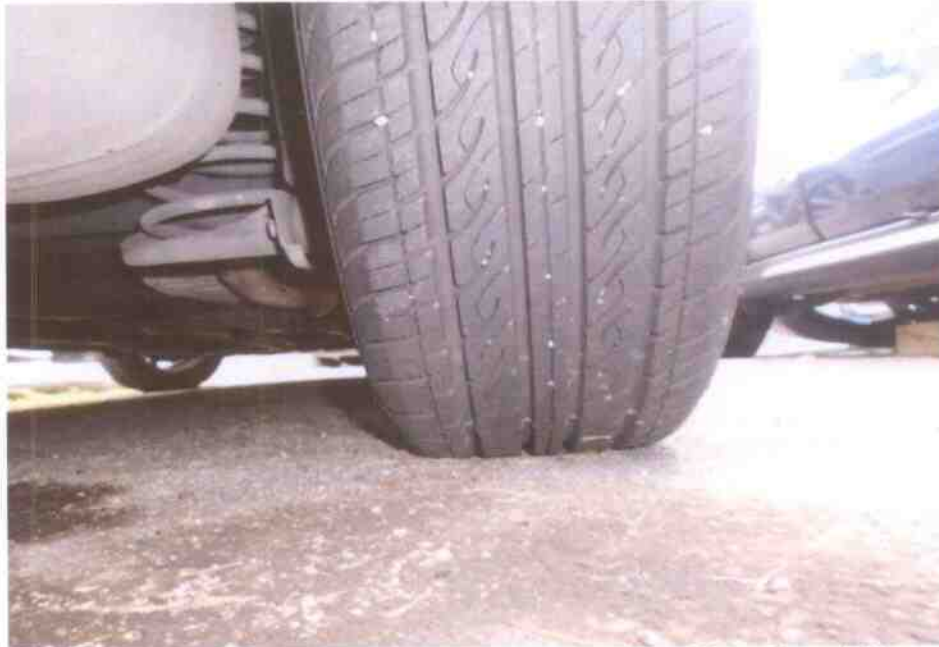
Photo 8 shows the condition of the rear right tyre of the Motor Car, which was observed to be in serviceable condition with remaining tread depth of approximately 6mm. There was also no tear, cut or burst mark(s) on the outer and the inner sidewalls as well as across the tread of the Motor Car's 4 tyres.

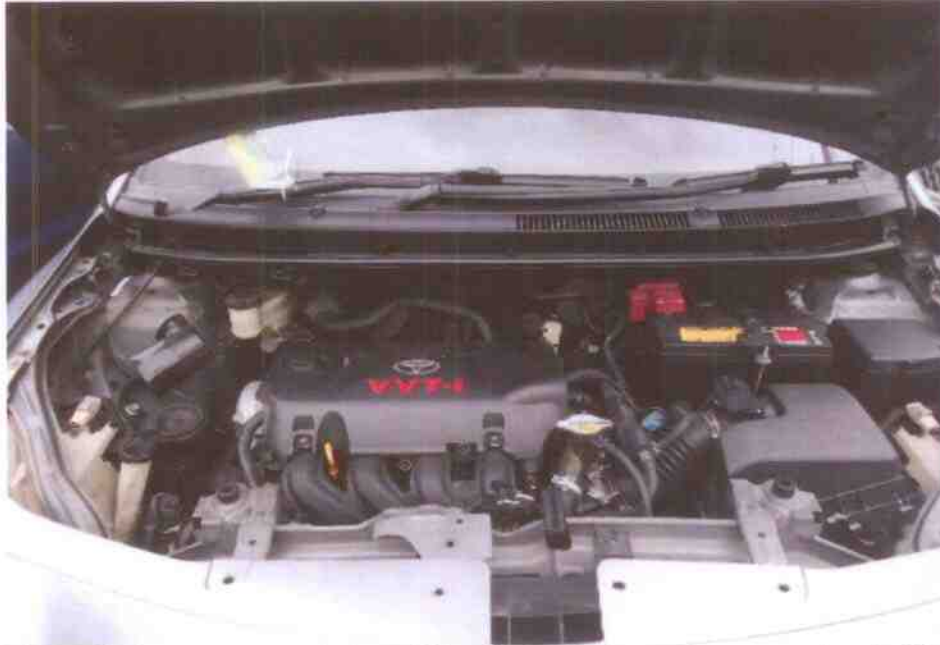
Photo 9 shows a general view of the Motor Car's engine compartment. The various parts and components inside the engine compartment were unaffected by the accident. There was also no sign(s) or indication(s) of fluid leakage and/or fluid stain within the engine compartment.

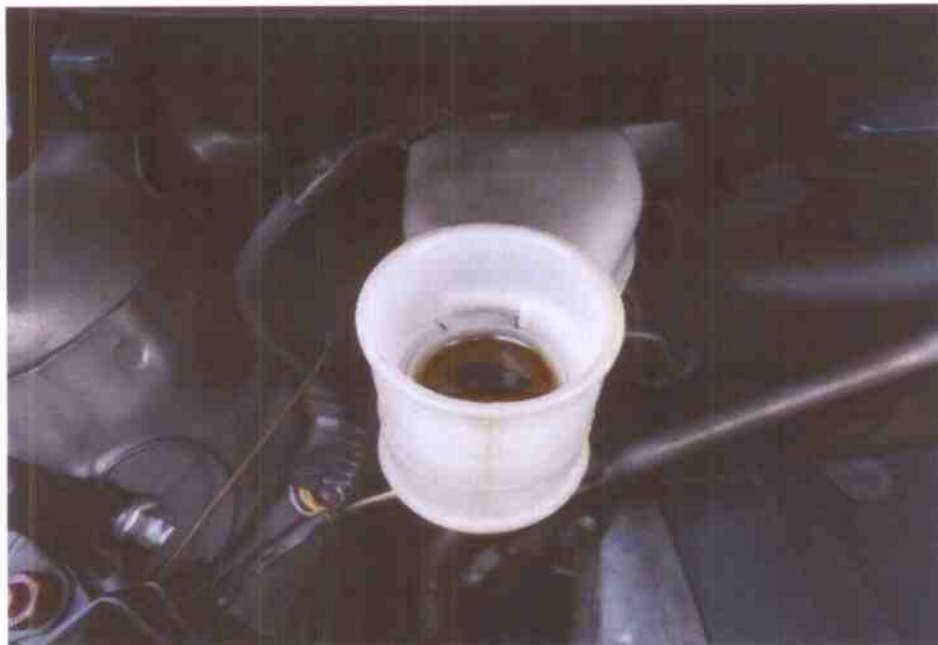
Photo 10 shows the brake fluid reservoir of the Motor Car at the time of my inspection. The brake fluid was observed to be of sufficient level and without any visible contamination.

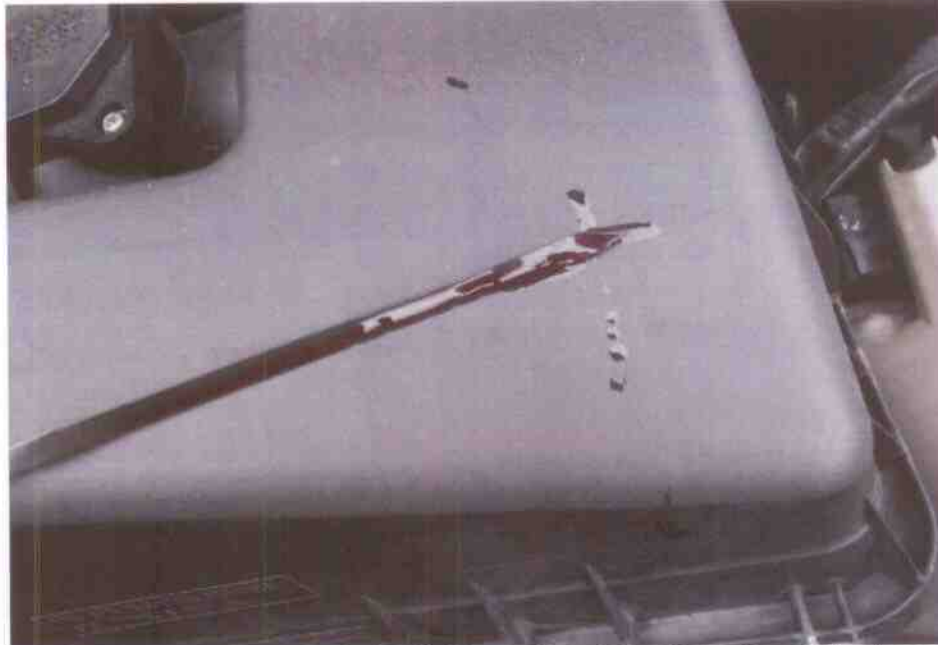
Photo 11 shows the transmission fluid reservoir of the Motor Car at the time of my inspection. The transmission fluid was observed to be of sufficient level and without any visible contamination.

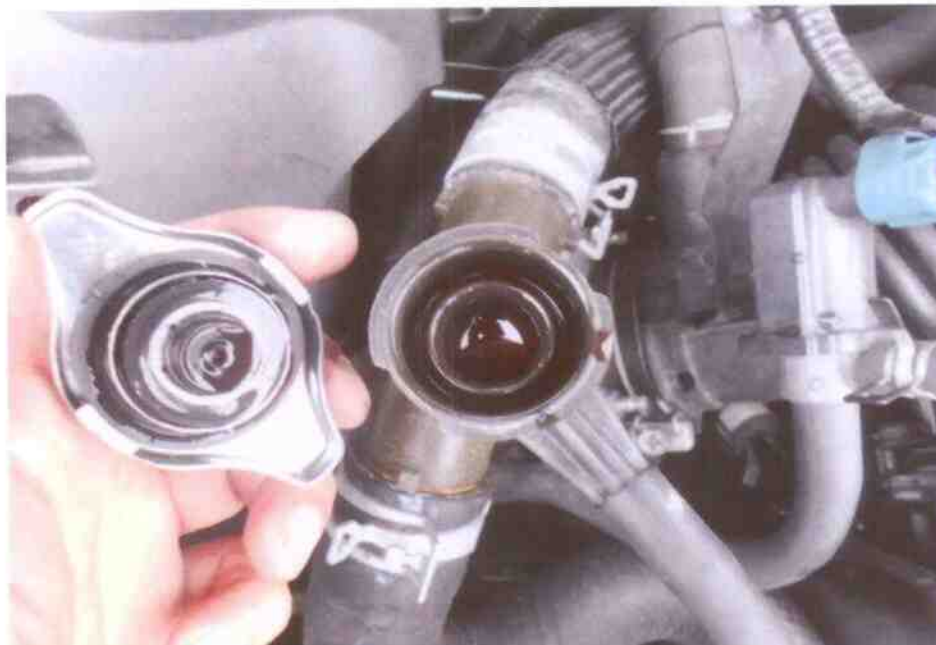
Photo 12 shows checks being carried out to the engine coolant of the Motor Car at the time of my inspection. The engine coolant was observed to be of sufficient level and without any visible contamination.

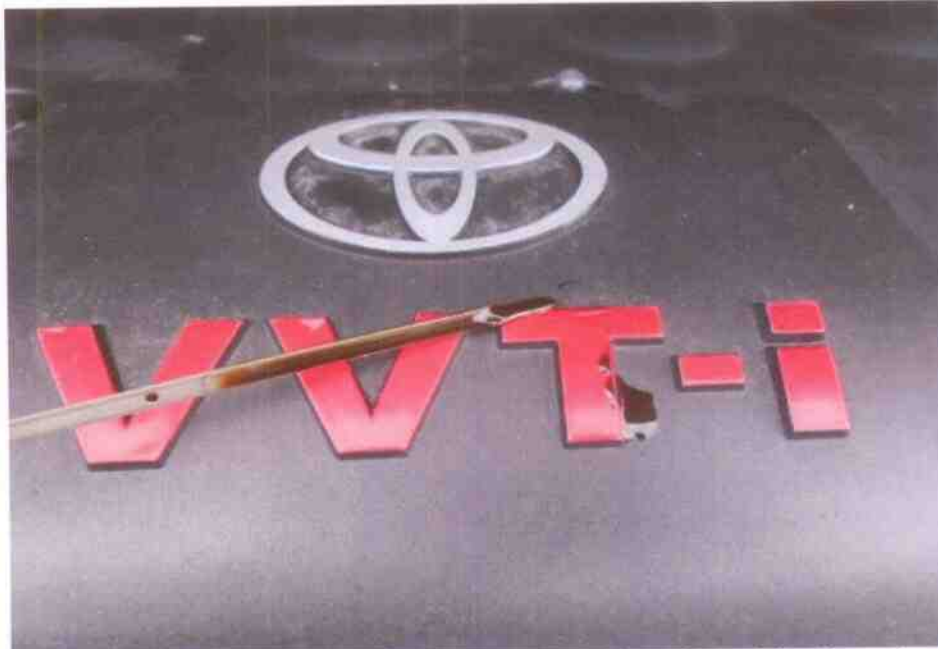
Photo 13 shows the engine oil dip stick of the Motor Car at the time of my inspection. The engine oil was observed to be of sufficient level and without any visible contamination.

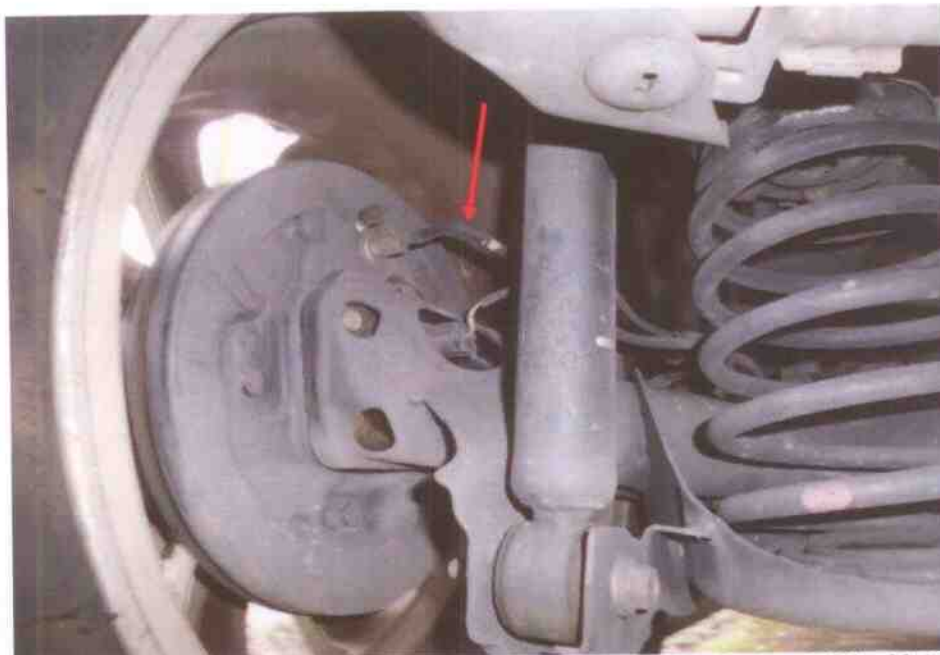
Photo 14 shows the brake hose/pipe (arrowed) at the rear left wheel of the Motor Car. I did not observe any leakage of brake fluid at the time of my inspection of the Motor Car. Static tests of the Motor Car's braking system had indicated that there was no internal leakage of pressure/vacuum. The undercarriage components of the Motor Car were also all found to be intact and without any visible damage.

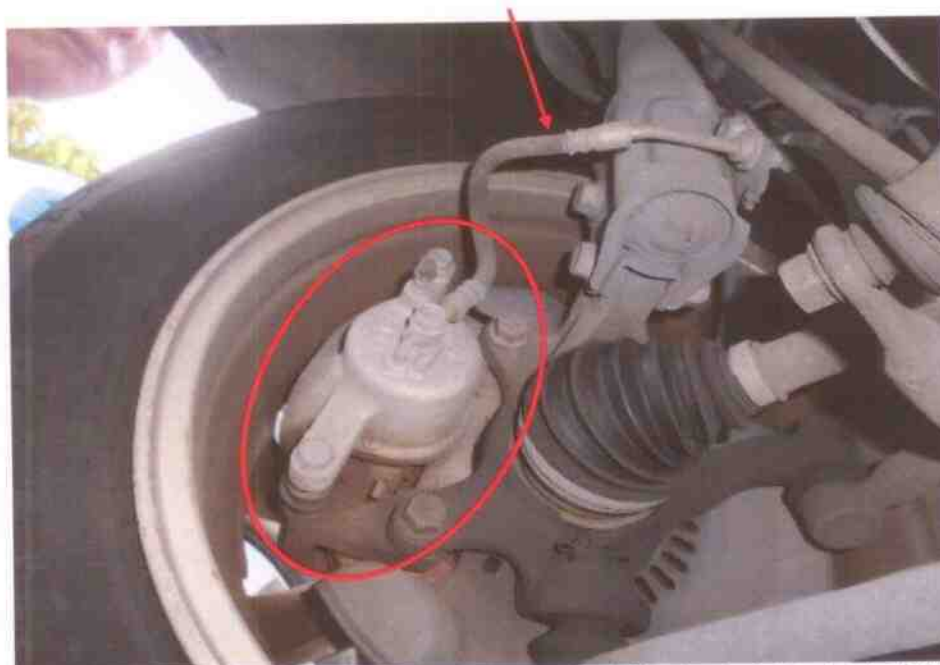
Photo 15 shows the brake hose/pipe (arrowed) at the front right wheel of the Motor Car. No leakage of brake fluid was observed. Visual examination of the various components of the braking system like the brake caliper (circled), brake booster, brake pedal etc had revealed all to be intact and without visible damage.

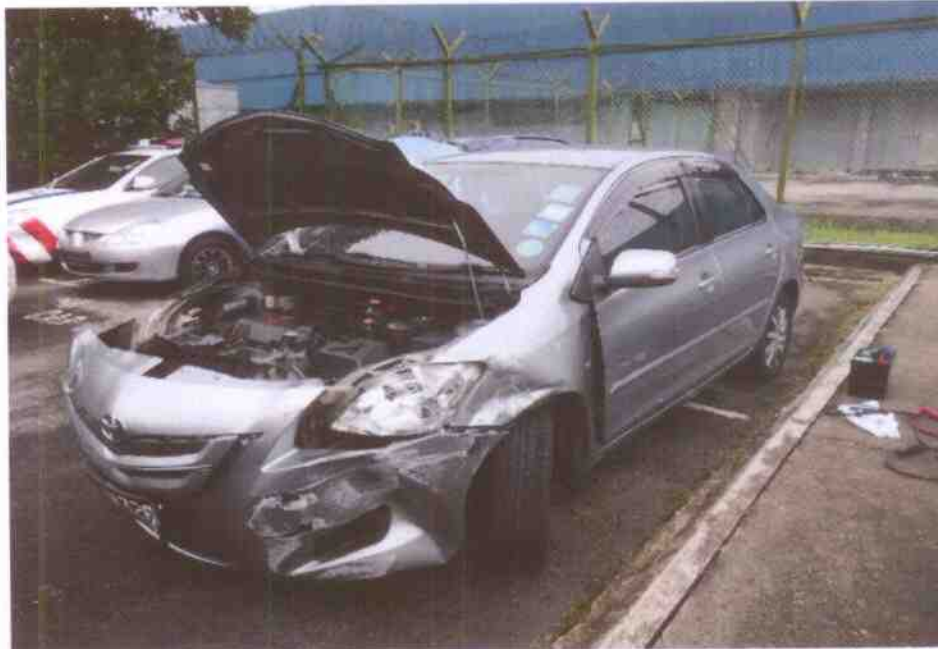
Photo 16 shows the front left wheel of the Motor Car turned to its full left. During my steering system test, I did not experience any abnormal free play and/or resistance when I had turned the steering wheel towards the left and right. This would suggest that the steering system of the Motor Car was likely to be in serviceable condition at the material time of accident.

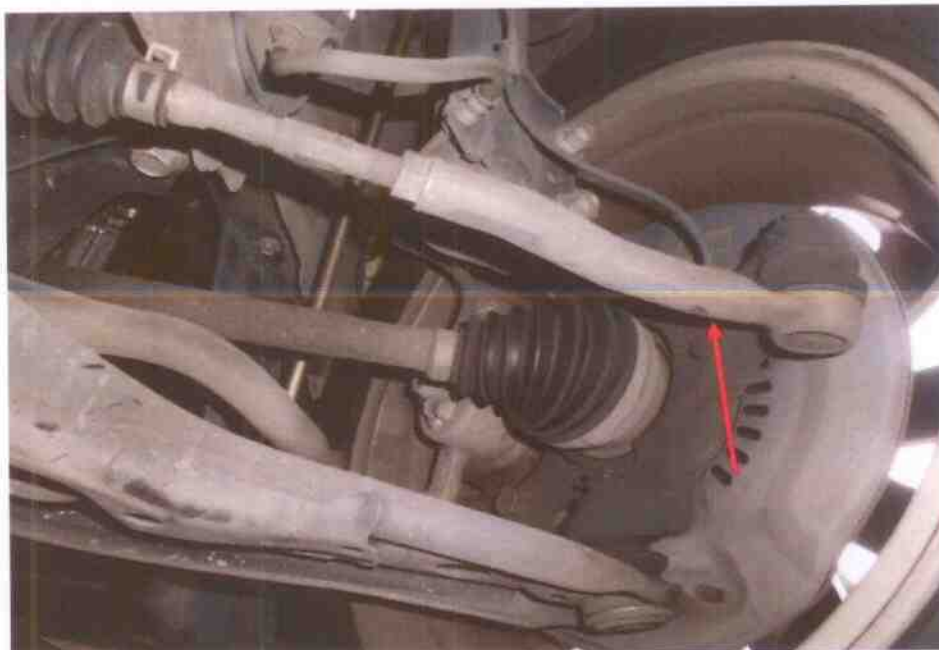
Photo 17 shows the various undercarriage components at the front right wheel of the Motor Car, in particular the steering tie rod (arrowed). The various steering components were all found to be intact, suggesting that the steering system of the Motor Car was likely to be in serviceable condition at the material time of accident. There was also no sign of fluid stain observed on the various undercarriage components at the front right wheel of the Motor Car.

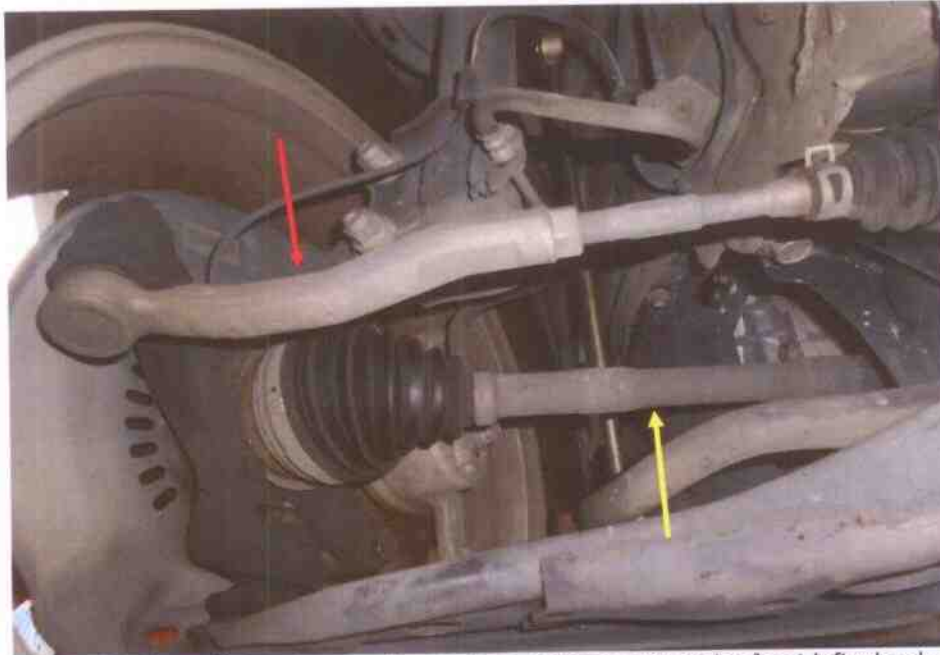
Photo 18 shows the various undercarriage components at the front left wheel of the Motor Car, which had included the steering tie rod (red arrow) and left drive shaft (yellow arrow). The various undercarriage components of the Motor Car were all found to be intact without any visible damage.

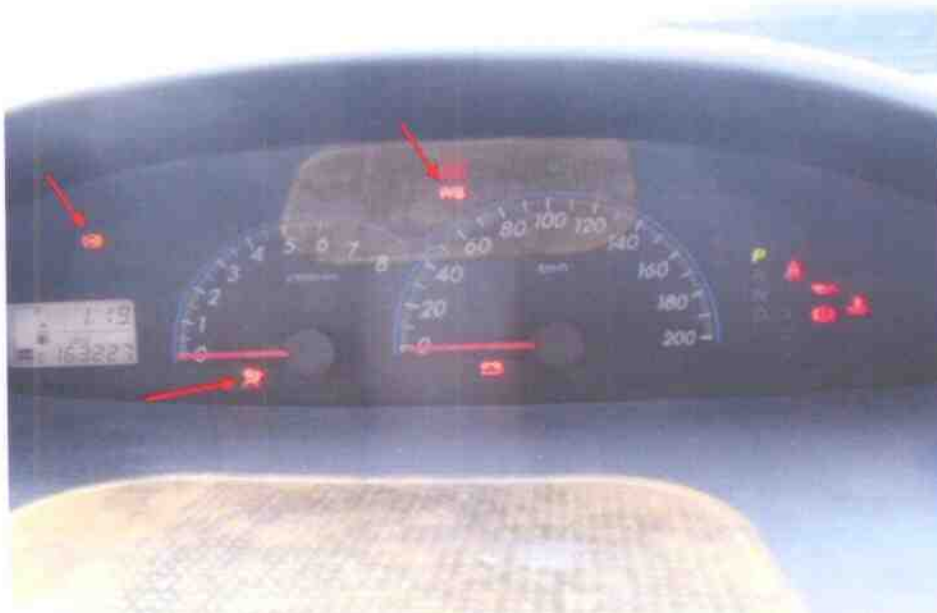
Photo 19 shows the warning lights for the various electronic operating systems of the Motor Car appearing on its instrument panel during the self-test when the engine is cranked, in particular the ABS light, PS light and SRS light (arrowed).

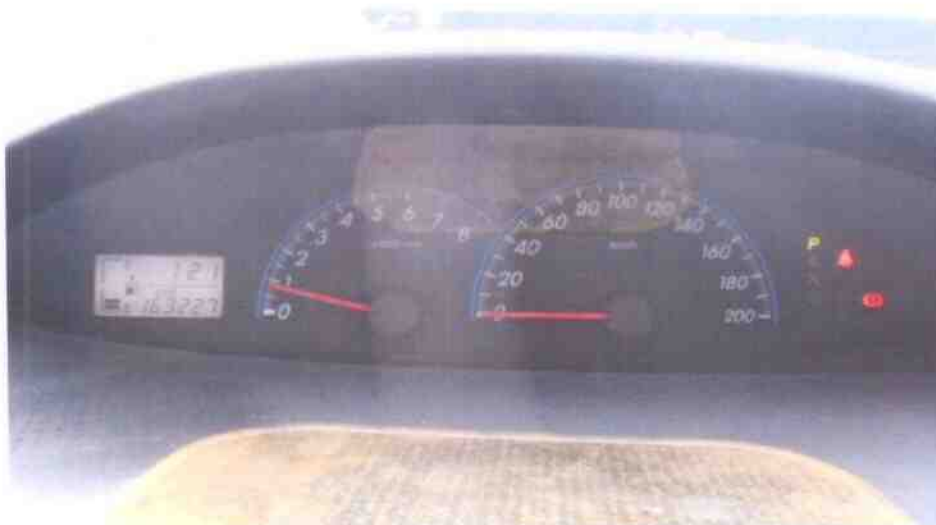
Photo 20 shows no warning lights illuminated on the instrument panel of the Motor Car after the engine was cranked. This would suggest that there was no abnormality to the various electronic operating systems of the Motor Car, like the ABS, PS and SRS etc.
