Your Ref: TP/IP/60531/2017
Our Ref : CI/TPD17022393/D

27 November 2017

MECHANICAL INSPECTION REPORT OF POLICE MOTOR CAR QX 509Y

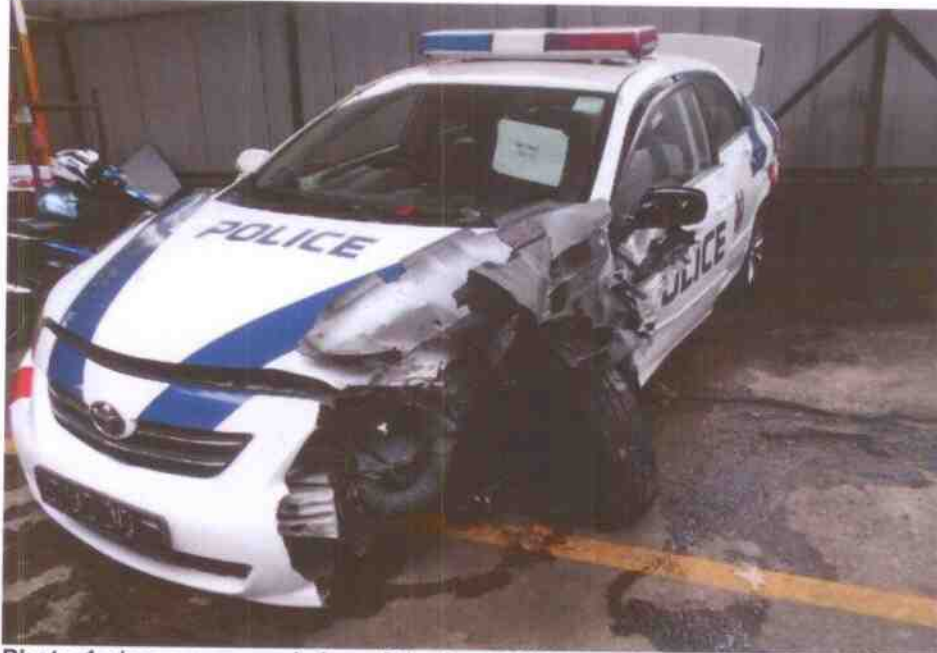
4. The mileage of the Police Car at the time of my inspection was not recorded due to damage to its ignition system.
5. The Police Car had sustained extensive impact damage along its left body. The impact force was relatively significant causing severe damage to its front bumper, front left headlamp, front left fender, front left wheel house, front bonnet, left wing mirror, left front door, left rear door, left rear fender and rear bumper amongst others. Almost all the undercarriage components at the front left wheel and front right wheel were also damaged as a result of the accident.
6. Several parts and components towards the left side of the engine compartment were also observed to have been damaged as a result of the impact force. See photo 1 – 4 below.

Photo 1 shows a general view of the front left body of the Police Car at the time of my inspection. The Police Car was observed to have sustained extensive impact damage along its left body. The impact force was relatively significant causing severe damage to its front bumper, front left headlamp, front left fender, front left wheel house, front bonnet and front left door amongst others.

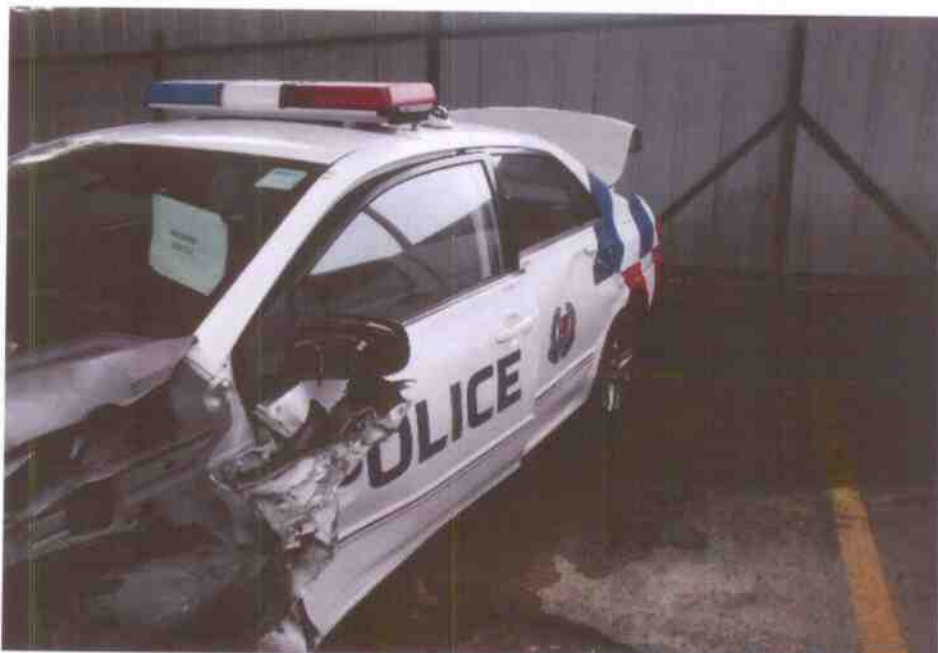
Photo 2 shows a closer view of the extent of damage along the left body of the Police Car. Its left wing mirror, front left fender and front left door were amongst the body parts that were severely damaged as a result of the impact force.

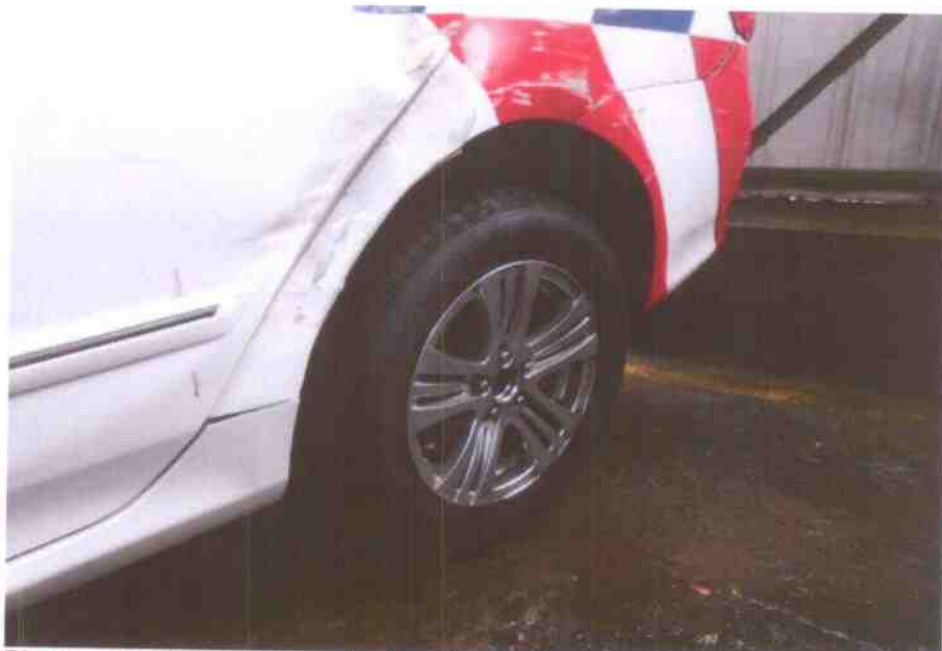
Photo 3 shows the left rear body of the Police Car. Its rear left door, left rear fender and rear bumper had also sustained damage arising from the accident.

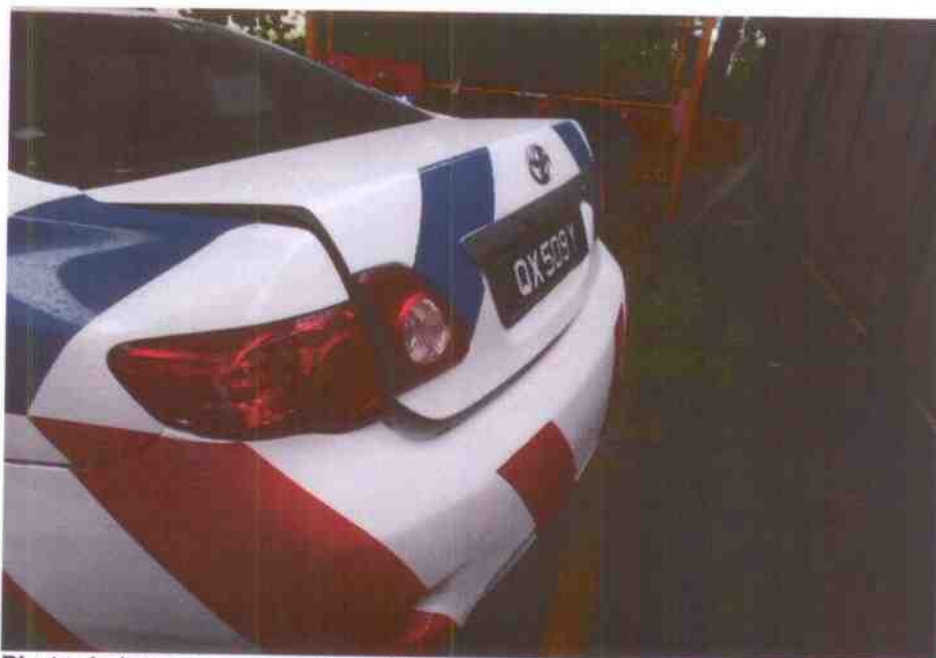
Photo 4 shows a general view of the rear body of the Police Car. The rear body and right side body of the Police Car were observed to be relatively unaffected from the accident.

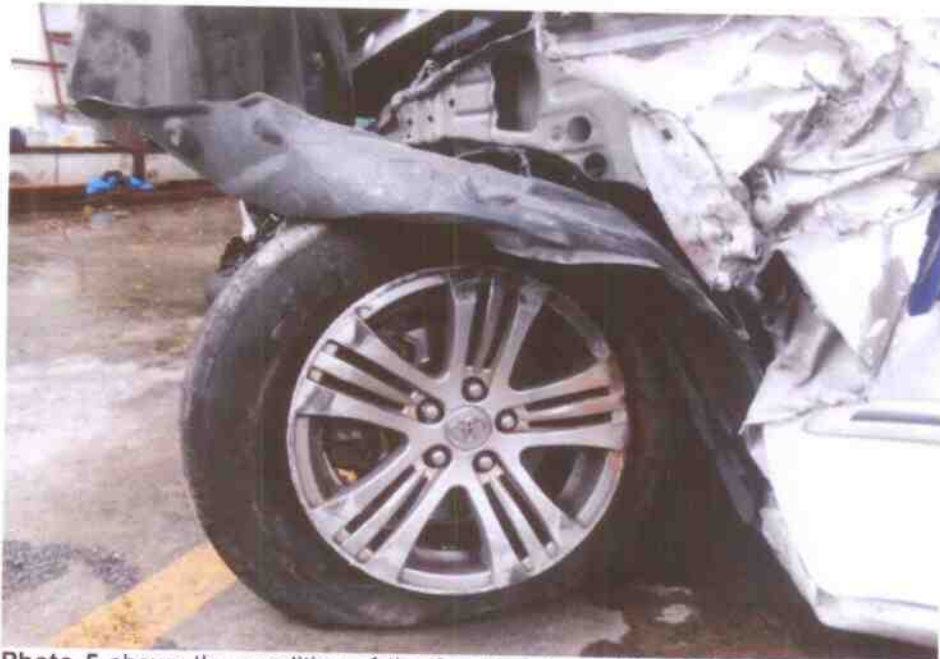
7. The Police Car's 4 tyres were all found to be deflated. The 4 tyres were wrapped around alloy wheel rims that were also found to be damaged. The rear tyres, still wrapped around their wheel rims, were found in the rear boot compartment of the Police Car while the front tyres were found to be wrapped around their wheel rims, attached to the body of the Police Car. The 4 wheel rims had mainly sustained grazing marks on their outer spokes. The front left wheel rim was observed to be broken as well.

8. The front left tyre and one of the rear tyres were found to be cut at their outer sidewall, which were a result of the accident. The remaining tread depth of all the tyres was approximately 5mm each with their tread pattern still clearly visible. Although the 4 tyres of the Police Car were found to be deflated, they were likely to be in serviceable condition prior to the accident as the deflation was a result of the accident. See photo 5 – 12 below.

Photo 5 shows the condition of the front left tyre of the Police Car, which was observed to be deflated. The outer sidewall of the tyre was found to be cut. The wheel rim was also observed to be broken with marks of grazing nature on its outer spokes, all of which were a result of the accident.

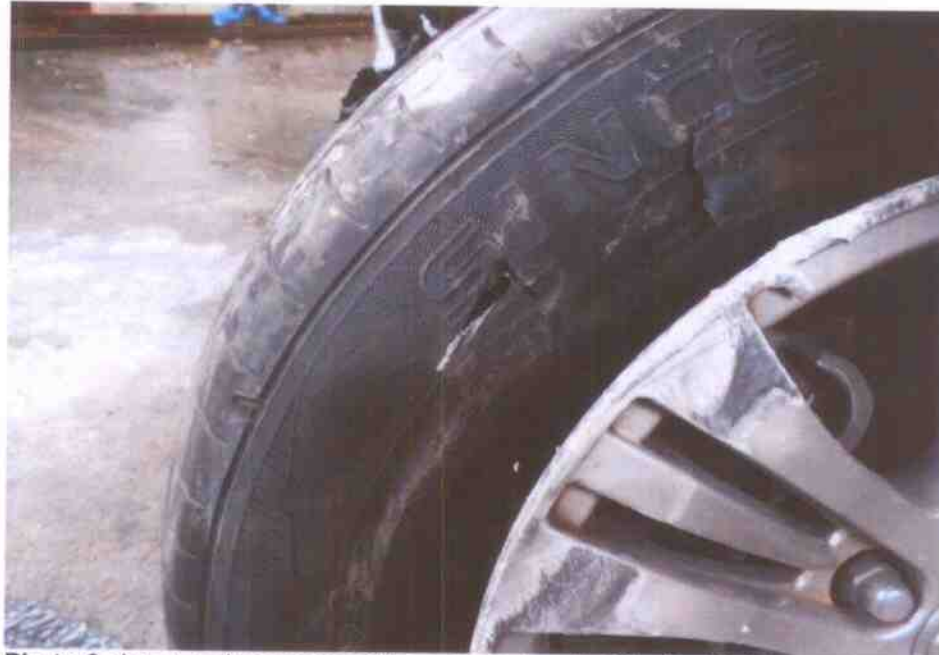
Photo 6 shows a closer view of the outer sidewall of the front left tyre, where the rubber was found to be cut. The wheel rim was also observed to be broken with marks of grazing nature on its outer spokes, all of which were a result of the accident.

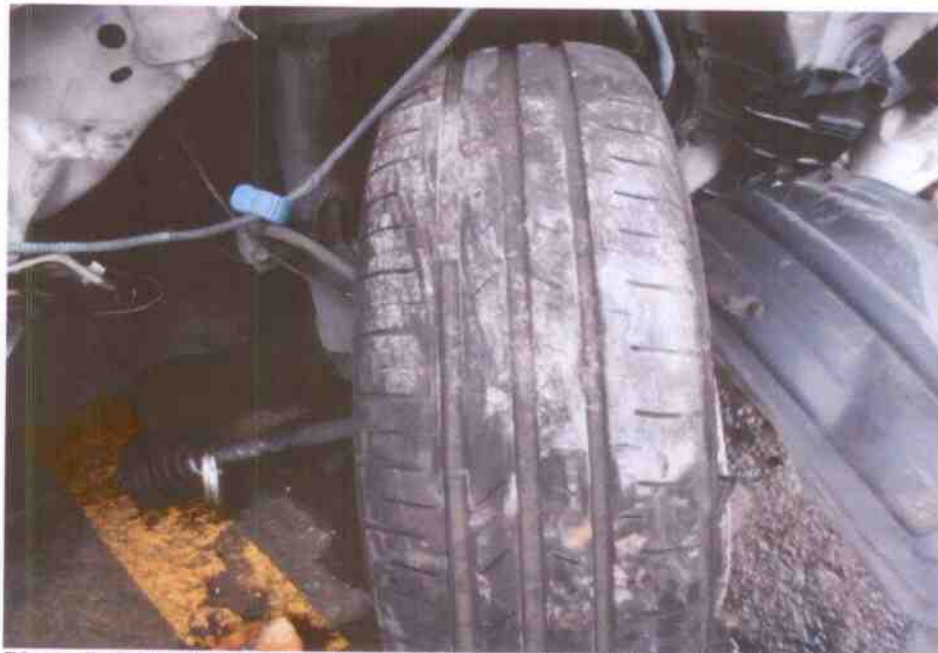
Photo 7 shows the tread of the front left tyre of the Police Car. Although the front left tyre was found to be deflated, it can still be considered to be in serviceable condition prior to the accident as the remaining tread depth of the tyre was approximately 5mm with its tread pattern clearly visible.

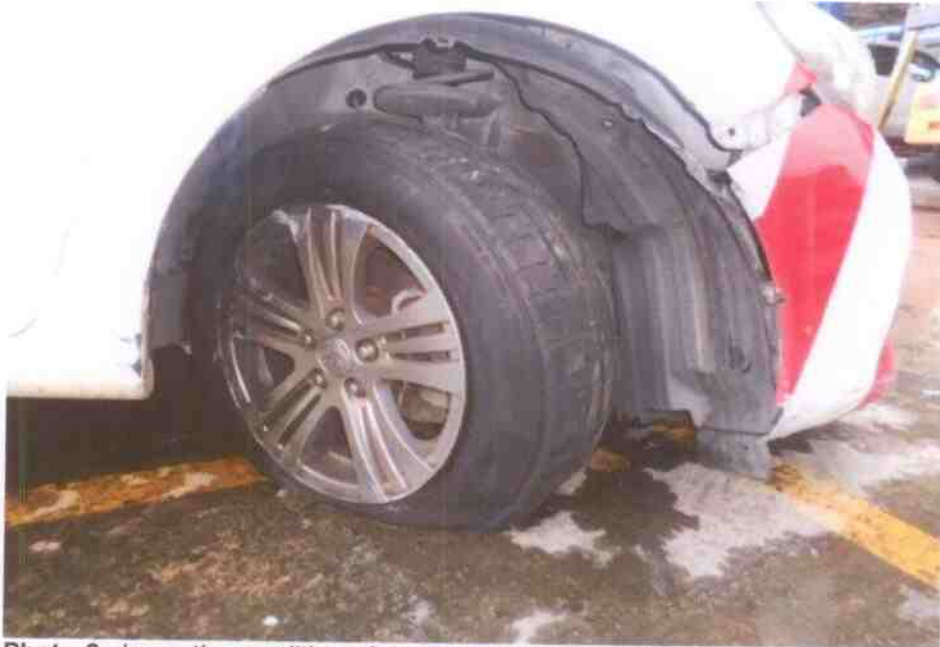
Photo 8 shows the condition of the front right tyre of the Police Car, which was observed to be deflated. The front right wheel rim was also observed to be damaged with marks of grazing nature on its outer spokes. The deflation of the tyre and damage to the wheel rim were both a result of the accident.

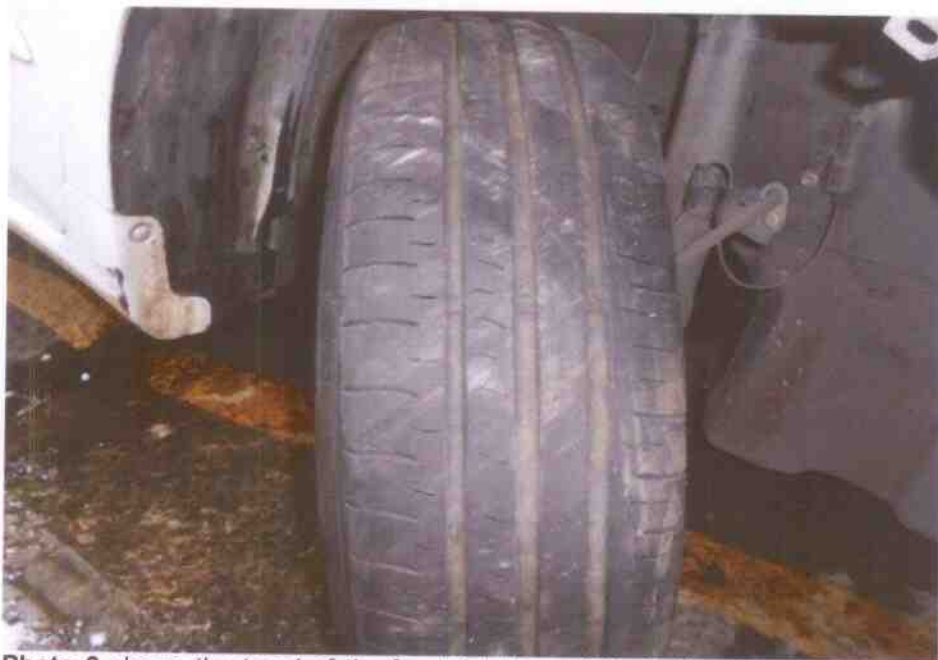
Photo 9 shows the tread of the front right tyre of the Police Car. Although the front right tyre was found to be deflated, it can still be considered to be in serviceable condition prior to the accident as the remaining tread depth of the tyre was approximately 5mm with its tread pattern clearly visible.

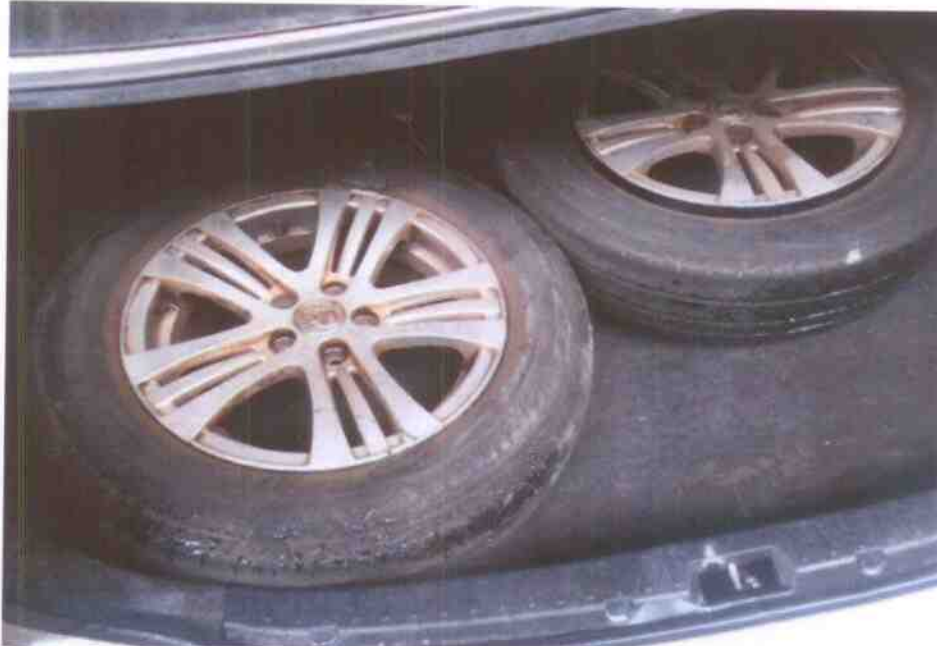
Photo 10 shows the 2 rear tyres of the Police Car that were found in the rear boot compartment. Both the tyres were found to be wrapped around their wheel rims and deflated. Both wheel rims were also found to be damaged as a result of the accident, with marks of grazing nature on their outer spokes.

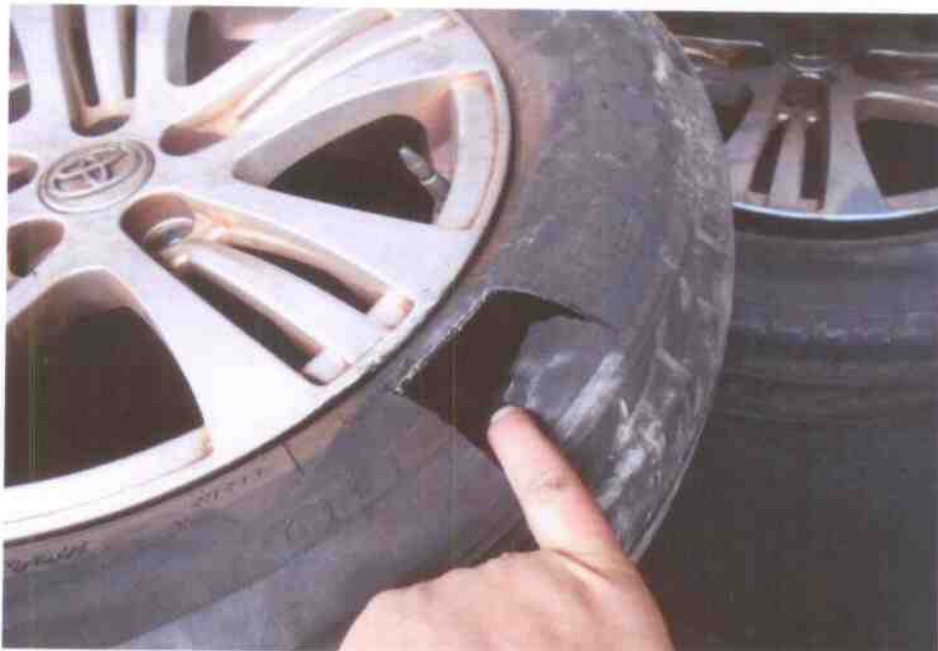
Photo 11 shows the cut observed on the outer sidewall of one of the tyres that were found in the rear boot compartment of the Police Car. The cut to the tyre and damage to the wheel rim were both arising from the accident.

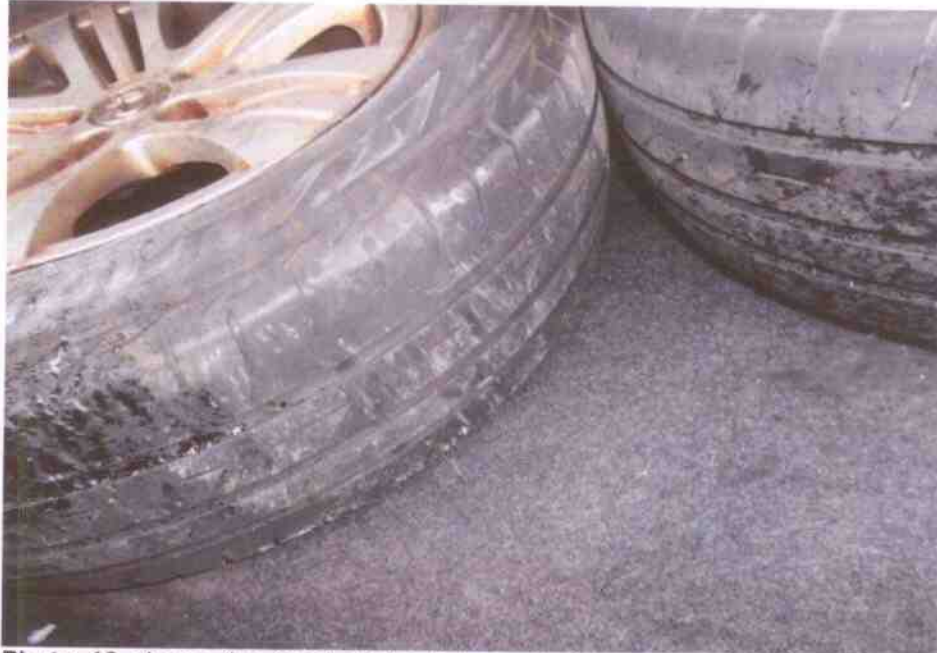
Photo 12 shows the tread of the 2 tyres that were found in the rear boot compartment of the Police Car. Although the 2 tyres were found to be deflated, both tyres can still be considered to be in serviceable condition prior to the accident as the remaining tread depth of the tyres were approximately 5mm with its tread pattern clearly visible.

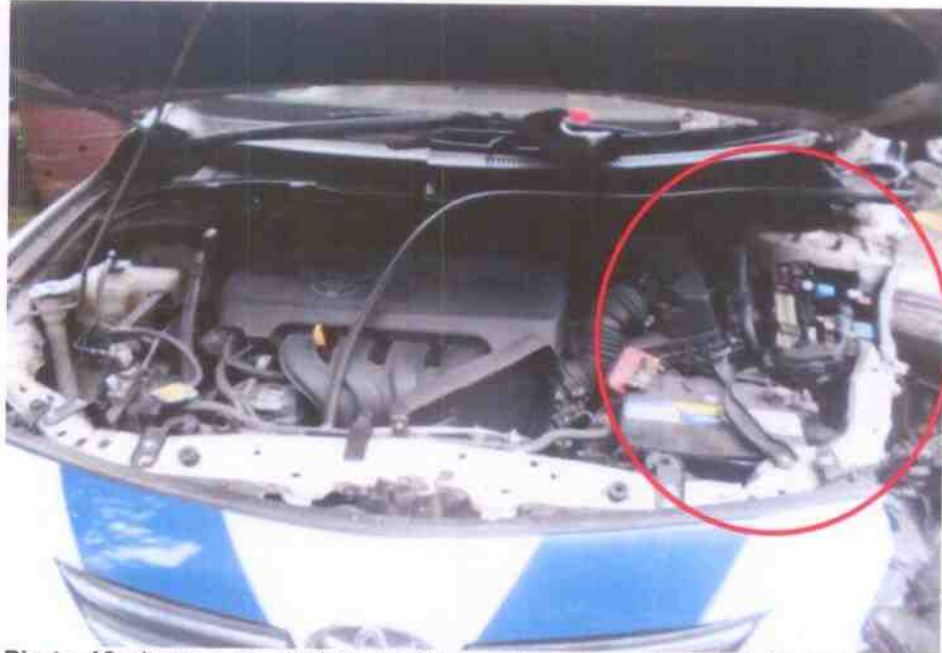
9. Upon examination of the engine compartment, I had observed that several parts towards the left of the engine compartment were affected by the impact from the collision. I was however still able to carry out checks to the various operating fluids of the Police Car.

Photo 13 shows a general view of the engine compartment of the Police Car. Several parts towards the left side (circled) of the engine compartment was damaged as a result of the accident.

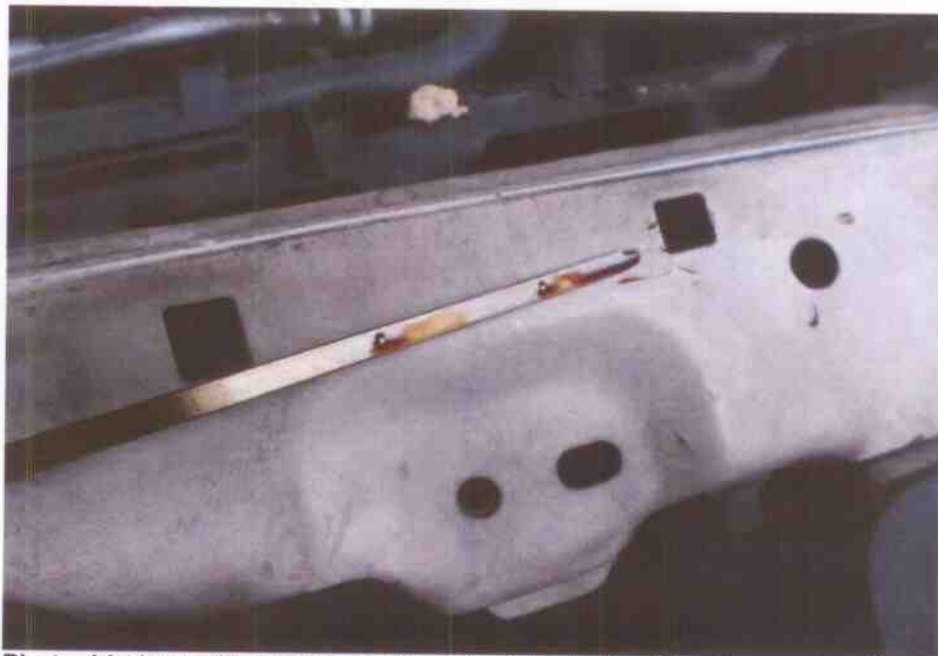
Photo 14 shows the engine oil dip stick of the Police Car. The engine oil was found to be sufficient level and without contamination for operating purposes.

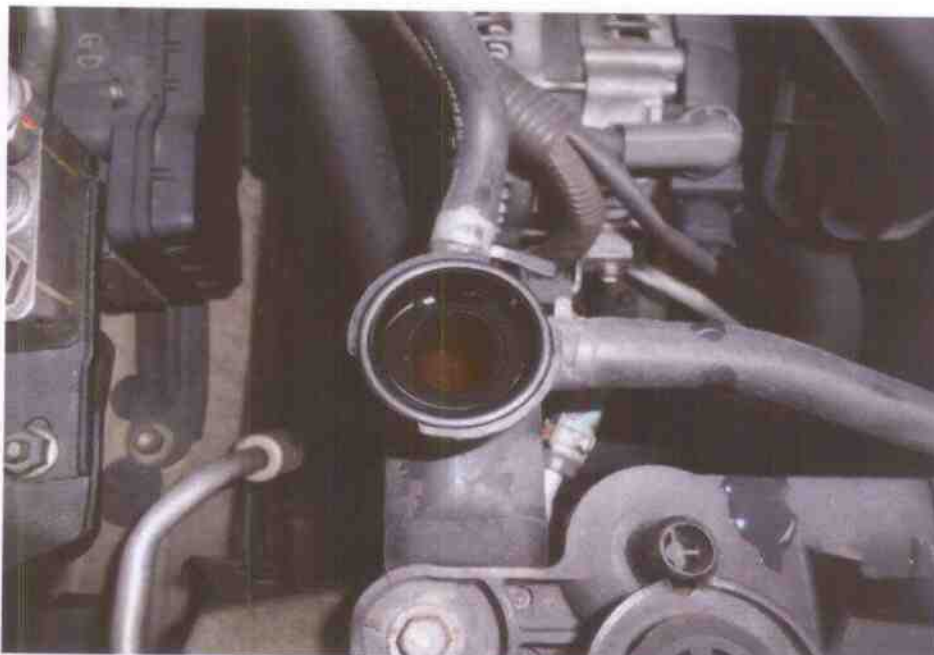
Photo 15 shows checks being carried out to the engine coolant of the Police Car at the time of my inspection. The engine coolant was observed to be of sufficient level and without any visible contamination.

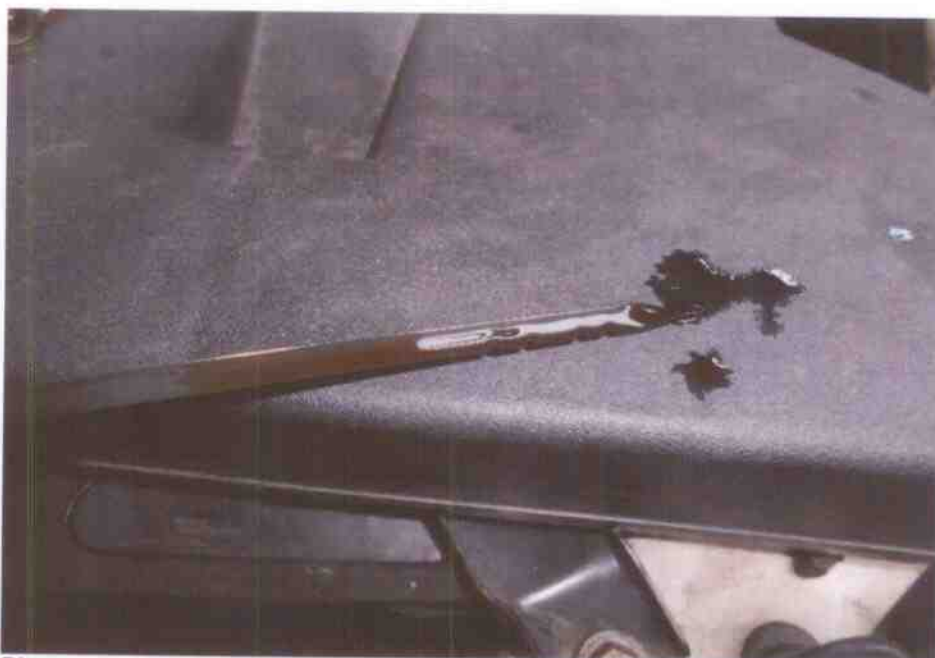
Photo 16 shows the transmission fluid dip stick of the Police Car. The transmission fluid was found to be sufficient level and without contamination for operating purposes.

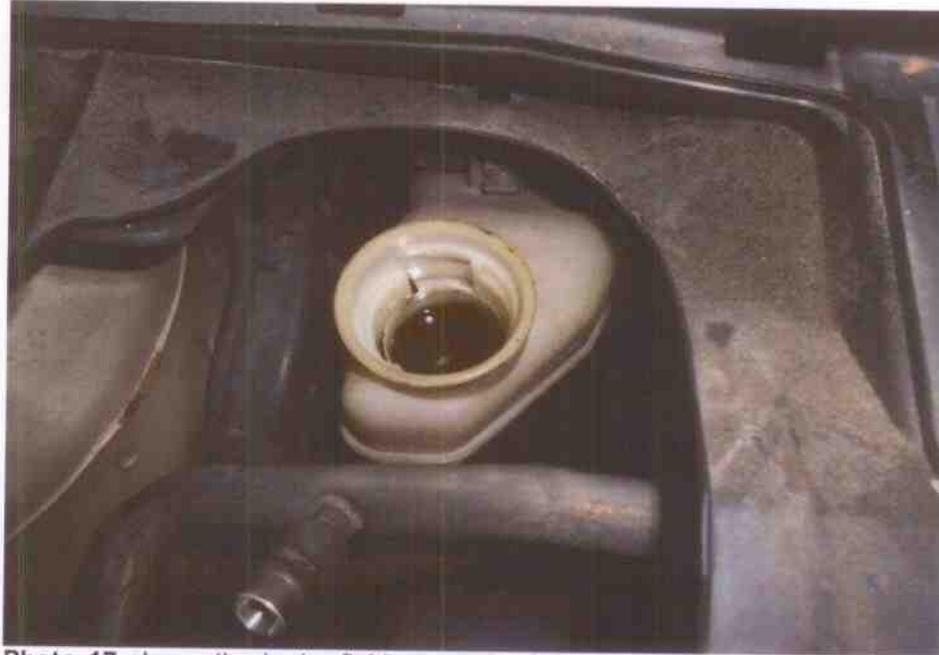
Photo 17 shows the brake fluid reservoir of the Police Car at the time of my inspection. The brake fluid was observed to be of sufficient level and without any visible contamination.

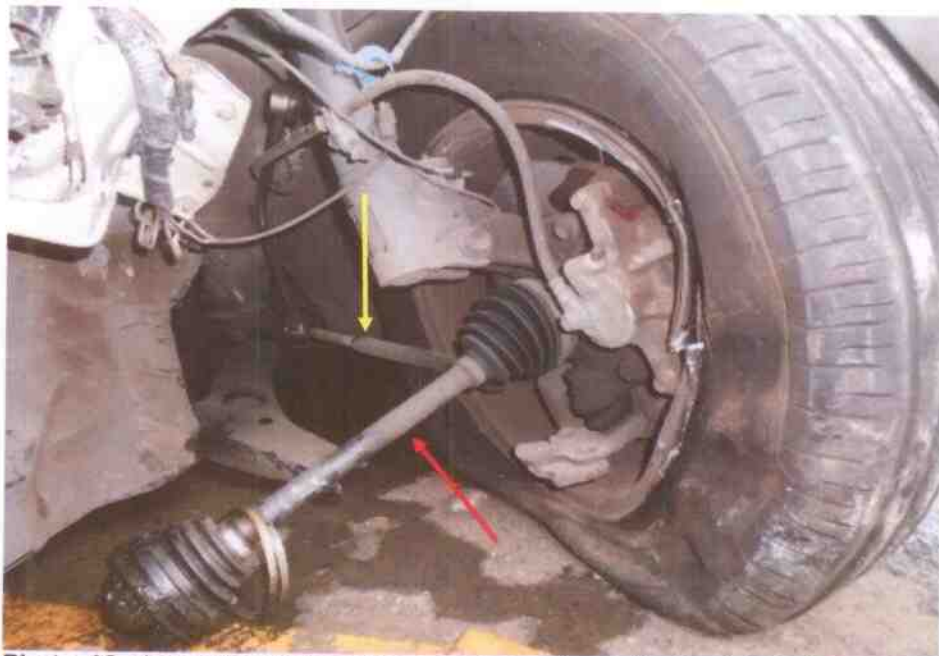
11. My subsequent checks on the underside of the Police Car revealed damage to the undercarriage components at both the front left wheel and front right wheel. Components like the front suspension, front lower arm, front drive shaft, front steering tie rod and front stabilizer bar were all damaged from the accident. See photo 13 – 19 below.

Photo 18 shows the undercarriage components at the front left wheel of the Police Car. My checks on the underside of the Police Car revealed damage to the undercarriage components at the front left wheel of the Police Car. Components like the front left suspension, front left lower arm, front left drive shaft (red arrow), front stabilizer bar and front left steering tie rod (yellow arrow) were all found to be have been damaged.

12. For this inspection, I was not able to conduct any tests on the steering system of the Police Car. This was largely due to the damage to the steering tie rod and other undercarriage components at the front left wheel and front right wheel of the Police Car. Refer to photograph 18 and 19 above.

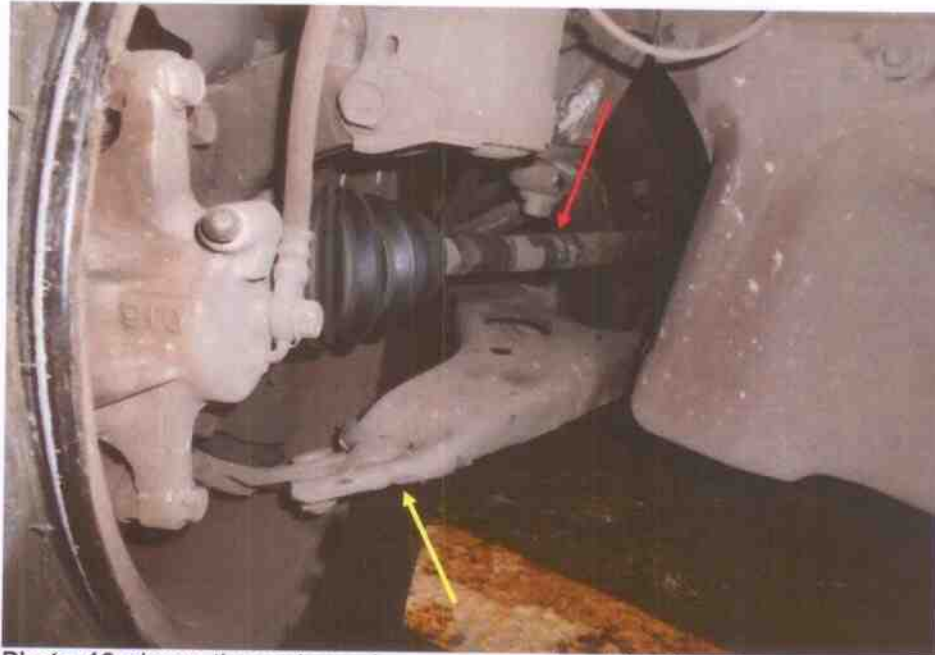
Photo 19 shows the undercarriage components at the front right wheel of the Police Car. My checks on the underside of the Police Car revealed damage to the undercarriage components at the front right wheel of the Police Car. Components like the front right suspension, front right lower arm (yellow arrow), front right drive shaft (red arrow) and front right steering tie rod were all found to be have been damaged.

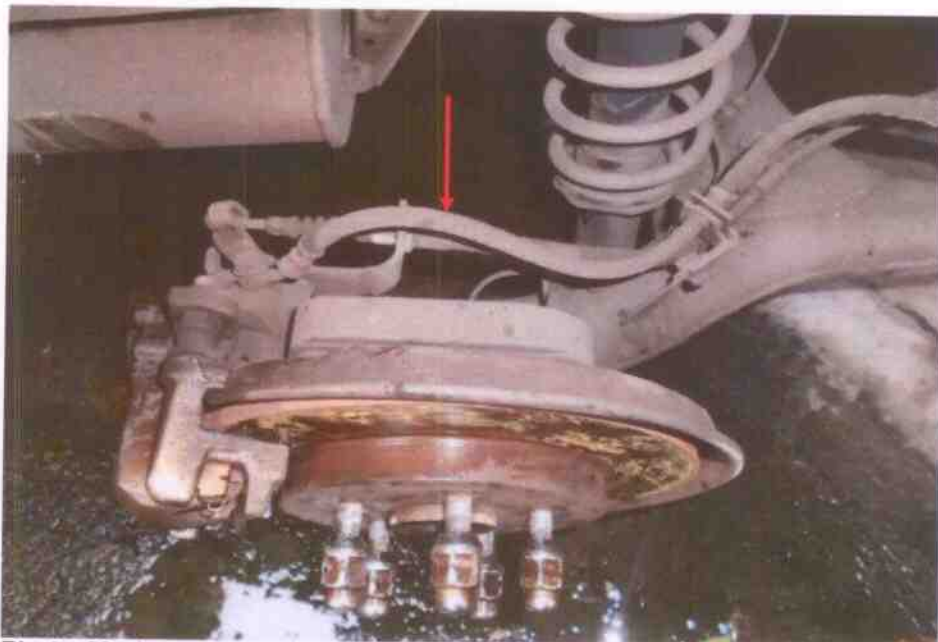
13. With regard to the braking system, I was also not able to carry out any static tests. This was due to the engine unable to be started (damage to ignition system). However my visual examination of the mechanical parts of the braking system like the brake booster, brake pipes/hoses and brake pedal revealed all the parts to be intact and undamaged. The braking system of the Police Car was therefore likely to be in serviceable condition at the material time. This was also taking into consideration that the brake fluid was of sufficient level, and also that there was no sign(s) of brake fluid leakage along the brake hoses and brake pipes. See photo 20 & 21 below.

Photo 20 shows the brake hose (arrowed) at the rear right wheel of the Police Car. I did not observe any leakage of brake fluid at the time of my inspection of the Police Car. My visual examination of the mechanical parts of the braking system like the brake booster, brake pipes/hoses and brake pedal revealed all the parts to be intact and undamaged.

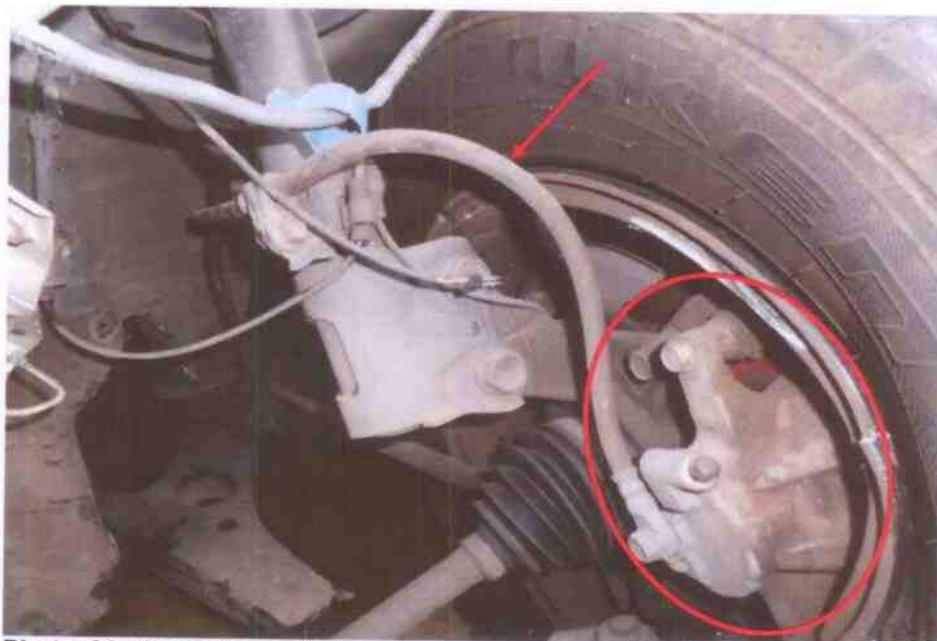
Photo 21 shows the undercarriage components at the front left wheel of the Police Car, in particular the brake hose (arrowed) and brake caliper (circled). The Police Car's braking system was likely to be in serviceable condition as my visual examination of the various mechanical parts in the braking system did not produce any observations that had suggested otherwise. This was also taking into consideration that the brake fluid was of sufficient level for operating purposes.
