CS/MSG17022433/THB/36

SLF 5840 K

# ASSIGNMENT

## VEHICLE DAMAGE INSPECTION REPORT

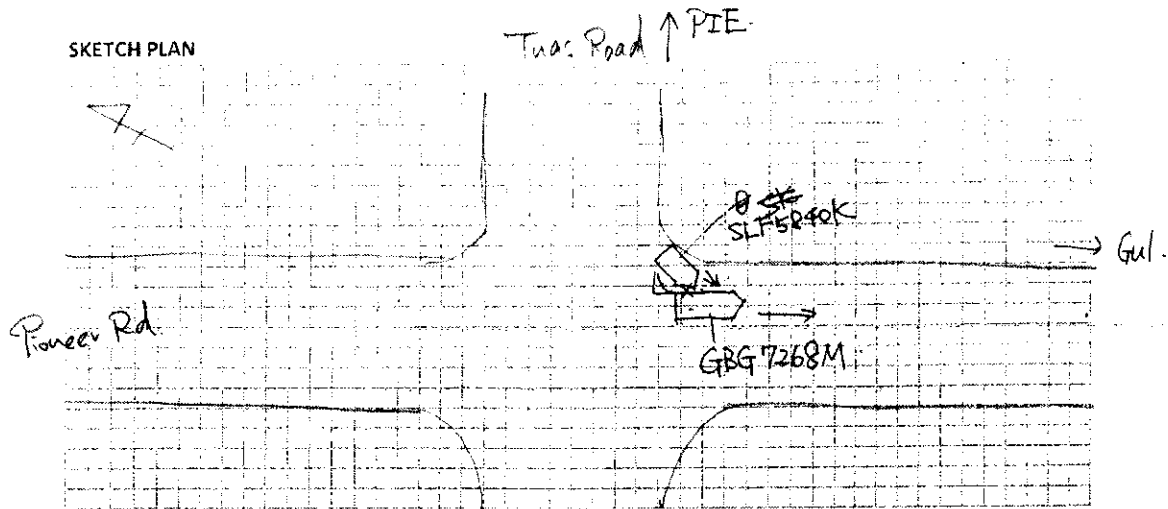
# Sketch Plan Pg. 2

When I drove car (SLF5840) and I tried to turn left at cross point of Tuas Rd and Pioneer Rd. There are several truck coming and turn right from front side.

I waited for upcoming truck finished to turn right and followed last truck without taking care of upcoming truck from right side (GBG 7268M).

My careless of upcoming truck from right side I hit the left side of truck.

GBG 7268M had damaged that scratched left back side SLF 5840K had damaged right side front fender
