Your Ref: GBC 8386U  
Our Ref : CI/TP17022490/D

07 December 2017

**AUTOMOBILE INSPECTION REPORT OF A TOYOTA HIACE MOTOR VAN  
WITH REGISTRATION NUMBER GBC 8386U**

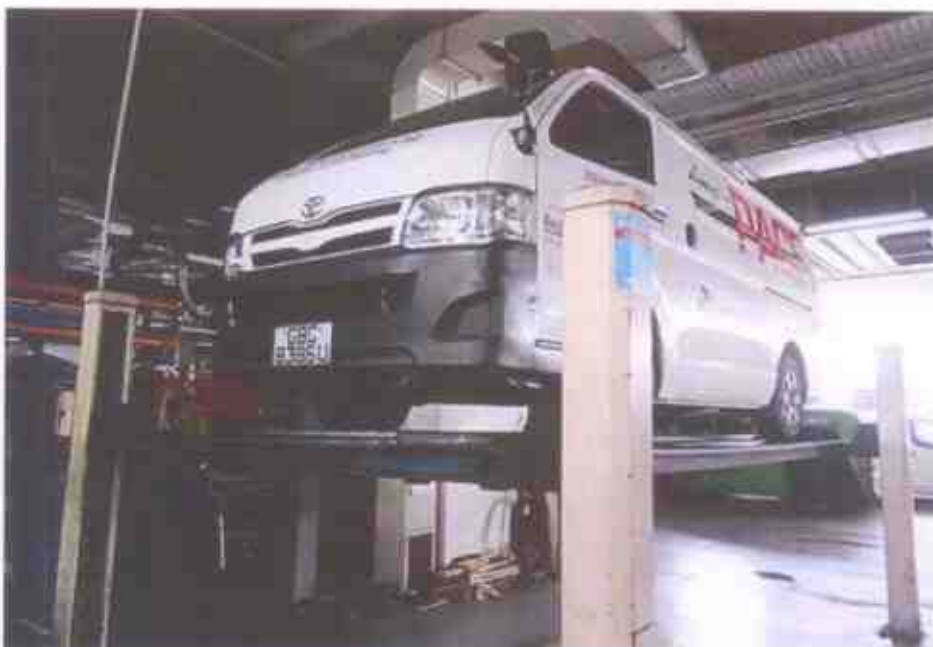
4. My observations and comments pertaining to this inspection are set out in the following paragraphs.
5. The motor van was observed to be in good general condition. There was no damage observed on its exterior body. The mileage of the motor van at the time of my inspection was 123,234km.

Photo 1 shows the motor van at the time of my inspection. The motor van was observed to be in good general condition with no visible damage observed on its exterior body. It was also hoisted up for checks on its underside during my inspection.

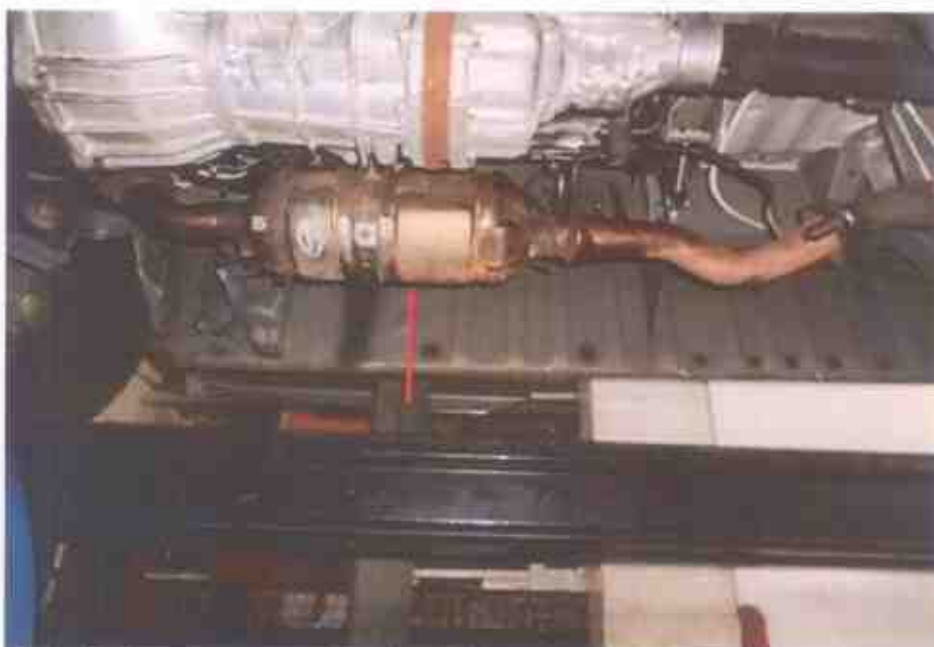
6. The motor van was subsequently hoisted up for checks on its underside, in particular to its DPF. My visual examination revealed that there was no exterior damage to the motor van's DPF.

Photo 2 shows a general view of the motor van's Diesel Particulate Filter (DPF). The DPF (arrowed) was noted to be without any visible damage to its exterior body.

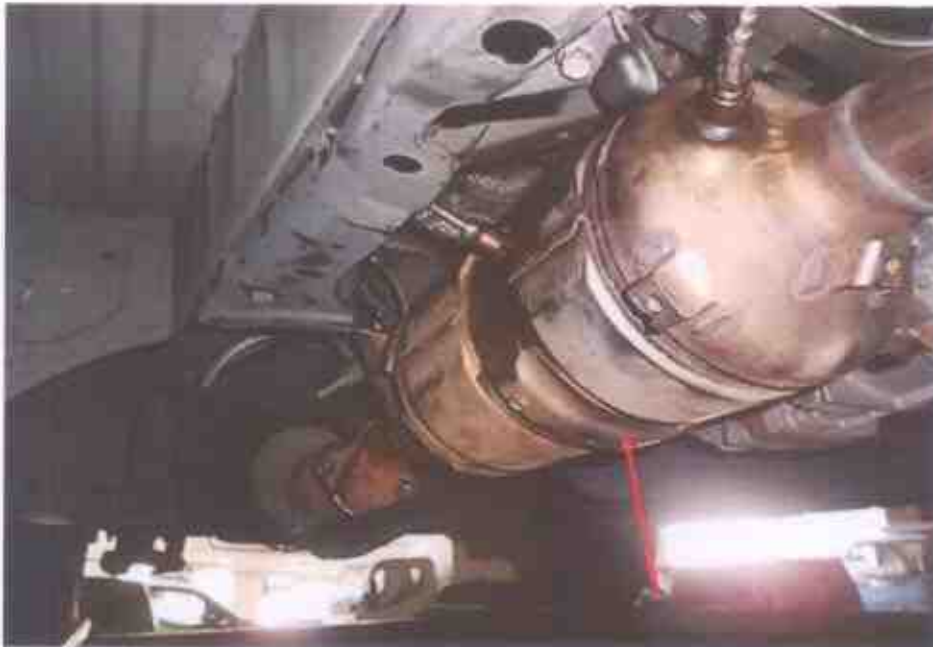
Photo 3 shows a general view of the motor van's Diesel Particulate Filter (DPF). The DPF (arrowed) was noted to be without any visible damage to its exterior body.

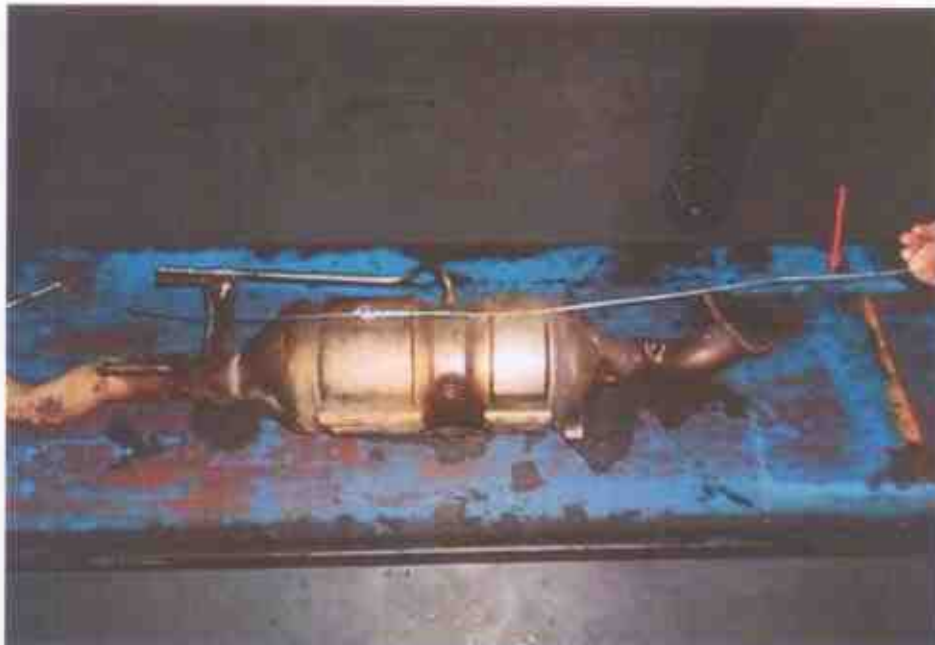
7. The DPF was subsequently dismantled and removed from the motor van for further checks, where it was discovered that the filter element contained inside the DPF was removed. This was determined given that a long metal strip was able to be inserted from one side of the DPF to the other side. I was also able to move the metal strip sideways, from one side of the inner wall to the other side of the inner wall, inside the DPF. In the event, if the DPF had contained its filter element, the metal strip will not be able to be inserted all the way through and move sideways due to blockage caused by the filter element. See photo 1 – 8 below.

Photo 4 shows the motor van's DPF removed for further checks. A long metal strip (arrowed) was able to be inserted from one side of the DPF to the other side. I was also able to move the metal strip sideways, from one side of the inner wall to the other side of the inner wall, inside the DPF. This would indicate that the filter element inside the DPF was removed.

13. For this case, the filter element inside the motor van's DPF was removed possibly due to clogging. Such removal is a method of permanently preventing the filter element from clogging. However as the DPF is part of the exhaust system of the motor van, removal of its filter element may not comply with the Land Transport Authority (LTA) emission standard for modern day diesel vehicles. The motor van would hence likely fail its mandatory road worthiness inspection stipulated by LTA.

14. In summary, the condition of the motor van's DPF would unlikely comply with LTA's emission standard for modern day diesel vehicles given that its filter element, which captures diesel particulates, has been removed. The motor van's DPF would have to be replaced with an original standard DPF for similar make and model vehicles.
15. The various sensors, which monitors the DPF during engine operation, like the exhaust temperature sensor and the differential pressure sensor would also have to be replaced accordingly.

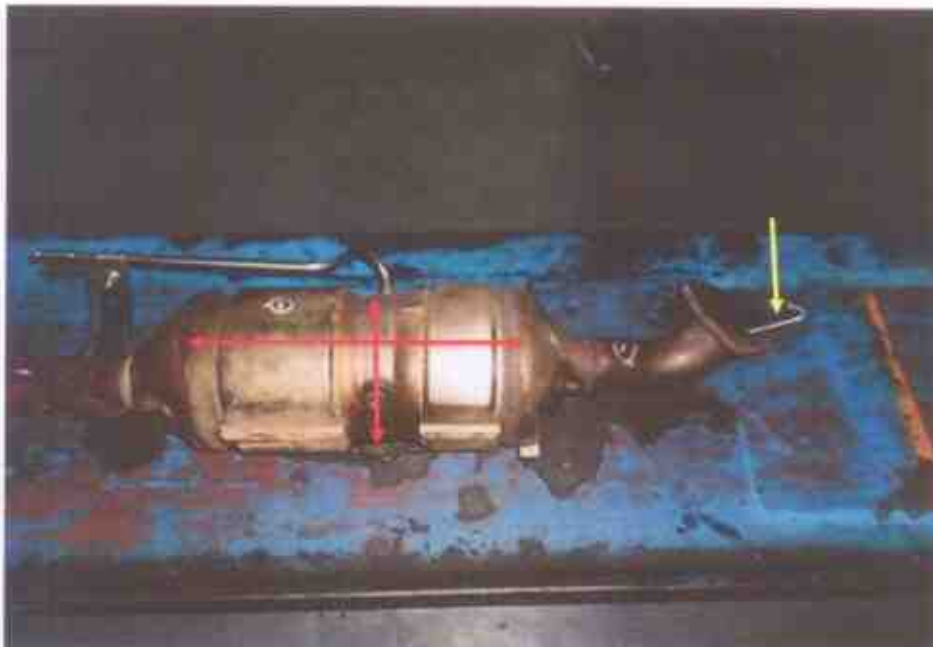
Photo 5 shows the metal strip (yellow arrow) was able to be inserted from one side of the DPF to the other side (horizontal red arrow). I was also able to move the metal strip sideways (vertical red arrow), from one side of the inner wall to the other side of the inner wall, inside the DPF. This would indicate that the filter element inside the DPF was removed.
