Your Ref: GBC 8386U
Our Ref : CI/TP17022490/D

07 December 2017

**AUTOMOBILE INSPECTION REPORT OF A TOYOTA HIACE MOTOR VAN
WITH REGISTRATION NUMBER GBC 8386U**

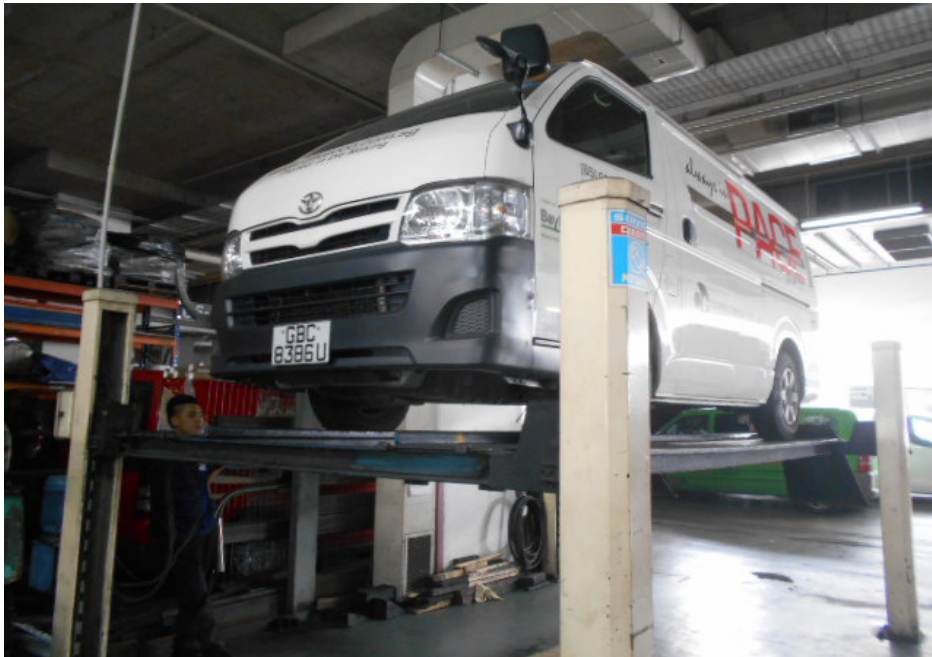
Photo 1 shows the motor van at the time of my inspection. The motor van was observed to be in good general condition with no visible damage observed on its exterior body. It was also hoisted up for checks on its underside during my inspection.

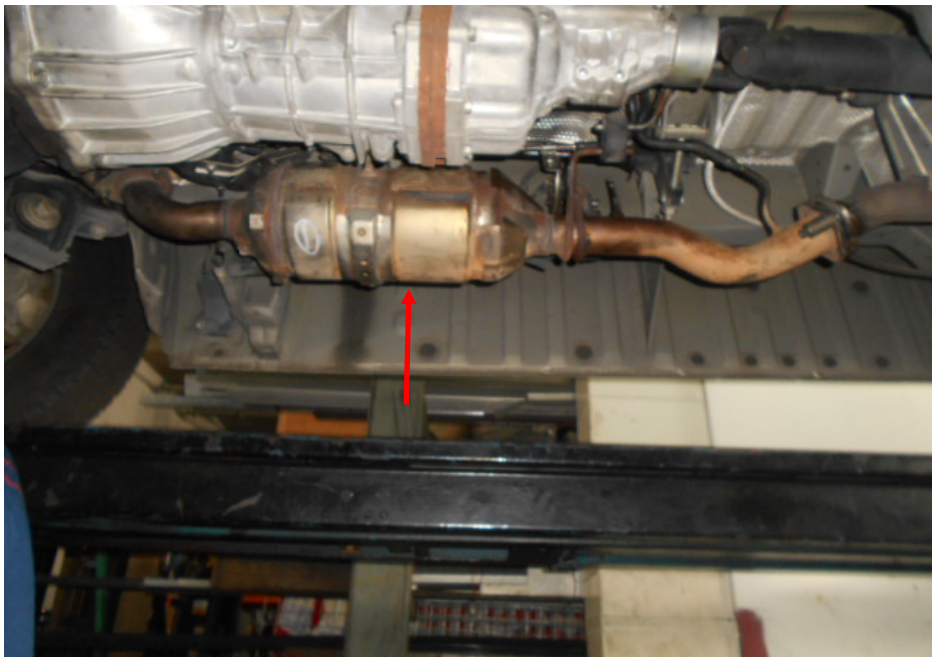
Photo 2 shows a general view of the motor van's Diesel Particulate Filter (DPF). The DPF (arrowed) was noted to be without any visible damage to its exterior body.

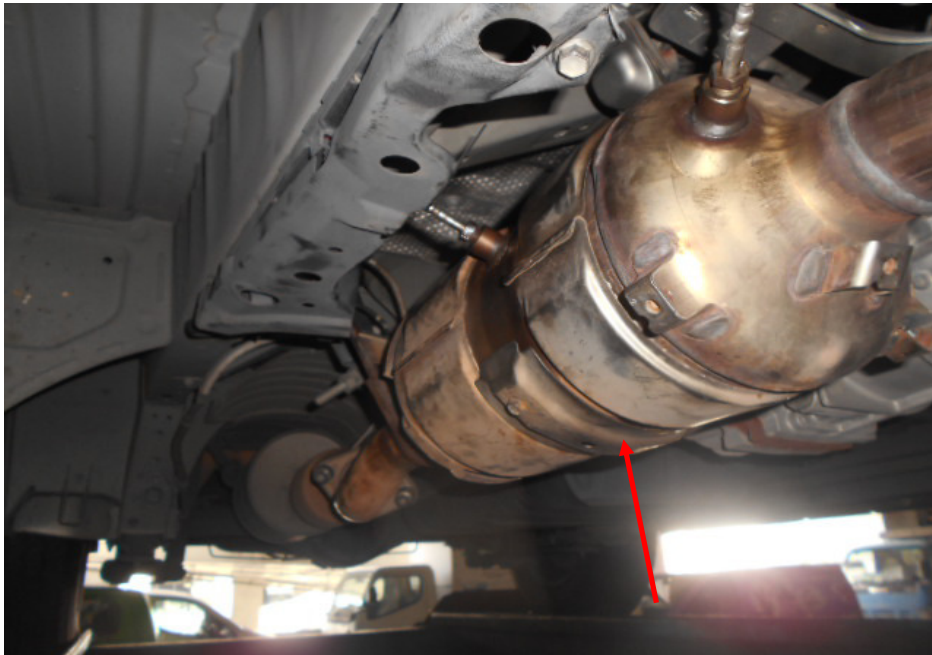
Photo 3 shows a general view of the motor van's Diesel Particulate Filter (DPF). The DPF (arrowed) was noted to be without any visible damage to its exterior body.

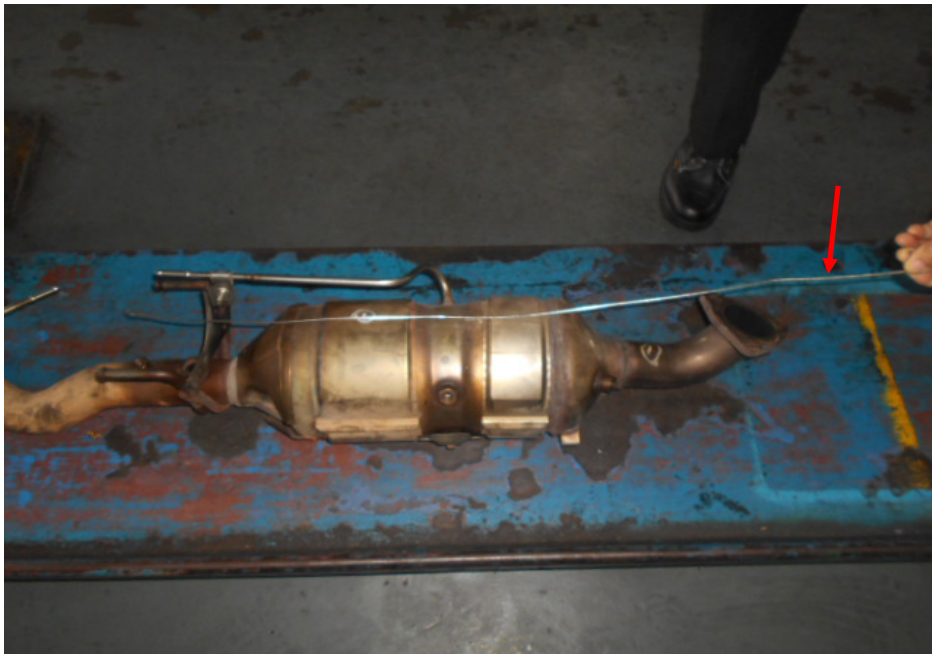
Photo 4 shows the motor van's DPF removed for further checks. A long metal strip (arrowed) was able to be inserted from one side of the DPF to the other side. I was also able to move the metal strip sideways, from one side of the inner wall to the other side of the inner wall, inside the DPF. This would indicate that the filter element inside the DPF was removed.

13. For this case, the filter element inside the motor van’s DPF was removed possibly due to clogging. Such removal is a method of permanently preventing the filter element from clogging. However as the DPF is part of the exhaust system of the motor van, removal of its filter element may not comply with the Land Transport Authority (LTA) emission standard for modern day diesel vehicles. The motor van would hence likely fail its mandatory road worthiness inspection stipulated by LTA.

14. In summary, the condition of the motor van's DPF would unlikely comply with LTA's emission standard for modern day diesel vehicles given that its filter element, which captures diesel particulates, has been removed. The motor van's DPF would have to be replaced with an original standard DPF for similar make and model vehicles.
15. The various sensors, which monitors the DPF during engine operation, like the exhaust temperature sensor and the differential pressure sensor would also have to be replaced accordingly.

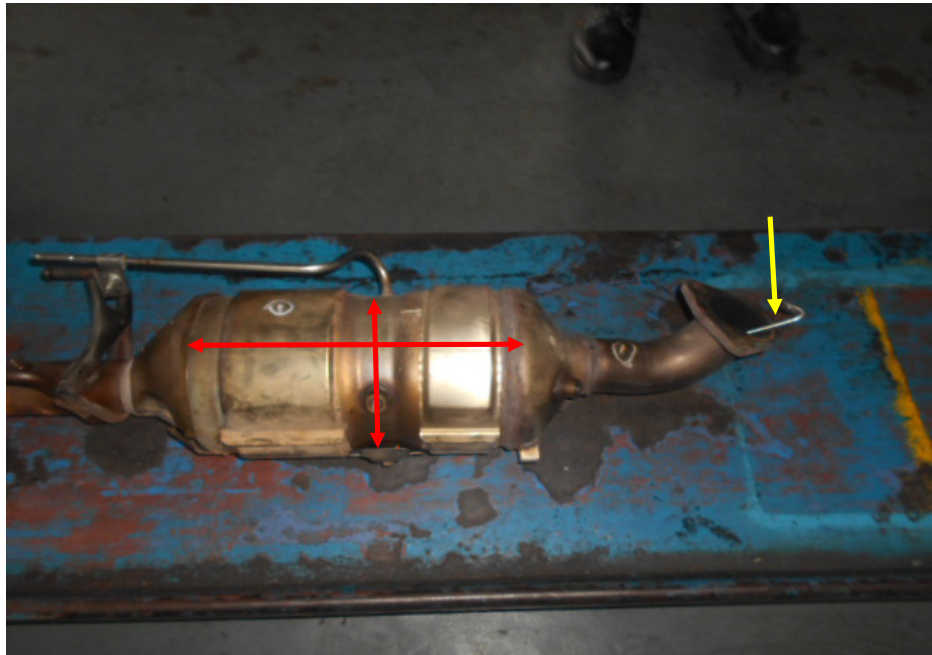
Photo 5 shows the metal strip (yellow arrow) was able to be inserted from one side of the DPF to the other side (horizontal red arrow). I was also able to move the metal strip sideways (vertical red arrow), from one side of the inner wall to the other side of the inner wall, inside the DPF. This would indicate that the filter element inside the DPF was removed.
