Your Ref: TP/IP/62249/2017  
Our Ref : CI/TPD17022498/D

**MECHANICAL INSPECTION REPORT OF MOTOR CAR SLT 6451U**

1. I refer to your request on 23 November 2017 to conduct a physical inspection of a motor car bearing registration number SLT 6451U (herein referred to as "**Motor Car**"), which was involved in a road traffic accident on 17 November 2017.
2. The objective of the inspection is to determine if there was any possible mechanical failure to the Motor Car that may have contributed to the accident.
3. Following the request, I had carried out a physical inspection of the Motor Car on 24 November 2017 at the premises of Traffic Police vehicle pound, 517 Airport Road Singapore 539942. I now set out below my observations and comments with respect to this inspection.

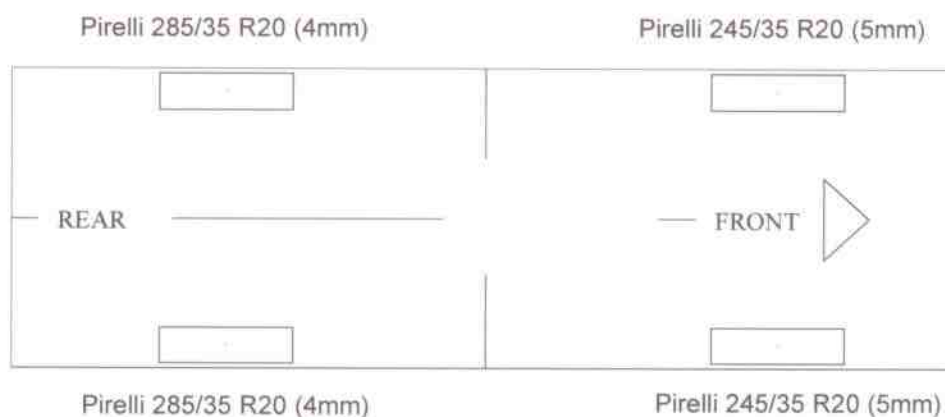
6. The condition of the Motor Car's 4 tyres was observed to be in serviceable condition. I did not find any tear, cut or burst mark(s) on the outer and the inner sidewalls as well as across the tread of the 4 tyres. The 4 tyres were also observed to be sufficiently inflated for vehicular operation. The tyre brand, tyre size and remaining tread depth of the 4 tyres were recorded as follows:-

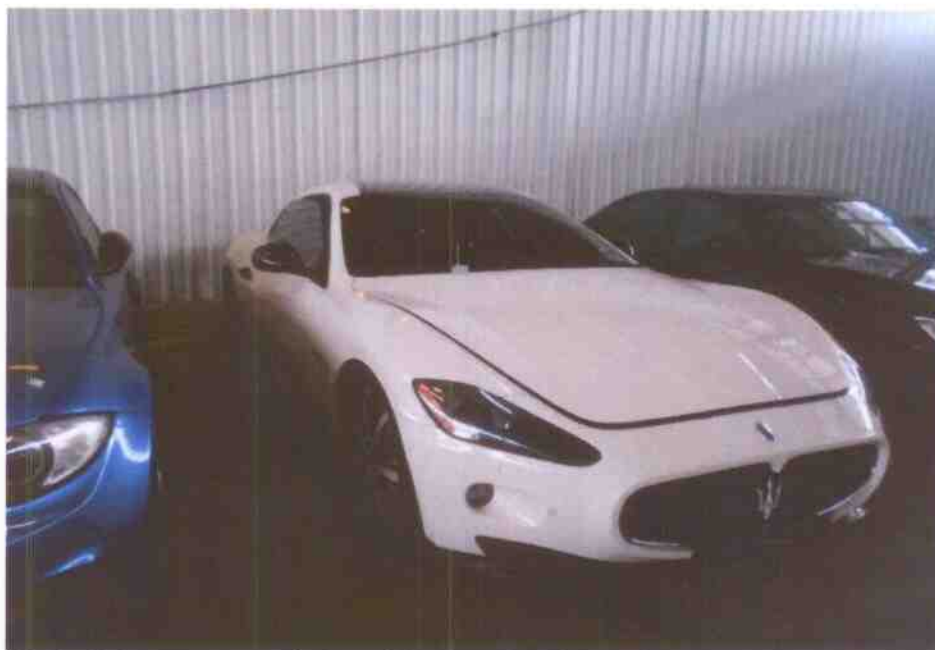
**Photo 1** shows a general view of the front right body of the Motor Car at the time of my inspection. The Motor Car was observed to be in good general condition. There was no loose fittings and/or visible damage observed to its exterior body. The mileage of the Motor Car at the time of my inspection was recorded to be 36,094km.

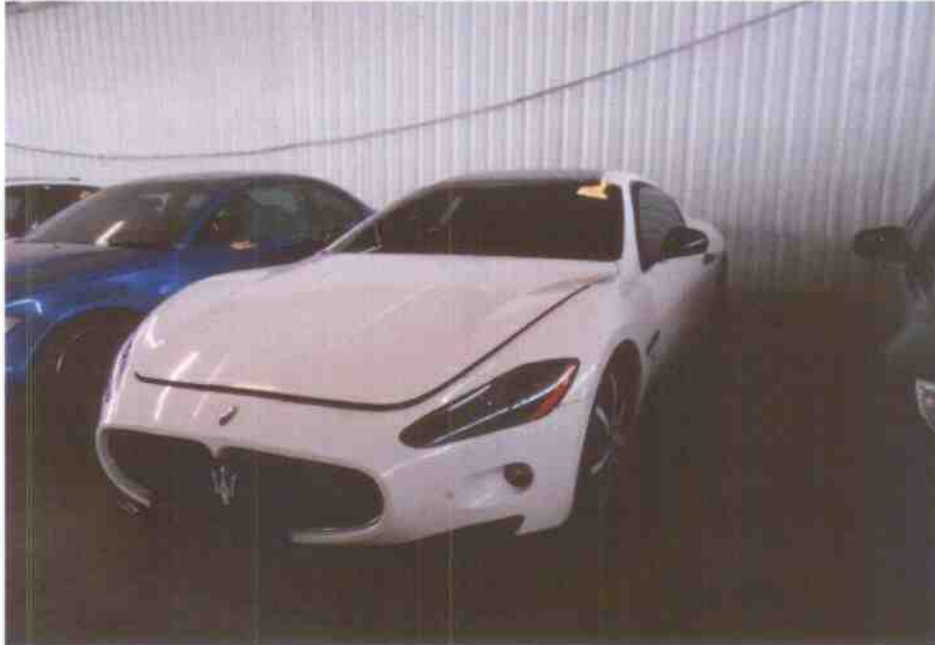
**Photo 2** shows a general view of the front left body of the Motor Car at the time of my inspection. The Motor Car was observed to be in good general condition. There was no loose fittings and/or visible damage observed to its exterior body. The mileage of the Motor Car at the time of my inspection was recorded to be 36,094km.

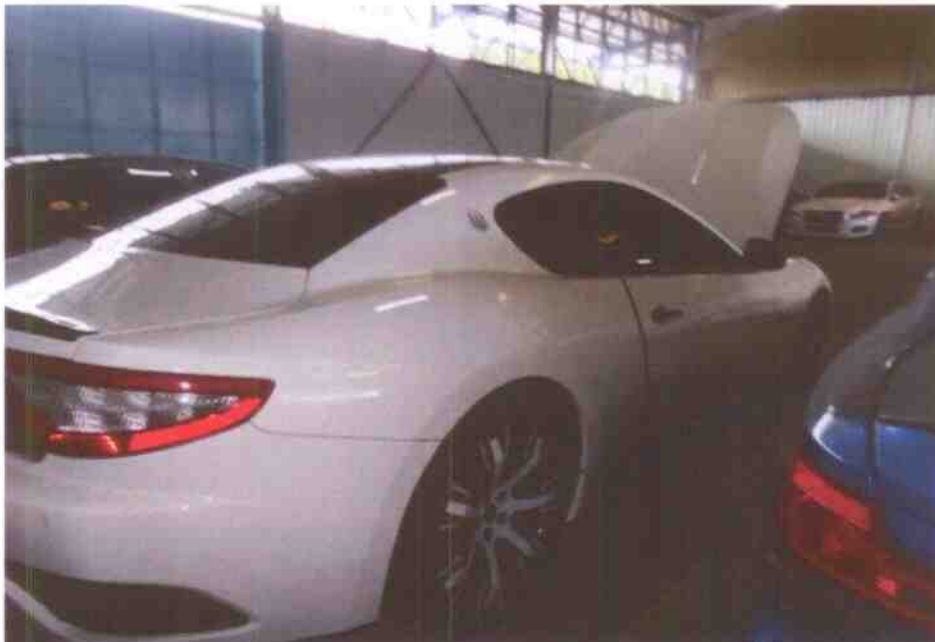
**Photo 3** shows a general view of the Motor Car's rear right body at the time of my inspection. There was no visible damage observed on the exterior body of the Motor Car at the time of my inspection.

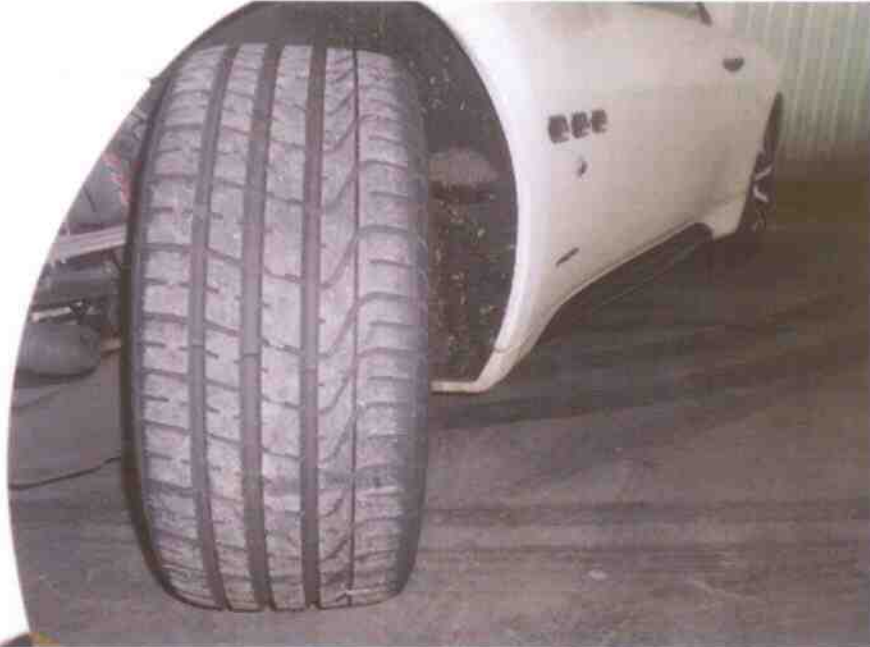
**Photo 4** shows the condition of the front left tyre of the Motor Car, which was observed to be in serviceable condition with remaining tread depth of approximately 5mm. The tyre was wrapped around alloy wheel rim that was found to be without any visible damage. The tyre was also observed to be sufficiently inflated for vehicular operation with no tear, cut or burst mark(s) on the outer and the inner sidewalls as well as across the tread.

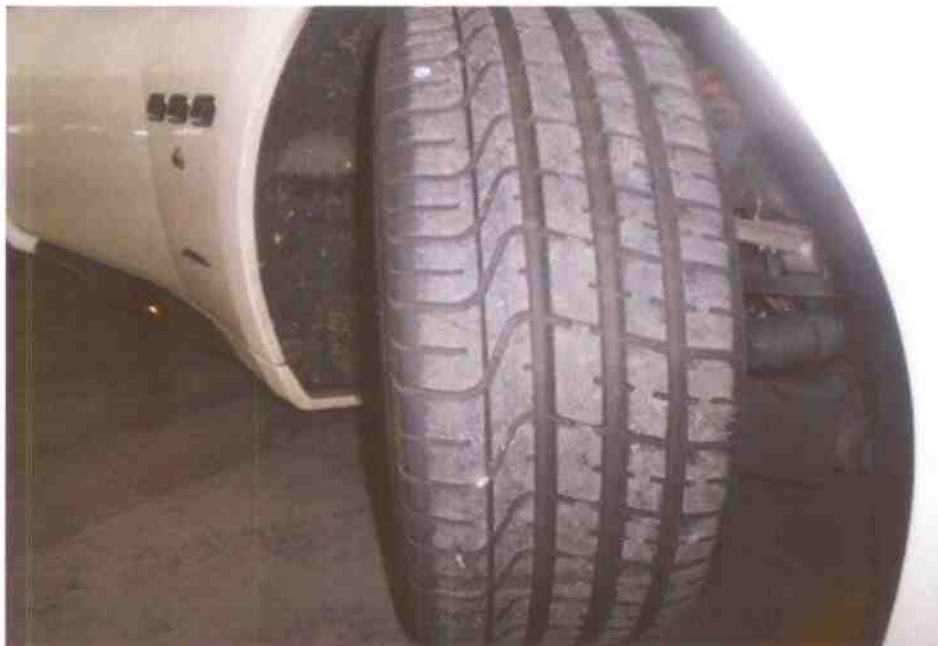
**Photo 5** shows the condition of the front right tyre of the Motor Car, which was observed to be in serviceable condition with remaining tread depth of approximately 5mm. The tyre, which was wrapped around alloy wheel rim, was also observed to be sufficiently inflated for vehicular operation.

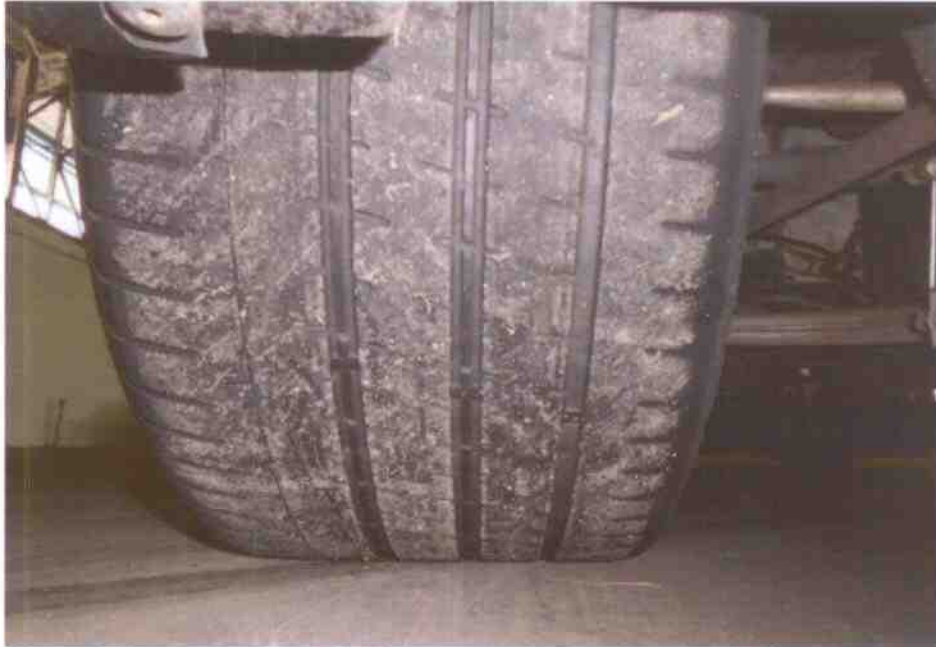
**Photo 6** shows the condition of the rear left tyre of the Motor Car, which was observed to be in serviceable condition with remaining tread depth of approximately 4mm. The tyre, which was wrapped around alloy wheel rim, was also observed to be sufficiently inflated for vehicular operation. There was also no visible damage found on the 4 wheel rims of the Motor Car.

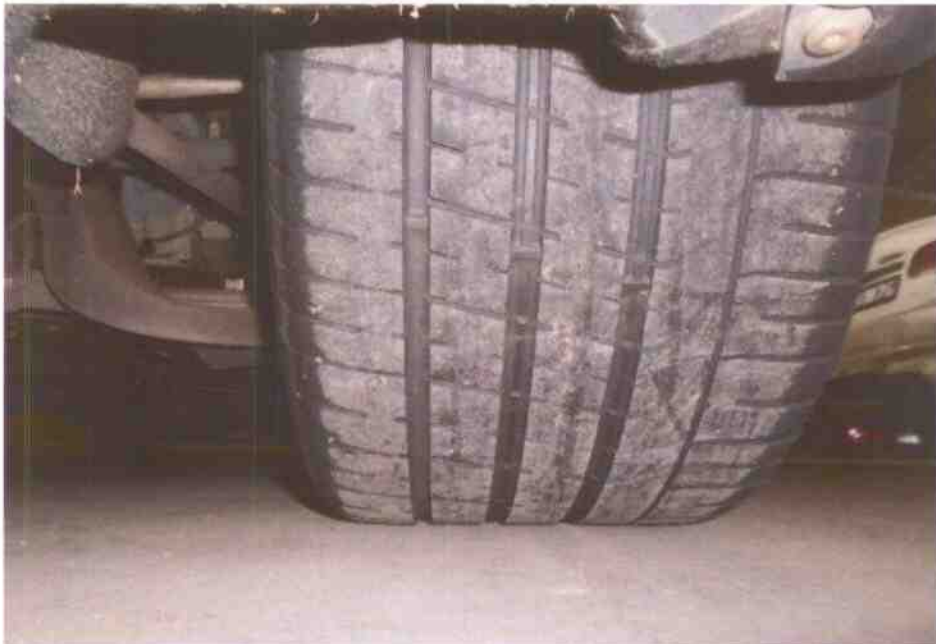
**Photo 7** shows the condition of the rear right tyre of the Motor Car, which was observed to be in serviceable condition with remaining tread depth of approximately 4mm. There was also no tear, cut or burst mark(s) on the outer and the inner sidewalls as well as across the tread of the Motor Car's 4 tyres.

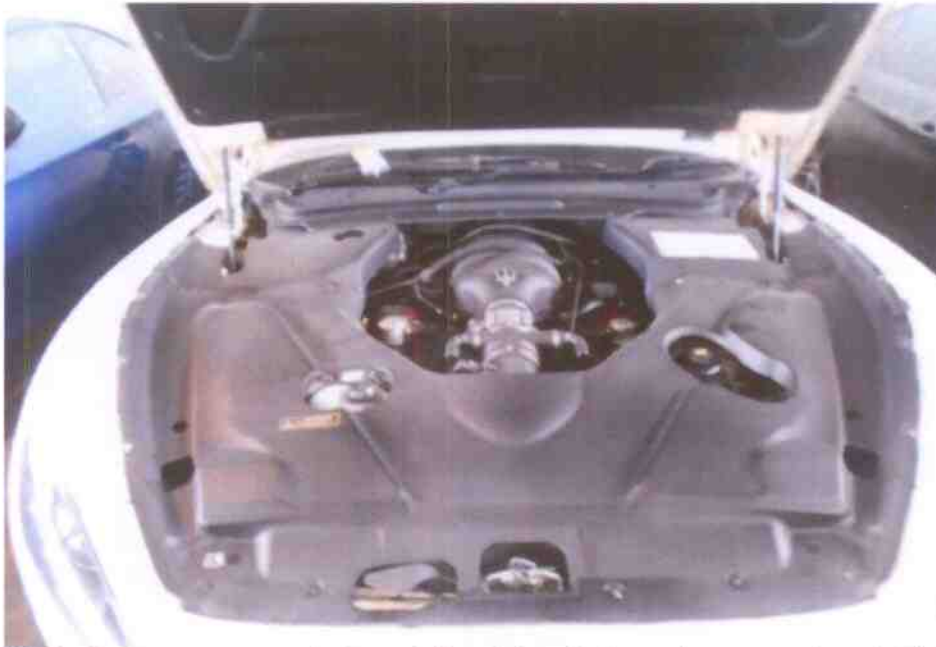
**Photo 8** shows a general view of the Motor Car's engine compartment. The various parts and components inside the engine compartment were unaffected by the accident. There was also no sign(s) or indication(s) of fluid leakage and/or fluid stain within the engine compartment.

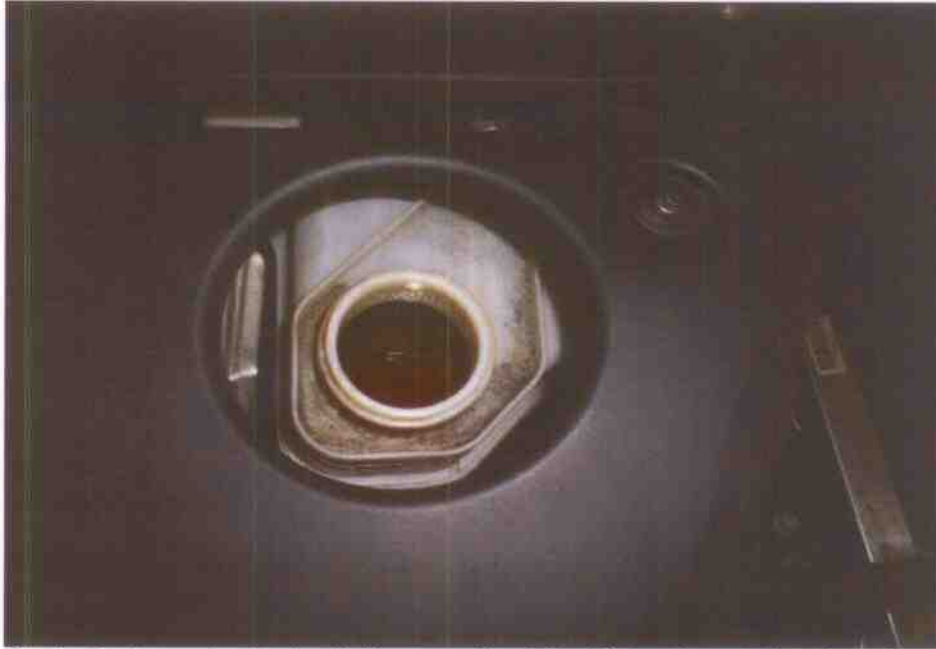
**Photo 9** shows the brake fluid reservoir of the Motor Car at the time of my inspection. The brake fluid was observed to be of sufficient level and without any visible contamination.

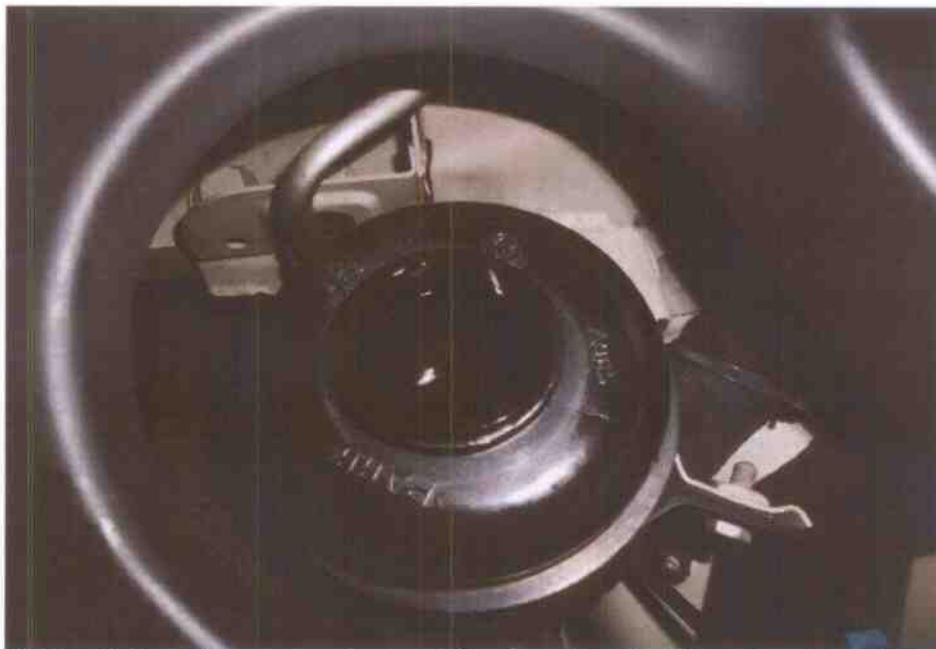
**Photo 10** shows the power steering fluid reservoir of the Motor Car at the time of my inspection. The power steering fluid was observed to be of sufficient level and without any visible contamination.

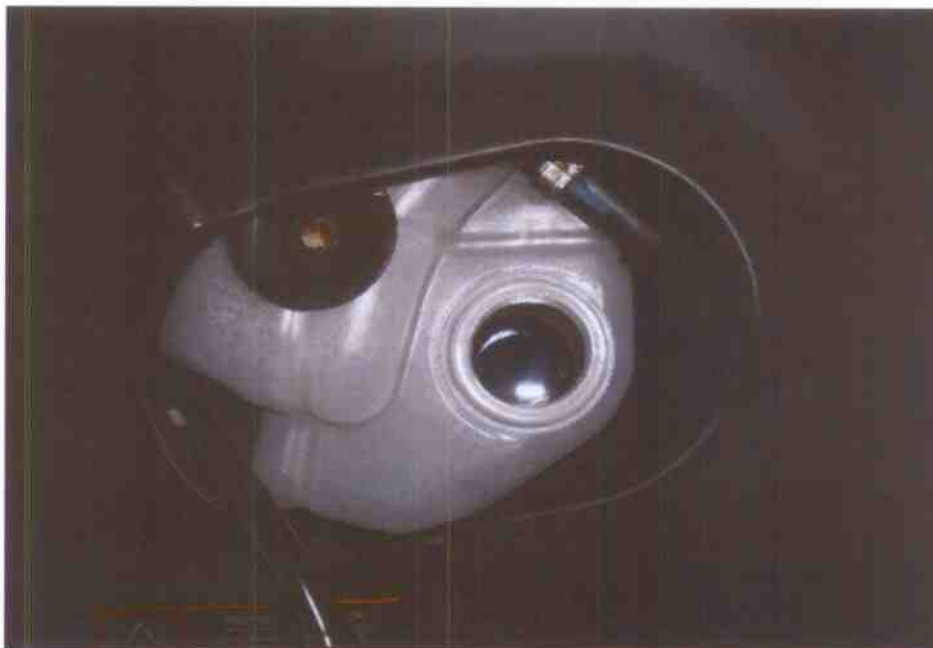
**Photo 11** shows checks being carried out to the engine coolant of the Motor Car at the time of my inspection. The engine coolant was observed to be of sufficient level and without any visible contamination.

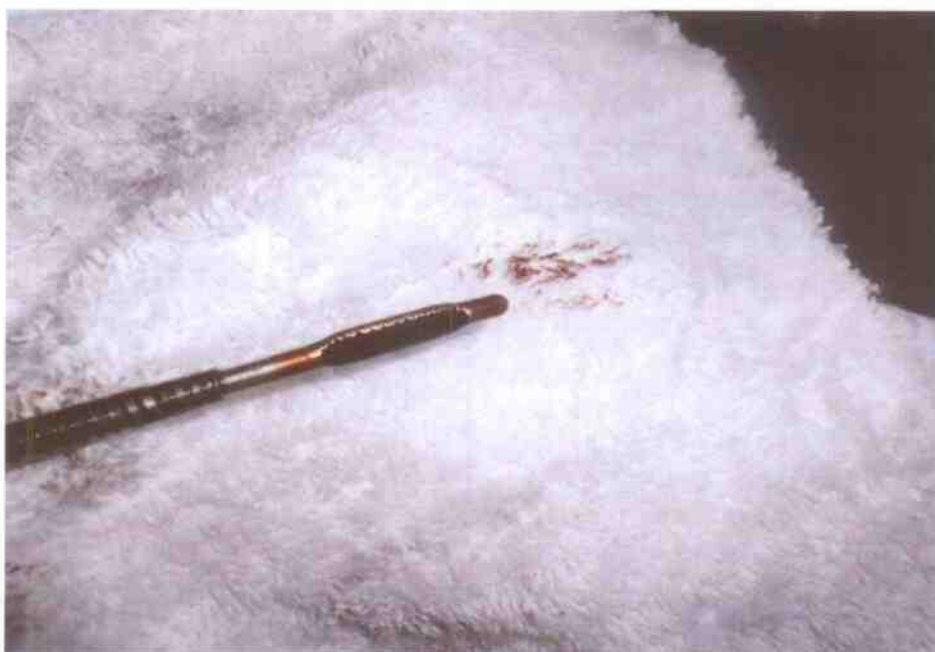
**Photo 12** shows the engine oil dip stick of the Motor Car at the time of my inspection. The engine oil was observed to be of sufficient level and without any visible contamination.

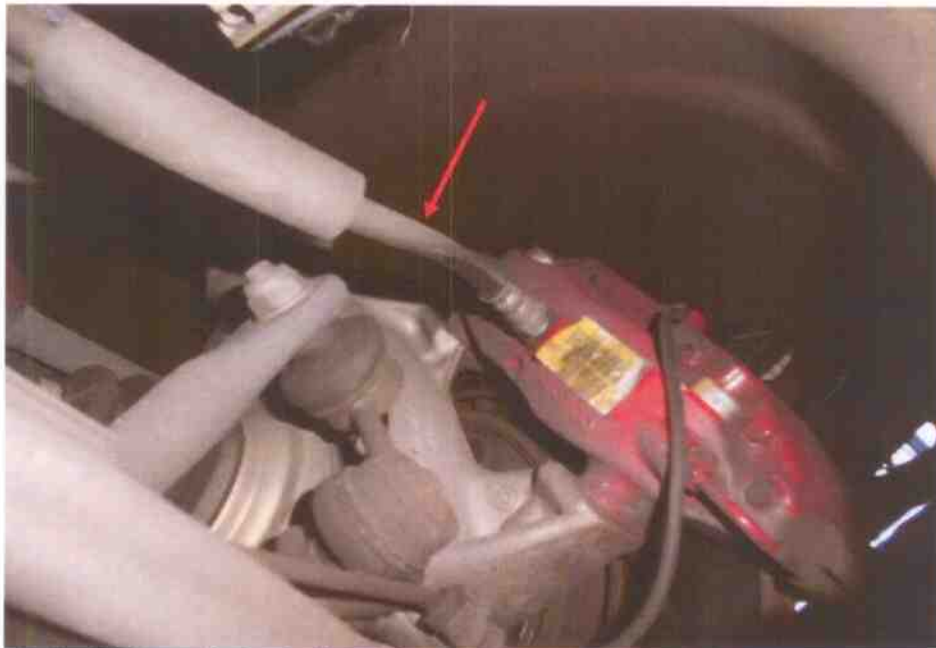
**Photo 13** shows the brake hose/pipe (arrowed) at the rear left wheel of the Motor Car. I did not observe any leakage of brake fluid at the time of my inspection of the Motor Car. Static tests of the Motor Car's braking system had indicated that there was no internal leakage of pressure/vacuum. The undercarriage components of the Motor Car were also all found to be intact and without any visible damage.

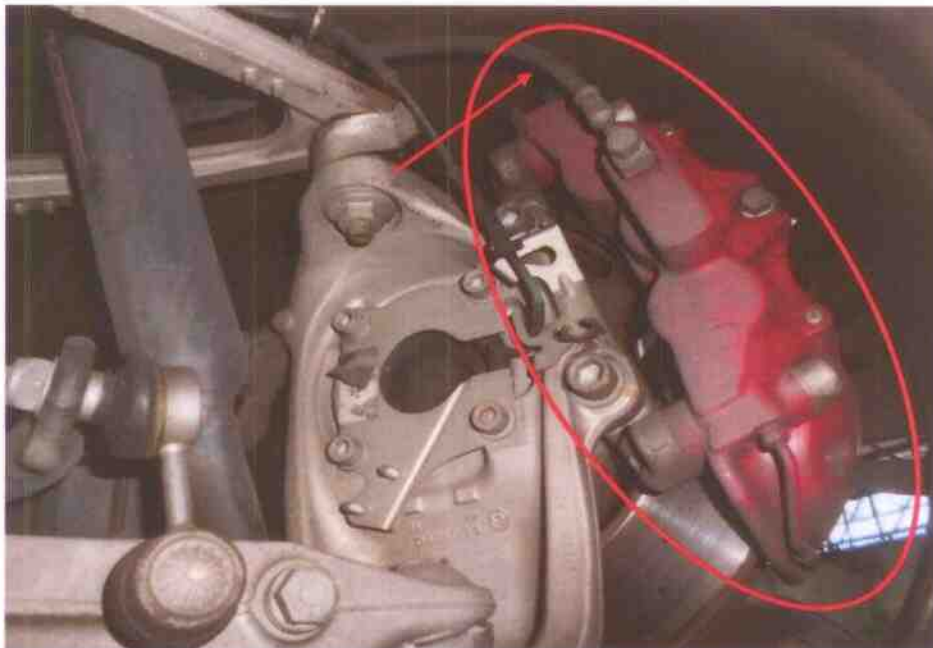
**Photo 14** shows the brake hose/pipe (arrowed) at the front right wheel of the Motor Car. No leakage of brake fluid was observed. Visual examination of the various components of the braking system like the brake caliper (circled), brake booster, brake pedal etc had revealed all to be intact and without visible damage.

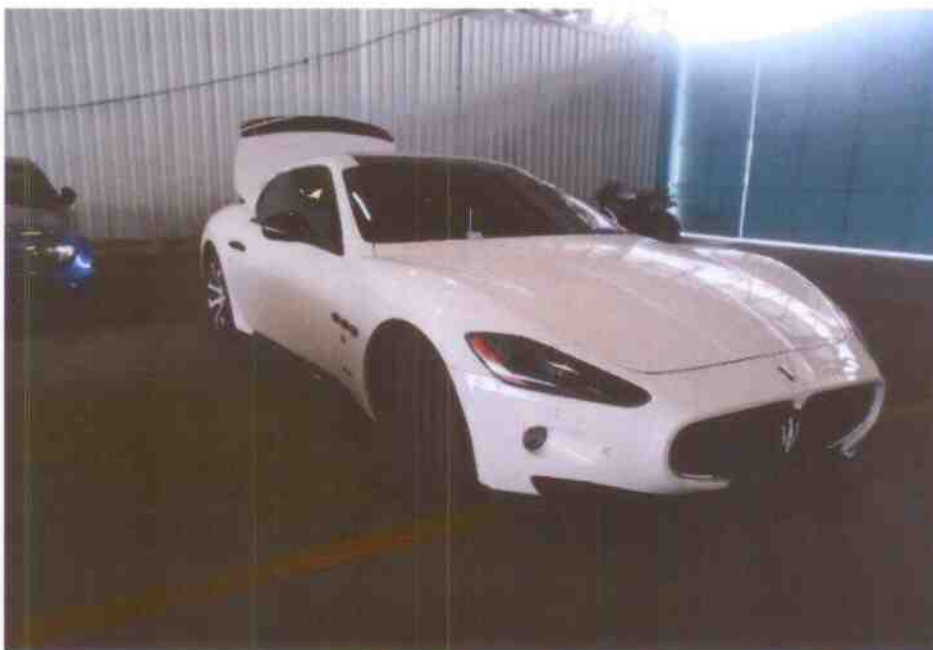
**Photo 15** shows the front right wheel of the Motor Car turned to its full right. During my steering system tests, I did not experience any abnormal free play and/or resistance when I had turned the steering wheel towards the left and right. This would suggest that the steering system of the Motor Car was likely to be in serviceable condition at the material time of accident.

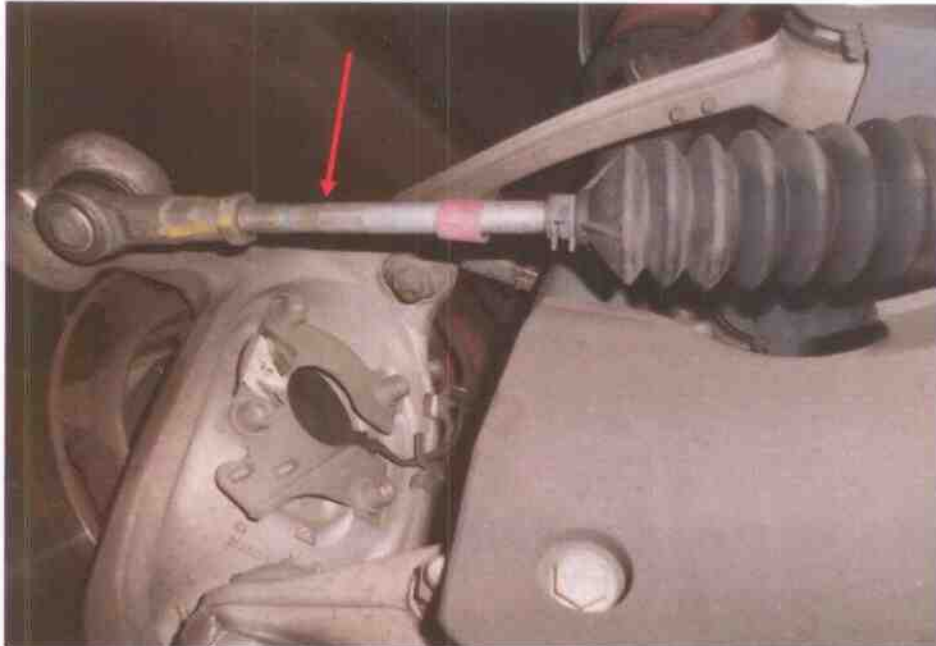
**Photo 16** shows the various undercarriage components at the front right wheel of the Motor Car, in particular the steering tie rod (arrowed). The various steering components were all found to be intact, suggesting that the steering system of the Motor Car was likely to be in serviceable condition at the material time of accident. There was also no sign of fluid stain observed on the various undercarriage components at the front right wheel of the Motor Car.

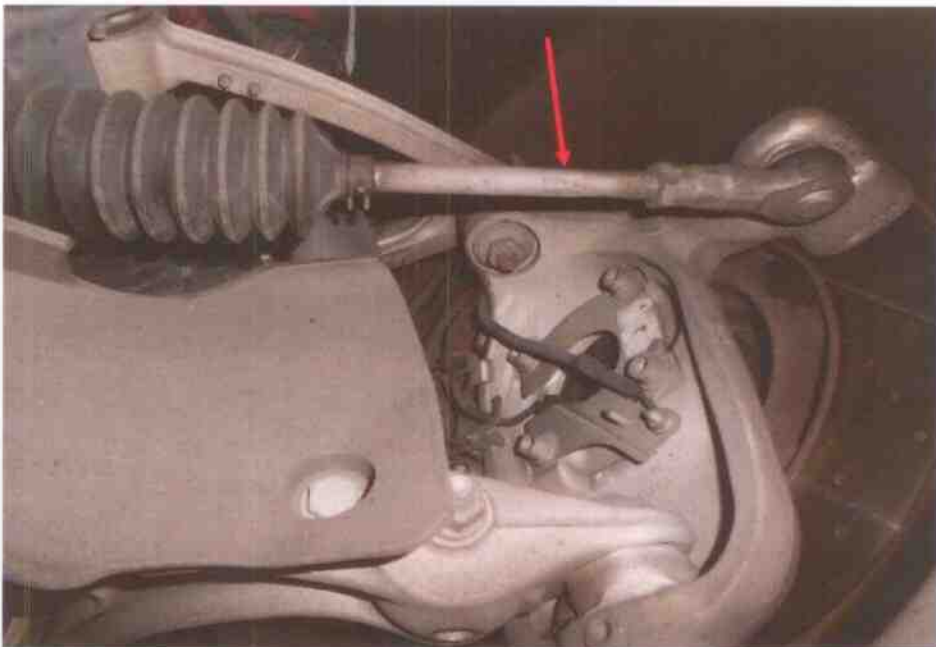
**Photo 17** shows the various undercarriage components at the front left wheel of the Motor Car, which had included the steering tie rod (arrowed). The various undercarriage components of the Motor Car were all found to be intact without any visible damage.

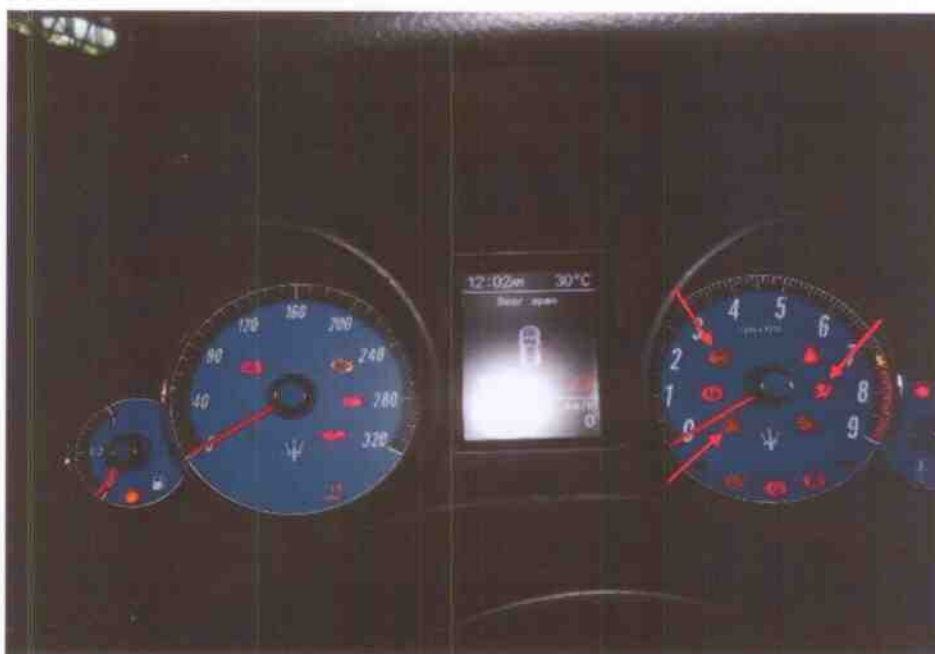
**Photo 18** shows the warning lights for the various electronic operating systems of the Motor Car appearing on its instrument panel during the self-test when the engine is cranked, in particular the ABS light, DSC light and SRS light (arrowed).

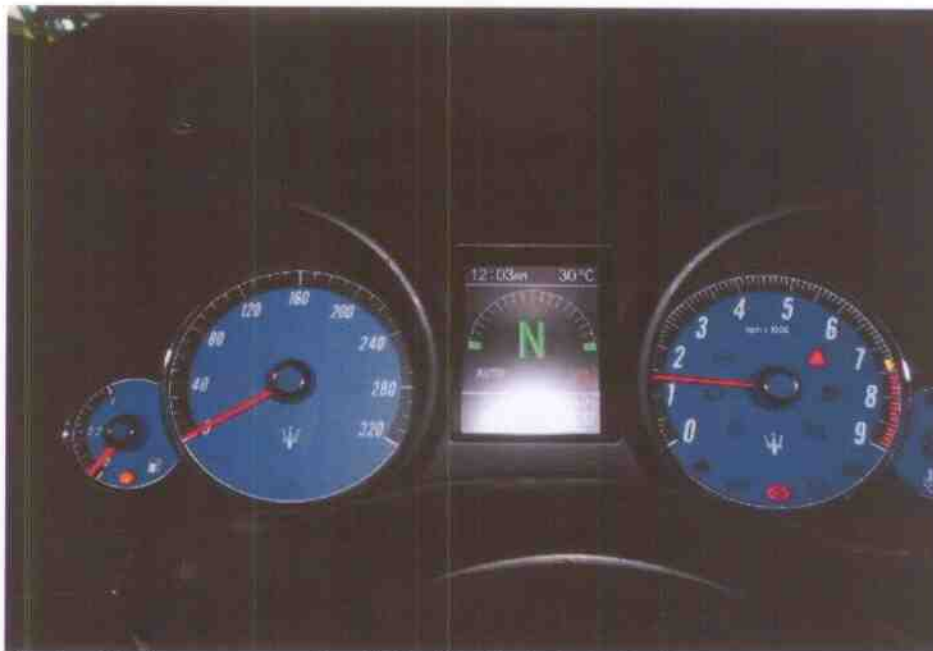
**Photo 19** shows no warning lights illuminated on the instrument panel of the Motor Car after the engine was cranked. This would suggest that there was no abnormality to the various electronic operating systems of the Motor Car, like the ABS, DSC and SRS etc.
