Your Ref: TP/IP/55631/2017  
Our Ref :CI/TPD17022589/Z

Traffic Police Department  
Singapore Police Force  
10 Ubi Avenue 3  
Singapore 408865

**INSPECTION REPORT OF ELECTRIC SCOOTER - TRAFFIC POLICE POUND  
REPORT NO. 7580/17.**

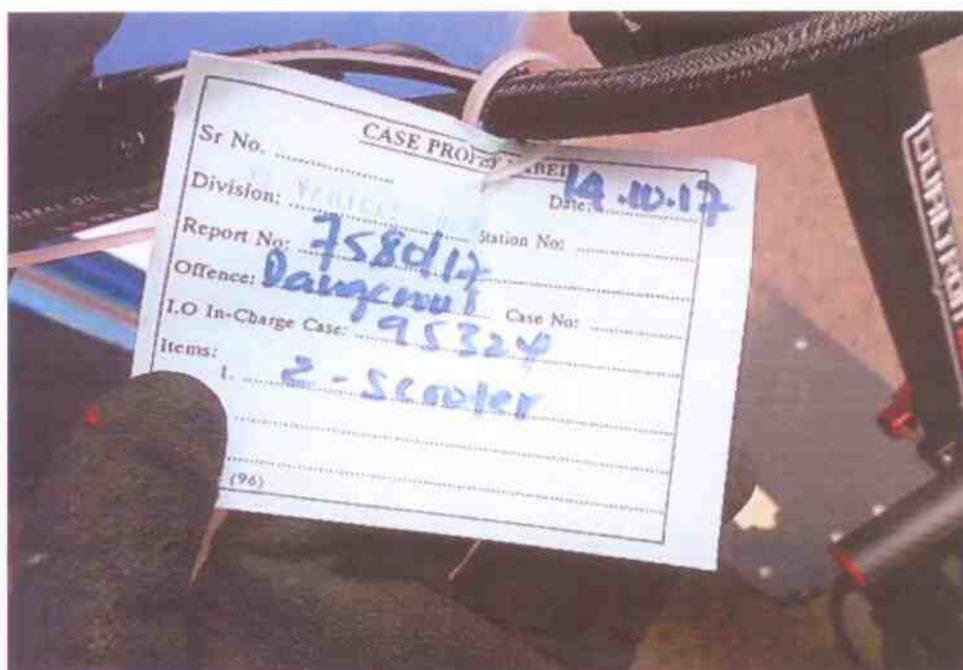
**Photo 1** shows the identification of the Electric Scooter with reference to Traffic Police Pound Report No. 7580/17.

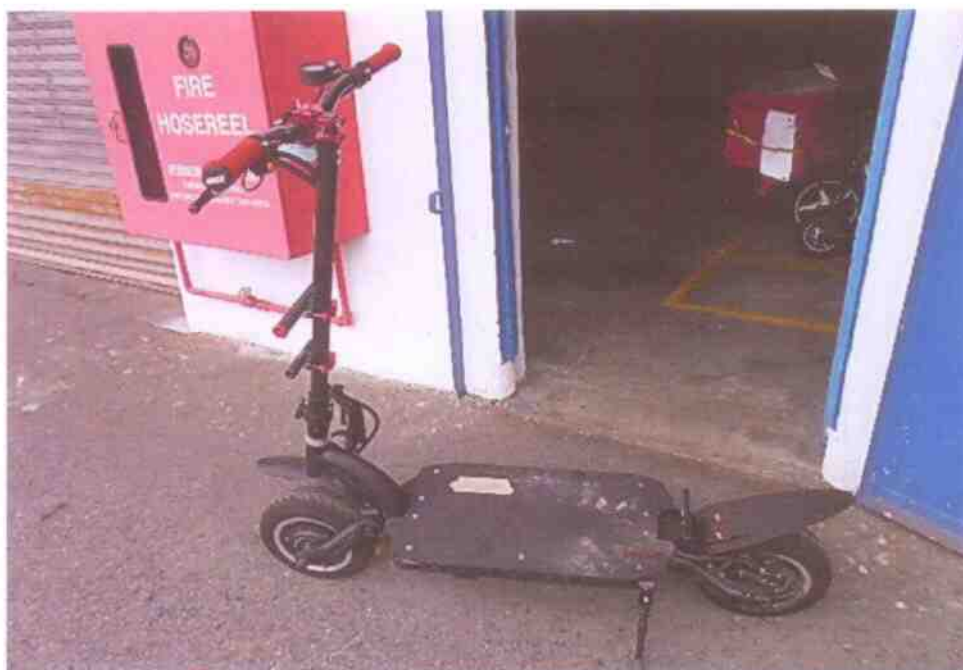
**Photo 2** shows the left portion of the Electric Scooter at time of inspection. A detailed inspection revealed that the Electric Scooter were in a good condition. No damages were noted on the Electric Scooter at the time of our inspection.

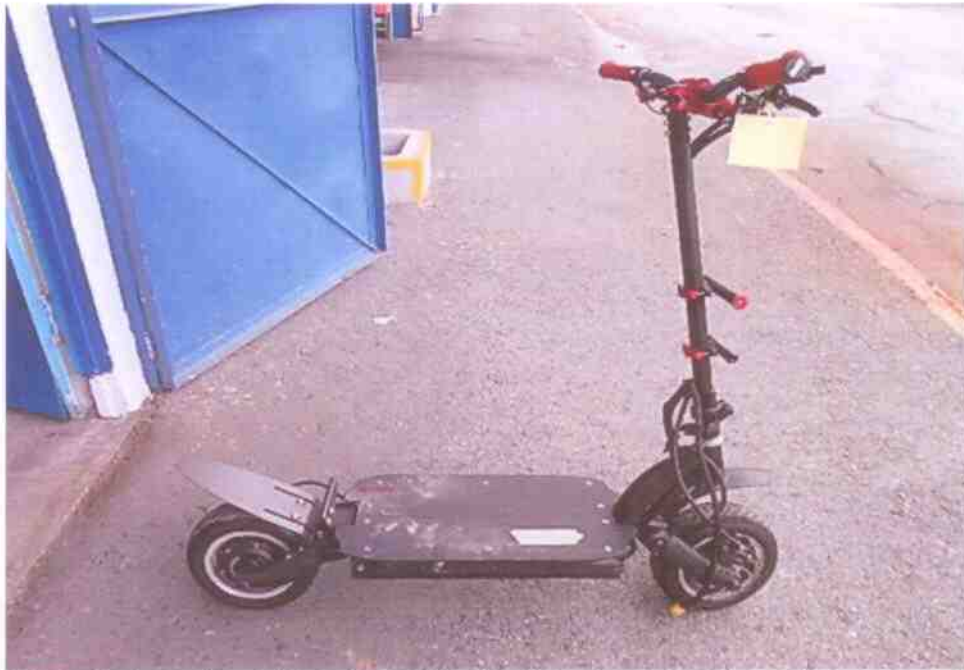
**Photo 3** shows the right portion of the Electric Scooter at time of inspection. A detailed inspection revealed that the Electric Scooter were in a good condition. No damages were noted on the Electric Scooter at the time of our inspection.

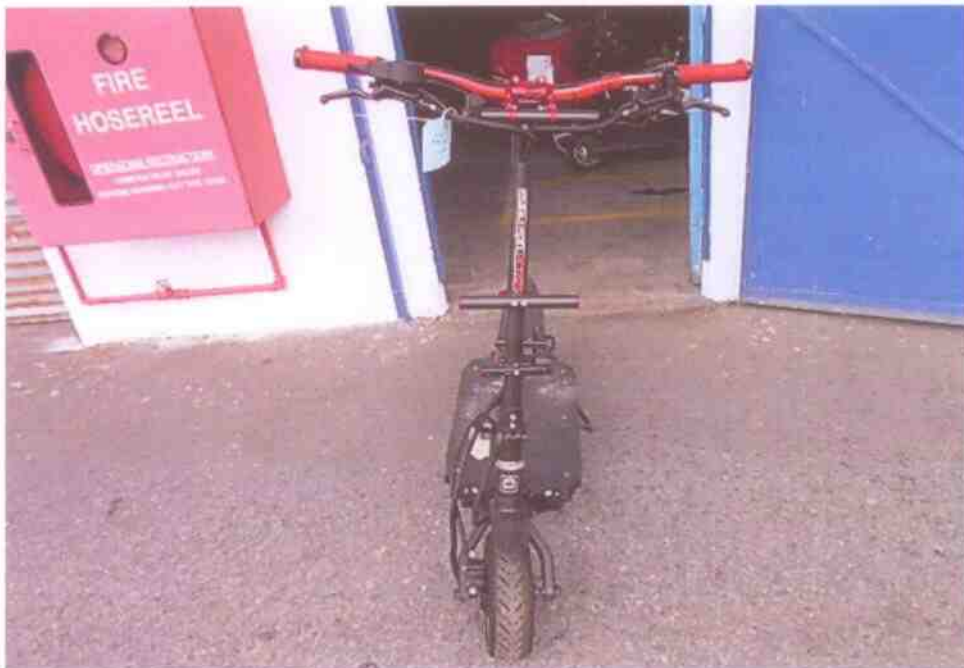
**Photo 4** shows the front portion of the Electric Scooter at time of inspection. A detailed inspection revealed that the Electric Scooter were in a good condition. No damages were noted on the Electric Scooter at the time of our inspection.

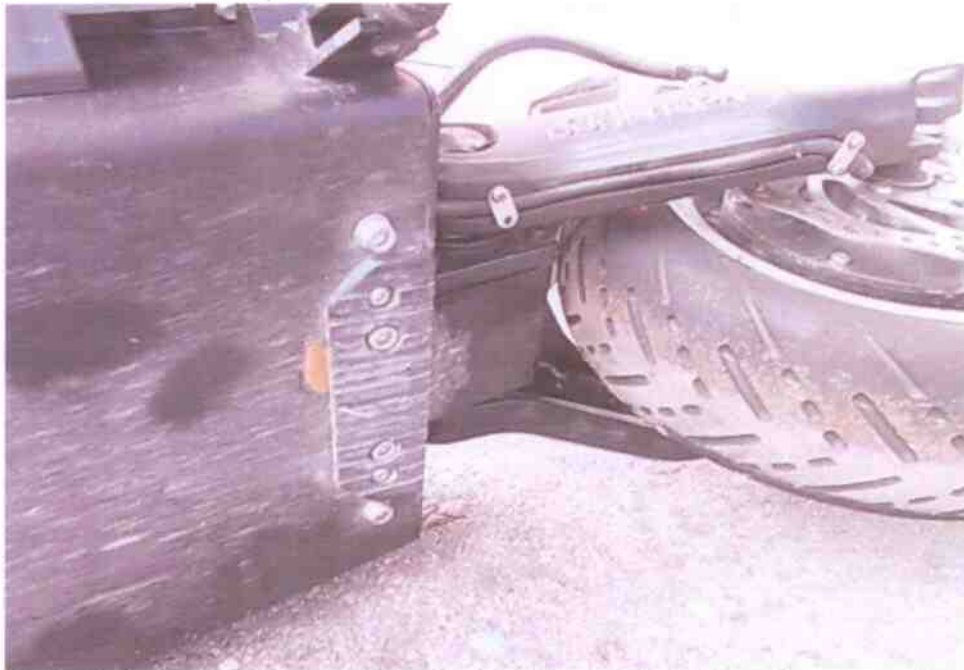
6. The tyres were wrapped around alloy wheel rim that was found to be without any significant damage. See photo 5 & 6 below

**Photo 5** shows the rear tyre of the Electric Scooter at the time of our inspection. The tread pattern of the 2 tyres was clearly visible. We did not observe any tear, burst mark(s) and/or punctured hole(s) on the sidewalls.

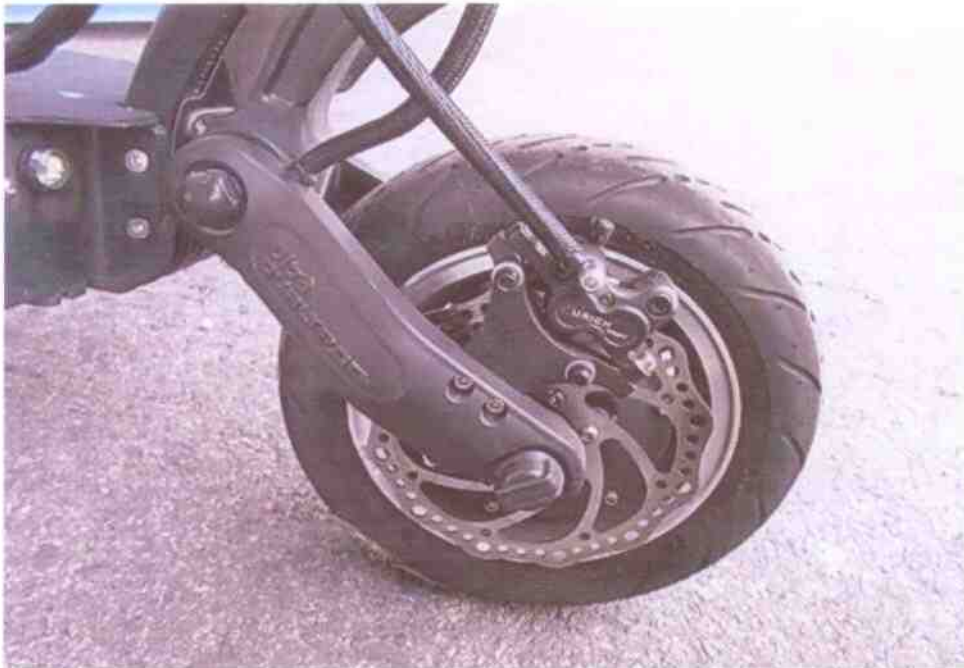
**Photo 6** shows the front tyre of the Electric Scooter at the time of our inspection. The tread pattern of the 2 tyres was clearly visible. We did not observe any tear, burst mark(s) and/or punctured hole(s) on the sidewalls.

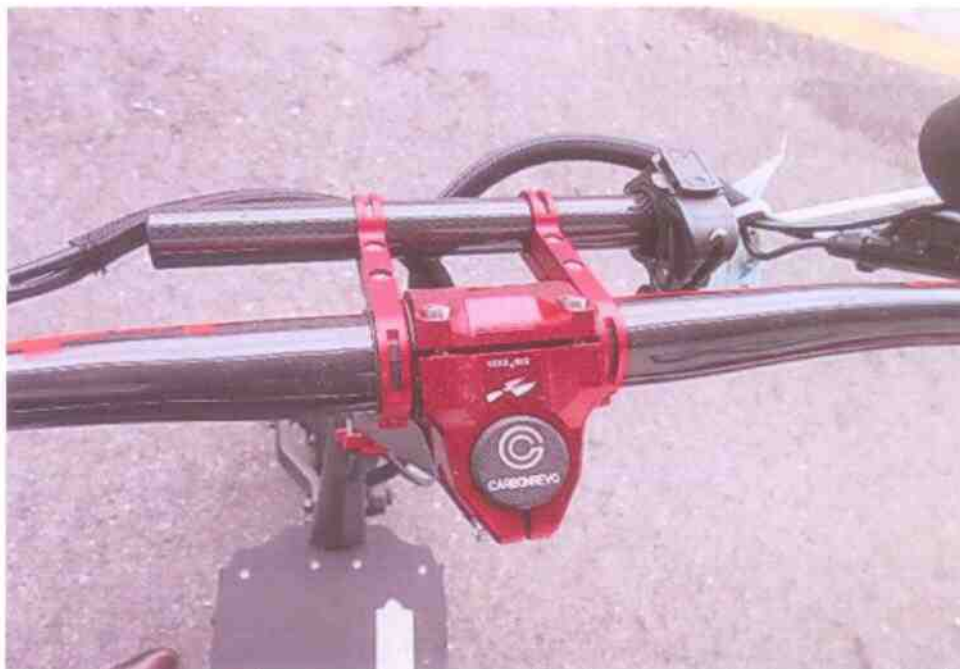
7. Our checks on the steering components of the Electric Scooter had revealed that its steering system was in serviceable condition & its front fork was found to be intact and undamaged. It was observed to be able to turn to full left & full right.

**Photo 7** shows steering components of the Electric Scooter had revealed that its steering system was in serviceable condition & its front fork was found to be intact and undamaged. It was observed to be able to turn to full left & full right.

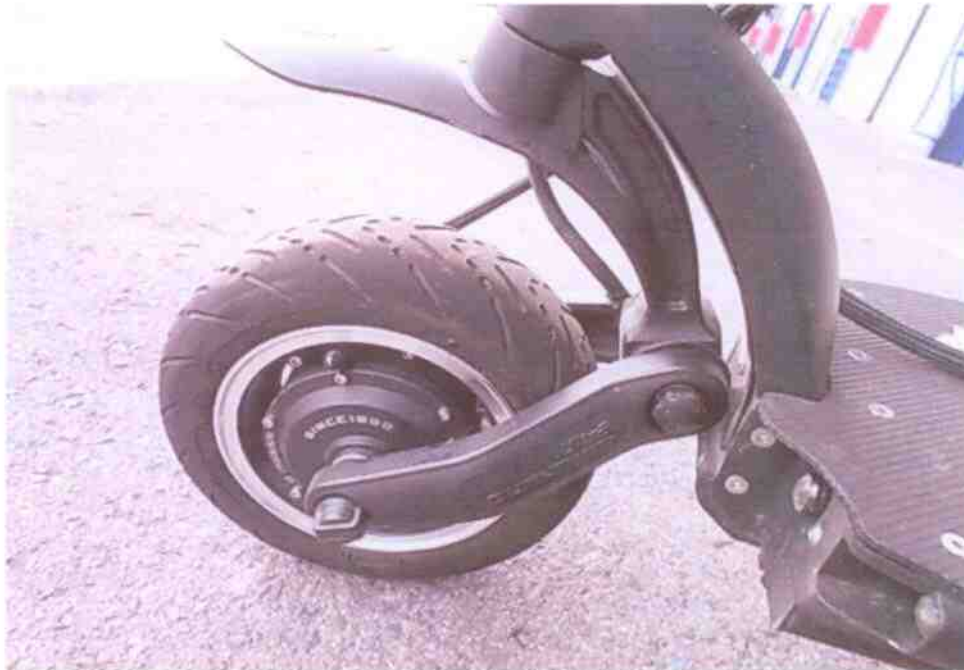
**Photo 8** shows steering components of the Electric Scooter had revealed that its steering system was in serviceable condition & its front fork was found to be intact and undamaged. It was observed to be able to turn to full left & full right.

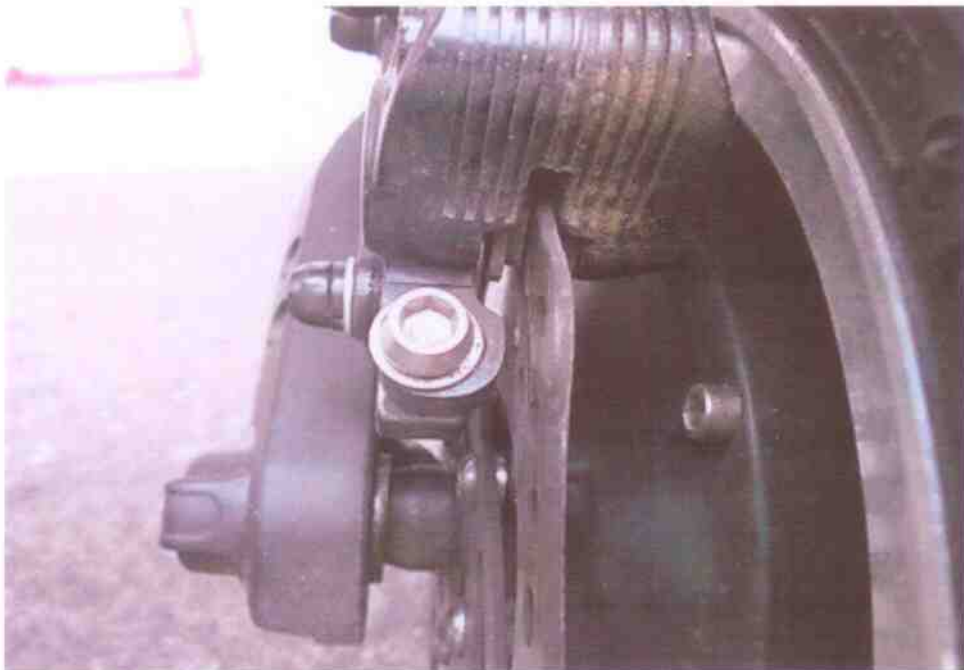
8. The braking system of the Electric Scooter was controlled by mechanical means (cables, callipers and springs). Our visual examination of the various components in the brake system, like the hand brake lever (left & right), brake callipers (front & rear), revealed that it was in a serviceable condition.

9. A static brake test was conducted on the Electric Scooter's front & rear brake. The test was conducted by lifting the tyre above ground & applies a little spinning action to it. The hand brake lever was then gripped in order to the stop the spinning tyre. The result was satisfactory. It stopped after gripping the hand brake to the fullest. It shows that the front & rear brake calliper was responding to the gripping action. This had appeared to indicate that both front & rear brake was in a serviceable condition.

**Photo 9** shows the front brake callipers (brake pad), revealed that it was in a serviceable condition.

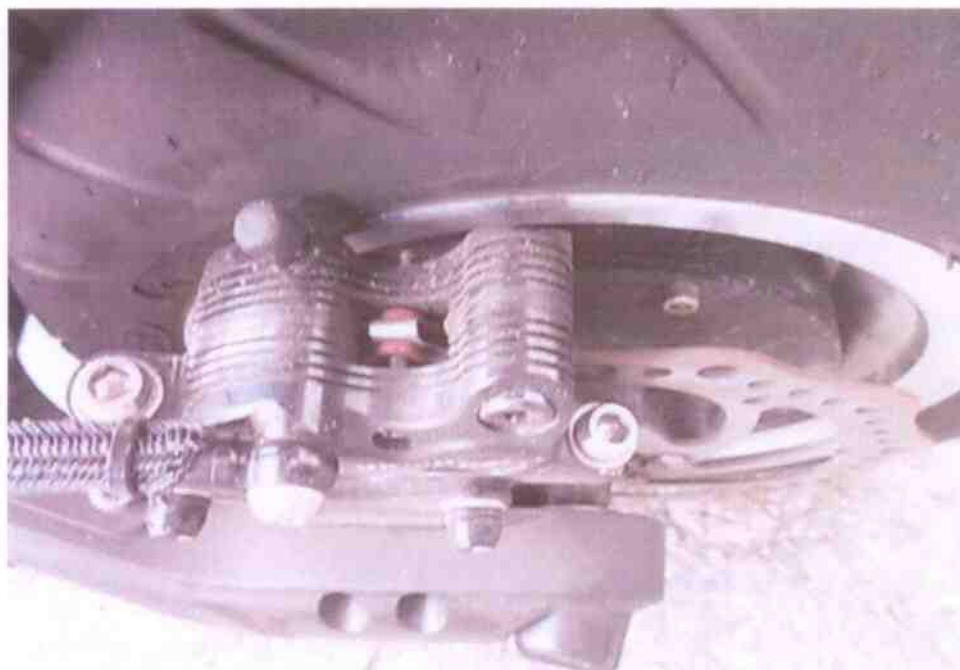
**Photo 10** shows the rear brake callipers (brake pad), revealed that it was in a serviceable condition.
