Your Ref: TP/IP/60517/2017  
Our Ref : CI/TPD17022590/Z

**Fatal Accident Investigation Team**

**MECHANICAL INSPECTION REPORT OF MOTOR VAN GW 5055E**

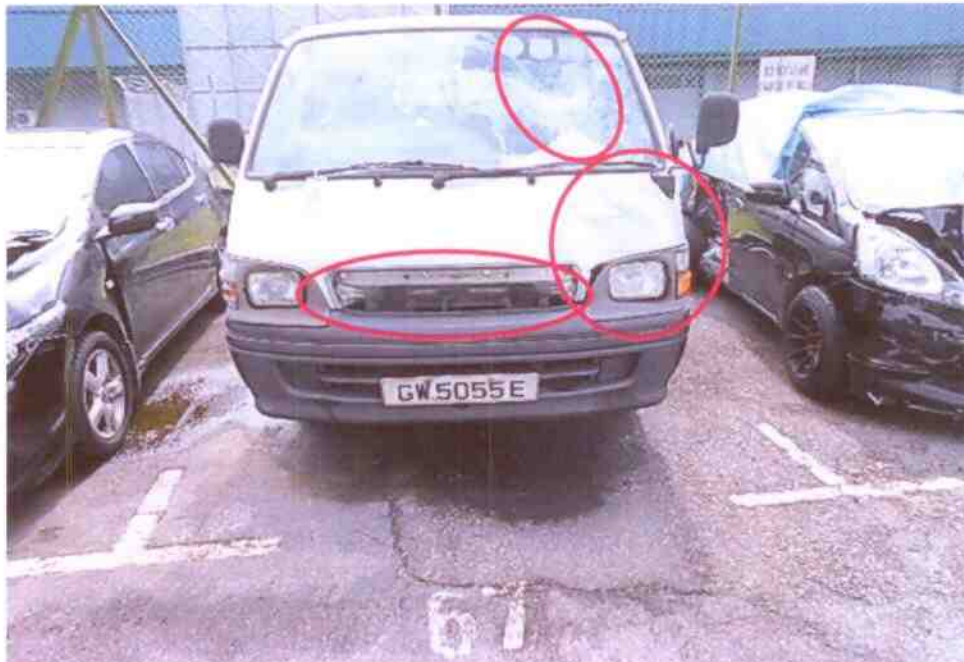
**Photo 1** shows a general view of the front left body of the Motor van at the time of our inspection. The Motor Van was observed to have sustained damages at its front left panel and front grille was amongst the body parts that were damaged as a result of the accident. Its front windscreen was also broken at the left area (circled).

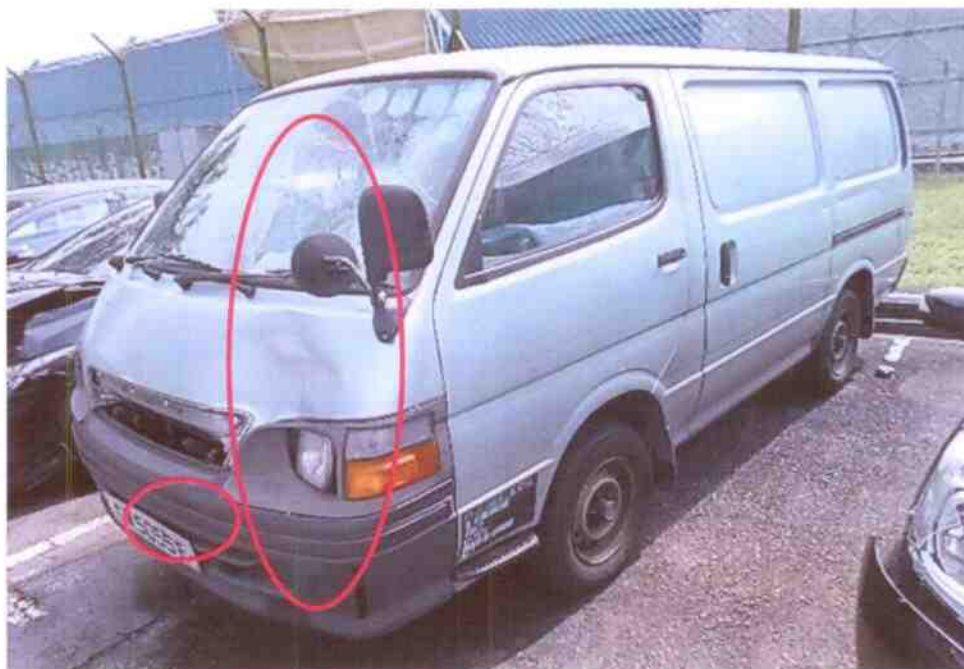
**Photo 2** shows a general view of the front left body of the Motor Van at the time of my inspection. The Motor Van was observed to have sustained damages at its left panel, front left wiper panel, front grille, were amongst the body parts that were damaged as a result of the accident. Its front windscreen was also broken at the left bottom area. Its left panel was observed to sustained scratches.

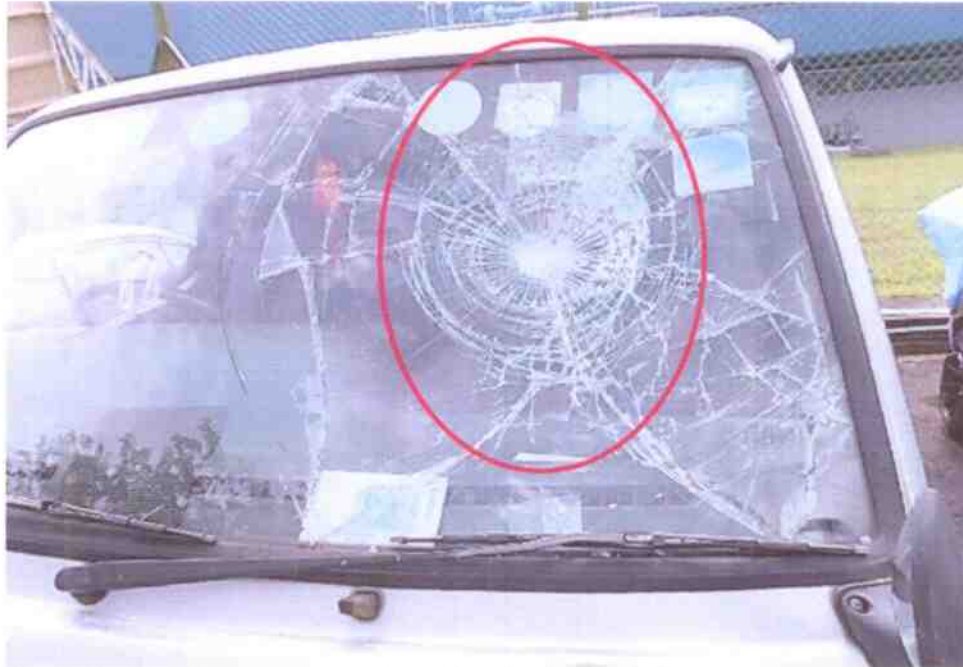
**Photo 3** shows the damage sustained on the front windscreen as a result of the accident.

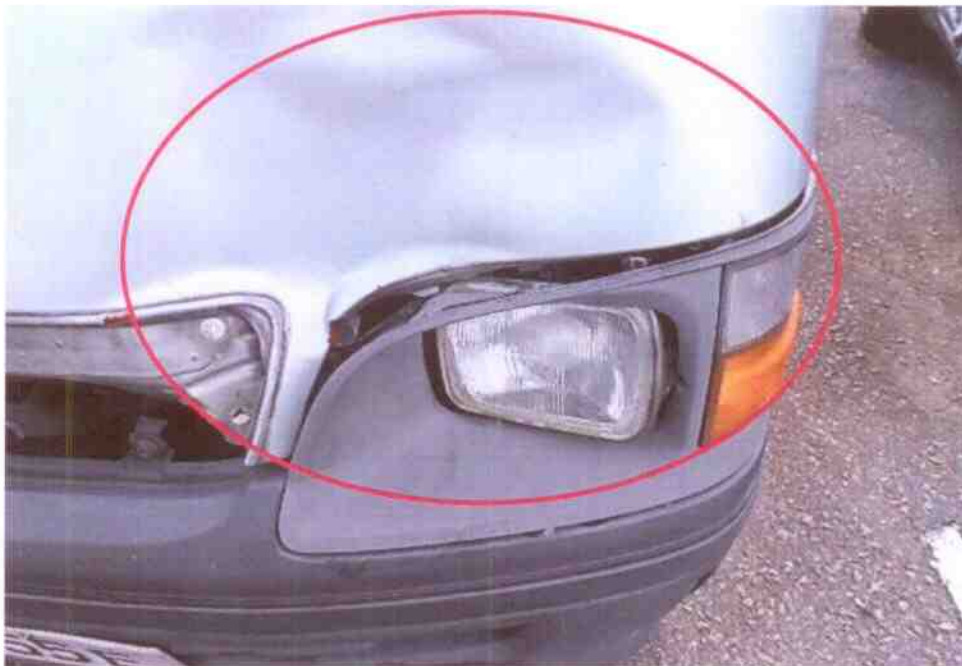
**Photo 4** shows the damage sustained on the front left panels & headlamp as a result of the accident.

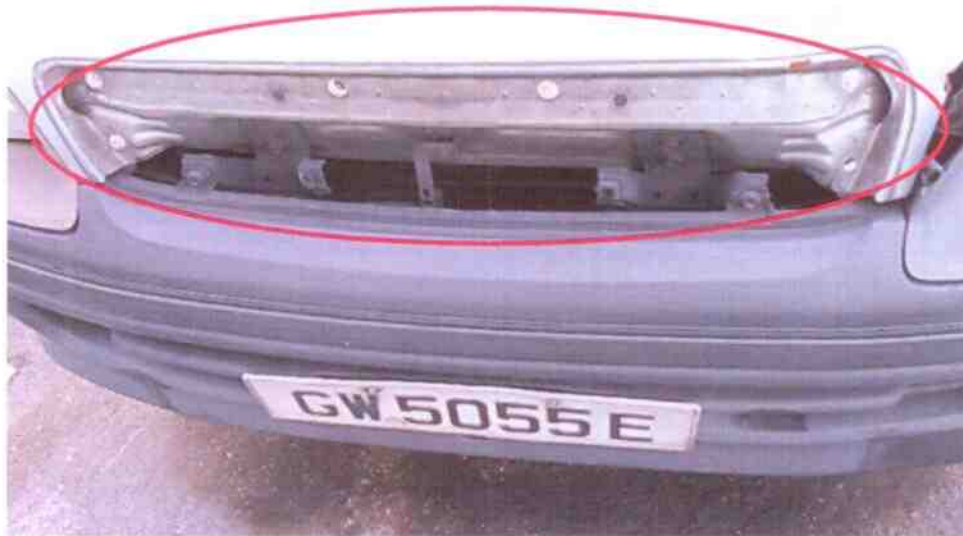
**Photo 5** shows the damage sustained on the front grille (missing) as a result of the accident.

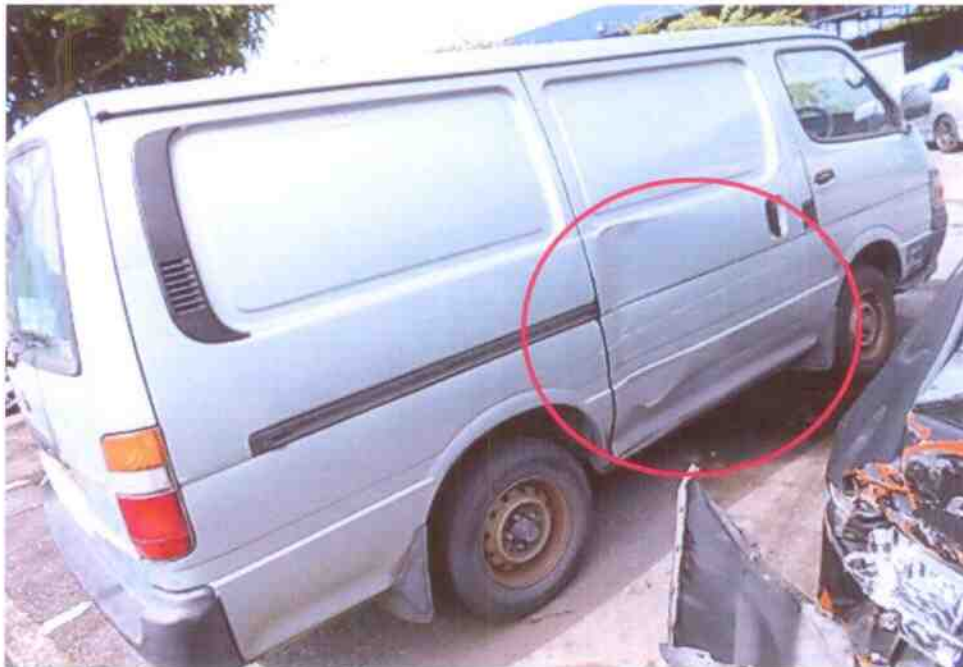
**Photo 6** shows the damage sustained on the right hand side dents & scratches.

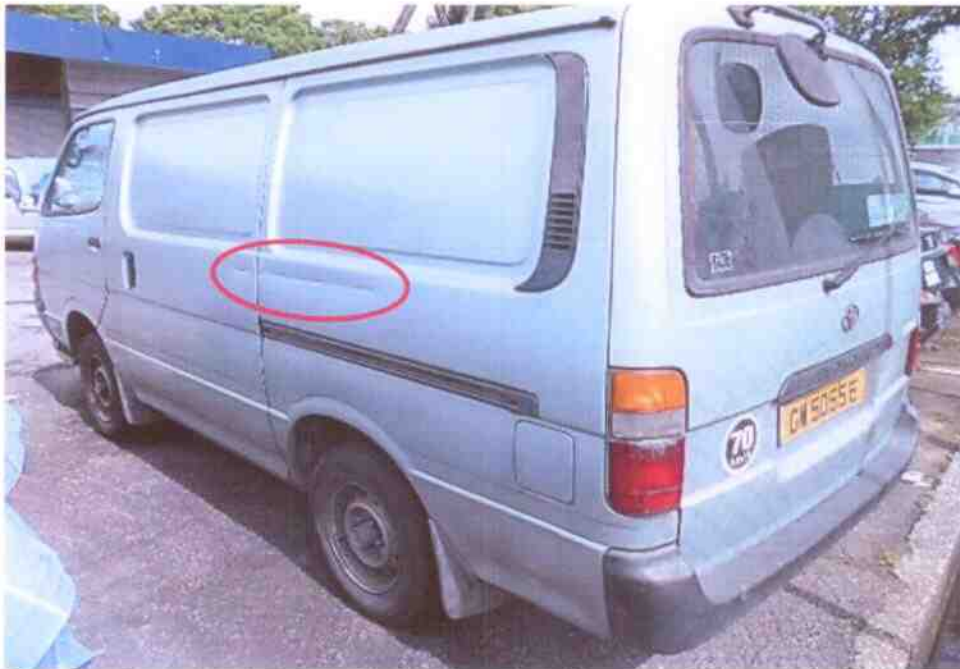
Photo 7 shows the damage sustained on the left hand side line scratch.

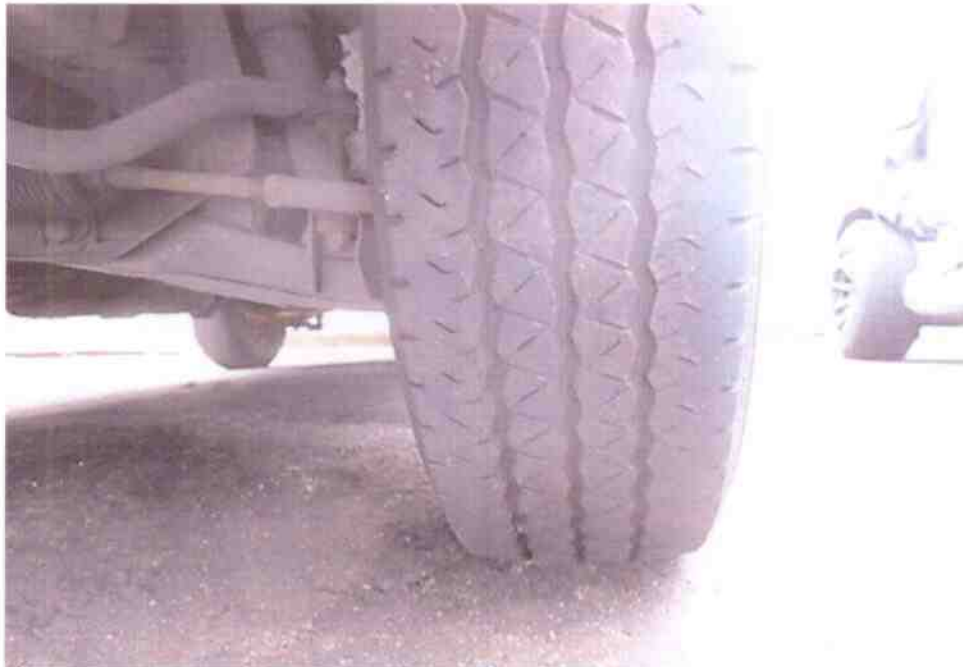
**Photo 8** shows the condition of the front left tyre of the Motor Van, which was observed to be in serviceable condition with remaining tread depth of approximately 6mm.

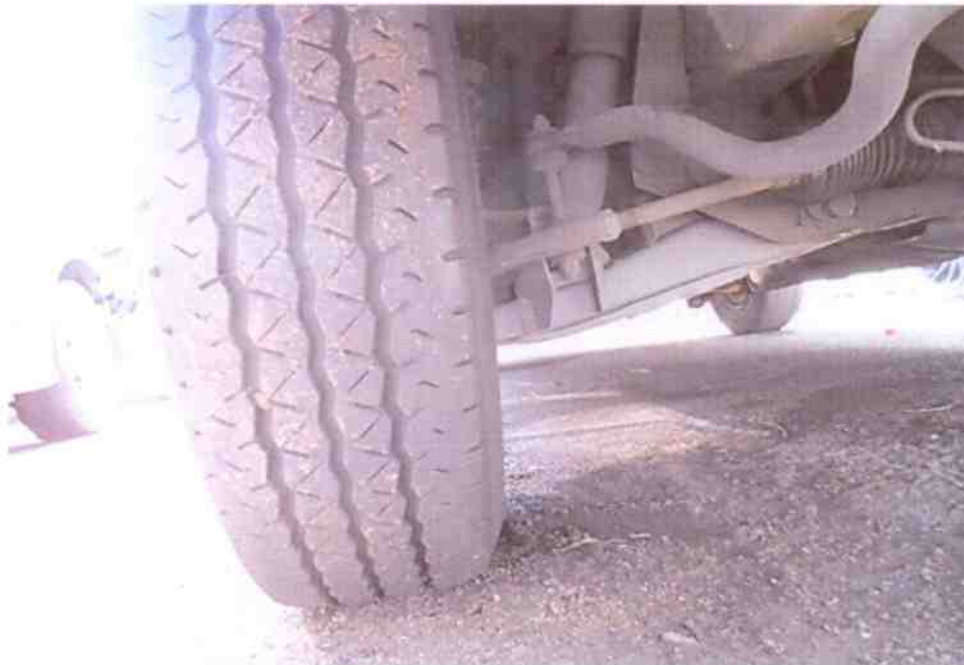
**Photo 9** shows the condition of the front right tyre of the Motor Van, which was observed to be in serviceable condition with remaining tread depth of approximately 5mm.

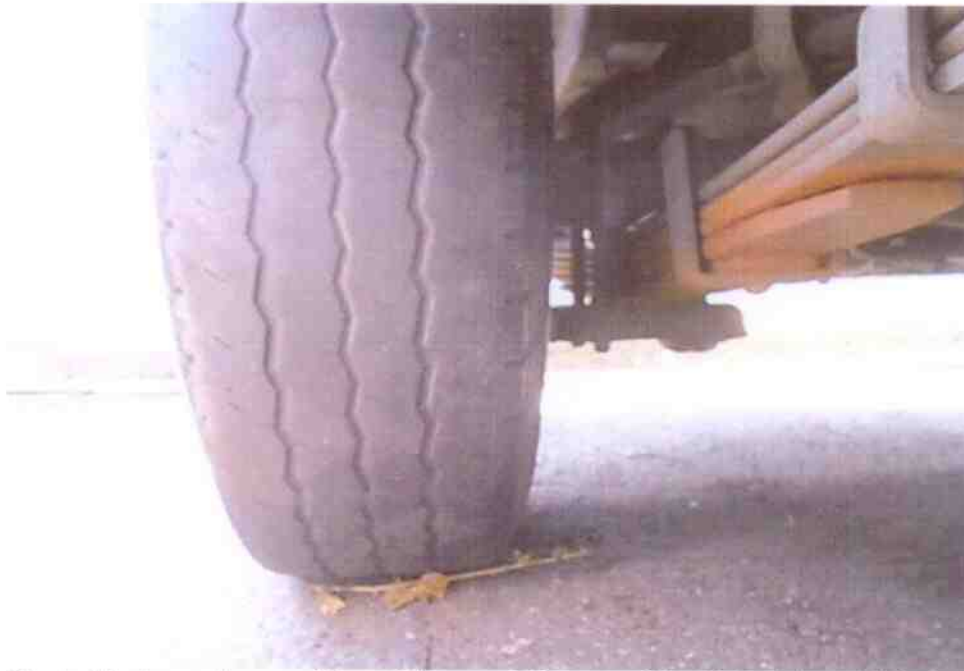
**Photo 10** shows the condition of the rear left tyres of the Motor Van, which was observed to be in serviceable condition with remaining tread depth of approximately 2mm. The tyres, which were wrapped around standard wheel rim, were also observed to be sufficiently inflated for vehicular operation.

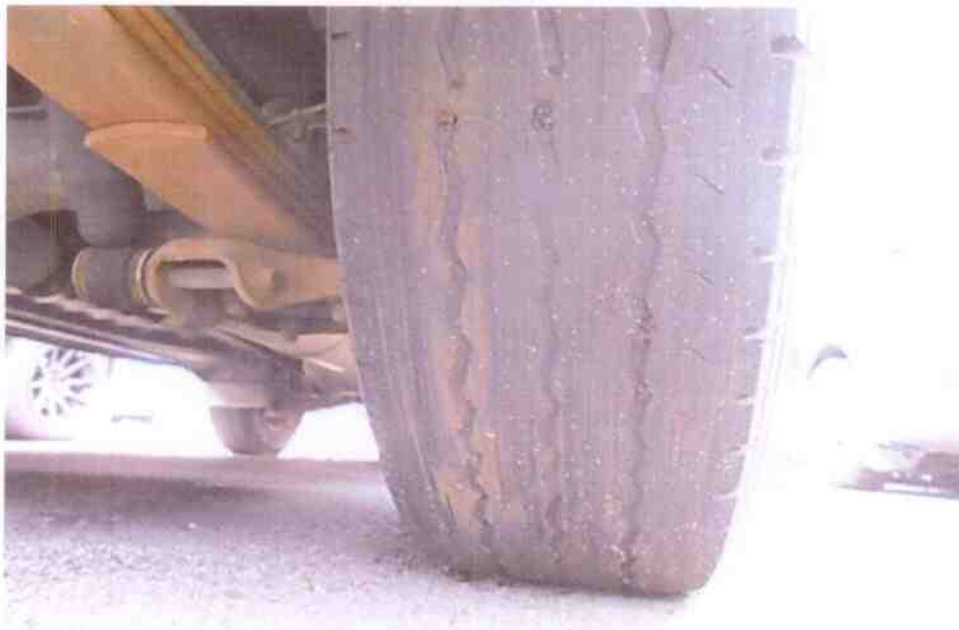
**Photo 11** shows the condition of the rear right tyres of the Motor Van, which were observed to be in serviceable condition with remaining, tread depth of approximately 1.6mm. There was also no tear, cut or burst mark(s) on the outer and the inner sidewalls as well as across the tread of the 4 tyres that were fitted on the Motor Van.

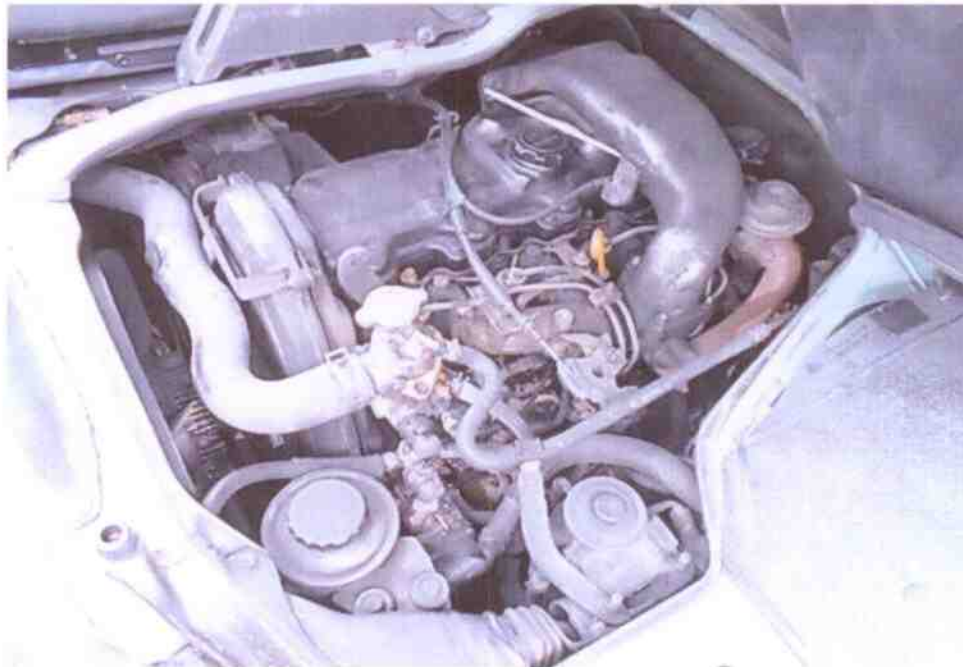
9. Further examination of the engine compartment found that there was no sign(s) or indication(s) of fresh fluid leakage and/or fluid stain within the engine compartment of the Motor Van. However, oil stain observed to be pre-existed prior the accident looking at the dust accumulated with it.

**Photo 12** shows a general view of the Motor Van's engine compartment, which was accessed by lifting the passenger's seat of the Motor Van. The various parts and components inside the engine compartment were unaffected by the accident. There was also no sign(s) or indication(s) of fresh fluid leakage and/or fluid stain within the engine compartment except oil stain was observed to be pre-existed prior the accident looking at the dust accumulated with it.

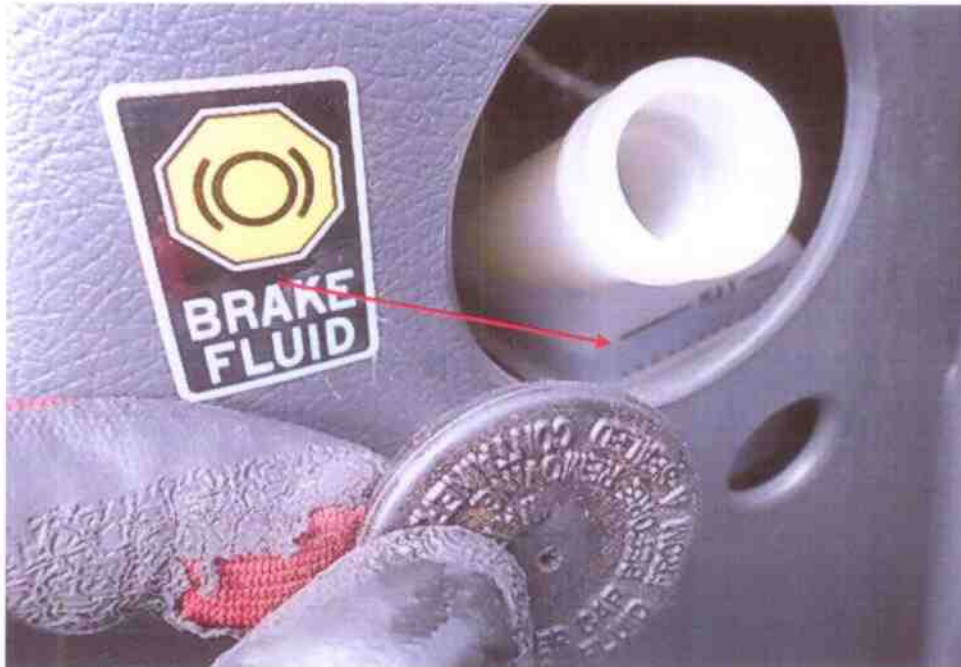
**Photo 13** shows the brake fluid reservoir of the Motor Van at the time of our inspection. The brake fluid was observed to be of sufficient level and without any visible contamination.

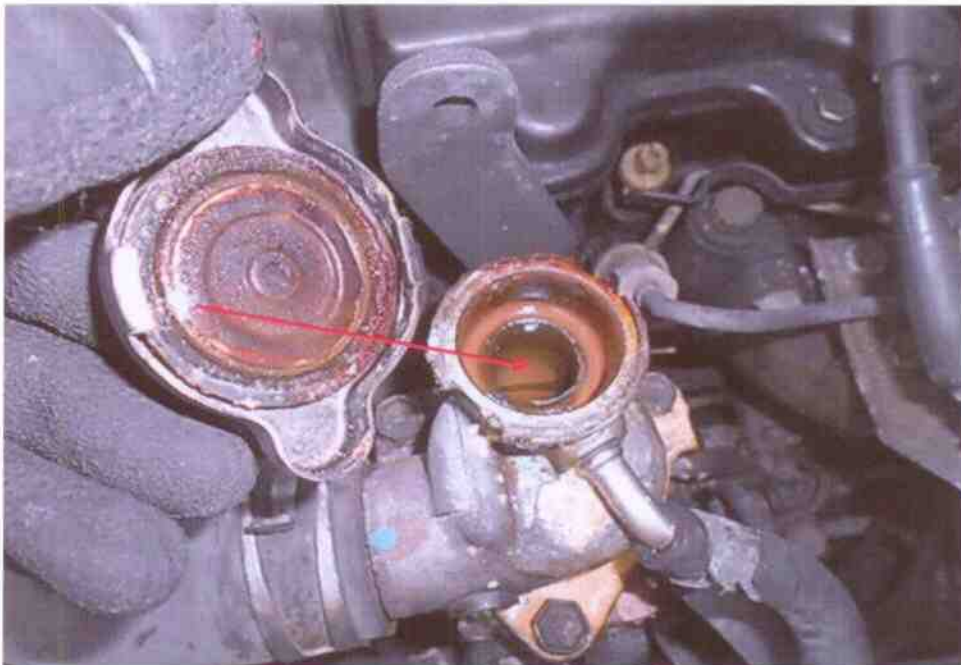
**Photo 14** shows the radiator coolant reservoir of the Motor van at the time of our inspection. The radiator coolant was observed to be of sufficient level and without any visible contamination.

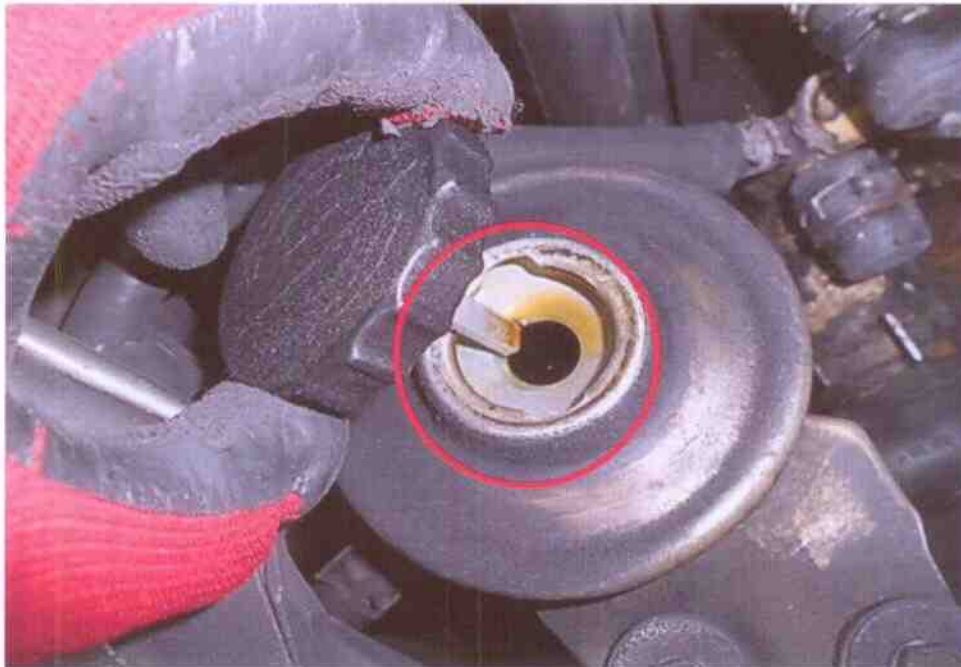
**Photo 15** shows the power steering fluid reservoir of the Motor Van at the time of our inspection. The power steering fluid (circled) was observed to be of sufficient level and without any visible contamination.

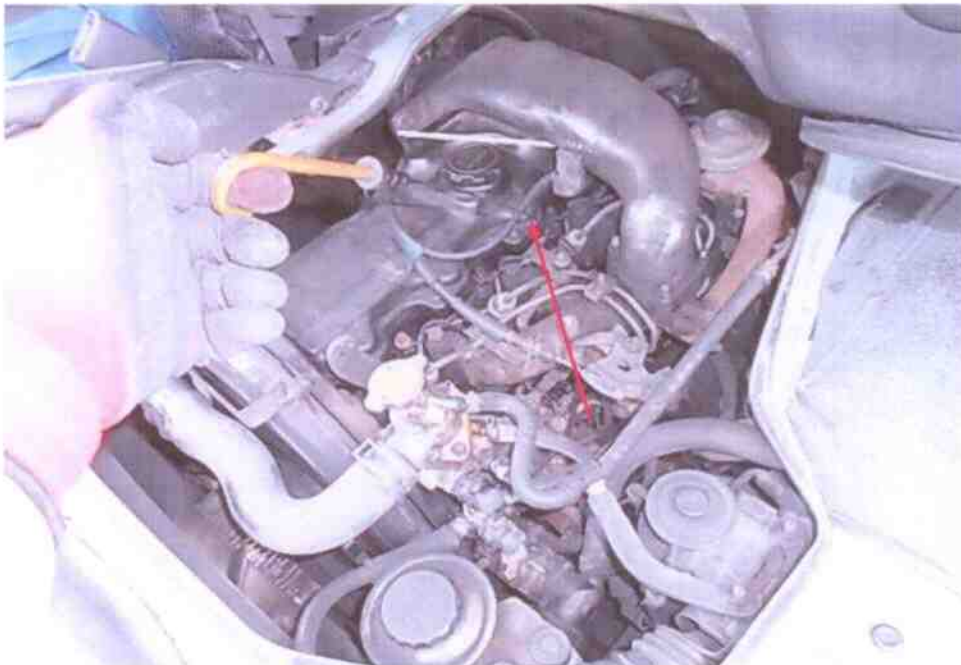
**Photo 16** shows the engine dip stick (general view) of the Motor Van at the time of our inspection. The engine oil was observed to be of sufficient level and without any visible contamination (arrowed).

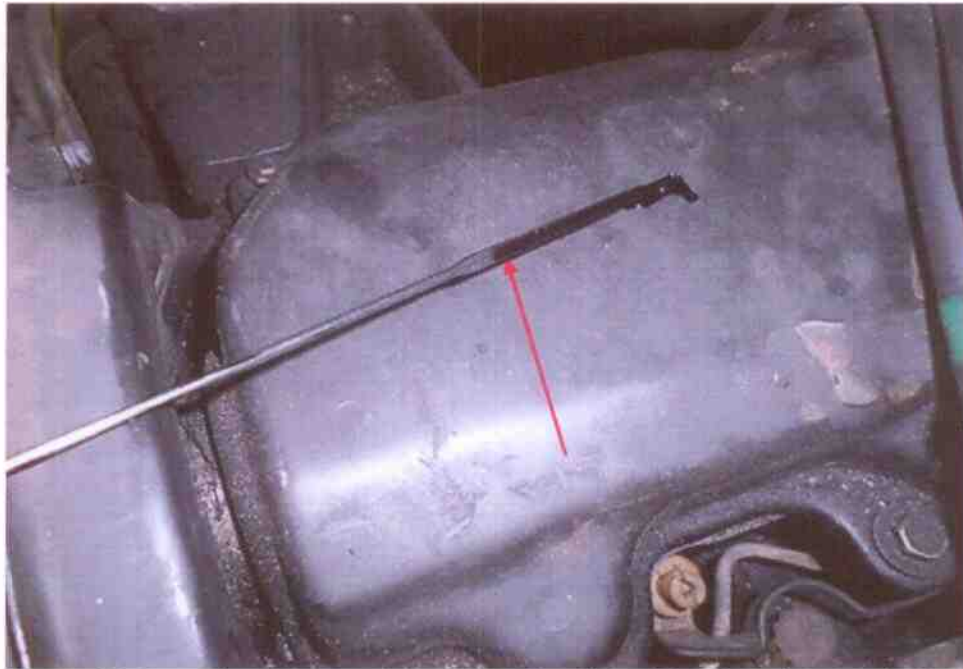
**Photo 17** shows the close-up view engine dip stick of the Motor Van at the time of our inspection. The engine oil was observed to be of sufficient level and without any visible contamination (arrowed).

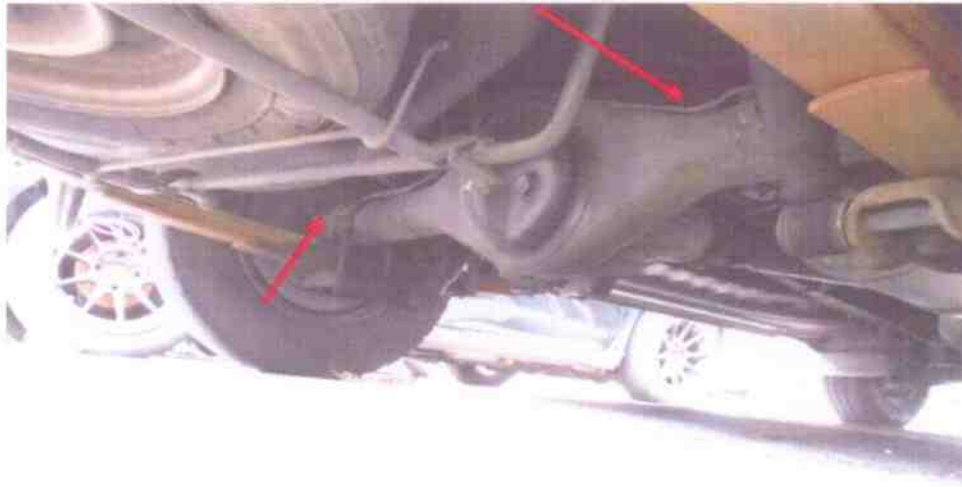
**Photo 18** shows the brake pipe (arrowed) at the rear right wheel of the Motor Van. We did not observe any leakage of brake fluid at the time of our inspection.

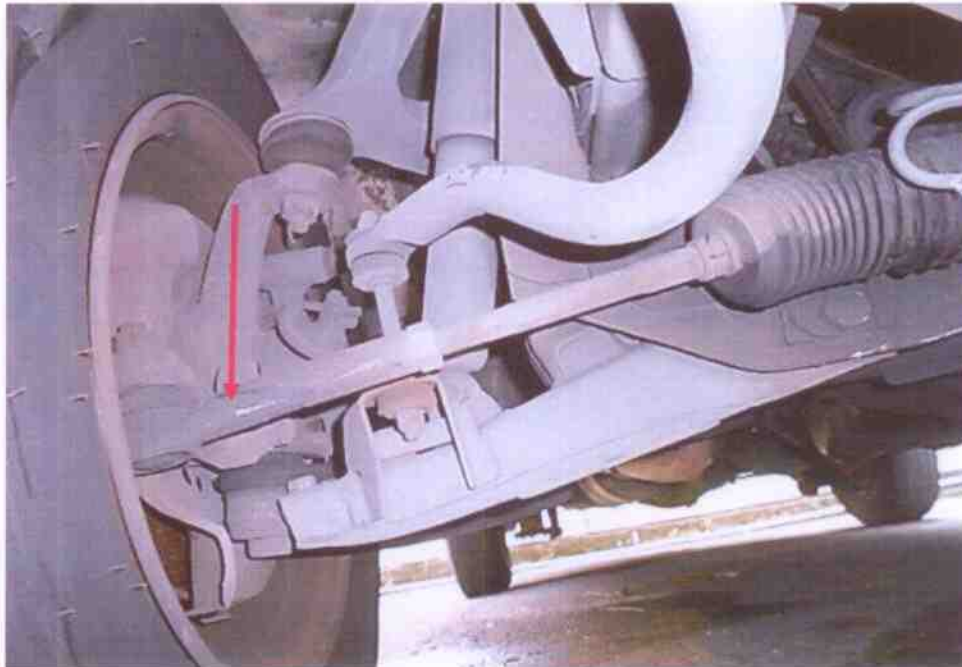
**Photo 19** shows the various undercarriage components at the front right wheel of the Motor van, in particular the steering tie rod end (arrowed). The various steering components were all found to be intact, suggesting that it's in serviceable condition at the material time of accident. There was also no sign of fluid stain(s) observed on the various undercarriage components.

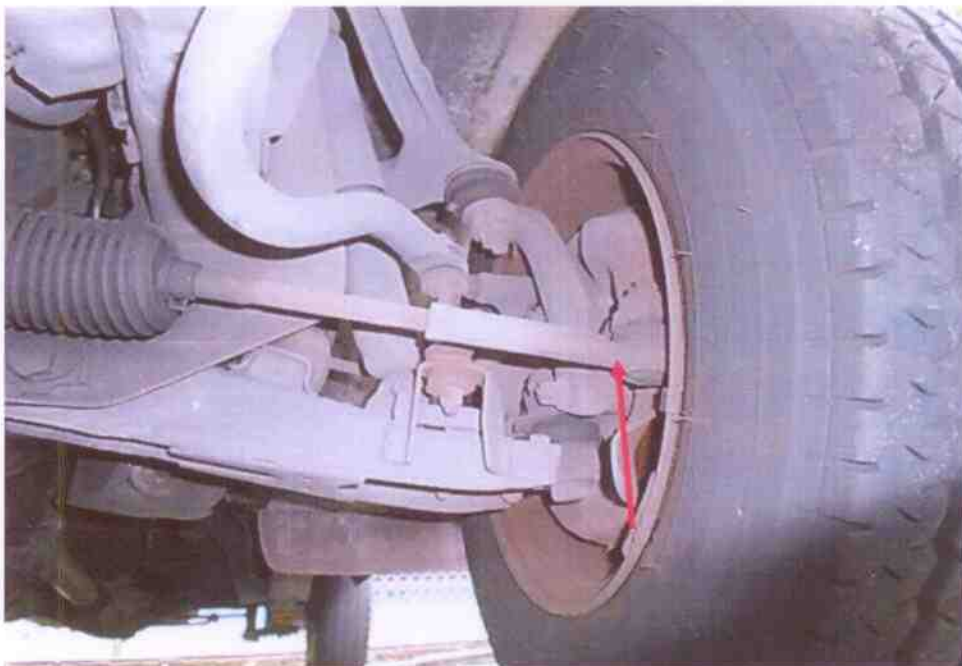
**Photo 20** shows the various undercarriage components at the front left wheel of the Motor Van, in particular the steering tie rod end (arrowed). The various undercarriage components of the Motor Van were all found to be intact without any visible damage. There was also no sign of fluid stain(s) observed on the various undercarriage components.
