**INSPECTION REPORT OF BICYCLE (BLACK) - TRAFFIC POLICE POUND
REPORT NO. 4663/17**

1. We refer to your request dated 16th November 2017 to conduct a physical inspection of a Bicycle bearing Traffic Police Pound Report no. 4663/17 (herein referred to as "**Bicycle**"), which was involved in a fatal road traffic accident on 08th November 2017.
2. The purpose of this inspection is to primarily determine if there was any possible mechanical failure to the Bicycle that may have contributed to the accident.
3. Following the request, we had carried out a physical inspection of the Bicycle on 27th November 2017 at the premises of Traffic Police vehicle pound, 517 Airport Road Singapore 539942. We now set out below my observations and comments with respect to this inspection.

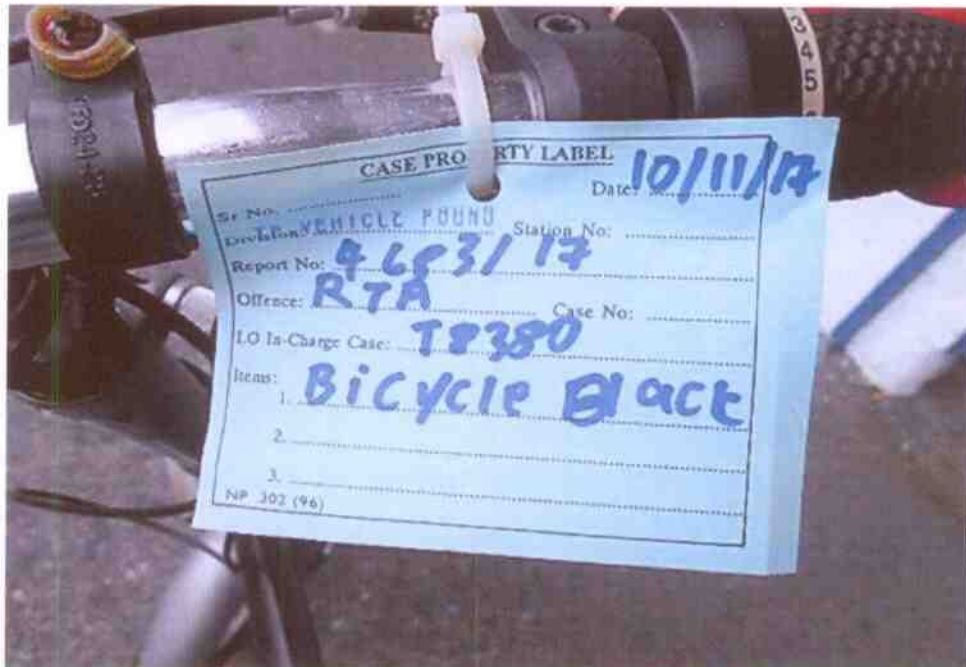
Photo 1 shows the identification of the Bicycle with reference to Traffic Police Pound Report No. 4663/17.

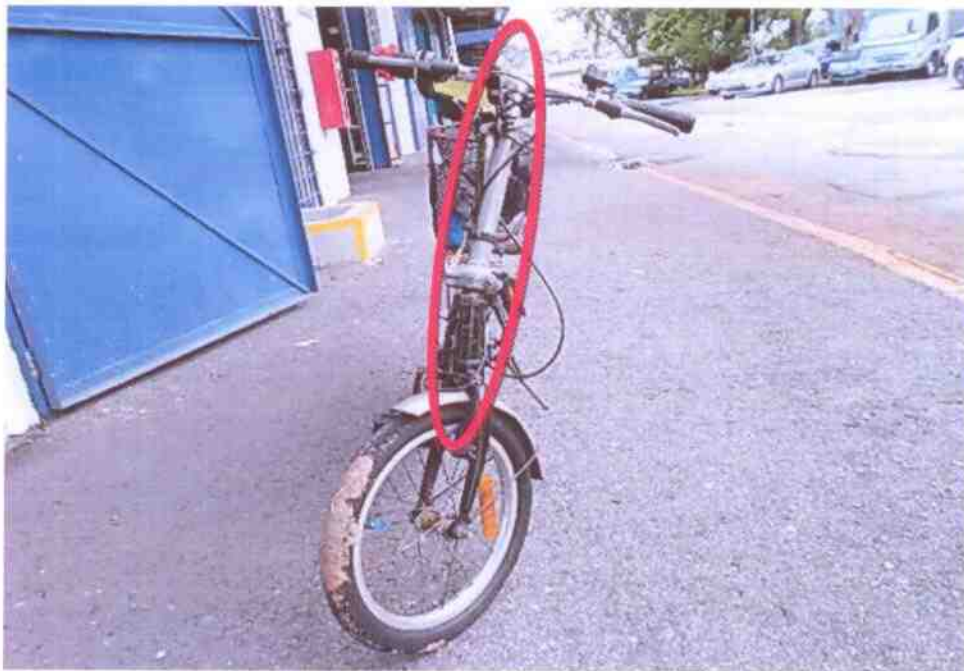
4. The Bicycle was observed to have sustained damages at the frontal portion & along both its left side and right side. The body parts that were found to have been damaged include its handle bar, bicycle pedals & gear train amongst others as a result of the accident.

Photo 2 shows the frontal portion of the Bicycle at time of inspection. Misalignment of the handle bar & front tyre was observed.

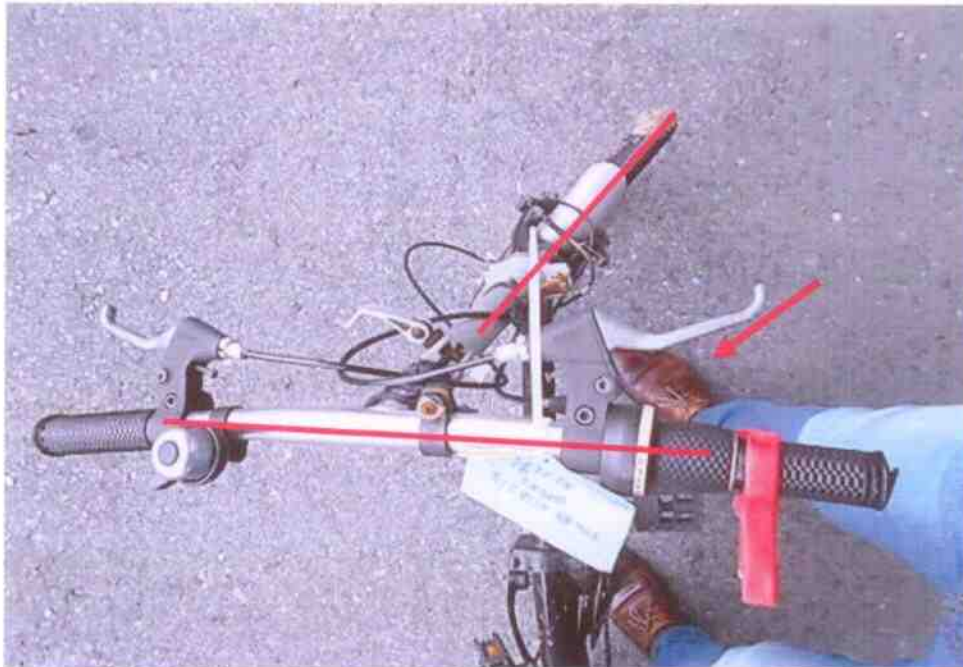
Photo 3 shows the frontal portion of the Bicycle (top view) at time of inspection. Misalignment of the handle bar & front tyre was observed.

8. For this case, we were not able to conduct any test(s) on the steering system of the Bicycle due to the damages on its front fork. The front fork was found to be misaligned as a result of the accident, hence causing the whole steering system to be out of alignment.
9. The brake system of the Bicycle was controlled by mechanical means (cables and springs). Our visual examination of the various components in the brake system, like the hand brake lever (left & right), brake clamps (front & rear), revealed all to be intact and without damage. There was also no visible tear or cut observed on the connecting cables.

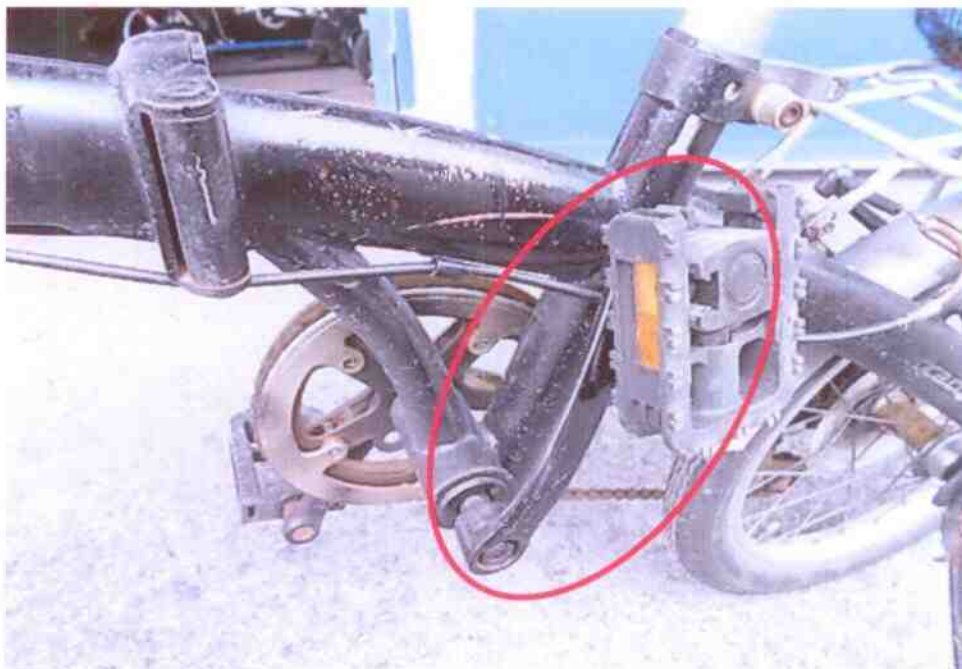
Photo 4 shows a close-up view of the left pedal of the Bicycle at the time of our inspection. It was observed to have sustained damages at the left pedal of the Bicycle.

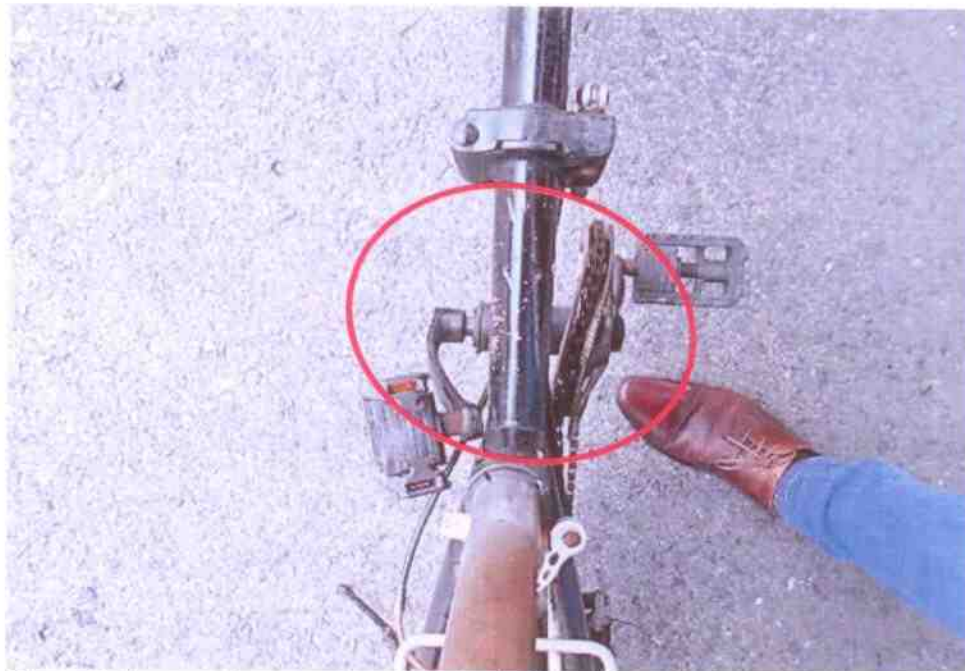
Photo 5 shows a close-up view (top view) of the left pedal & the drive train of the Bicycle at the time of our inspection. It was observed to have sustained damages at the circled area of the Bicycle due to the accident.

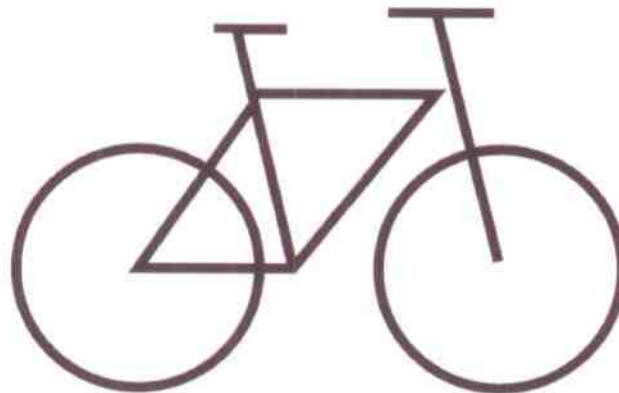
5. The condition of the Bicycle's front & rear tyres was observed to be in serviceable condition. The tread pattern of the 2 tyres was clearly visible. We did not observe any tear, burst mark(s) and/or punctured hole(s) on the sidewalls as well as across the tread of the 2 tyres. The tyres were observed to be sufficiently inflated for vehicular operation. The tyre brand, tyre size and remaining tread depth of the 2 tyres were recorded as follows:-

Cheng Shin Tire 47-305 16 X 1.75 (2mm)

Wandaking 47-305 16 X 1.75 (2mm)

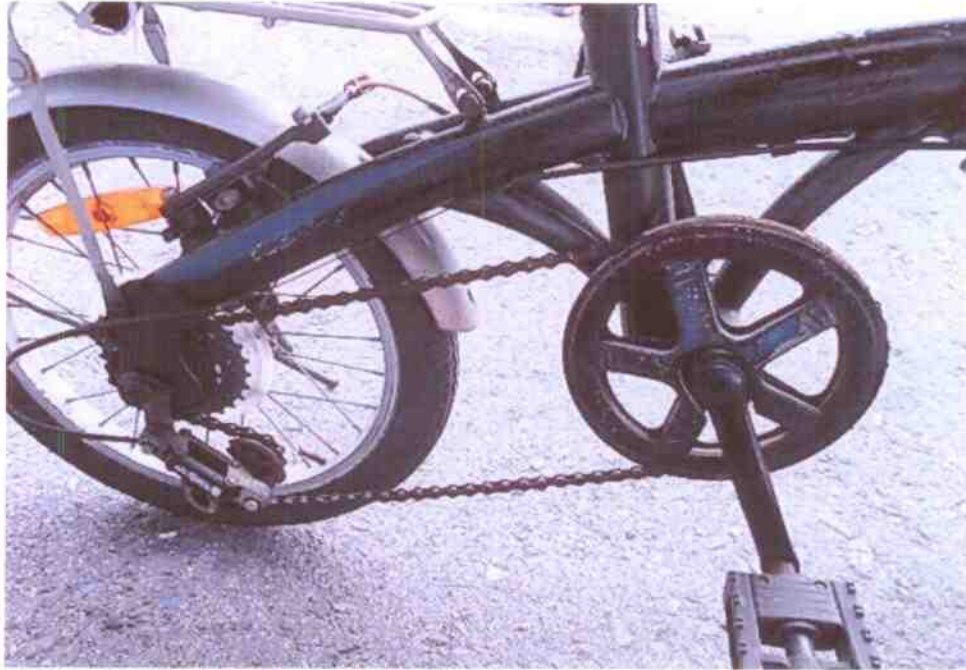
6. The tyres were wrapped around alloy spork wheel rim that was found to be without any significant damage. See photo 6 & 7 below

Photo 6 shows the rear tyre of the Bicycle at the time of our inspection. The rear tyre was observed to be in serviceable condition with remaining tread depth of approximately 2mm. The tyre was also observed to be sufficiently inflated for vehicular operation.

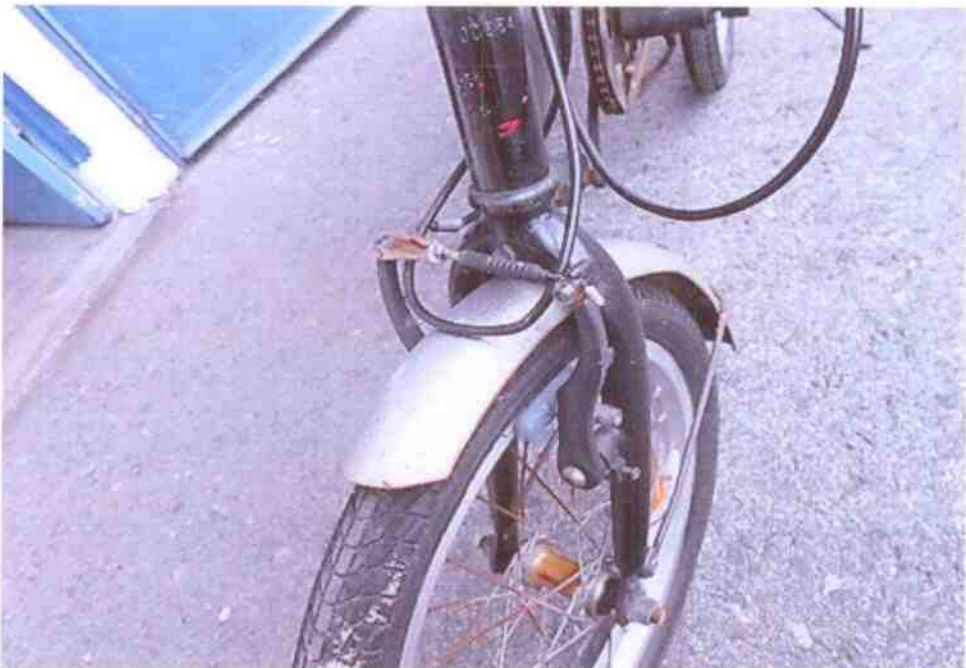
Photo 7 shows the front tyre of the Motorcycle. The pattern of the tread was clearly visible. There was no tear, burst mark(s) and/or punctured hole(s) on the sidewalls as well as across the tread of the front tyre.

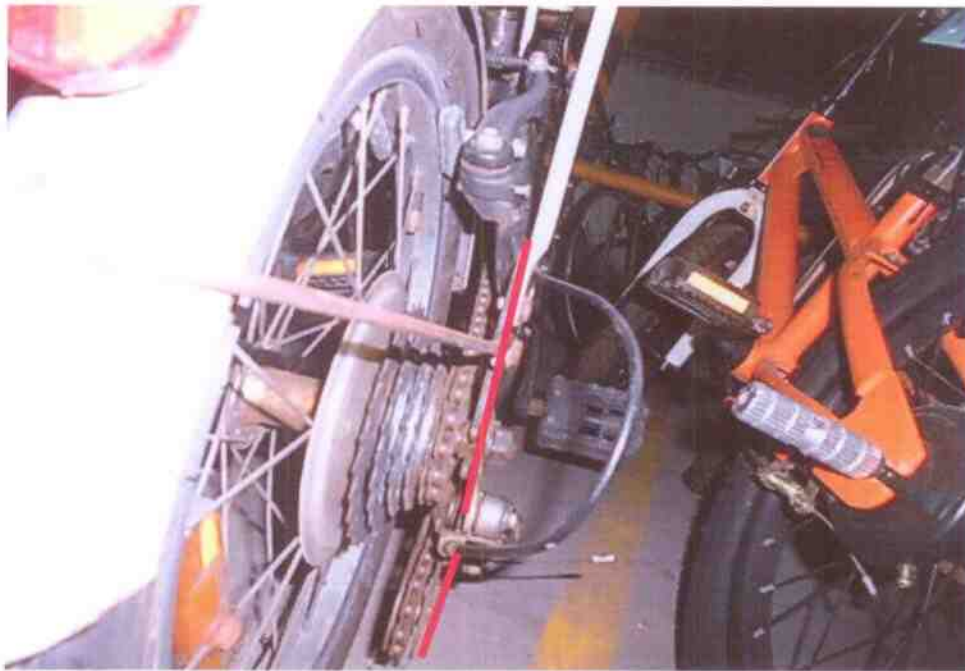
7. The gear chain of the Bicycle was found to be deformed & misaligned as a result of the accident. Free play tension test was found to be unacceptable. See photo 8 below.

Photo 8 shows the general view of the gear train of the Motorcycle, which was observed to be misaligned due to the accident. It was not adequately lubricated at time of inspection.

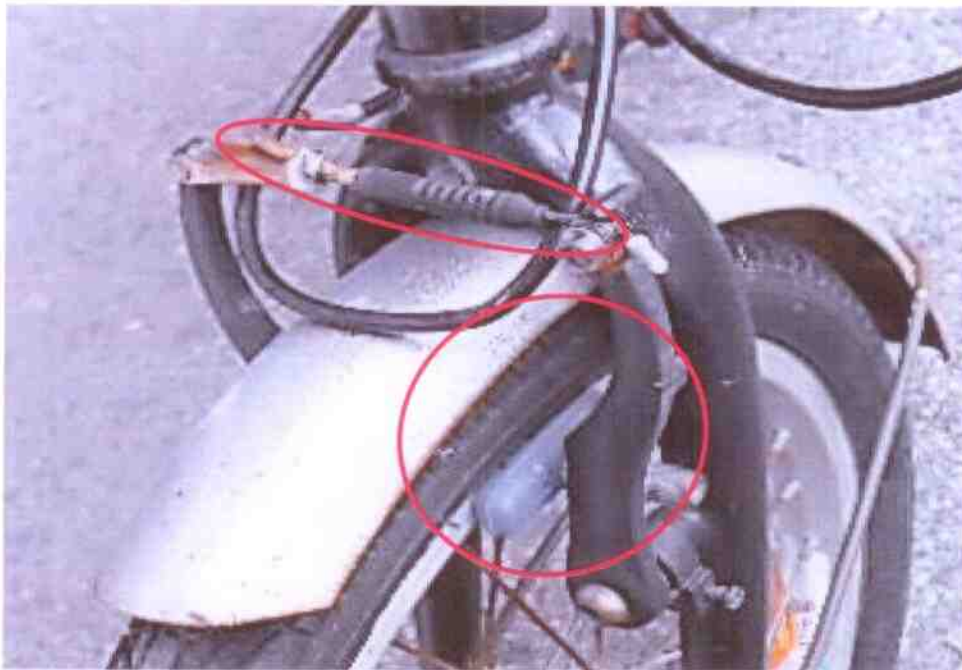
Photo 9 shows the front brake (circled) was observed to be intact without any damages. Static brake test was conducted on both front & rear brake & found to be in serviceable condition.

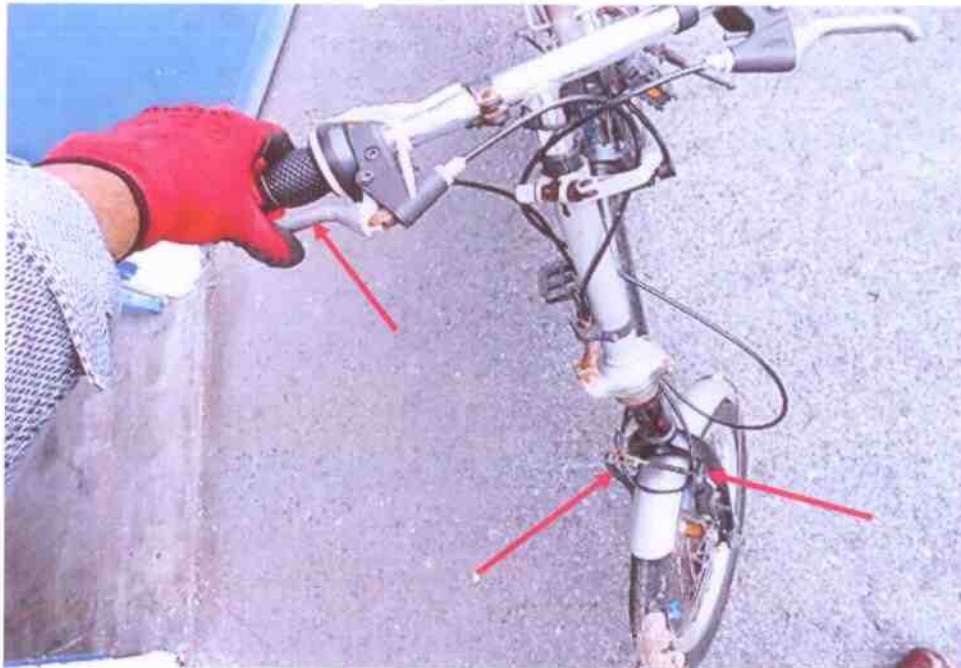
Photo 11 shows the front brake static test upon gripping the brake lever. It responded to the braking action indicates that it was in serviceable condition.

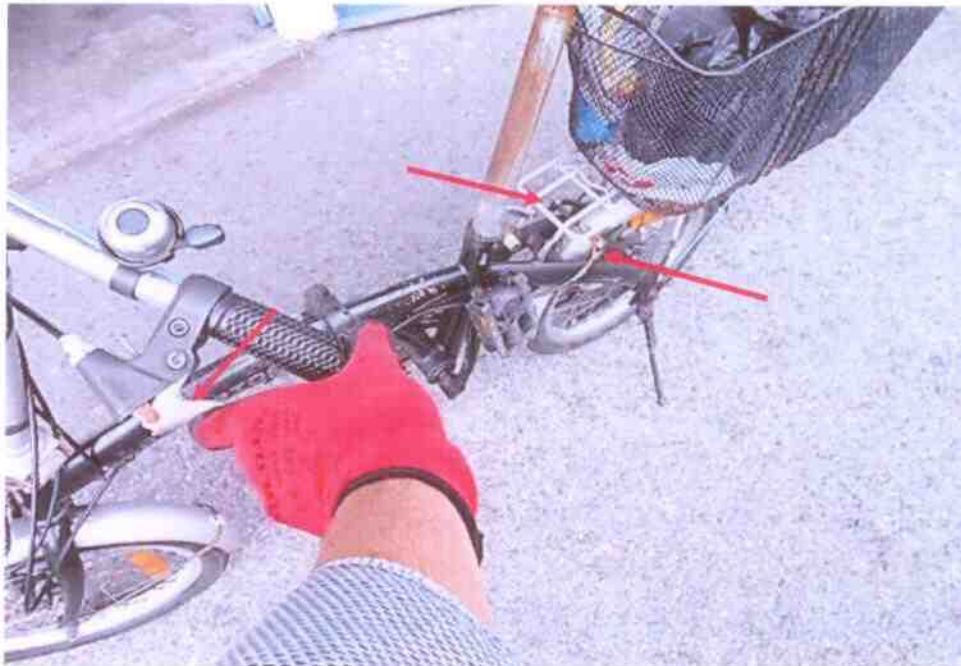
Photo 13 shows the rear brake static test upon gripping the brake lever. It responded to the braking action indicates that it was in serviceable condition.
