Auto
Consultants
Pte Ltd

Your Ref: TP/IP/60517/2017
Our Ref : CI/TPD17022591/Z

**INSPECTION REPORT OF BICYCLE (BLACK & YELLOW) - TRAFFIC POLICE
POUND REPORT NO. 4663/17**

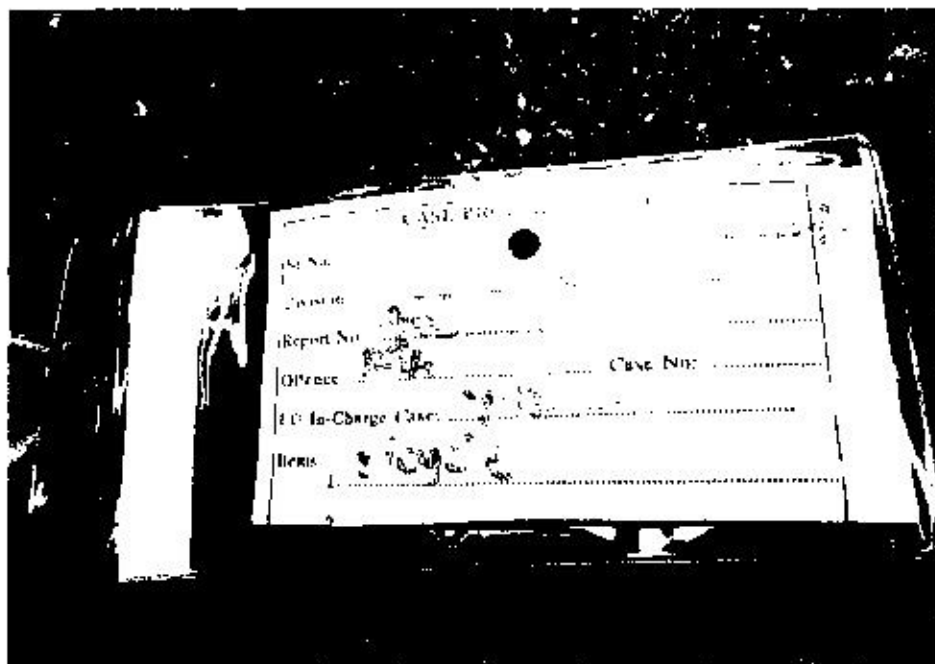
Photo 1 shows the identification of the Bicycle with reference to Traffic Police Pound Report No. 4663/17.

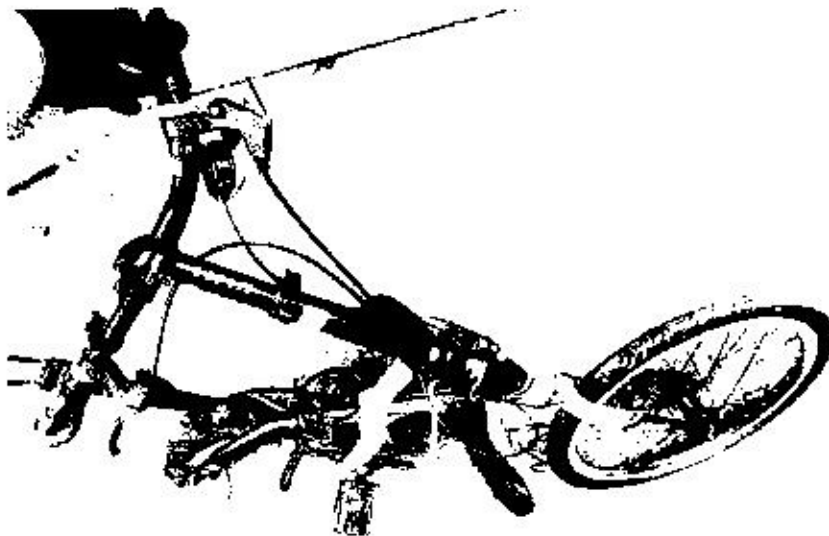
4. The Bicycle was observed to have sustained extensive damages at the frontal portion, rear portion & along both its left side and right side. The body parts that were found to have been damaged include its handle bar, foot pedals, dislodged rear tyre, missing sea, bent rims & gear train amongst others as a result of the accident. See photo 1 to 5 below.

Photo 2 shows the frontal portion of the Bicycle at time of inspection. Misalignment of the handle bar & front tyre was then result of the accident.

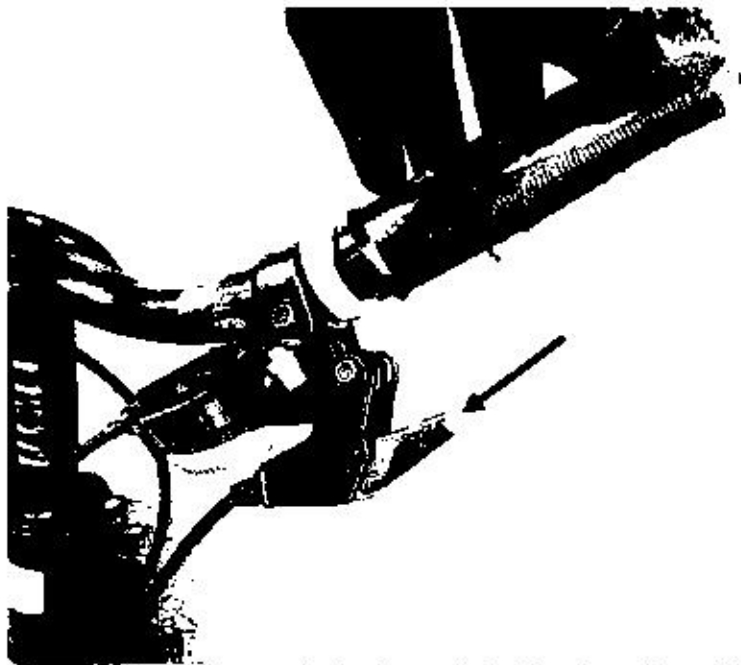
Photo 3 shows the rear brake lever of the Bicycle at time of inspection. It was observed to be broken as a result of the accident.

10. A static brake test can only be conducted on the front brake of the Bicycle. There was some resistance felt (spongy like feel) upon gripping right hand brake lever. This was further confirmed by looking at front brake clamps while we gripped on the brake lever. It shows that the front brake clamps responded to the gripping action. This had appeared to indicate that the front brake was in serviceable condition. As for the rear brake we could not conduct any test due to the broken brake lever on the left side of the handle bar.

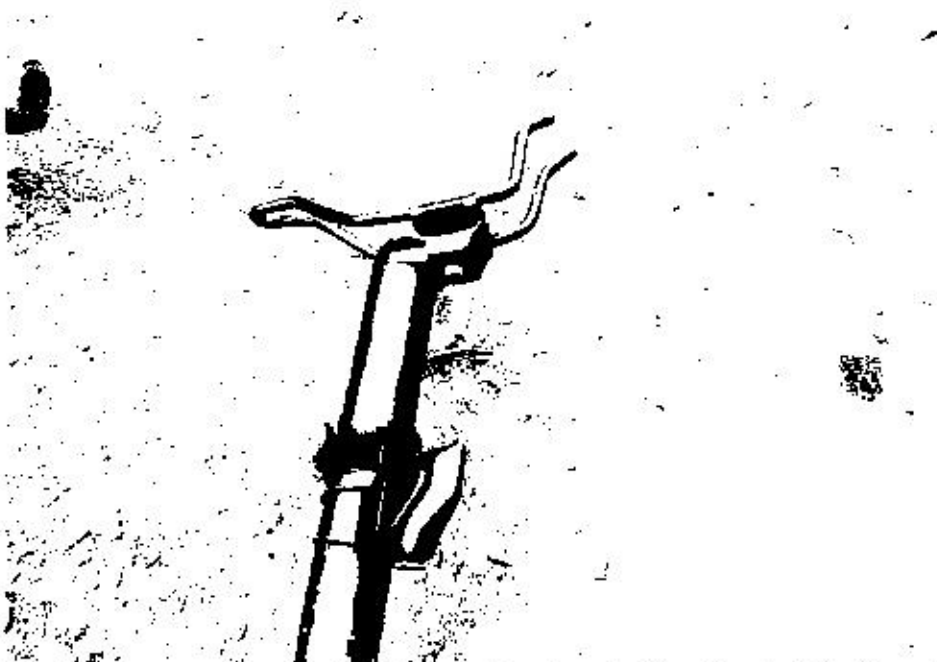
Photo 4 shows a close-up view of the dislodged seat of the Bicycle at the time of our inspection. It was due to the result of the accident.

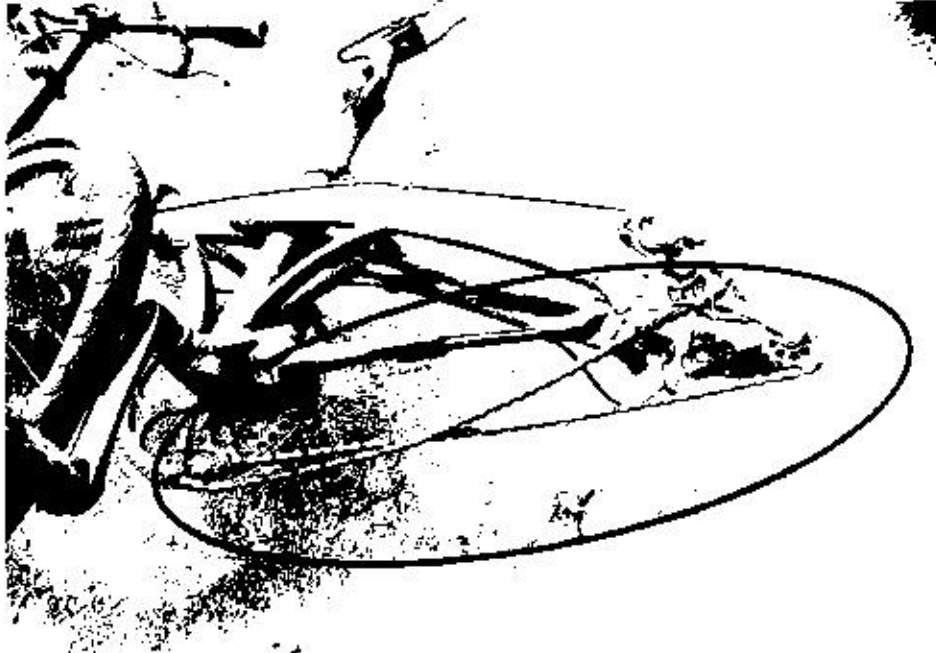
Photo 5 shows a close-up view of the drive train of the Bicycle at the time of our inspection. It was observed to have sustained damages at the circled area of the Bicycle due to the accident.

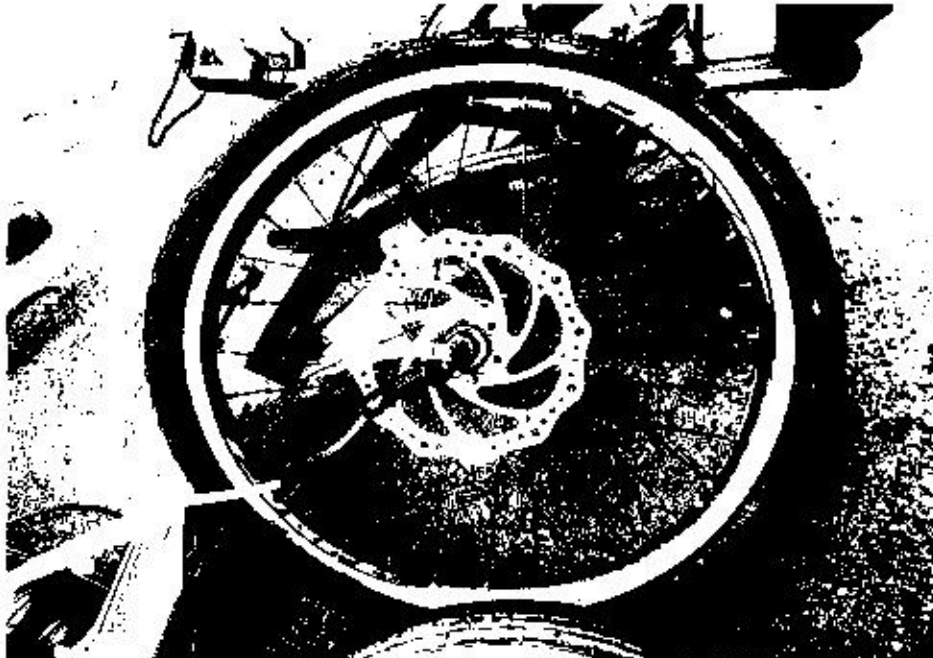
6. Both tyres were wrapped around alloy spork wheel rims. Only the rear spork wheel rims were observed to be bent as a result of the accident's impact. See photo 6 & 7 below

Photo 6 shows although the rear tyre was observed to be in serviceable condition with remaining tread depth of approximately 1.6mm. The tyre was also observed to be dislodged from the rear bracket & bent due to the accident.

14. Both tyres of the Bicycle were found to be in a serviceable condition. There was no tear, cut or burst mark(s) on the outer and the inner sidewalls as well as across the tread of the tyres. It was sufficiently inflated for vehicular operation with remaining tread depth of approximately 1.6mm each. However, the rear tyre was observed to be dislodged from the original installation due to the accident's impact.

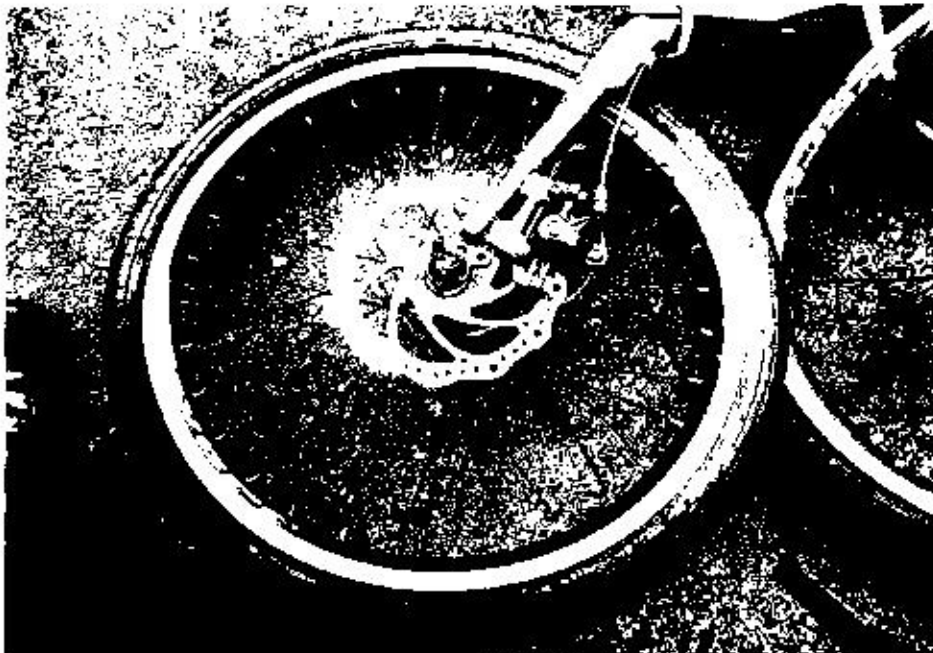
Photo 7 shows the front tyre of the Motorcycle. The pattern of the tread was clearly visible. There was no tear, burst mark(s) and/or punctured hole(s) on the sidewalls as well as across the tread of the front tyre.

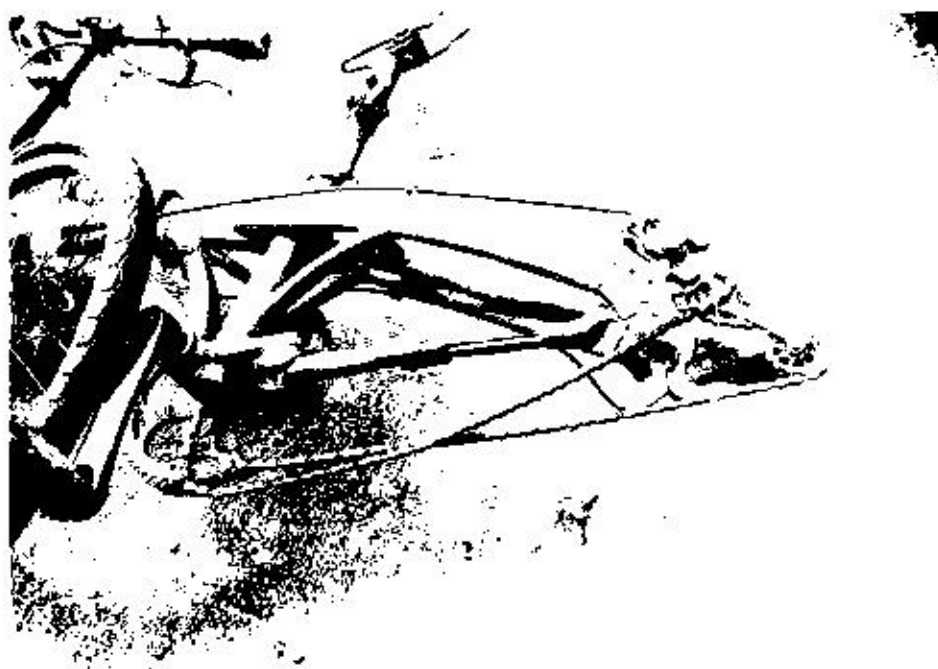
7. The gear chain of the Bicycle was found to be severely damaged as a result of the accident. No free play tension test can be conducted due to the extensive damages. See photo 8 below.

Photo 8 shows the general view of the gear train of the Bicycle, which was observed to be with severe damages as a result of the accident.

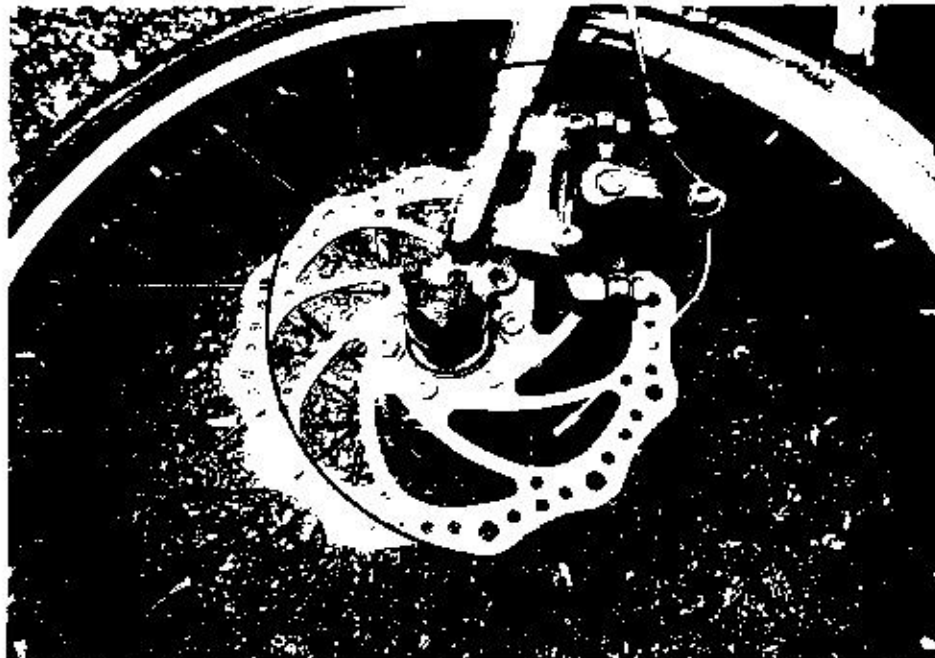
Photo 9 shows the front brake (circled) was observed to be intact without any damages. Static brake test was conducted on front brake found to be in serviceable condition.

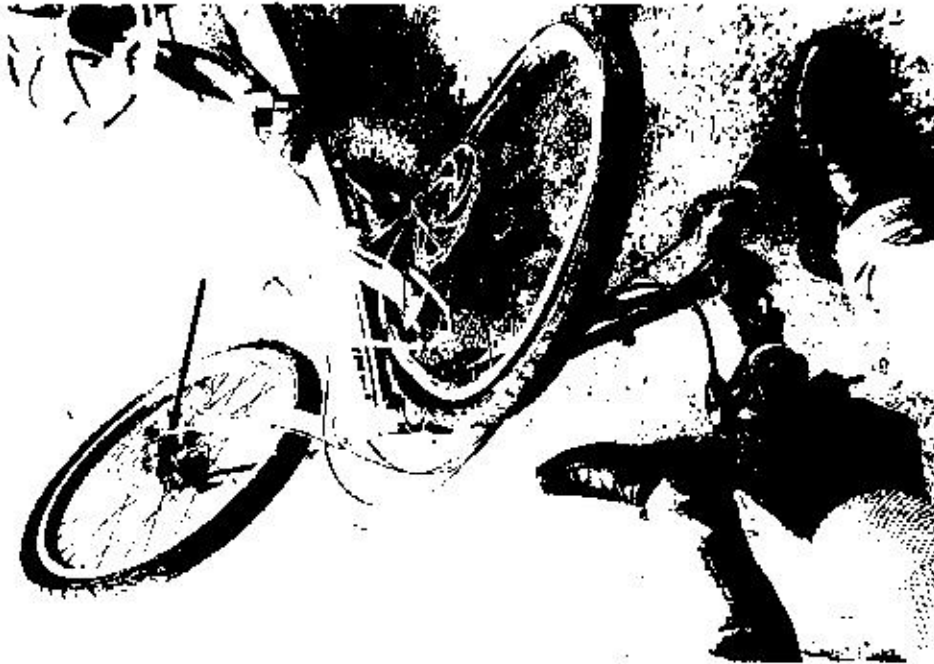
Photo 10 shows the response from the front brake static test upon gripping the brake lever. It was observed to be in serviceable condition.
