Your Ref: TP/IP/59635/2017  
Our Ref :CI/TPD17022592/Z

**Fatal Accident Investigation Team**

**INSPECTION REPORT OF MOTORCYCLE FBH 9470B**

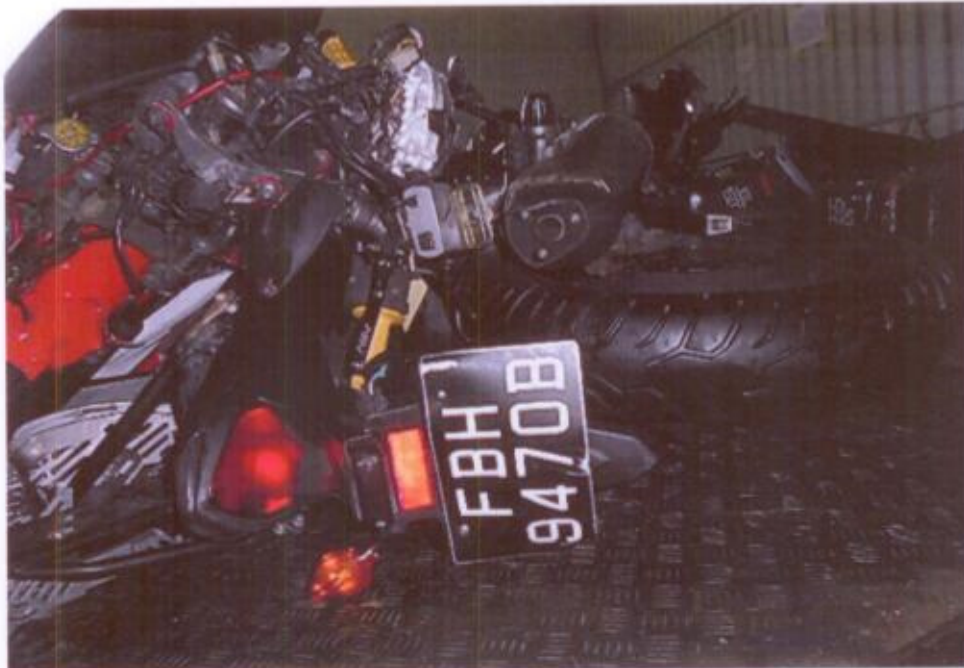
**Photo 1** shows the Motorcycle number plate for identification.

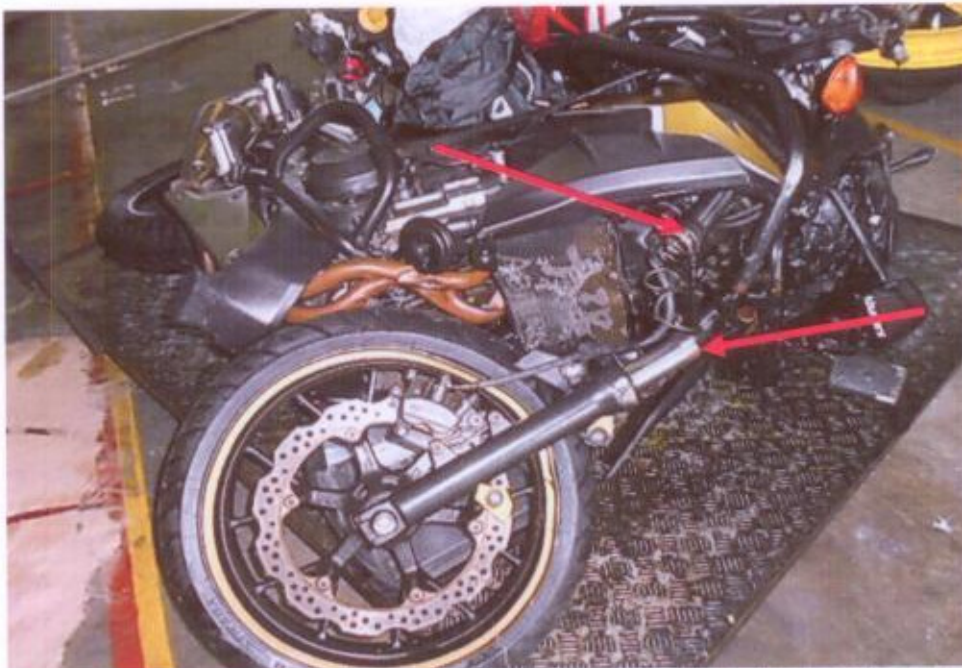
**Photo 2** shows a general view of the front right body of the Motorcycle at the time of our inspection. The Motorcycle was observed to have sustained with relatively extensive impact due to the accident collision. Amongst the body parts damaged was its front fork (arrowed), which was observed to be broken into 2 pieces.

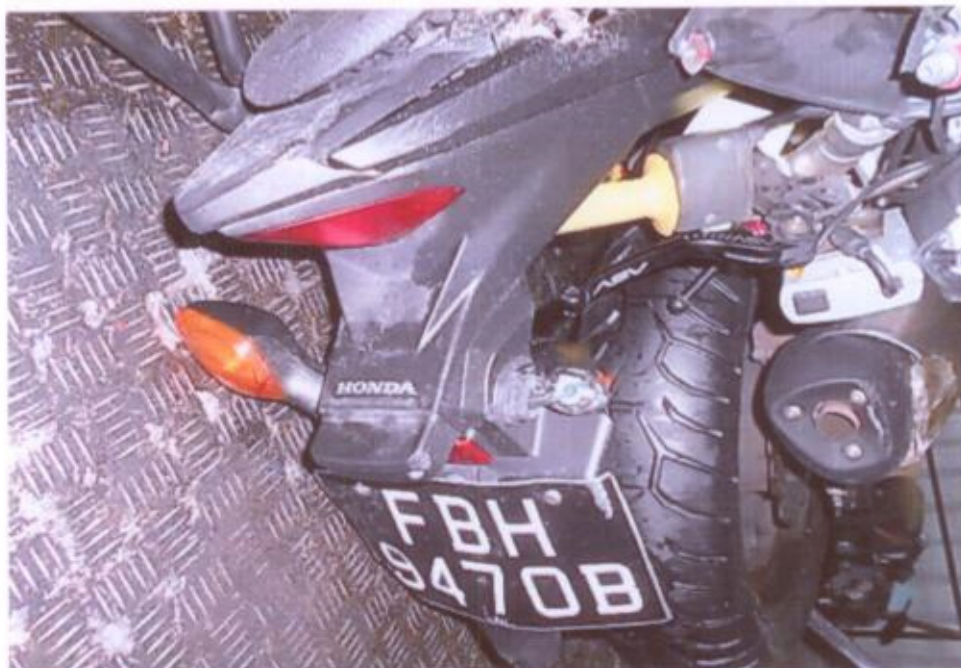
**Photo 3** shows a general view of the rear left body of the Motorcycle at the time of our inspection. The Motorcycle was observed to have sustained damages at the frontal portion, rear portion, along both its left side and right side.

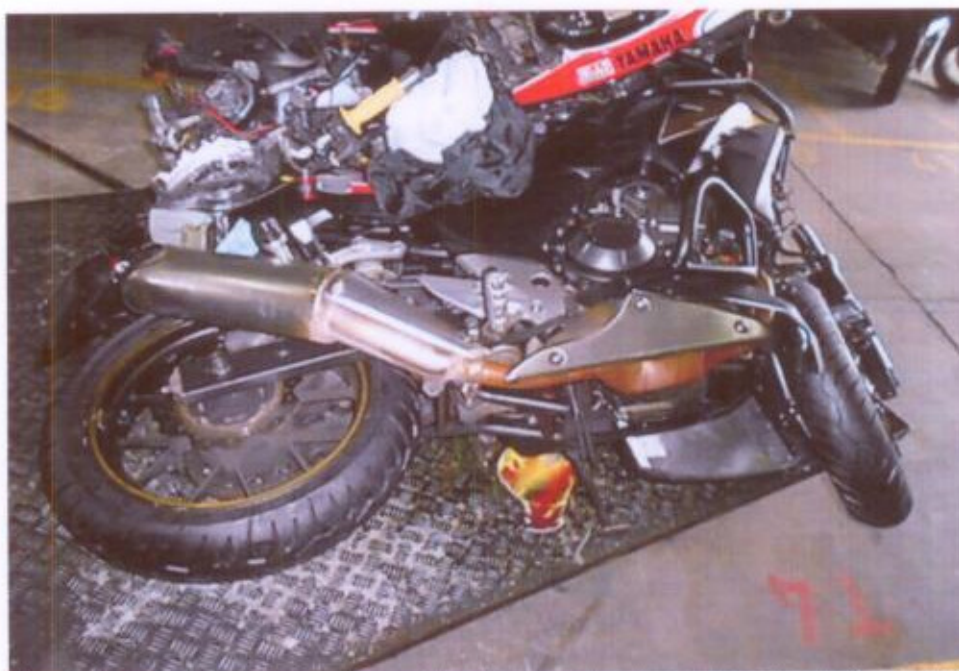
**Photo 4** shows a general view of the Motorcycle at the time of our inspection. The Motorcycle was observed to have sustained relatively extensive impact due to the accident collision.

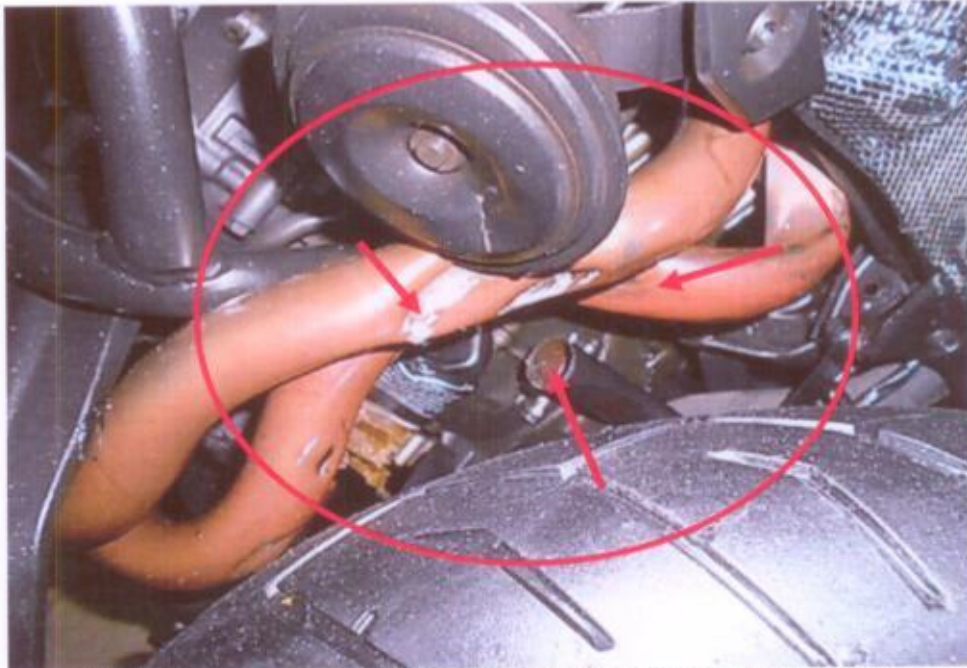
**Photo 5** shows a close-up view of the frontal portion of the Motorcycle at the time of our inspection. The Motorcycle was observed to have sustained relatively extensive impact including damages to the exhaust manifold & broken crash bar (circled) likely due to the accident collision.

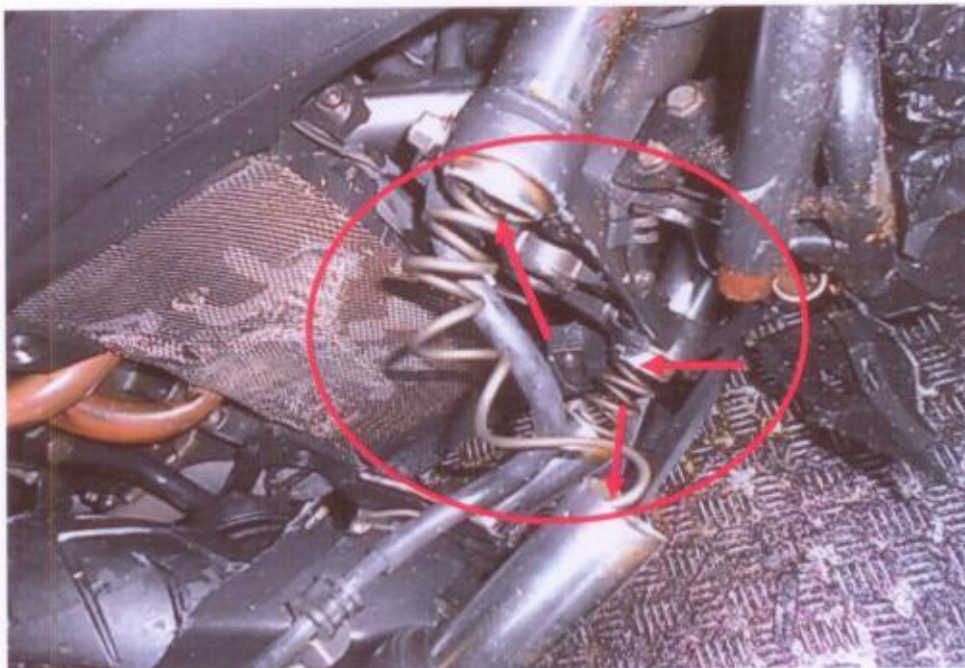
**Photo 6** shows a close-up view of the frontal portion of the Motorcycle at the time of our inspection. The Motorcycle was observed to have sustained relatively extensive impact including damages to the broken front fork (circled) likely due to the accident collision.

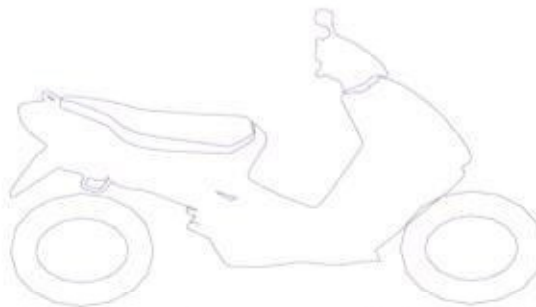
Pirelli Diablo Strada 160/60 – 17(5mm)

Pirelli Diablo Strada 160/60 - 17 (3mm)

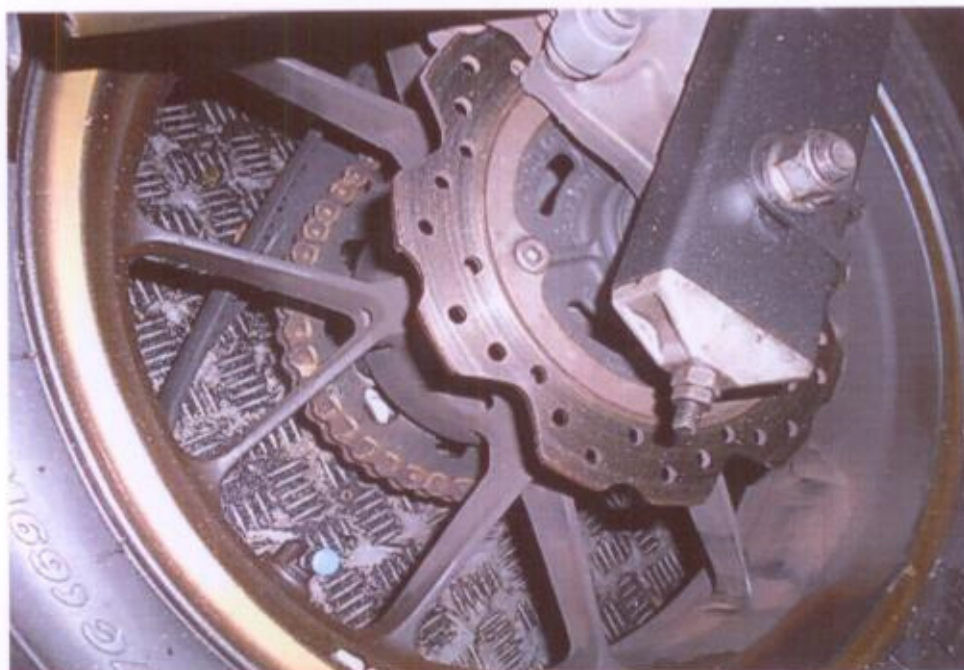
**Photo 7** shows the rear tyre of the Motorcycle at the time of our inspection. The rear tyre was observed to be in serviceable condition with remaining tread depth of approximately 5mm. The tyre was also observed to be sufficiently inflated for vehicular operation. There was no significant damage observed on the rear wheel rim & tyre.

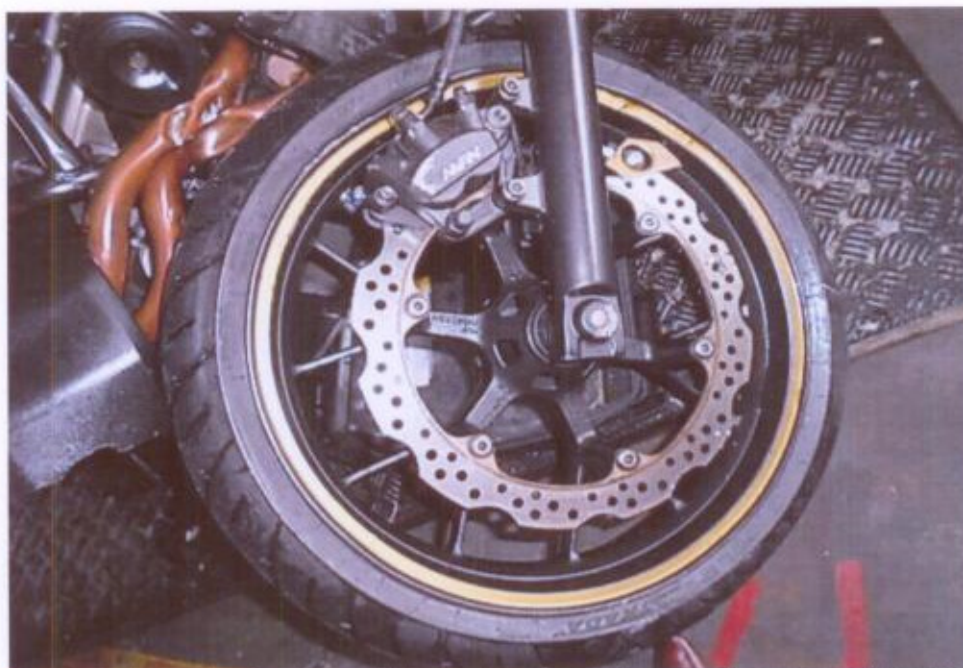
**Photo 8** shows the front tyre of the Motorcycle at the time of our inspection. The pattern of the tread was clearly visible. There was no tear, burst mark(s) and/or punctured hole(s) on the sidewalls as well as across the tread of the front tyre.

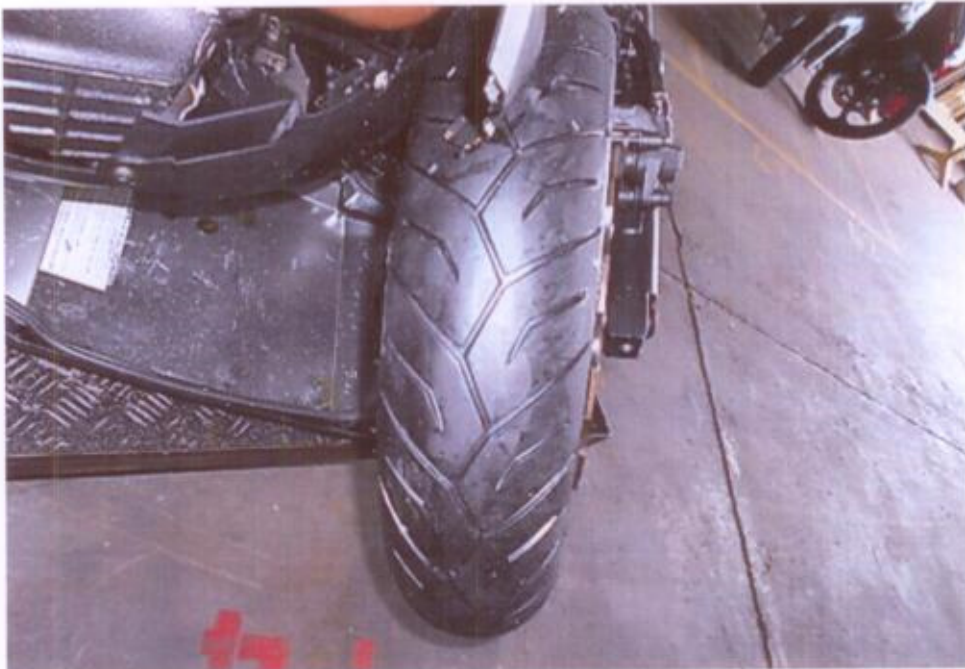
**Photo 9** shows the front tyre of the Motorcycle at the time of our inspection. The pattern of the tread was clearly visible. There was no tear, burst mark(s) and/or punctured hole(s) on the sidewalls as well as across the tread of the front tyre.

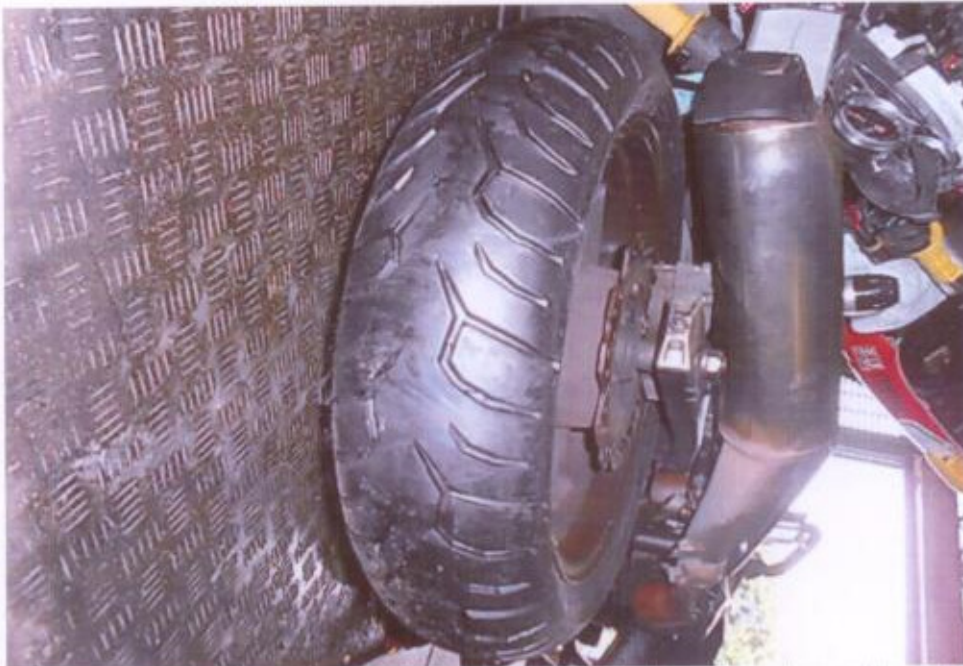
**Photo 10** shows the rear tyre of the Motorcycle at the time of our inspection. The pattern of the tread was clearly visible. There was no tear, burst mark(s) and/or punctured hole(s) on the sidewalls as well as across the tread of the front tyre.

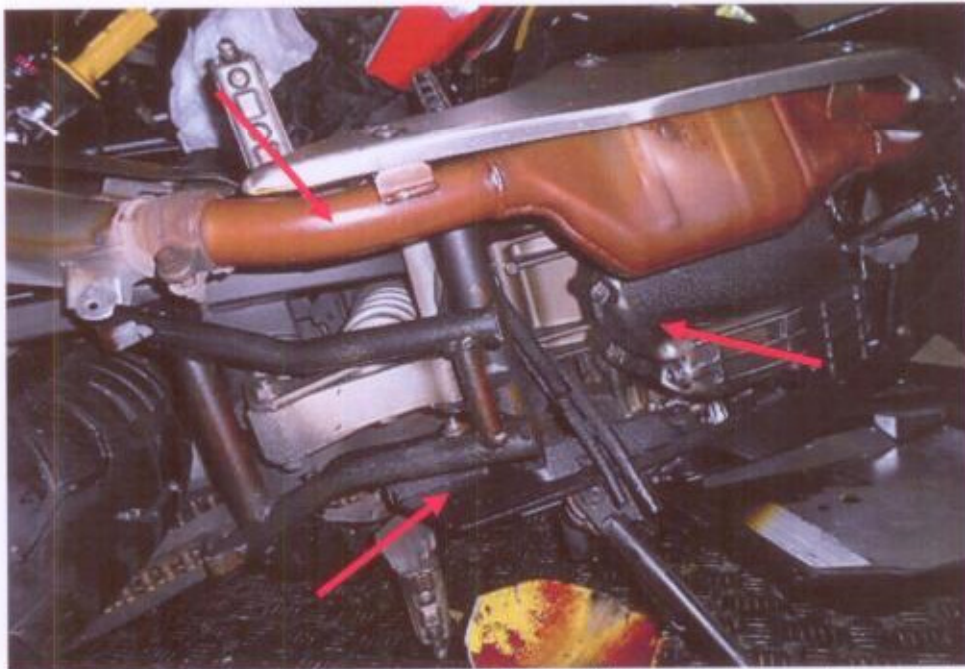
8. Upon examination of the engine area of the Motorcycle, we had observed that the various engine related parts and components were intact with no visible damage. The engine underside was however observed to be covered with reddish fluid, suggesting leakage of fluid. There was no accumulation of dust and/or dirt particles on the engine housing where the fluid stains had formed. This would indicate that the fluid leakage was a fresh leak and likely to be a result of the accident.
9. The gear chain of the Motorcycle was found to be intact without any misalignment. It was also adequately lubricated for operating purposes. See photo 11 – 13 below.

**Photo 11** shows sign(s) or indication(s) of fluid leakage observed around the engine's underside area of the Motorcycle.

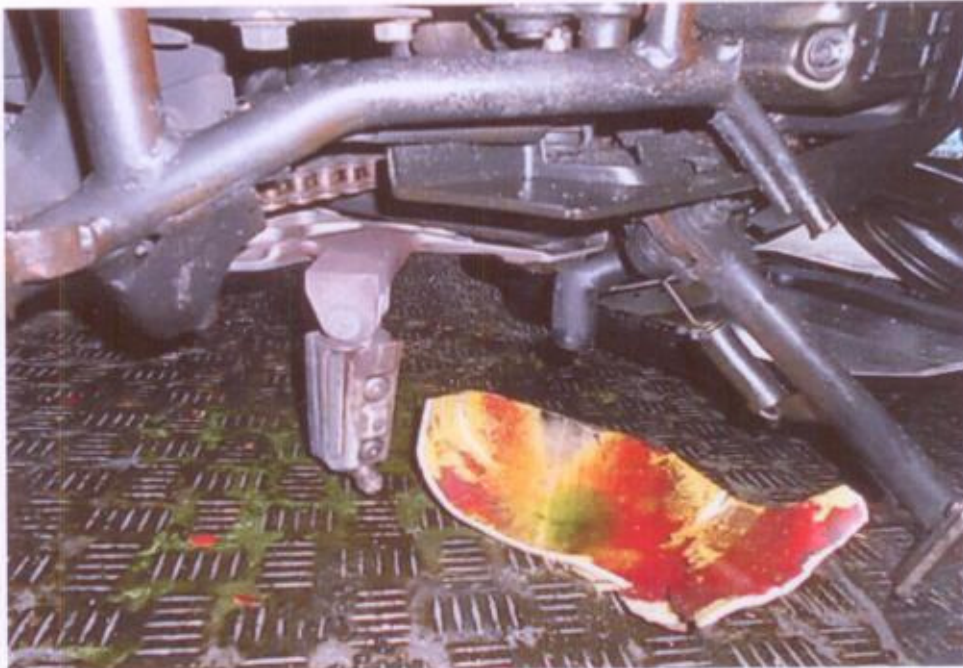
**Photo 12** shows sign(s) or indication(s) of fluid leakage observed around the engine's area of the Motorcycle.

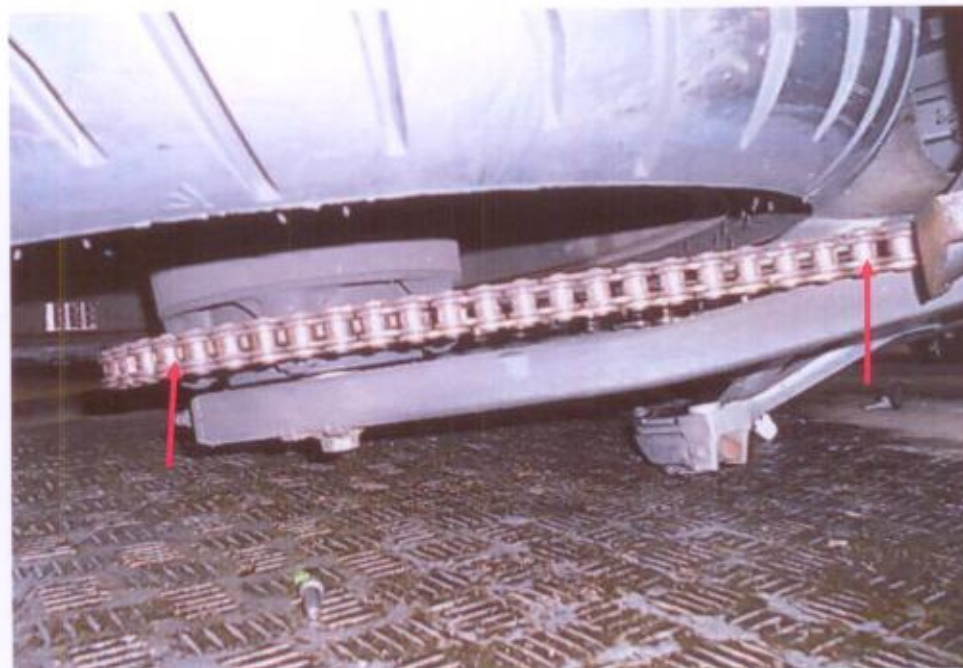
**Photo 13** shows the general view of the gear train (arrowed) of the Motorcycle, which was observed to be intact with no misalignment. It was also adequately lubricated for operating purposes.

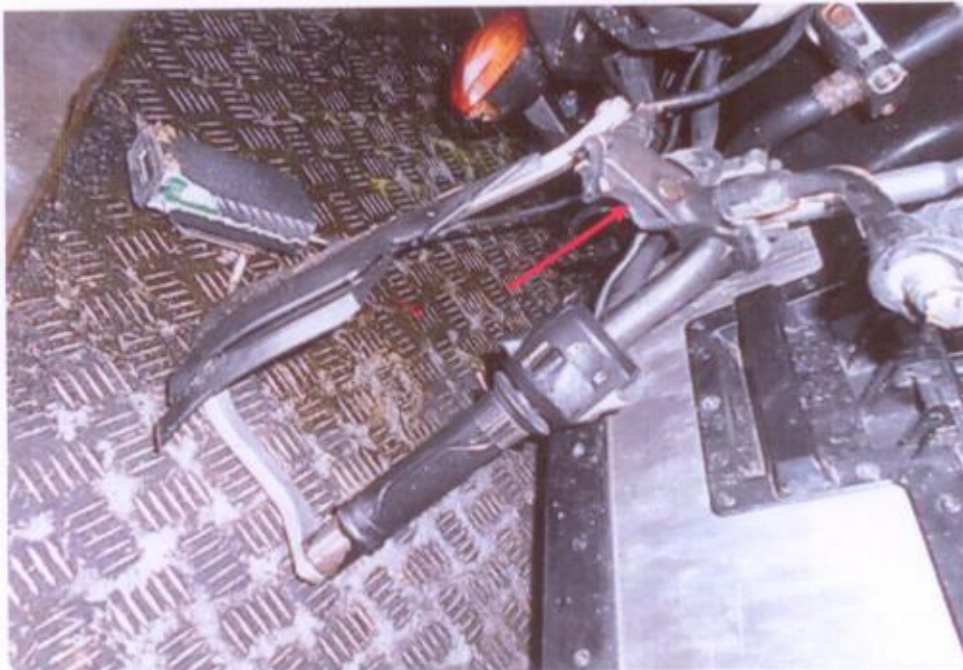
12. Static brake tests was unable to be conducted on the Motorcycle front brake due to some braking components were noted to be extensively damaged such as hand brake lever & brake fluid leakage at the material time of our inspection.

**Photo 14** shows the hand brake lever (arrowed) was observed to be broken likely due to the result of the accident. Hence, we are unable to conduct any tests on the braking system of the Motorcycle.

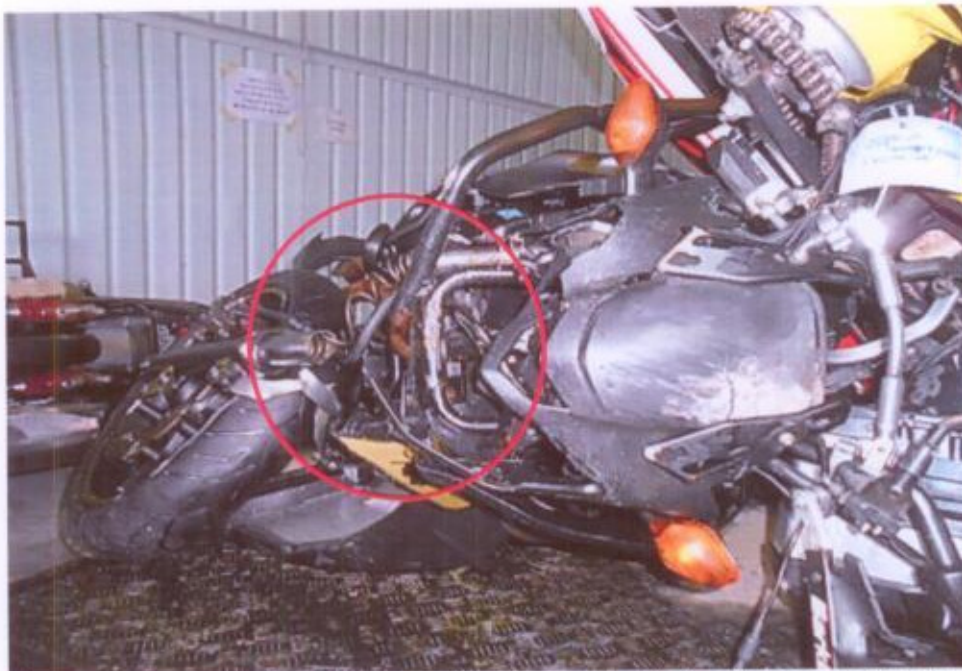
10. For this case, we were not able to conduct any test(s) on the steering system of the Motorcycle due to the damages on its front fork. The front fork was found to be broken as a result of the accident, hence causing the whole steering system to be in a state of immobility.

**Photo 15** shows the front fork (circled) was observed to be broken as a result of the accident. Hence, we are unable to conduct any tests on the steering system of the Motorcycle.

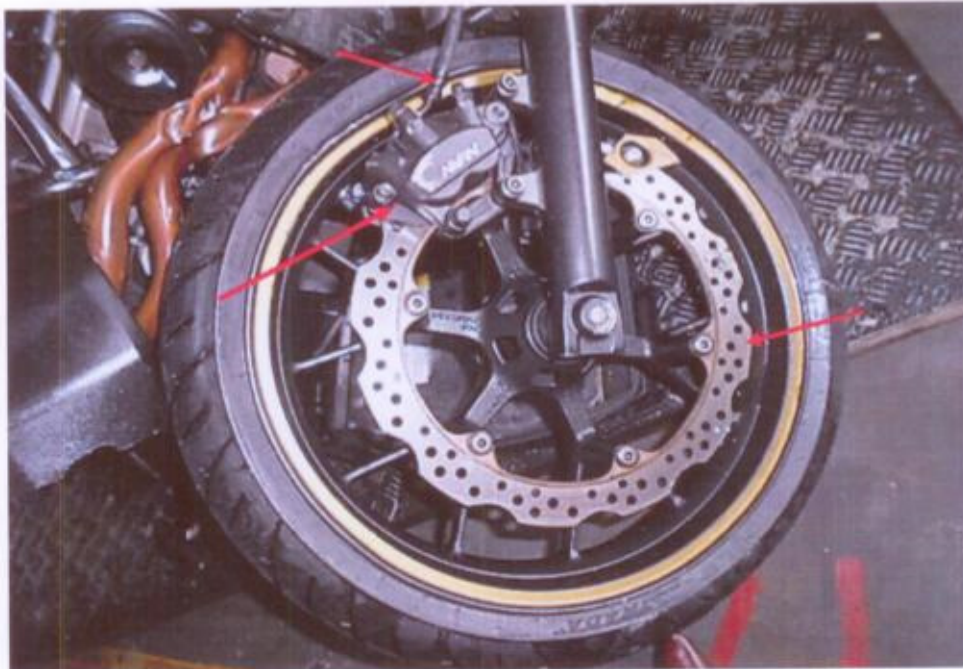
**Photo 16** shows the front brake calliper, front brake disc and front brake hose of the Motorcycle (arrowed in red), which are all part of the components in the front brake system of the Motorcycle. Our visual checks of these various components had revealed all to be intact with no visible damage.

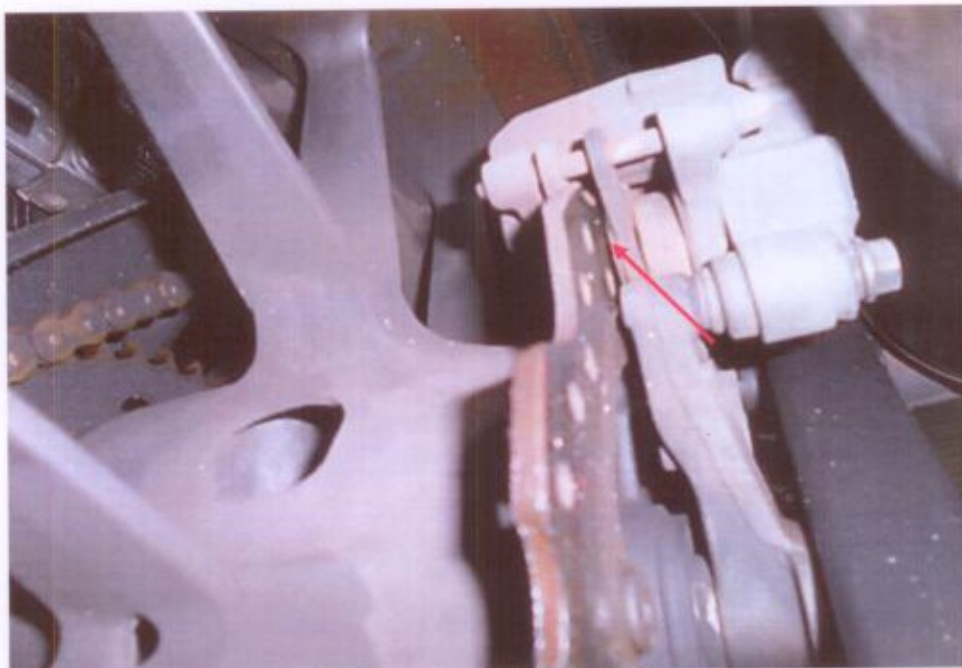
**Photo 17** shows the rear brake pad, which is part of the components in the rear brake system of the Motorcycle. Our visual checks had revealed that it is still in serviceable condition, intact with no visible damage.

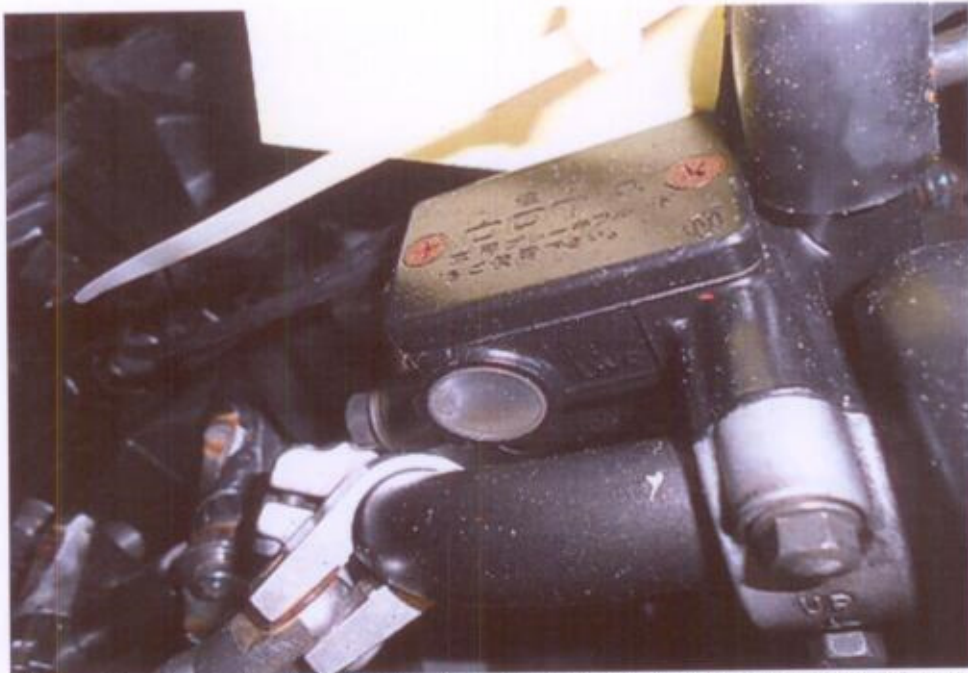
**Photo 18** shows the front brake fluid reservoir of the Motorcycle which was observed to be insufficient due to the leakage likely caused by the accident's collision.

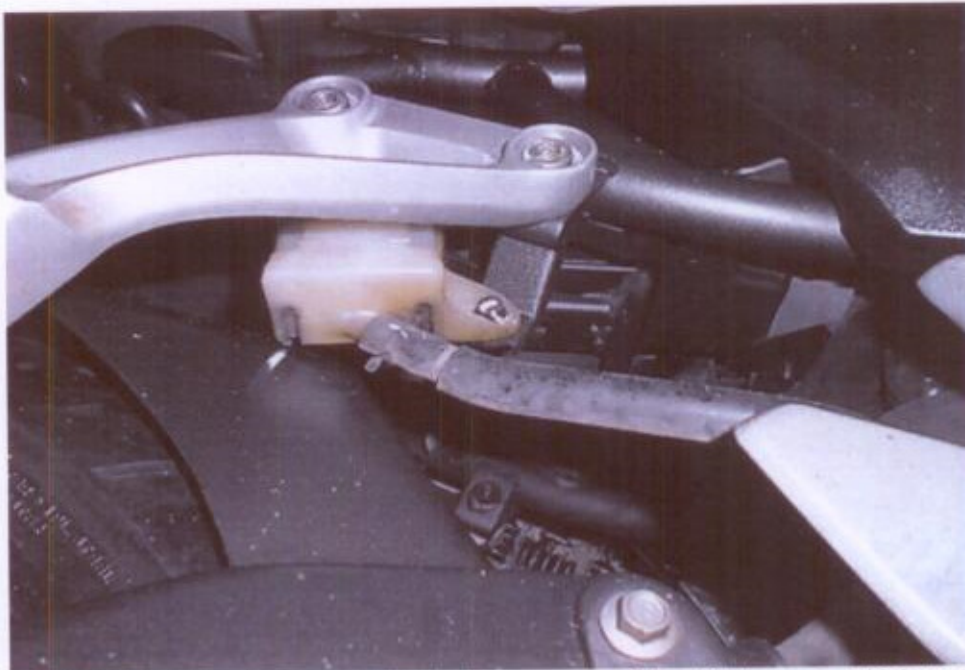
**Photo 19** shows the rear brake fluid reservoir of the Motorcycle which was observed to be sufficient at time of our inspection.
