Your Ref: TP/IP/59635/2017
Our Ref : CI/TPD17022593/Z

Fatal Accident Investigation Team

MECHANICAL INSPECTION REPORT OF MOTOR VAN GBD 8149H

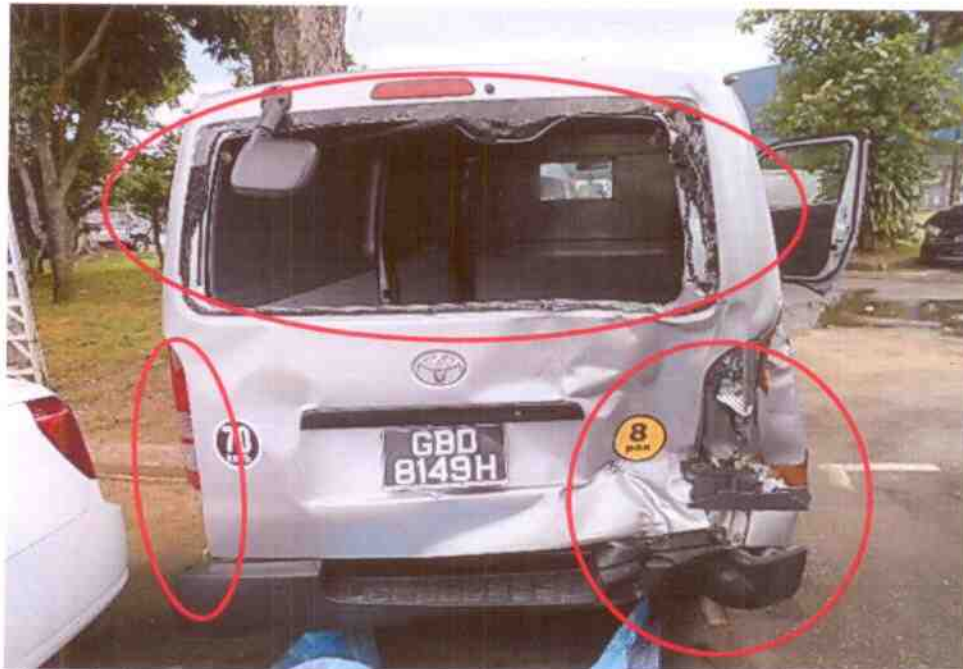
Photo 1 shows a general view of the rear body of the Motor van at the time of our inspection. The Motor Van was observed to have sustained damages at its rear right portion, rear window glass, rear tail lamp, rear exhaust pipe, rear door, rear lower bumper & left rear lower side panel, was amongst the body parts that were damaged as a result of the accident. (circled).

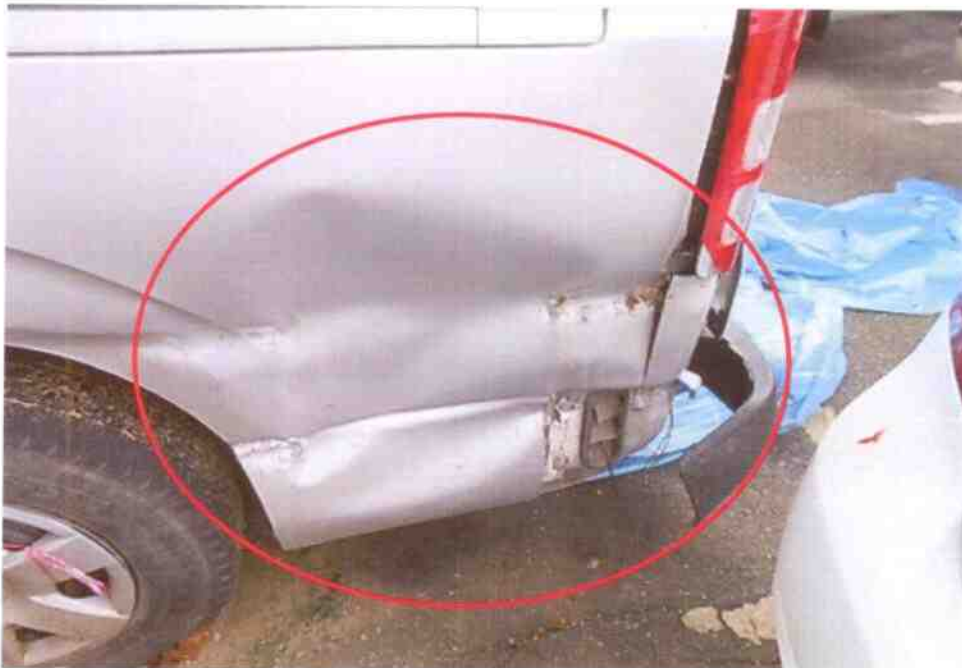
Photo 2 shows a general view of the rear left body of the Motor Van at the time of my inspection. The Motor Van was observed to have sustained damages at its rear left panel.

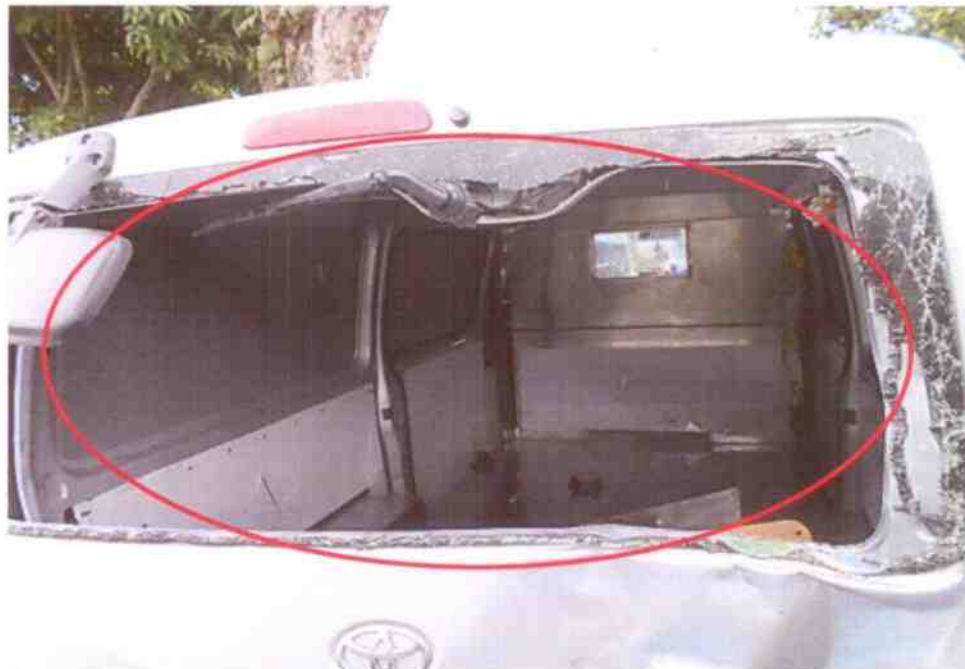
Photo 3 shows the damage sustained on the rear window glass as a result of the accident.

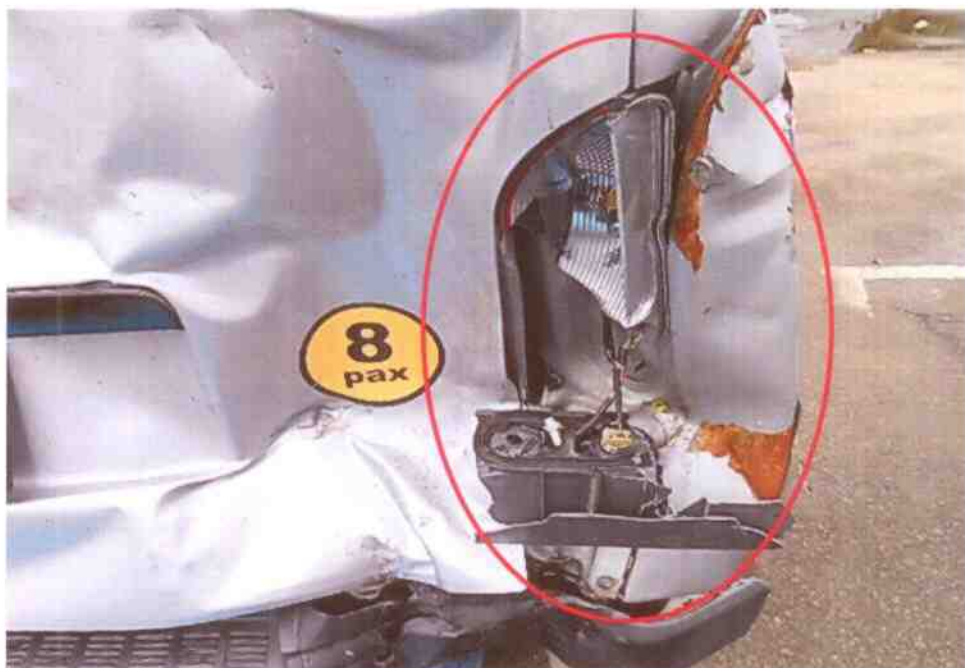
Photo 4 shows the damage sustained on the rear right tail lamp as a result of the accident.

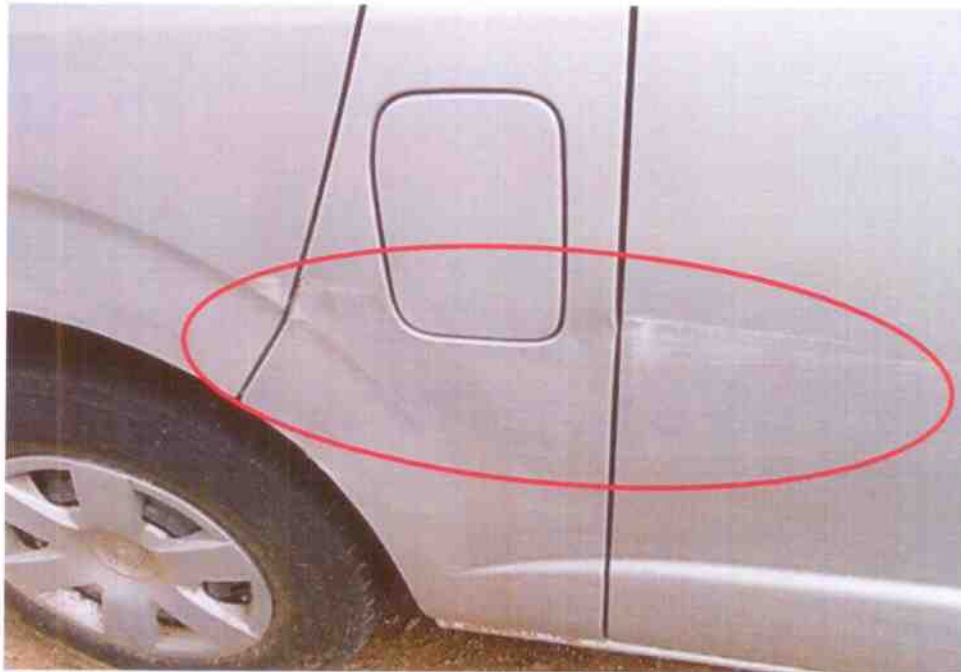
Photo 5 shows the damage sustained on the left side sliding door & passenger door.

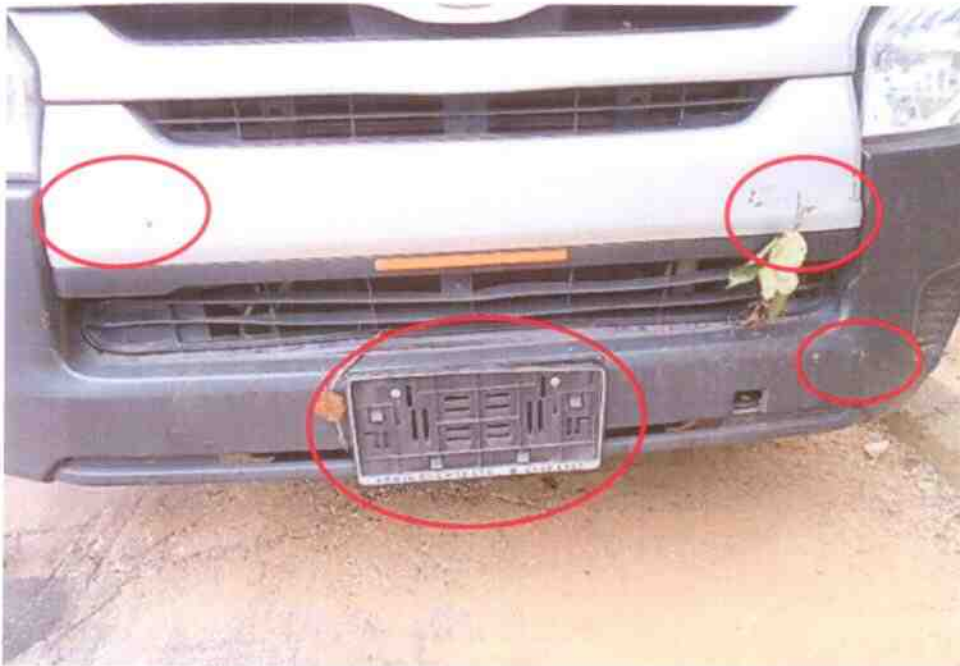
Photo 6 shows the damage sustained on the frontal portion dents & scratches inclusive number plate base.

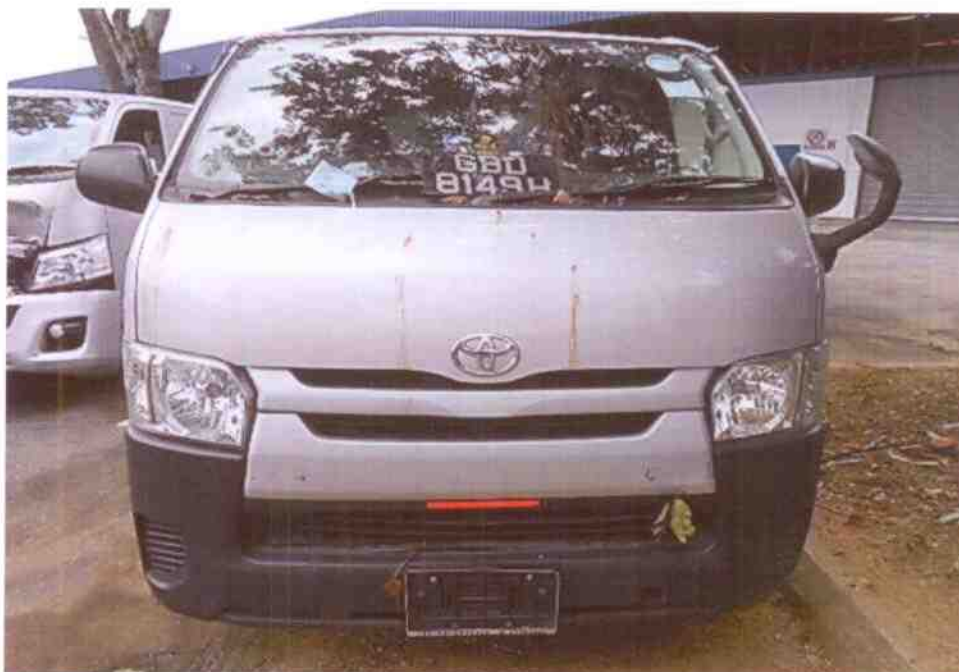
Photo 7 shows the frontal portion of the Motor Van with some minor damages.

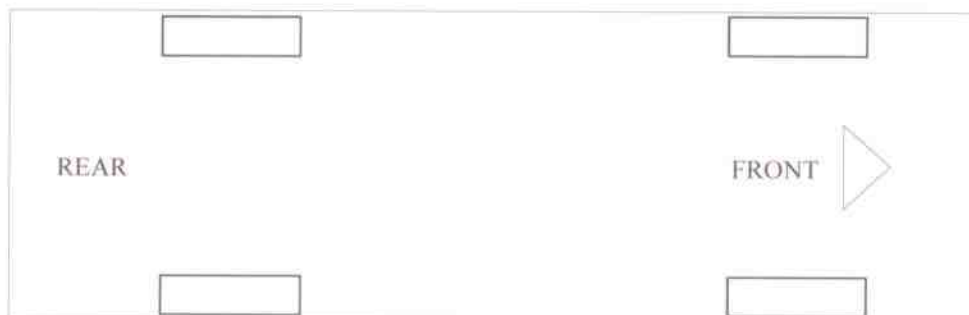
6. The 2 front tyres and 2 rear tyres of the Motor Van were observed to be in serviceable condition and sufficiently inflated for vehicular operation. We did not find any tear, cut or burst mark(s) on the outer and the inner sidewalls as well as across the tread of the 4 tyres. The tyre brand, tyre size and remaining tread depth of the 4 tyres of the Motor Van were recorded as follows:-

GT Radial Maxmiler Pro 195R15 (2mm)

Bridgestone 195R15 (6mm)

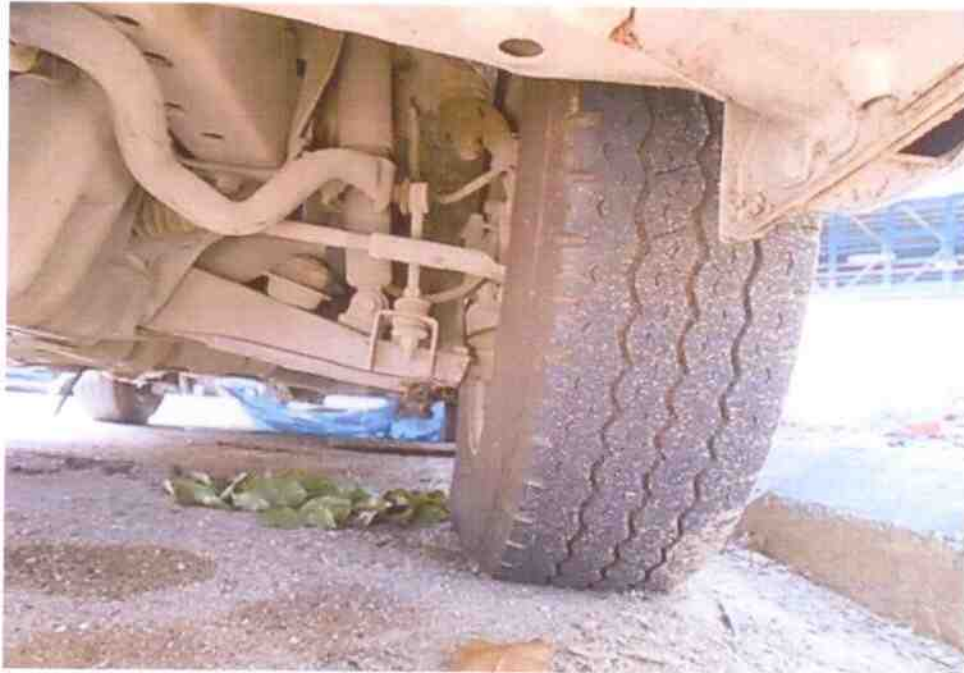
Photo 8 shows the condition of the front left tyre of the Motor Van, which was observed to be in serviceable condition with remaining tread depth of approximately 6mm.

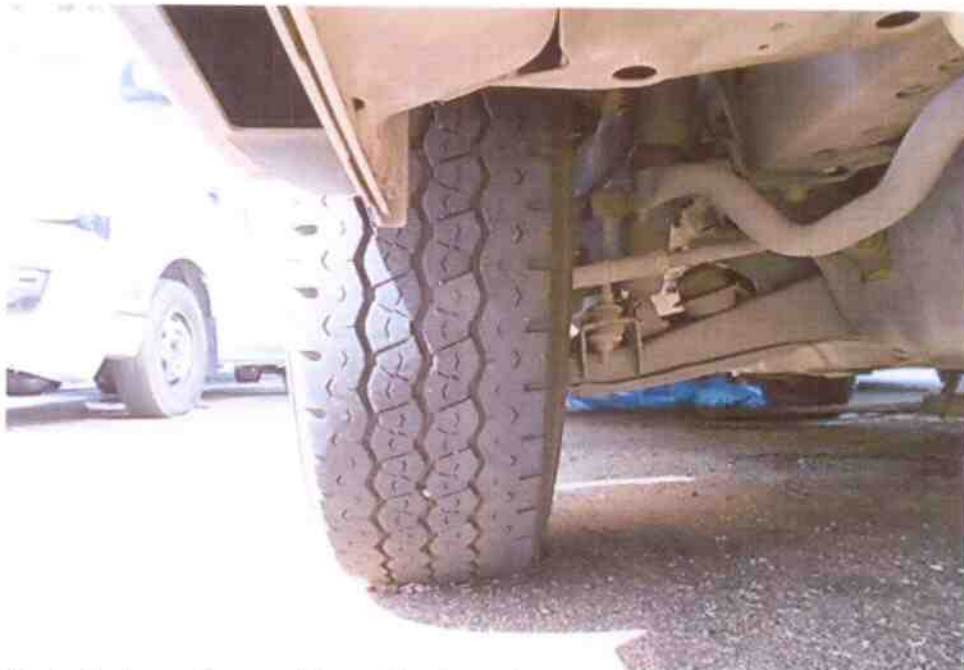
Photo 9 shows the condition of the front right tyre of the Motor Van, which was observed to be in serviceable condition with remaining tread depth of approximately 6mm.

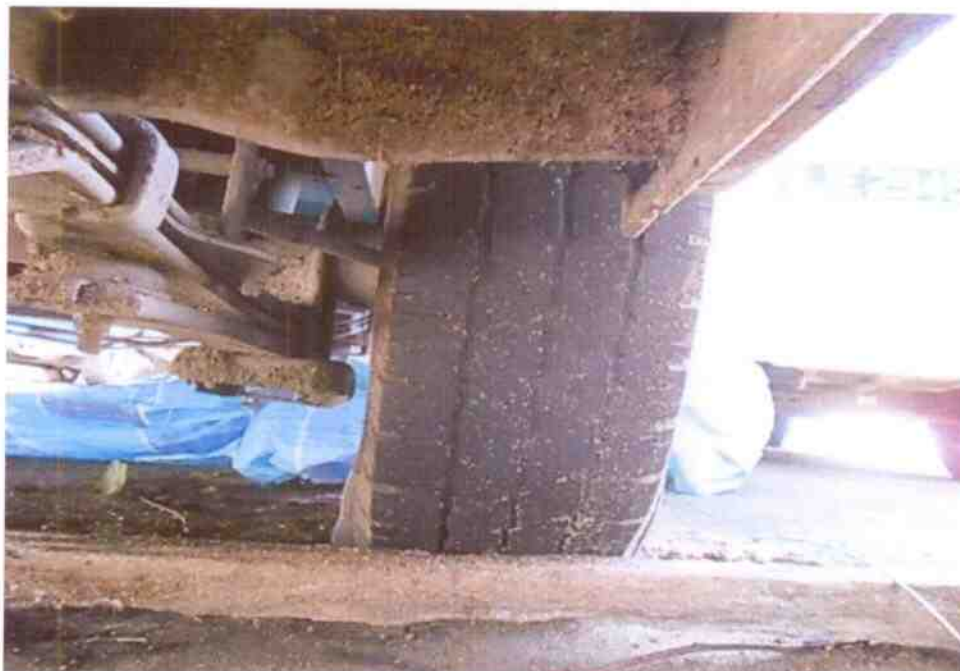
Photo 10 shows the condition of the rear left tyres of the Motor Van, which was observed to be in serviceable condition with remaining tread depth of approximately 2mm. The tyres, which were wrapped around standard wheel rim, were also observed to be sufficiently inflated for vehicular operation.

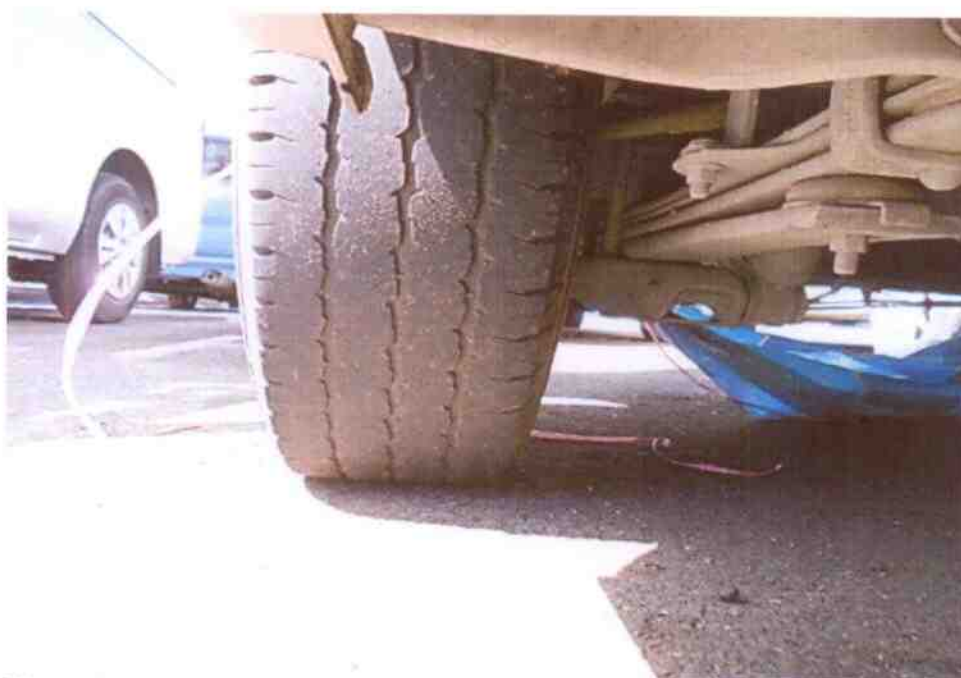
Photo 11 shows the condition of the rear right tyres of the Motor Van, which were observed to be in serviceable condition with remaining tread depth of approximately 2mm. There was also no tear, cut or burst mark(s) on the outer and the inner sidewalls as well as across the tread of the 4 tyres that were fitted on the Motor Van.

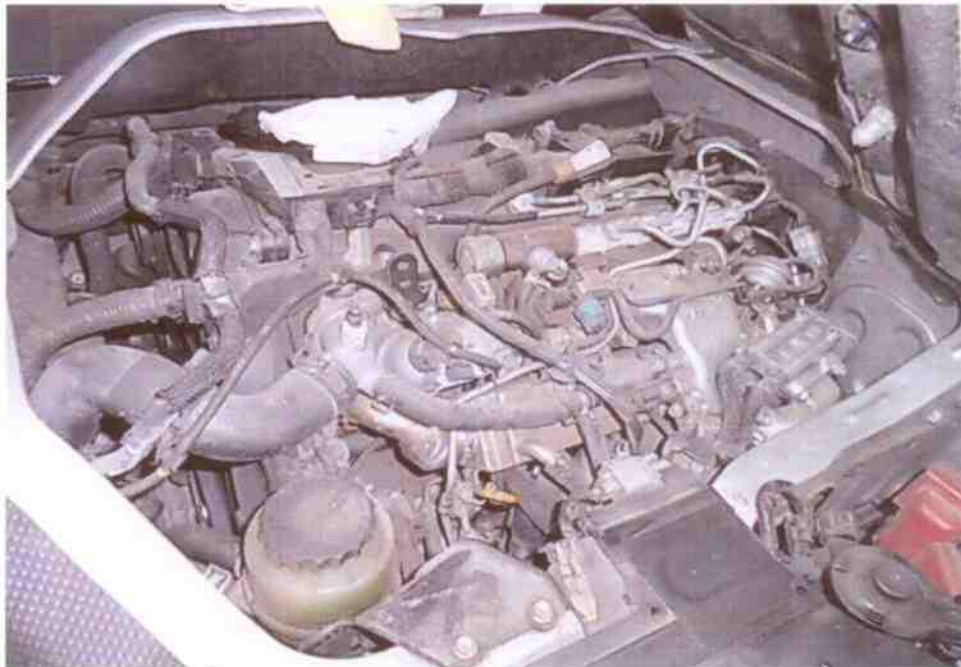
Photo 12 shows a general view of the Motor Van's engine compartment, which was accessed by lifting the passenger's seat of the Motor Van. The various parts and components inside the engine compartment were unaffected by the accident. There was also no sign(s) or indication(s) of fresh fluid leakage and/or fluid stain within the engine compartment.

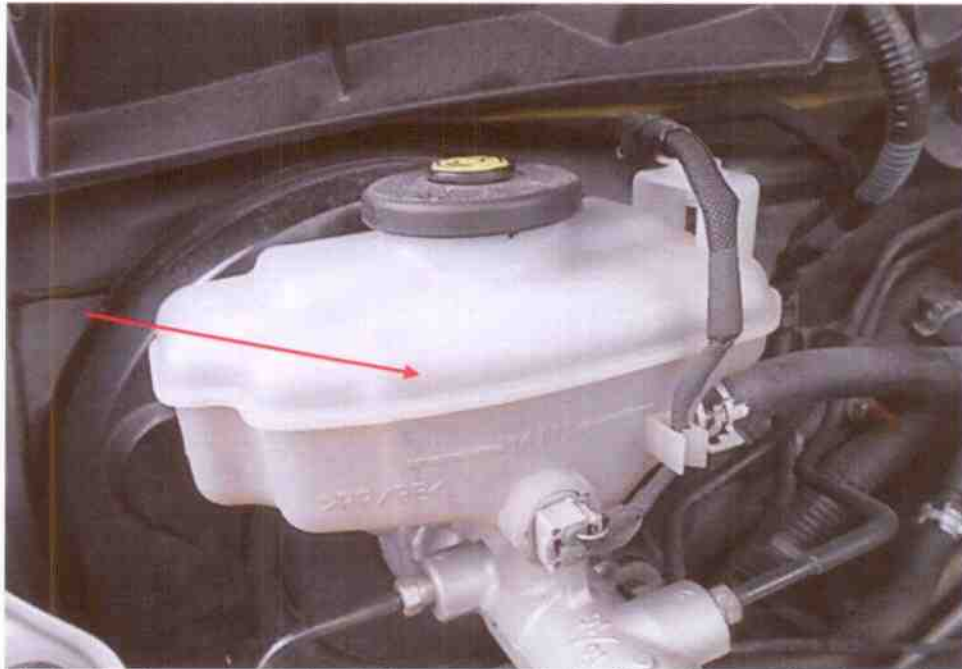
Photo 13 shows the brake fluid reservoir of the Motor Van at the time of our inspection. The brake fluid was observed to be of sufficient level and without any visible contamination.

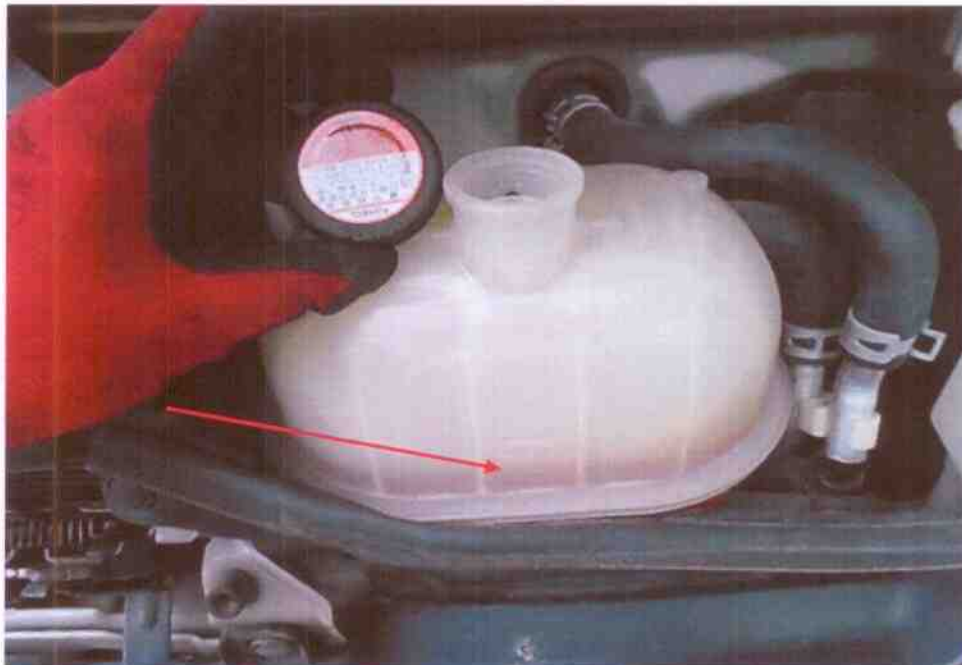
Photo 14 shows the engine coolant reservoir of the Motor van at the time of our inspection. The coolant was observed to be of sufficient level and without any visible contamination.

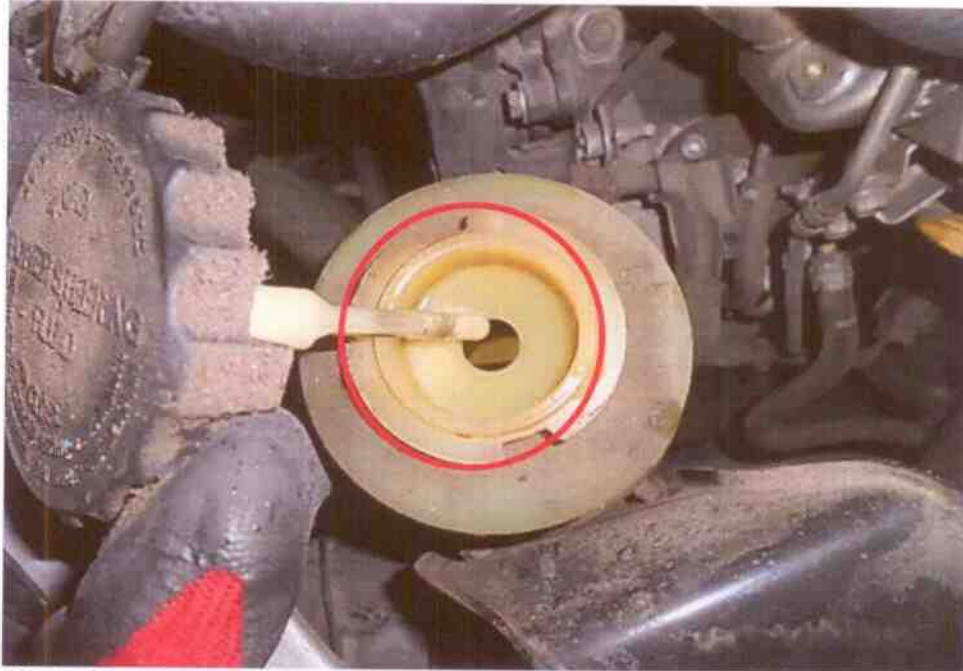
Photo 15 shows the power steering fluid reservoir of the Motor Van at the time of our inspection. The power steering fluid (circled) was observed to be of sufficient level and without any visible contamination.

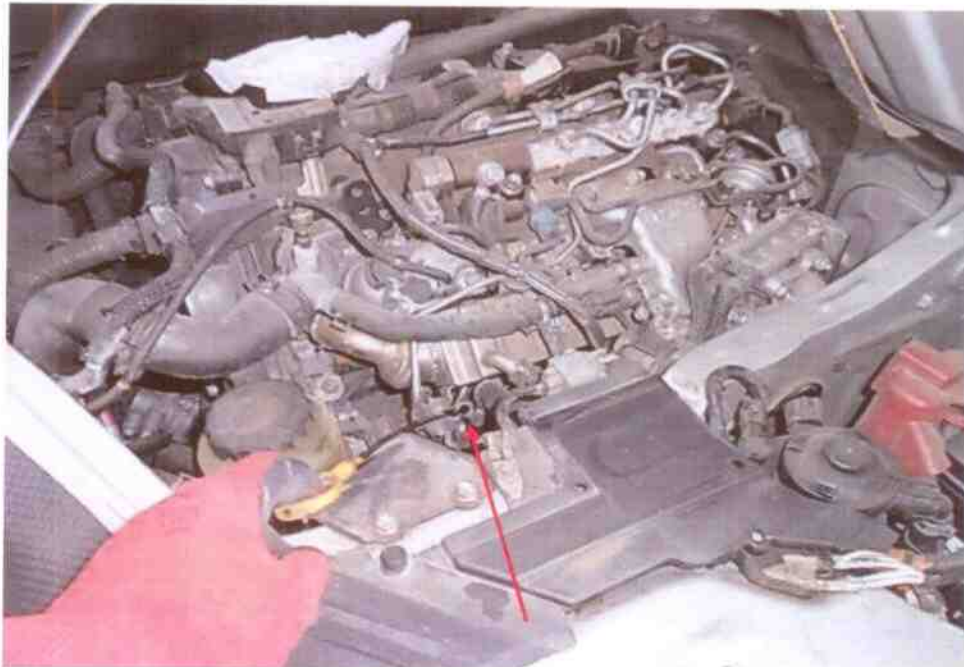
Photo 16 shows the engine dip stick (general view) of the Motor Van at the time of our inspection. The engine oil was observed to be of sufficient level and without any visible contamination (arrowed).

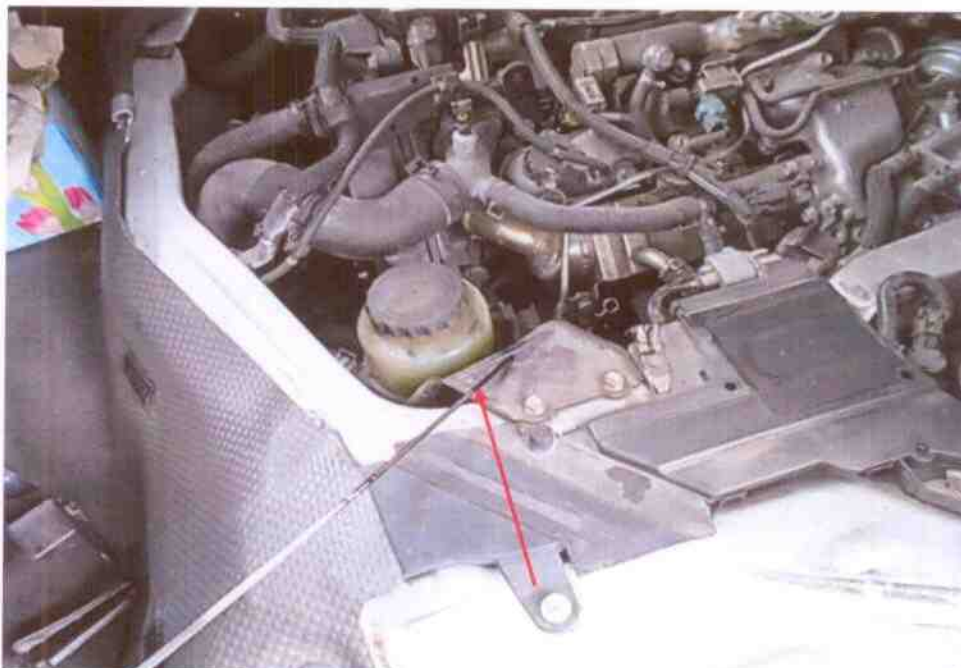
Photo 17 shows the close-up view engine dip stick of the Motor Van at the time of our inspection. The engine oil was observed to be of sufficient level and without any visible contamination (arrowed).

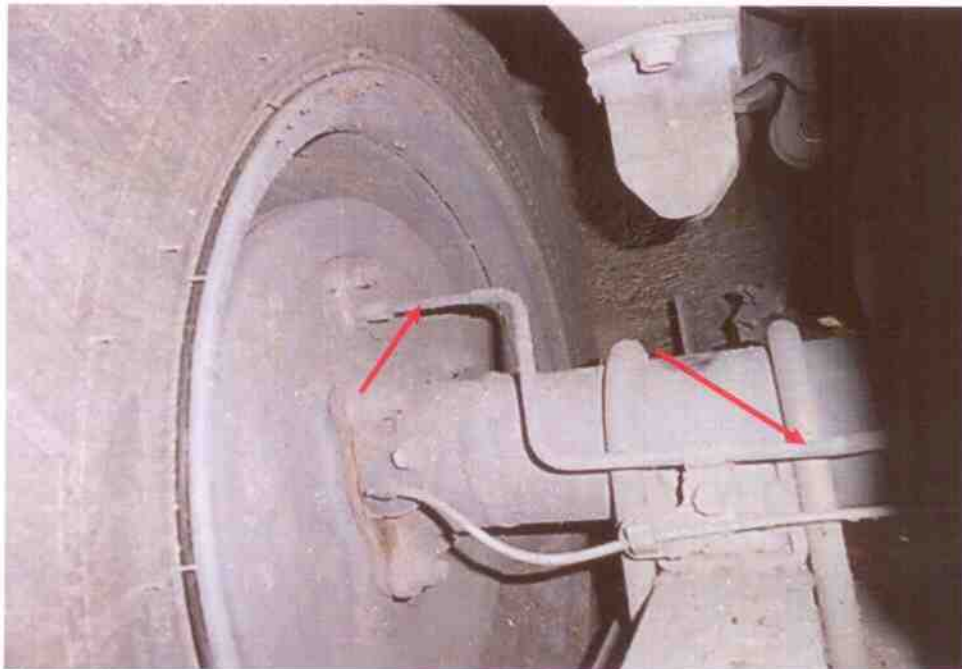
Photo 18 shows the brake pipe (arrowed) at the rear right wheel of the Motor Van. We did not observe any leakage of brake fluid at the time of our inspection.

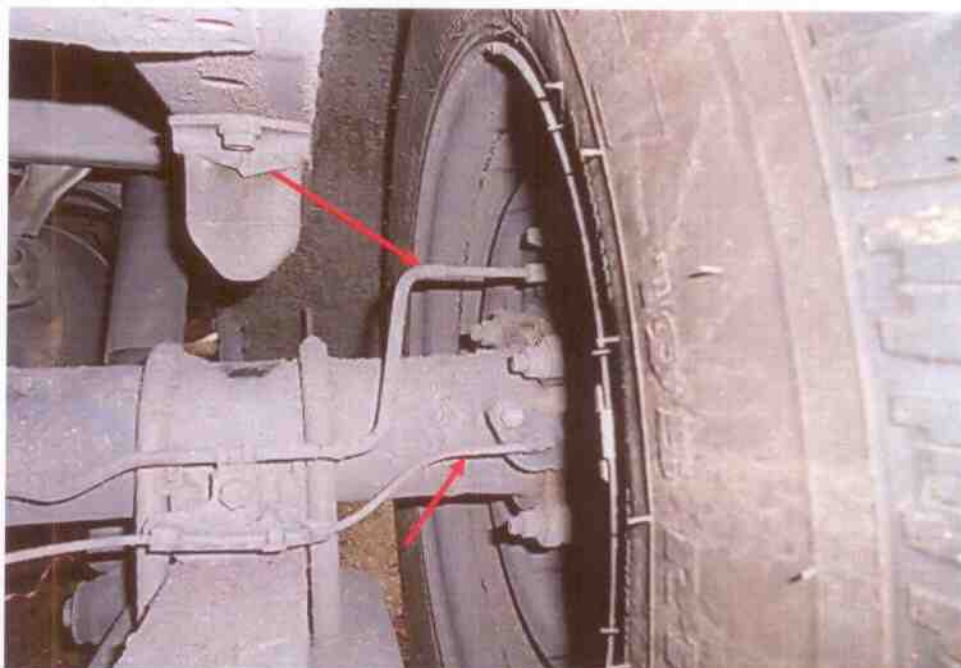
Photo 19 shows the brake pipe (arrowed) at the rear right wheel of the Motor Van. We did not observe any leakage of brake fluid at the time of our inspection.

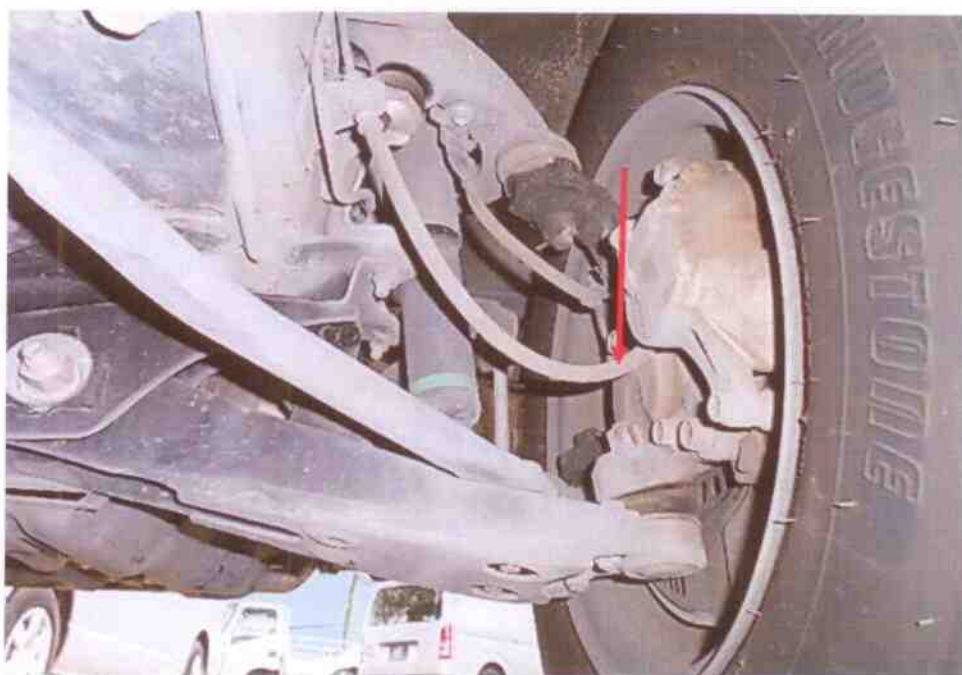
Photo 20 shows the various undercarriage components at the front right wheel of the Motor van, in particular the steering tie rod end. The various steering components were all found to be intact, suggesting that it's in serviceable condition at the material time of accident. There was also no sign of fluid stain(s) observed on the various undercarriage components. (arrowed)

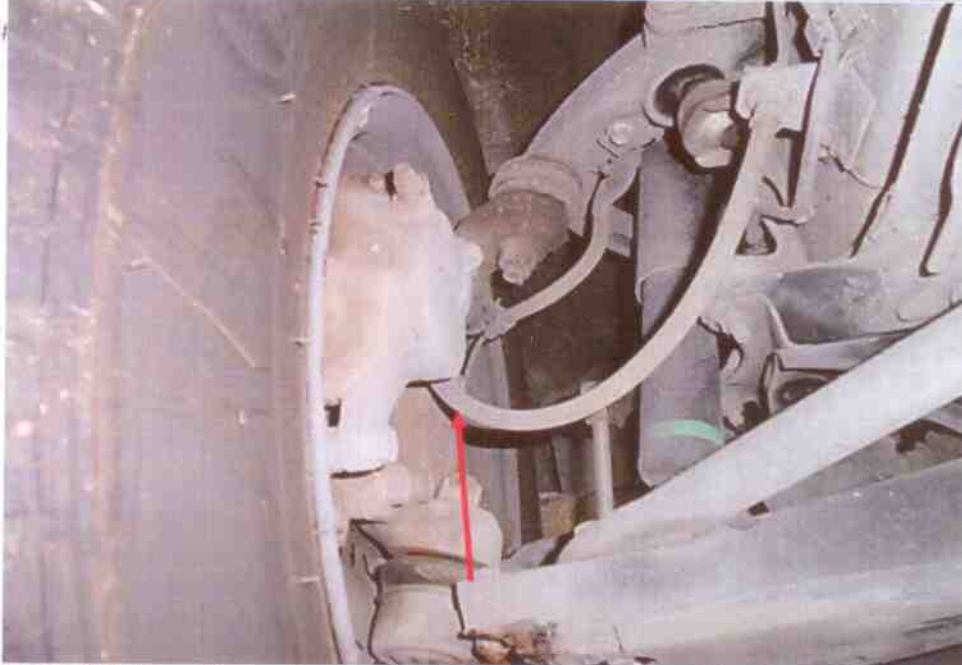
Photo 21 shows the various undercarriage components at the front left wheel of the Motor Van, in particular the steering tie rod end. The various undercarriage components of the Motor Van were all found to be intact without any visible damage. There was also no sign of fluid stain(s) observed on the various undercarriage components. (arrowed)
