Your ref: D17010964MFSH  
Our ref: CS/FCI17022616/Uvb

**INITIAL INSPECTION REPORT OF VEHICLE NO. XD 2975T**

## Estimate Repair Cost to Vehicle No :XD2975T

## ADJUSTMENT ON REPAIR COST FOR VEHICLE NO. XD 2975T

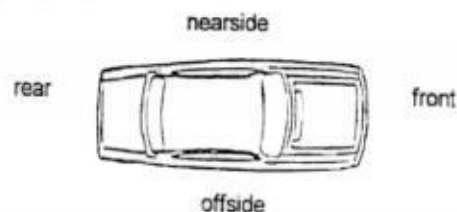
**Description of Damage:**

The vehicle sustained damages at the o/s front portion.

Comments/Present Status:  
Damages Consistent
