Your Ref: M1705581  
Our Ref :CS/TMI17022639/D

**Tokio Marine Insurance Singapore Ltd**

**TECHNICAL INVESTIGATION REPORT OF FIRE INCIDENT INVOLVING THE  
INSURED VEHICLE SLM 1200Y ON 30 OCTOBER 2017**

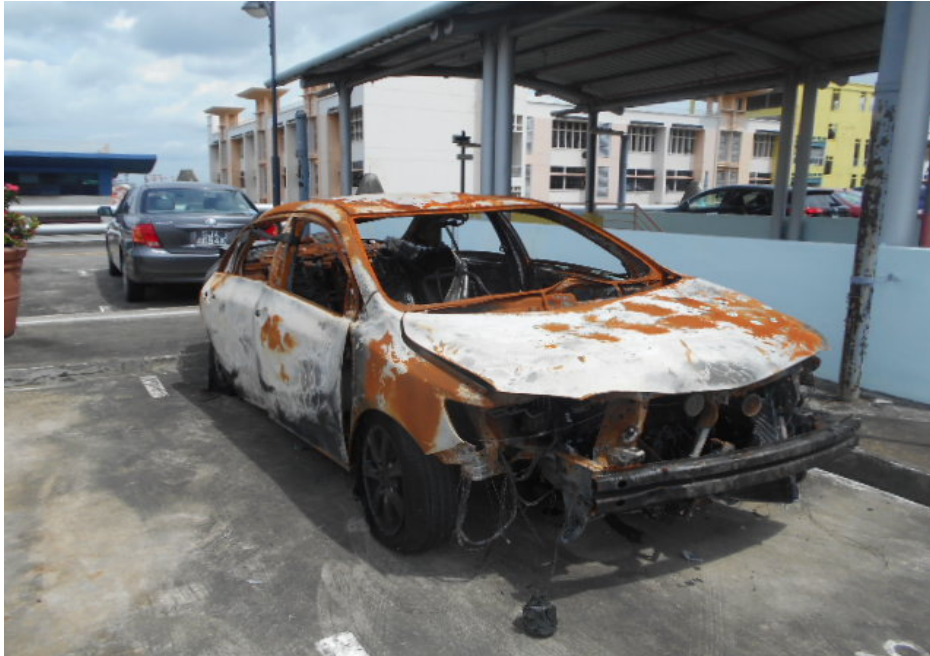
**Photo 1** shows a general view of the front right body of the Insured Vehicle at the time of my inspection. The Insured Vehicle was observed to have sustained extensive fire damage all around. Almost all the body panels were found to have been burnt to char. Its front bonnet, front fenders, front doors, rear door and roof panel were all extensively burnt.

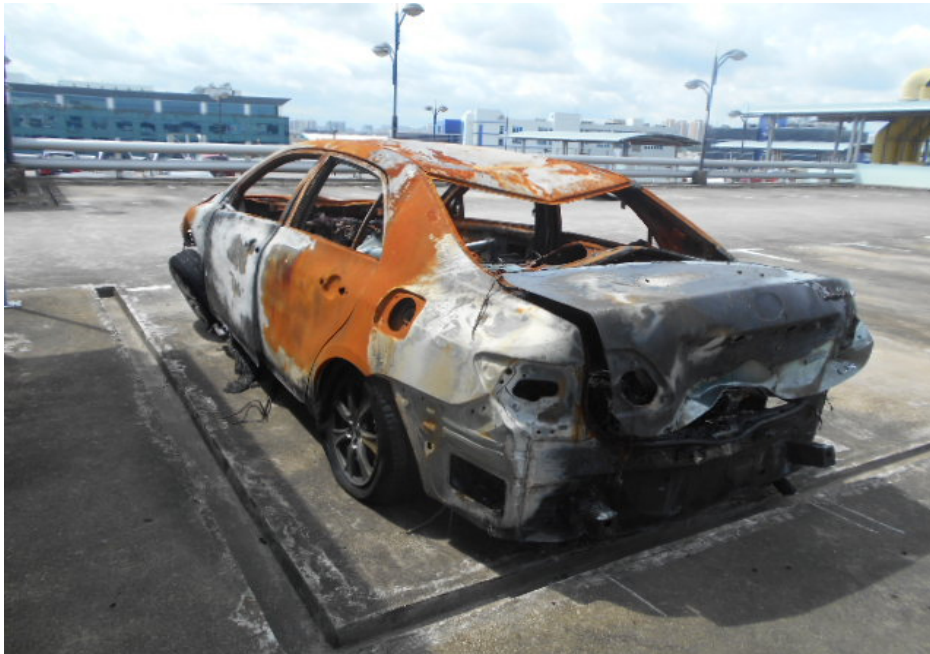
**Photo 2** shows a general view of the rear left body of the Insured Vehicle at the time of my inspection. The Insured Vehicle was observed to have sustained extensive fire damage all around. Almost all the body panels were found to have been burnt to char.

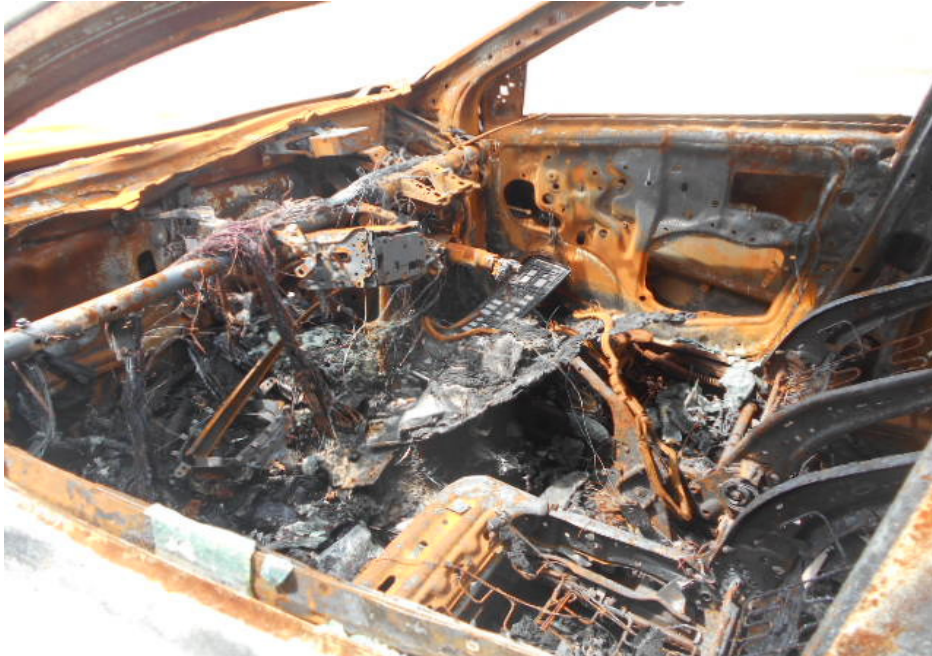
**Photo 3** shows the interior compartment of the Insured Vehicle. All the parts inside the interior compartment were found to be burnt and/or melted. Its front seats, rear seats, roof upholstery, carpet and various trims were all burnt and/or melted as a result of the fire.

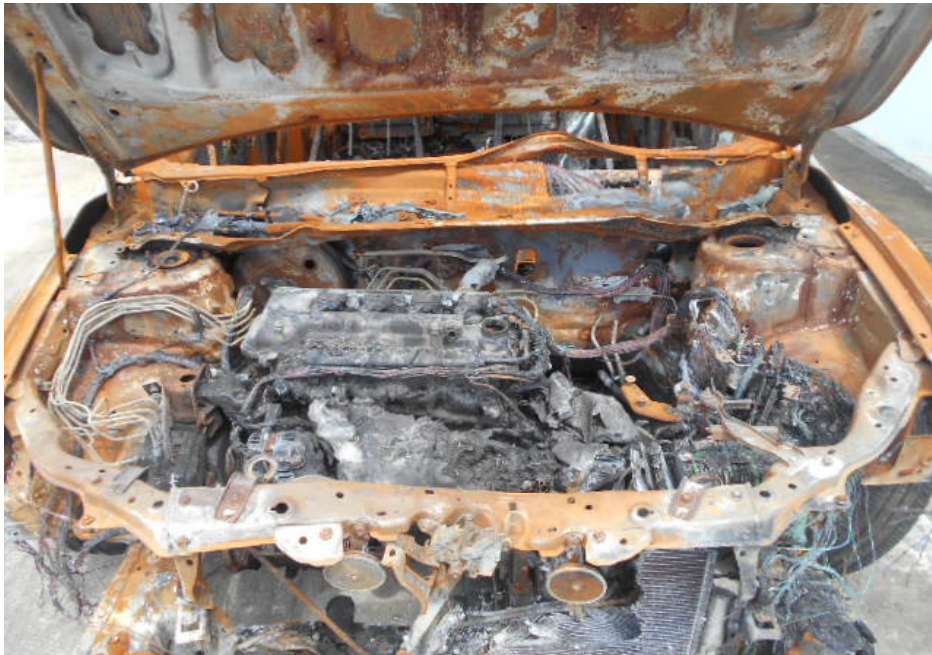
**Photo 4** shows the engine compartment of the Insured Vehicle at the time of my inspection. The various parts and components inside the engine compartment were observed to have been completely burnt.

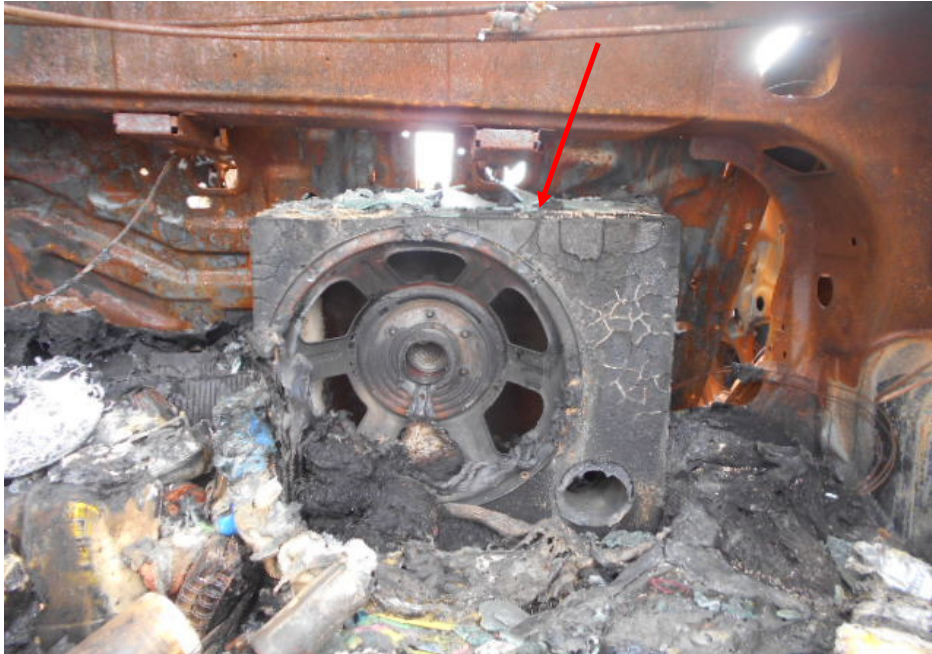
**Photo 5** shows the woofer speaker (arrowed) that was found fitted inside the rear boot compartment of the Insured Vehicle at the time of my inspection.

22. For this case, the Insured Vehicle was found to be additionally fitted with 2 audio amplifiers and a woofer speaker. These additionally fitted electrical/electronic components could have possibly caused overloading to the electrical system of the Insured Vehicle. However considering that the installation was carried out about 1 year plus ago prior to the fire incident, the overloading was likely to be minimal. The installation of these components falls within the allowed category under the modifications guidelines stipulated by Land Transport Authority.

26. The Insured Vehicle was found to be additionally fitted with 2 audio amplifiers and a woofer speaker. Although these electrical/electronic components are all LTA compliant, they could have caused overloading of the Insured Vehicle's electrical system, enhancing the deterioration of rubber wire insulators.

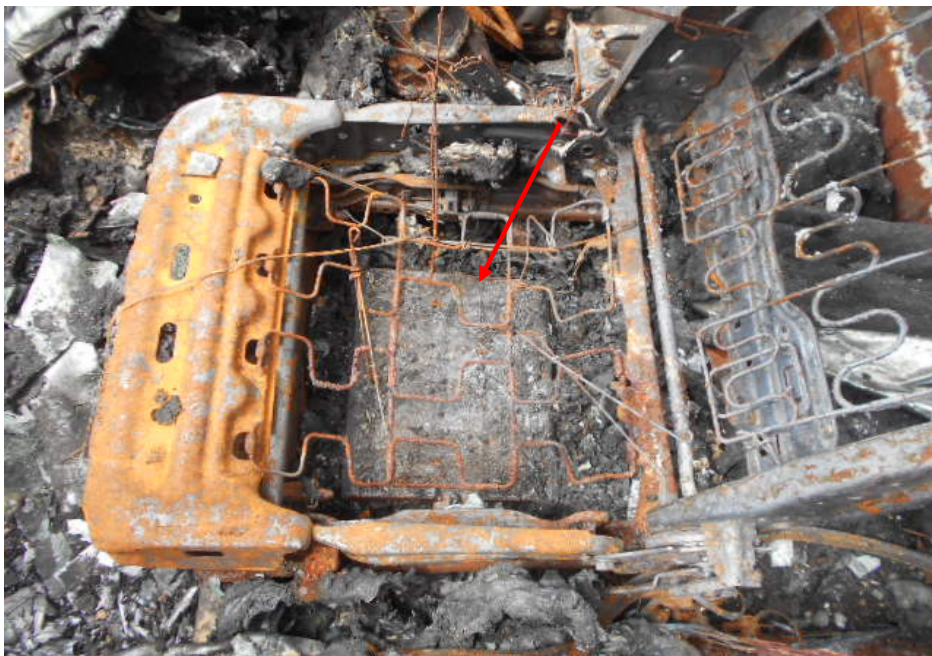
**Photo 6** shows the audio amplifier (arrowed) that was found fitted under the front left passenger seat of the Insured Vehicle at the time of my inspection.

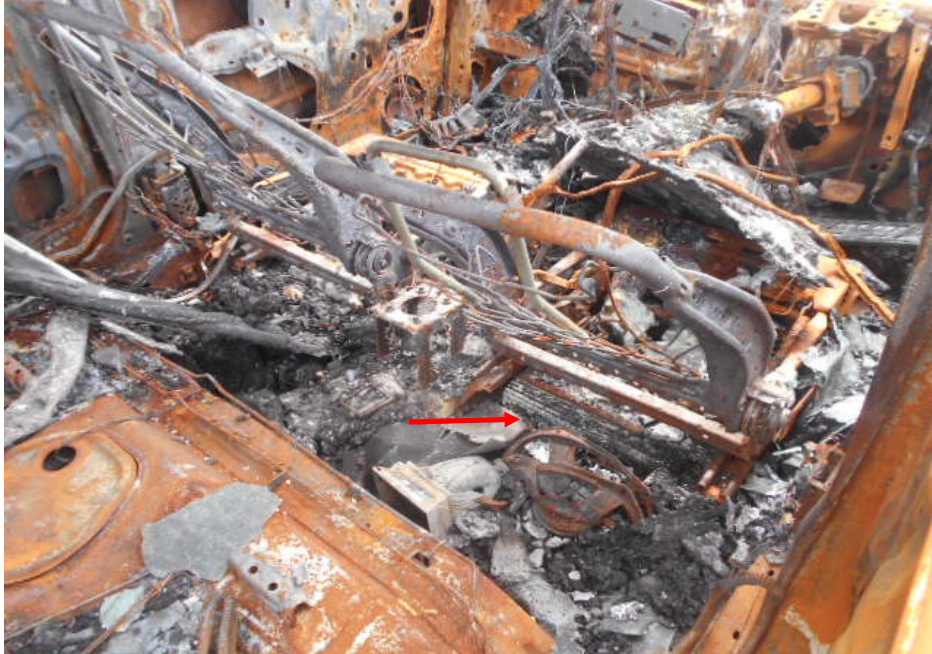
**Photo 7** shows the audio amplifier (arrowed) that was found fitted under the driver's seat of the Insured Vehicle at the time of my inspection.

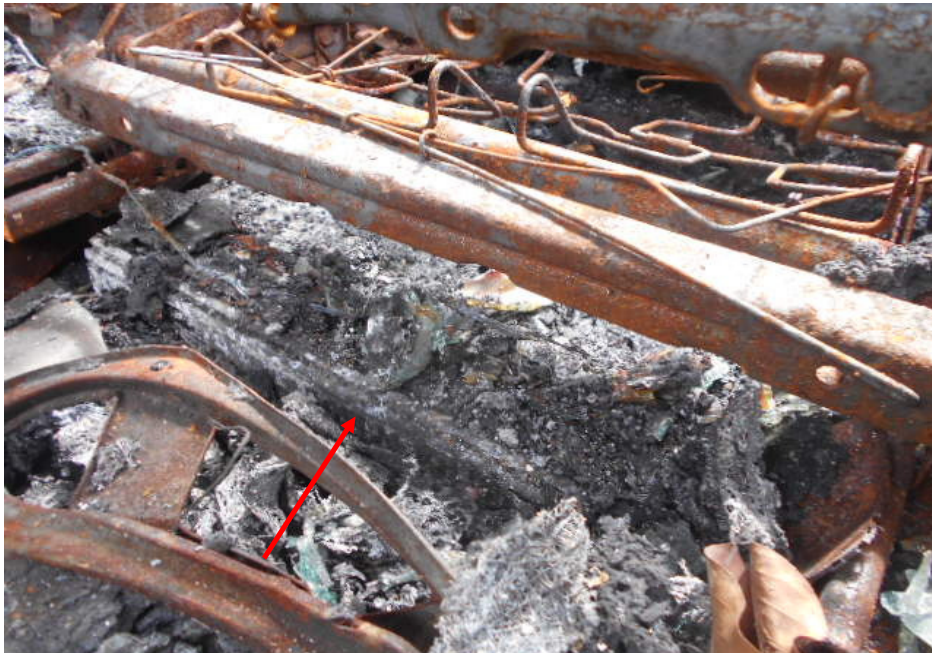
**Photo 8** shows a closer view of the audio amplifier (arrowed) that was found fitted under the driver's seat of the Insured Vehicle at the time of my inspection.

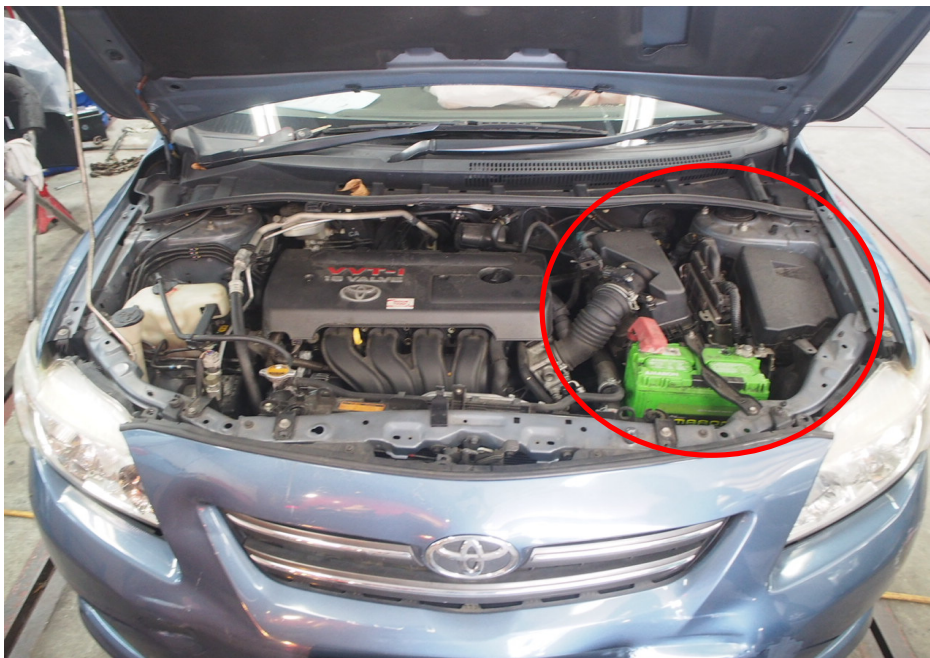
17. Leakage of fluid within the engine compartment may cause a fire to be ignited when the leaked fluid comes into contact with hot surfaces (usually exhaust pipes). The leaked fluid could possibly reach temperature sufficient for it to self-ignite. Following Mr Ang's description of flames coming out from the left side of the front bonnet, I had compared the left side of the engine compartment of a similar make and model vehicle as the Insured Vehicle and it was noted that there was no fluid carrying hoses or pipes at the left side of the engine compartment. Fire as a result of fluid leakage would then seem unlikely for this case. See photo 9 below showing the engine layout of a similar make and model vehicle as the Insured Vehicle.

**Photo 9** shows the engine layout of a similar make and model vehicle as the Insured Vehicle. There was no fluid carrying hoses or pipes around the left side of the engine compartment (circled), which could have leaked onto the hot surfaces of the exhaust pipes. Fire as a result of fluid leakage would then seem unlikely for this case. This follows the description of Mr Ang that flames were seen coming out from the left side of the front bonnet.

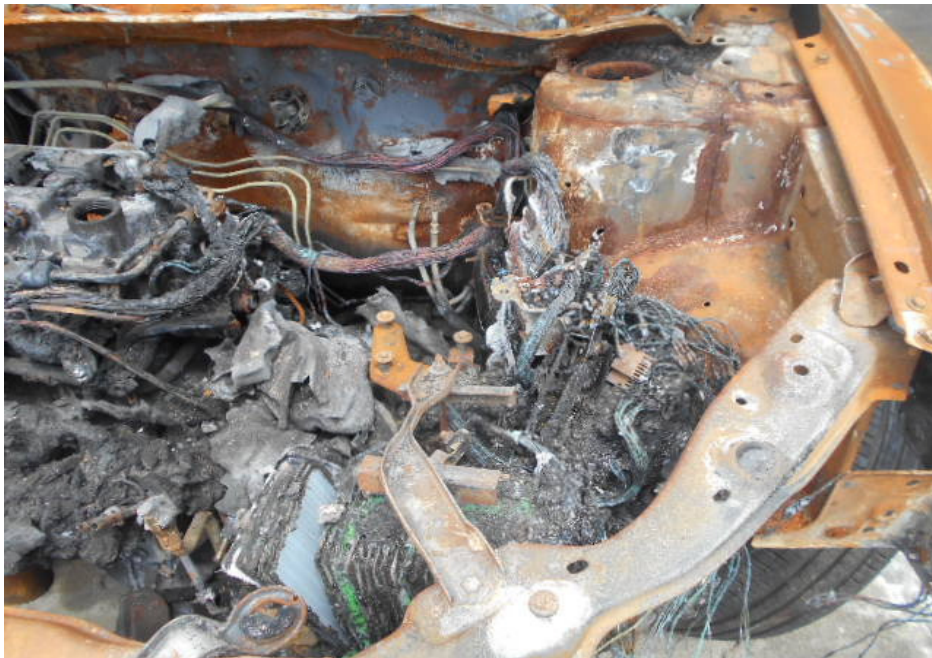
18. Since engine overheating and leakage of fluid were both unlikely the cause of fire, the most probable cause would then be electrical in nature. This seems to be supported by my observations during inspection of the Insured Vehicle, where I had noted that the battery, engine control unit and fuse box were amongst the parts that were around the left side of the engine compartment. This was similarly seen by me upon my comparison of the engine layout of a similar make and model vehicle as the Insured Vehicle (refer to photograph 9 above).

**Photo 10** shows the engine compartment of the Insured Vehicle, at the left side area. The driver of the Insured Vehicle had seen flames coming from the left side of the front bonnet. From my observations, the battery, engine control unit and fuse box were amongst the parts that were around the left side of the engine compartment.

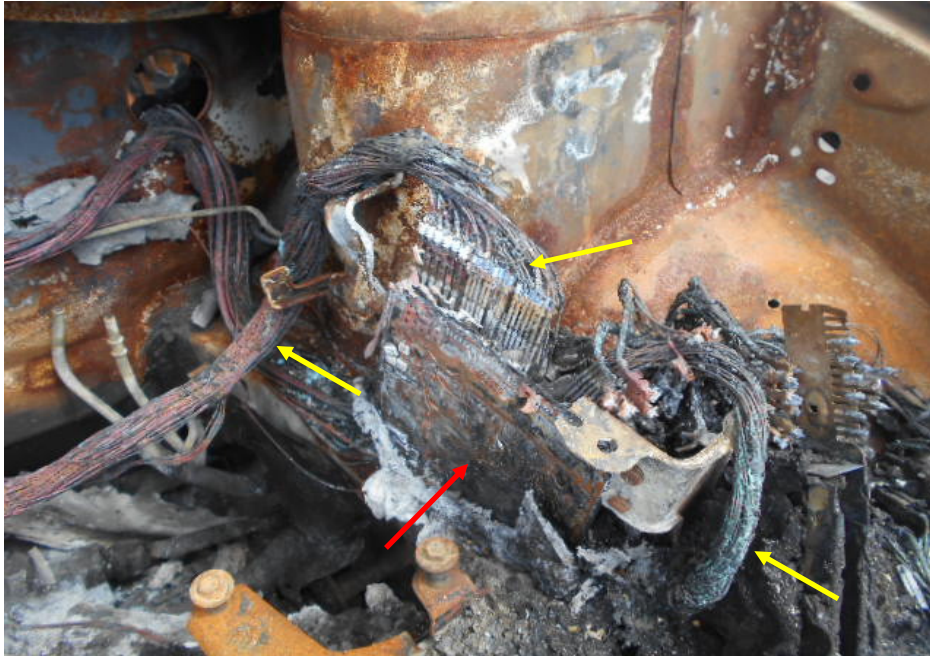
19. Upon further examination of the engine compartment, at the left side area, I had found greenish residue on several stretches of wirings. The wirings were original wires connecting to the engine control module of the Insured Vehicle. The presence of greenish residue indicates internal heating of copper wires, a sign of an electrical short circuit occurring. The greenish residue is normally left behind from oxidation as a result of chemical reaction involving the copper wires. This physical evidence would then appear to indicate that the cause of fire to the Insured Vehicle was of electrical in nature. See photo 10 – 12 below.

**Photo 11** shows the engine compartment of the Insured Vehicle, at the left side area. Upon further examination, I had found greenish residue on several stretches of wirings (yellow arrow) around this area. The wirings were original wires connecting to the engine control module (red arrow) of the Insured Vehicle. The presence of greenish residue indicates internal heating of copper wires, a sign of an electrical short circuit occurring.

20. Heat from engine operation could cause the rubber insulation of the wires and/or wiring harness within the engine compartment to lose its flexibility and become hardened after a prolonged period of time. The hardened rubber insulation may then become brittle and break off bits by bits, exposing live wires that may come into contact with each other and/or the metal body of the vehicle, creating sparks that could ignite a fire.

25. For this case, I am of the view that the fire had originated around the left area of the Insured Vehicle's engine compartment. The cause of fire was likely to be of electrical in nature, where deterioration of rubber wire insulators could have caused live wires to come into contact with each other and/or the metal body of the vehicle, creating sparks that had ignited the fire.

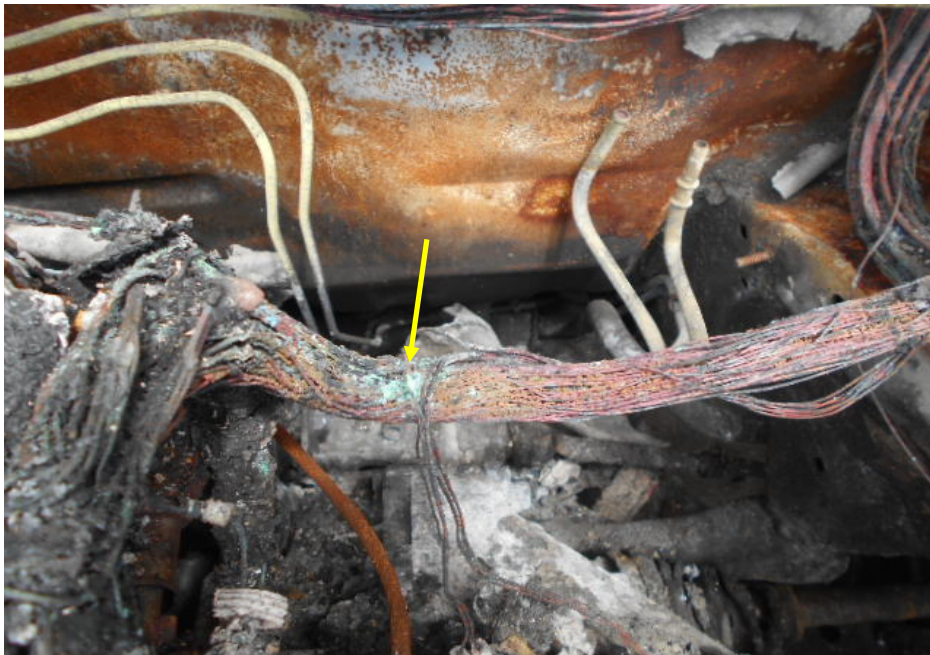
**Photo 12** shows another stretch of wirings, at the left side of the engine compartment, where greenish residue were found. The wirings were original wires connecting to the engine control module of the Insured Vehicle.
