Your Ref: TP/IP/62029/2017
Our Ref :CI/TPD17022677/Z

Fatal Accident Investigation Team

INSPECTION REPORT OF MOTORCYCLE FBA 890T

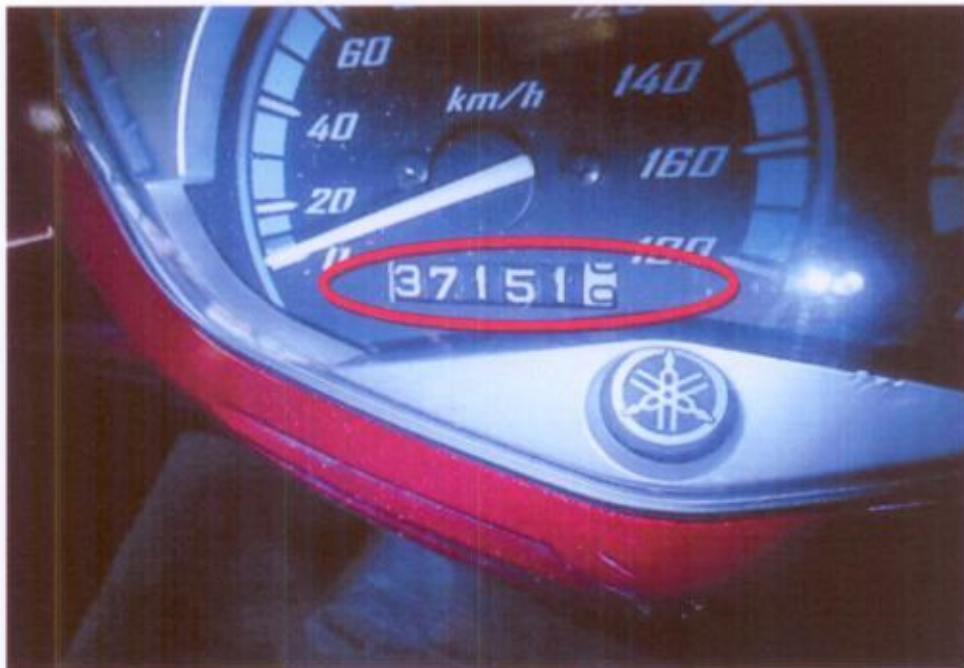
4. The mileage of the Motorcycle at the time of our inspection was 371,518km.
5. The Motorcycle was observed to have sustained damages at the frontal portion and its right side. The body parts that were found to have been damaged include its front left wing mirror, broken pillion's right foot rest, minor scratches at right hand side fairing and exhaust pipe amongst others. Its front fork assembly was also observed to be bent slightly to the right as a result of the accident.

Photo 1 shows the mileage at the time of inspection was recorded to be 371,518km.

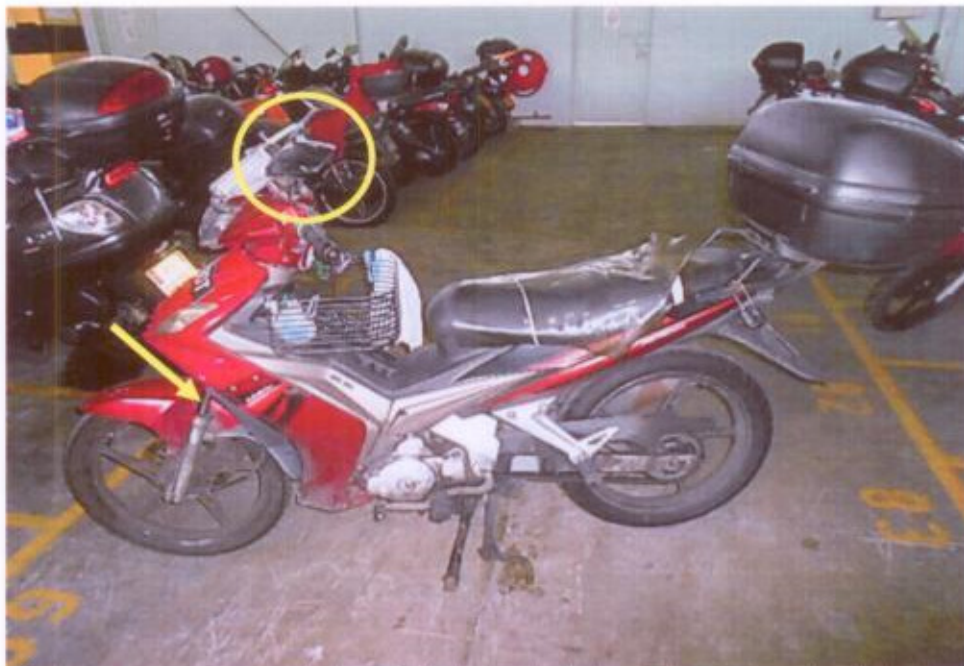
Photo 2 shows a general view of the left side body of the Motorcycle at the time of our inspection. The Motorcycle was observed to be sustained with relatively minor impact due to the accident collision. The body parts that were found to have been damaged include its front left wing mirror & its front fork assembly as a result of the accident.

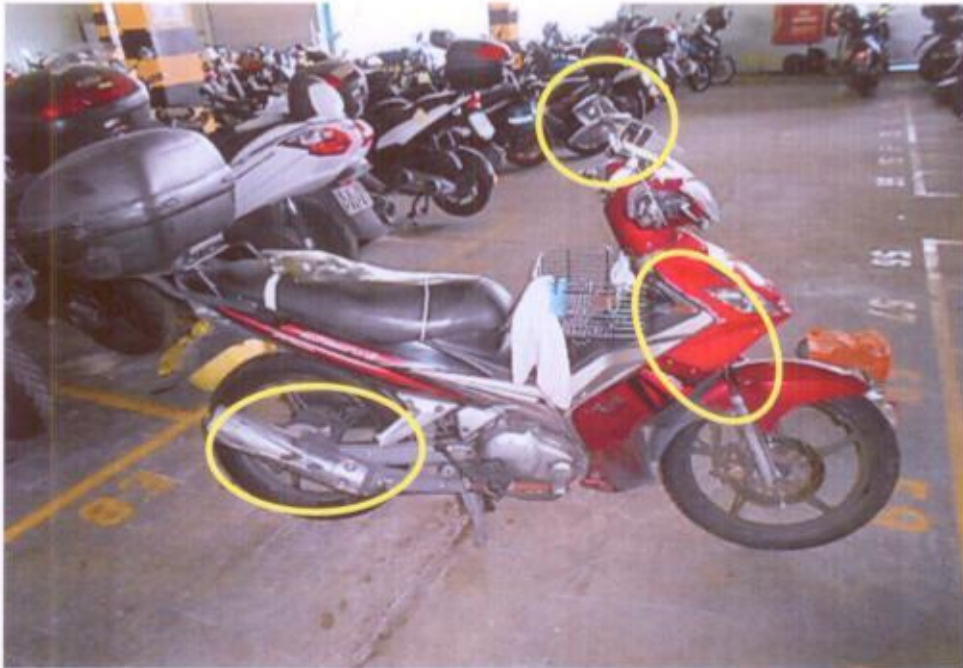
Photo 3 shows a general view of the right side body of the Motorcycle at the time of our inspection. The body parts that were found to have been damaged include its front left wing mirror, broken pillion's right foot rest, minor scratches at right hand side fairing and exhaust pipe amongst others. Its front fork assembly was also observed to be bent slightly to the right as a result of the accident.

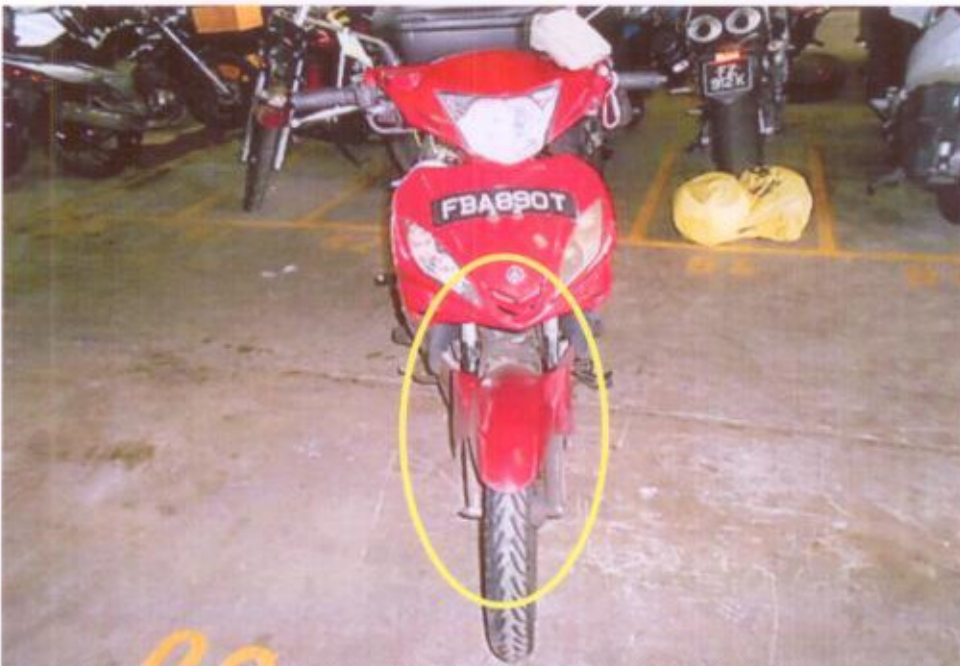
Photo 4 shows a general view of the frontal portion of the Motorcycle at the time of our inspection. The Motorcycle was observed to have sustained with relatively minor impact due to the accident collision. Which includes its front fork assembly was also observed to be bent slightly to the right.

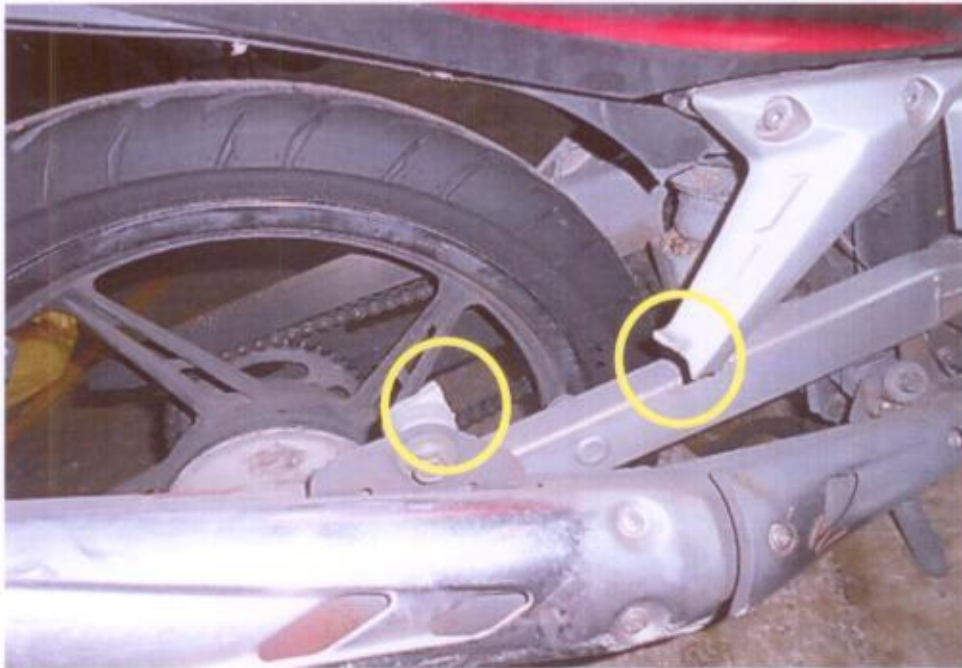
Photo 5 shows a close-up view of the broken passenger foot rest of the Motorcycle due to the accident collision.

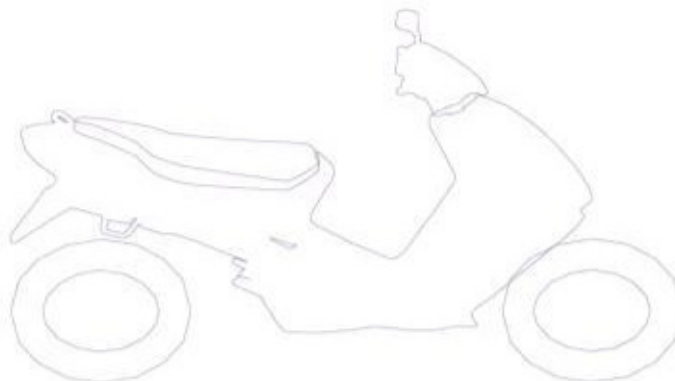
6. The conditions of the Motorcycle's tyres were observed to be in serviceable condition. The tread pattern of the 2 tyres was clearly visible. We did not observe any tear, burst mark(s) and/or punctured hole(s) on the sidewalls as well as across the tread of the 2 tyres. Both tyres were observed to be sufficiently inflated for vehicular operation. The tyre brand, tyre size and remaining tread depth of the 2 tyres were recorded as follows:-

Bridgestone Battlax BT 39-F
90/80 - 17 (3mm)

Pirelli Angel C.T
70/90 - 17 (2mm)

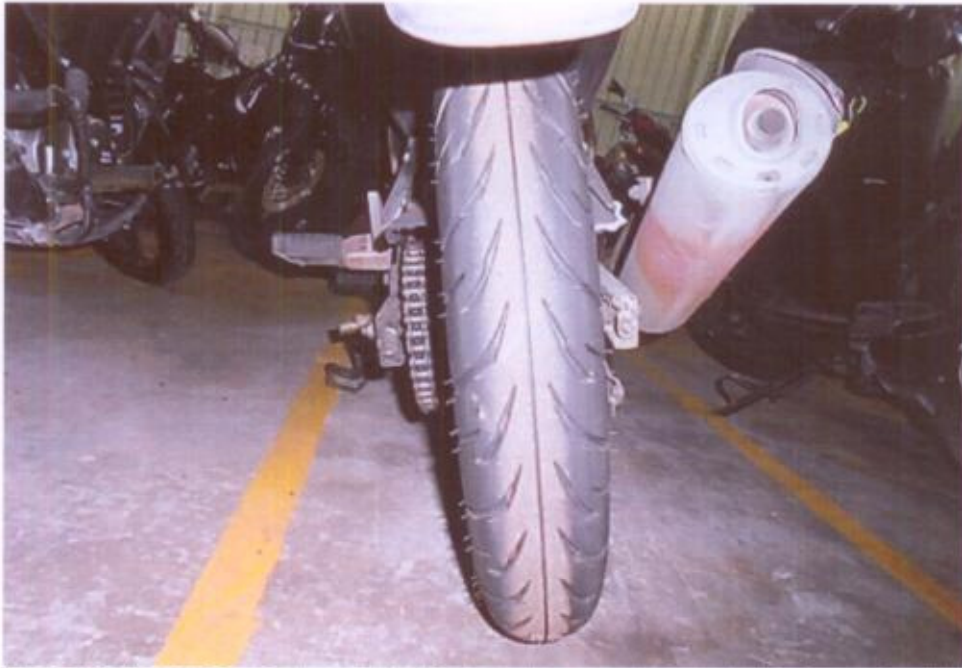
Photo 6 shows the rear tyre of the Motorcycle was observed to be in serviceable condition with remaining tread depth of approximately 3mm. The tyre was also observed to be sufficiently inflated for vehicular operation. There was no significant damage observed on the rear wheel rim & tyre.

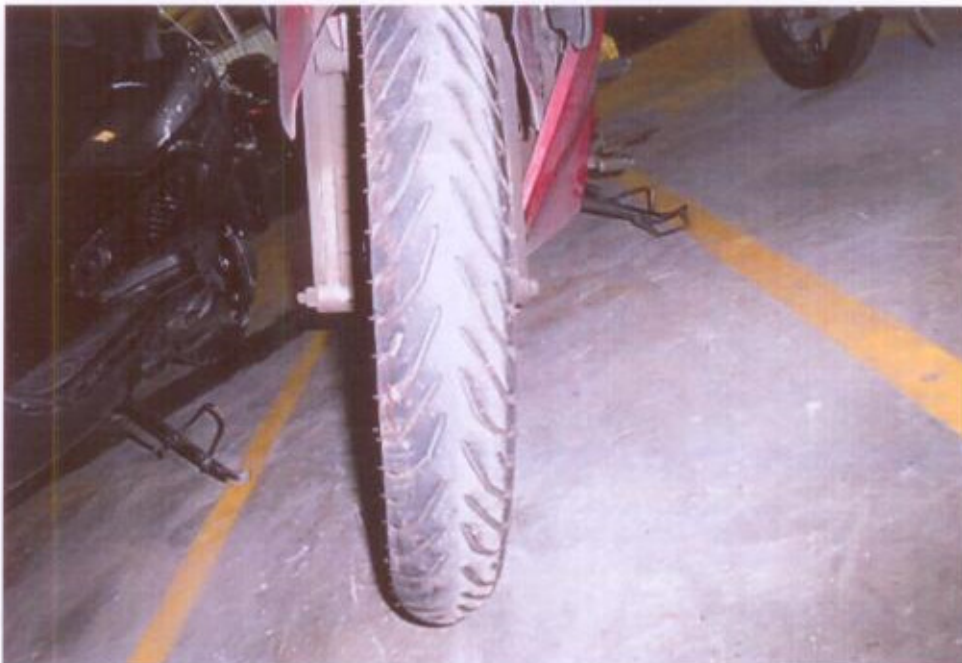
Photo 7 shows the front tyre of the Motorcycle. There was no tear, burst mark(s) and/or punctured hole(s) on the sidewalls as well as across the tread of the front tyre.

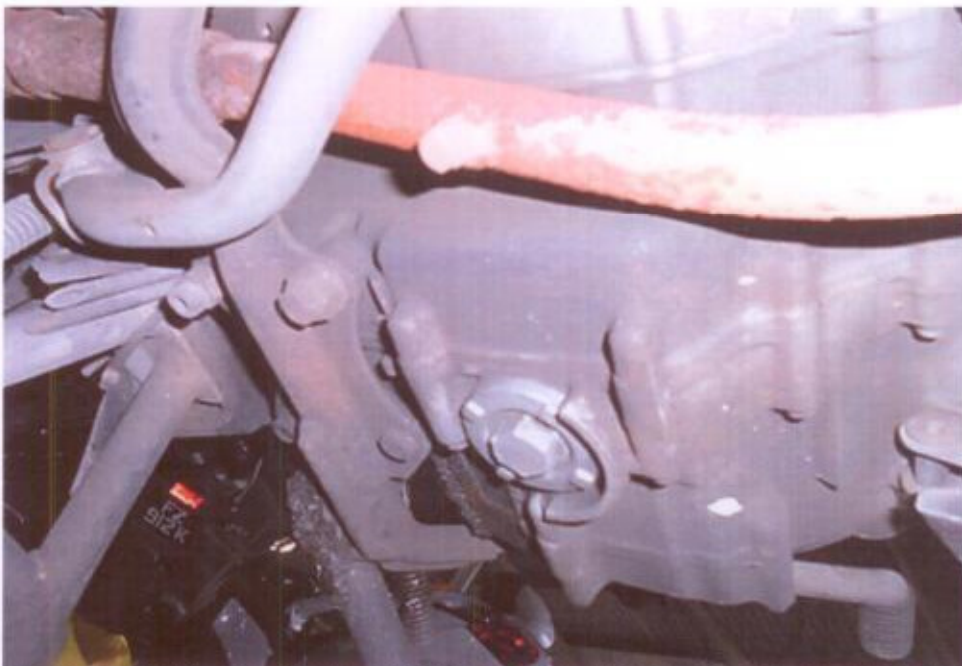
Photo 8 shows the engine underside view. There was also no sign(s) or indication(s) of fluid leak observed around the engine area of the Motorcycle.

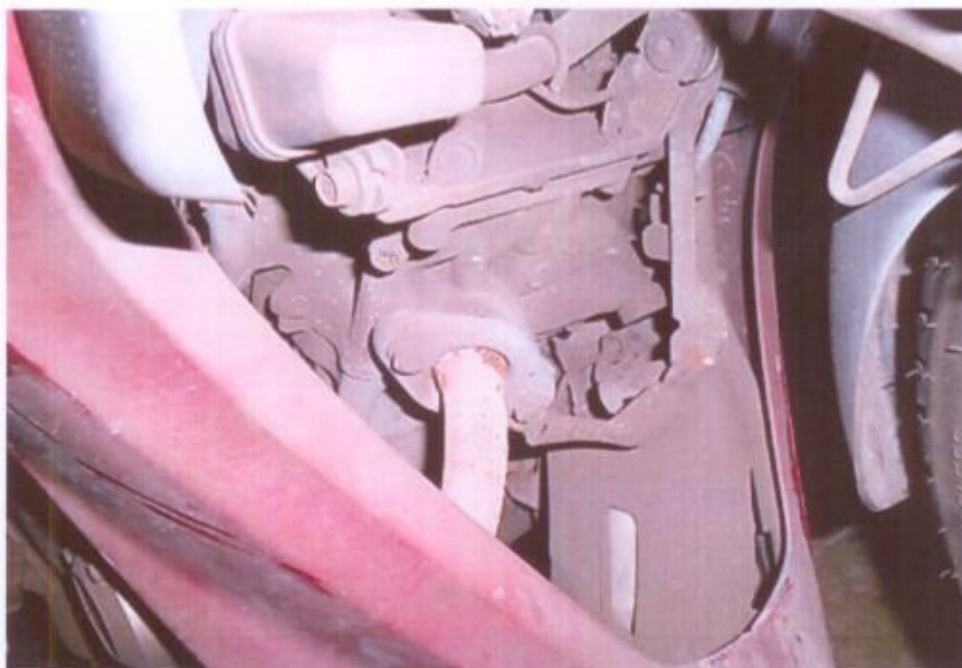
Photo 9 shows the engine area view. There was also no sign(s) or indication(s) of fluid leak observed around the engine area of the Motorcycle.

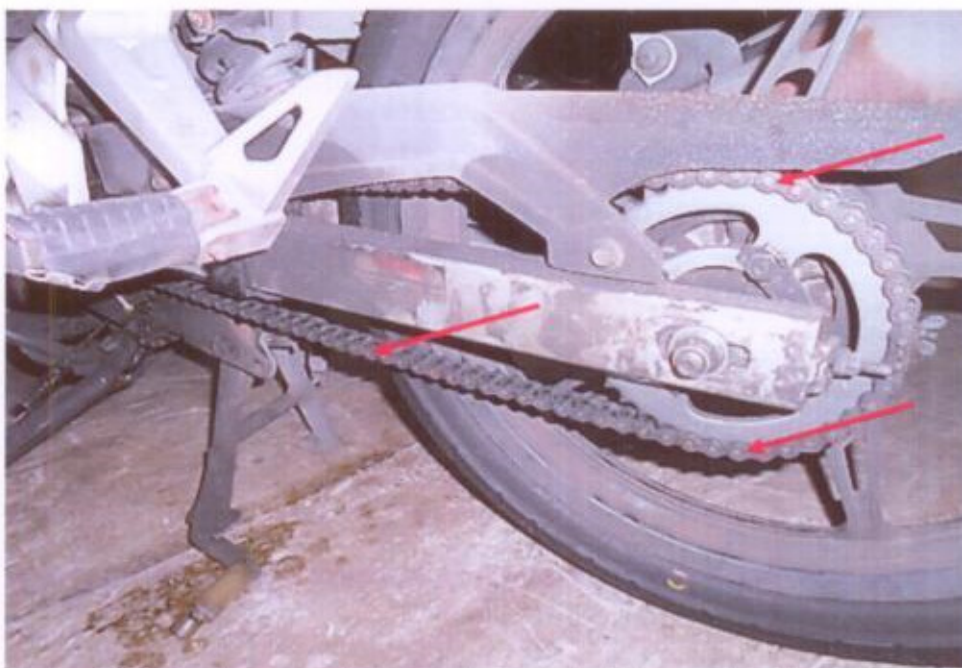
Photo 10 shows the general view of the gear train (arrowed) of the Motorcycle, which was observed to be intact with no misalignment. It was also adequately lubricated for operating purposes.

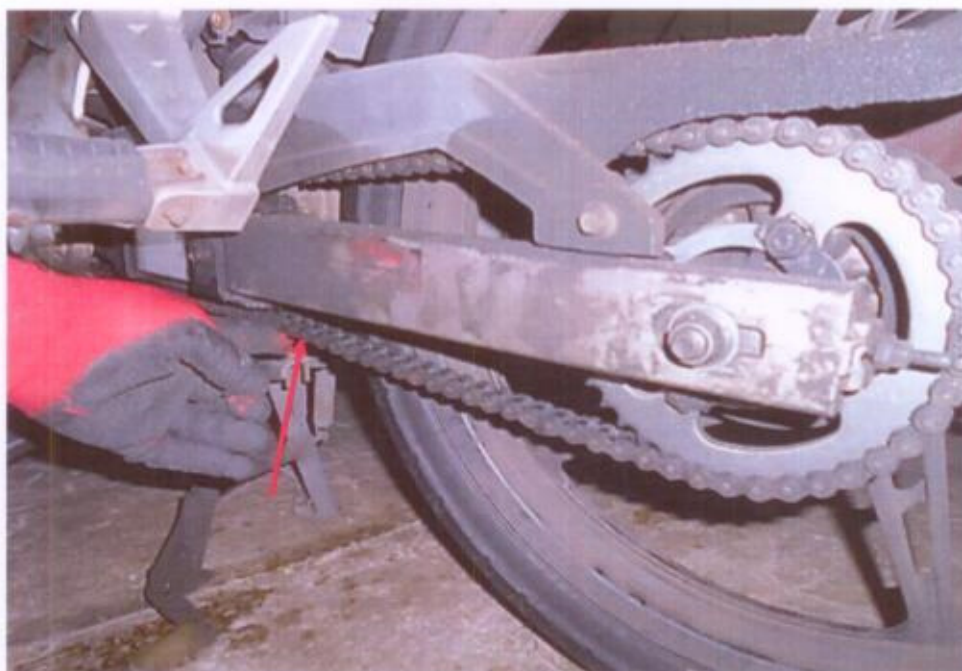
Photo 11 shows the general view of the gear train (arrowed) of the Motorcycle, which was observed to be intact with no misalignment. It was also adequately lubricated for operating purposes. Free play tension was also observed & found adequately acceptable.

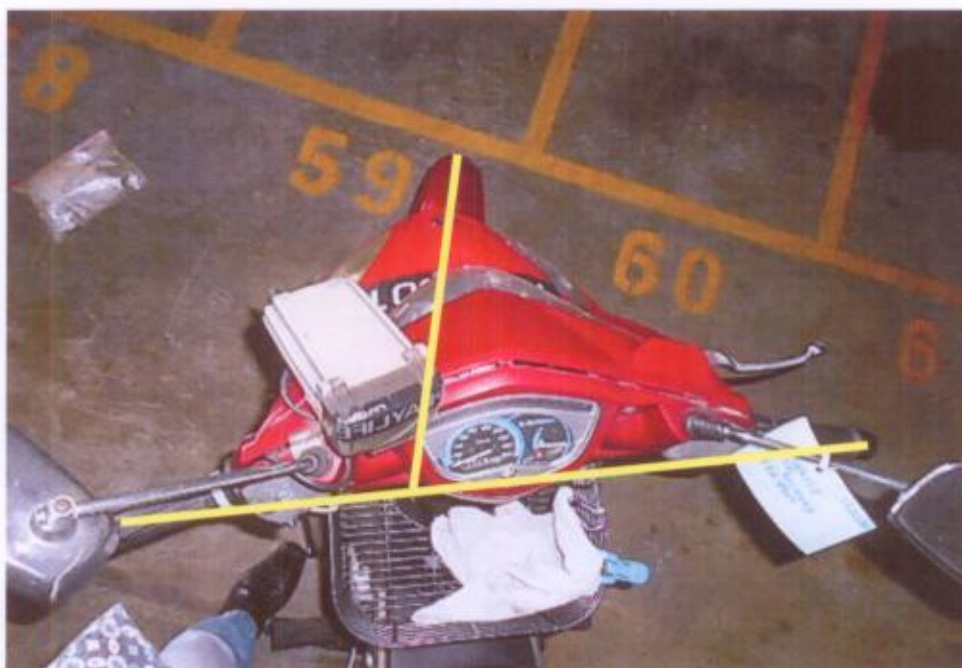
10. For this case, we were not able to conduct any test(s) on the steering system of the Motorcycle due to the damage on its front fork. Its front fork assembly was observed to be bent slightly to the right as a result of the accident.
11. The brake system of the Motorcycle was of a semi-hydraulic type, where hydraulic (brake fluid) pressure controls the brake for the front wheel while the brake for the rear wheel is controlled by mechanical means (cables and springs). Our visual examination of the various components in the brake system, like the brake disc, brake calliper, drum and brake foot pedal, revealed all to be intact and without damage. There was also no visible tear or cut observed on the connecting hoses and cables.

Photo 12 shows the front fork (yellow line) was observed to be misaligned as a result of the accident. Hence, we are not able to conduct any tests on the steering system of the Motorcycle.

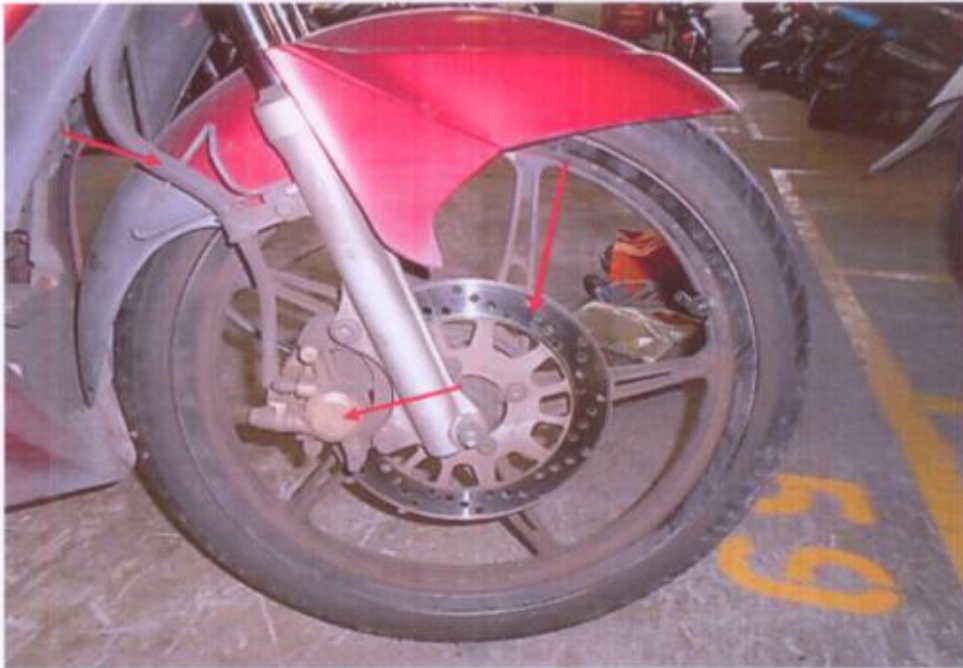
Photo 13 shows the front brake calliper, front brake disc and front brake hose of the Motorcycle (arrowed), which are all part of the components in the front brake system of the Motorcycle. Our visual checks of these various components had revealed all to be intact with no visible damage. No leakage of brake fluid was also observed.

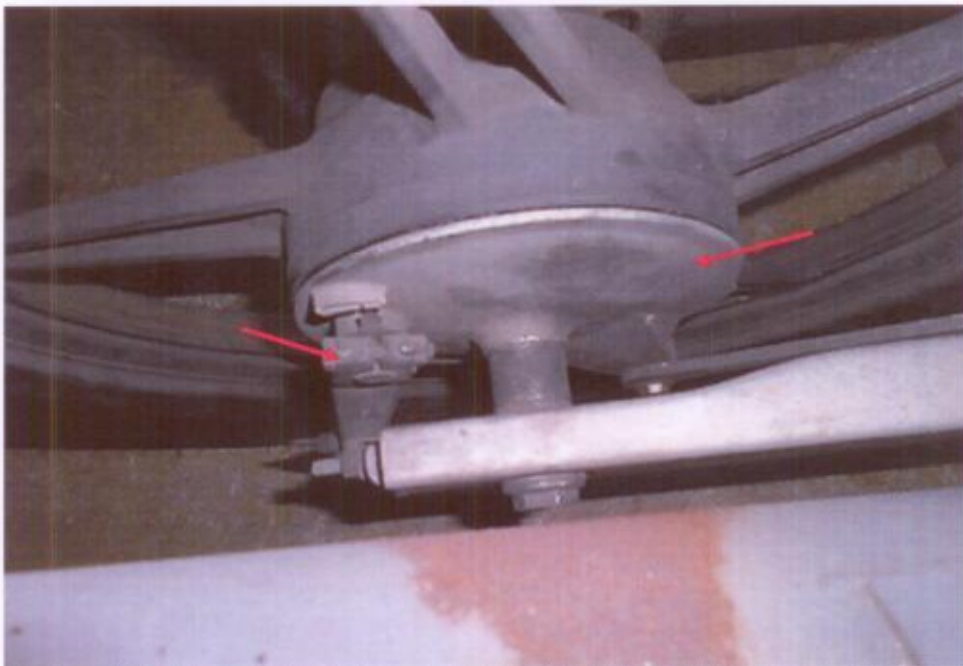
Photo 14 shows the rear brake system of the Motorcycle (arrowed). Our visual checks of these various components had revealed all to be intact with no visible damage.

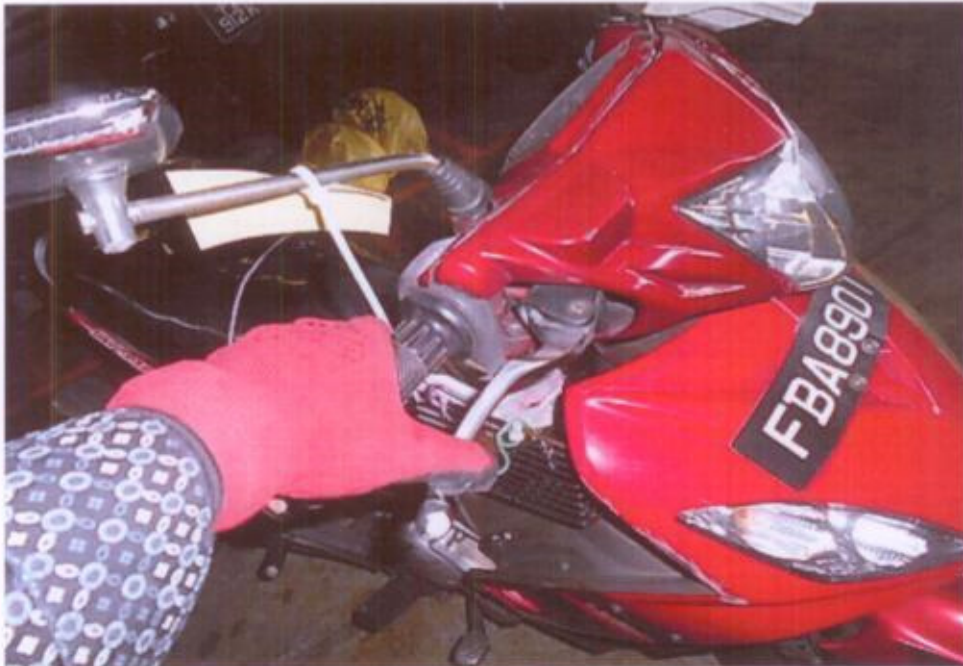
12. Static brake tests conducted on the Motorcycle had appeared to indicate that the brake system of the Motorcycle was in serviceable condition. There was some resistance felt (spongy like feel) upon gripping the hand brake lever & stepping on the rear brake foot paddle. This would indicate that there was no leakage of pressure/vacuum in the brake system also on the rear brake drum mechanical parts. Our checks on the brake fluid had also indicated that the brake fluid was of sufficient level for operational purposes, and without contamination.
13. For this case, we was not able to carry out any operational tests to the steering system and brake system of the Motorcycle due to the damage of its front fork, which had rendered the Motorcycle abnormality for the operational tests. See photo 12 - 16 below.

Photo 15 shows the front brake static test. It was observed to be in serviceable condition at time of our inspection.

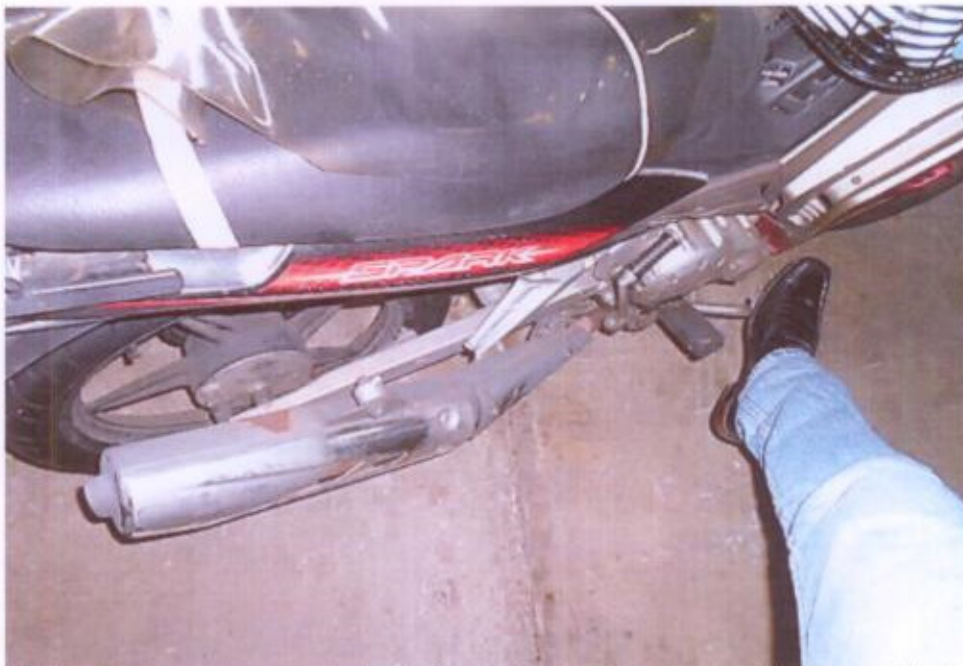
Photo 16 shows the rear brake static test of the Motorcycle. The type of brake system for the rear wheel was of mechanical type, controlled by the brake foot pedal of the Motorcycle. Our static brake test revealed that the rear brake system of the Motorcycle was in serviceable condition without damage.
