# LKK Auto Consultants Pte Ltd

### **DAMAGED VEHICLE (SCK 5 T) INSPECTION REPORT (WITHOUT PREJUDICE)**

## ASSESSMENT OF REPAIRS AND SPARE PARTS COSTS FOR VEHICLE NO: SCK 5 T

## ADJUSTMENT ON REPAIR COST FOR VEHICLE NO. SCK 5T

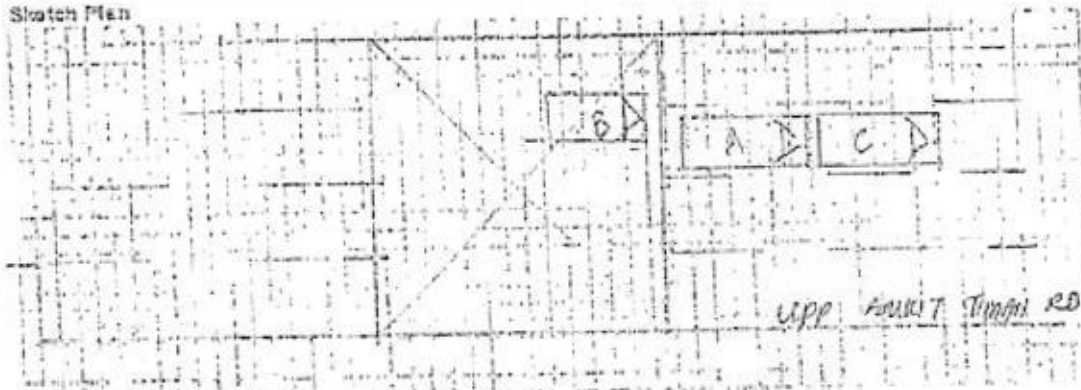
Sketch Plan

A: 8CK 5T  
 B: 8JX 4422U

C: 8GW 3502U

On mentioned date and time, I was driving along 4pp  
Robert Timah Road. When I approached the traffic  
junction, the front vehicle SW 35024 stopped and I  
followed him. Both our vehicles were in stationary  
position. Few seconds later, SJX 44224 crashed against  
my vehicle with great force. My vehicle surge forward  
and hit onto SW 35024. I got down to inspect and  
exchange particulars and SJX 44224 driver  
admitted that he couldn't stop in time and caused  
the whole accident. I went to seek medical treatment  
and I was given 3 days medical leave.

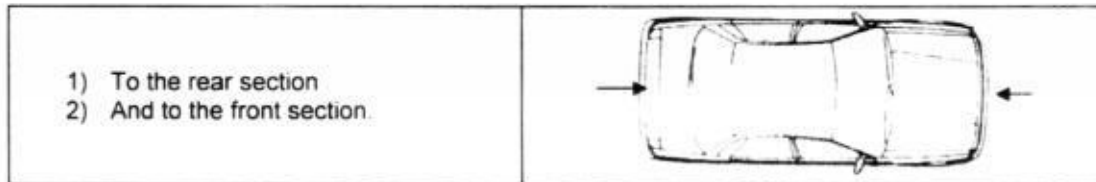
**(E) Point of Impact**

The impact of the collision has damaged/affected the rear bumper, boot lid, rear end panel, front bumper, front grille and etc.

Our adjusted cost of lump sum repair is **\$14,300.00** and an estimated **9** days are required to repair the vehicle. Please refer to the Annex for a detailed account of the cost estimates.
