Your Ref : 73740  
Our Ref : CI/DAI17022799/N

20 November 2017

## **TECHNICAL INVESTIGATION REPORT OF FIRE INCIDENT INVOLVING THE INSURED MOTORCYCLE FT 4200L ON 13 NOVEMBER 2017**

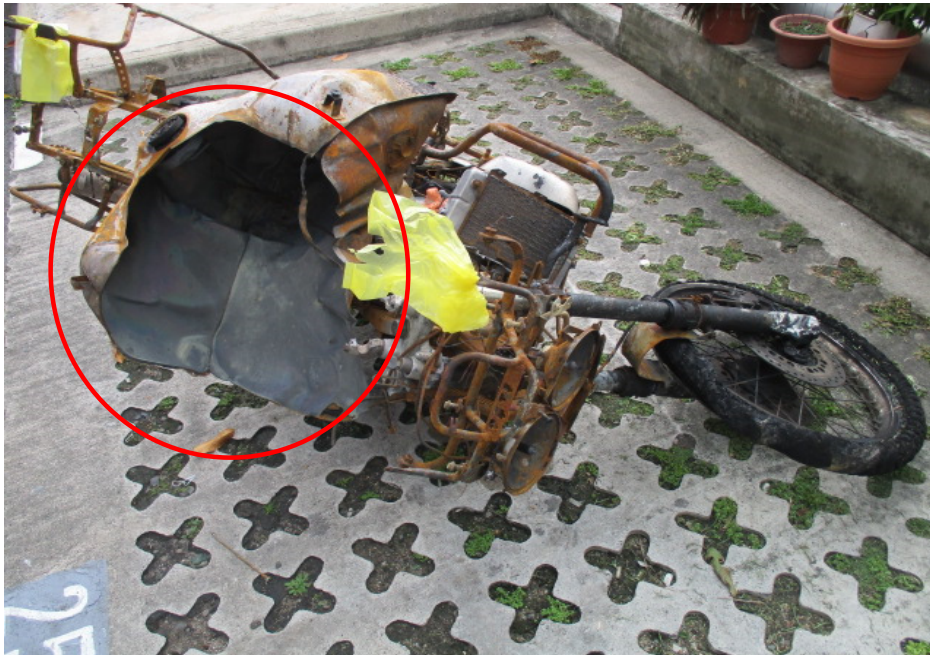
**Photo 1** shows the general front view of the Insured Motorcycle at the time of inspection. The Insured Motorcycle was observed to have sustained severe fire damage all around. The fire caused the fuel tank to explode, exposing the internal part of the fuel tank (circled). Parts that were made of plastic and rubber type of material at its exterior body as well as some of its engine components were found to be severely burnt and/or melted. The drive train had sustained extensive fire damage, rendering the Insured Motorcycle immobile. Rust had accumulated all over the Insured Motorcycle as a result of exposure to environmental condition for a period of time.

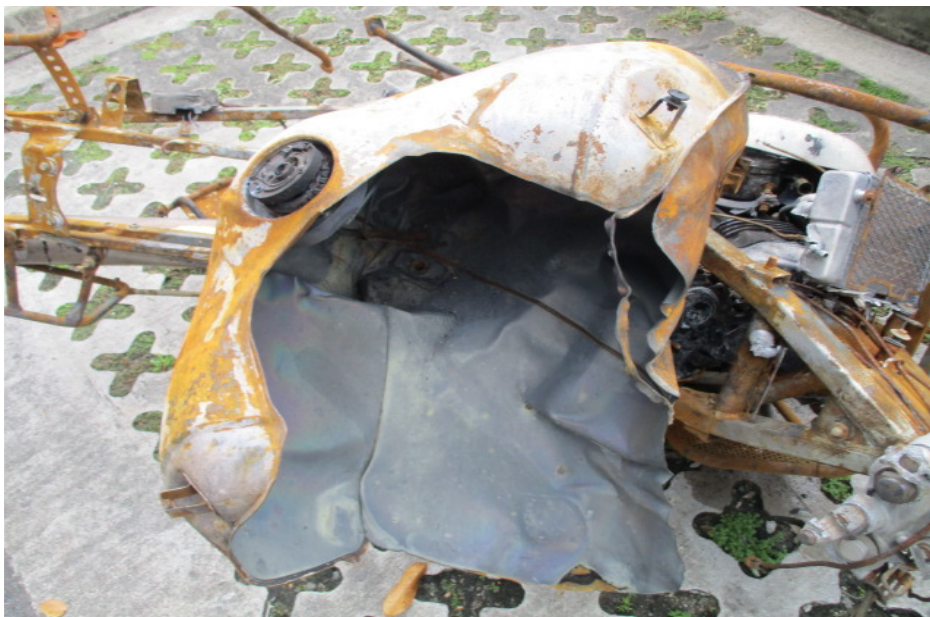
**Photo 2** shows a closer view of the exposed internal part of the fuel tank as a result of the explosion caused by the fire.

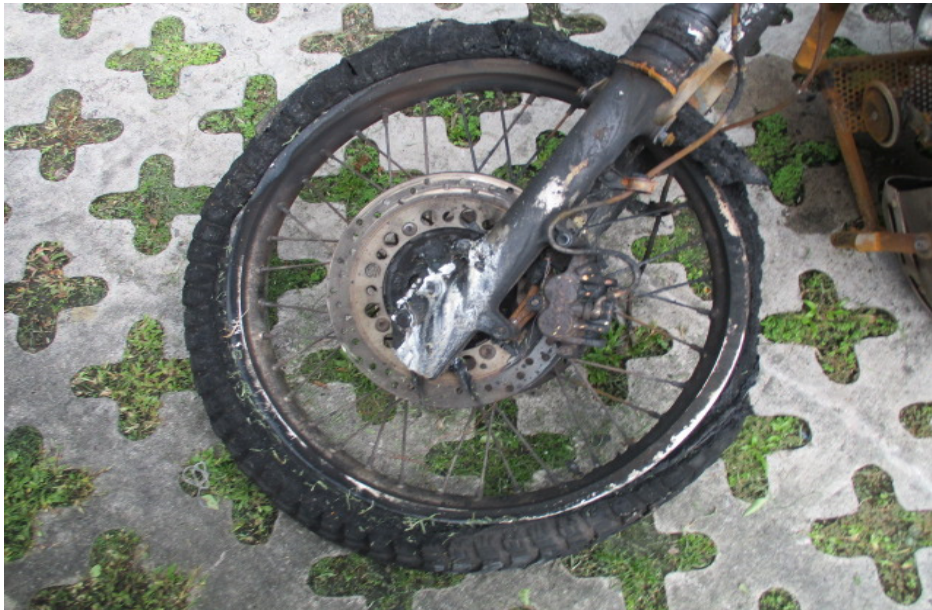
**Photo 3** shows a closer view of the partially burnt front wheel rim and melted front tyre.

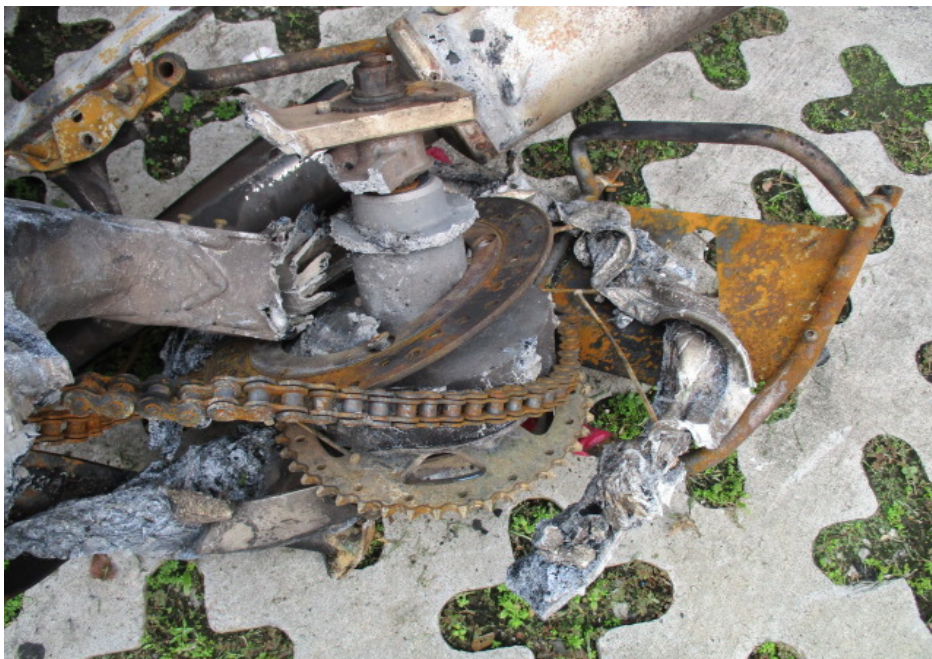
**Photo 4** shows a closer view of the drive train which had sustained extensive fire damage, rendering the Insured Motorcycle immobile.

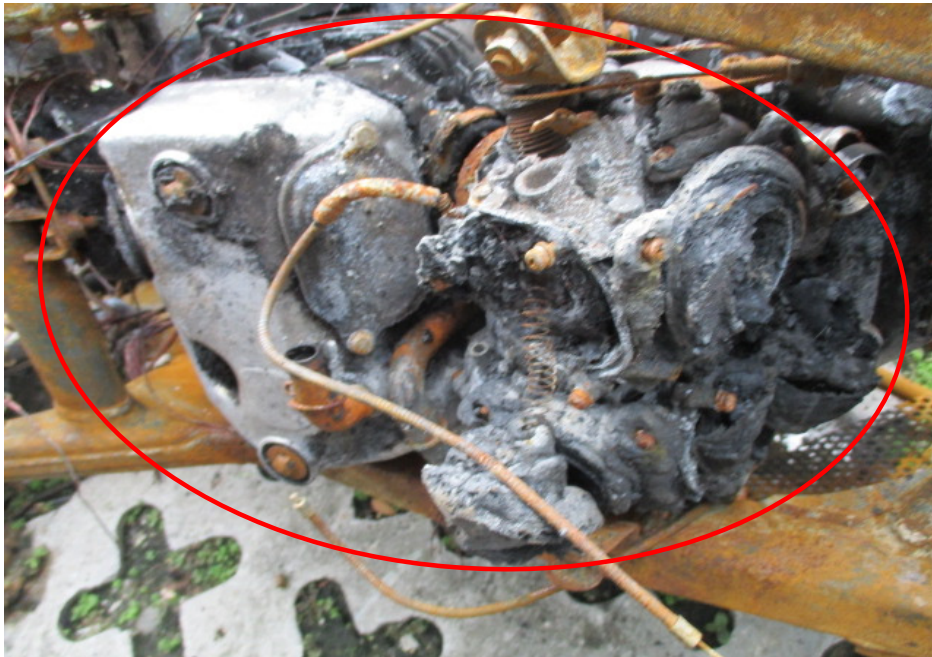
**Photo 5** shows a close up view of the severely burnt and/or melted engine components of the Insured Motorcycle as a result of the fire (circled).

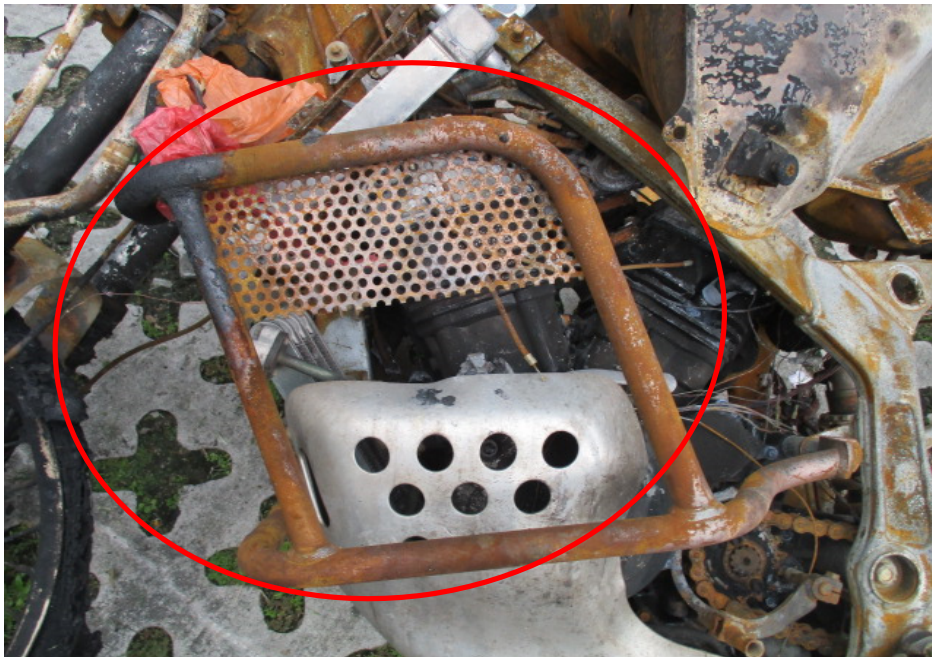
**Photo 6** shows the engine crash bar (circled) fitted on the Insured Motorcycle which had accumulated rust as a result of exposure to environmental condition for a period of time.

28. Although the aftermarket engine crash bars, side pannier racks and rear exhaust muffler fitted on the Insured Motorcycle were not the standard type for the Insured Motorcycle, we are of the view that these parts did not cause and/or contribute to the fire incident.

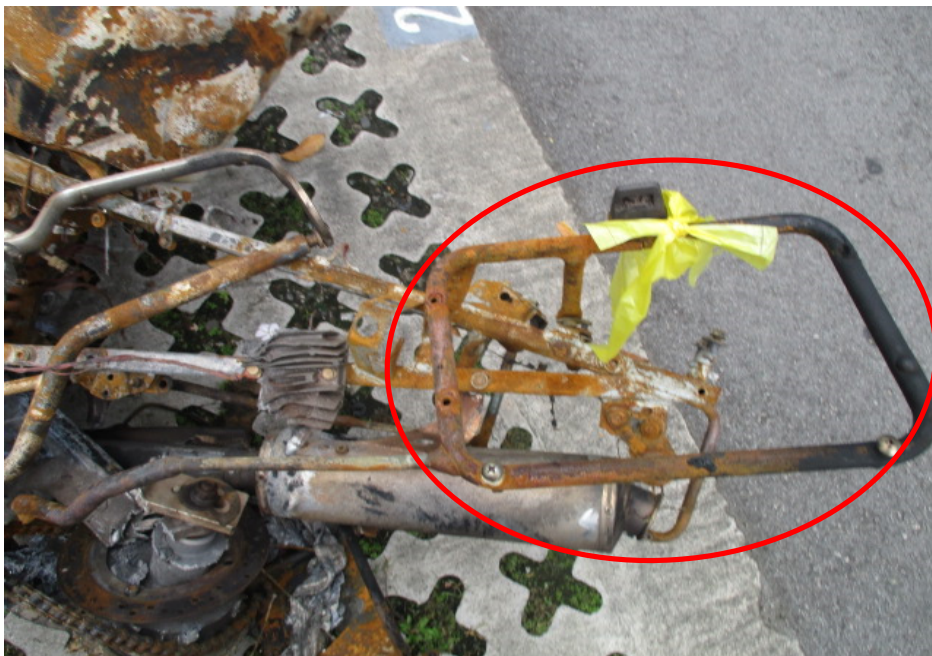
**Photo 7** shows the side pannier rack (circled) fitted on the Insured Motorcycle which had accumulated rust as a result of exposure to environmental condition for a period of time.

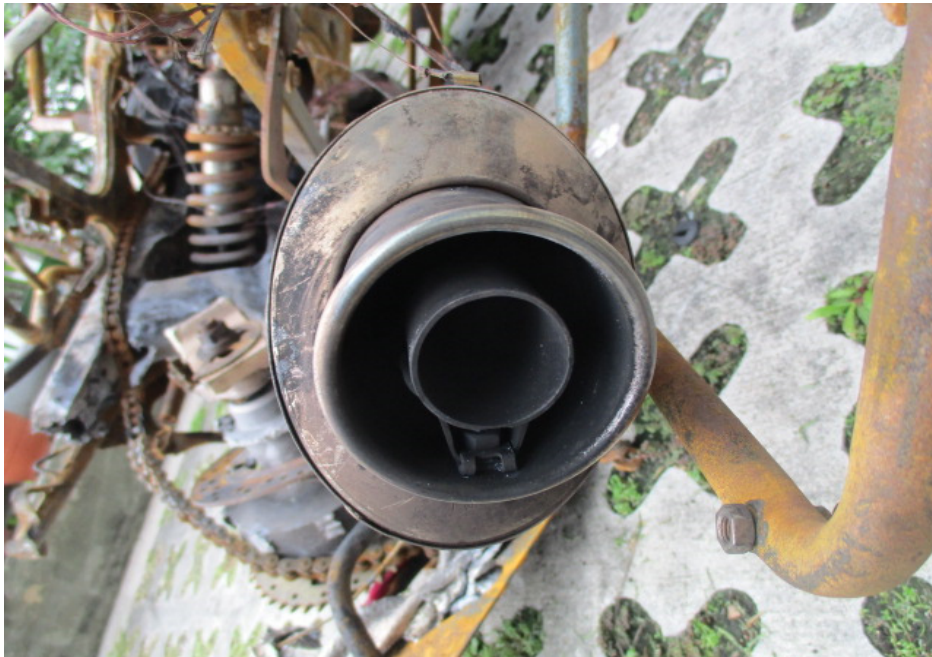
**Photo 8** shows the front view of the non-standard rear exhaust muffler that was found to be fitted on the Insured Motorcycle at the time of our inspection.

27. We found the Insured Motorcycle to be fitted with aftermarket engine crash bars, side pannier racks and rear exhaust muffler. The engine crash bars and side pannier racks fitted do not require prior approval from LTA however the non-standard rear exhaust muffler would require prior approval from LTA. Mr Simon has provided documents to prove that the non-standard rear exhaust muffler has been approved by the LTA.

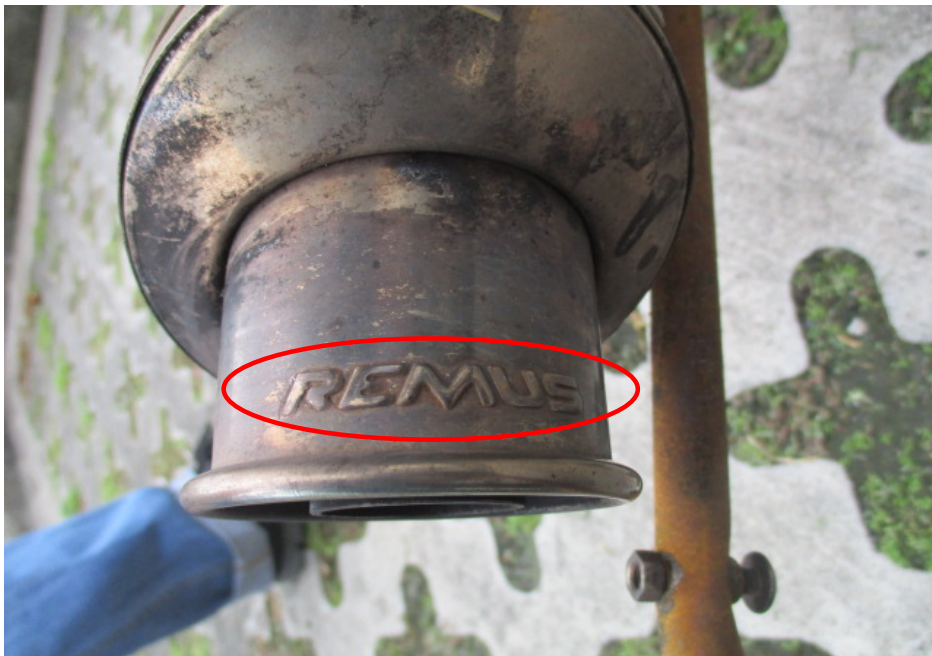
**Photo 9** shows a close up top view of the non-standard rear exhaust muffler that was found to be fitted on the Insured Motorcycle at the time of our inspection. The brand of the rear exhaust muffler was 'REMUS' (circled).

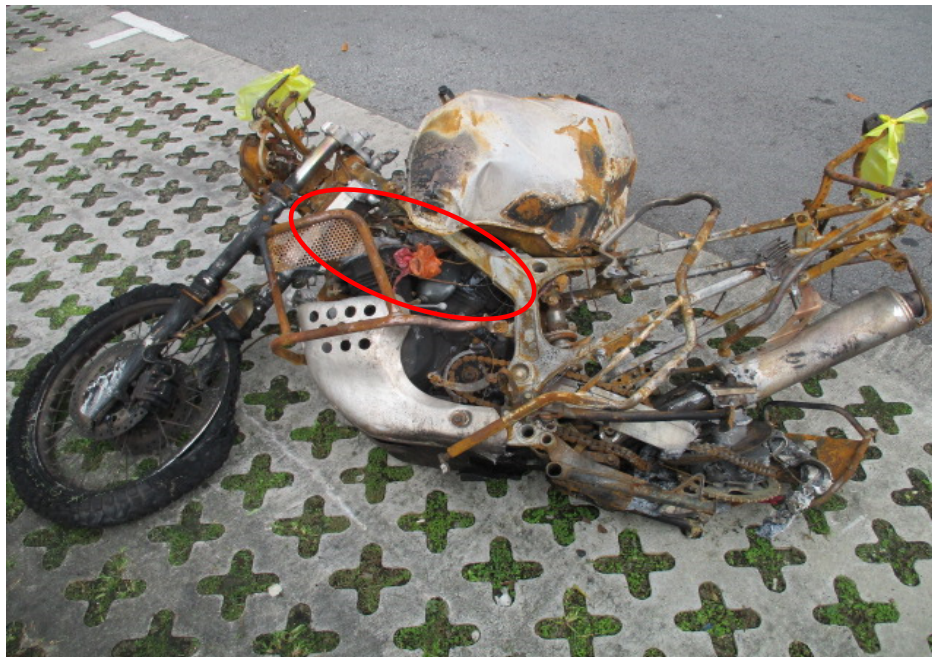
**Photo 10** shows a view of the left side of the Insured Motorcycle. Upon closer examination of the left side of the Insured Motorcycle below the fuel tank which was where the fire had likely started, we had found several stretches of wirings with greenish residue (circled). These wirings were original factory fitted wirings. The presence of such greenish residue suggests occurrence of an electrical short circuit.

26. Having investigated and technically analysed the damages of burnt nature to the Insured Motorcycle, we are of the view that the cause of fire to the Insured Motorcycle was of electrical in nature. For this particular case, the fire had originated along the wirings underneath the left side of the fuel tank of the Insured Motorcycle. The wirings were original factory wirings of the Insured Motorcycle.

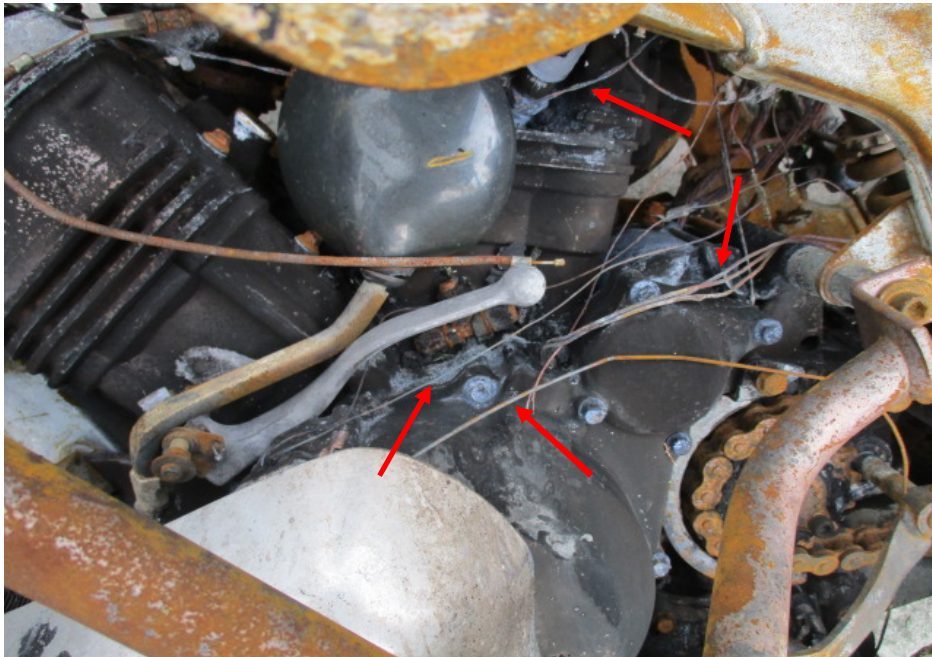
**Photo 11** shows a closer view of the left side of the Insured Motorcycle below the fuel tank which was where the fire had likely started. We had found several stretches of wirings with greenish residue (red arrows). The presence of greenish residue indicates internal heating of copper wires, a sign of an electrical short circuit occurring.

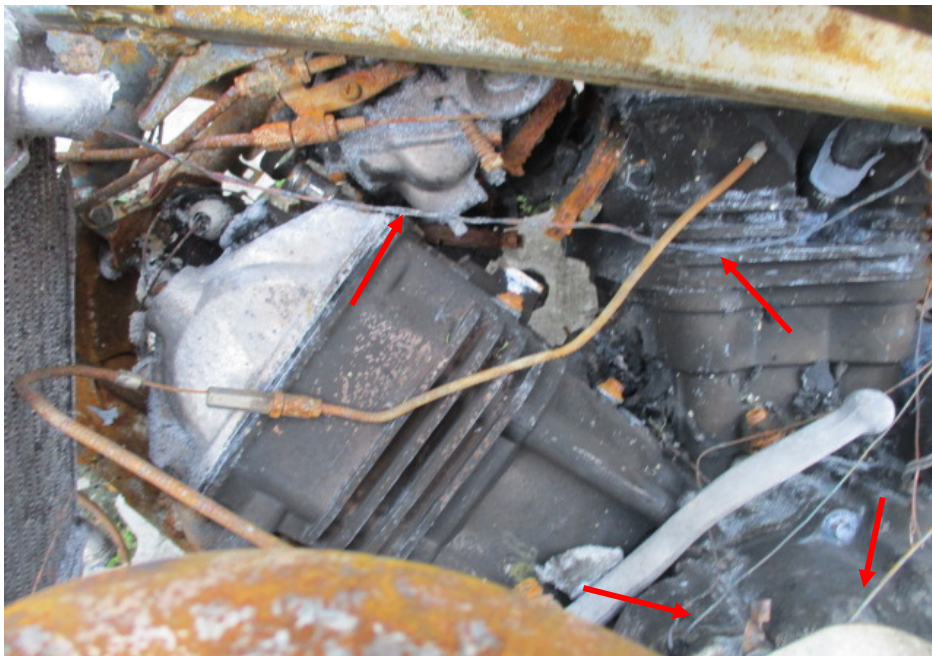
**Photo 12** shows a closer view of the wirings with greenish residue (red arrows). The presence of greenish residue indicates internal heating of copper wires, a sign of an electrical short circuit occurring.

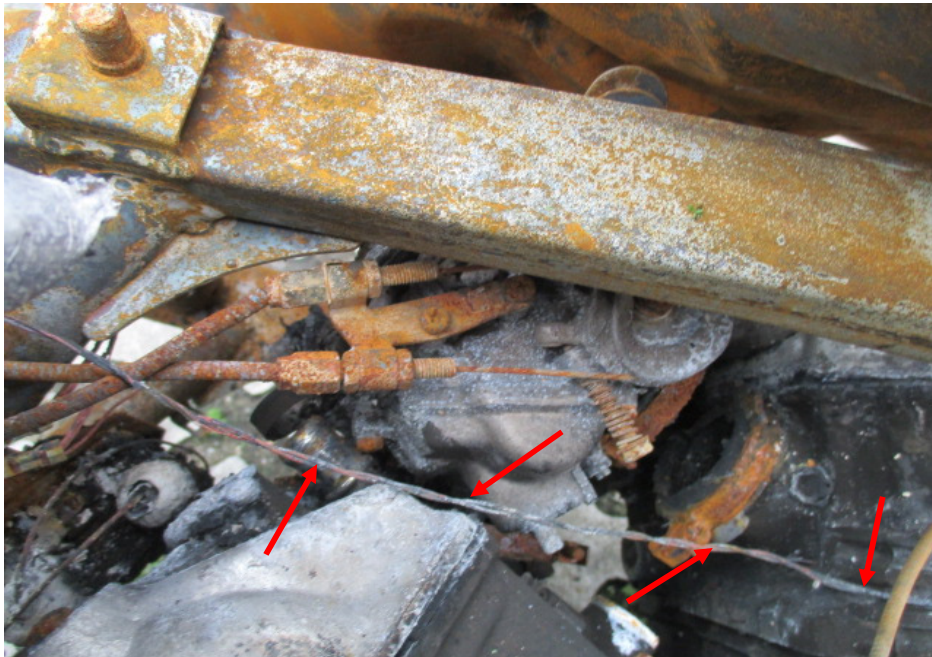
**Photo 13** shows a close up view of the wirings with greenish residue (red arrows). The presence of greenish residue indicates internal heating of copper wires, a sign of an electrical short circuit occurring.

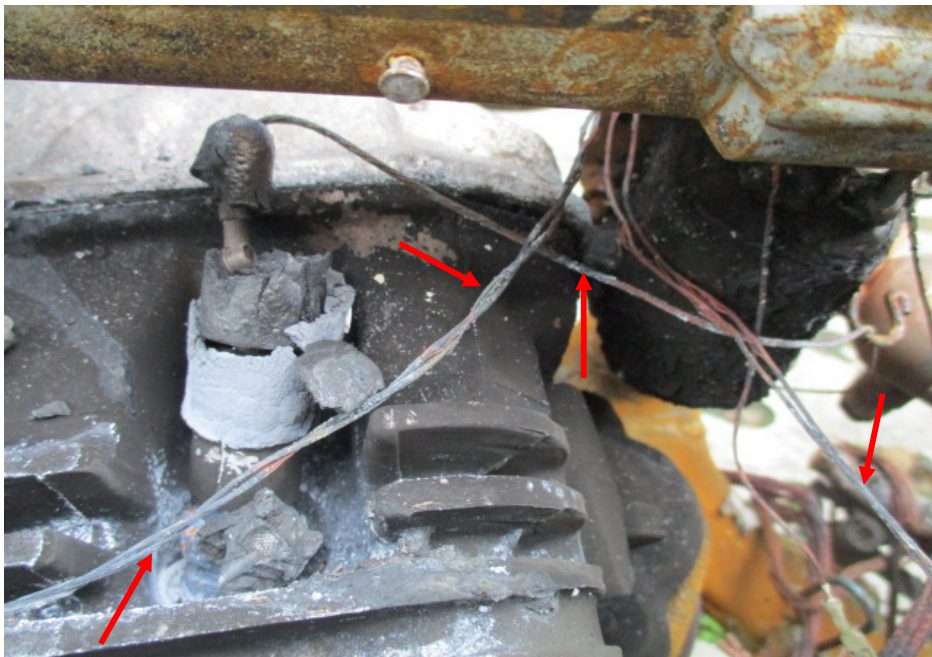
**Photo 14** shows a close up view of the wirings with greenish residue (red arrows). The presence of greenish residue indicates internal heating of copper wires, a sign of an electrical short circuit occurring.

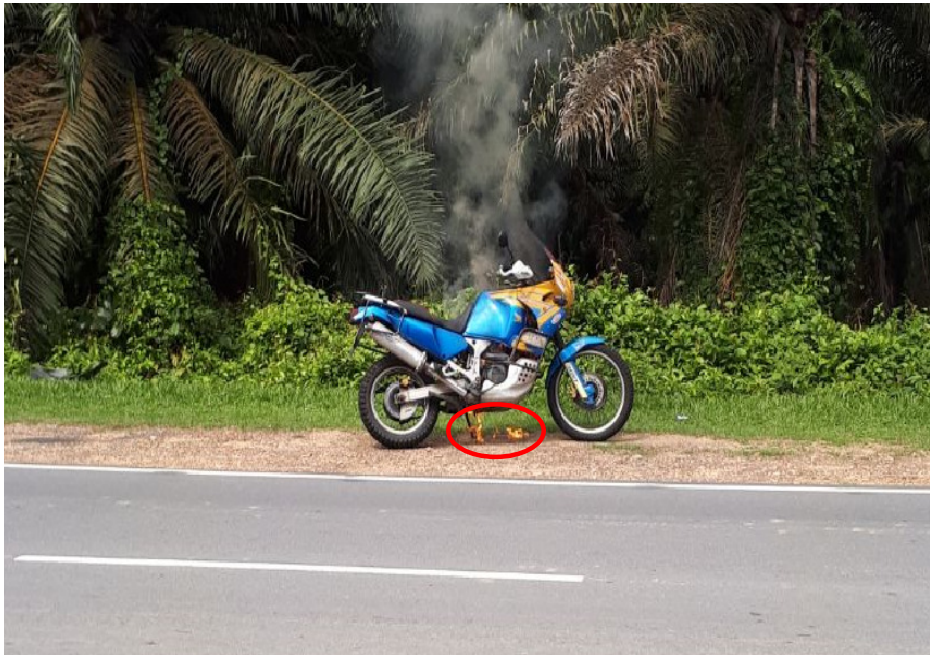
**Photo 17** shows the Insured Motorcycle after the fire had started (circled). In general, the information that could be gathered from this photograph had corresponded to the events that were related to us by Mr Simon, which is the fire started from the left side.

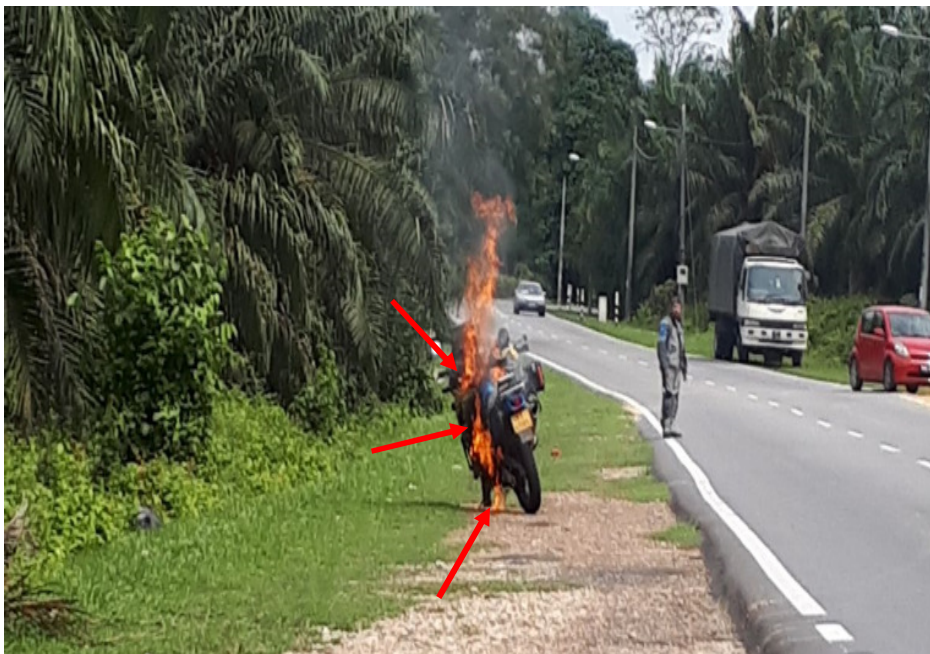
**Photo 18** shows the rear view of the Insured Motorcycle as the fire began to spread. In general, the information that could be gathered from this photograph had corresponded to the events that were related to us by Mr Simon, which is the fire started from the left side (red arrows).

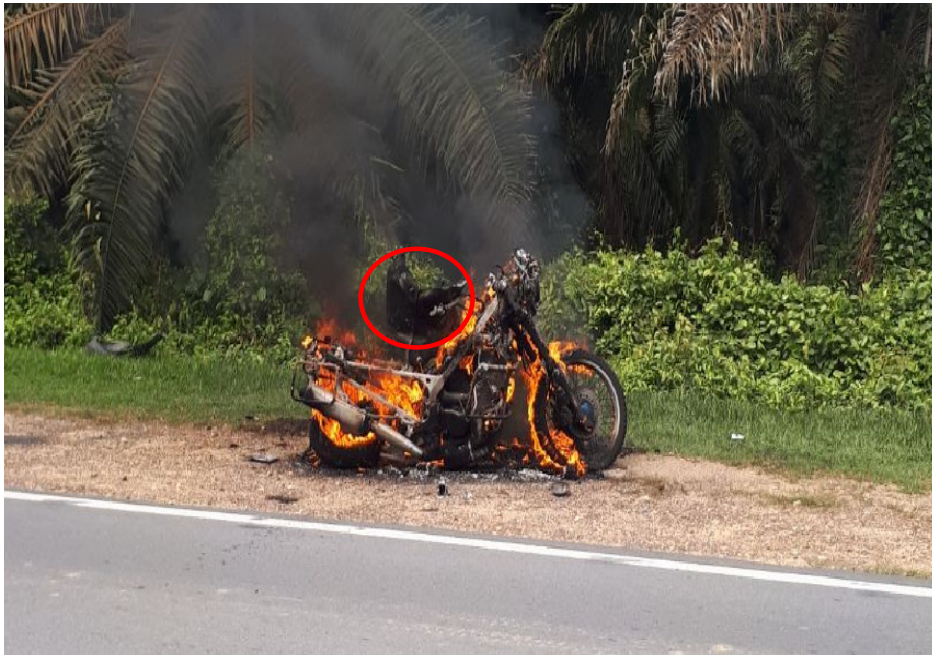
**Photo 19** shows flames engulfing the Insured Motorcycle. In general, the information that could be gathered from this photograph had corresponded to the events that were related to us by Mr Simon, which is the fuel tank exploded shortly after the fire broke out (circled).

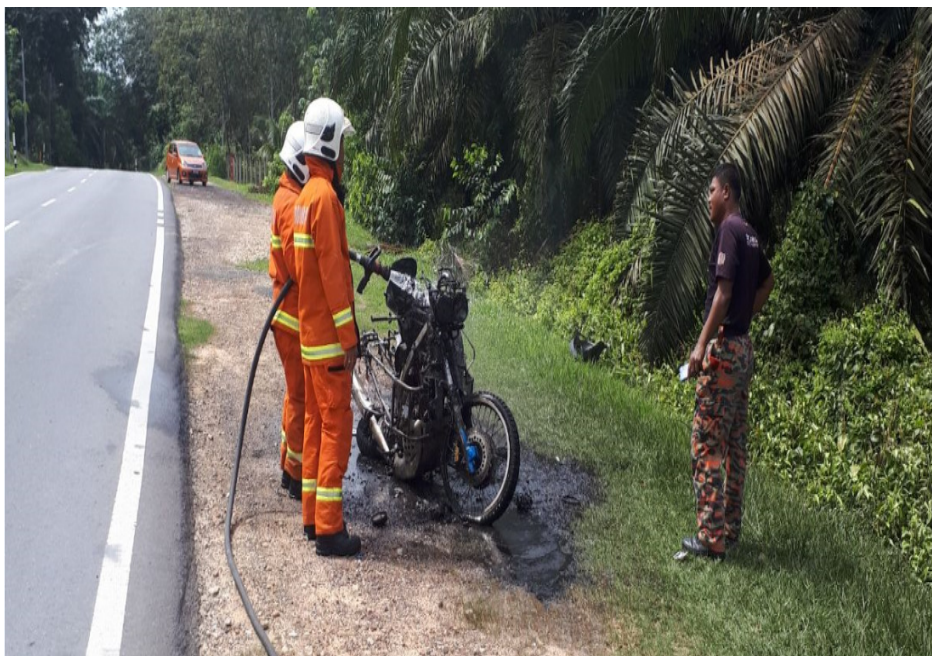
**Photo 20** shows Malaysian firefighters extinguishing the last remnants of the fire to the Insured Motorcycle.
