Your Ref : 73740
Our Ref : CI/DAI17022799/N

20 November 2017

TECHNICAL INVESTIGATION REPORT OF FIRE INCIDENT INVOLVING THE INSURED MOTORCYCLE FT 4200L ON 13 NOVEMBER 2017

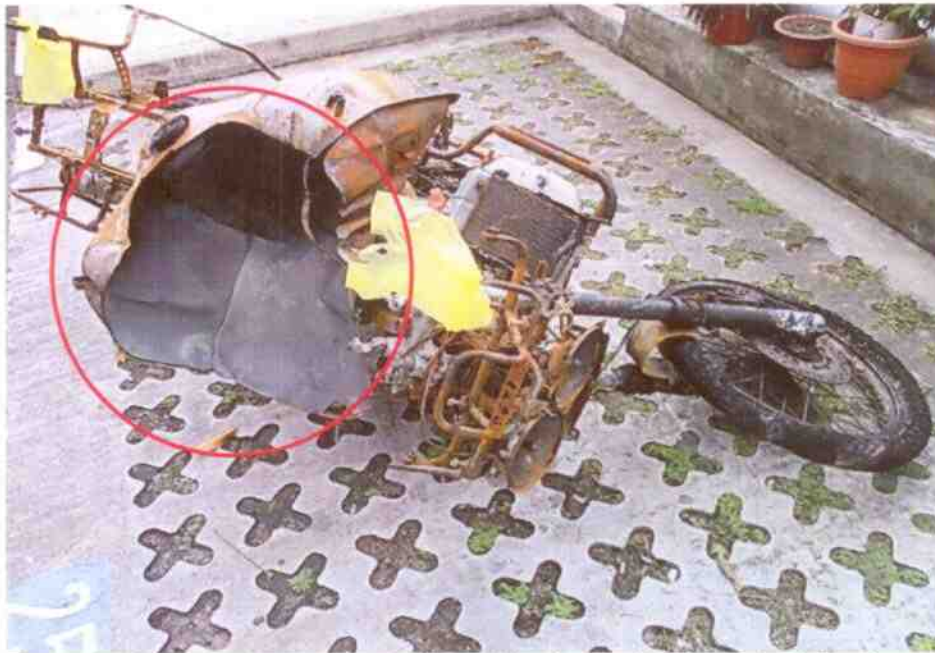
5. The Insured Motorcycle was observed to have sustained severe fire damage all around. The fire caused the fuel tank to explode, exposing the internal part of the fuel tank. Parts that were made of plastic and rubber type of material at its exterior body as well as some of its engine components were found to be severely burnt and/or melted. The drive train had sustained extensive fire damage, rendering the Insured Motorcycle immobile. Rust had accumulated all over the Insured Motorcycle as a result of exposure to environmental condition for a period of time. See photos 1 – 5 below.

Photo 1 shows the general front view of the Insured Motorcycle at the time of inspection. The Insured Motorcycle was observed to have sustained severe fire damage all around. The fire caused the fuel tank to explode, exposing the internal part of the fuel tank (circled). Parts that were made of plastic and rubber type of material at its exterior body as well as some of its engine components were found to be severely burnt and/or melted. The drive train had sustained extensive fire damage, rendering the Insured Motorcycle immobile. Rust had accumulated all over the Insured Motorcycle as a result of exposure to environmental condition for a period of time.

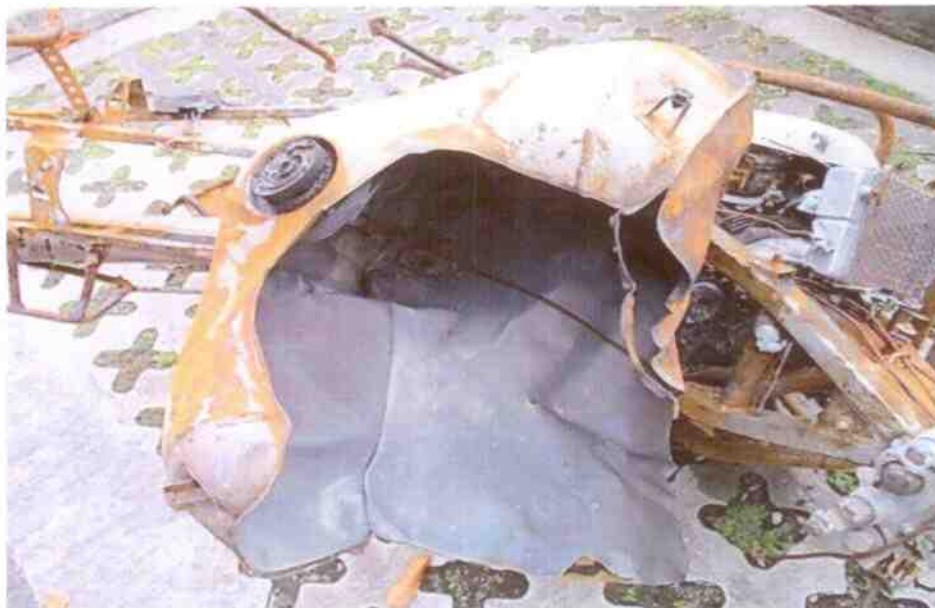
Photo 2 shows a closer view of the exposed internal part of the fuel tank as a result of the explosion caused by the fire.

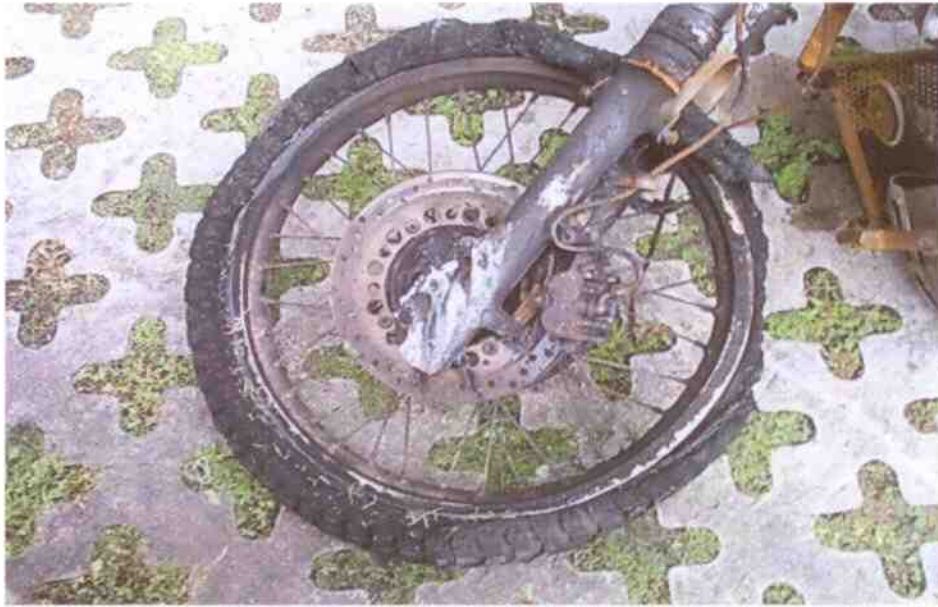
Photo 3 shows a closer view of the partially burnt front wheel rim and melted front tyre.

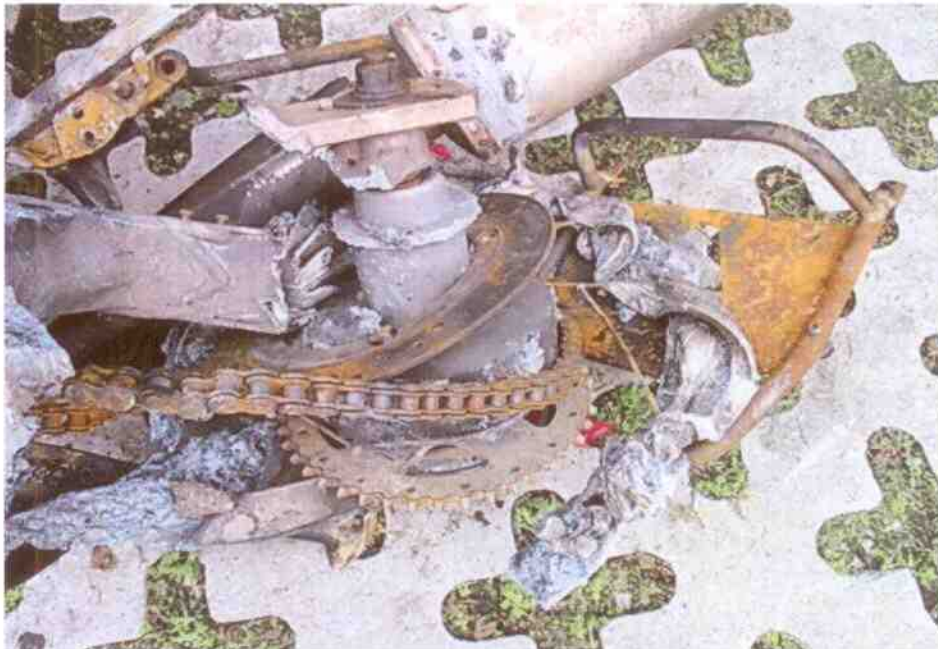
Photo 4 shows a closer view of the drive train which had sustained extensive fire damage, rendering the Insured Motorcycle immobile.

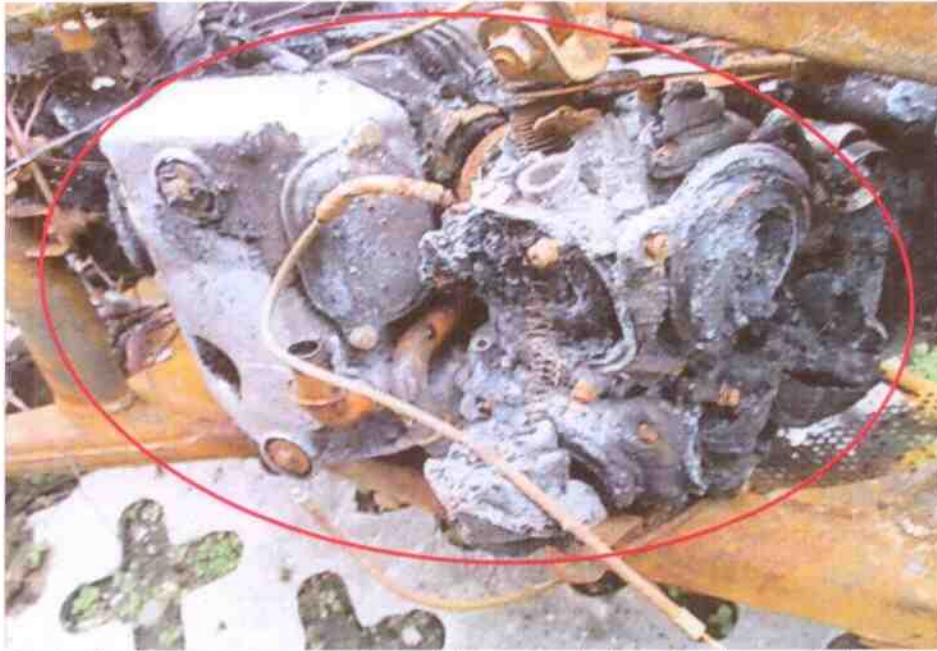
Photo 5 shows a close up view of the severely burnt and/or melted engine components of the Insured Motorcycle as a result of the fire (circled).

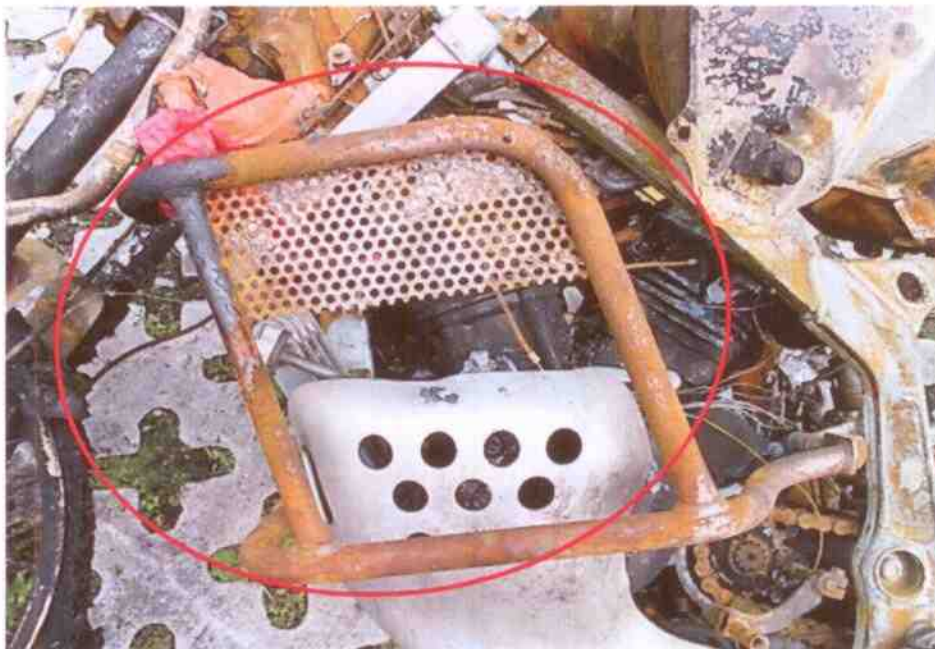
Photo 6 shows the engine crash bar (circled) fitted on the Insured Motorcycle which had accumulated rust as a result of exposure to environmental condition for a period of time.

28. Although the aftermarket engine crash bars, side pannier racks and rear exhaust muffler fitted on the Insured Motorcycle were not the standard type for the Insured Motorcycle, we are of the view that these parts did not cause and/or contribute to the fire incident.

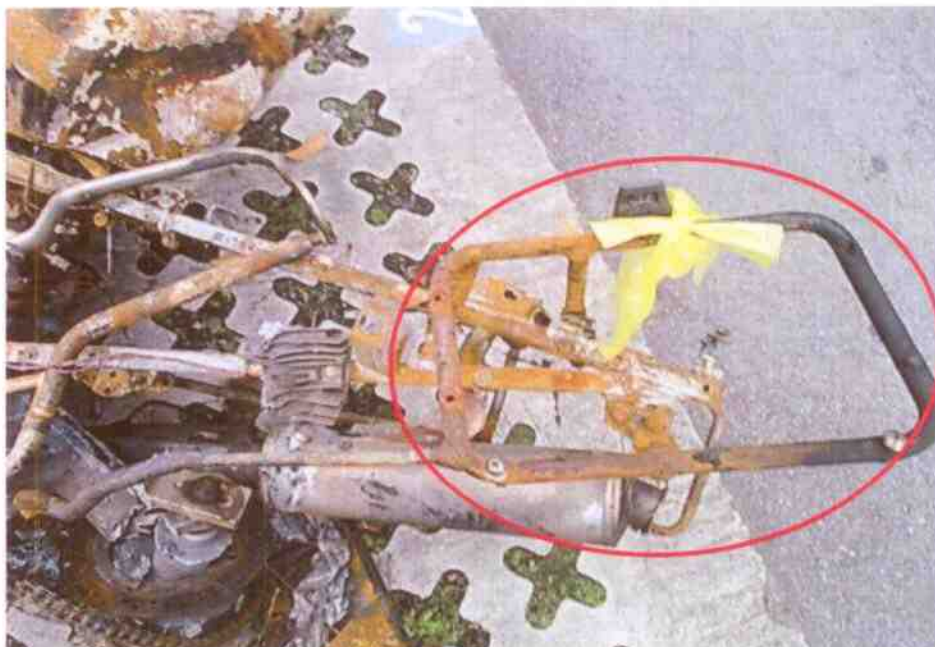
Photo 7 shows the side pannier rack (circled) fitted on the Insured Motorcycle which had accumulated rust as a result of exposure to environmental condition for a period of time.

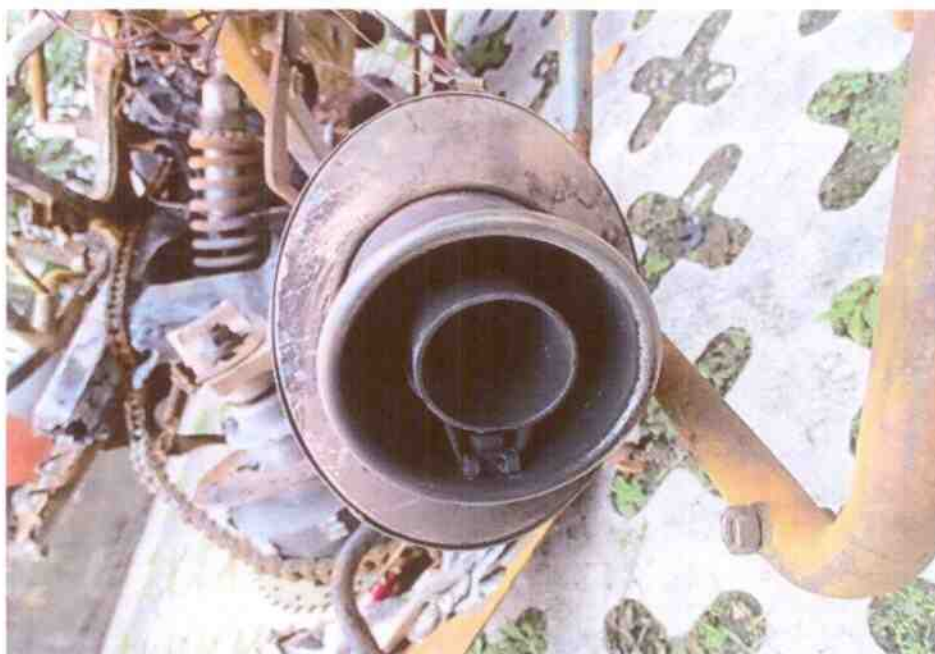
Photo 8 shows the front view of the non-standard rear exhaust muffler that was found to be fitted on the Insured Motorcycle at the time of our inspection.

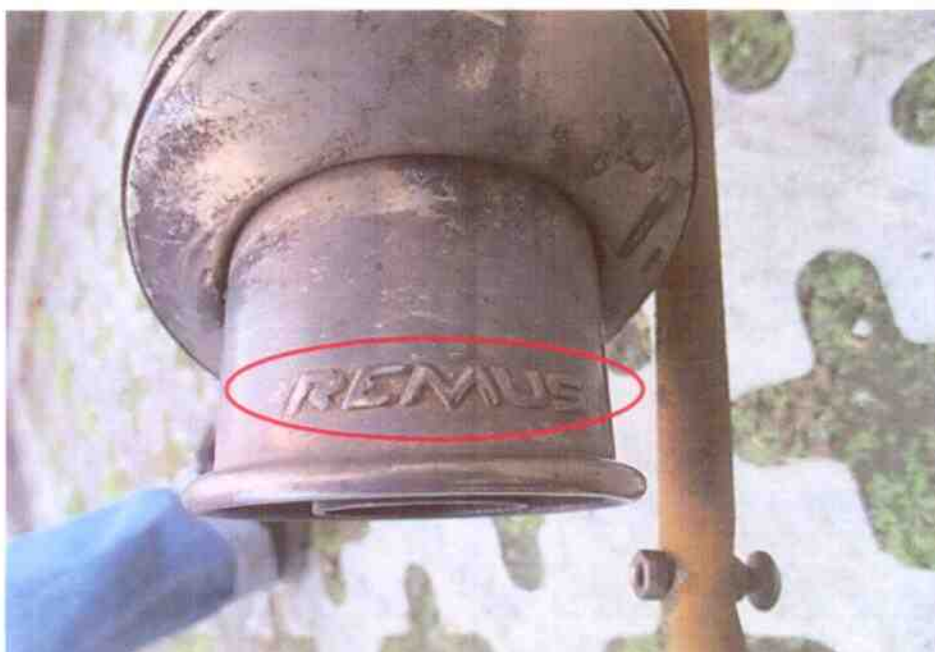
Photo 9 shows a close up top view of the non-standard rear exhaust muffler that was found to be fitted on the Insured Motorcycle at the time of our inspection. The brand of the rear exhaust muffler was 'REMUS' (circled).

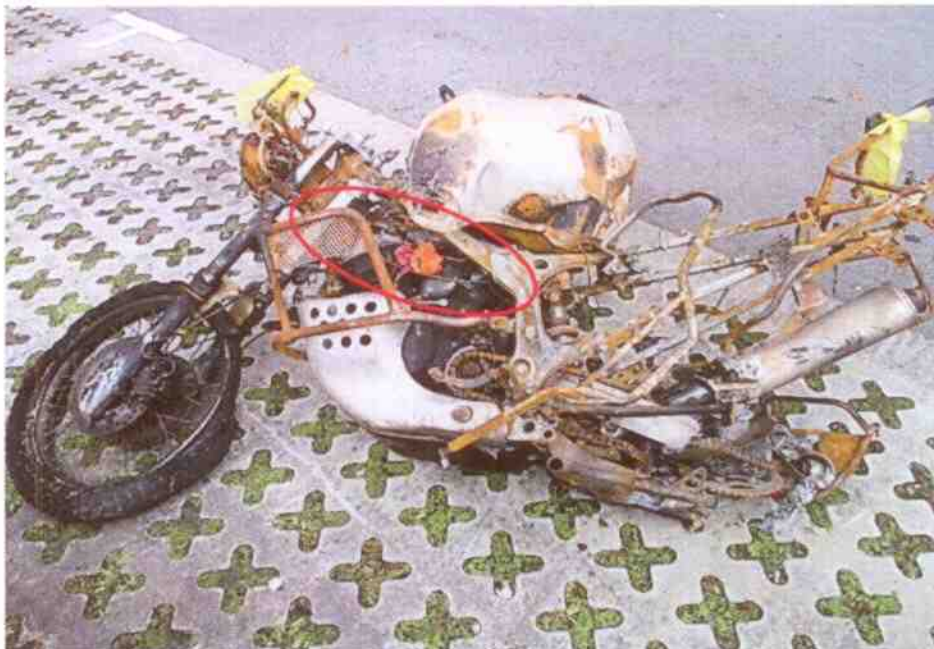
8. Upon closer examination of the left side of the Insured Motorcycle below the fuel tank which was where the fire had likely started, we had found several stretches of wirings with greenish residue. These wirings were original factory fitted wirings. The presence of greenish residue indicates internal heating of copper wires, a sign of an electrical short circuit occurring. The greenish residue is normally left behind from oxidation as a result of chemical reaction involving the copper wires. This physical evidence would appear to suggest that the cause of fire to the Insured Motorcycle could have possibly been due to electrical in nature. See photos 10 – 14 below.

Photo 10 shows a view of the left side of the Insured Motorcycle. Upon closer examination of the left side of the Insured Motorcycle below the fuel tank which was where the fire had likely started, we had found several stretches of wirings with greenish residue (circled). These wirings were original factory fitted wirings. The presence of such greenish residue suggests occurrence of an electrical short circuit.

26. Having investigated and technically analysed the damages of burnt nature to the Insured Motorcycle, we are of the view that the cause of fire to the Insured Motorcycle was of electrical in nature. For this particular case, the fire had originated along the wirings underneath the left side of the fuel tank of the Insured Motorcycle. The wirings were original factory wirings of the Insured Motorcycle.

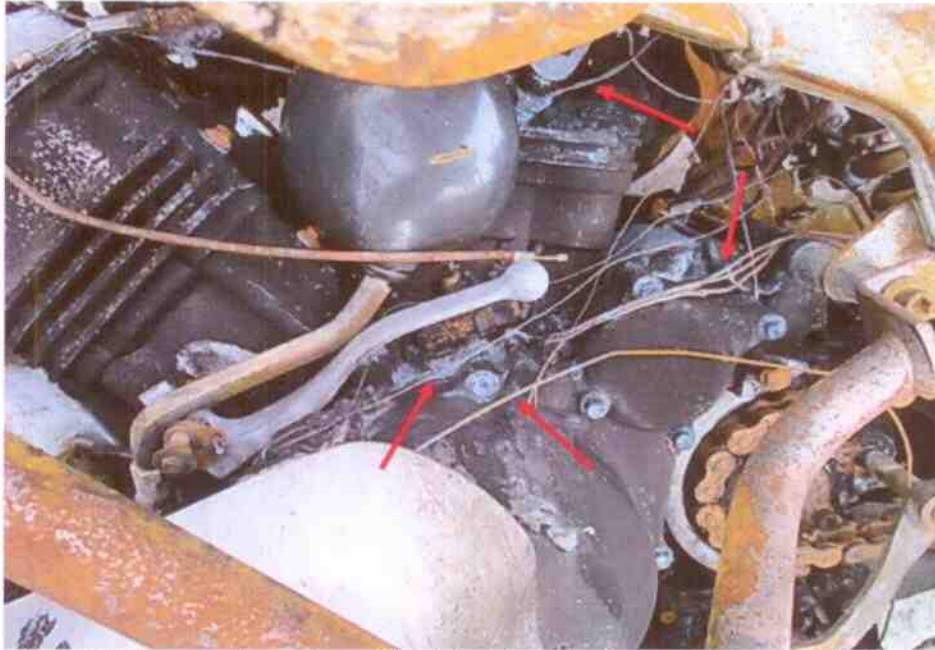
Photo 11 shows a closer view of the left side of the Insured Motorcycle below the fuel tank which was where the fire had likely started. We had found several stretches of wirings with greenish residue (red arrows). The presence of greenish residue indicates internal heating of copper wires, a sign of an electrical short circuit occurring.

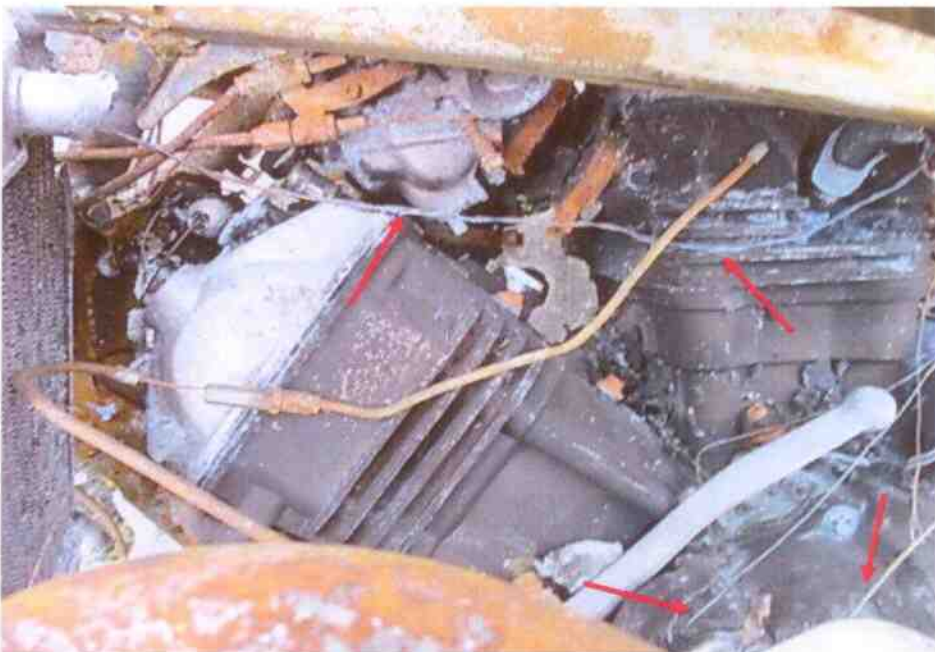
Photo 12 shows a closer view of the wirings with greenish residue (red arrows). The presence of greenish residue indicates internal heating of copper wires, a sign of an electrical short circuit occurring.

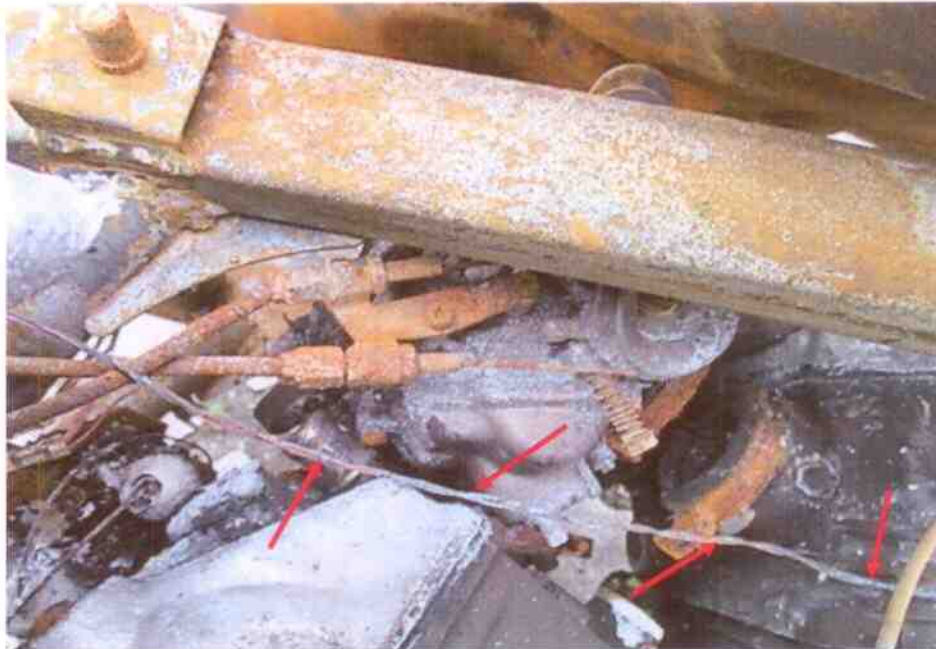
Photo 13 shows a close up view of the wirings with greenish residue (red arrows). The presence of greenish residue indicates internal heating of copper wires, a sign of an electrical short circuit occurring.

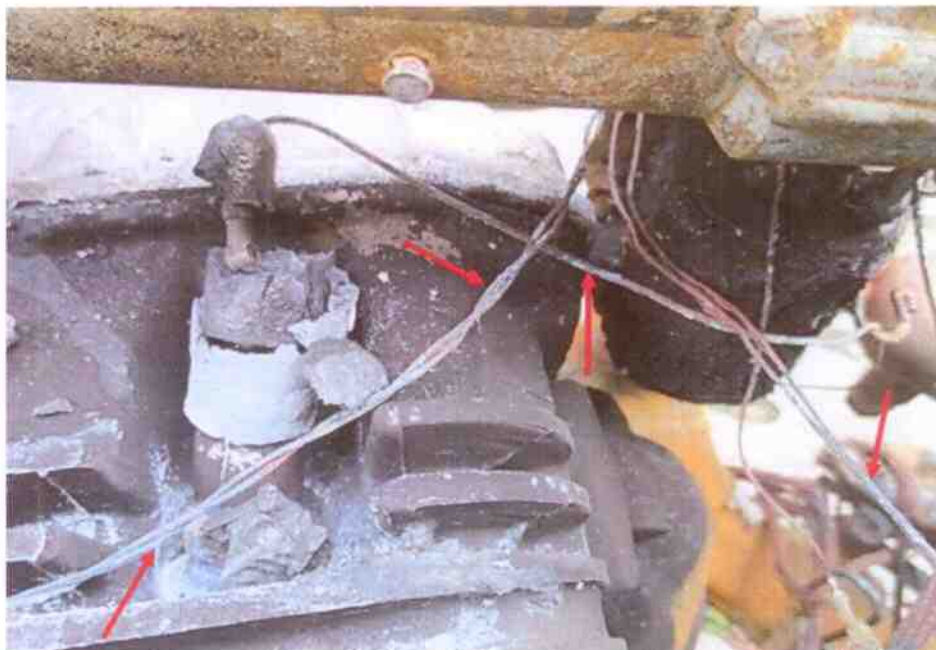
Photo 14 shows a close up view of the wirings with greenish residue (red arrows). The presence of greenish residue indicates internal heating of copper wires, a sign of an electrical short circuit occurring.

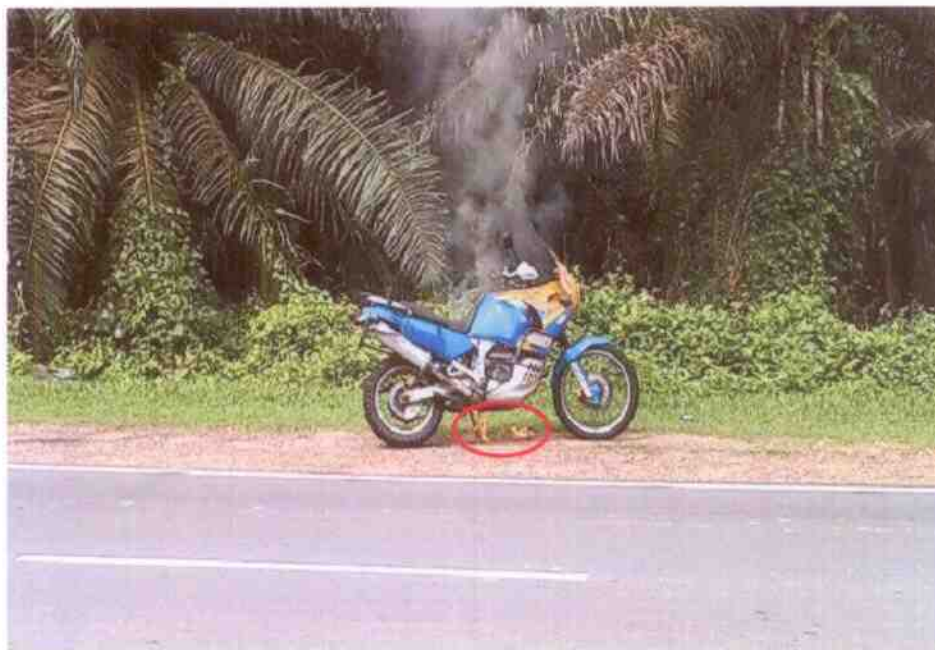
Photo 17 shows the Insured Motorcycle after the fire had started (circled). In general, the information that could be gathered from this photograph had corresponded to the events that were related to us by Mr Simon, which is the fire started from the left side.

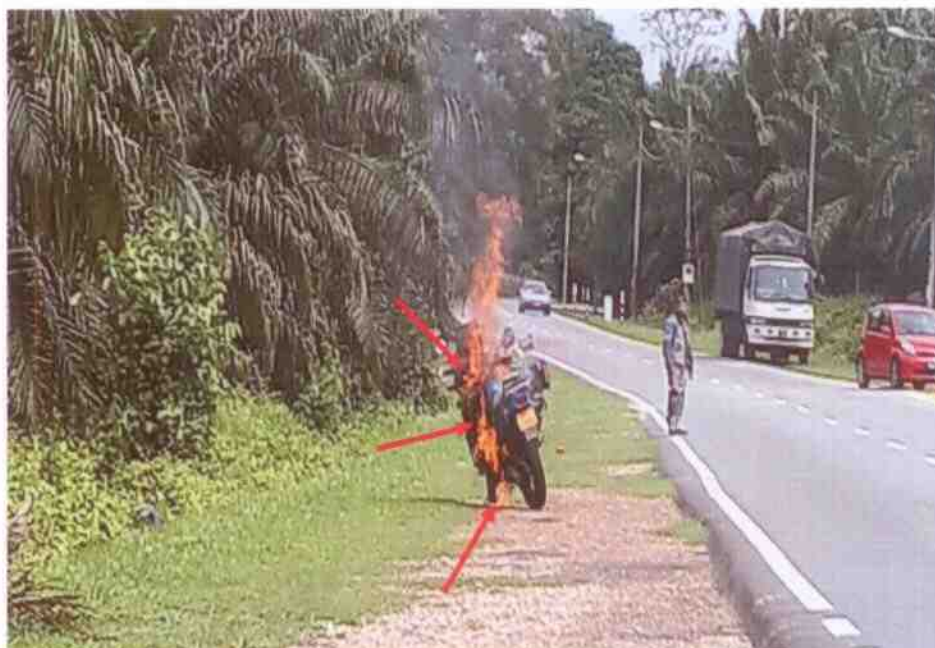
Photo 18 shows the rear view of the Insured Motorcycle as the fire began to spread. In general, the information that could be gathered from this photograph had corresponded to the events that were related to us by Mr Simon, which is the fire started from the left side (red arrows).

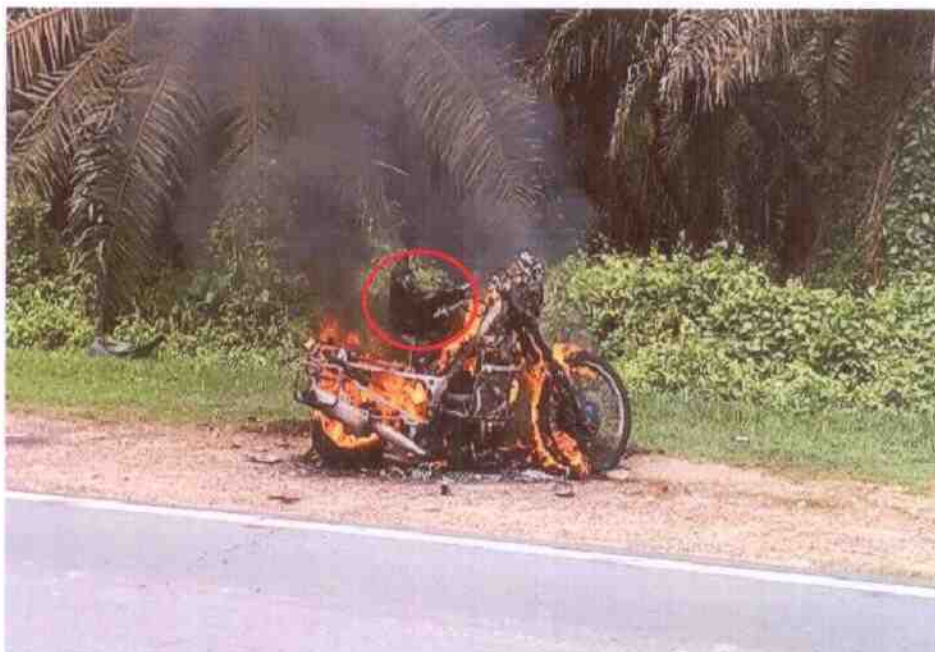
Photo 19 shows flames engulfing the Insured Motorcycle. In general, the information that could be gathered from this photograph had corresponded to the events that were related to us by Mr Simon, which is the fuel tank exploded shortly after the fire broke out (circled).

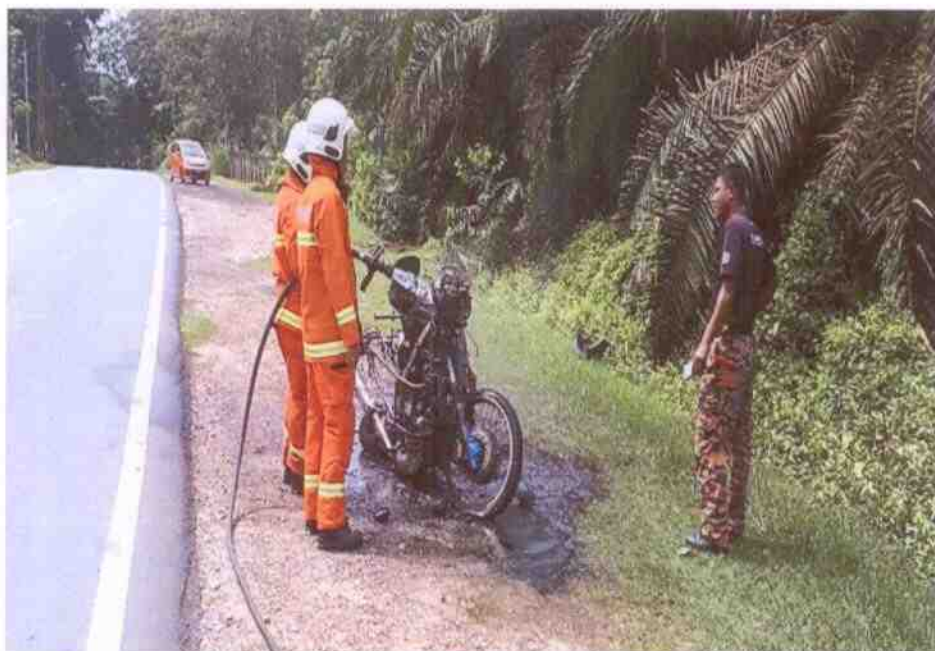
Photo 20 shows Malaysian firefighters extinguishing the last remnants of the fire to the Insured Motorcycle.
