Your Ref: TP/IP/52793/2017  
Our Ref : CI/TPD17022962/Z

**Fatal Accident Investigation Team**

**MECHANICAL INSPECTION REPORT OF MOTOR TAXI SHA 8770H**

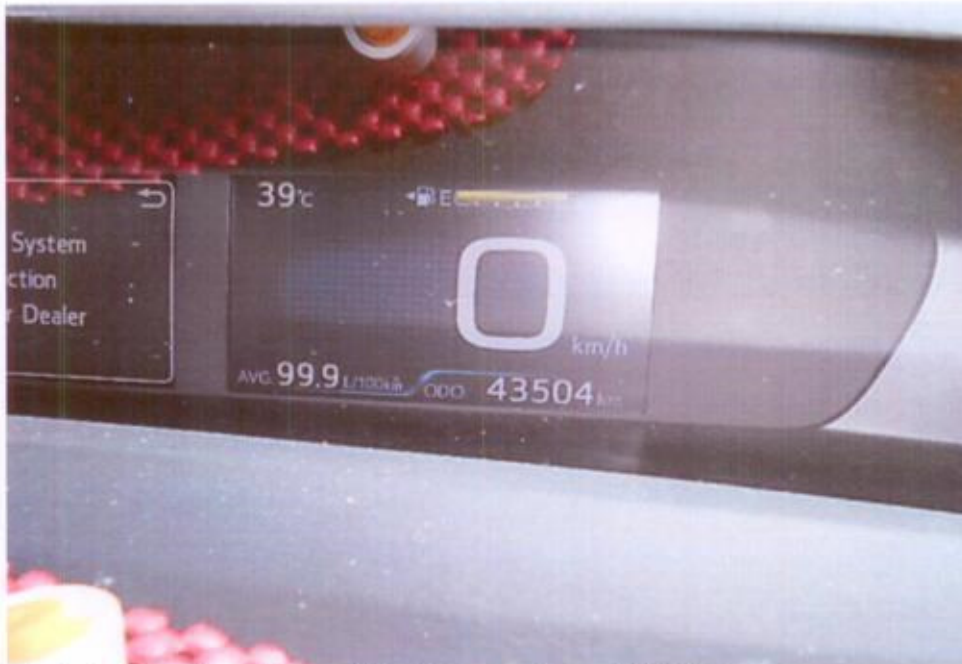
**Photo 1** shows the mileage of the Motor Taxi was 43,504 km.

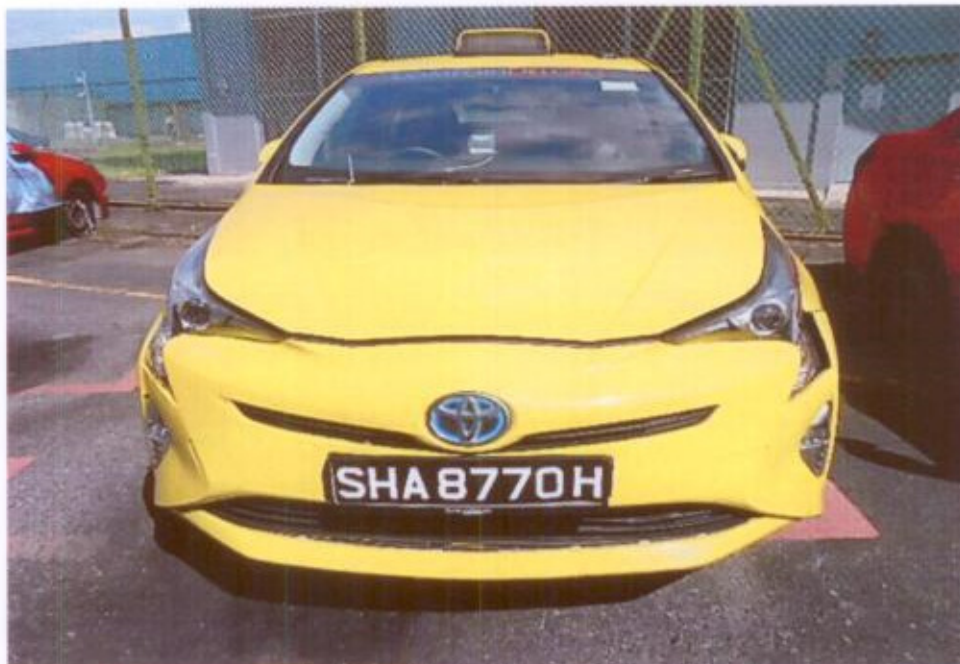
4. The mileage of the Motor taxi at the time of our inspection was 43,504 km.
5. The Motor taxi had sustained a relatively minor impact damages that was confined to its frontal portion. Its front left hand outer pillar was observed to have been dented; its front left hand lower bumper was observed to have scratches & broken clips; its number plate & base was observed to have been dented; its front plastic grille was noted to be deformed & its front left windshield was observed to have cracks.

**Photo 2** shows a general view of the front body of the Motor Taxi at the time of our inspection. The Motor Taxi was observed to be in good general condition except for minor damages at the frontal portion.

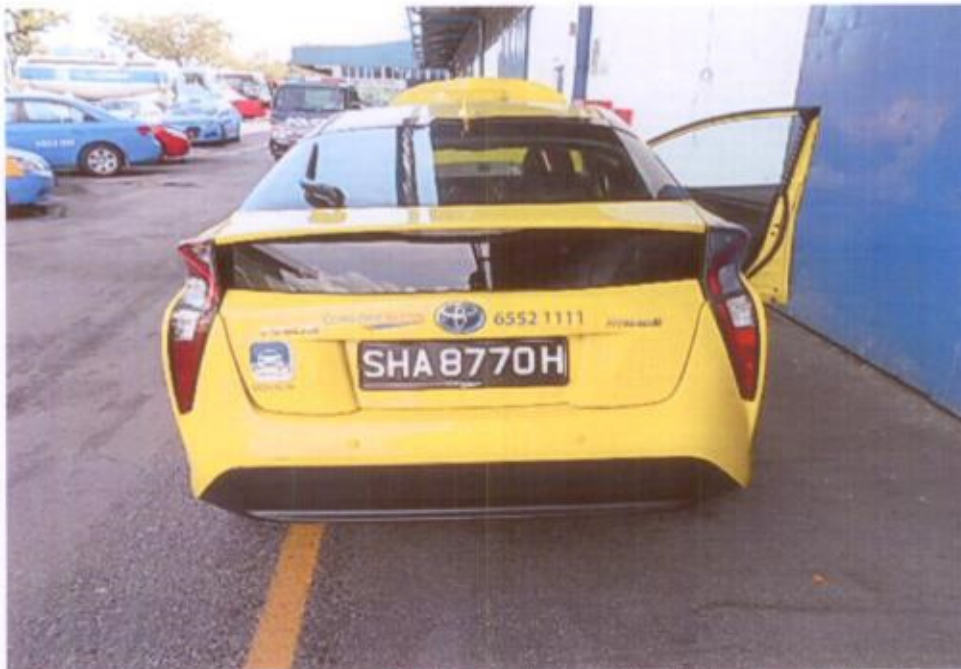
**Photo 3** shows a general view of the rear body of the Motor Taxi at the time of our inspection. The Motor Taxi was observed to be in good general condition.

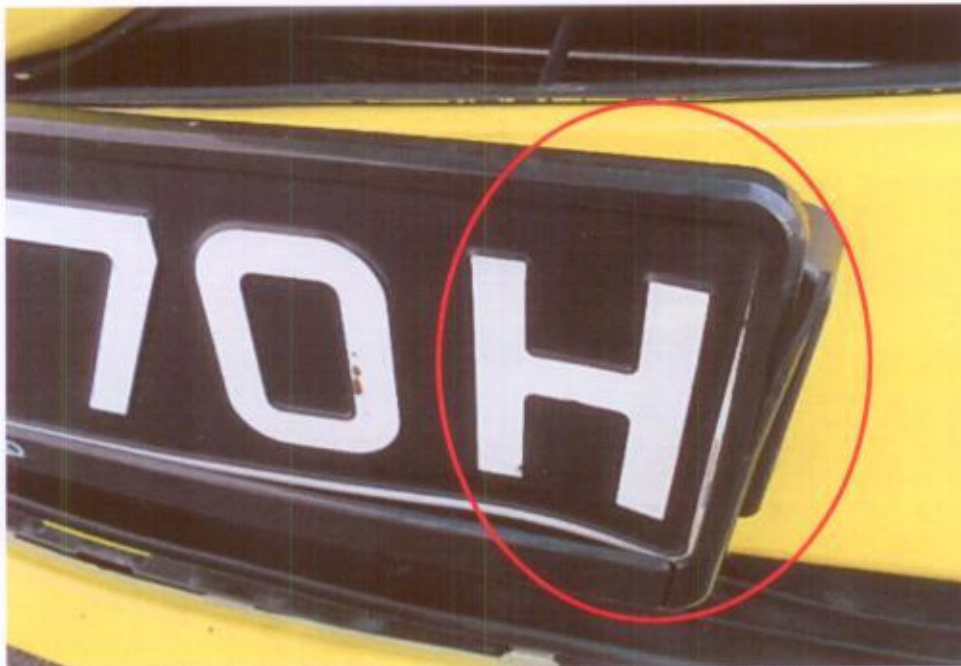
**Photo 4** shows a close up view of the front number plate/base of the Motor Taxi at the time of our inspection. The Motor Taxi had sustained relatively minor impact at the front number plate/base of the Motor Car.

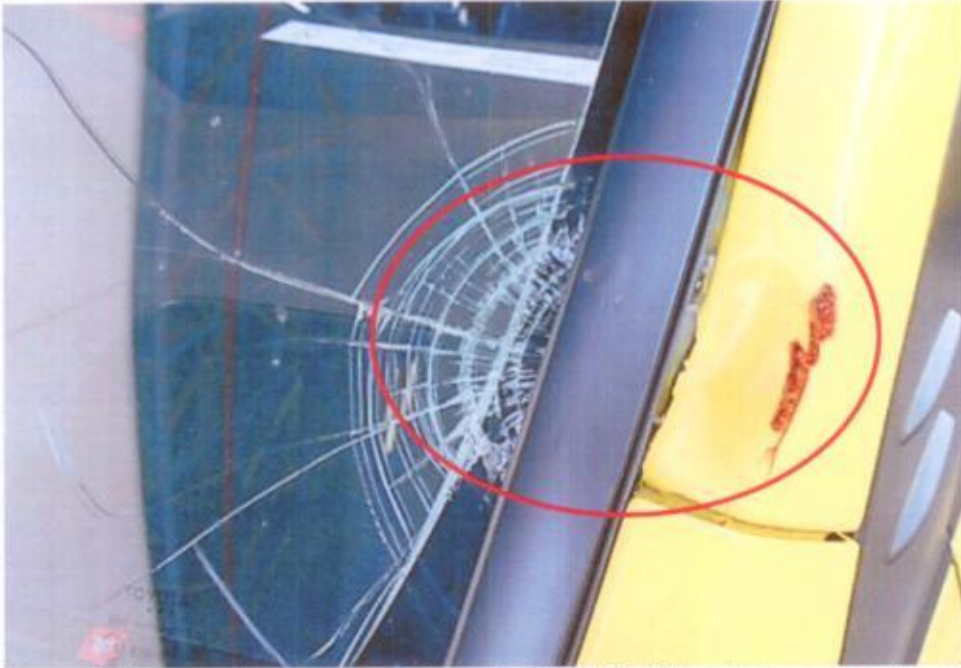
**Photo 5** shows a close up view of the windshield & left hand door outer pillar of the Motor Taxi at the time of our inspection. It was observed to have sustained relatively minor impact at the highlighted area of the Motor Taxi.

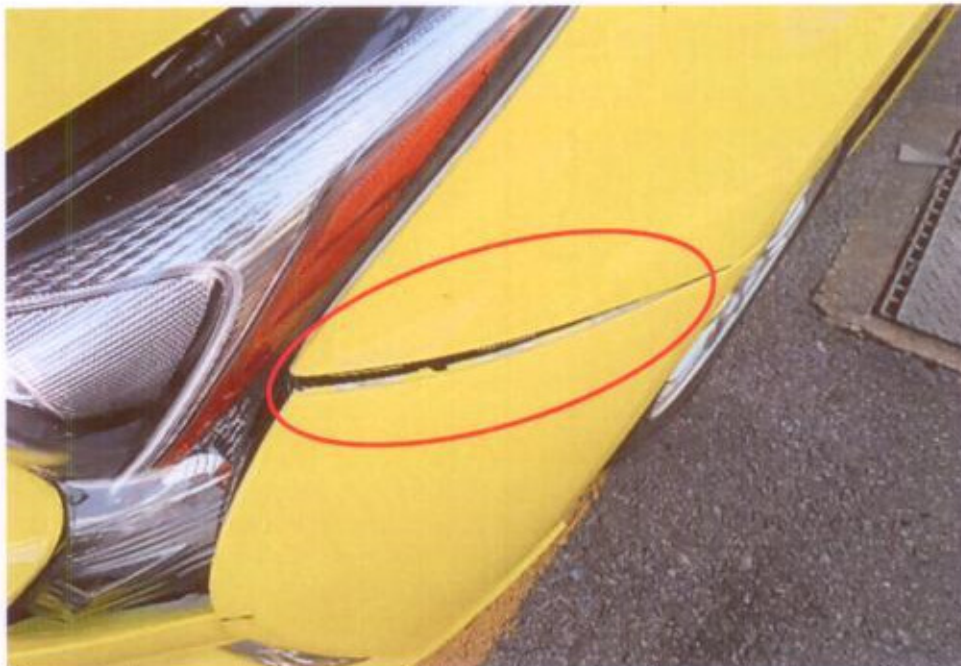
**Photo 6** shows a close up view of the front bumper of the Motor Taxi at the time of our inspection. The Motor Taxi had sustained relatively minor impact at the front bumper of the Motor Taxi.

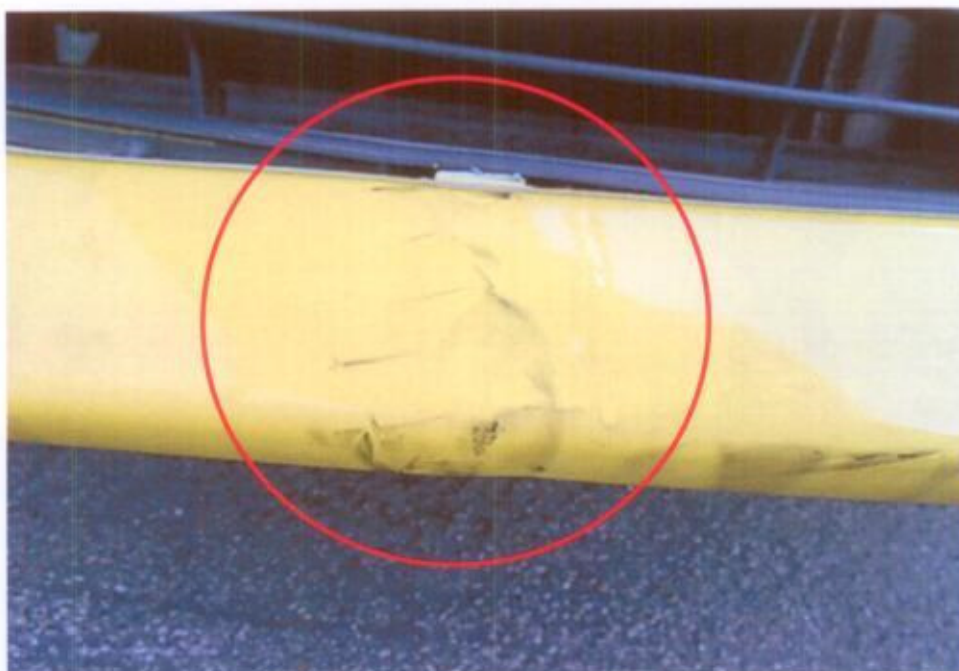
**Photo 7** shows a close up view of the lower bumper of the Motor Taxi at the time of our inspection. The Motor Taxi had sustained relatively minor impact at the lower bumper of the Motor Taxi.

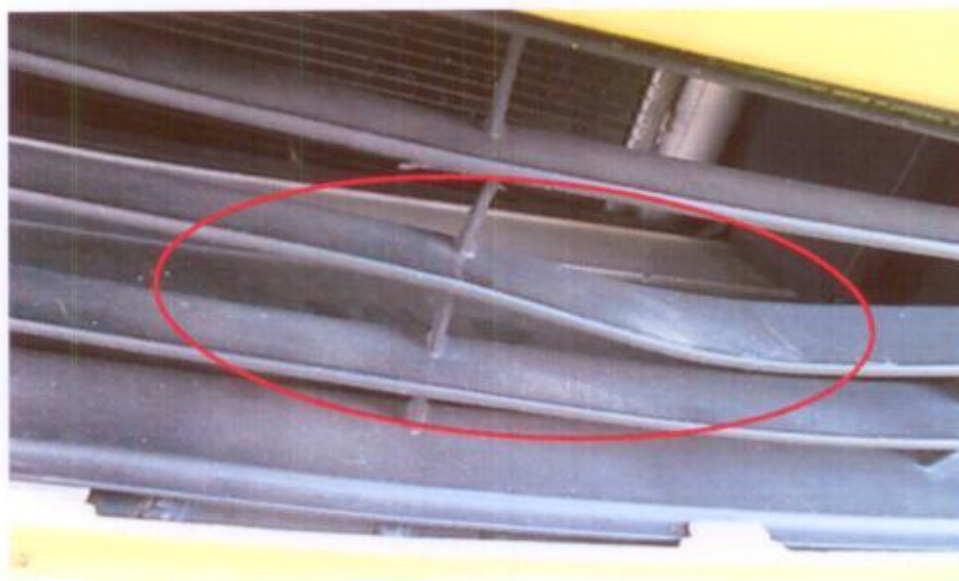
**Photo 8** shows a close up view of the front plastic grille of the Motor Taxi at the time of my inspection. The Motor Taxi had sustained relatively minor scratch at the headlight of the Motor Taxi.

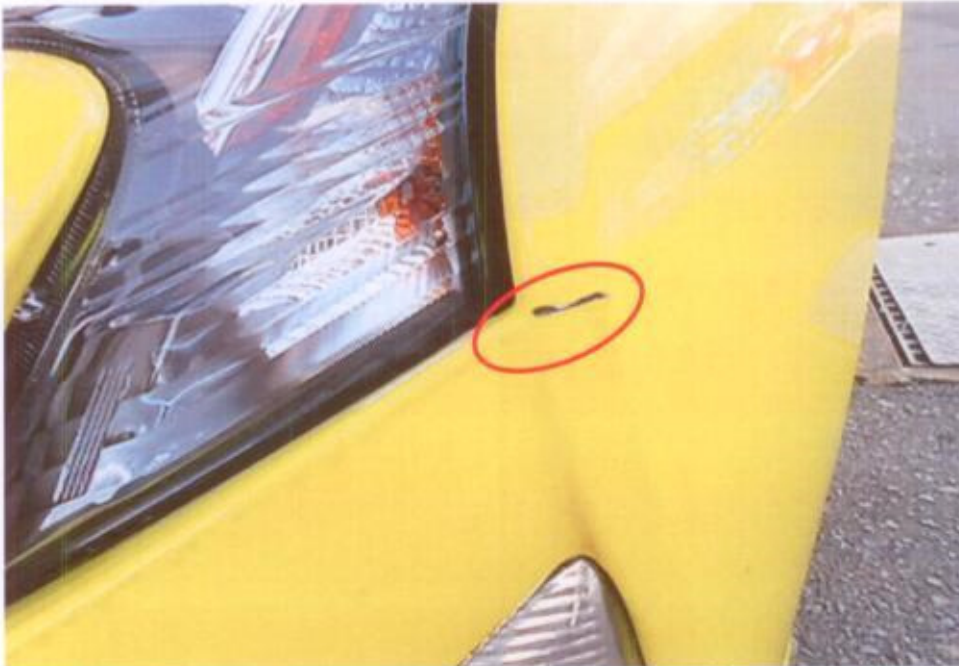
**Photo 9** shows a close up view of the front bumper of the Motor Taxi at the time of our inspection. The Motor Taxi had sustained relatively minor scratch at the front bumper of the Motor Taxi.

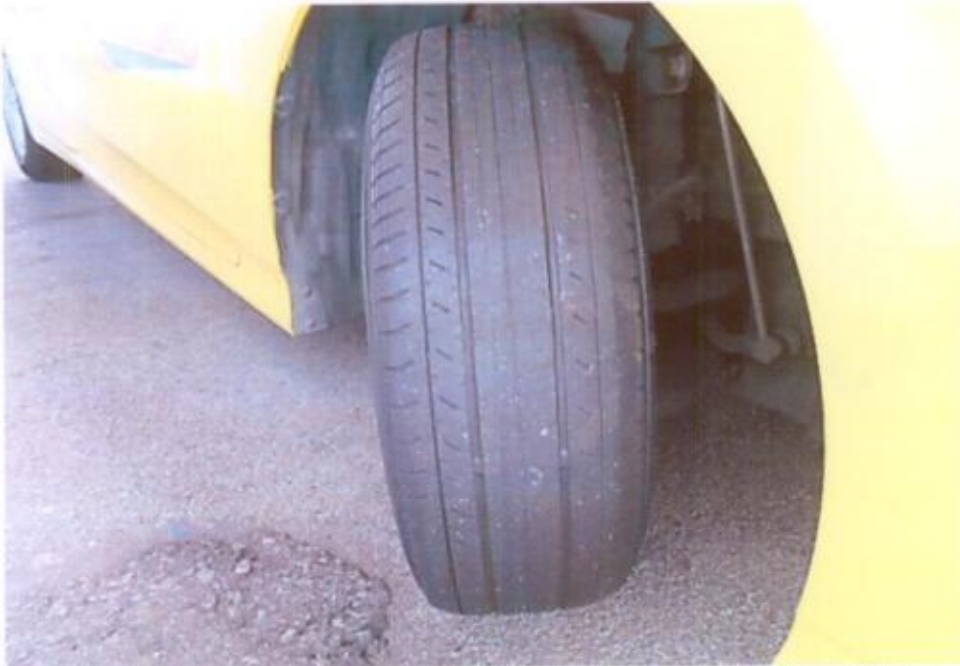
7. The 4 tyres were observed to be wrapped around alloy wheel rims that were found to be without any significant damage except for some marks of grazing nature on the outer spokes of the wheel rims, which are commonly associated to grazing against a road kerb. See photo 10 – 13 below.

**Photo 10** shows the condition of the front right tyre of the Motor Taxi, which was observed to be in serviceable condition with remaining tread depth of approximately 3mm. There was no tear, cut or burst mark(s) on the outer and the inner sidewalls.

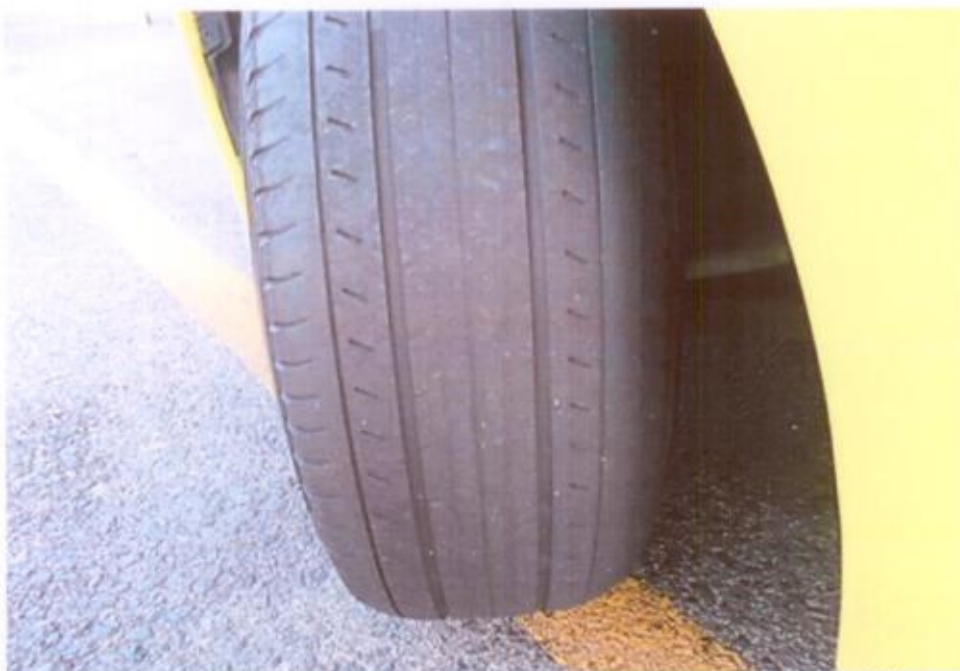
**Photo 11** shows the condition of the front left tyre of the Motor Taxi, which was observed to be in serviceable condition with remaining tread depth of approximately 4mm. The tyre, which was wrapped around alloy wheel rim, was also observed to be sufficiently inflated for vehicular operation.

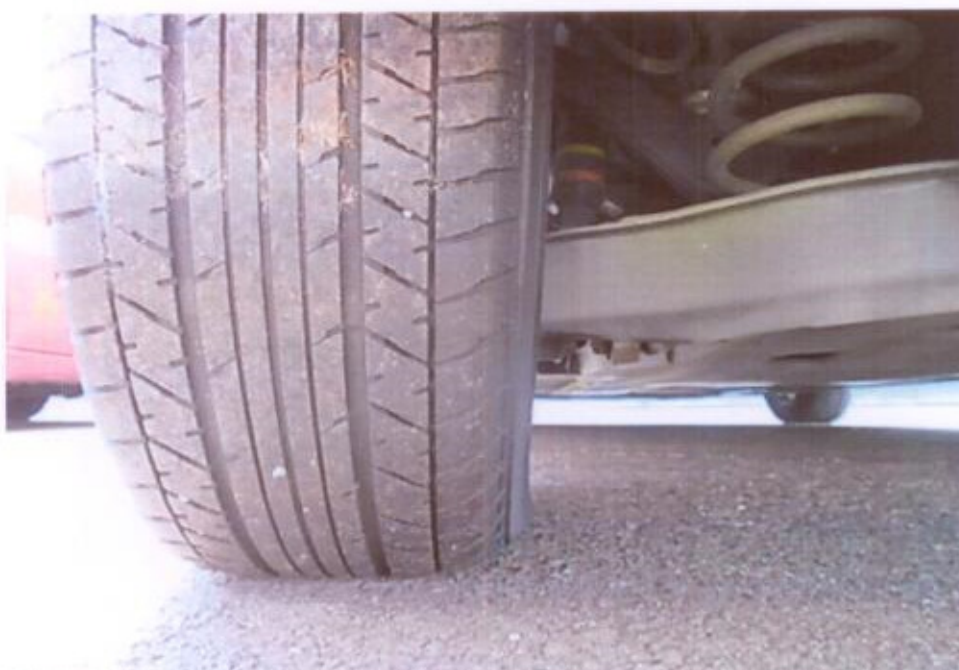
**Photo 12** shows the condition of the rear left tyre of the Motor Taxi, which was observed to be in serviceable condition with remaining tread depth of approximately 5mm. The tyre, which was wrapped around alloy wheel rim, was also observed to be sufficiently inflated for vehicular operation.

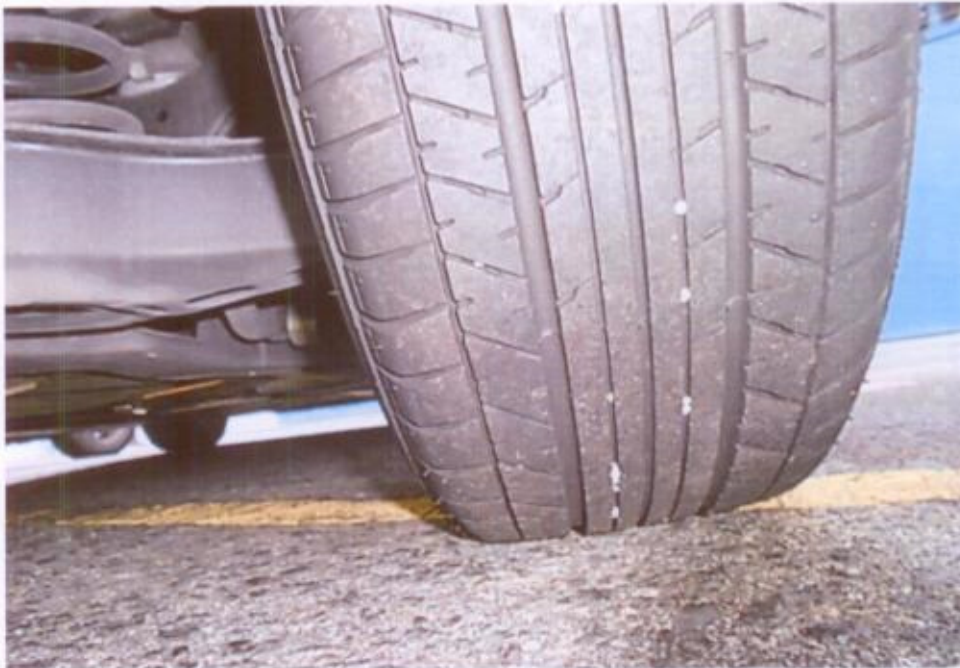
**Photo 13** shows the condition of the rear right tyre of the Motor Taxi, which was observed to be in serviceable condition with remaining tread depth of approximately 5mm. There was also no tear, cut or burst mark(s) on the outer and the inner sidewalls as well as across the tread of the 4 tyres.

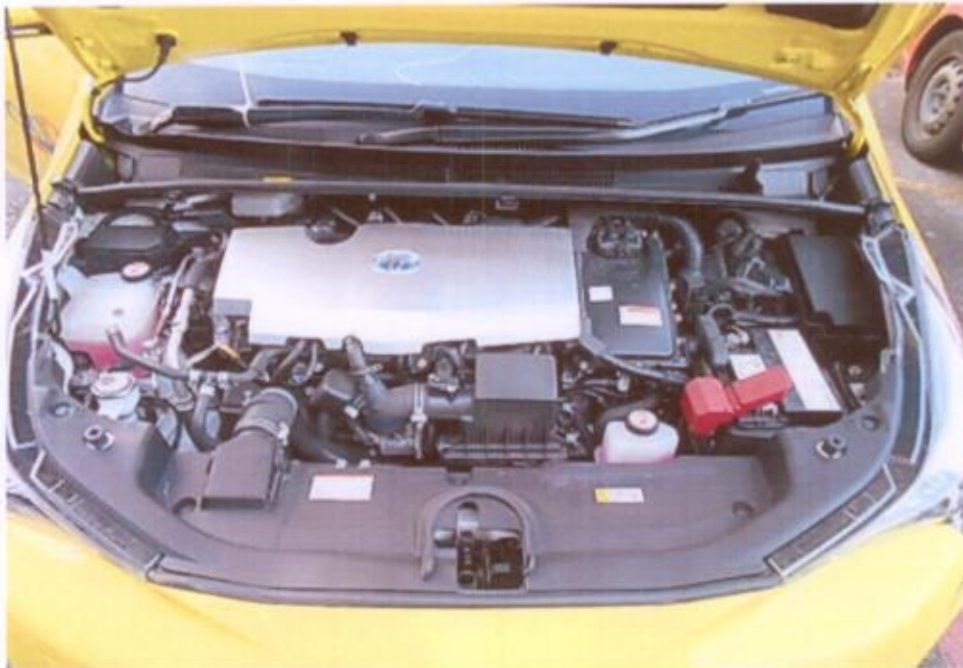
**Photo 14** shows a general view of the Motor Car's engine compartment. The various parts and components inside the engine compartment were unaffected by the accident. There was also no sign(s) or indication(s) of fluid leakage and/or fluid stain within the engine compartment.

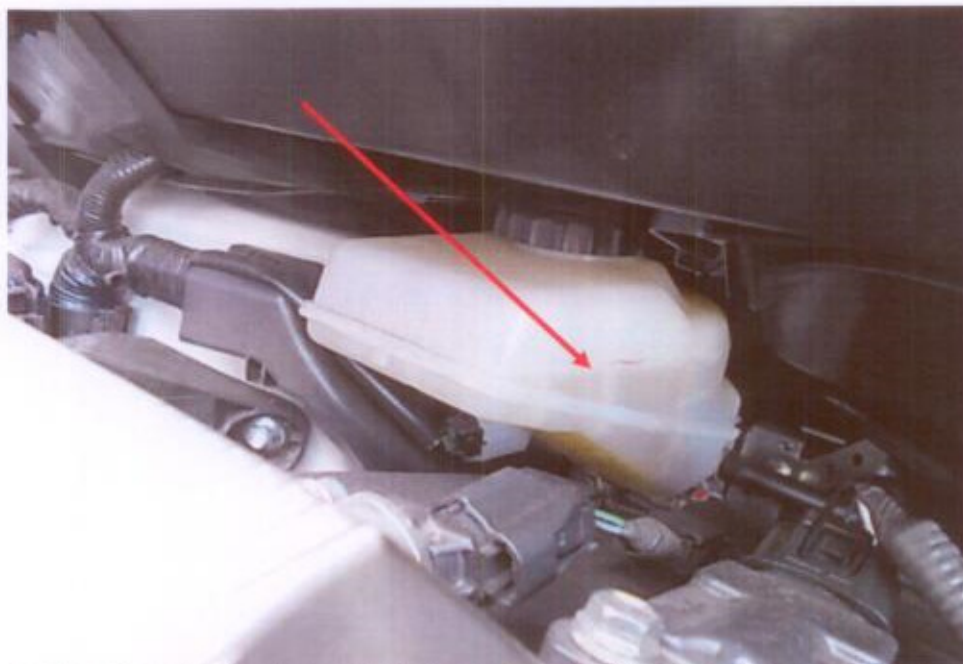
**Photo 15** shows the brake fluid reservoir of the Motor Taxi at the time of our inspection. The brake fluid was observed to be of sufficient level (arrowed) and without any visible contamination.

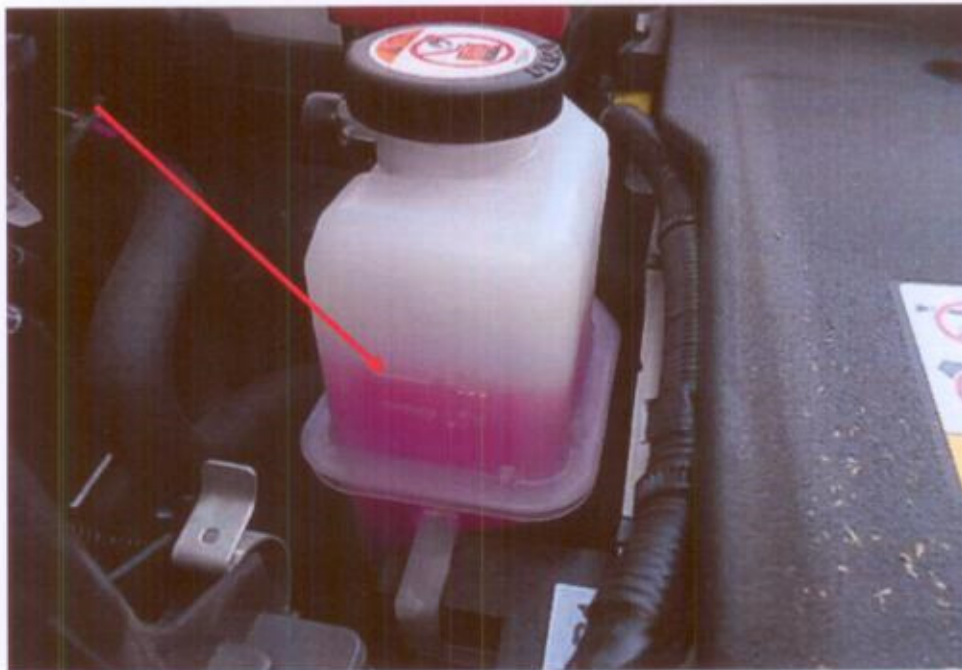
**Photo 16** shows the engine coolant fluid reservoir of the Motor Taxi at the time of our inspection. The engine coolant fluid was observed to be of sufficient level and without any visible contamination.

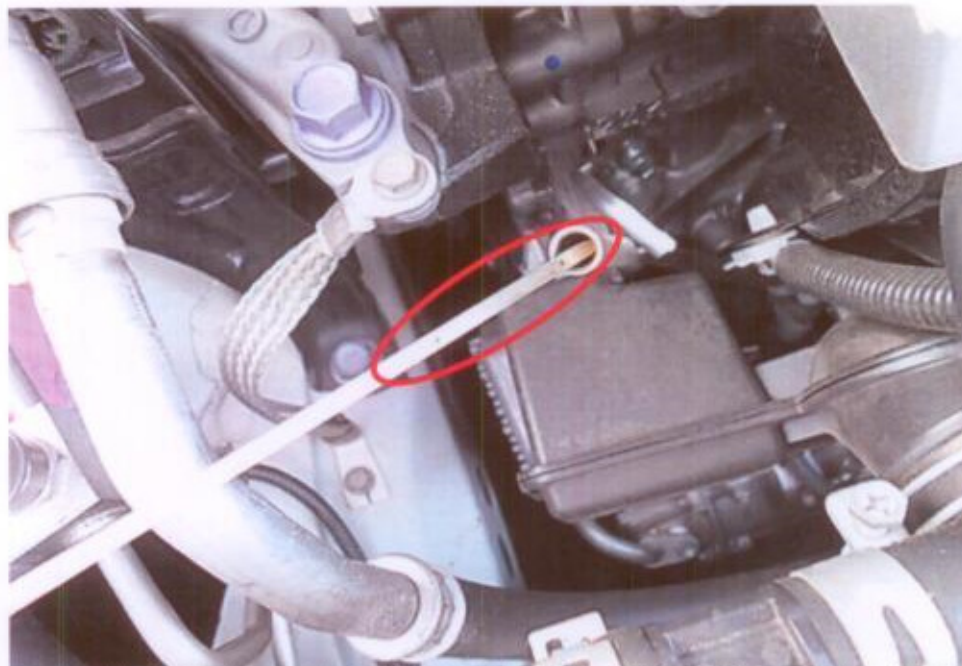
**Photo 17** shows the engine oil dip stick of the Motor Taxi at the time of our inspection. The engine oil was observed to be of sufficient level and without any visible contamination.

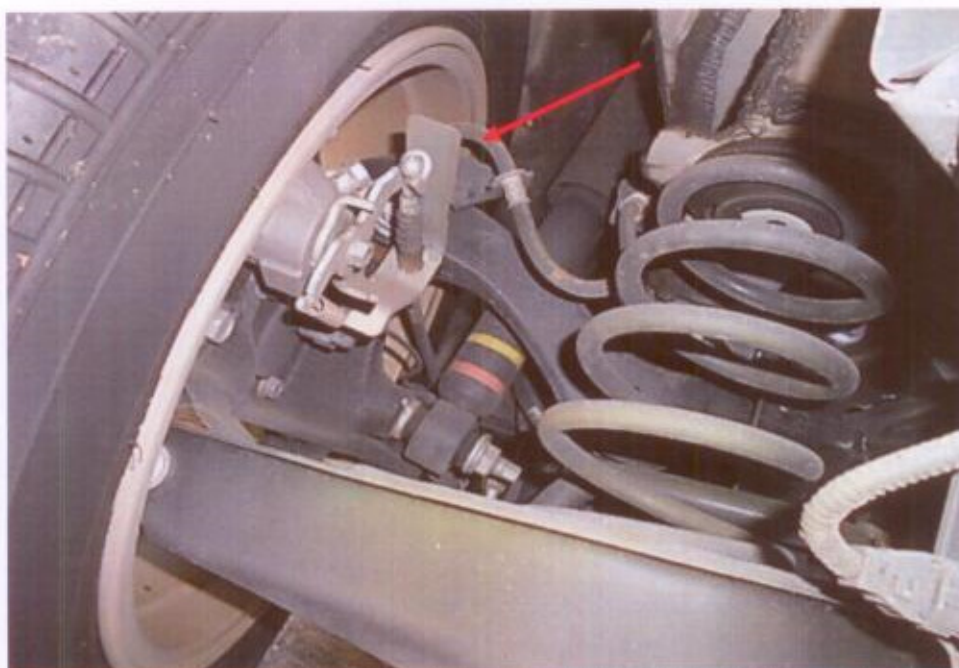
**Photo 18** shows the brake hose (arrowed) at the rear left wheel of the Motor Taxi. We did not observe any leakage of brake fluid at the time of our inspection of the Motor Taxi. Our visual inspection of the various mechanical components of the Motor Taxi's braking system revealed all to be intact and without visible damage, indicating that the braking system was likely to be in serviceable condition at the material time of accident.

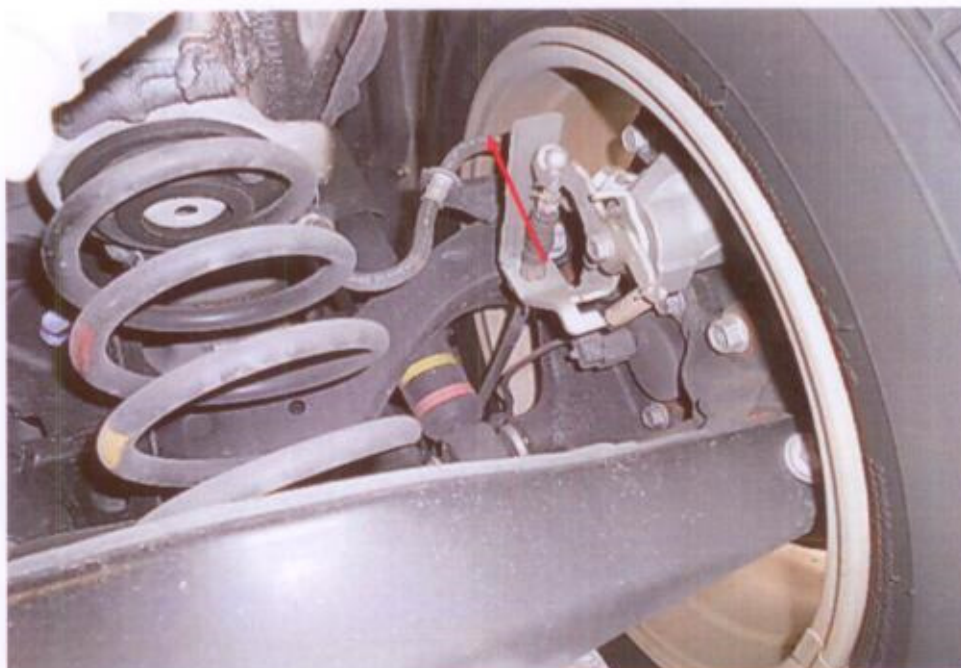
**Photo 19** shows the brake hose (arrowed) at the rear right wheel of the Motor Taxi. We did not observe any leakage of brake fluid at the time of our inspection of the Motor Taxi. Our visual inspection of the various mechanical components of the Motor Taxi's braking system, including its brake calliper (circled), revealed all to be intact and without visible damage, indicating that the braking system was likely to be in serviceable condition at the material time of accident.

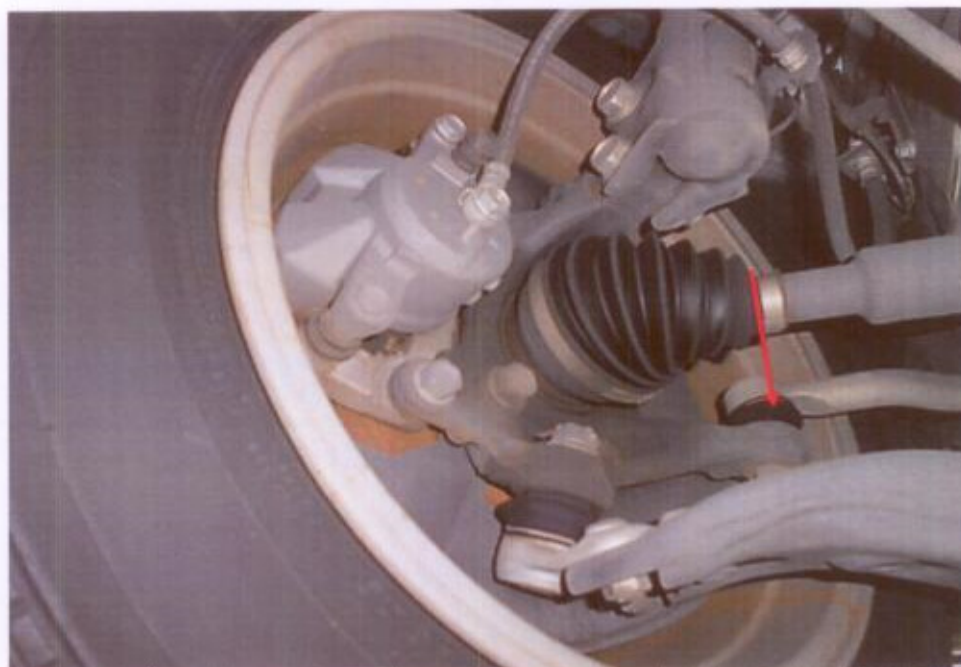
**Photo 20** shows the various undercarriage components at the front right wheel of the Motor Taxi, in particular the steering tie rod (arrowed). The various steering components were all found to be intact, suggesting that the steering system of the Motor Taxi was likely to be in serviceable condition.

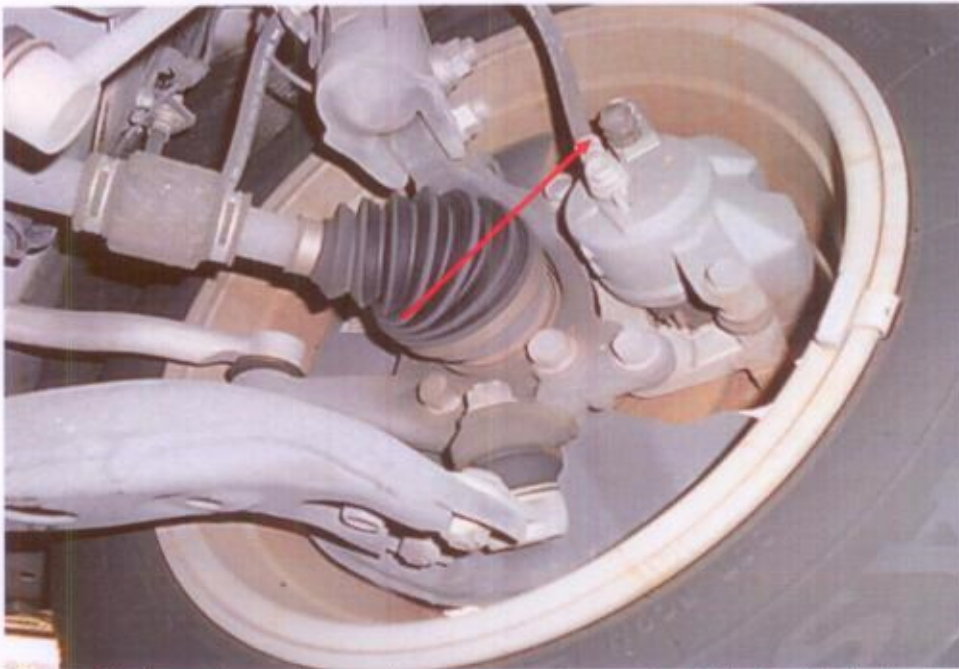
**Photo 21** shows the various undercarriage components at the front left wheel of the Motor Taxi. We did not observe any leakage of brake fluid (arrowed) at the time of our inspection of the Motor Taxi. Our visual inspection of the various mechanical components of the Motor Taxi's braking system revealed all to be intact and without visible damage, indicating that the braking system was likely to be in serviceable condition at the material time of accident.

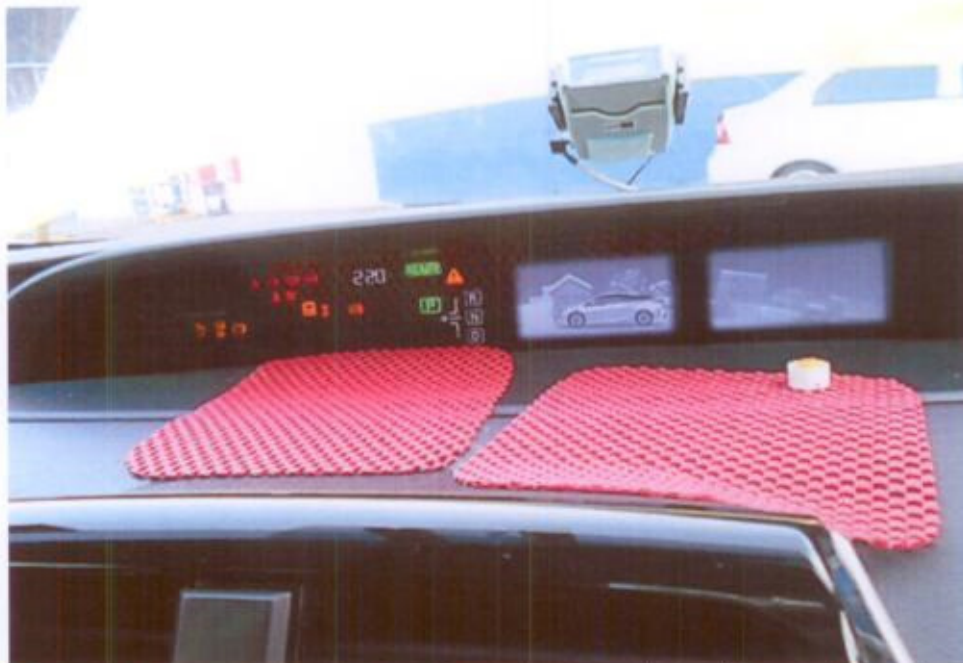
**Photo 22** shows the warning lights for the various electronic operating systems of the Motor Taxi appearing on its instrument panel during the self-test when the engine is cranked, in particular the ABS light and SRS light.

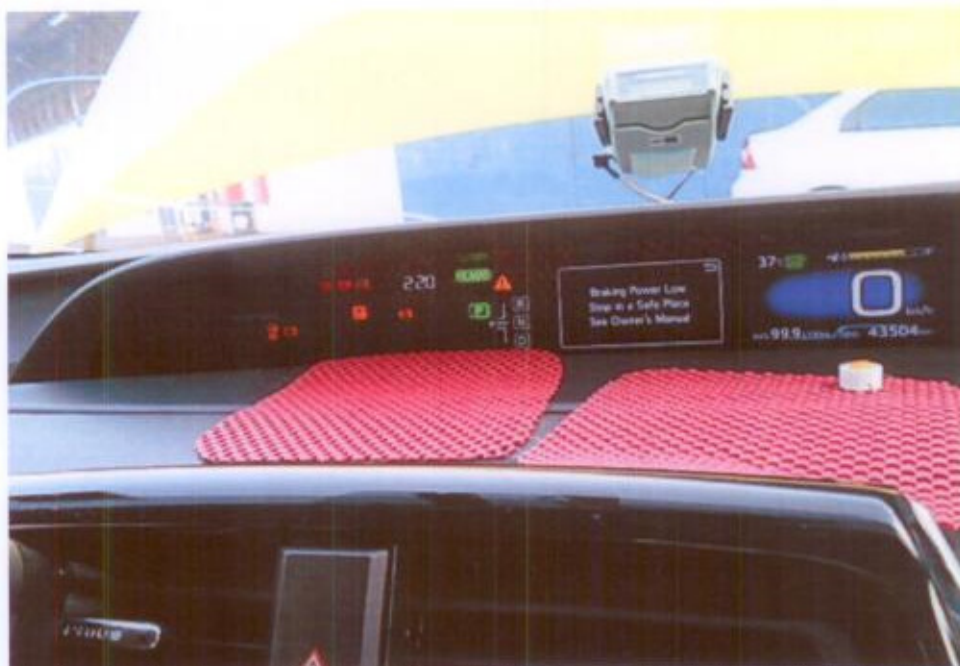
**Photo 23** shows no warning lights illuminated on the instrument panel of the Motor Taxi after the engine was cranked. This would suggest that there was no abnormality to the various electronic operating systems of the Motor Taxi, like the ABS and SRS.

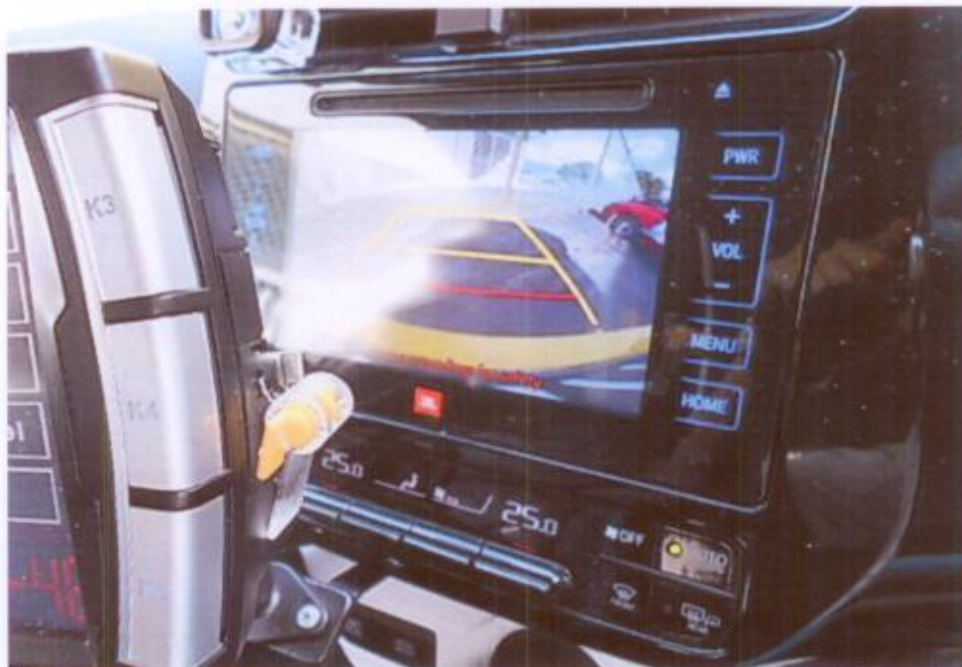
**Photo 24** shows reverse sensor camera on the LCD panel of the Motor Taxi while performing operational test. This would suggest that it was able to move forward and backward normally.
