Your Ref: TP/IP/52001/2017
Our Ref : CI/TPD17022963/Z

05th December 2017

MECHANICAL INSPECTION REPORT OF MOTOR TAXI SHC 8826X

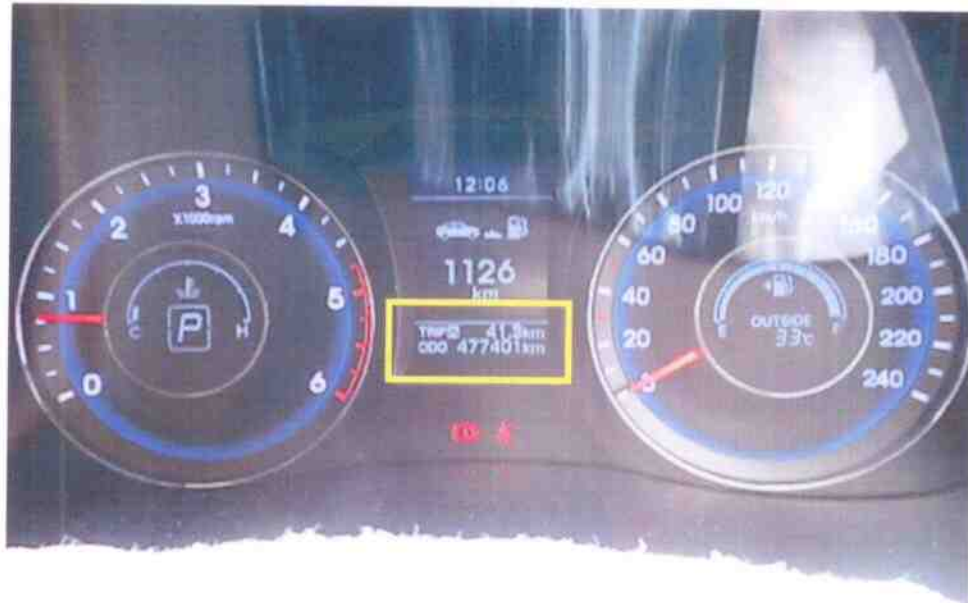
Photo 1 shows the mileage of the Motor Taxi was 477,401 km.

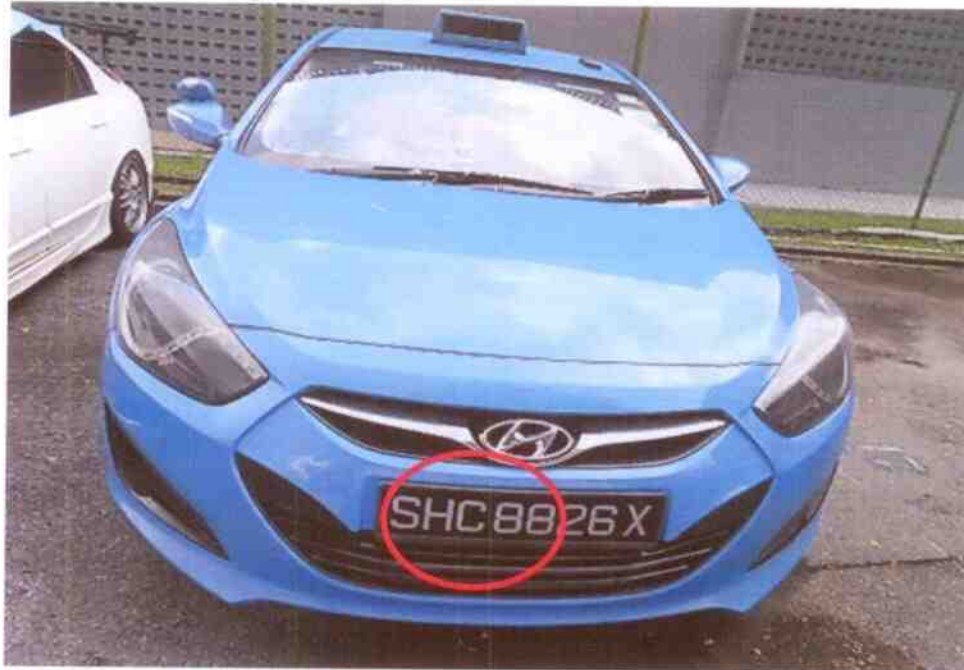
4. The mileage of the Motor taxi at the time of our inspection was 477,401 km.
5. The Motor taxi had sustained a relatively minor impact damages that was confined to its frontal portion. Its front number plate was observed to have minor crack likely due to the accident.

Photo 2 shows a general view of the front body of the Motor Taxi at the time of our inspection. The Motor Taxi was observed to be in good general condition except for minor damages at the frontal portion.

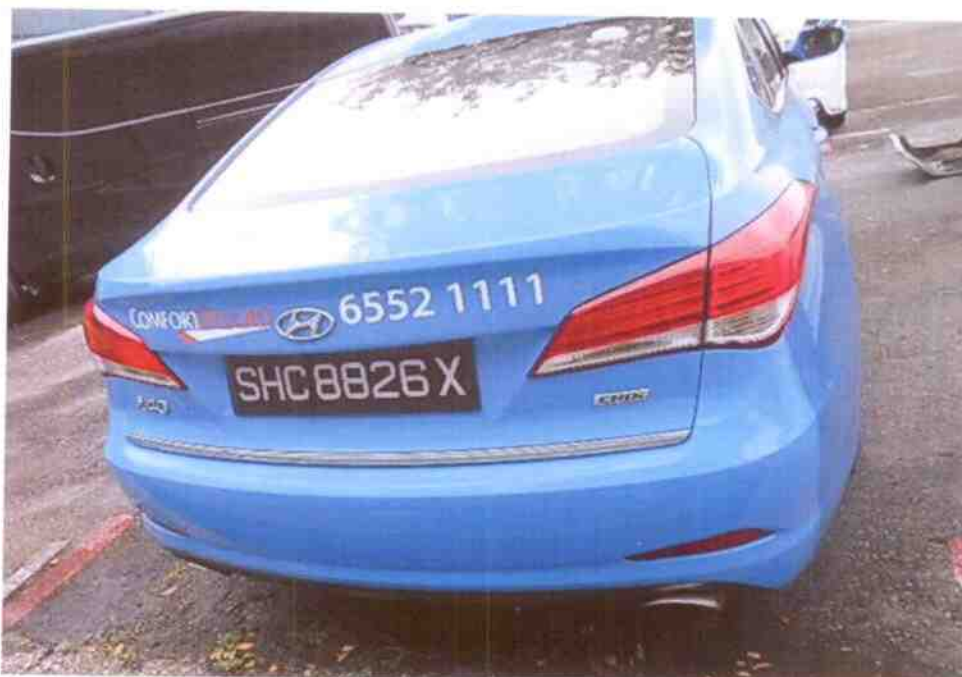
Photo 3 shows a general view of the rear body of the Motor Taxi at the time of our inspection. The Motor Taxi was observed to be in good general condition.

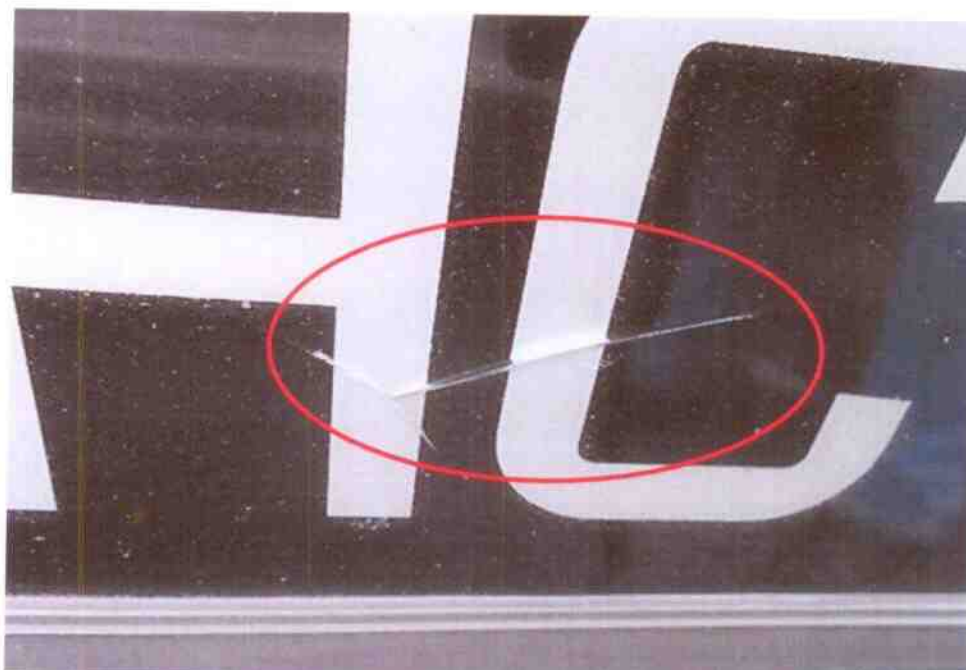
Photo 4 shows a close up view of the front number plate of the Motor Taxi at the time of our inspection. The Motor Taxi had sustained relatively minor crack at the front number plate of the Motor Car.

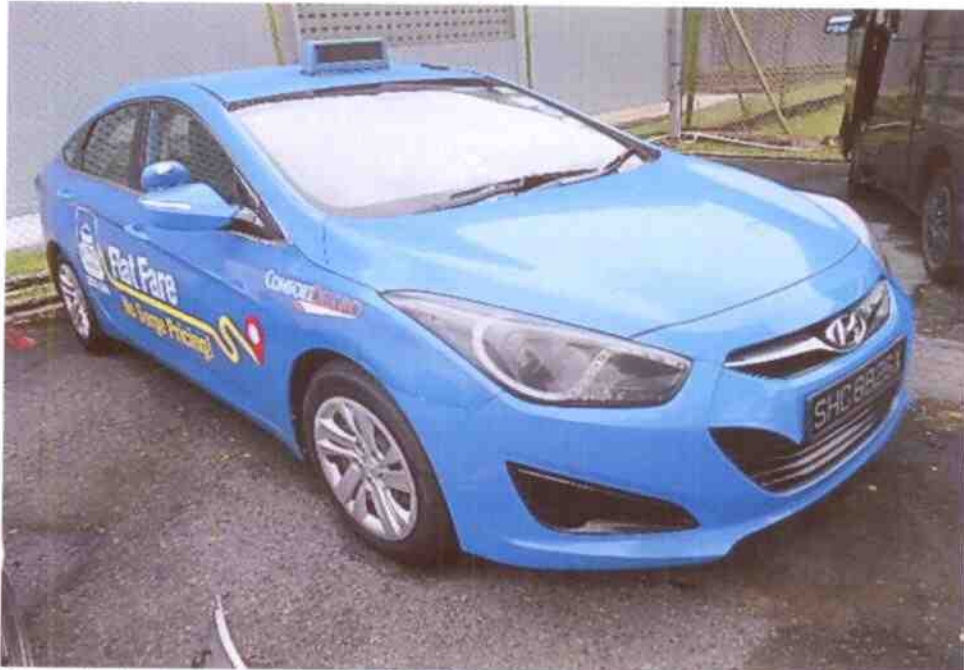
Photo 5 shows a general view of the front right body of the Motor Taxi at the time of our inspection. The Motor Taxi was observed to be in good general condition.

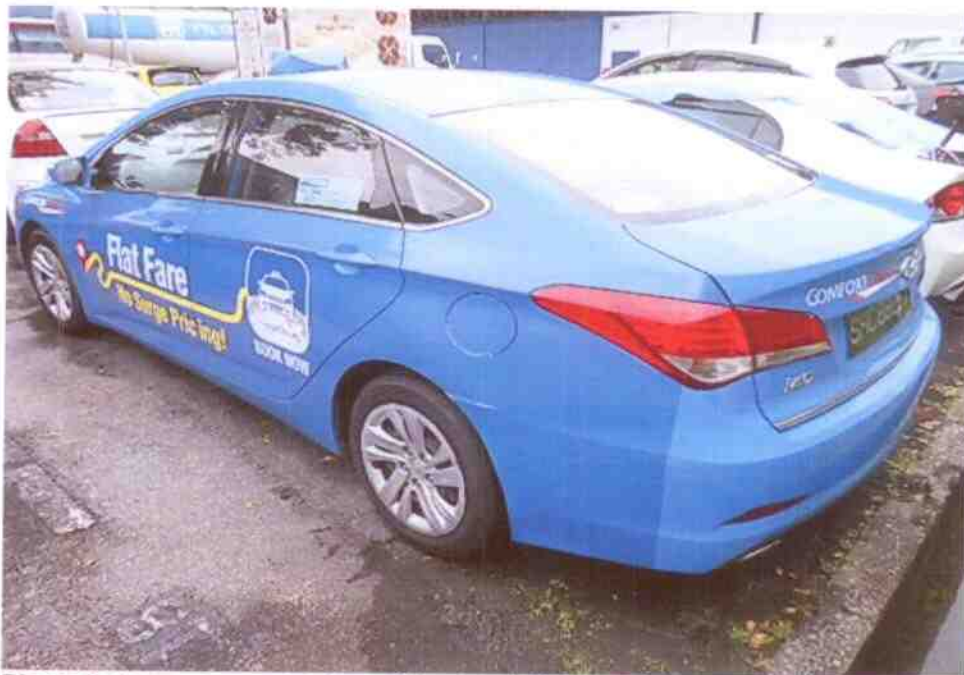
Photo 6 shows a general view of the rear left body of the Motor Taxi at the time of our inspection. The Motor Taxi was observed to be in good general condition.

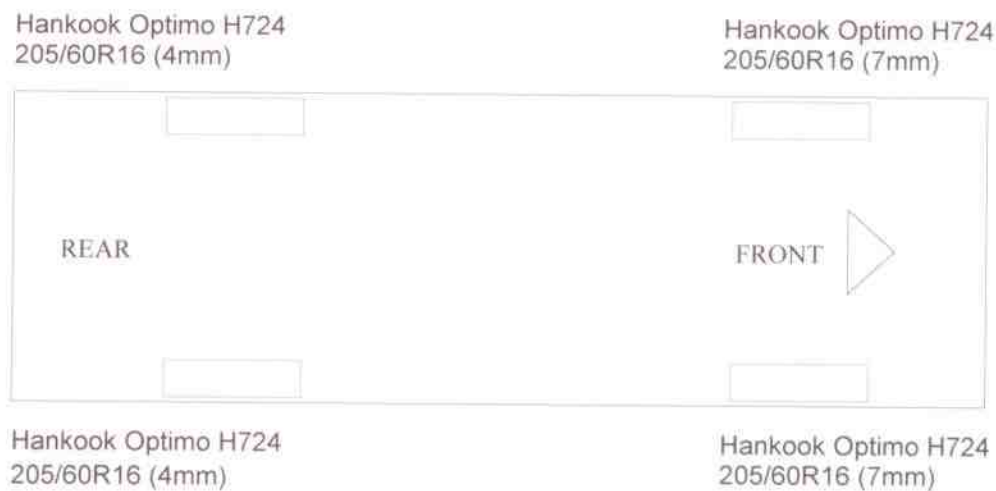
6. The condition of the Motor Taxi's 4 tyres was observed to be in serviceable condition. We did not find any tear, cut or burst mark(s) on the outer and the inner sidewalls as well as across the tread of the 4 tyres. The 4 tyres were also observed to be sufficiently inflated for vehicular operation. The tyre brand, tyre size and remaining tread depth of the 4 tyres were recorded as follows:-

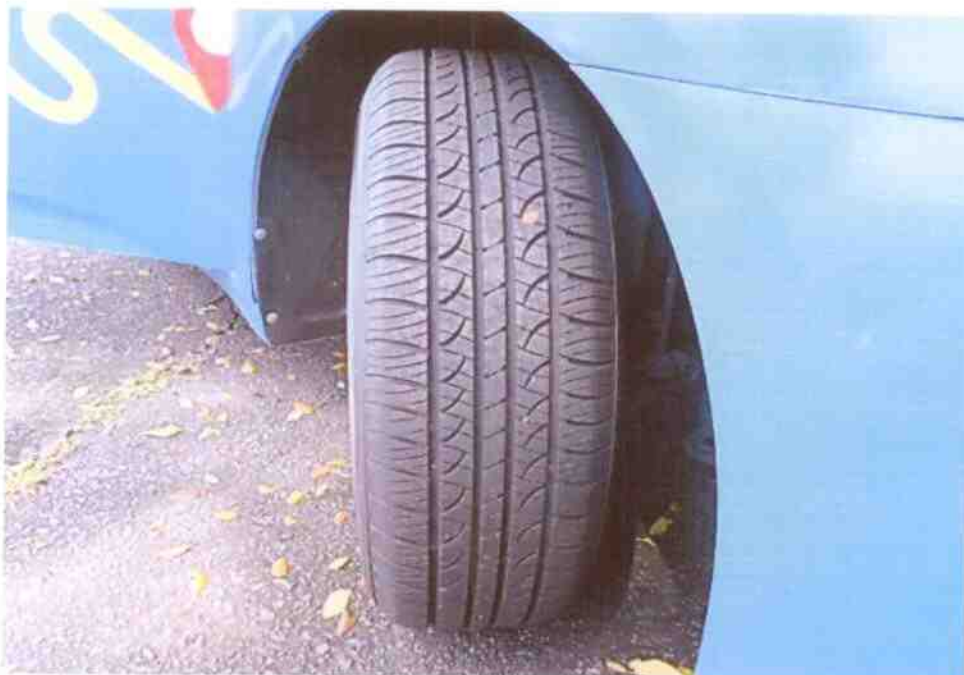
Photo 7 shows the condition of the front right tyre of the Motor Taxi, which was observed to be in serviceable condition with remaining tread depth of approximately 7mm. There was no tear, cut or burst mark(s) on the outer and the inner sidewalls.

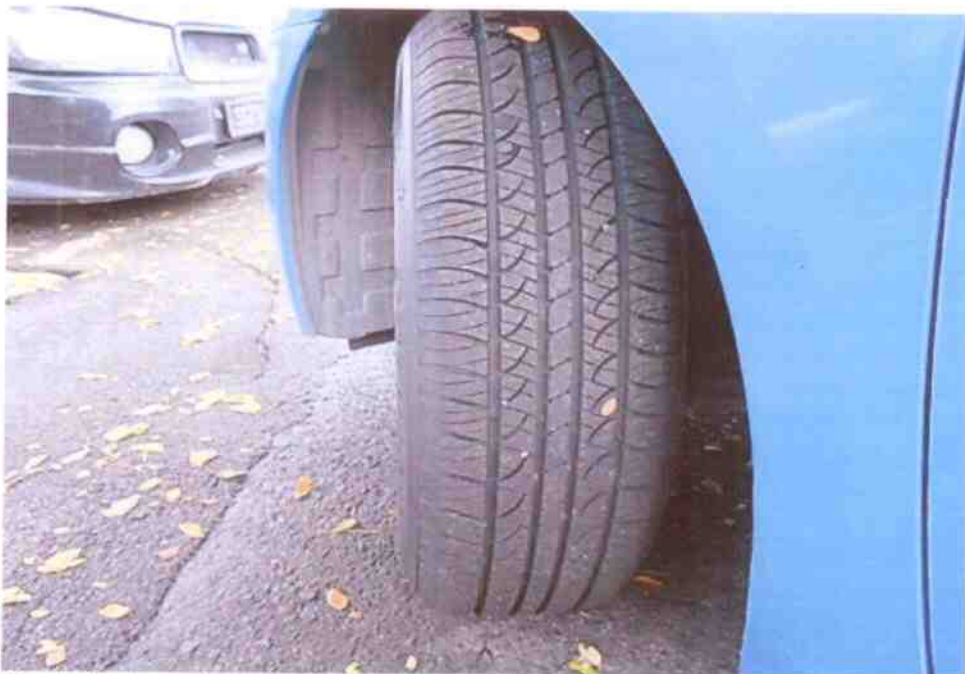
Photo 8 shows the condition of the front left tyre of the Motor Taxi, which was observed to be in serviceable condition with remaining tread depth of approximately 7mm. The tyre, which was wrapped around alloy wheel rim, was also observed to be sufficiently inflated for vehicular operation.

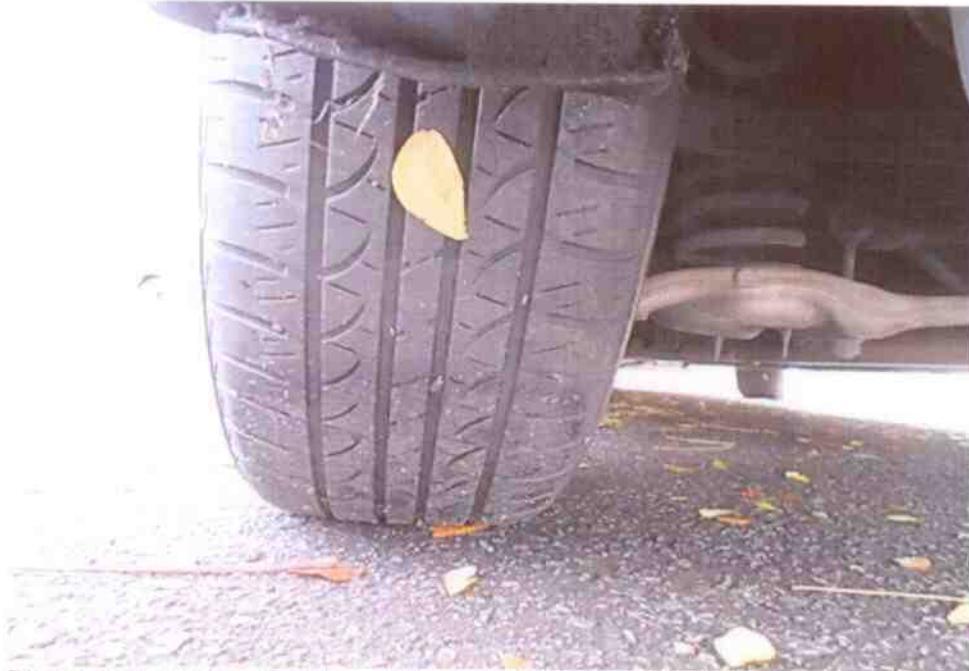
Photo 9 shows the condition of the rear left tyre of the Motor Taxi, which was observed to be in serviceable condition with remaining tread depth of approximately 4mm.

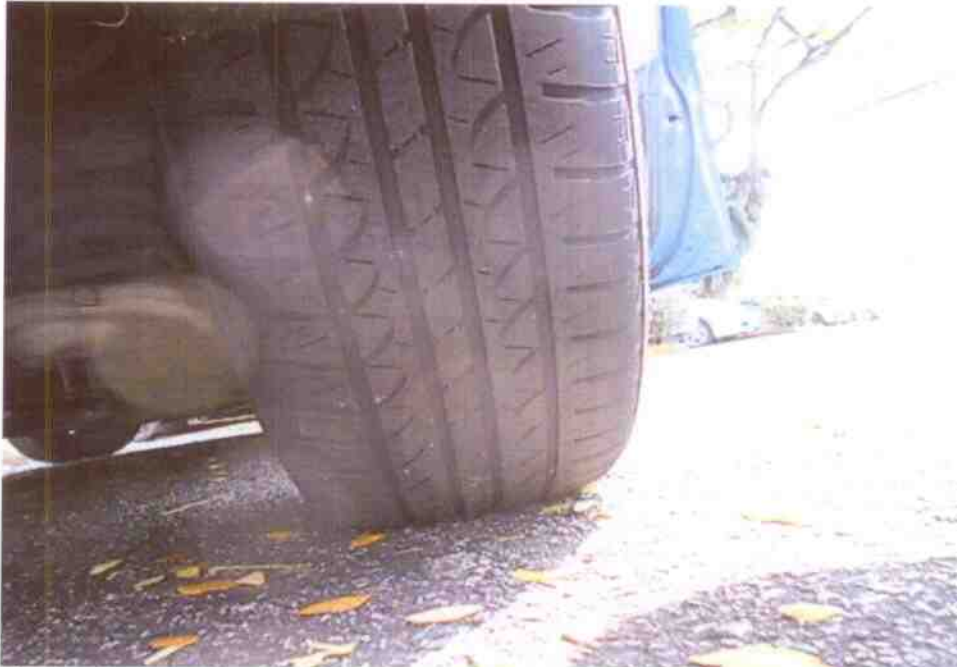
Photo 10 shows the condition of the rear right tyre of the Motor Taxi, which was observed to be in serviceable condition with remaining tread depth of approximately 4mm.

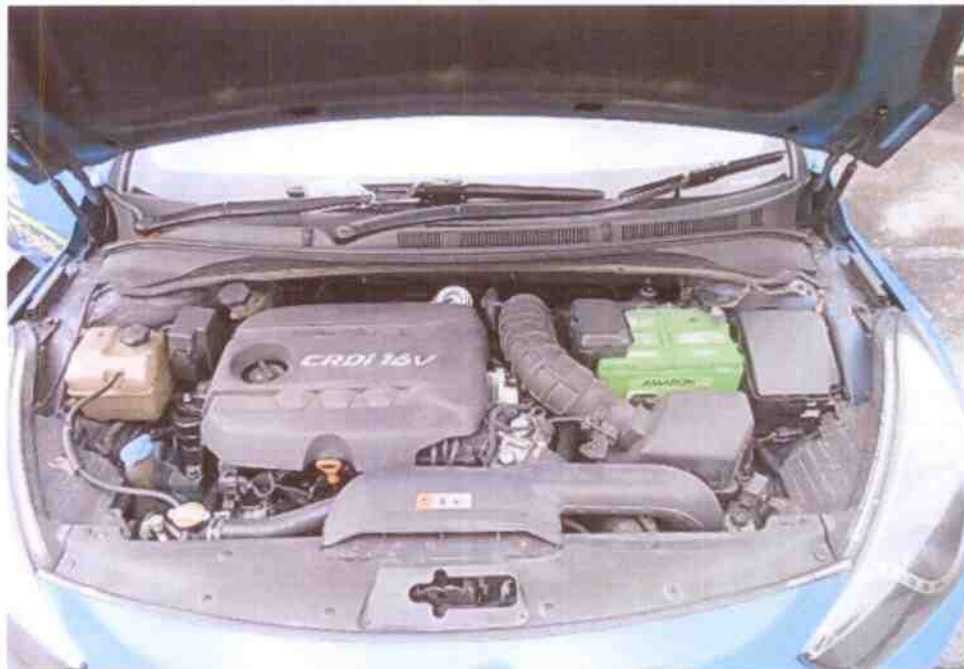
Photo 11 shows a general view of the Motor Car's engine compartment. The various parts and components inside the engine compartment were unaffected by the accident. There was also no sign(s) or indication(s) of fluid leakage and/or fluid stain within the engine compartment.

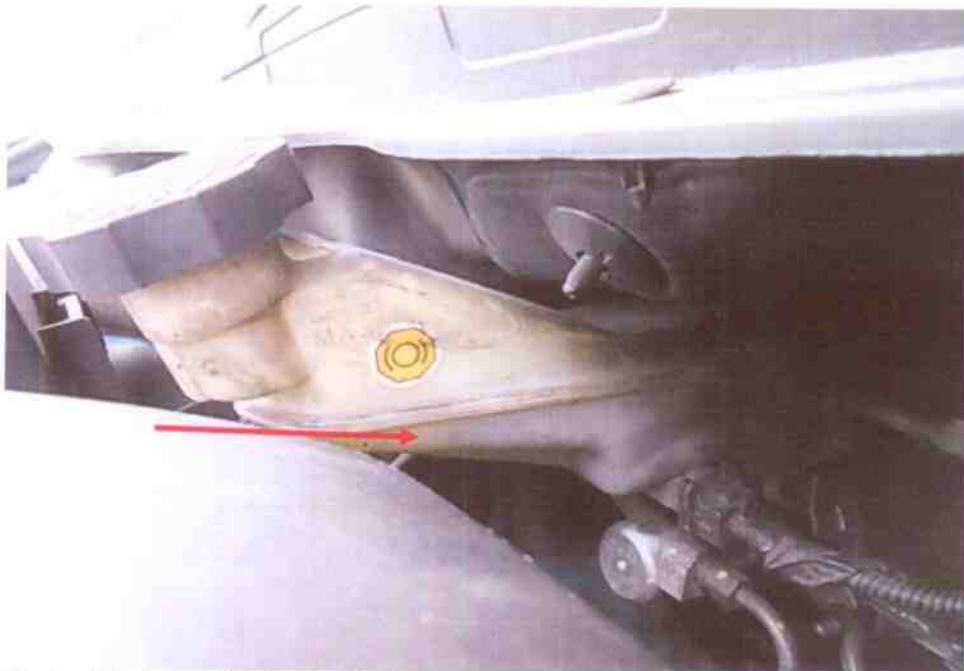
Photo 12 shows the brake fluid reservoir of the Motor Taxi at the time of our inspection. The brake fluid was observed to be of sufficient level (arrowed) and without any visible contamination.

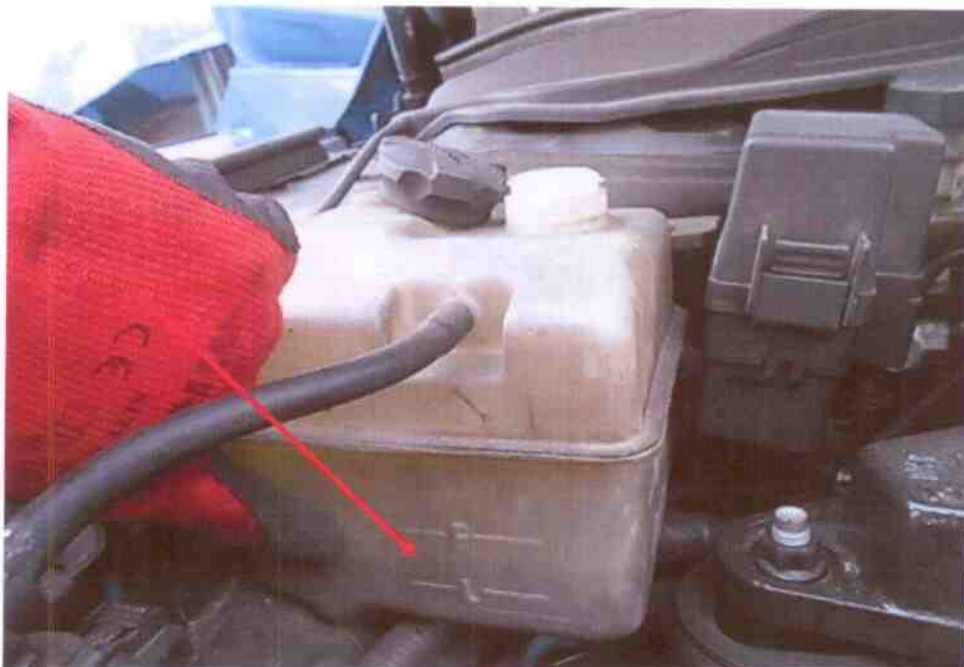
Photo 13 shows the engine coolant fluid reservoir of the Motor Taxi at the time of our inspection. The engine coolant fluid was observed to be of sufficient level and without any visible contamination.

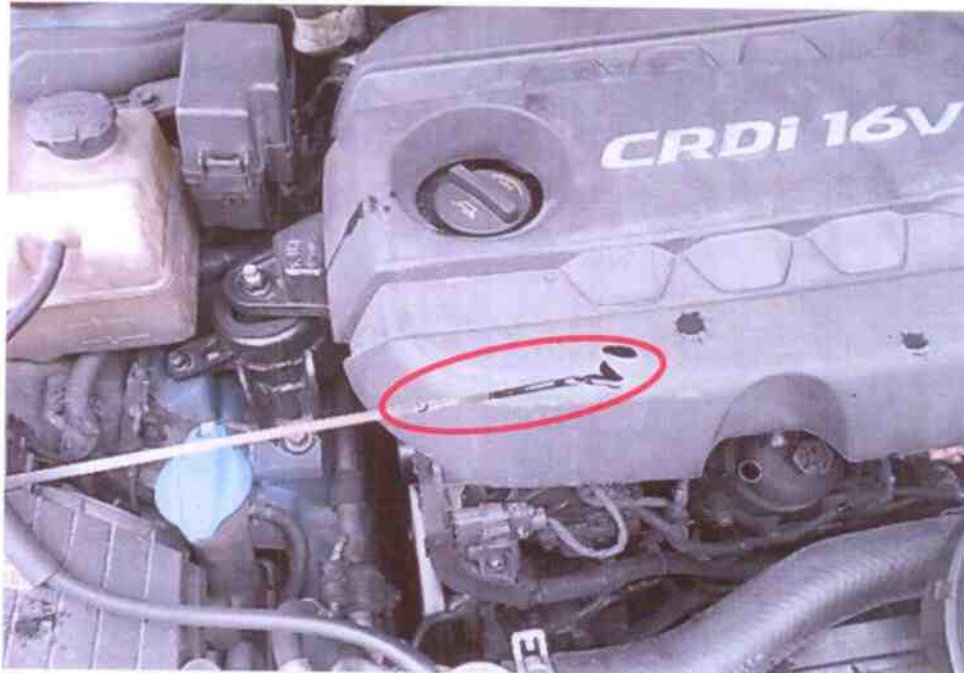
Photo 14 shows the engine oil dip stick of the Motor Taxi at the time of our inspection. The engine oil was observed to be of sufficient level and without any visible contamination.

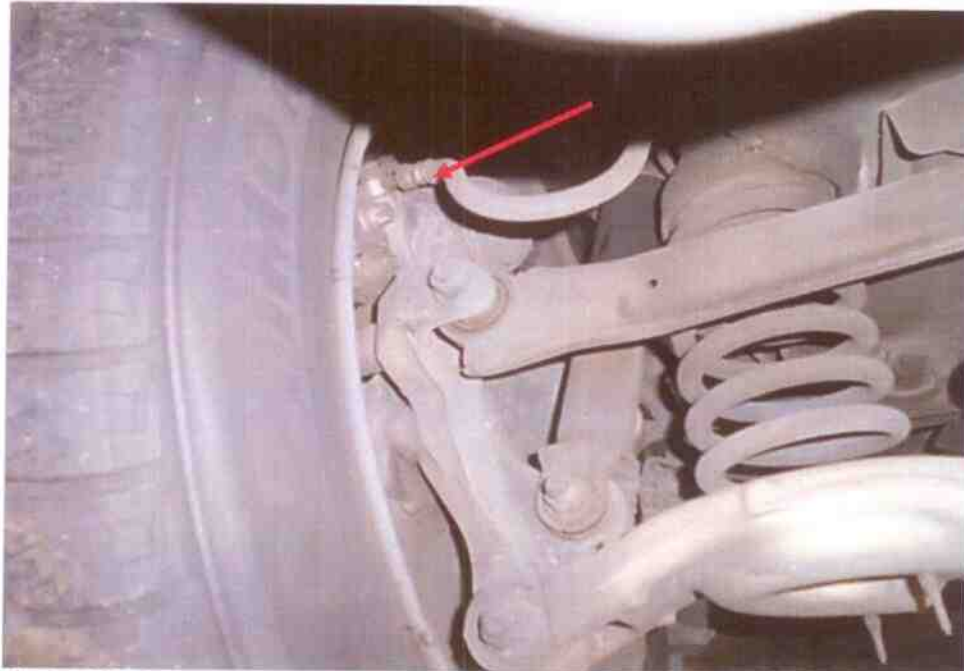
Photo 15 shows the brake hose (arrowed) at the rear left wheel of the Motor Taxi. We did not observe any leakage of brake fluid at the time of our inspection of the Motor Taxi. Our visual inspection of the various mechanical components of the Motor Taxi's braking system revealed all to be intact without visible damage.

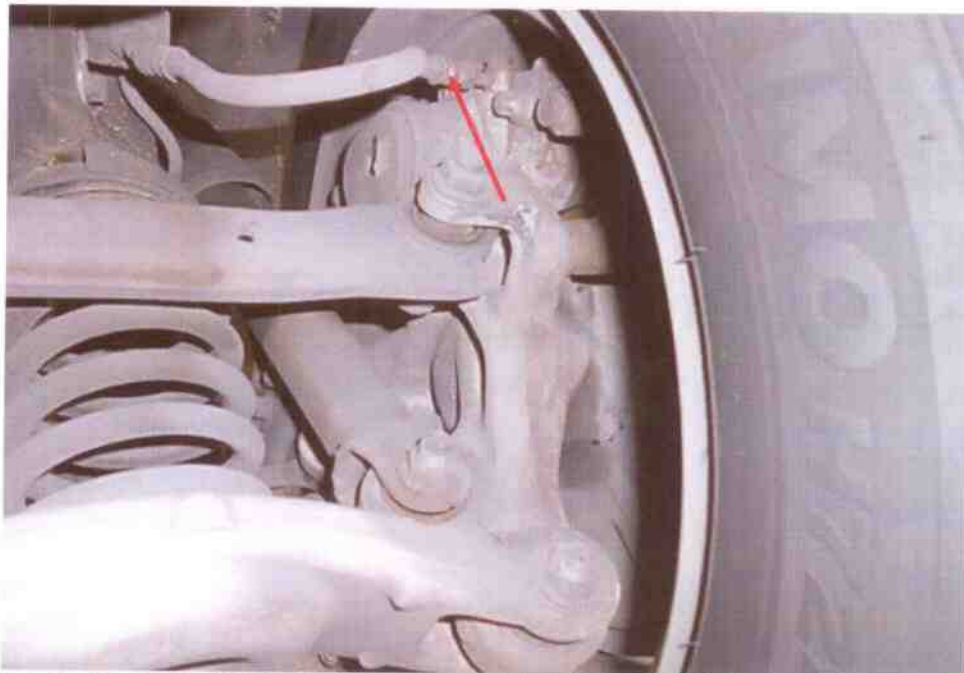
Photo 16 shows the brake hose (arrowed) at the rear right wheel of the Motor Taxi. We did not observe any leakage of brake fluid at the time of our inspection of the Motor Taxi. Our visual inspection of the various mechanical components of the Motor Taxi's braking system revealed all to be intact without visible damage.

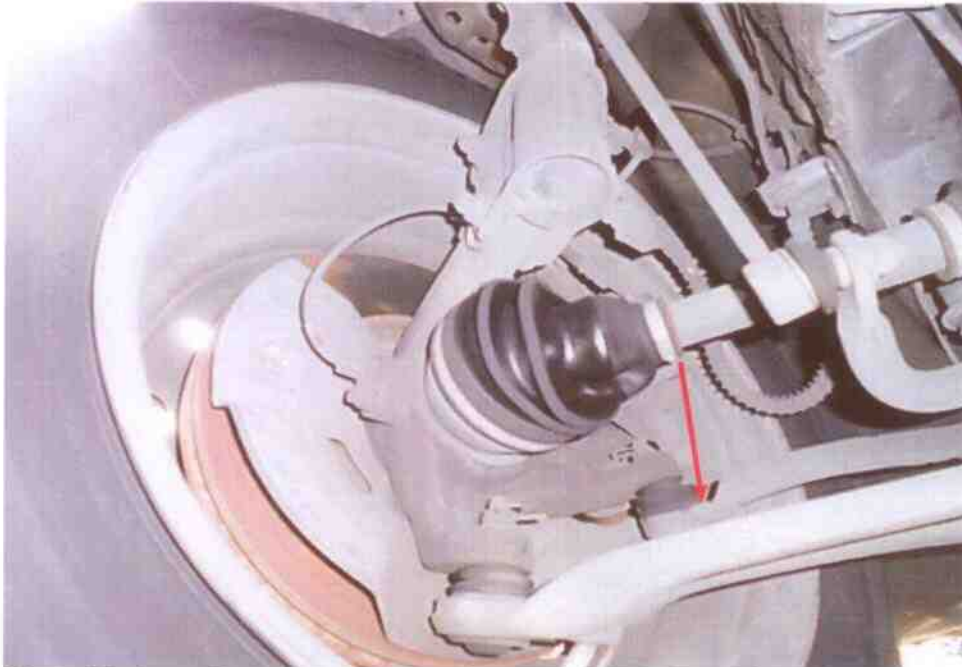
Photo 17 shows the various undercarriage components at the front right wheel of the Motor Taxi, in particular the steering tie rod (arrowed). The various steering components were all found to be intact, suggesting that the steering system of the Motor Taxi was likely to be in serviceable condition.

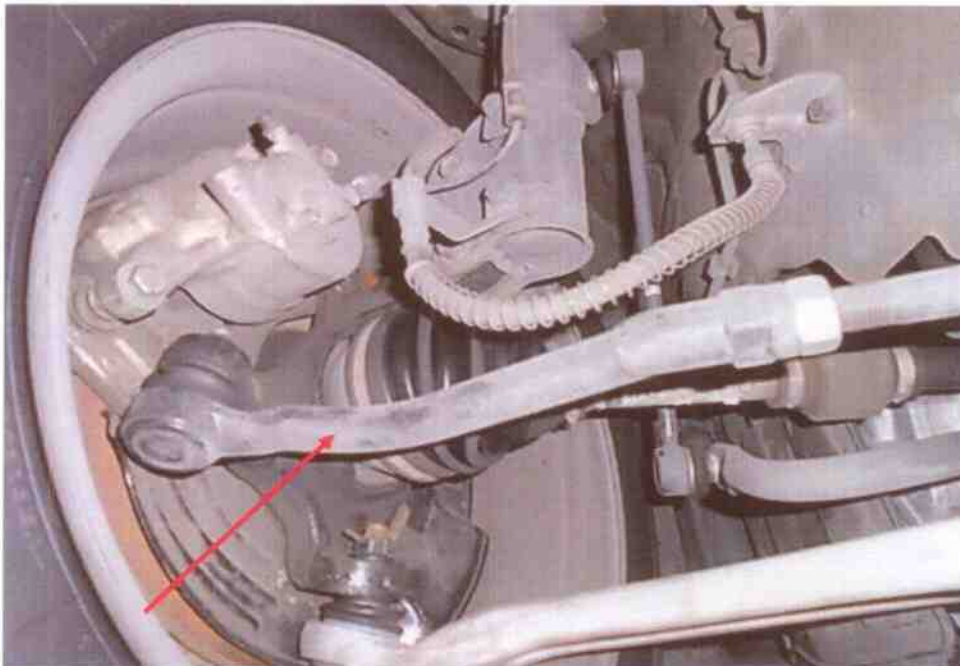
Photo 18 shows the various undercarriage components at the front left wheel of the Motor Taxi. We did not observe any leakage of brake fluid (arrowed) at the time of our inspection of the Motor Taxi. Our visual inspection of the various mechanical components of the Motor Taxi's braking system revealed all to be intact and without visible damage, indicating that the braking system was likely to be in serviceable condition at the material time of accident.

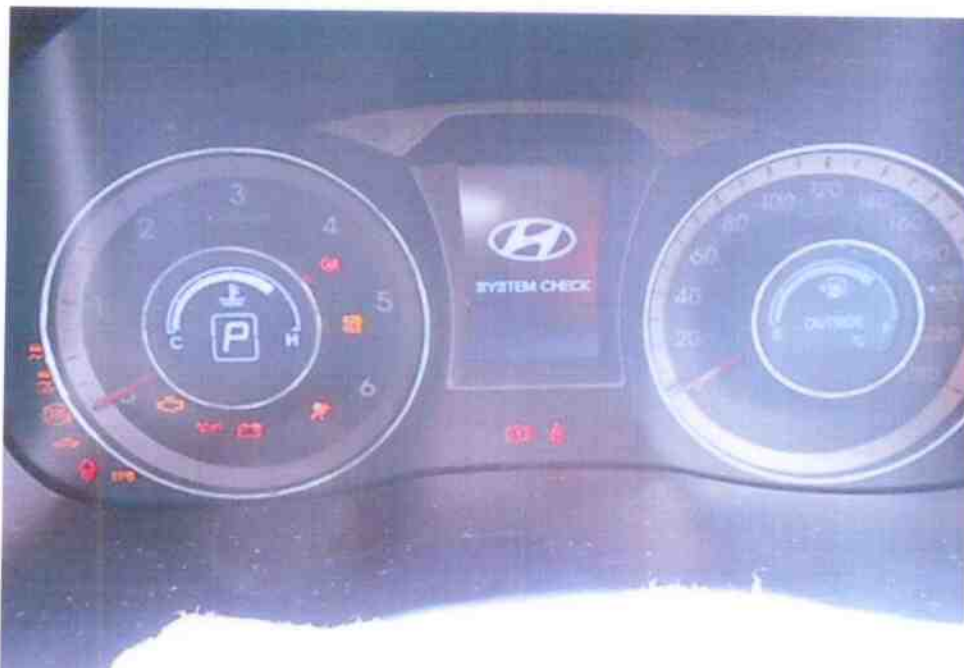
Photo 19 shows the warning lights for the various electronic operating systems of the Motor Taxi appearing on its instrument panel during the self-test when the engine is cranked, in particular the ABS light and SRS light.

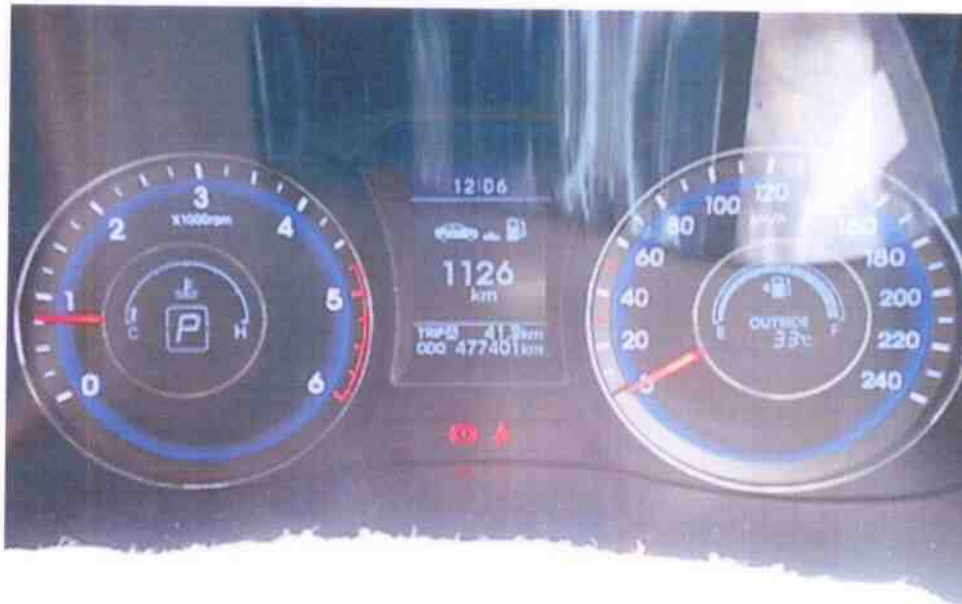
Photo 20 shows no warning lights illuminated on the instrument panel of the Motor Taxi after the engine was cranked. This would suggest that there was no abnormality to the various electronic operating systems of the Motor Taxi, like the ABS and SRS.
