Your Ref: 8771463315SG
Our Ref :CC3/AIG17023077/D

18 December 2017

**TECHNICAL INVESTIGATION REPORT OF FIRE INCIDENT INVOLVING THE
INSURED VEHICLE SKB 3988P ON 01 DECEMBER 2017**

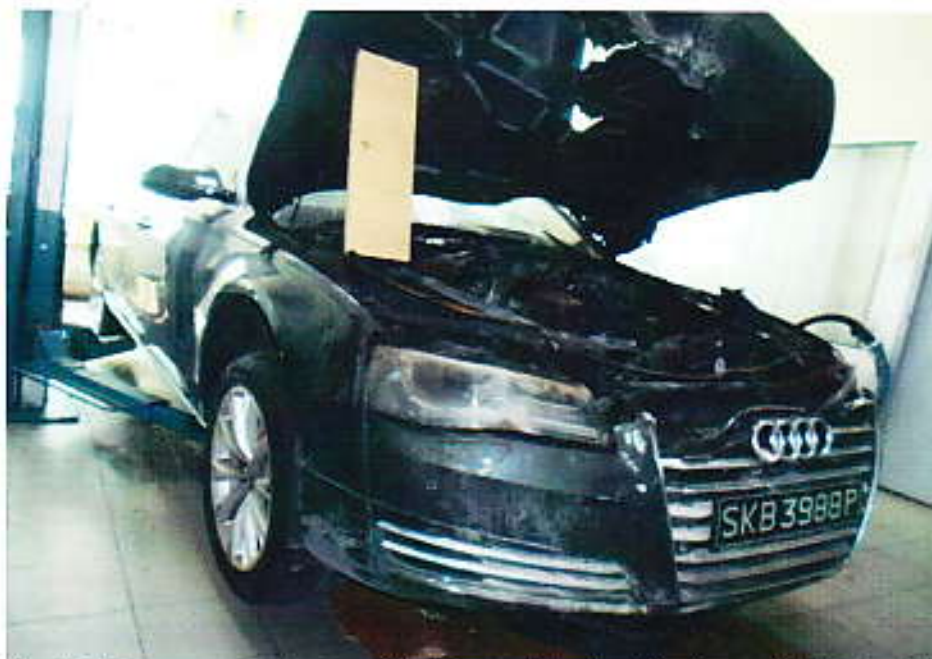
Photo 1 shows a general view of the front right body of the Insured Vehicle at the time of inspection. The Insured Vehicle was observed to be severely burnt at its front body. Its front bumper, front bonnet, front grille, front right headlamp and front right fender were amongst the body parts that were found to have been affected as a result of the fire.

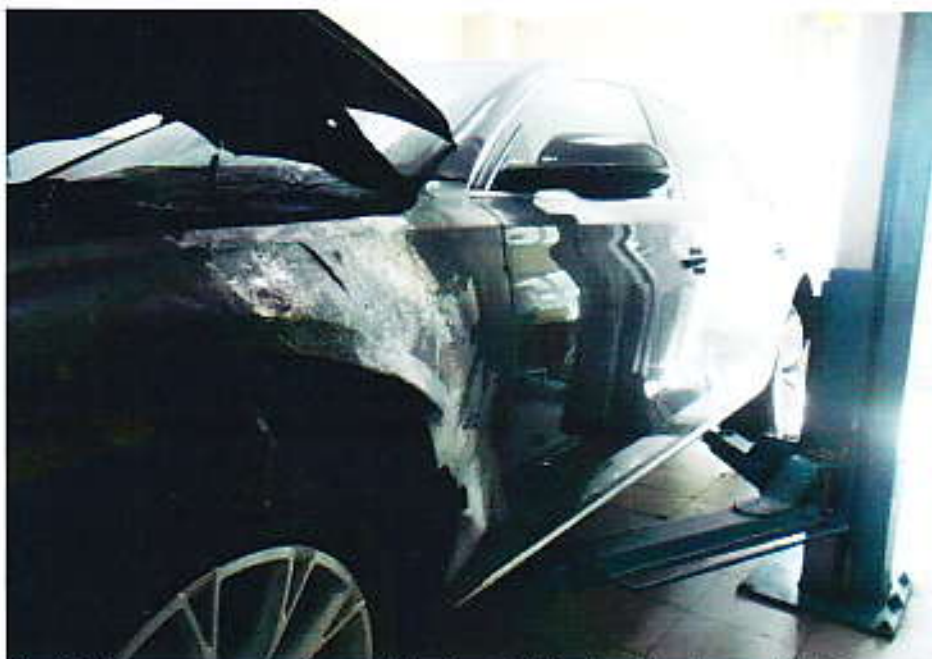
Photo 2 shows a general view of the front left body of the Insured Vehicle at the time of inspection. The Insured Vehicle was observed to be severely burnt at its front body. Its front left fender, front left wheel rim, front left tyre, front bonnet and front windscreen were amongst the body parts that were found to have been burnt and/or melted as a result of the fire.

19. For this case, the burnt pattern of the Insured Vehicle suggest that the fire had originated at the left rear area of its engine compartment. This can be established by the whitish burn marks found on the front left fender, at the area nearer to the front left door of the Insured Vehicle (refer to photograph 2 above). These whitish burn marks are a result of exposure to high heat intensity and can normally be used to indicate where a vehicle fire had originated. As can be seen from the photographs and videos, flames were correspondingly concentrated at the area towards the back of the front left wheel of the Insured Vehicle.

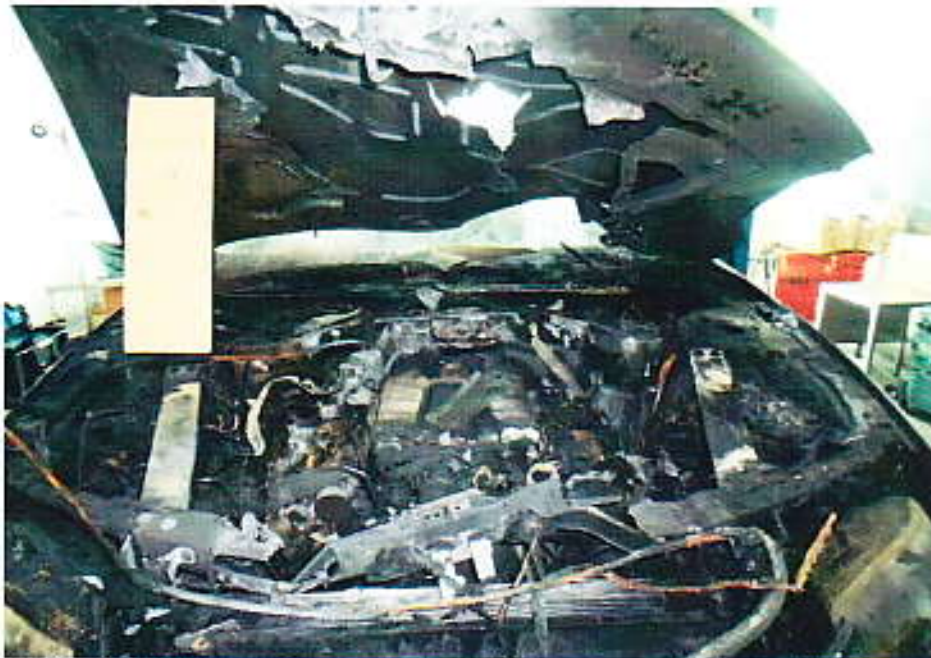
Photo 3 shows the engine compartment of the Insured Vehicle at the time of inspection. Almost all the parts inside the engine area were observed to be burnt and/or melted as a result of the fire. These parts had included its radiator, air condenser, cooling fan, intake manifold, front bonnet absorbers, air duct, hoses and pipes amongst others.

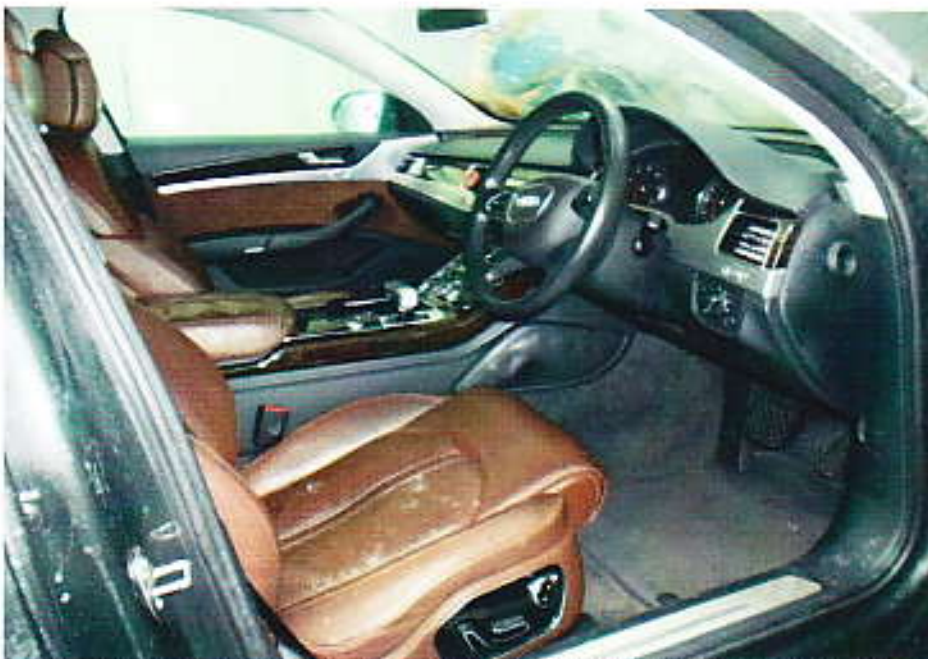
Photo 4 shows the interior compartment of the Insured Vehicle at the time of inspection. The interior compartment and rear body of the Insured Vehicle was unaffected by the fire.

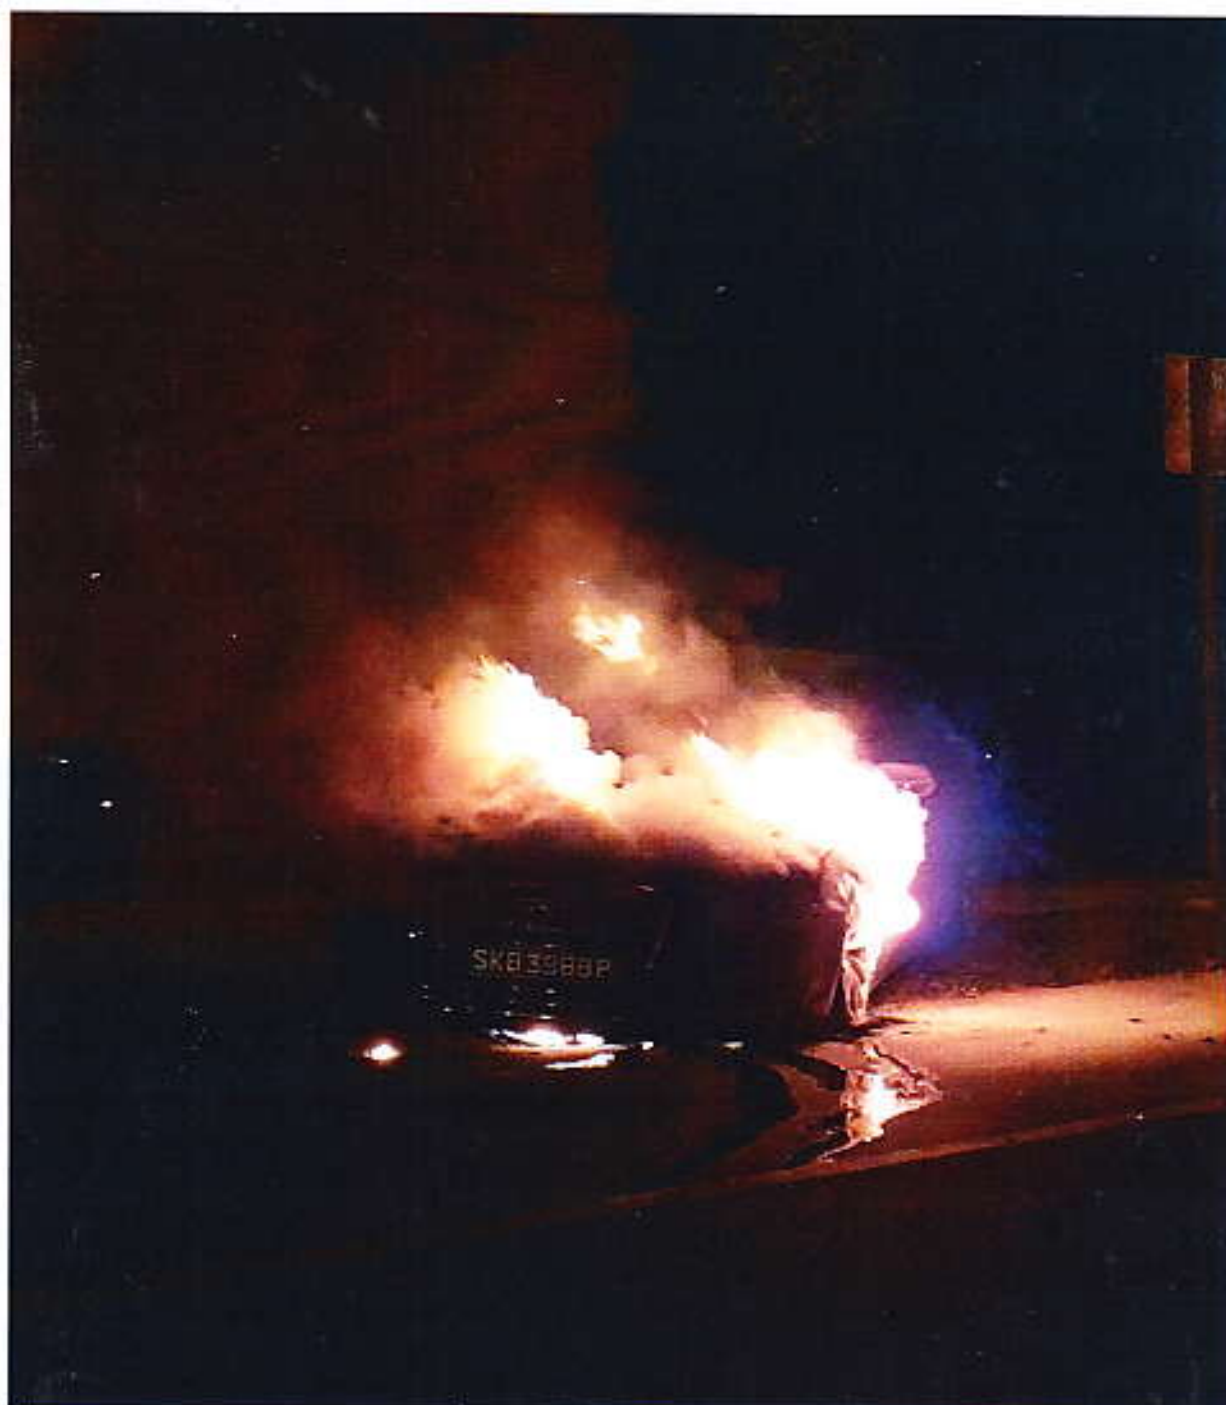
18. Upon further examination of the photographs and videos, I had also noted that there was no unusual foreign material(s) and/or object(s) on the ground in the immediate area of where the Insured Vehicle was parked. I did however observed fluid trails on the ground, beneath the front left side and in front of the Insured Vehicle. These fluids were likely leakage from the engine compartment of the Insured Vehicle but however were not the source of fire ignition given that the fluid was not combusted. See photo 5 & 6 below.

Photo 5 shows the Insured Vehicle at the incident scene with flames engulfing its left front body. Trails of fluid could be seen on the ground beneath the front left side, and in front of the Insured Vehicle. These leaked fluid were unlikely the source of fire as the fluid were not combusted. There was also no unusual foreign material(s) and/or object(s) on the ground in the immediate area of where the Insured Vehicle was parked.

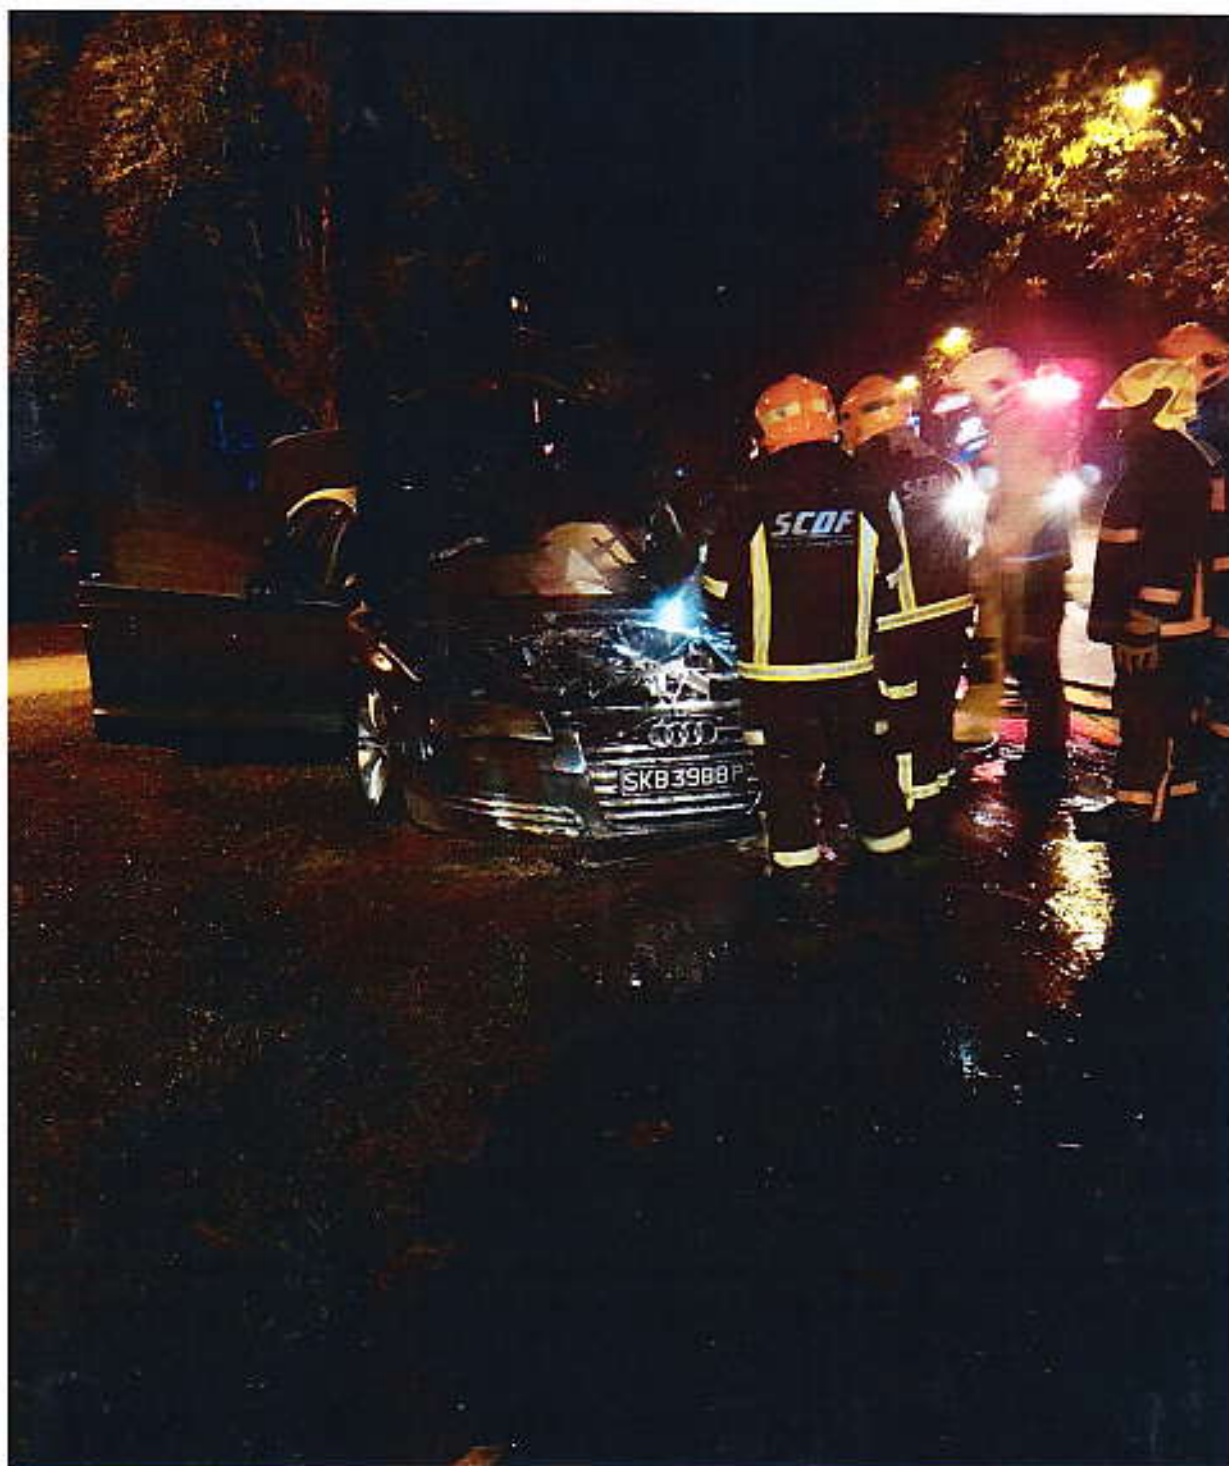
17. The photographs and videos provided to me had showed the Insured Vehicle with flames mainly engulfing its front left side. SCDF officers were seen examining the left side of the engine compartment after the fire was extinguished. This appears to correspond to the location (front left side of the Insured Vehicle) where smoke was first detected by the driver of the Insured Vehicle, and also where flames were first seen by another driver.

Photo 6 shows the Insured Vehicle at the incident scene after the fire was extinguished. SCDF officers could be seen examining the left side of the engine compartment. The left front side of the Insured Vehicle was where smoke was first detected by the driver of the Insured Vehicle and also where flames were first seen by another driver

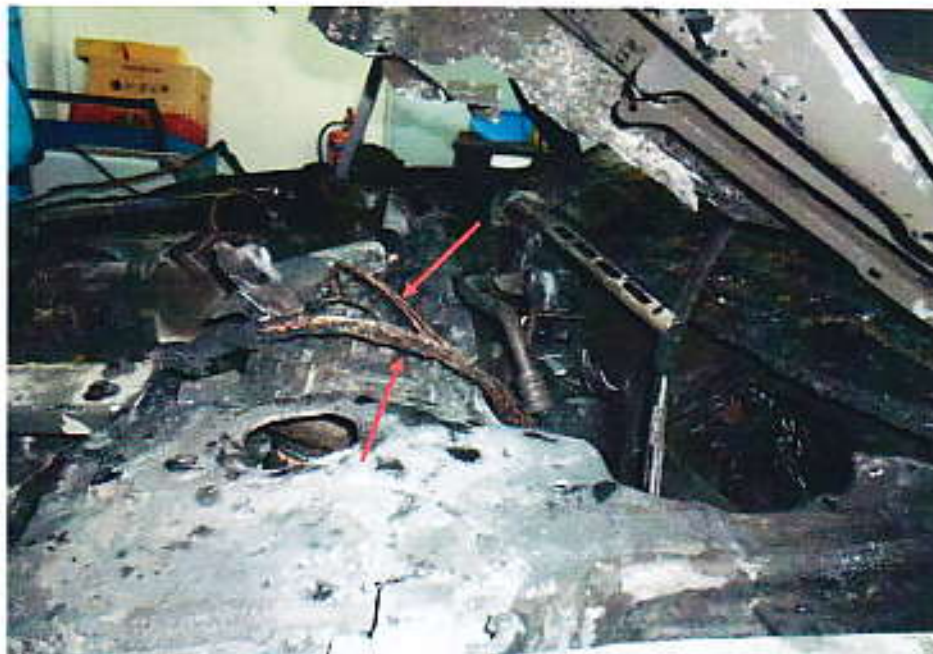
20. My examination of the left rear area of the engine compartment during my inspection of the Insured Vehicle revealed wirings that were completely burned to its copper state. The wirings were likely to be original wire harnesses of the Insured Vehicle. The bright reddish colour of the copper wires suggest that the wirings were exposed to high heat. Such condition normally indicate internal heating of copper wires which is a sign of an electrical short circuit occurring. This would then appear to suggest that the cause of fire to the Insured Vehicle could have possibly been due to electrical in nature. See photo 7 – 9 below,

Photo 7 shows the wirings at the left rear area of the Insured Vehicle's engine compartment. The wirings (arrowed) were found to be completely burned to its bare copper state. The bright reddish colour of the copper wires suggest that the wirings were exposed to high heat. Such condition normally indicate internal heating of copper wires which is a sign of an electrical short circuit occurring. The wires were likely to be original wire harnesses of the Insured Vehicle.

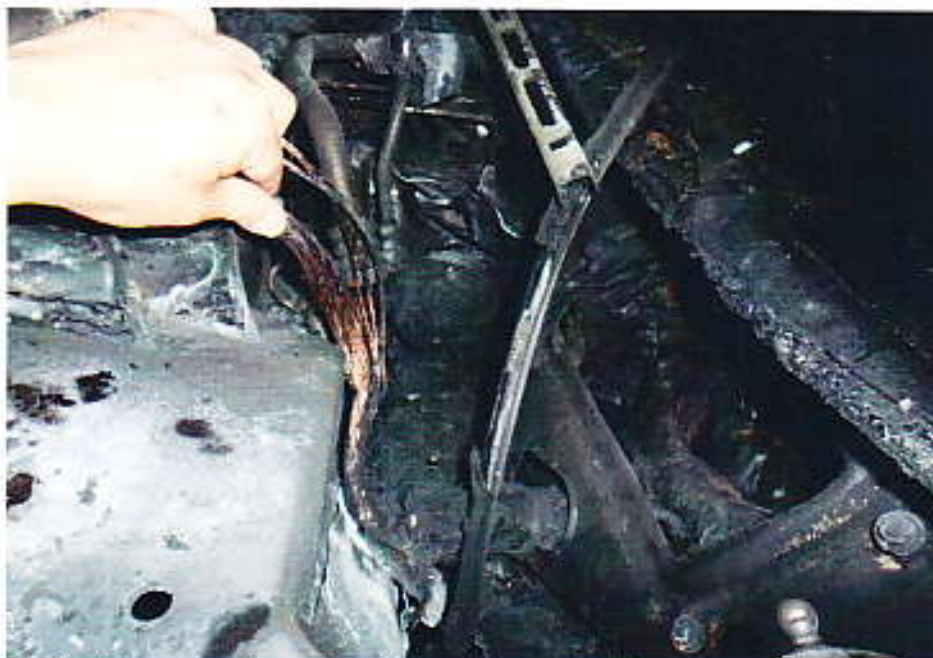
Photo 8 shows a closer view of the wirings at the left rear area of the Insured Vehicle's engine compartment. The wirings were found to be completely burned to its bare copper state. Such condition normally indicate internal heating of copper wires which is a sign of an electrical short circuit occurring.

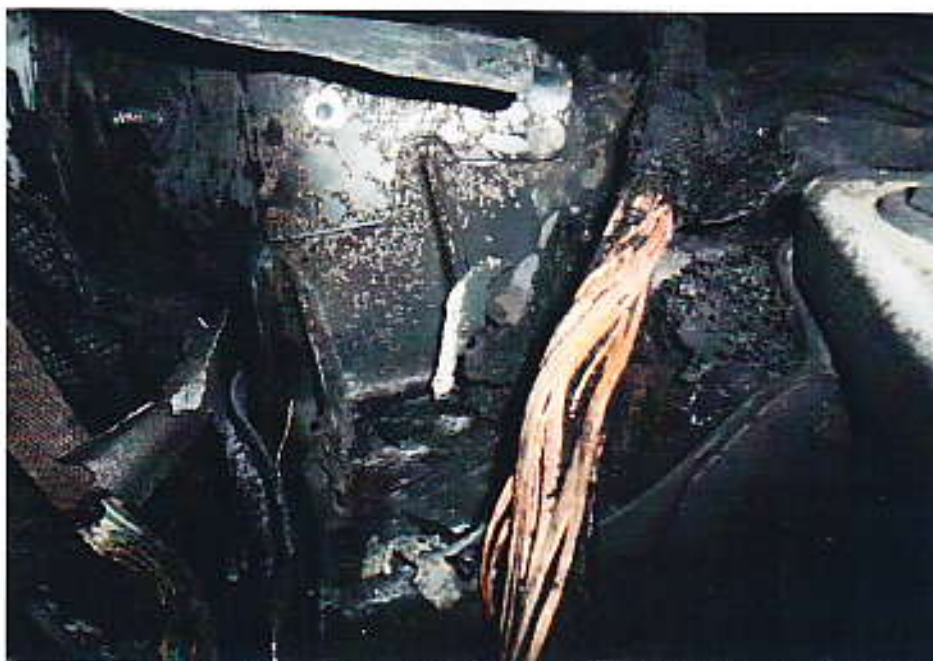
Photo 9 shows a closer view of another stretch of wirings at the left rear area of the Insured Vehicle's engine compartment. The bright reddish colour of the copper wires suggest that the wirings were exposed to high heat. Such condition normally indicate internal heating of copper wires which is a sign of an electrical short circuit occurring. This would then appear to suggest that the cause of fire to the Insured Vehicle could have possibly been due to electrical in nature.
